UNITED STATES DEPARTMENT OF THE INTERIOR  
NATIONAL PARK SERVICE  
**NATIONAL REGISTER OF HISTORIC PLACES  
INVENTORY -- NOMINATION FORM**  
FOR FEDERAL PROPERTIES

The Carriage Paths, Bridges and Gatehouses, Acadia National Park

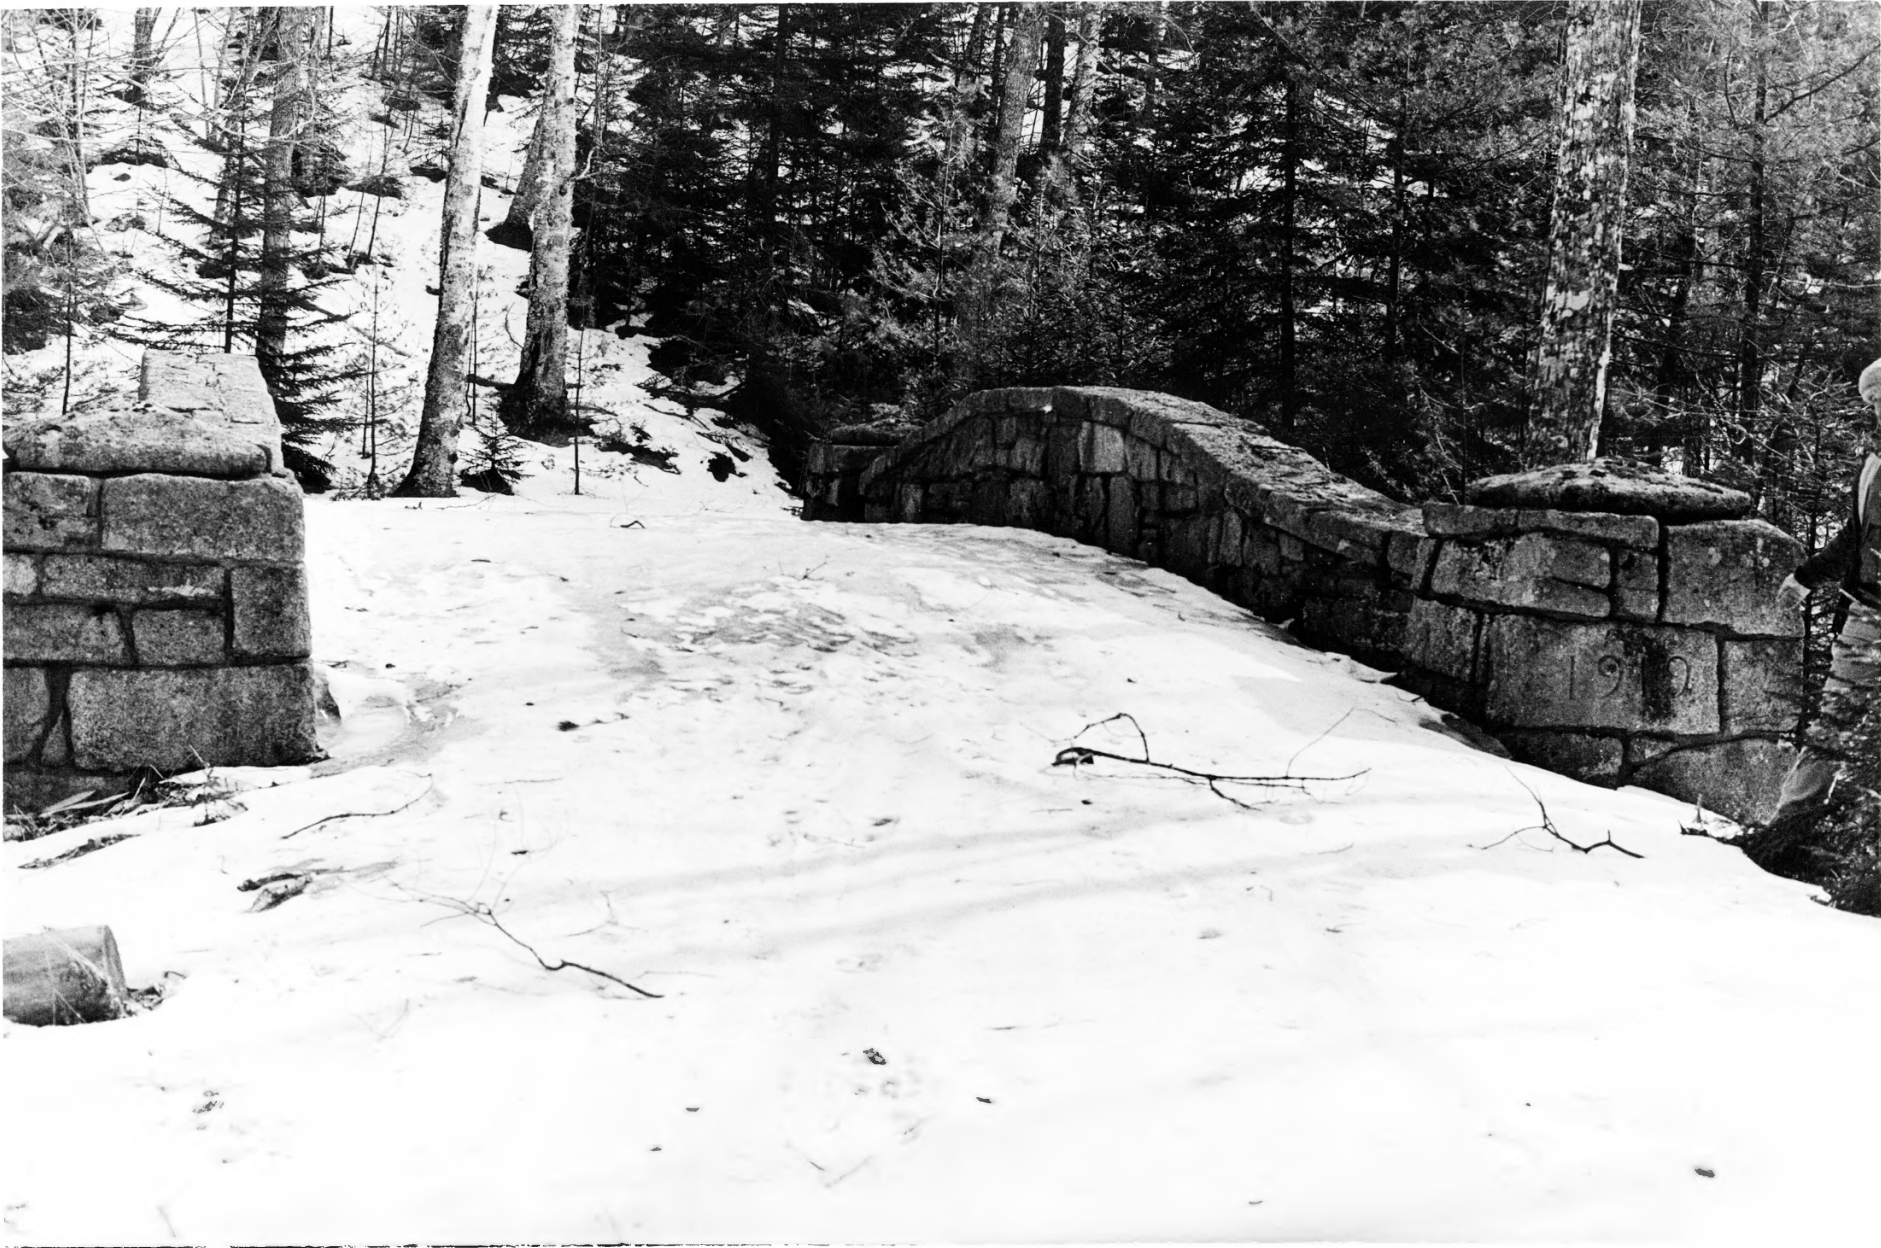
The Small Stone bridge, built in 1919, carries a two lane gravel surfaced carriage path over Little Harbor Brook. The bridge is 40 feet long, relatively shorter than other bridges along the Carriage Paths, and has a main span twenty feet long and a

deck twenty feet wide. The single round arch bridge is faced with random laid ashlar with a stone and mortar substructure.

Little Harbor Brook 1919

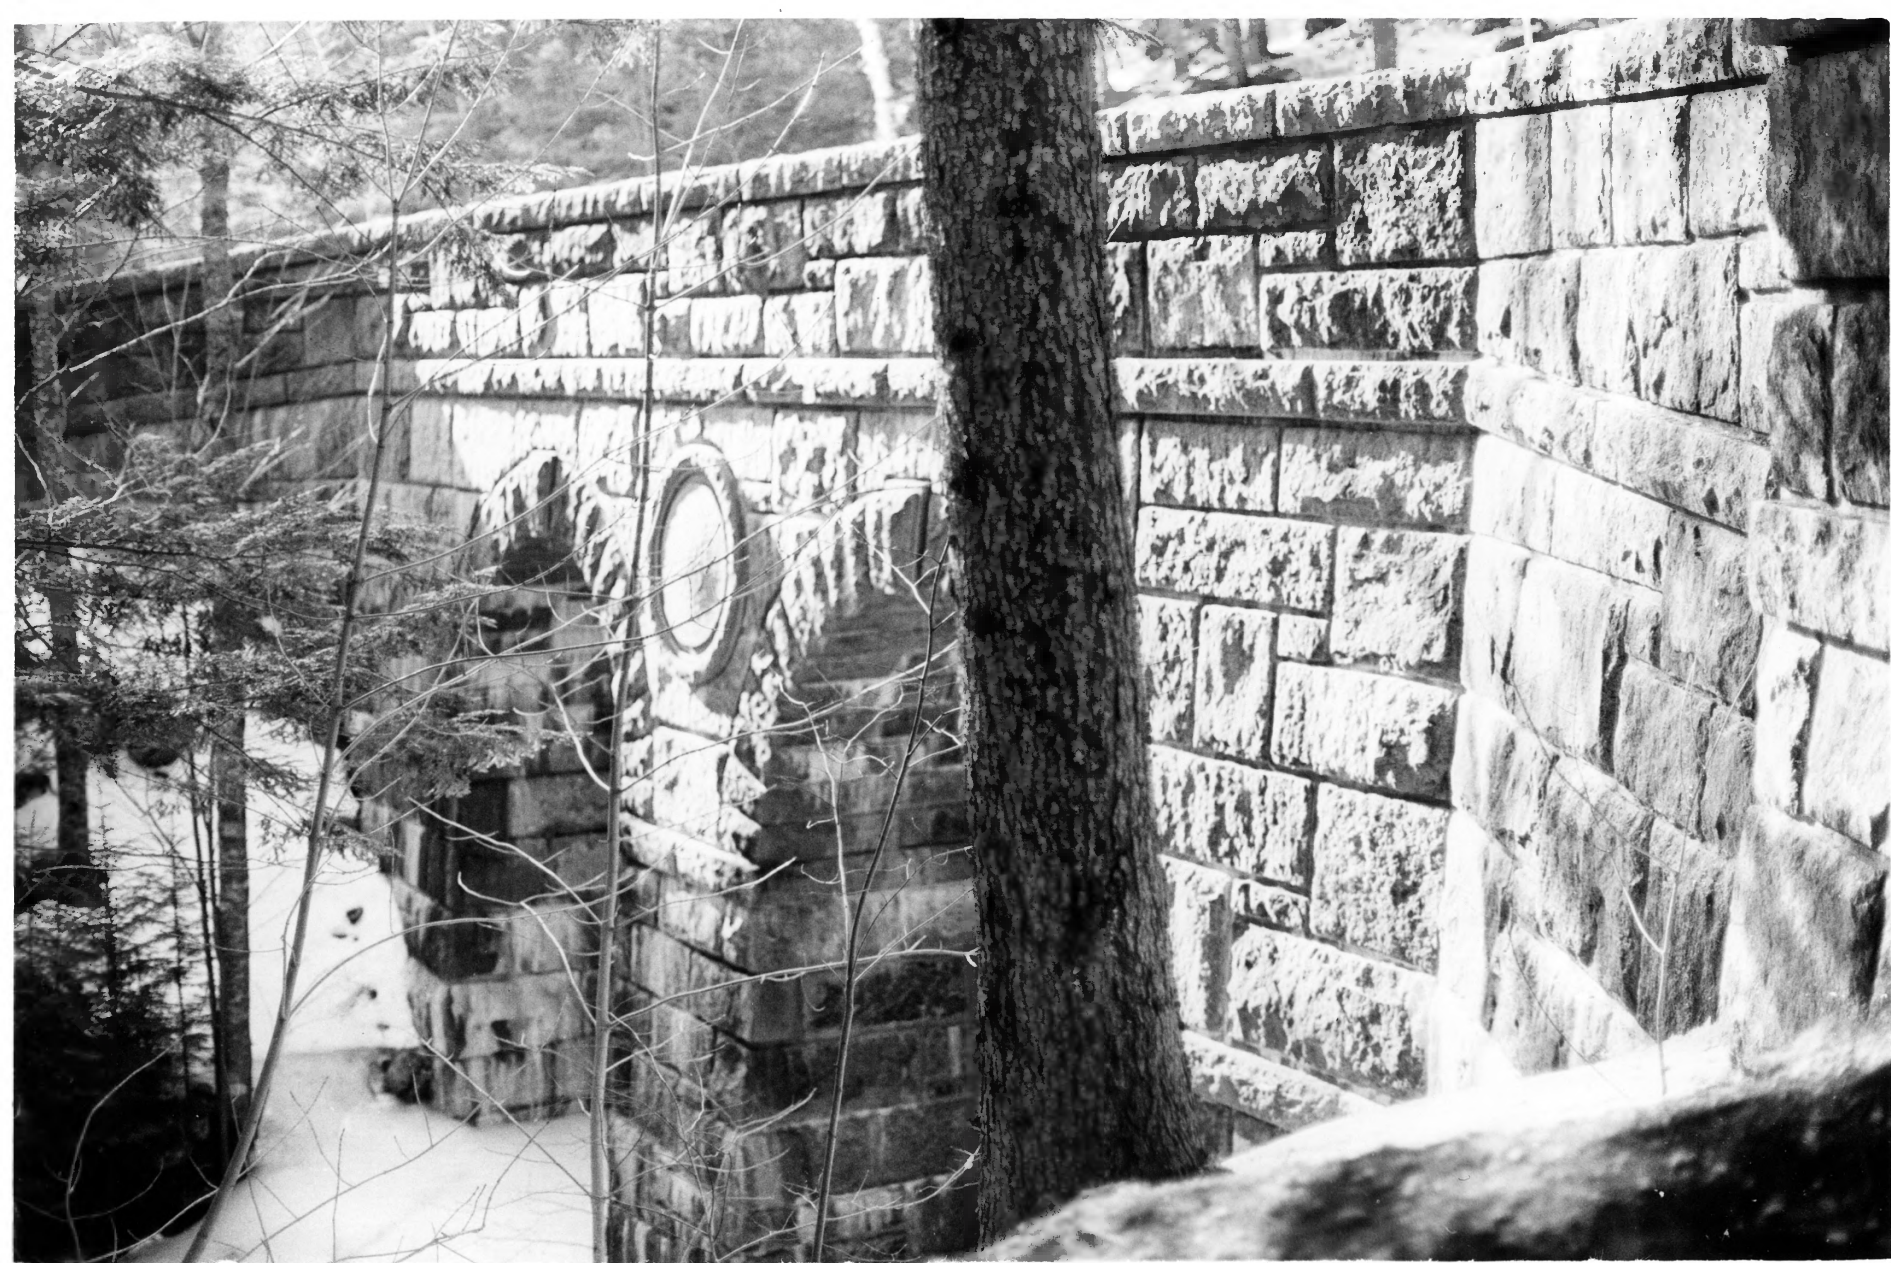
# 138/30

The Deer Brook Bridge, completed in 1925, is a two-lane structure that soars high above its namesake near the Jordan Cliffs. It is 140 foot long, two-lane bridge that has a gravel-surfaced deck and is flared at either end. The two-rounded arches are tall and narrow 8-foot spans, separated by a delicate pier and outlined by slender radiating voussoirs. The entire stone and mortar substructure is clad in quarry-faced random laid ashlar. Set into the spandrel of the arches is a plain, circular medallion into which has been carved the year 1925.

Deer Brook Bridge 1925

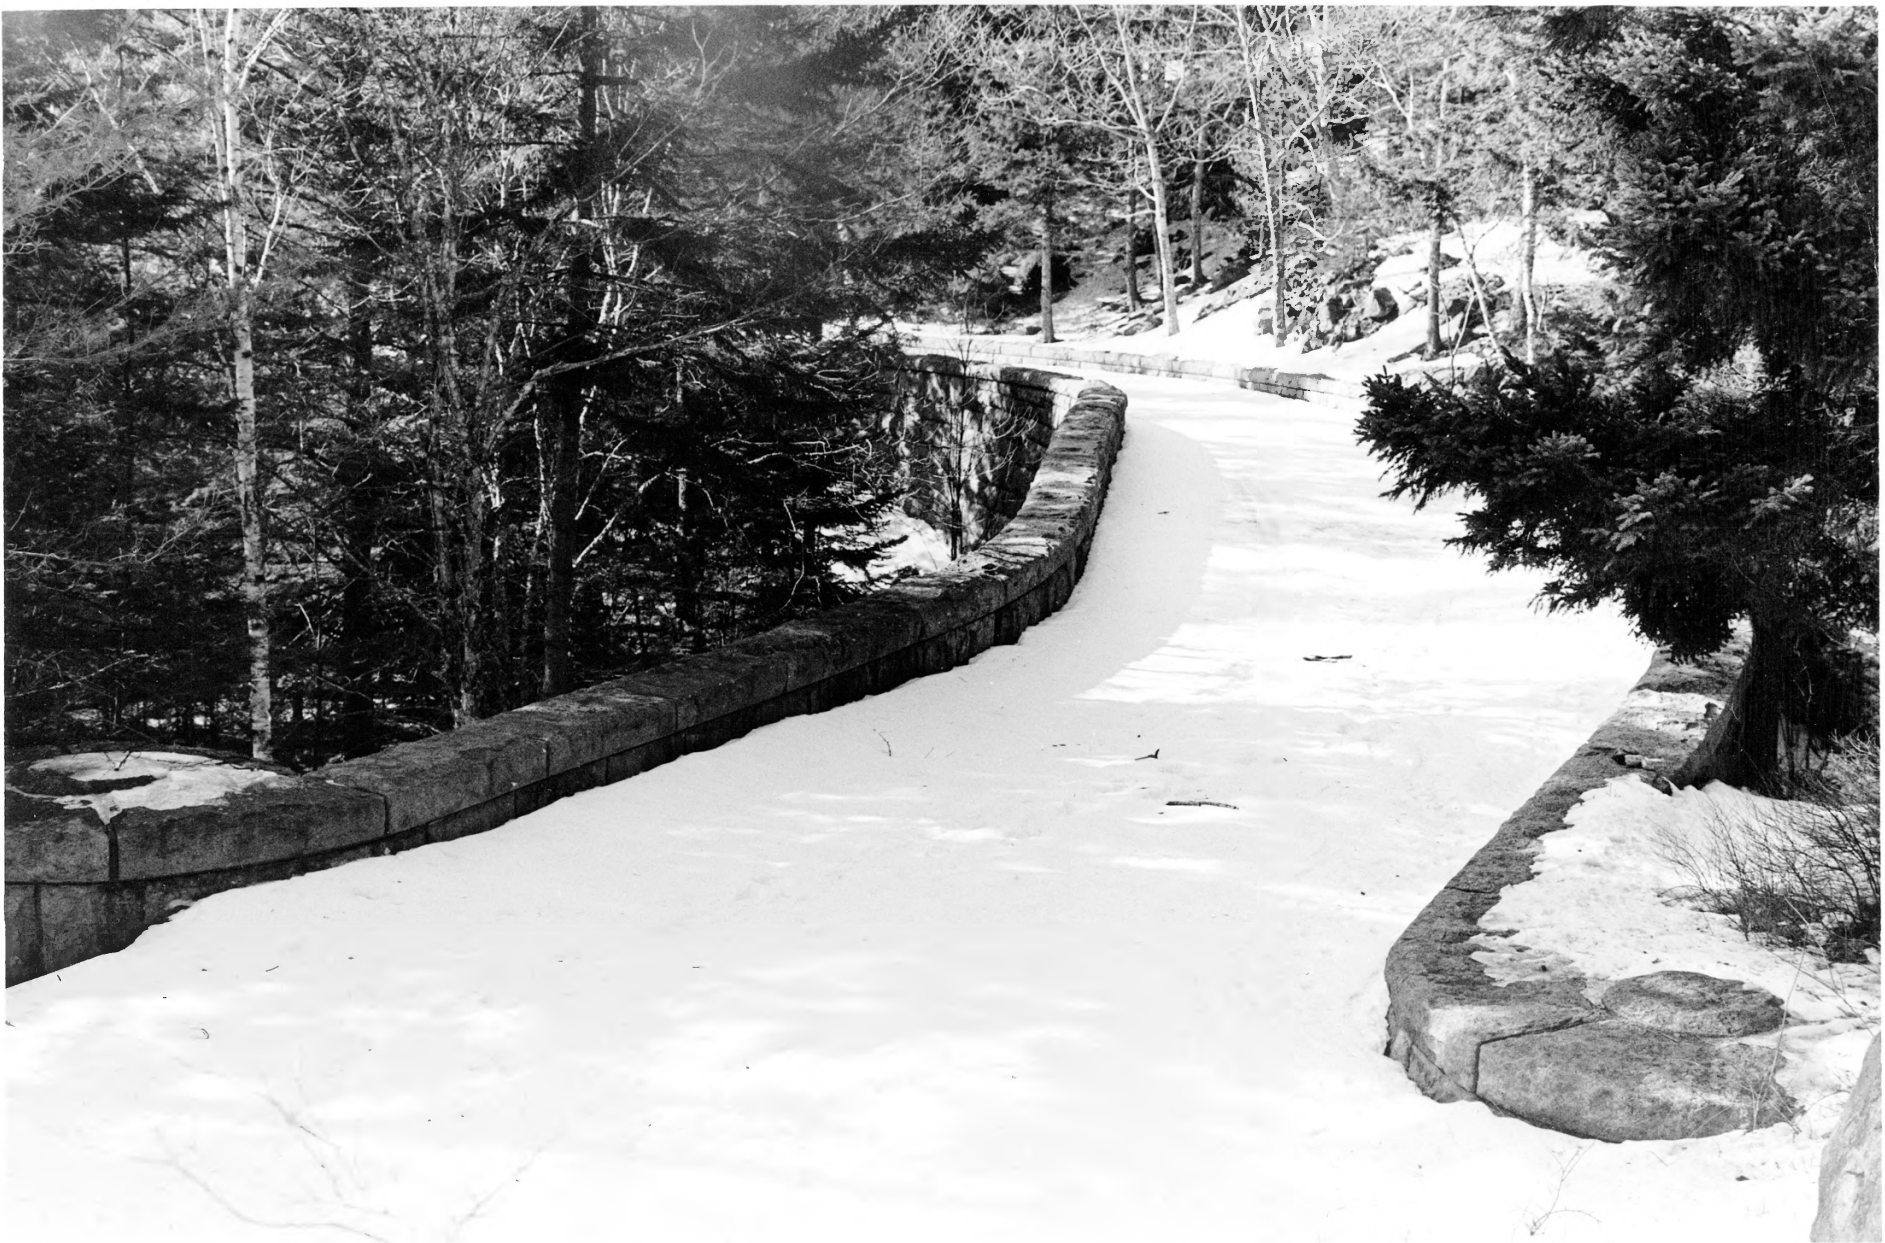
# 14 of 30

The Hemlock Bridge, built in 1925, is a massive Gothic-arched structure crossing Maple Spring Brook. It is a very long 185 feet that curves back sharply in a flare at either end. The Gothic arch span is 30 feet across and is sharply outlined in radiating voussoirs. The stone and mortar substructure is entirely clad in quarry-faced random laid ashlar and the rail coping of large solid square of granite are similarly dressed.

Maple Spring or Hemlock Brook Bridge 1924

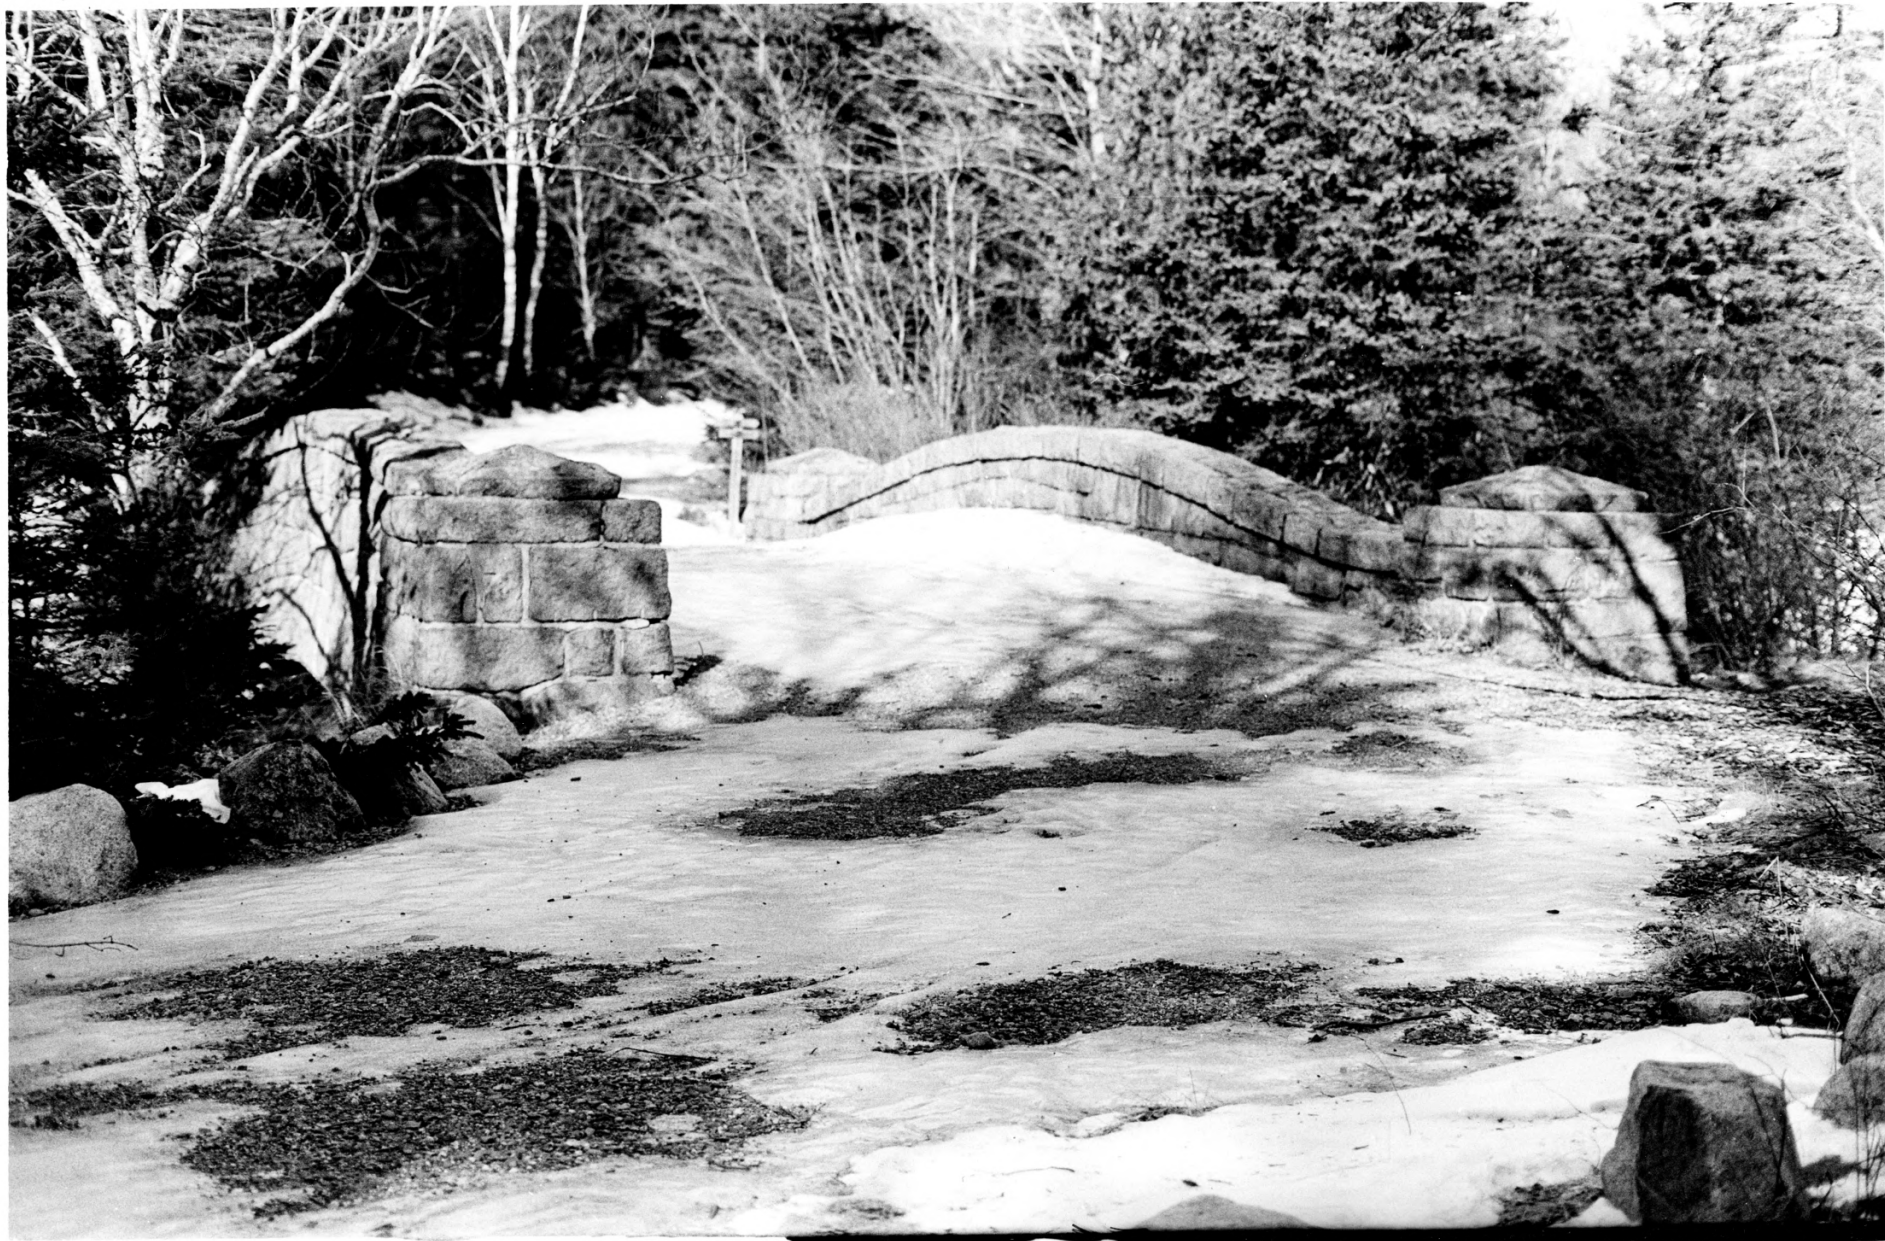
# 158/30

The Small Stone Bridge was completed in 1920 and is a compact and powerful 40-foot length with a 20-foot single segmental-arched span. Its two-lane, arched, gravel deck is flared at either end. The stone masonry substructure is surfaced in quarry-faced granite blocks which are laid both random and polygonally between the radiating voussoirs of the arch and orderly coping stones of the gently arched rail. The abutments are square, solid masses surfaced in random ashlar and with a flattened pyramidal capstone.

Small Stone Bridge - Jordan Stream 1920

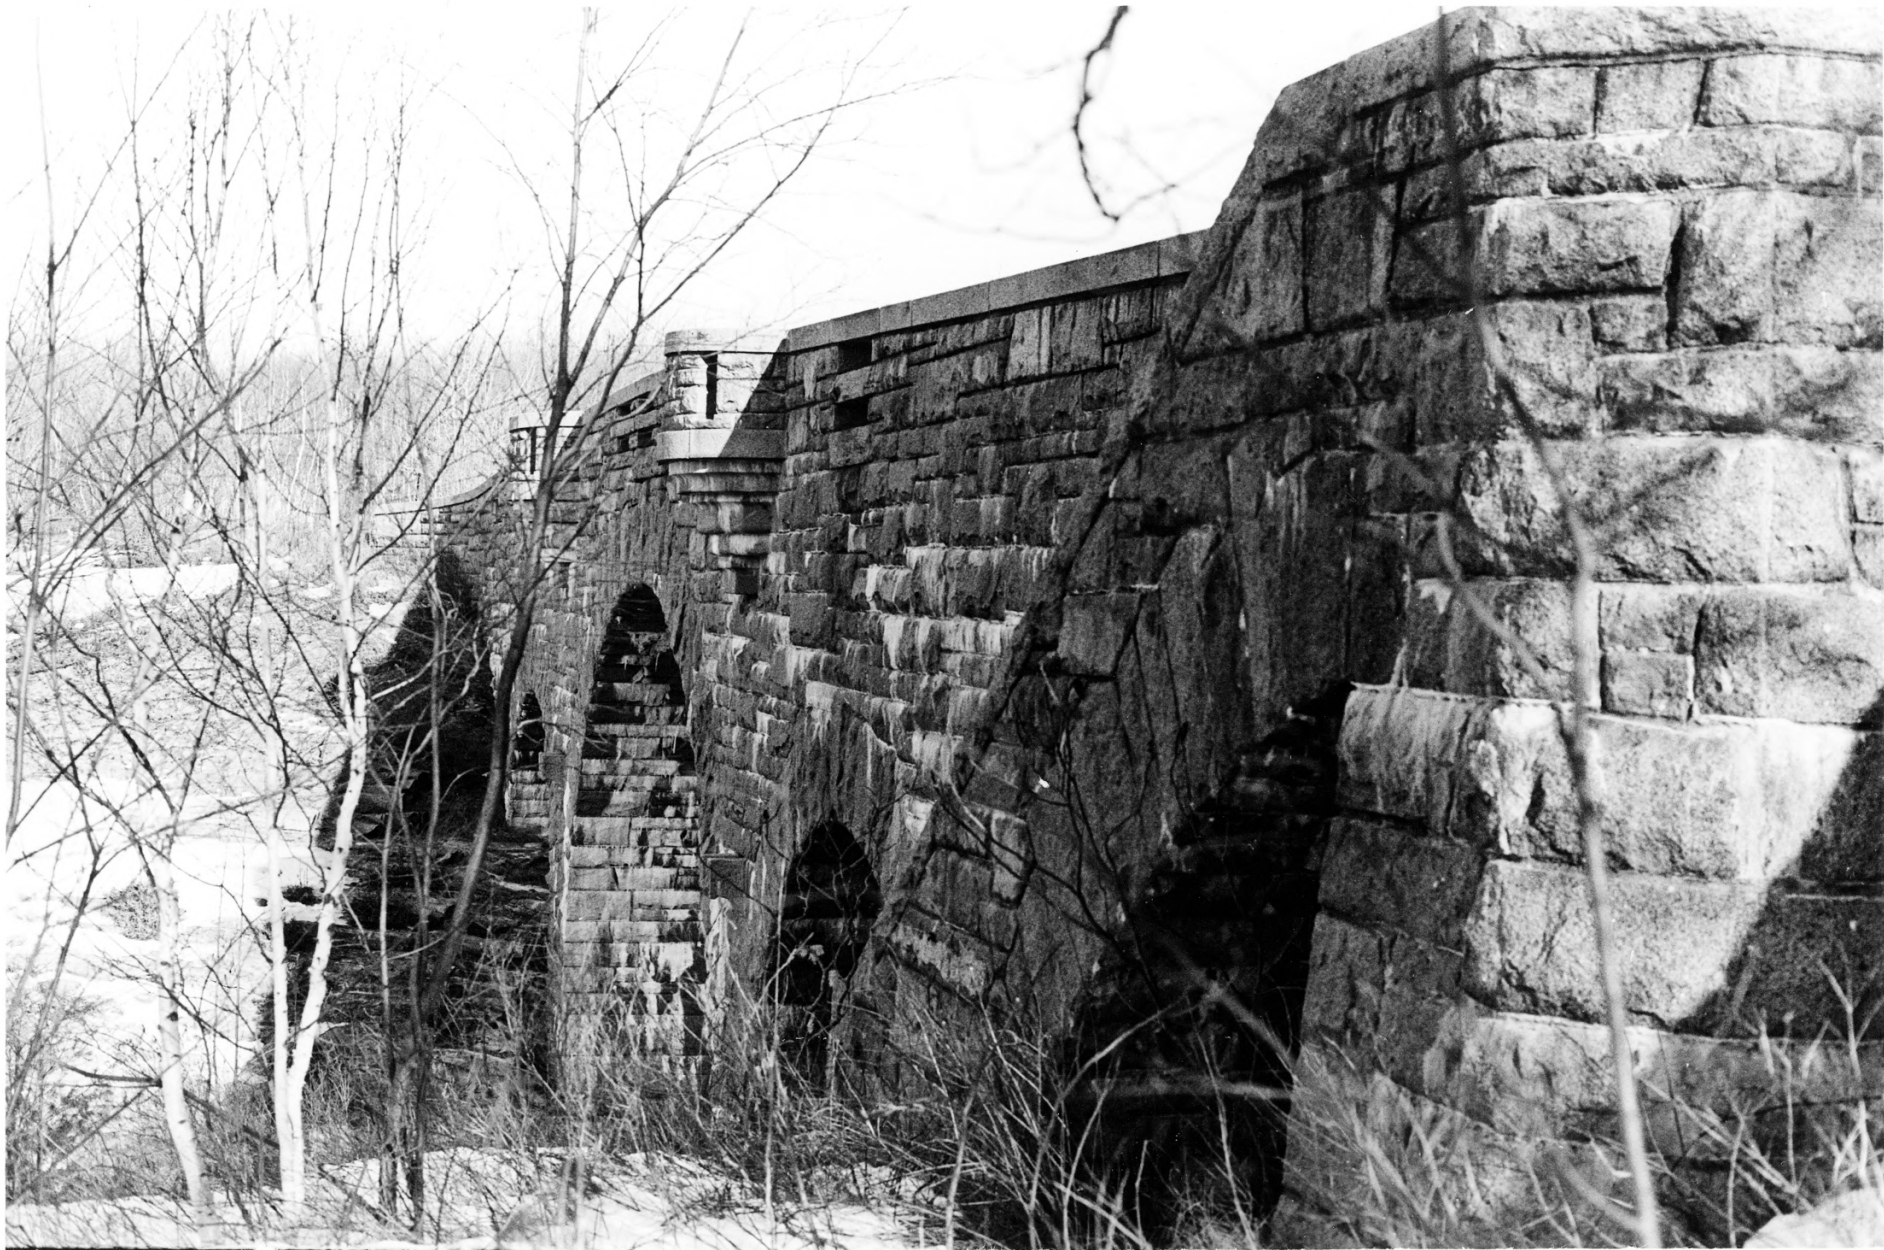
# 16 of 30

The Duck Brook Bridge is a spectacular, three-arch structure which carries the two-lane Carriage Path over Duck Brook. Completed in 1929, there is a central 30-foot span flanked by smaller 20-foot spans, each of which has rough-dressed uneven radiating voussoirs with prominent keystones. The stone and mortar substructure is clad in quarry-faced random laid ashlar. The gravel-surfaced deck is 200 feet in length and flares at either end. The railing has dressed ashlar copings and there are pairs of rectangular openings piercing the railing above the lesser arches and three pairs above the main arch. Above the spandrels of the arches, corbelled semi-circular balconies extend into space from the deck to allow the traveller to absorb the scenic wealth from excellent vantage points. The copings on this bridge have been repointed.

Duck Brook Bridge 1929

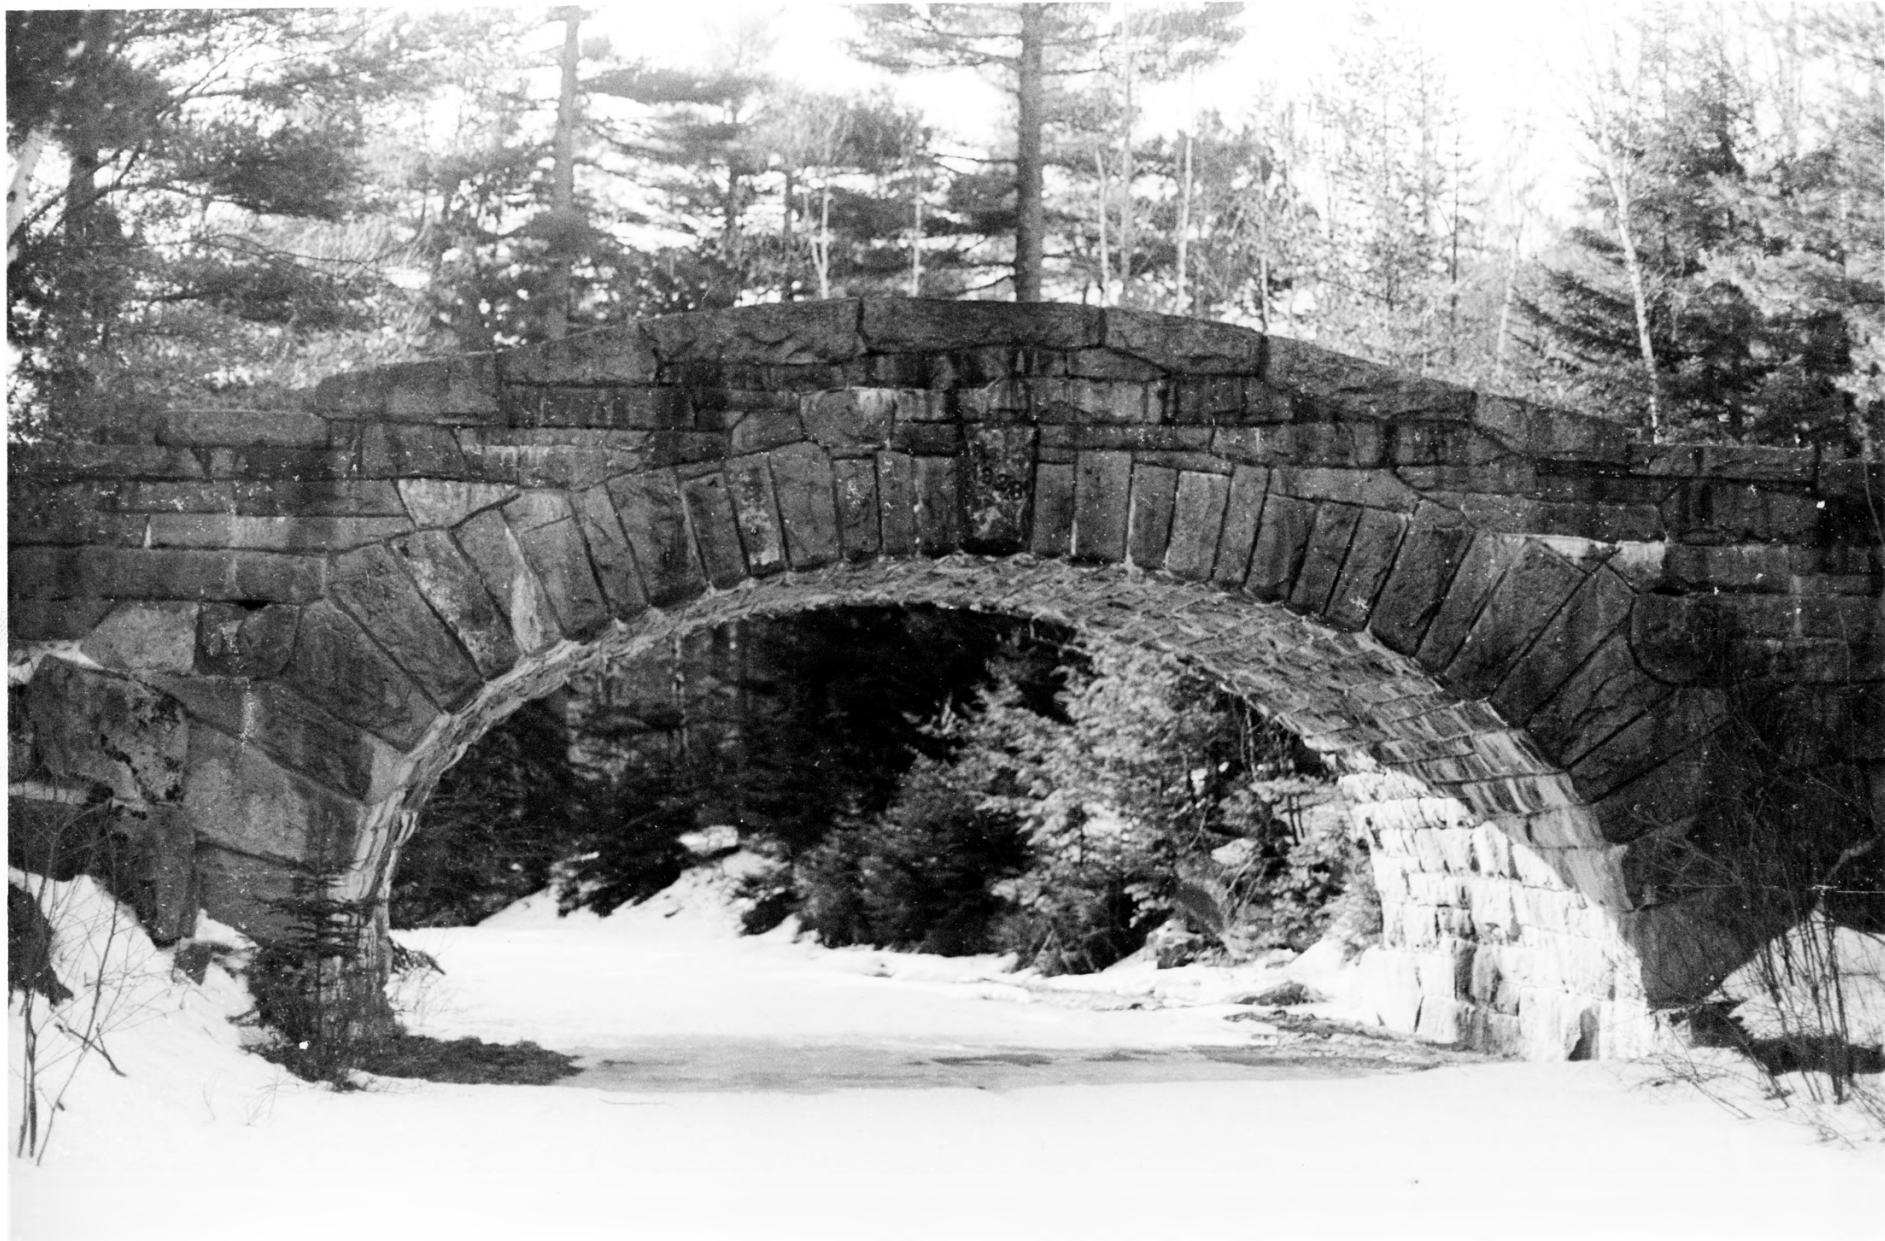
# 18430

The Bubble Pond Bridge, completed in 1928, is an elliptical-arched structure rustic in detail. It traverses a two-lane Carriage Path and carries two lanes, both of which are gravel surfaced. The 30-foot elliptic span is echoed in the railing arch which slopes outward beyond the opening to a more horizontal plane. The deck is a full 200 feet in length and flares gently at the end. The stone and mortar substructure are surfaced in rough-dressed random laid rubblestone. The uneven and rough-dressed radiating voussoirs form the graceful arch and the keystone block has been carved with the year 1928. The rail copings, too, are rough-dressed and jaggedly set, but still provide a strong horizontal element in this bridge's distinctive profile.

Bubble Pond Bridge 1928

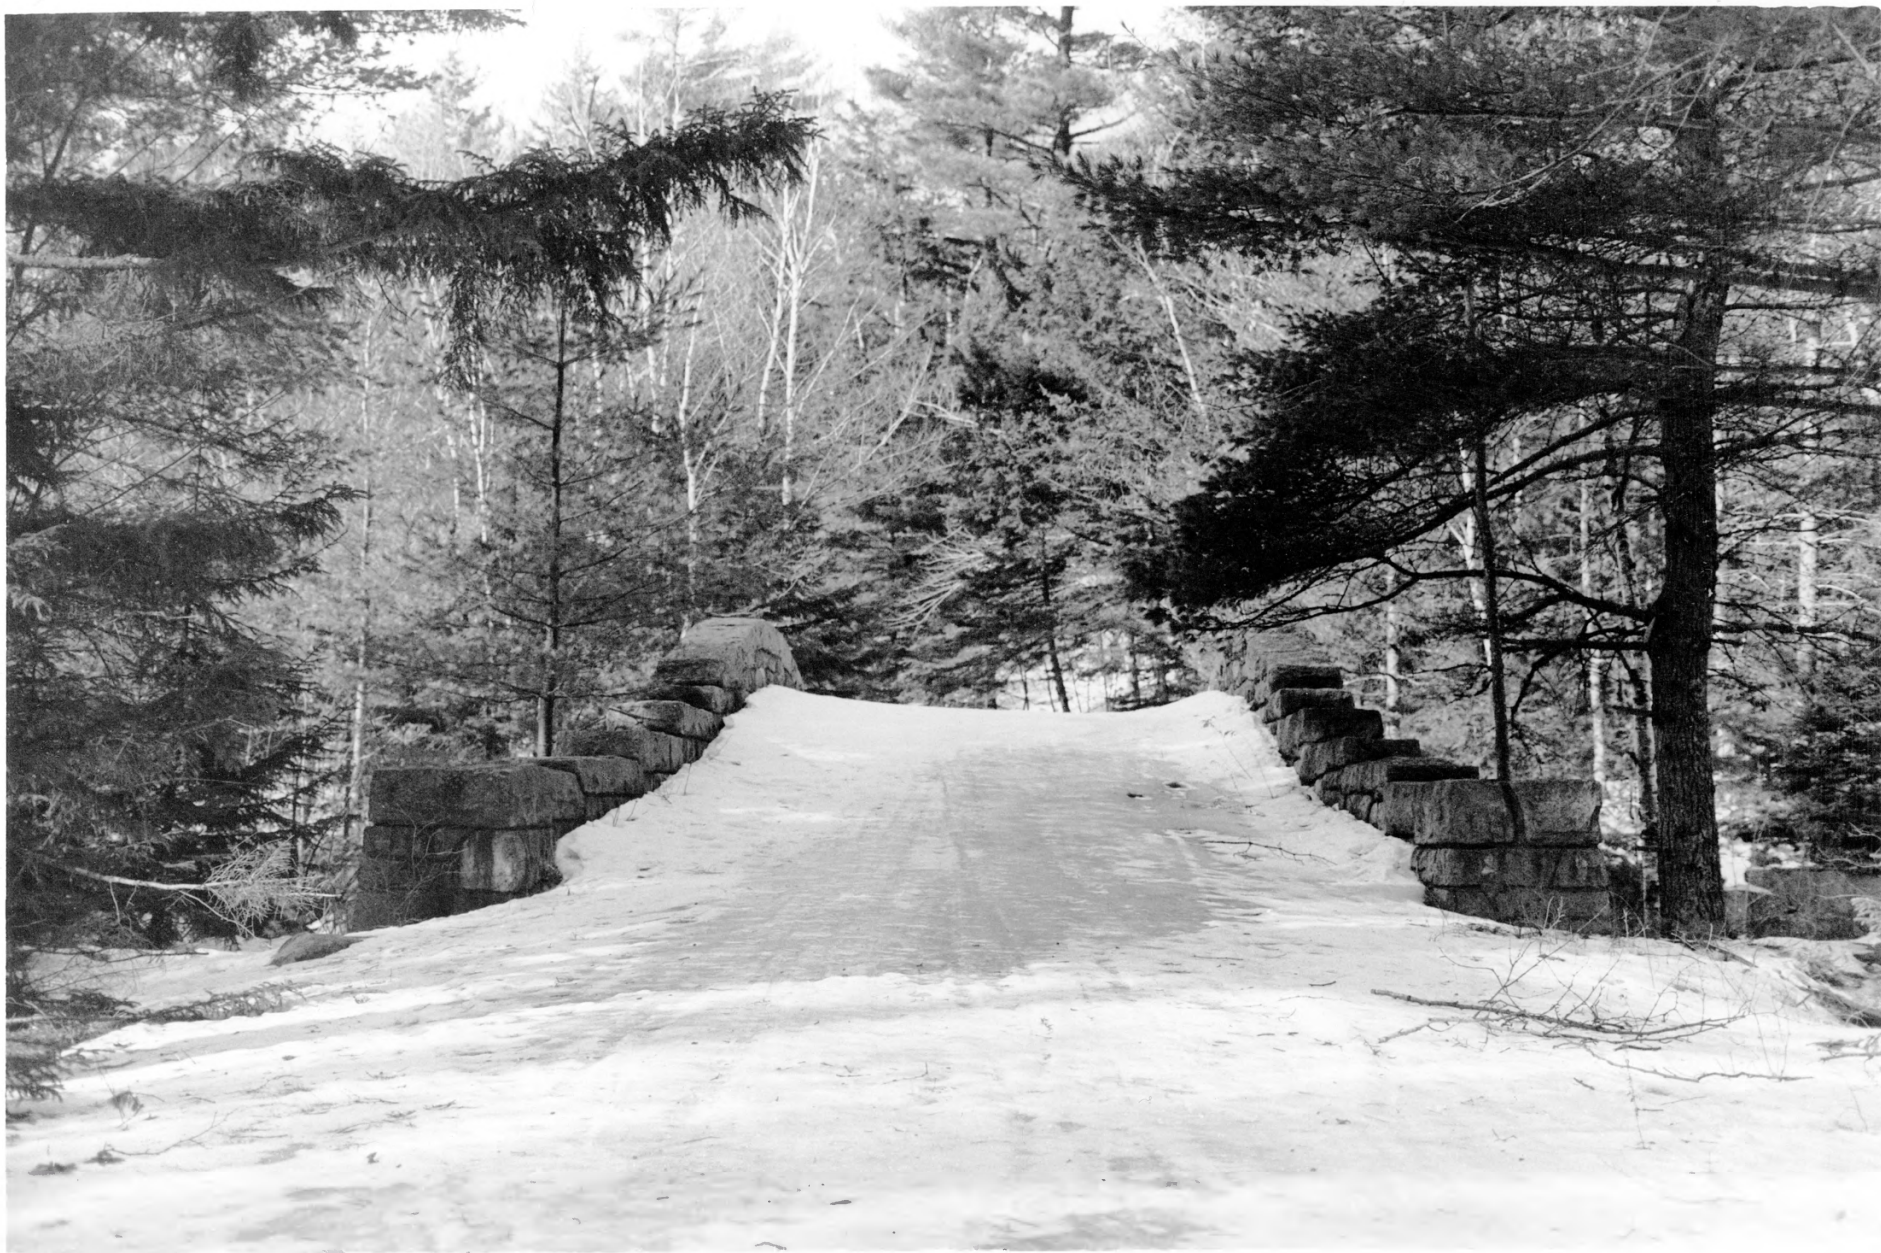
Bubble Pond Bridge 1928

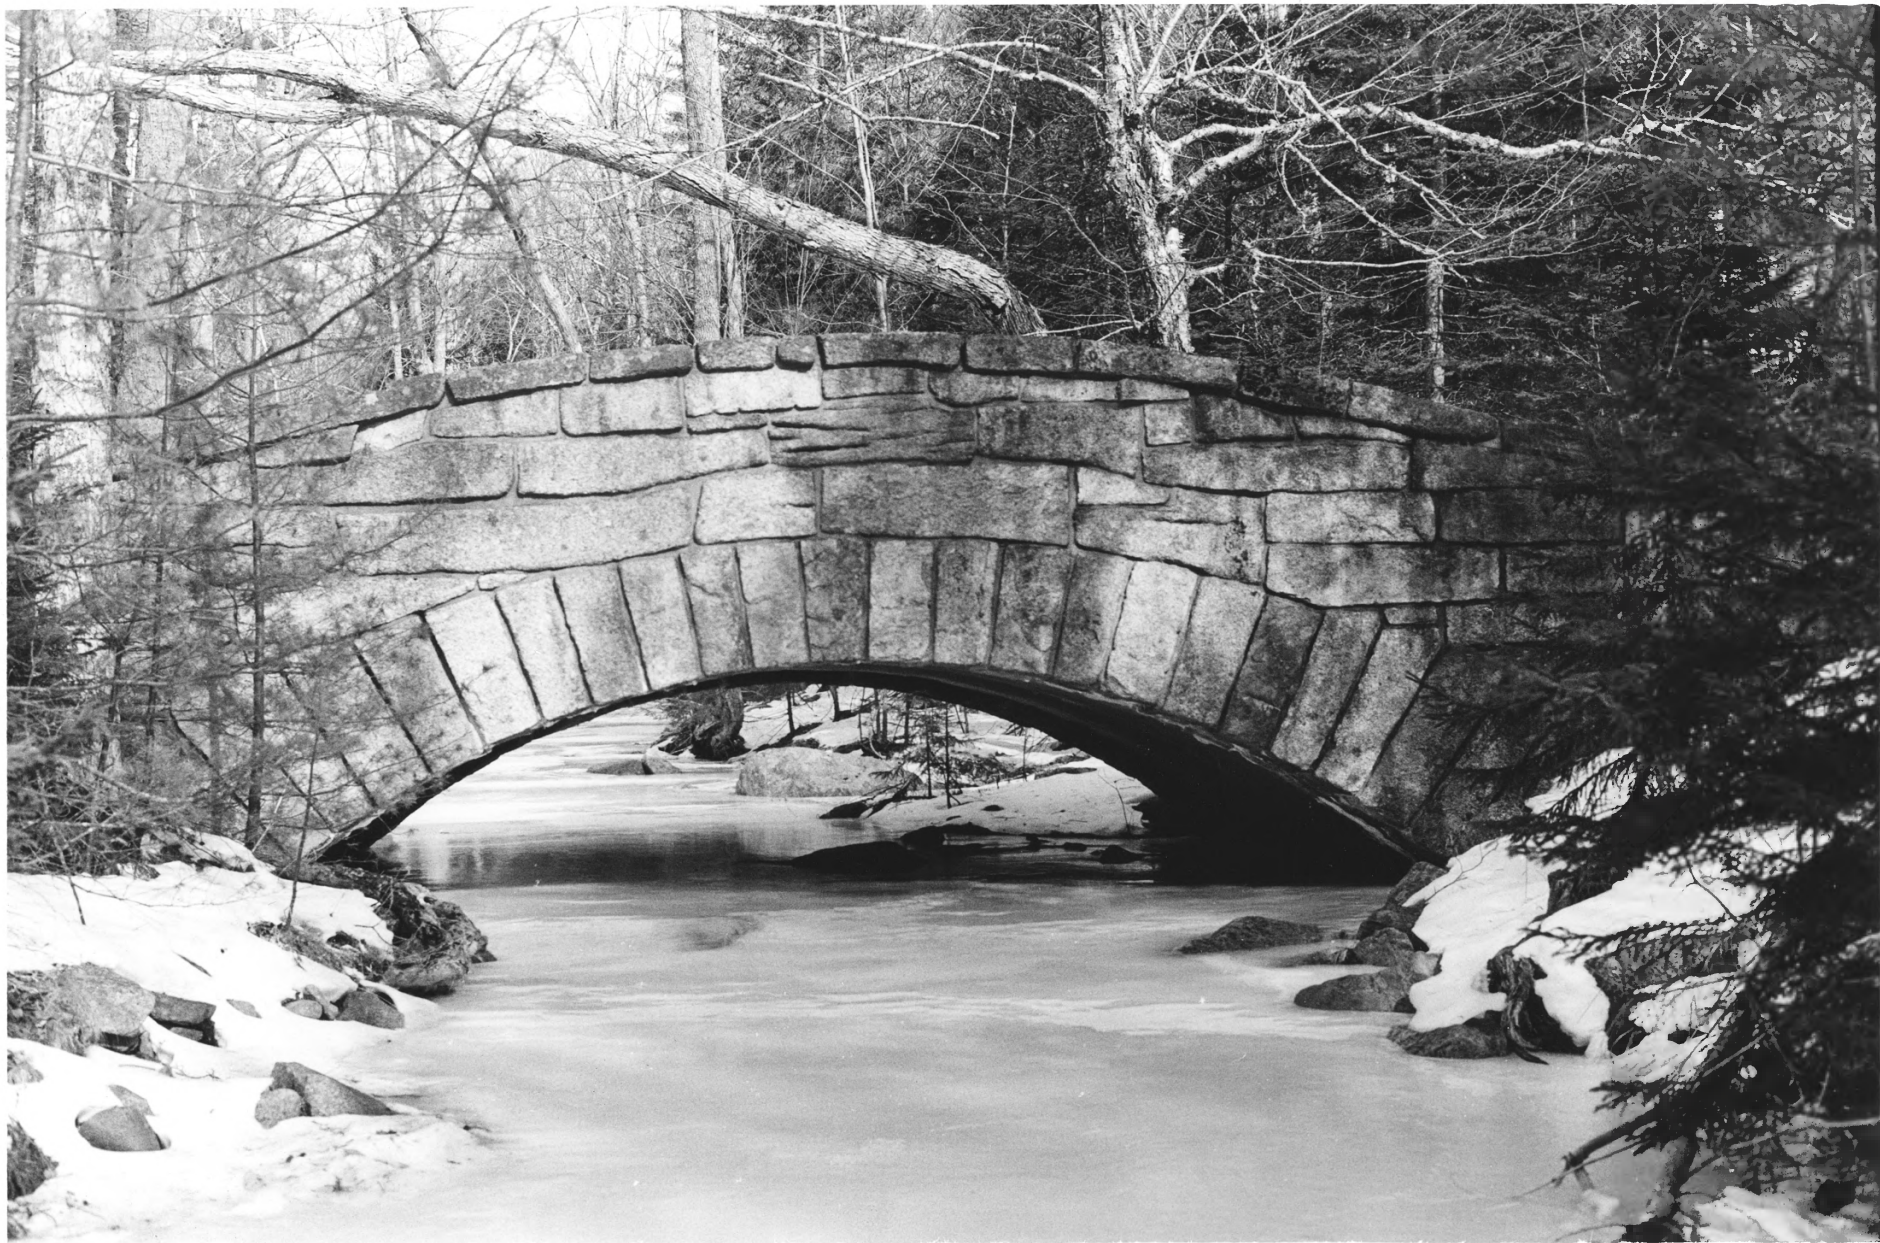
# 248/25

Little Harbor Brook 1919.

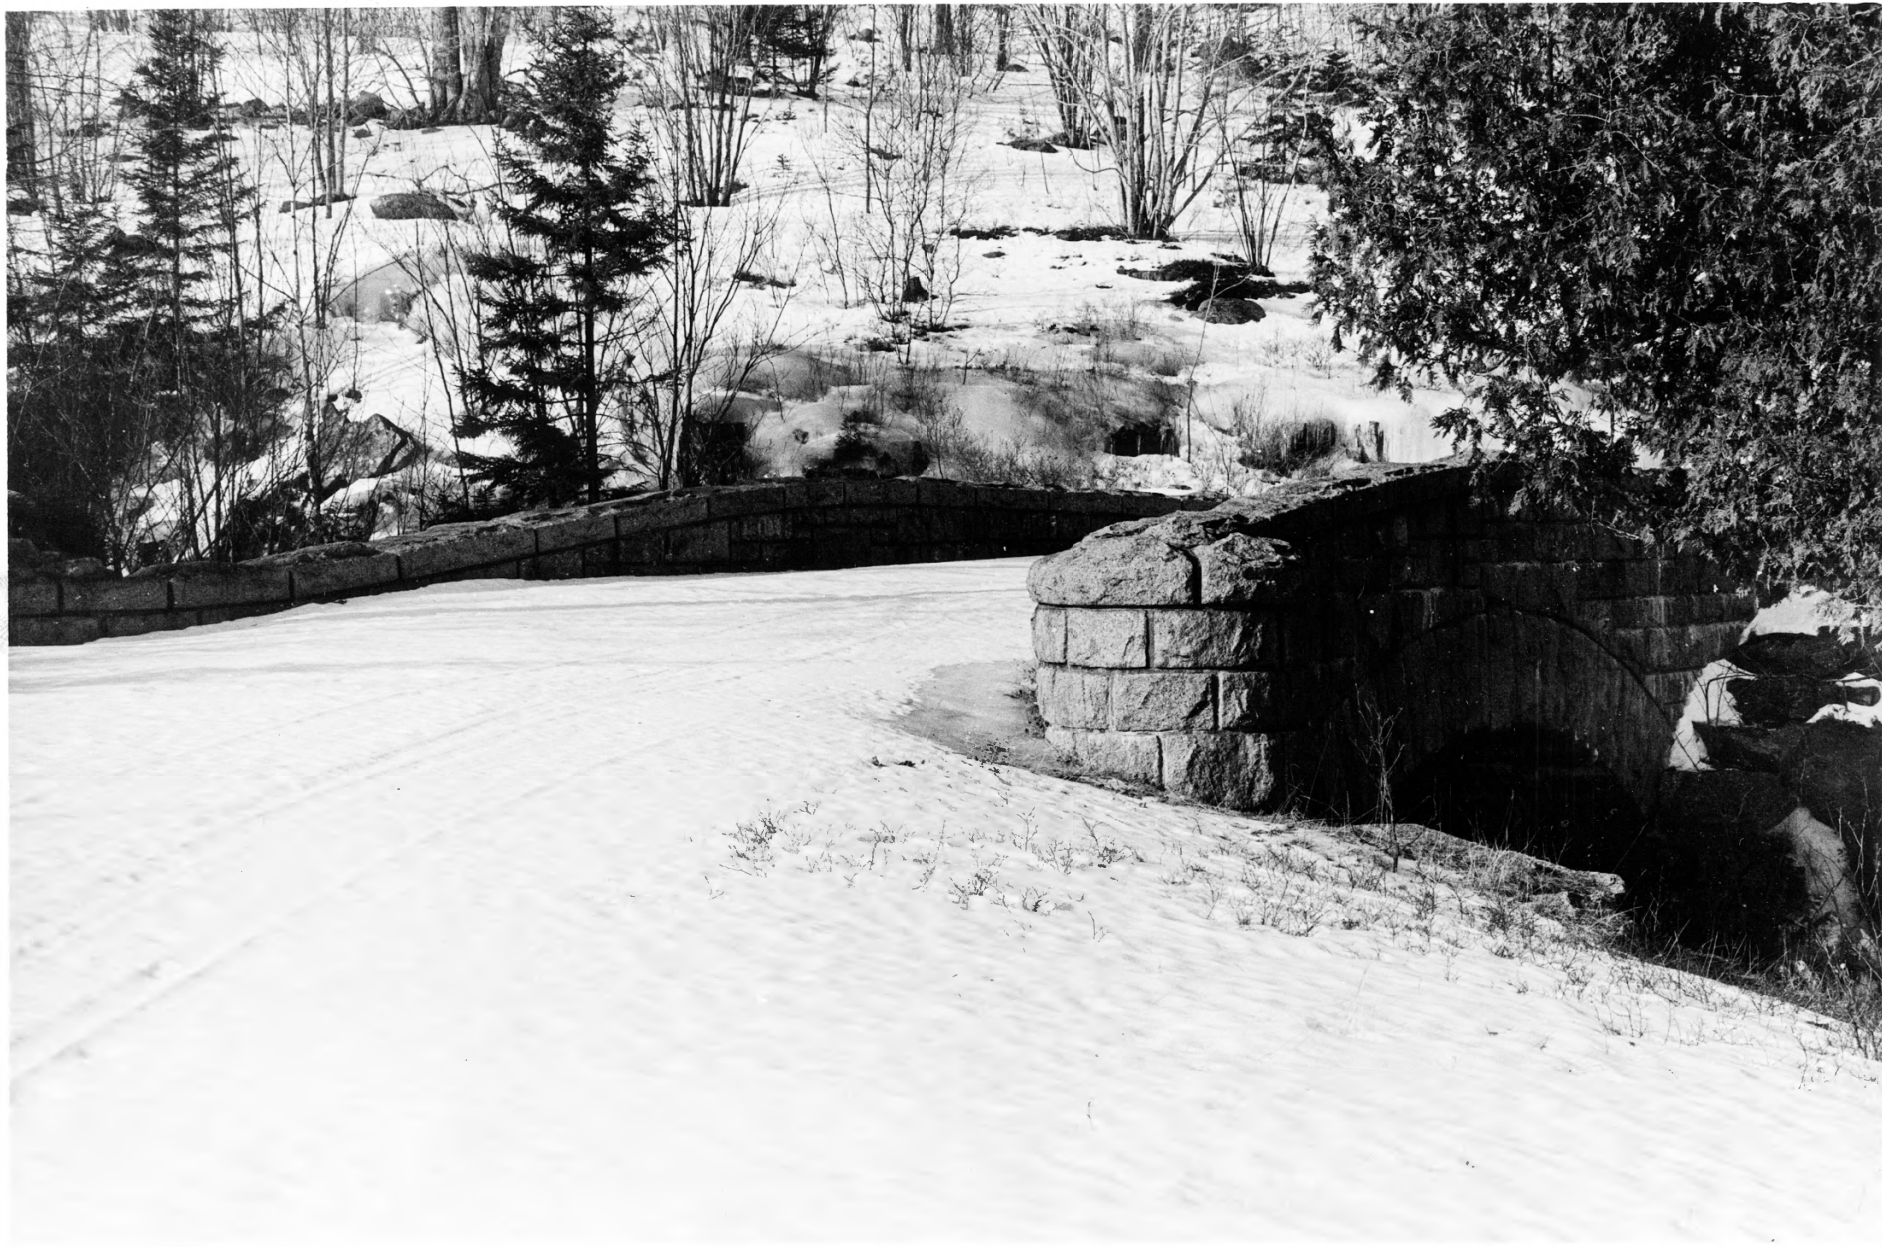
#25/30

The Chasm Brook Bridge, completed in 1927, is a rustic and small-scaled 20-foot span that is 40 feet in length. It is built over Chasm Brook and has a stone and mortar substructure clad in quarry-faced random laid ashlar. The long, slender, radiating voussoirs and keystone of the segmental arch and the railing copings are also dressed in the same manner. The two-lane, gravel-surfaced deck is handsomely flared and terminates at pairs of rounded abutments which form pedestals for their gently peaked caps.

Chasm Brook Bridge 1927-28
