UNITED STATES DEPARTMENT OF THE INTERIOR  
NATIONAL PARK SERVICE  
**NATIONAL REGISTER OF HISTORIC PLACES  
INVENTORY -- NOMINATION FORM**  
FOR FEDERAL PROPERTIES

The Carriage Paths, Bridges and Gatehouses, Acadia National Park

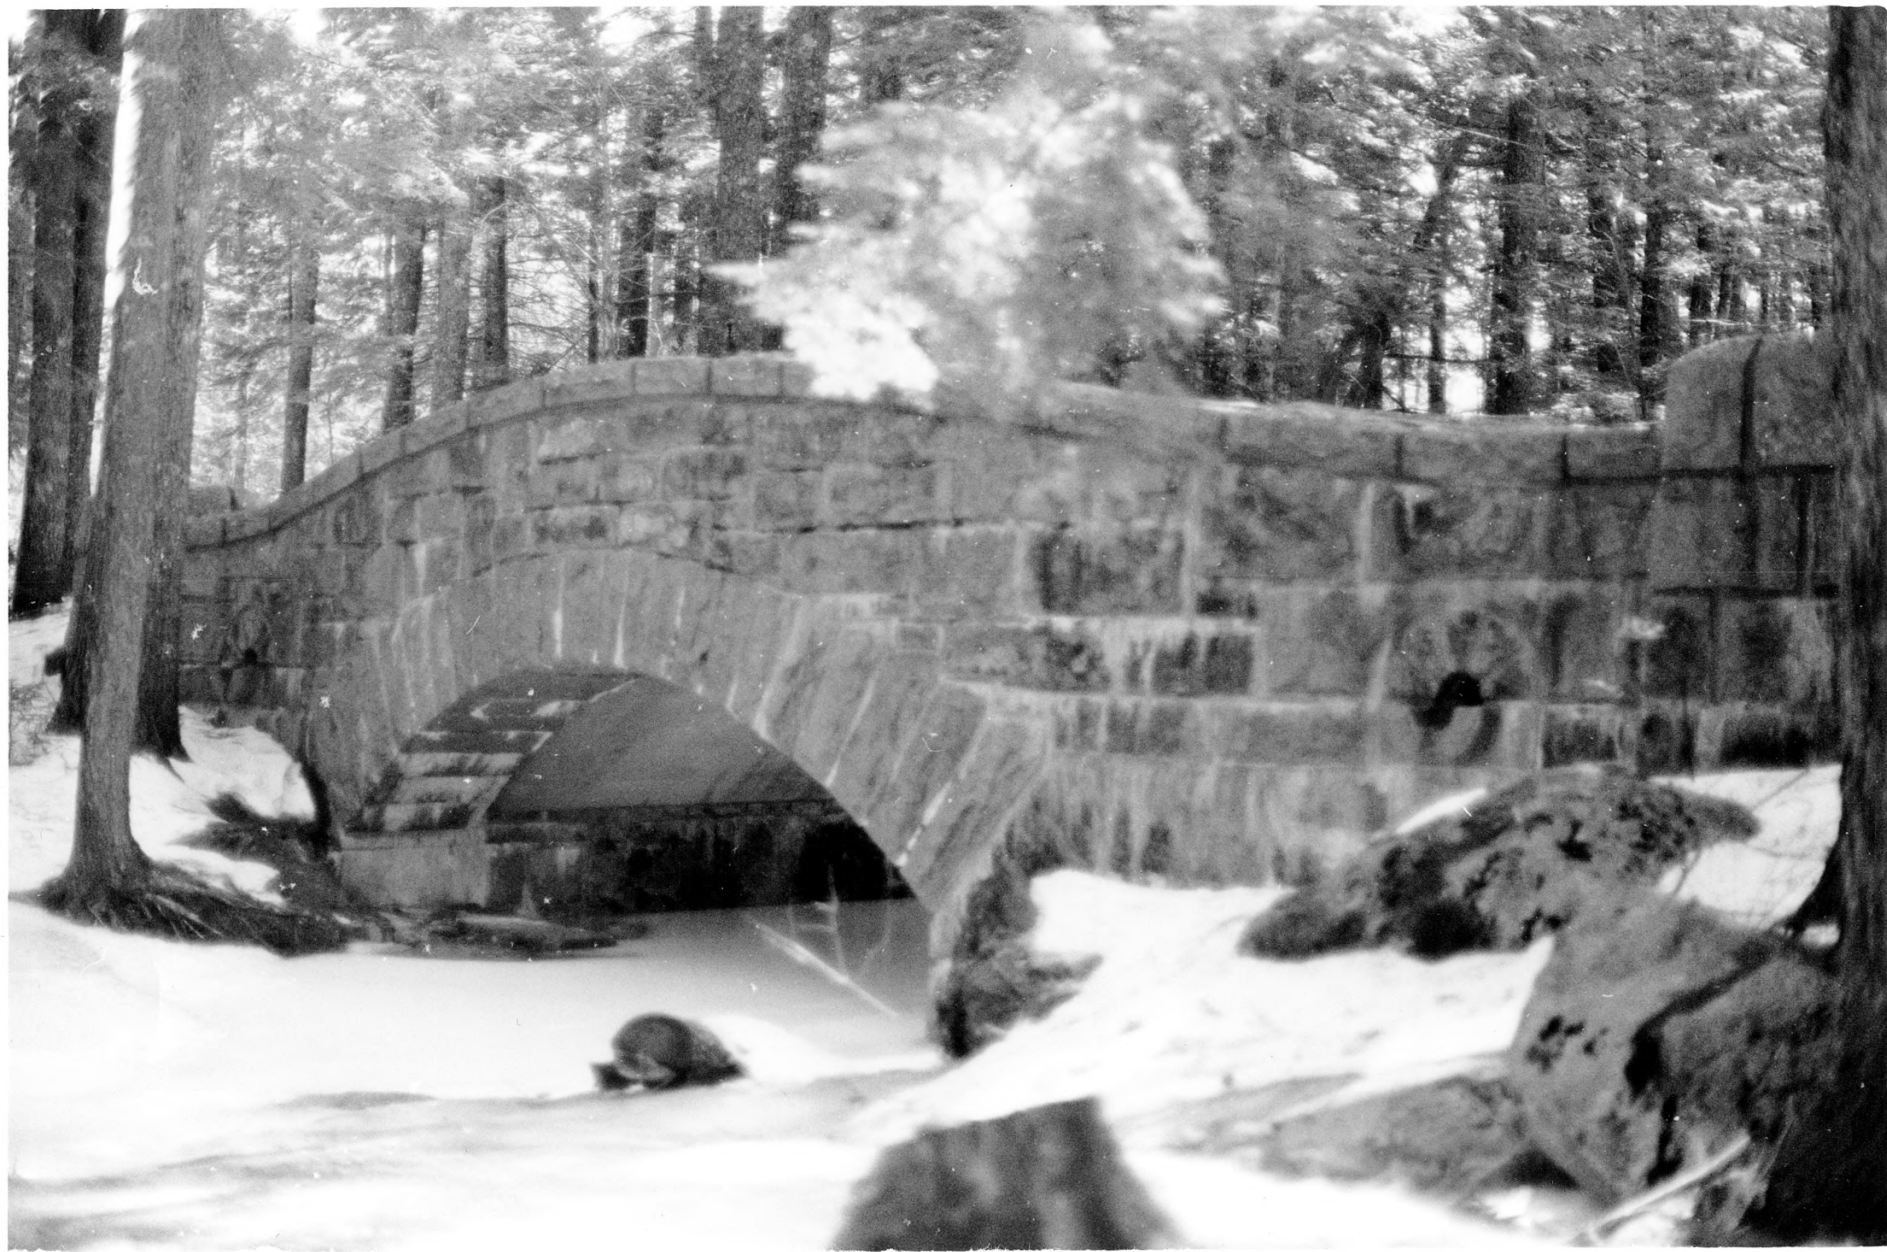
# 26 of 30

The Lower Hadlock Brook Bridge, completed in 1926, is a small-scaled 40-foot length over a 20-foot span segmental arch. The rail of the bridge follows the line of the arch and flares out gently at either end. There are strong abutments with chinky rounded capstones. The stone and masonry substructure is clad in very rough, quarry-faced ashlar, laid random. The radiating voussoirs and rail copings are similar in texture and the two-lane deck is gravel surfaced. The bridge traverses the quiet Hadlock Brook.

Small Stone Bridge - Hadlock Brook 1926

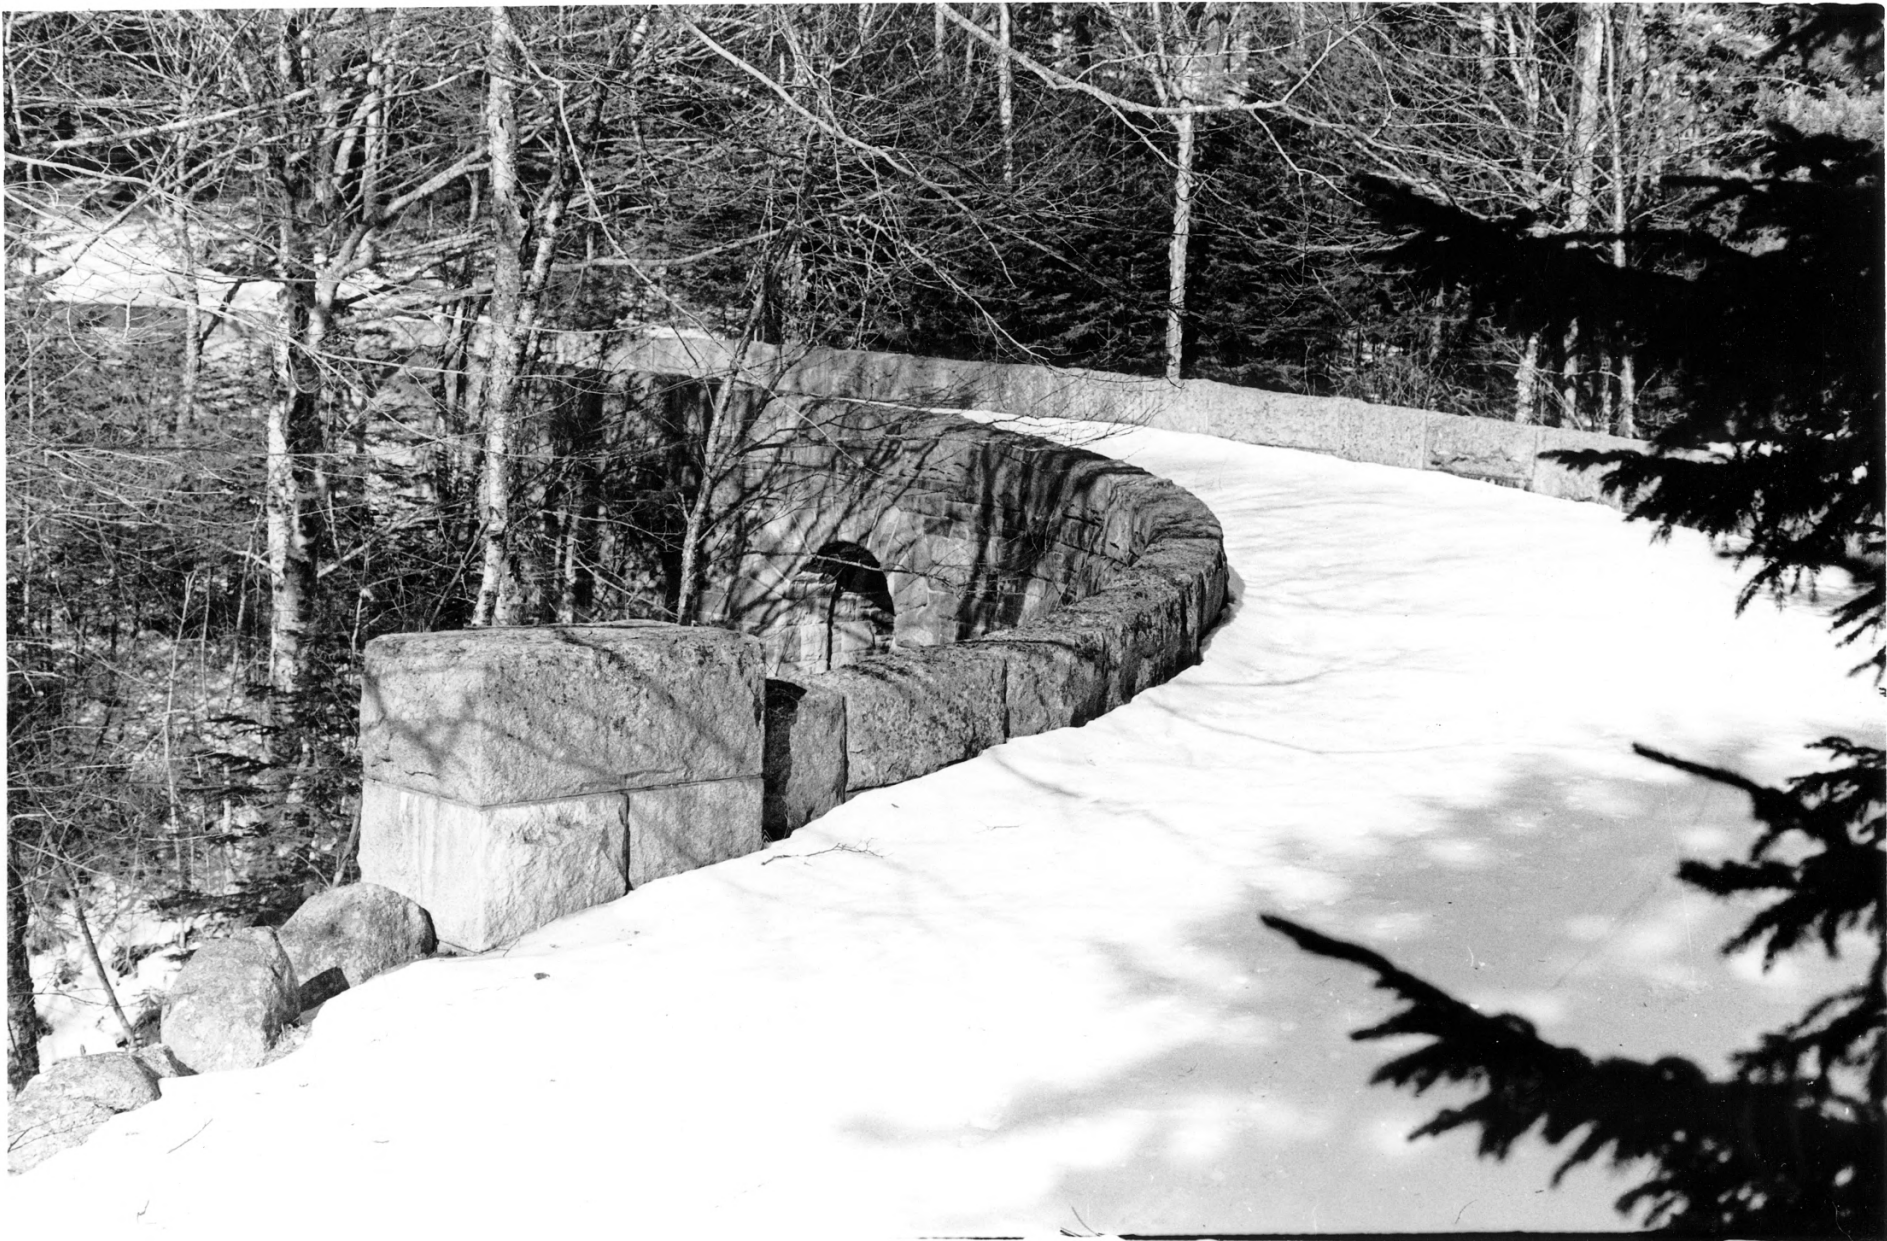
# 270/30

The West Branch Bridge is a very long, 170-foot structure which has a flared and skew approach to its two-lane gravel-surfaced deck. The bridge curves sharply over the ravine formed by Jordan Stream and has a small 6-foot stone arch span. The stone and mortar substructure is very simply clad in quarry-faced random laid ashlar and laid ashlar and lacks even copings on its side railings. It was built in 1931 and may have been begun several years prior.

West Branch Jordan Stream  
Bridge 1931

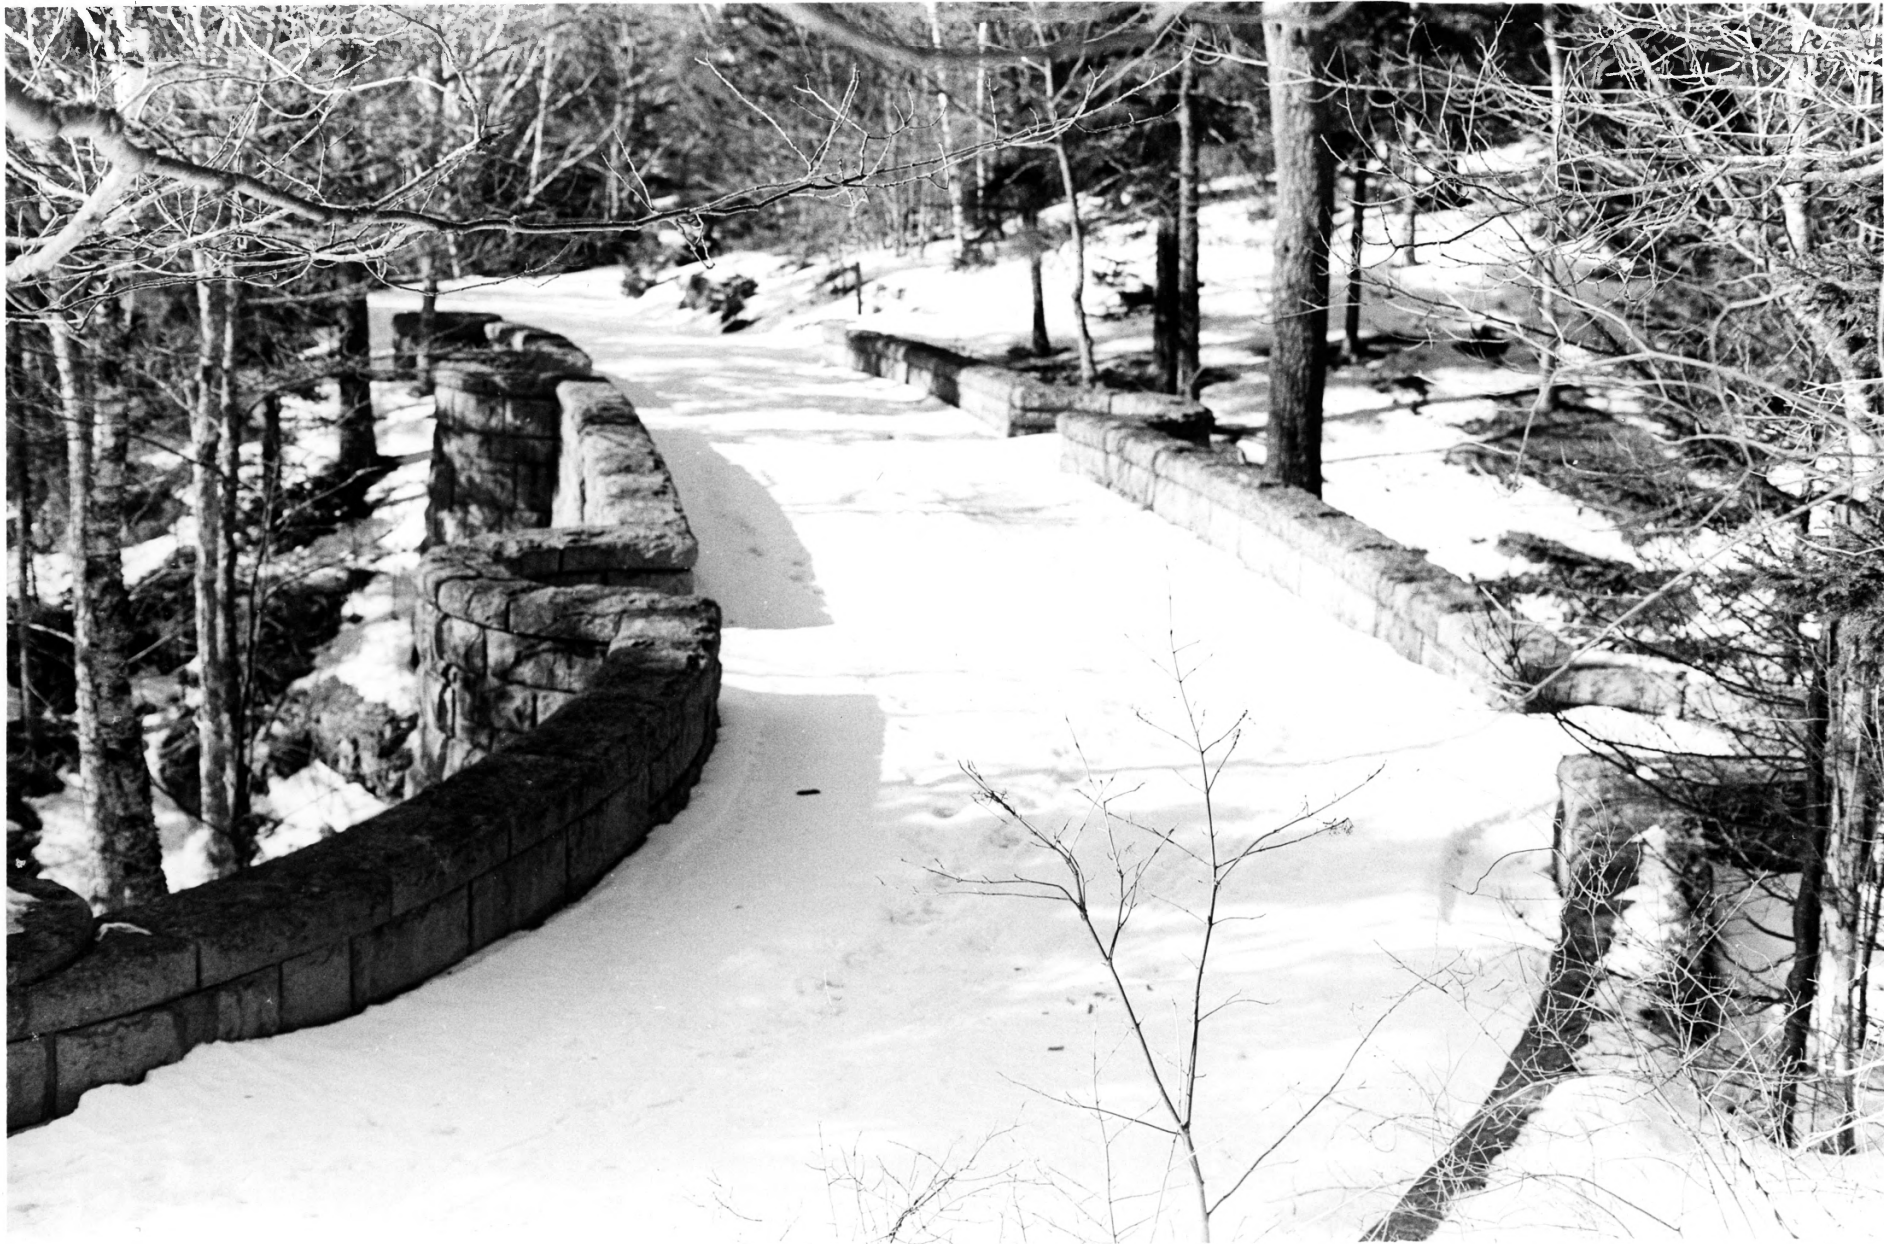
# 28 of 30

The Waterfall Bridge, completed in 1925, carries the two-lane gravel-surfaced deck over Hadlock Brook. The structure is 125 feet in length and flares gently at the ends. The 20-foot span of its rounded arch is outlined by a firm row of quarry-faced radiating voussoirs. The stone and mortar substructure is clad in quarry-faced random laid ashlar and bold blocks of the same material form the railing copings. A pair of semi-circular viewing platforms bow out on either side to take advantage of the tread and deep ravine.

Waterfall Bridge 1925
