UNITED STATES DEPARTMENT OF THE INTERIOR  
NATIONAL PARK SERVICE  
**NATIONAL REGISTER OF HISTORIC PLACES  
INVENTORY -- NOMINATION FORM**

Rattlesnake Springs Historic District

Rattlesnake Springs Historic District  
Carlsbad vicinity, New Mexico

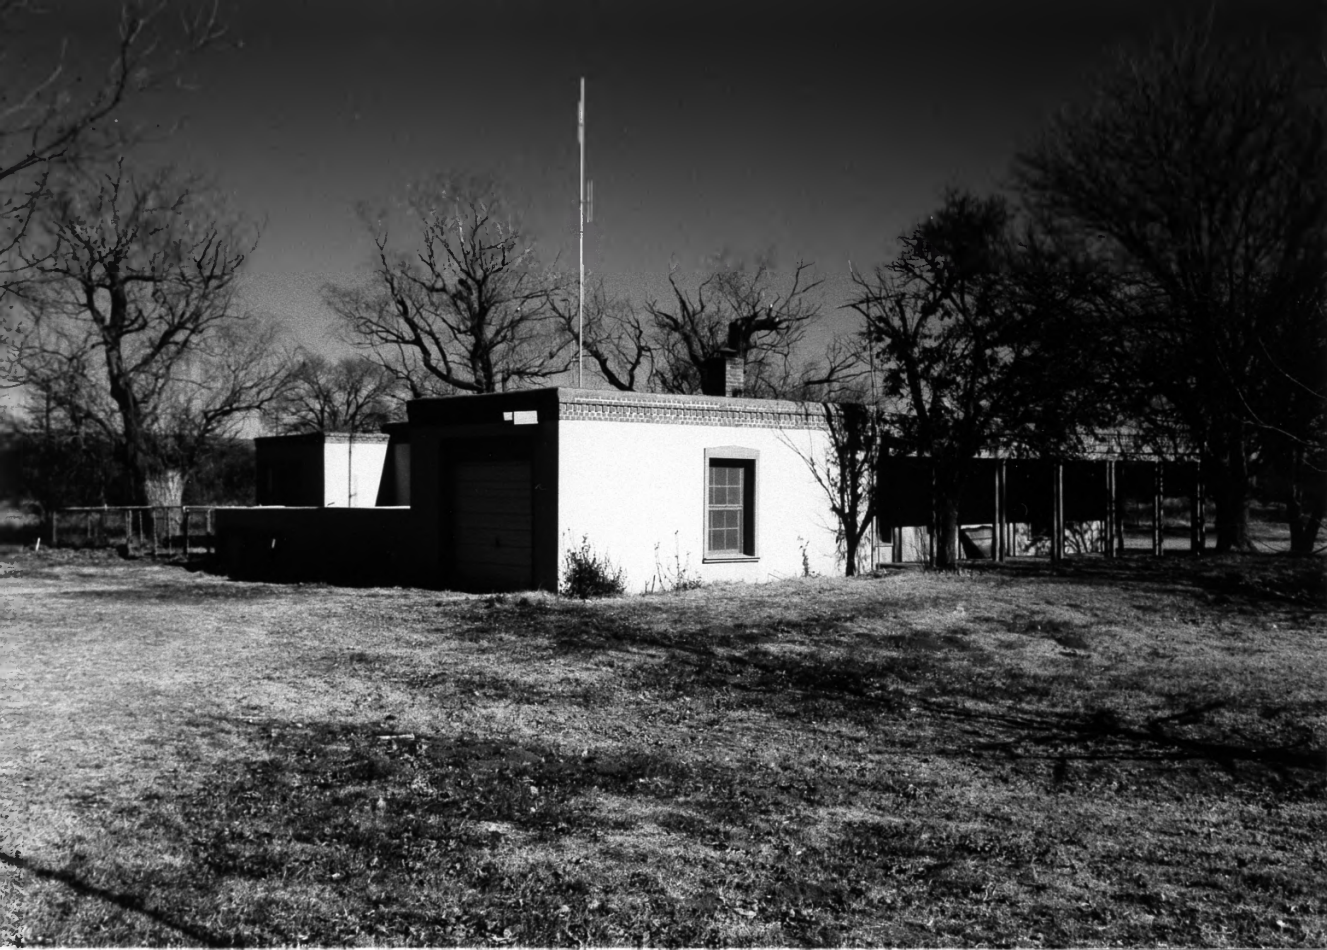
(1) Ranger's Residence, NPS Bldg #22,  
(C), front looking NE.

The house is in use as a residence and is in good condition.

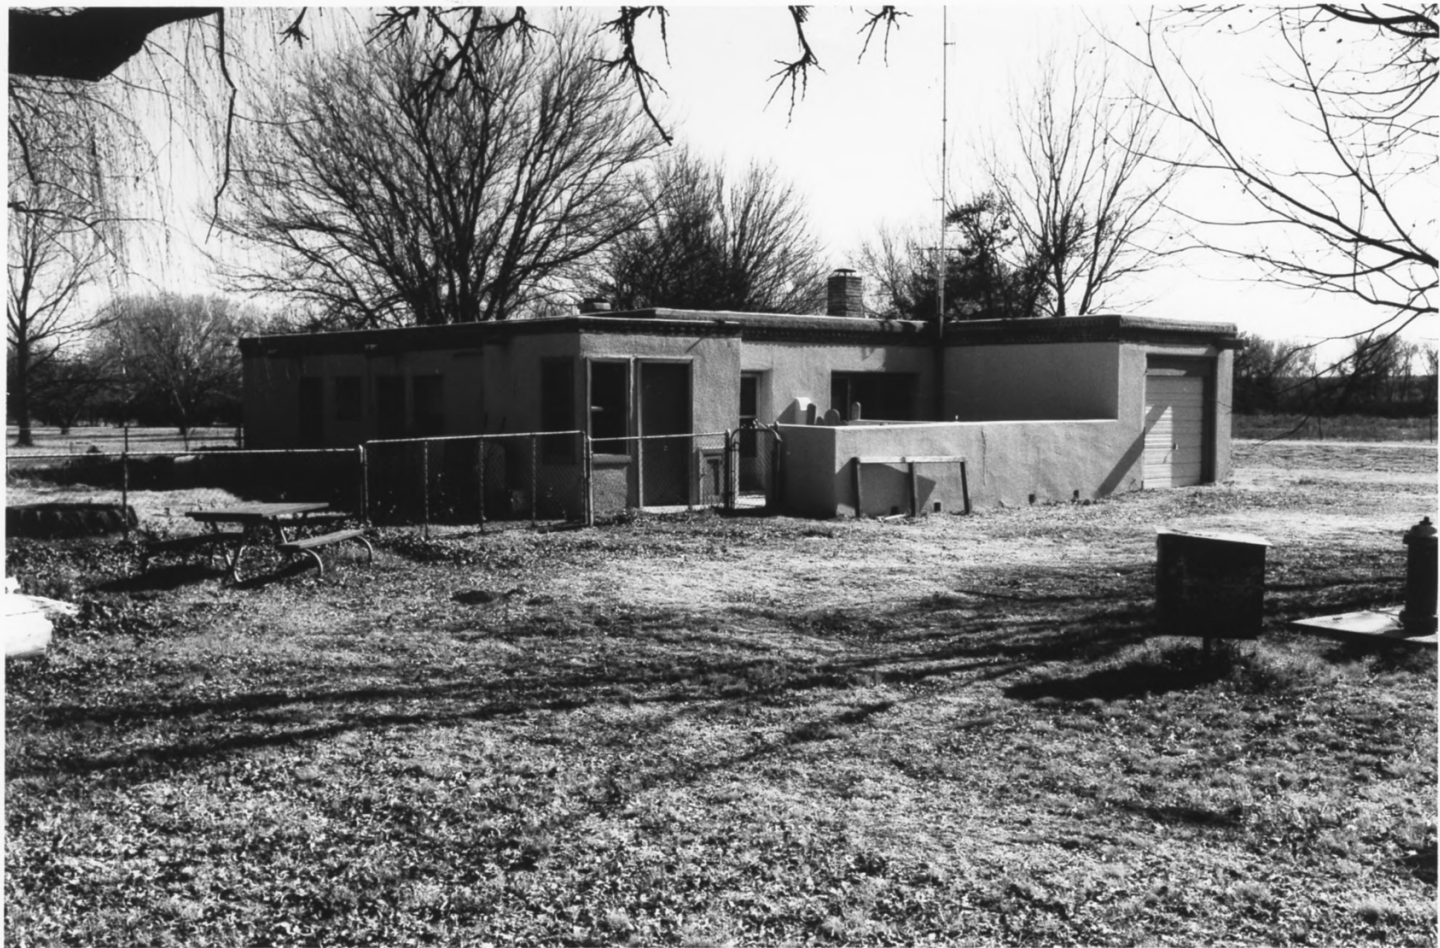
(1) Ranger's Residence, NPS Bldg #22,  
(C), rear looking SE.

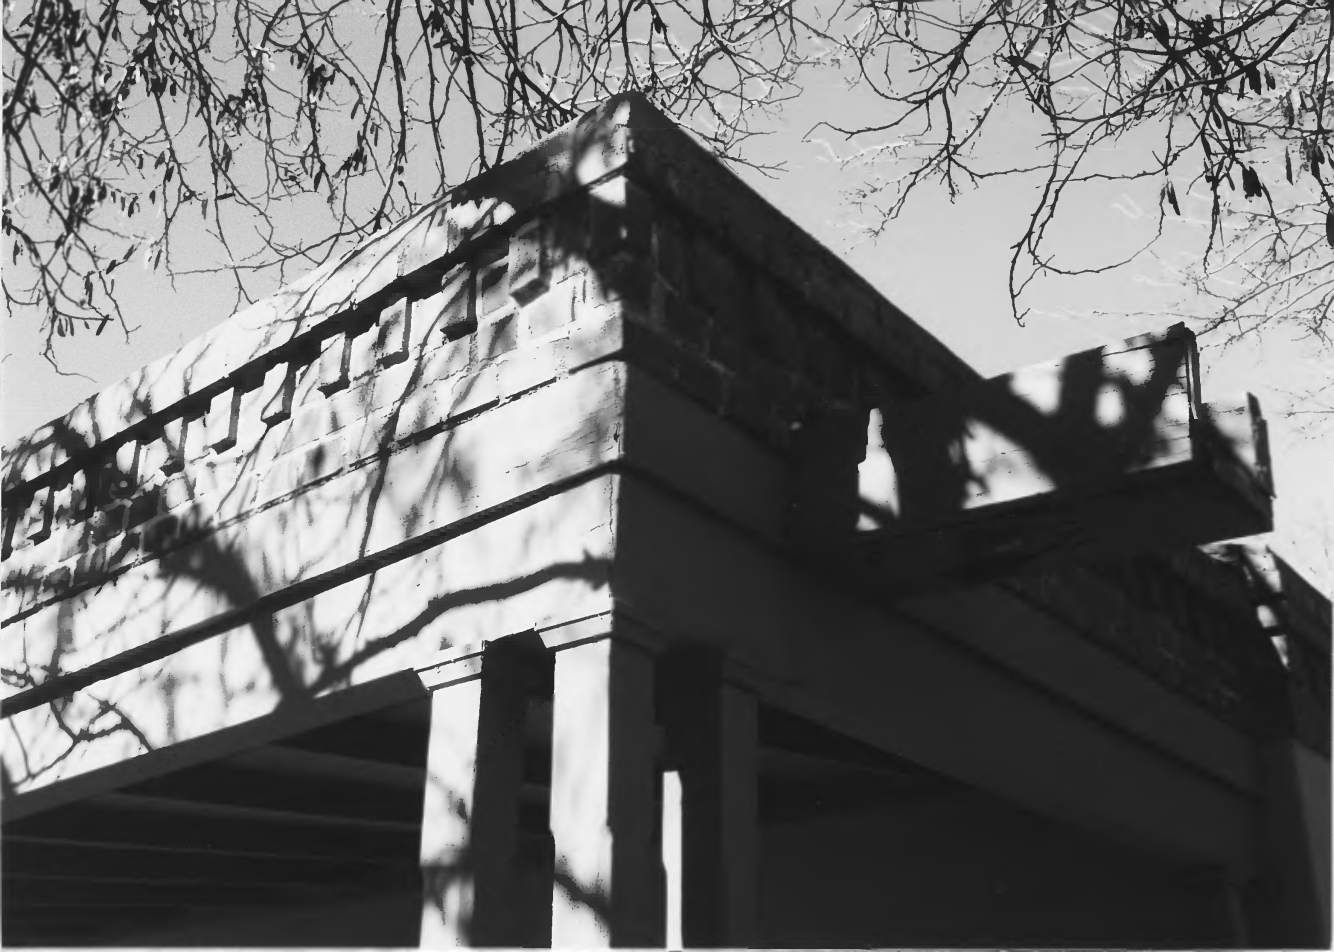
(1) Ranger's Residence, NPS Bldg #22,  
(C), SE corner of portal showing  
chamfered box columns with Doric  
caps, wooden entablature, brick-  
denticulated cornice, and wooden  
canale.

The windows are wooden and are double-hung, with 6/6 lites. They have recently been inset with aluminum screens. The openings under the portal, consisting of the entrance door and three windows, have wooden surrounds with pedimented lintels. The lintels are moulded and are surmounted by plain, unmoulded pediments which give a diminutive effect. They were patterned after the same unusual type of pedimented lintel that is found on some of the windows of the Palace of the Governors in Santa Fe. The window of the garage on the front facade has lost the moulded lintel of its pedimented surround. As designed, none of the windows and doors of the back and sides of the building have surrounds. The doors of both exterior and interior are the original wooden panelled doors. The garage door is a recent metal replacement for the

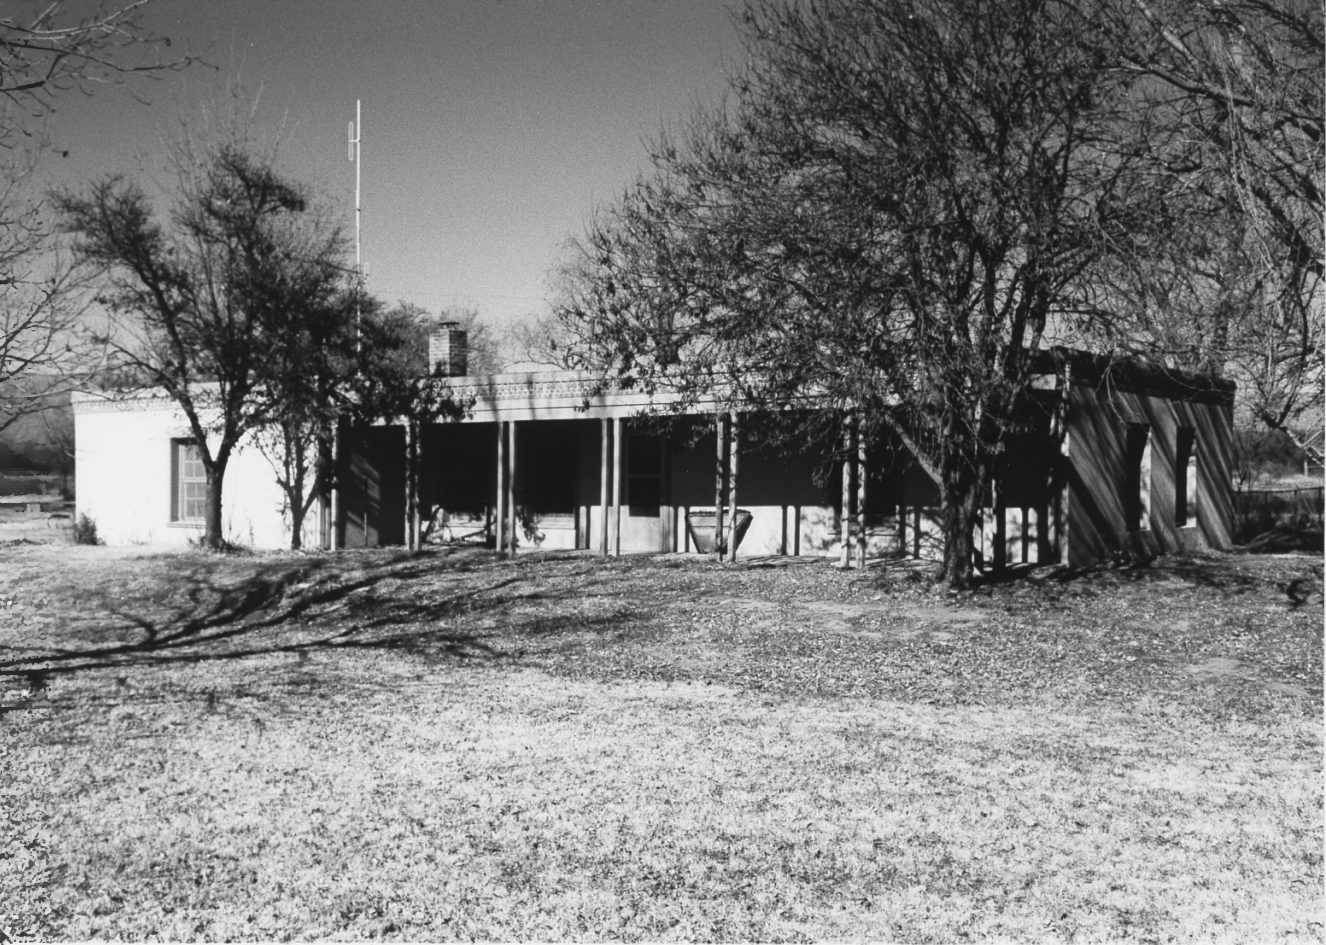
(1) Ranger's Residence, NPS Bldg #22,  
(C), front looking NW.

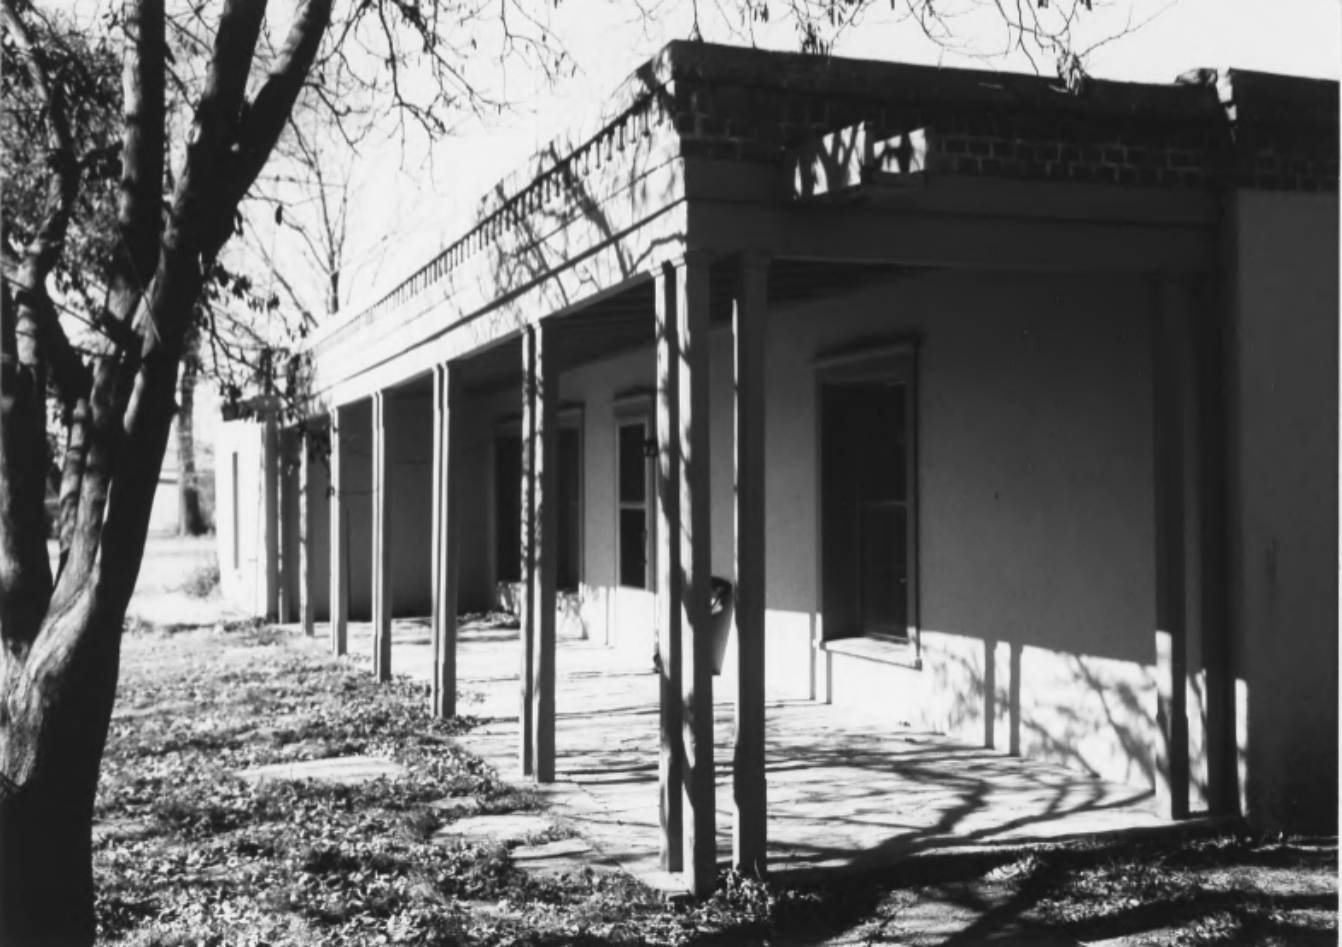
(1) Ranger's Residence, NPS Bldg #22,  
(C), portal looking W.

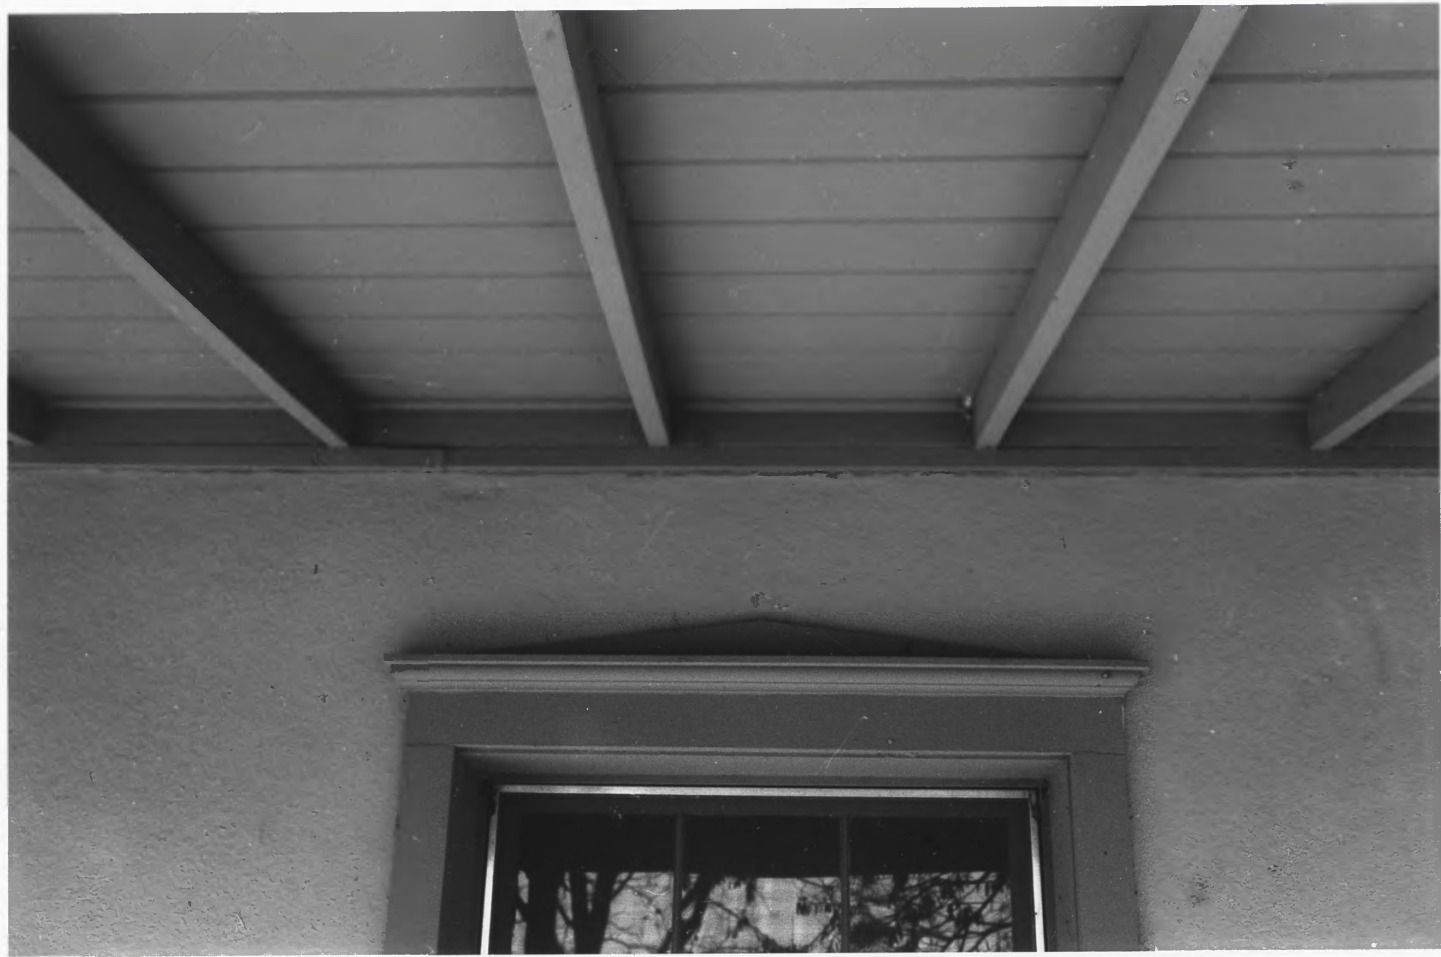
(1) Ranger's Residence, NPS Bldg #22,  
(C), portal ceiling showing tongue-  
and-grove planks supported by  
small cross-beams, and pedimented  
lintel of window in facade.

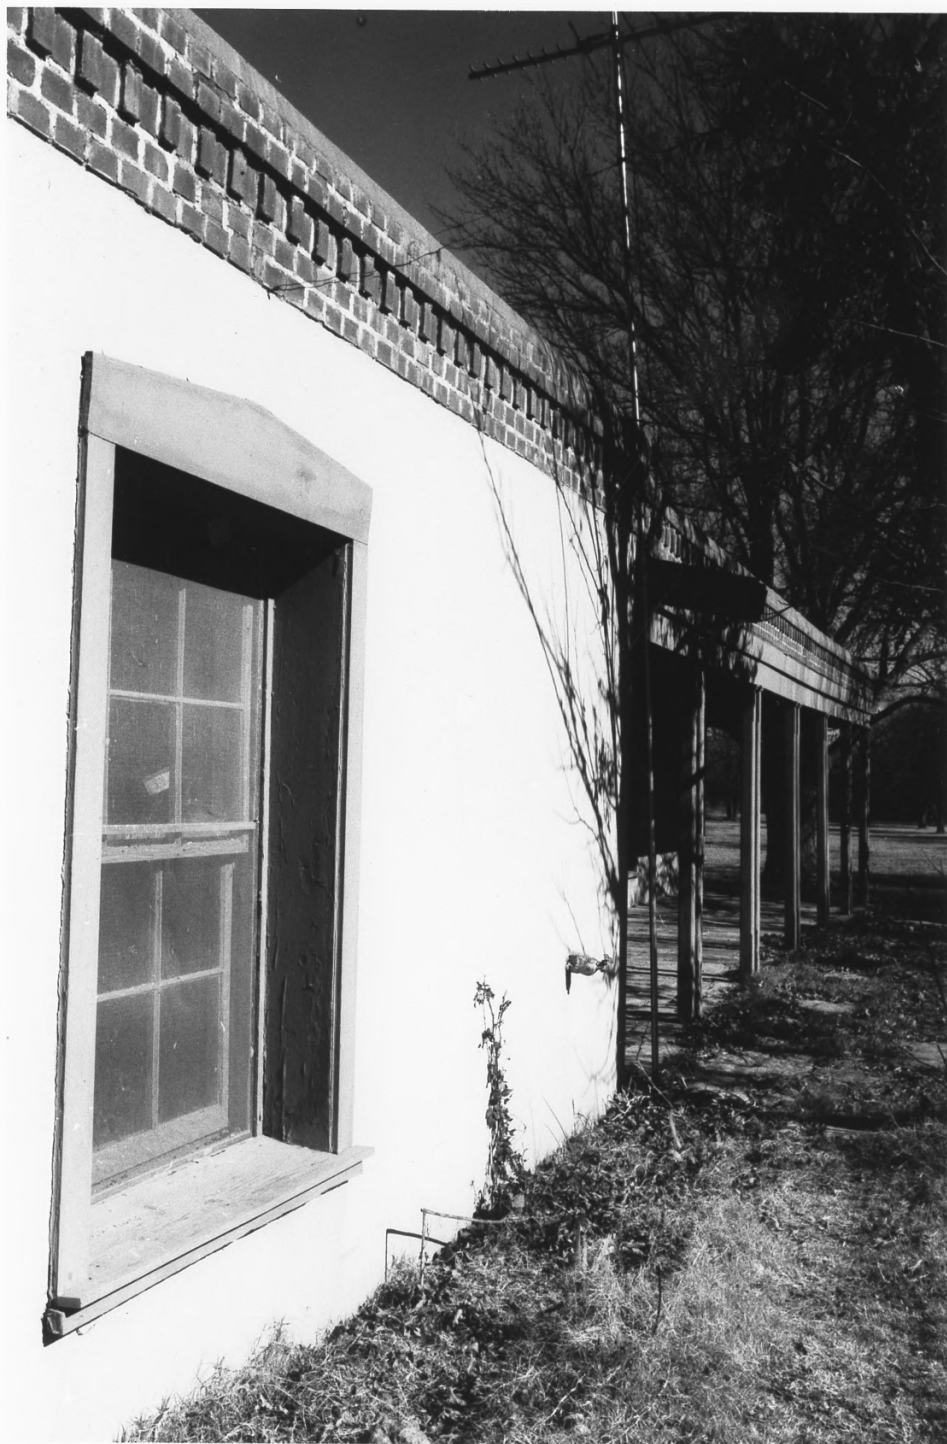
(1) Ranger's Residence, NPS Bldg #22,  
(C), looking E along front facade  
showing window of garage, denti-  
culated brick cornice, and portal.

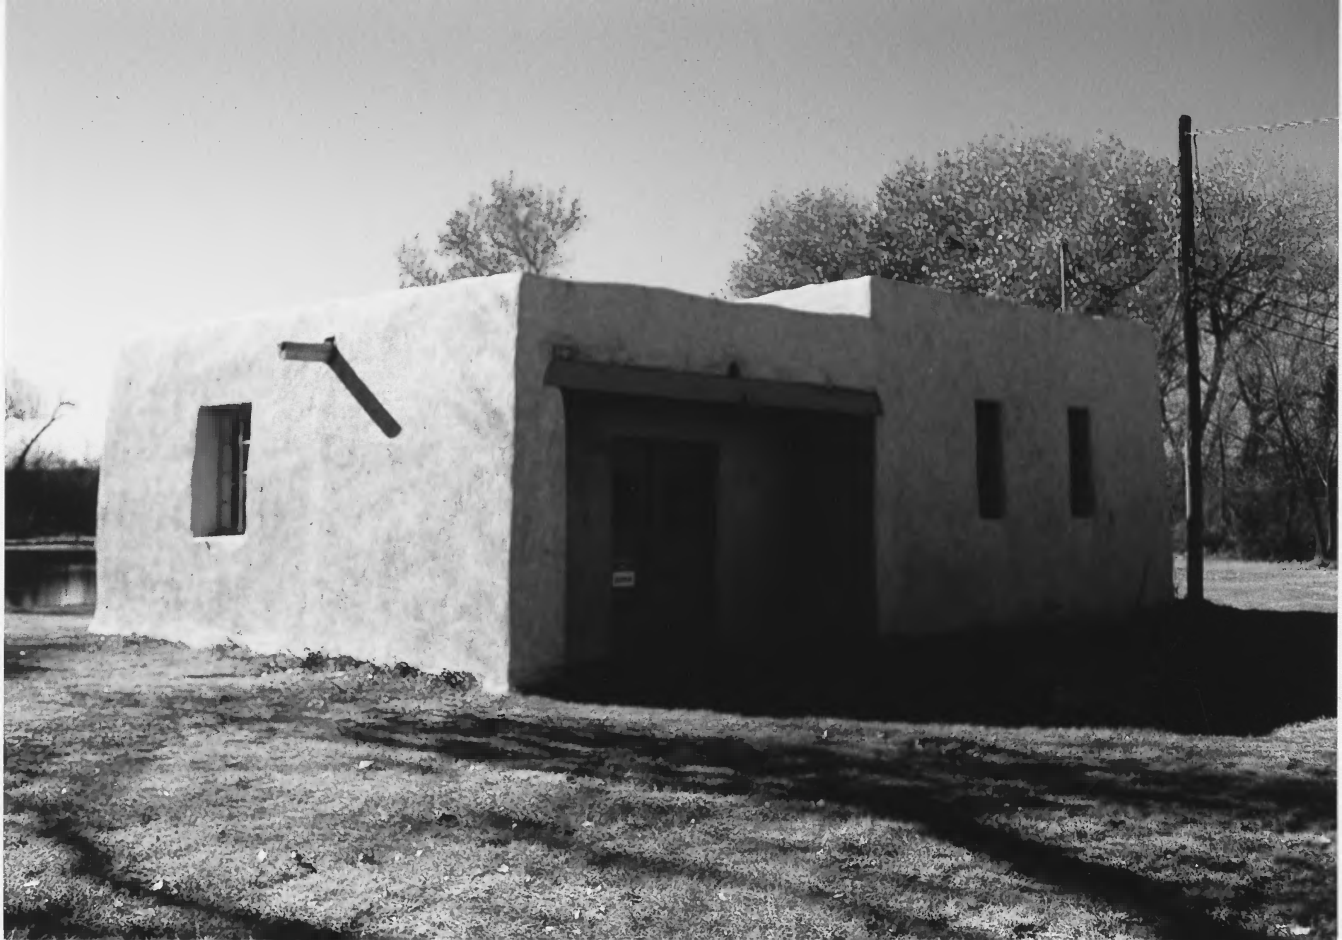
(2) Pump House, NPS Bldg #20, (C),  
front looking SW.

The pump house is perhaps one quarter the size of a typically monumental pueblo mission church of the Spanish colonial period. The diminutive appearance of the mission church-pump house contributes to the building quaint and picturesque qualities characteristic of the "rustic" mode.

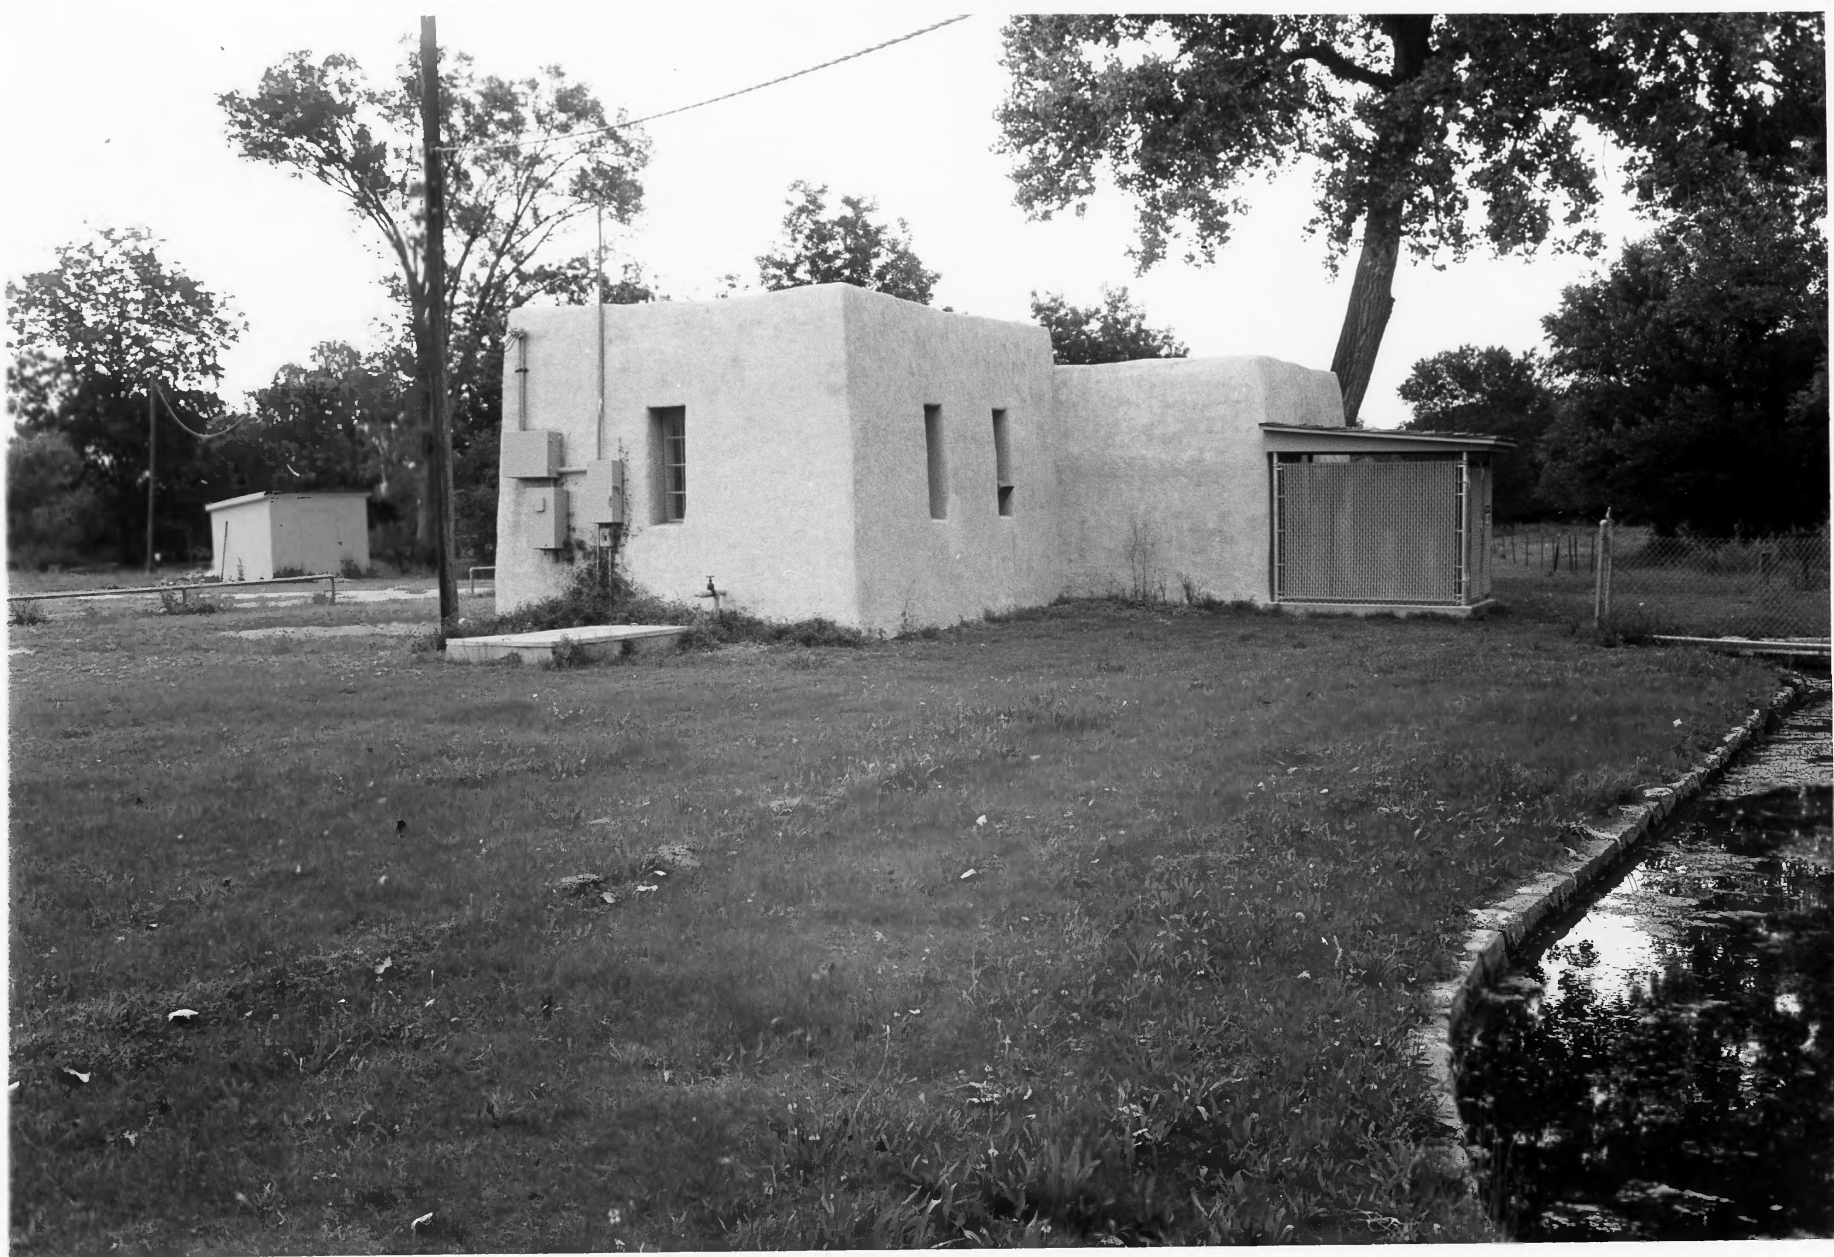
- (2) Pump House, NPS Bldg #20, (C)  
rear looking NE showing 1986  
addition to house chlorine tank.
- (3) Pond (C) at right.
- (12) Shed (NC) at left.

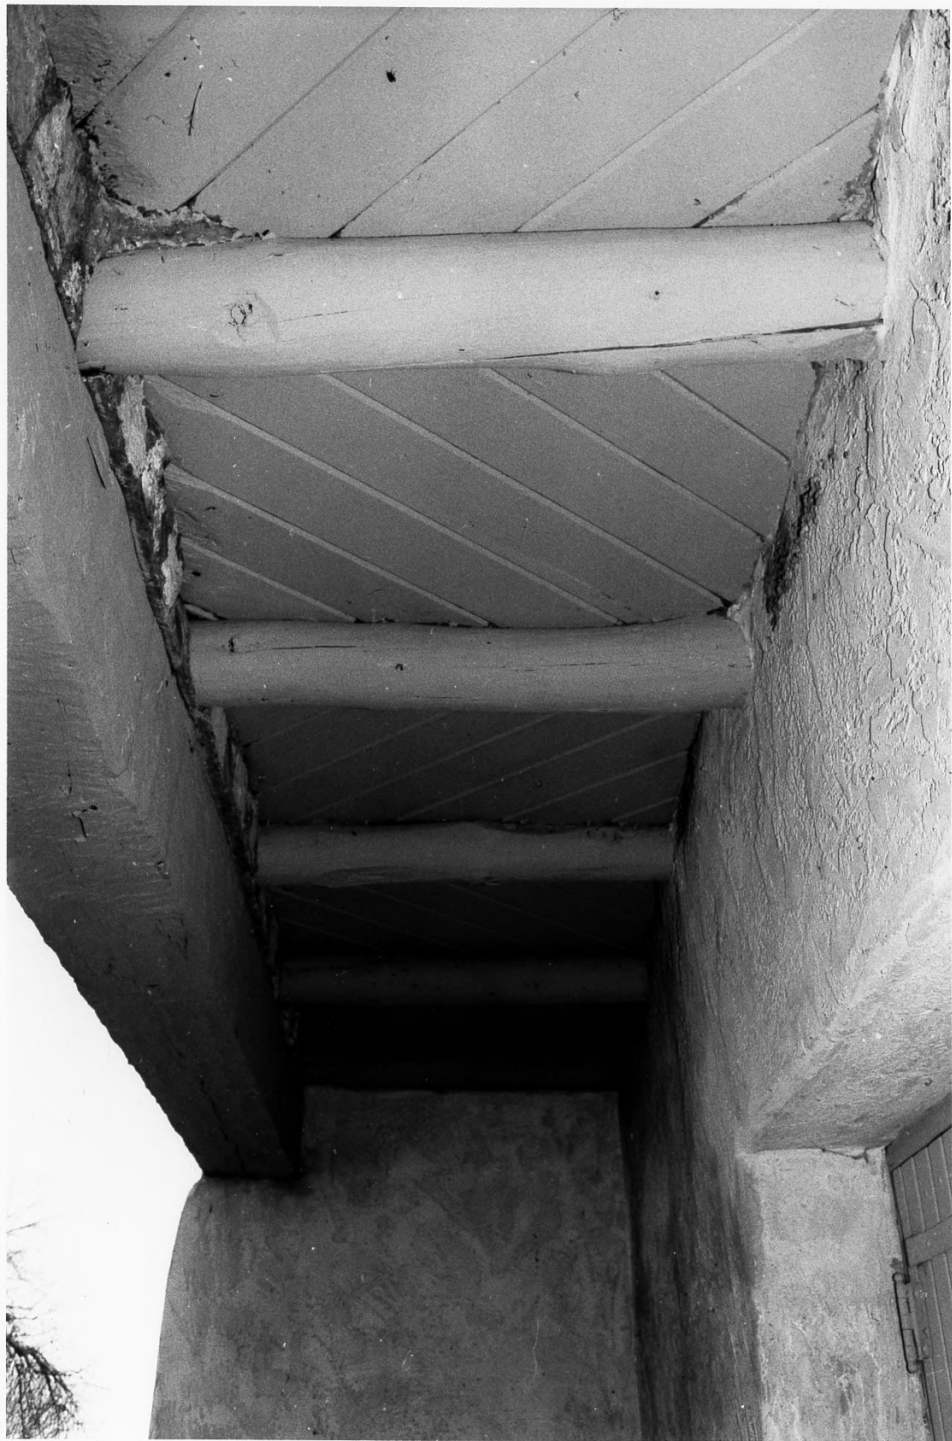
(2) Pump House, NPS Bldg #20, (C),  
ceiling of recessed entrance or  
narthex, showing vigas, planks  
laid in herringbone pattern,  
adzed lintel.

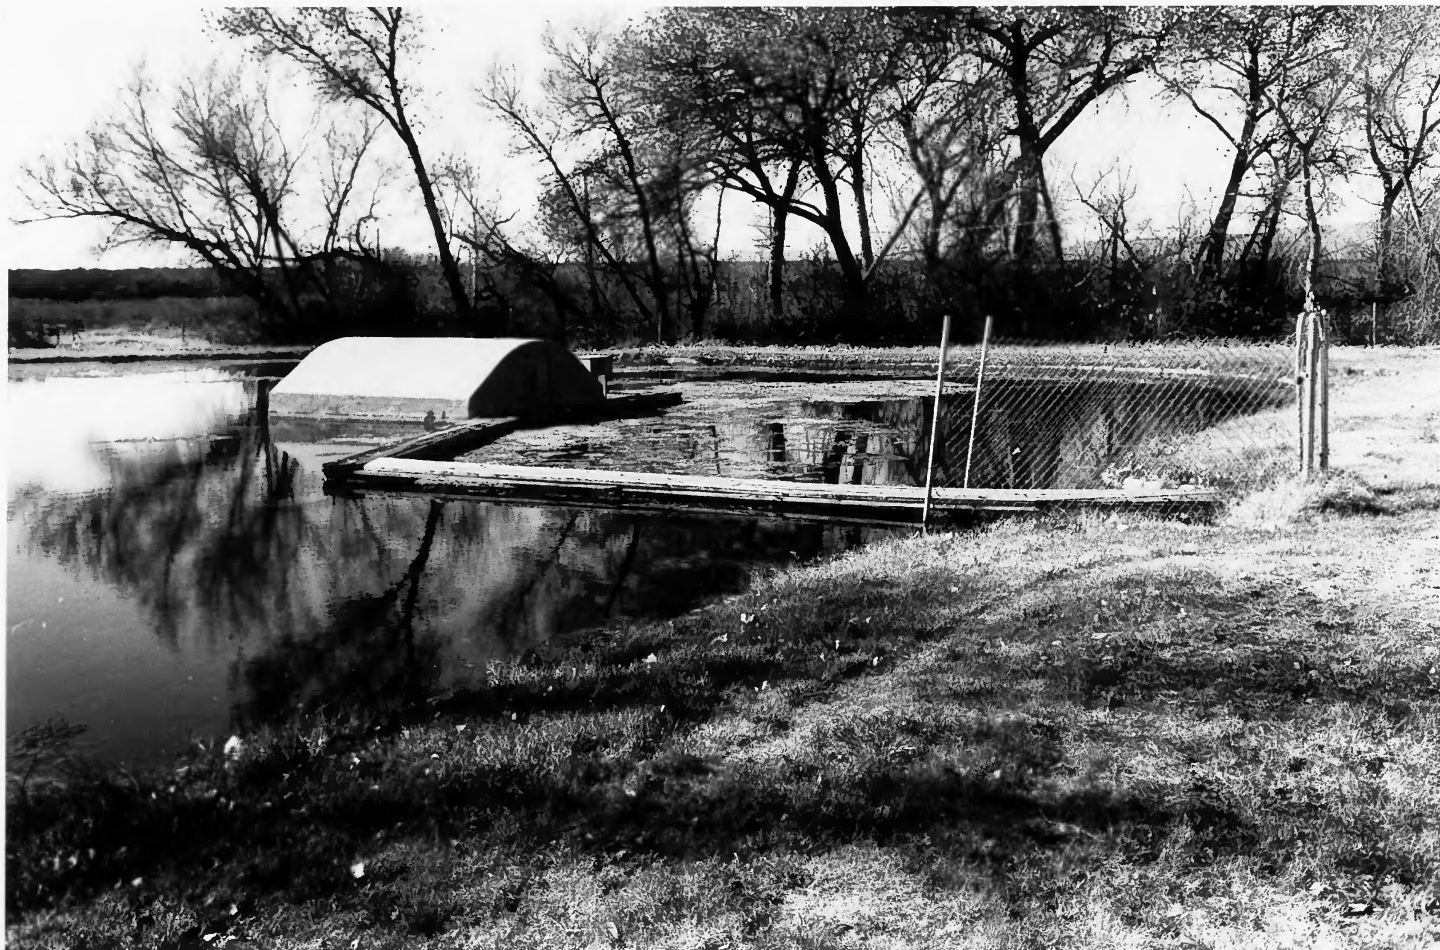
(3) Rattlesnake Springs Pond, spring  
house (C), looking SW.

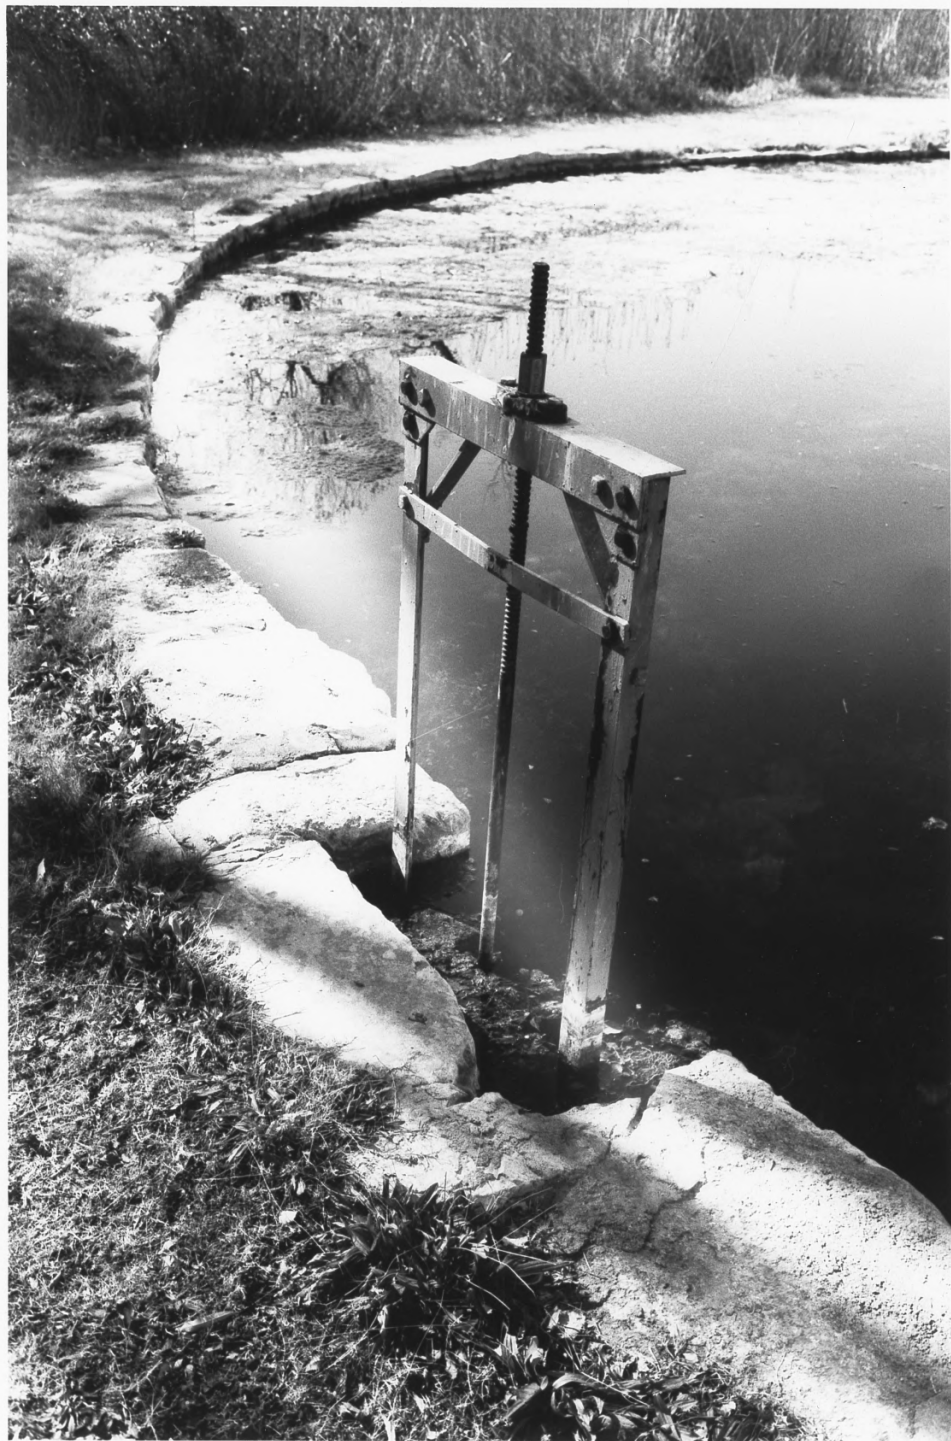
(3) Rattlesnake Springs Pond, limestone block wall of east side of pond, showing iron headgate,  
(C). Looking S.

Following purchase by the United States government of a portion of the Harrison property in 1934, the NPS made additional improvements to the springs in order that the springs might serve as the source of water supply for Carlsbad Caverns. Plans were drawn under the direction of NPS Acting Chief Engineer A. W. Burney for an underground pipeline to extend six miles to the caverns, and for a spring house and pump house at the spring (see separate description of pump house, #2). The original location chosen for these improvements on the east side of the pond had to be abandoned because of the marshy character of the soil and the high watertable. New locations were chosen on the north side of the pond, and work was completed in 1935. In that year, the spring house, also called the "inlet box," was erected in the pond near the north side. It is a partially submerged concrete structure measuring about 12 feet by 12 feet with a vaulted roof, small iron door at one end, and small louvered window at the other end. It contains a turbine sump pump that lifts water from the pond reservoir for delivery to the pump house on shore by means of a subsurface six-inch suction pipe connecting the two structures. Attached to the west side of the spring house is a small object called a "metal gage house" or "stilling well recorder house," built in 1961. It consists of a steel box with a lid, measuring 24 inches by 16 inches, resting on top of an upright 12-inch corrugated metal culvert which sits in the pond. Both these facilities are accessible from the shore by means of a wooden catwalk which is enclosed with a fence and gate at the shore. A four-inch buried pipe line conducts water from the pumphouse on shore to the caverns six miles away.

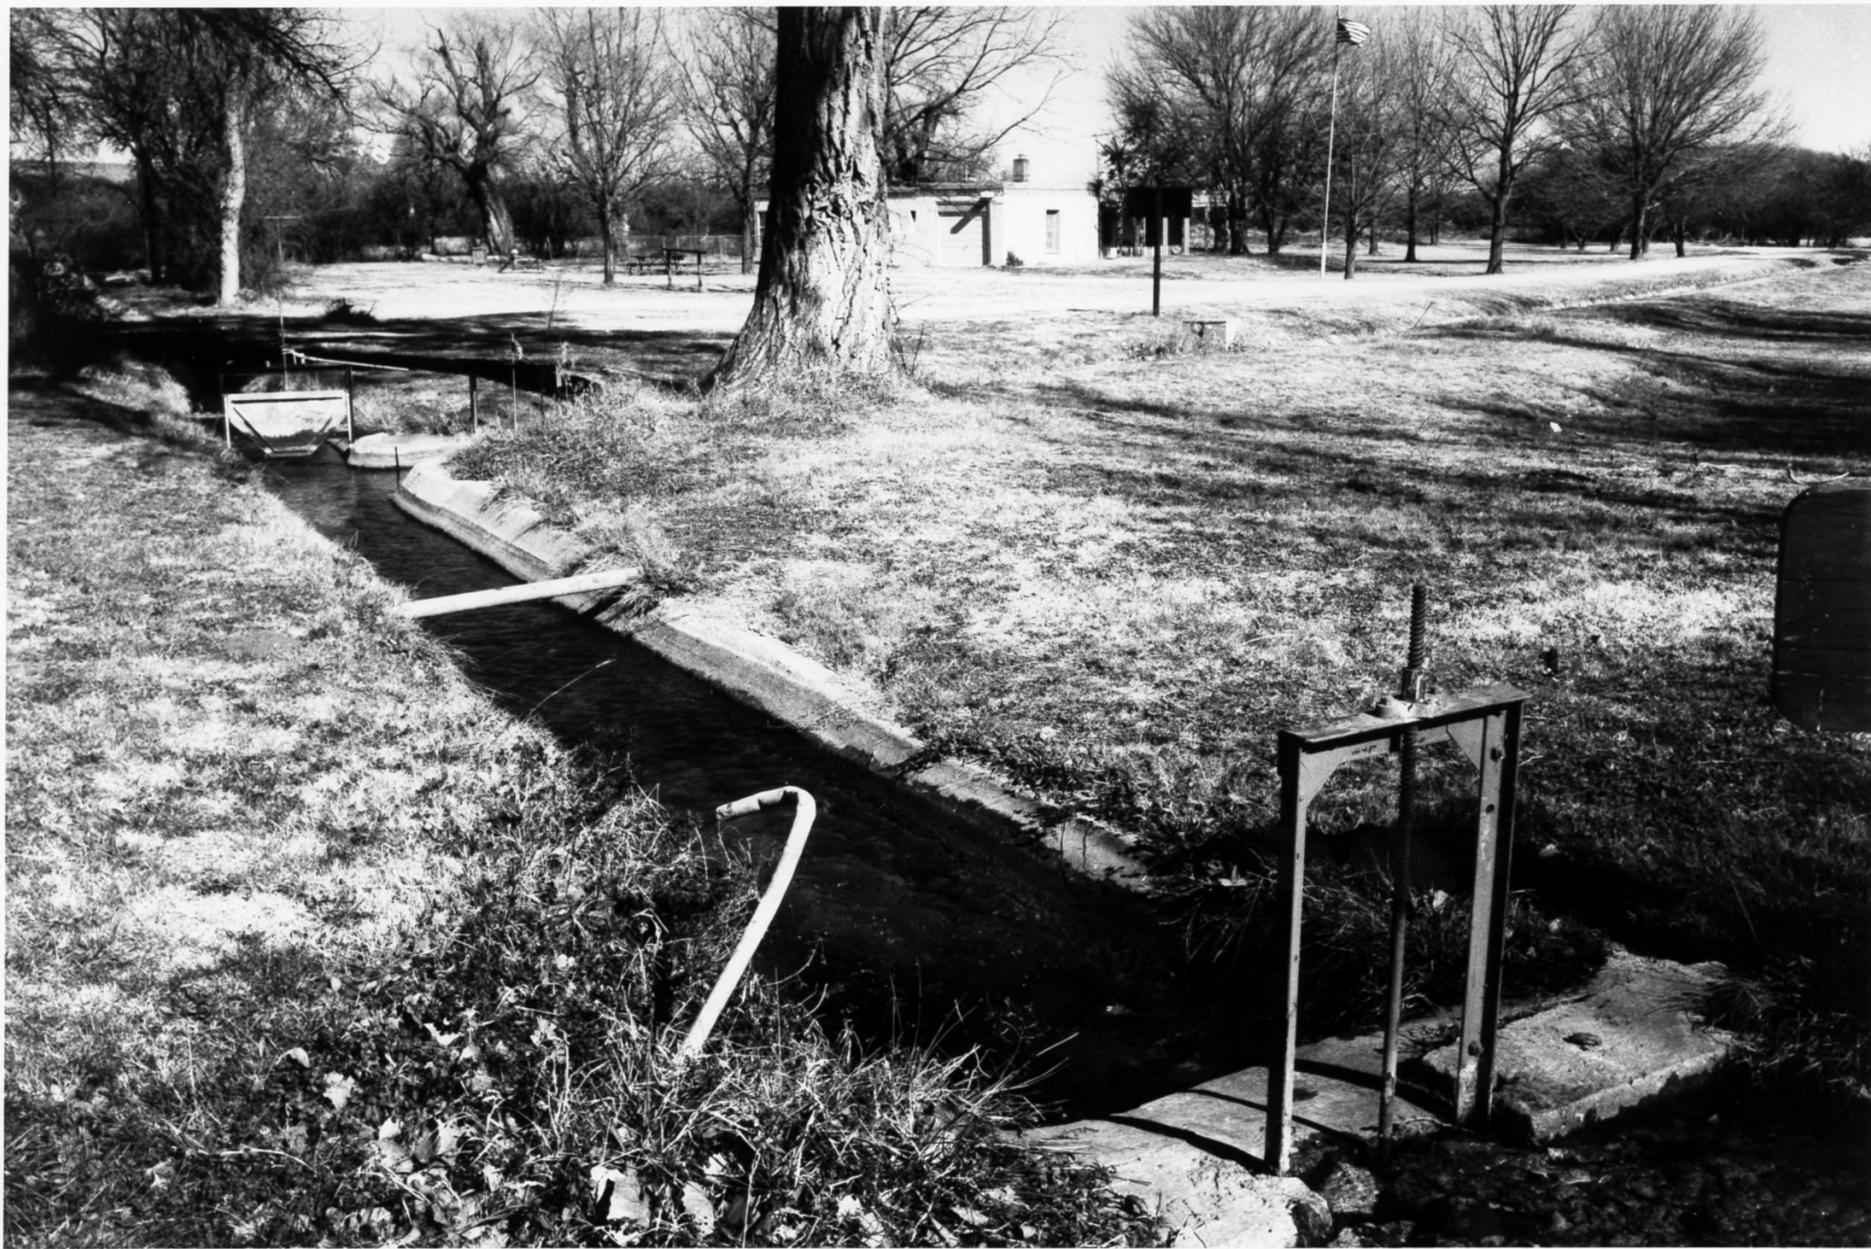
(3) Rattlesnake Springs irrigation  
ditches, looking NE toward (1)  
ranger residence from pond. (C)  
Headgate in foreground; orchard  
(4) in background at right. (C).

An irrigation system constructed by homesteader Henry Harrison in 1881-2, which utilizes the natural slopes of the land, is still in use, with some additions and improvements. As designed by the homesteader, ditches edge the sides of the draw at the highest level by which water can be carried by gravity. Lateral ditches, some added subsequent to the homesteader's ownership, feed water by means of flume gates from the main ditches onto the slopes of the draw.<sup>1</sup>

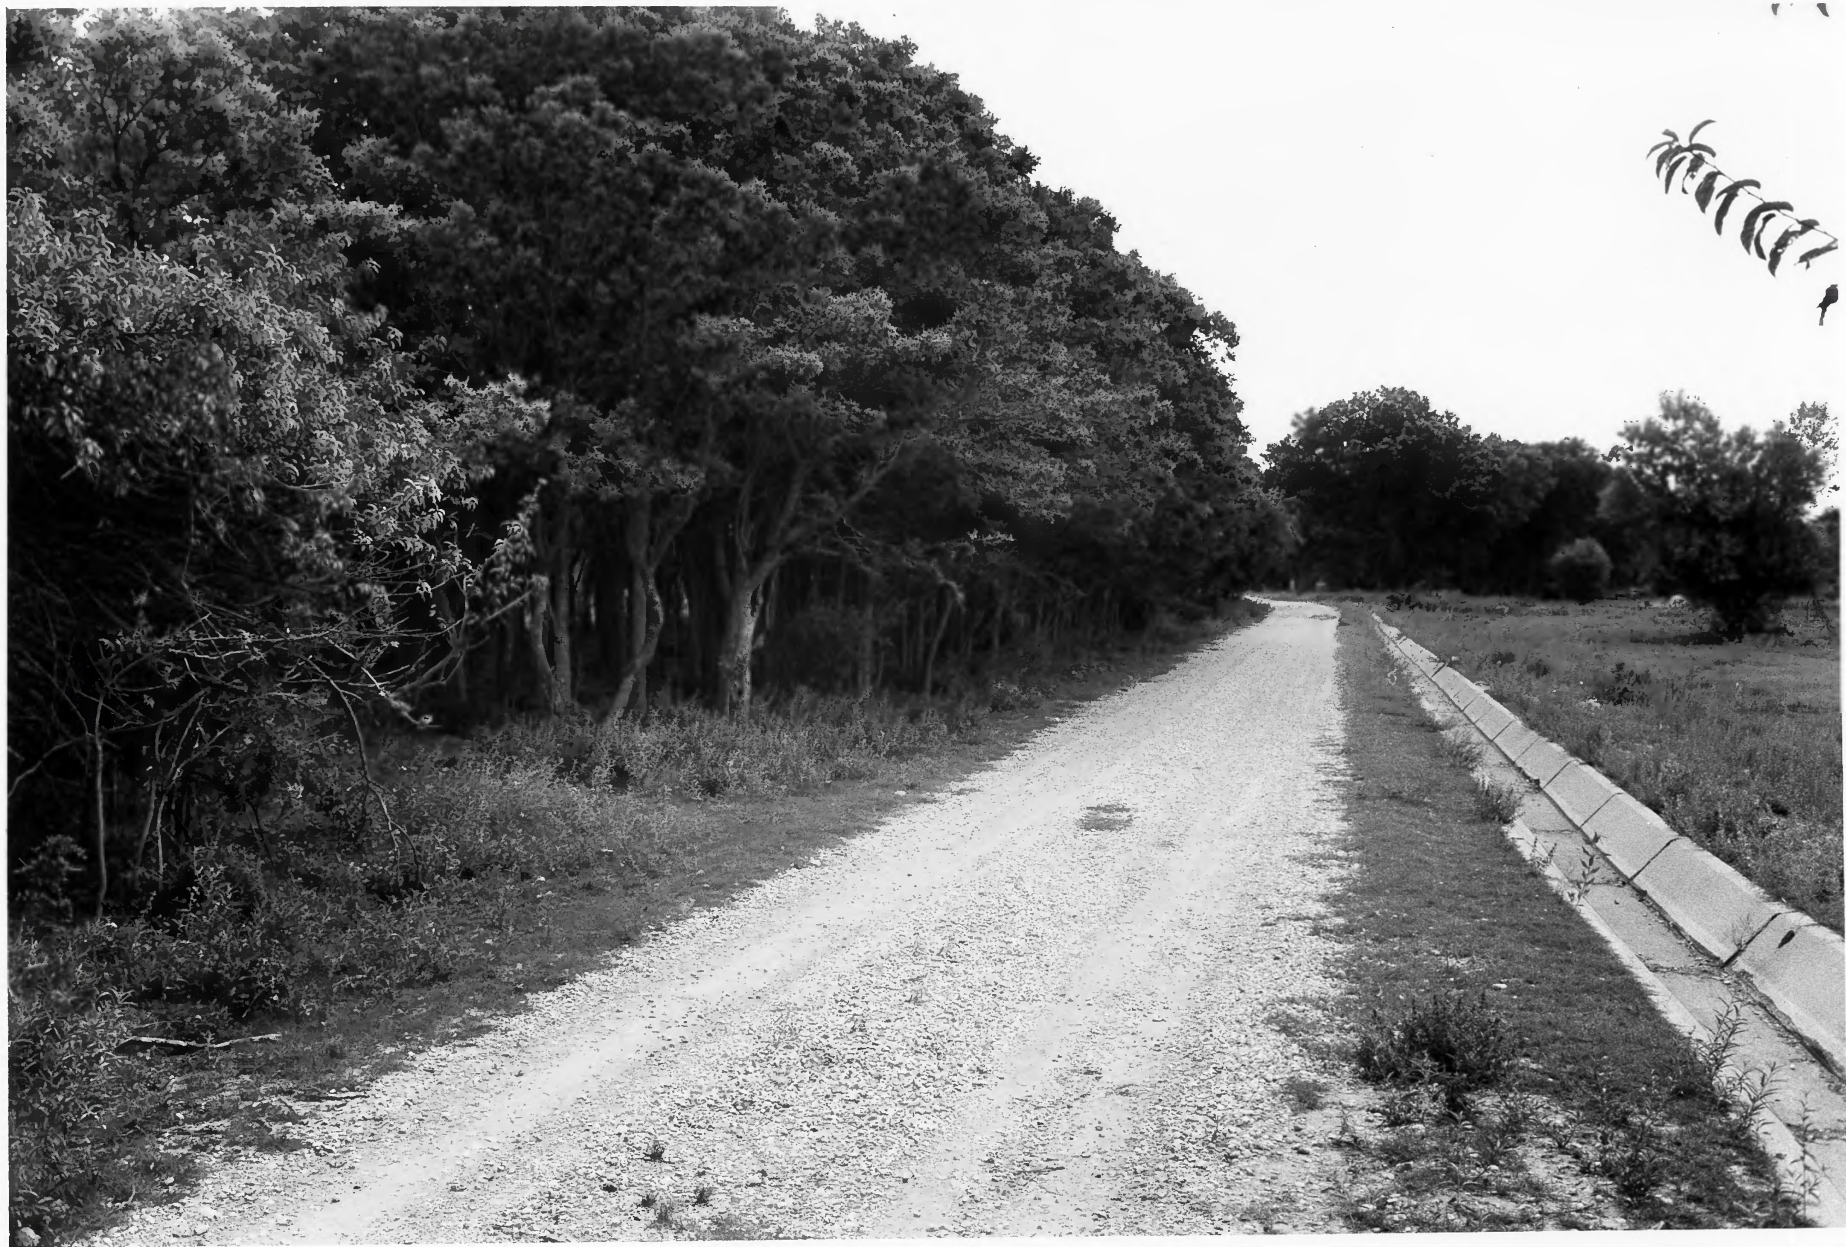
Service road, looking E from fruit orchard toward CCC camp area, showing irrigation ditch (3) and horse pasture (6) at right, Western soapberry thicket at left. All (C).
