UNITED STATES DEPARTMENT OF THE INTERIOR  
NATIONAL PARK SERVICE  
**NATIONAL REGISTER OF HISTORIC PLACES  
INVENTORY -- NOMINATION FORM**

Rattlesnake Springs Historic District

Rattlesnake Springs Historic District  
Carlsbad vicinity, New Mexico

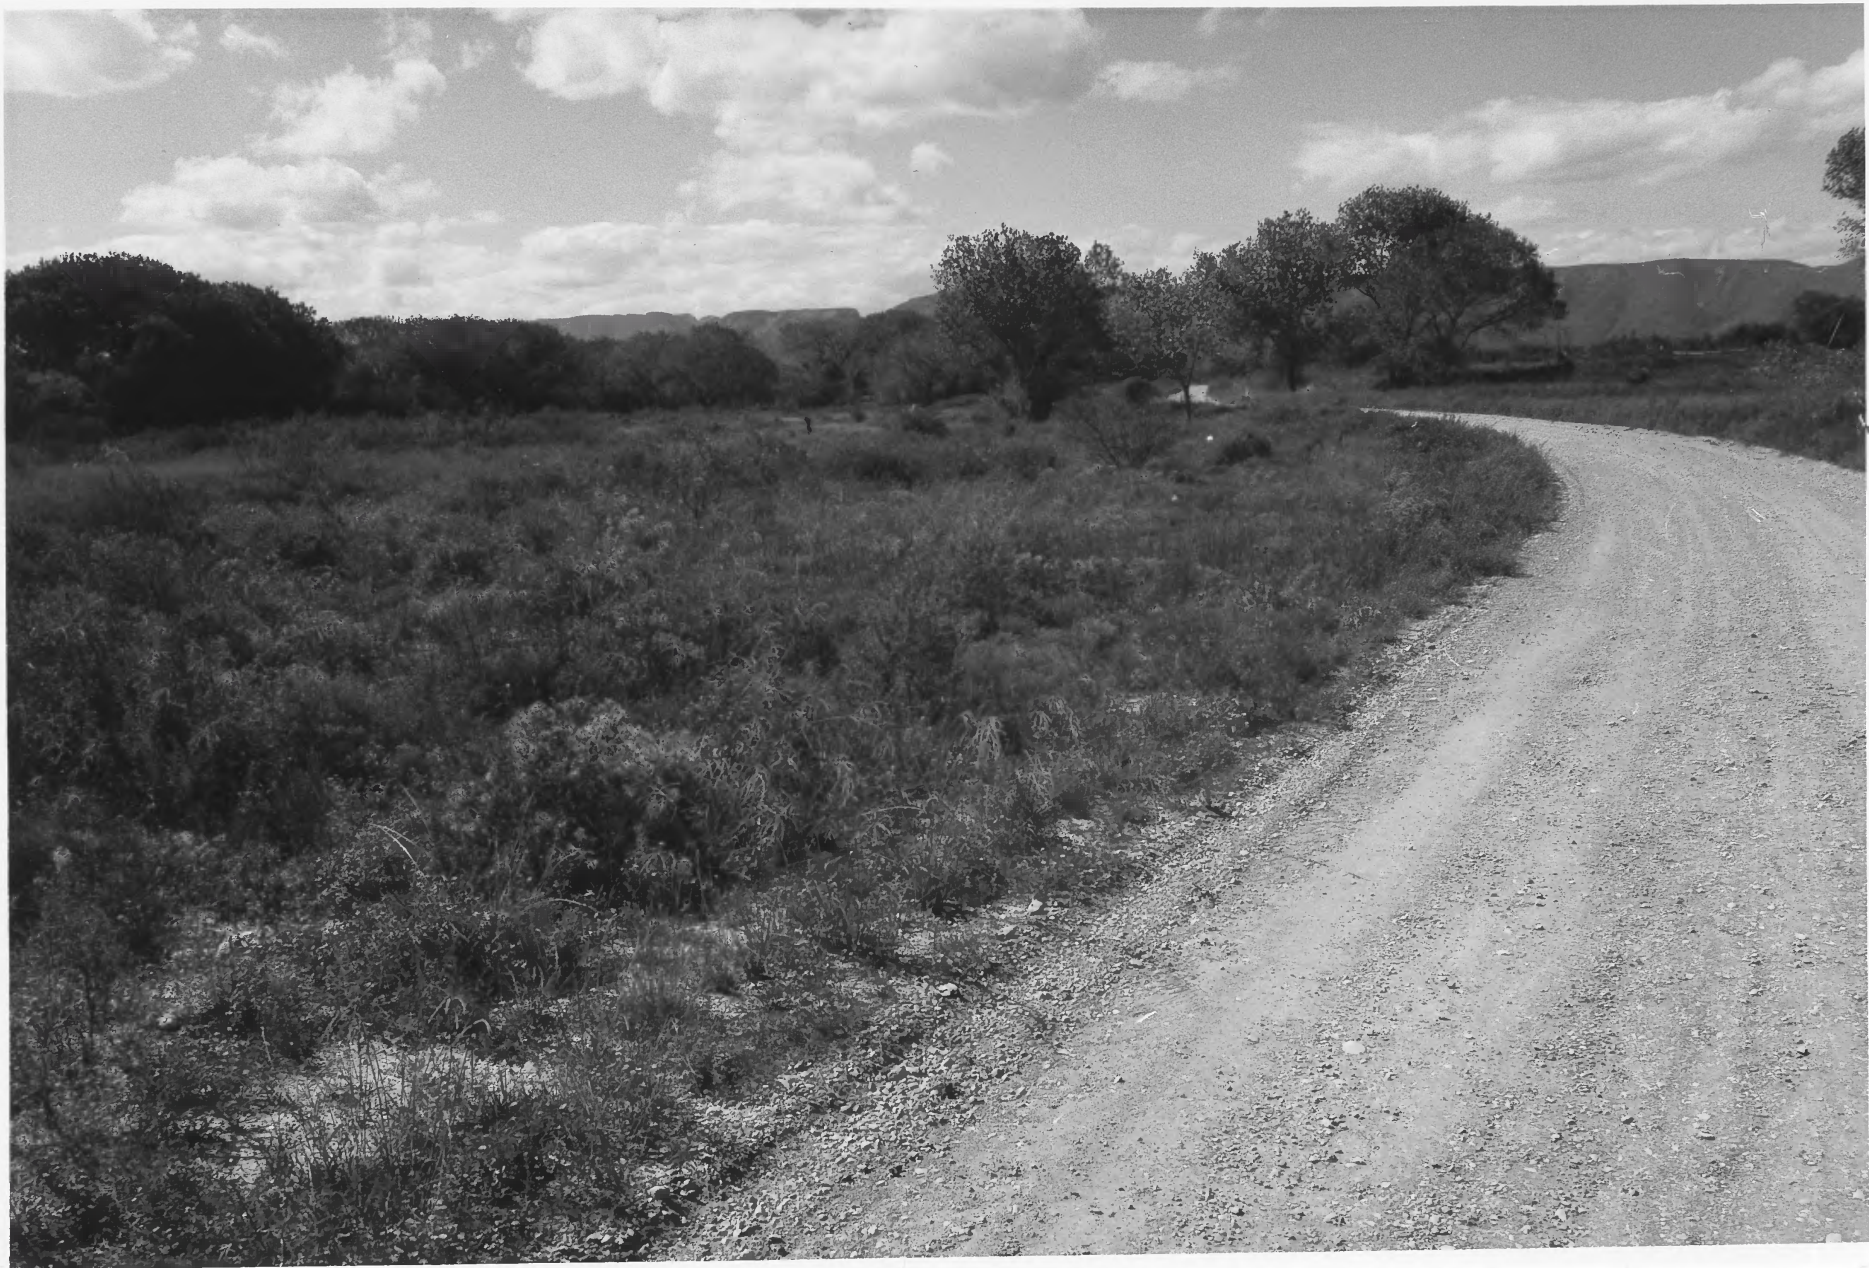
(6) Pasture at east end of property, looking E toward Guadalupe Mountains and cottonwood trees of Civilian Conservation Corps camp (7), showing road, position of old CCC road (at center) and position of buried swimming pool (in distance at left). (C)

Building of the pool necessitated moving the CCC entrance road from the central route leading to the flagstaff circle, and relocating the road on the north edge of the property where it is today. The bed of the old CCC entrance road can be seen diverging from the present road near the entrance to the Rattlesnake Springs property, and running across the open pasture land. The old road bed is most visible in summer when it is densely covered with snakeweed (Gutierrezia sarothrae), a subshrub covered with small yellow flowers. Snakeweed is abundantly found where land has been overgrazed or disturbed, as on old road beds. A baseball diamond and basketball court were also located in this open area, but their precise former locations are not known.

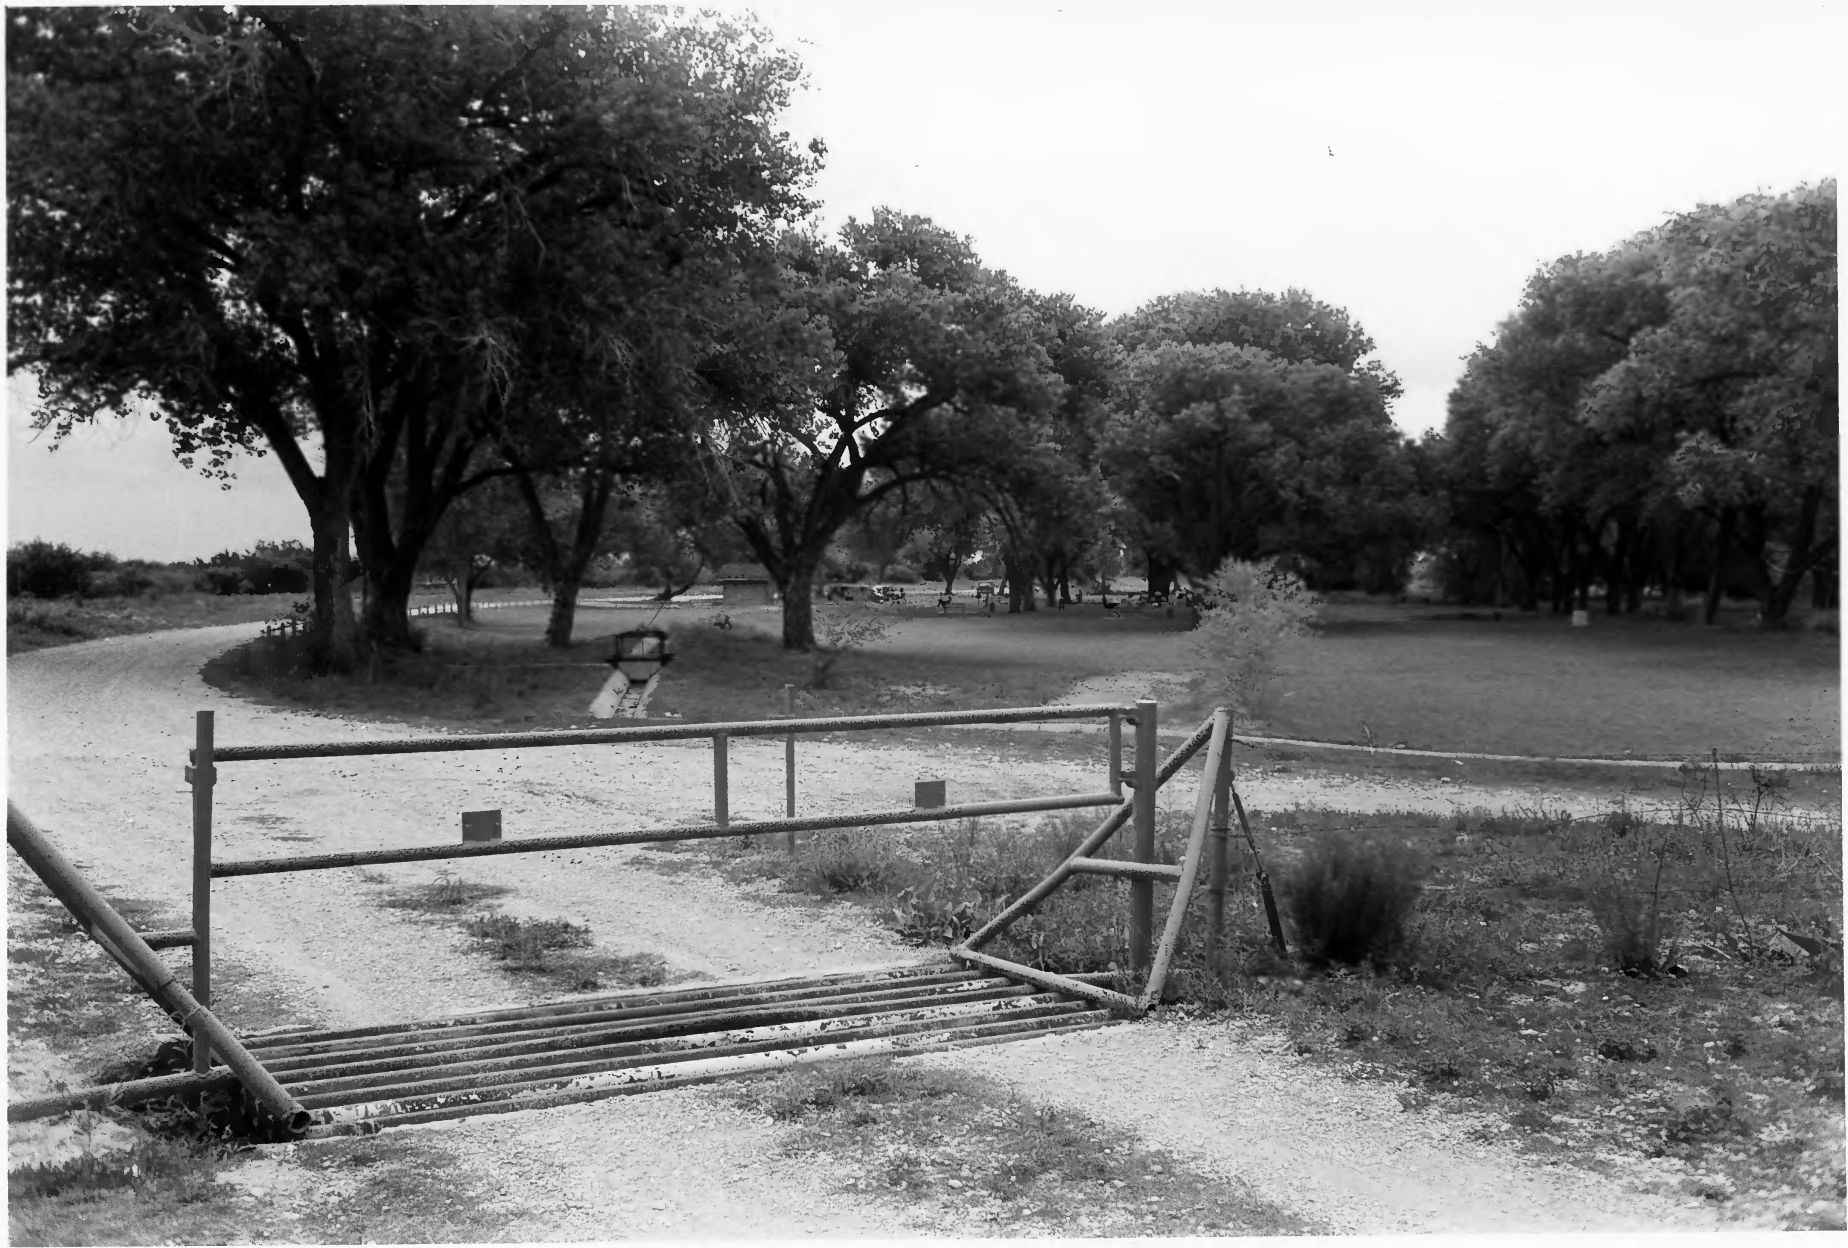
(7) Civilian Conservation Corps camp  
site with rows of cottonwood trees  
looking E. (C)

In 1986, the NPS cut five of the trees from the CCC camp site rows in the belief that the trees are growing old and may present a safety hazard. Although the wood is weak and the limbs need frequent pruning, cottonwoods grow for hundreds of years and aged examples are noted for gracing certain historic public areas. According to the American Forestry Association publication by G. H. Collingwood and Warren D. Brush, Knowing Your Trees,

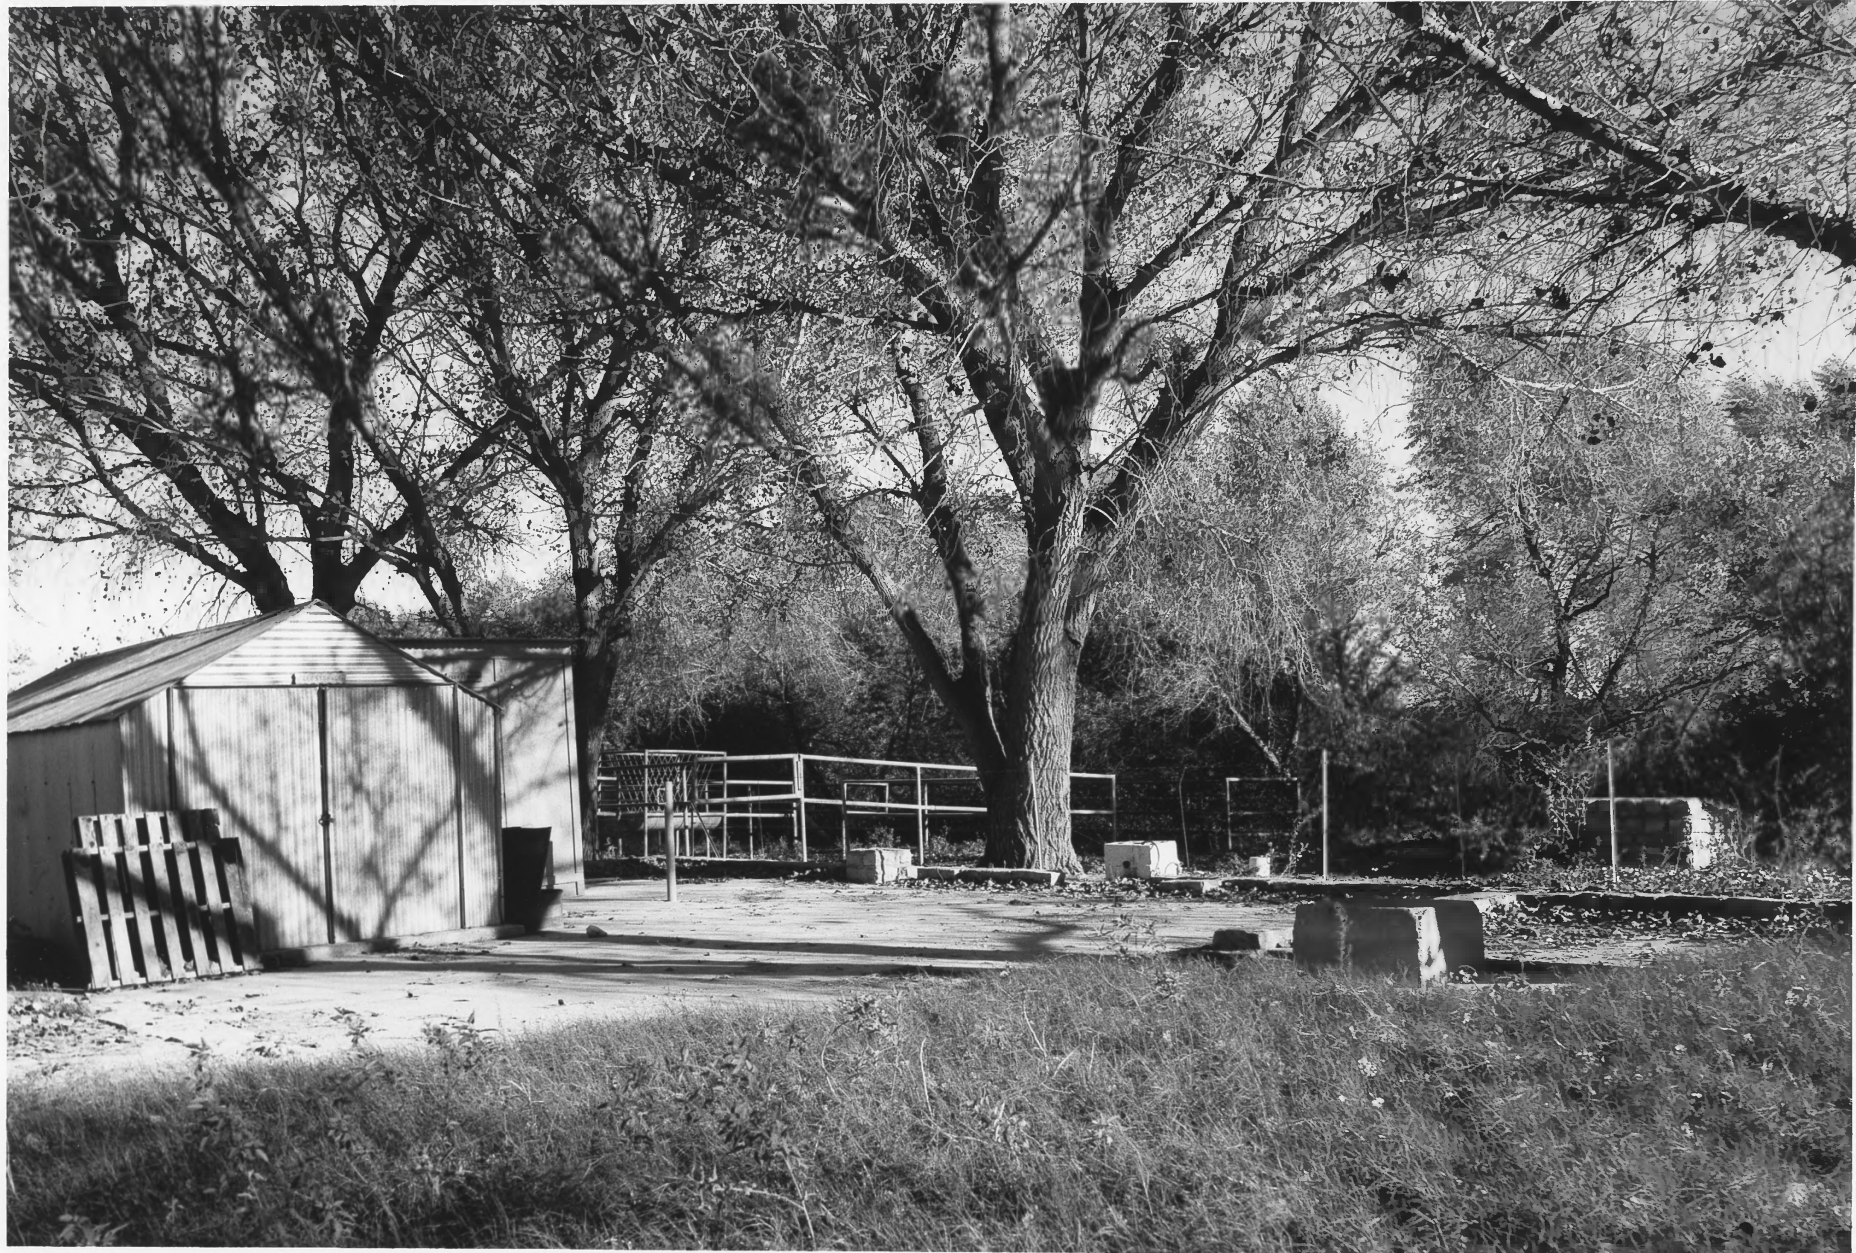
Horse corral area on stone foundations of CCC Utility Building (7) (C), showing Horse Feed Storage Shed at left (10) (NC), Tack Shed behind it (11) (NC), metal corral (NC), Stone loading ramp at right (7) (C). Looking SE toward Rattlesnake Springs Seep.

The rock foundations and concrete floors of this building remain and are used as part of a horse corral and feeding area. The rectangular foundations measure about 50 feet by about 20 feet. A metal building and a plywood building have been erected on the foundations for tack and feed storage. A metal corral with a concrete feeding trough is located at the rear of the foundations. All of these constructions are recent and are therefore non-contributing to the district.

At the rear of the foundation, near the south NPS property line, is a mortared limestone loading ramp measuring about 15 feet long, 18 feet wide, and three feet high. The stones used to construct the ramp are both rough-cut and uncut. The sides of the ramp are stepped with four tiers. This is the only intact above-ground structural feature remaining on the site of the CCC camp. A concrete slab and stone rubble in a pasture about 100 feet west of the utility building mark the site of the blacksmith shop.

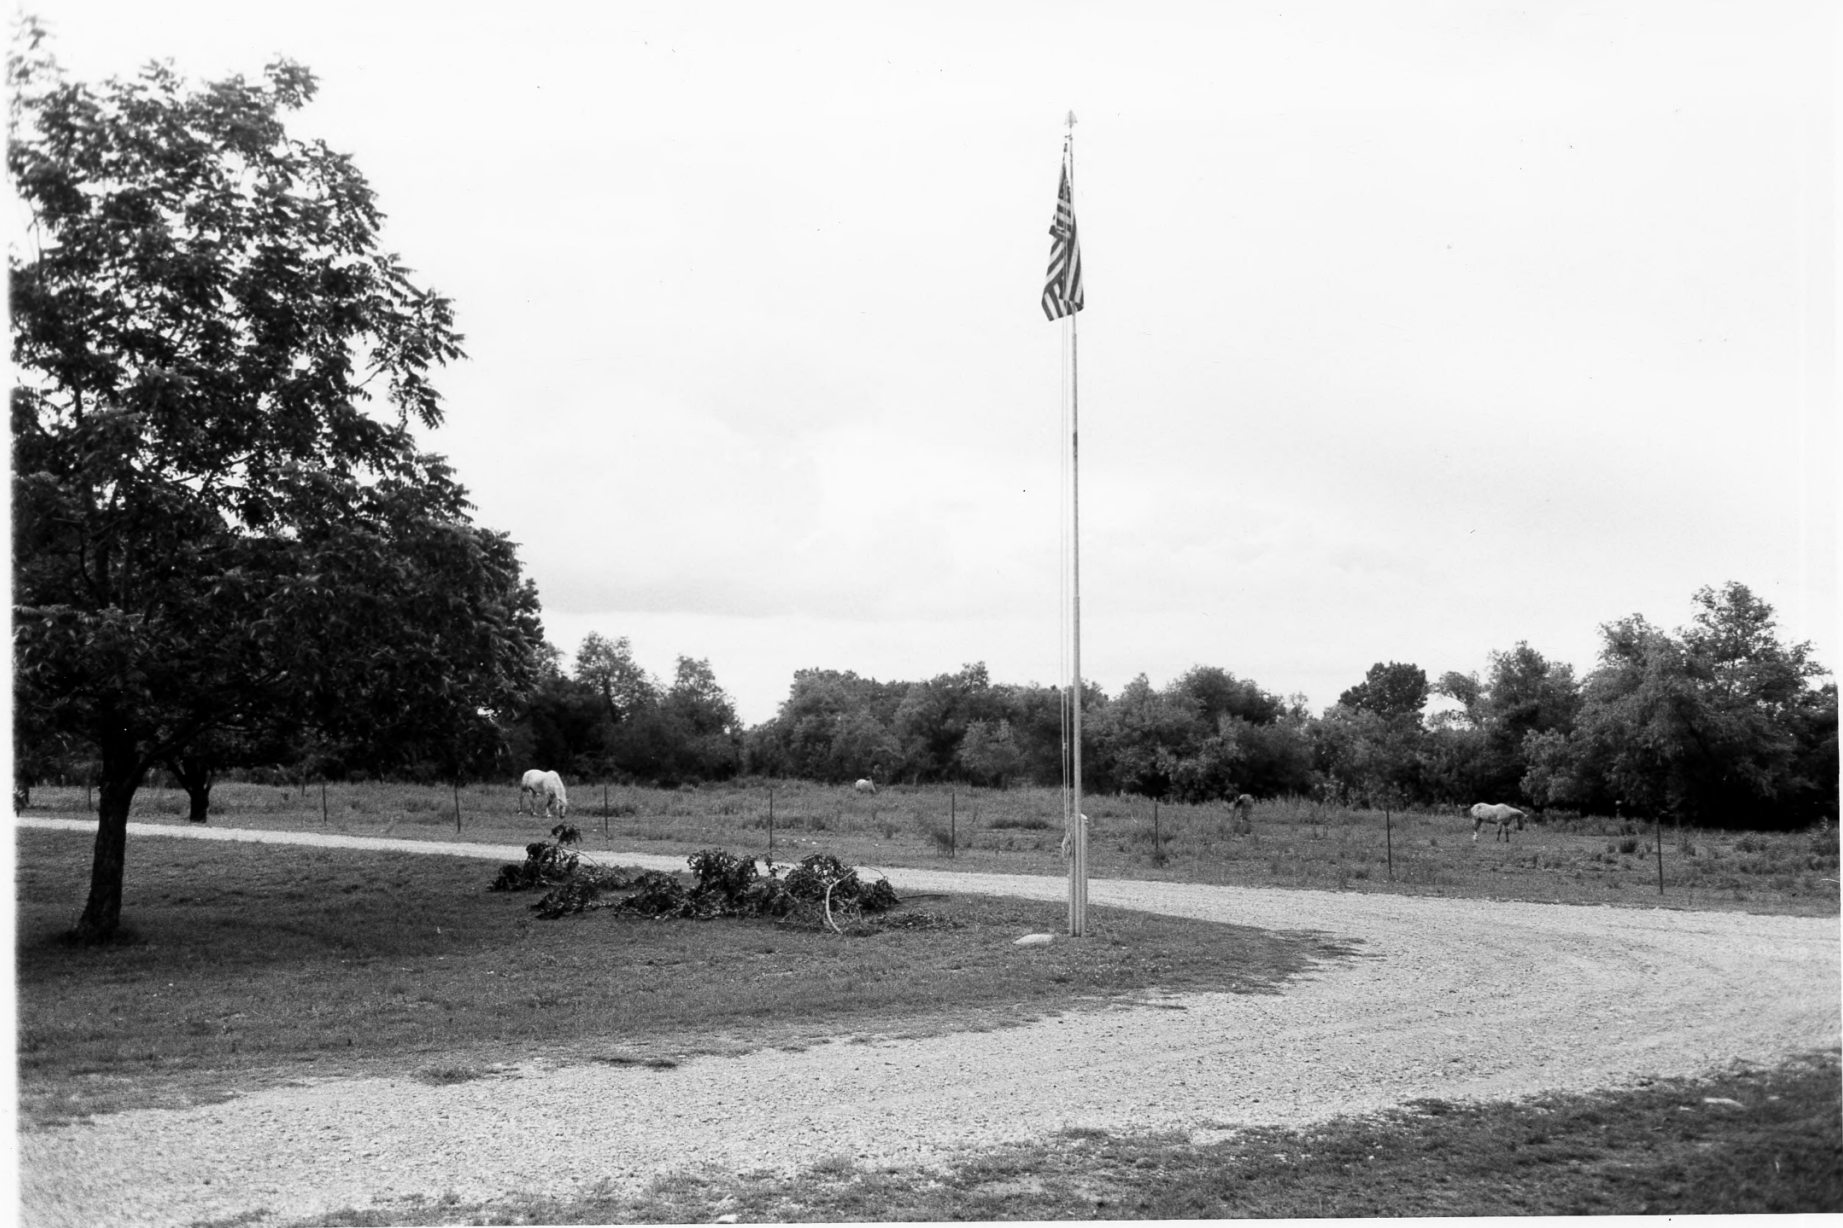
(8) Henry Harrison homestead house  
site, in pasture area (6), looking  
S from yard of ranger residence(C)

According to family tradition, the house was a large adobe building of five rooms. The raised area may represent dissolved adobe from the walls of the house. The rectangular area is scattered with small stones which were typically used in the foundations of adobe houses. It is also scattered with historical artifacts, including ceramics; brick fragments; a shell button; a large wrought-iron frying pan handle; a piece of a horseshoe; and purple, green, white and brown glass fragments, some of which have been melted by heat.

Archaeological excavation would be needed to attempt to determine the actual age of the house site across from the ranger residence. The 1921 "Map of the Harrison Ditch System" shows a house located on or near this site. However, information derived from family sources indicates that, at some point in time, Harrison also had a four-room frame house near the spring pond. The 1921 map also shows a building located on or near the site of the ranger residence. This building was possibly a barn, but no surface evidence of the former structure could be found in examination of the ground around the ranger residence. The NPS demolished remaining homestead buildings after acquisition of the property in 1934.

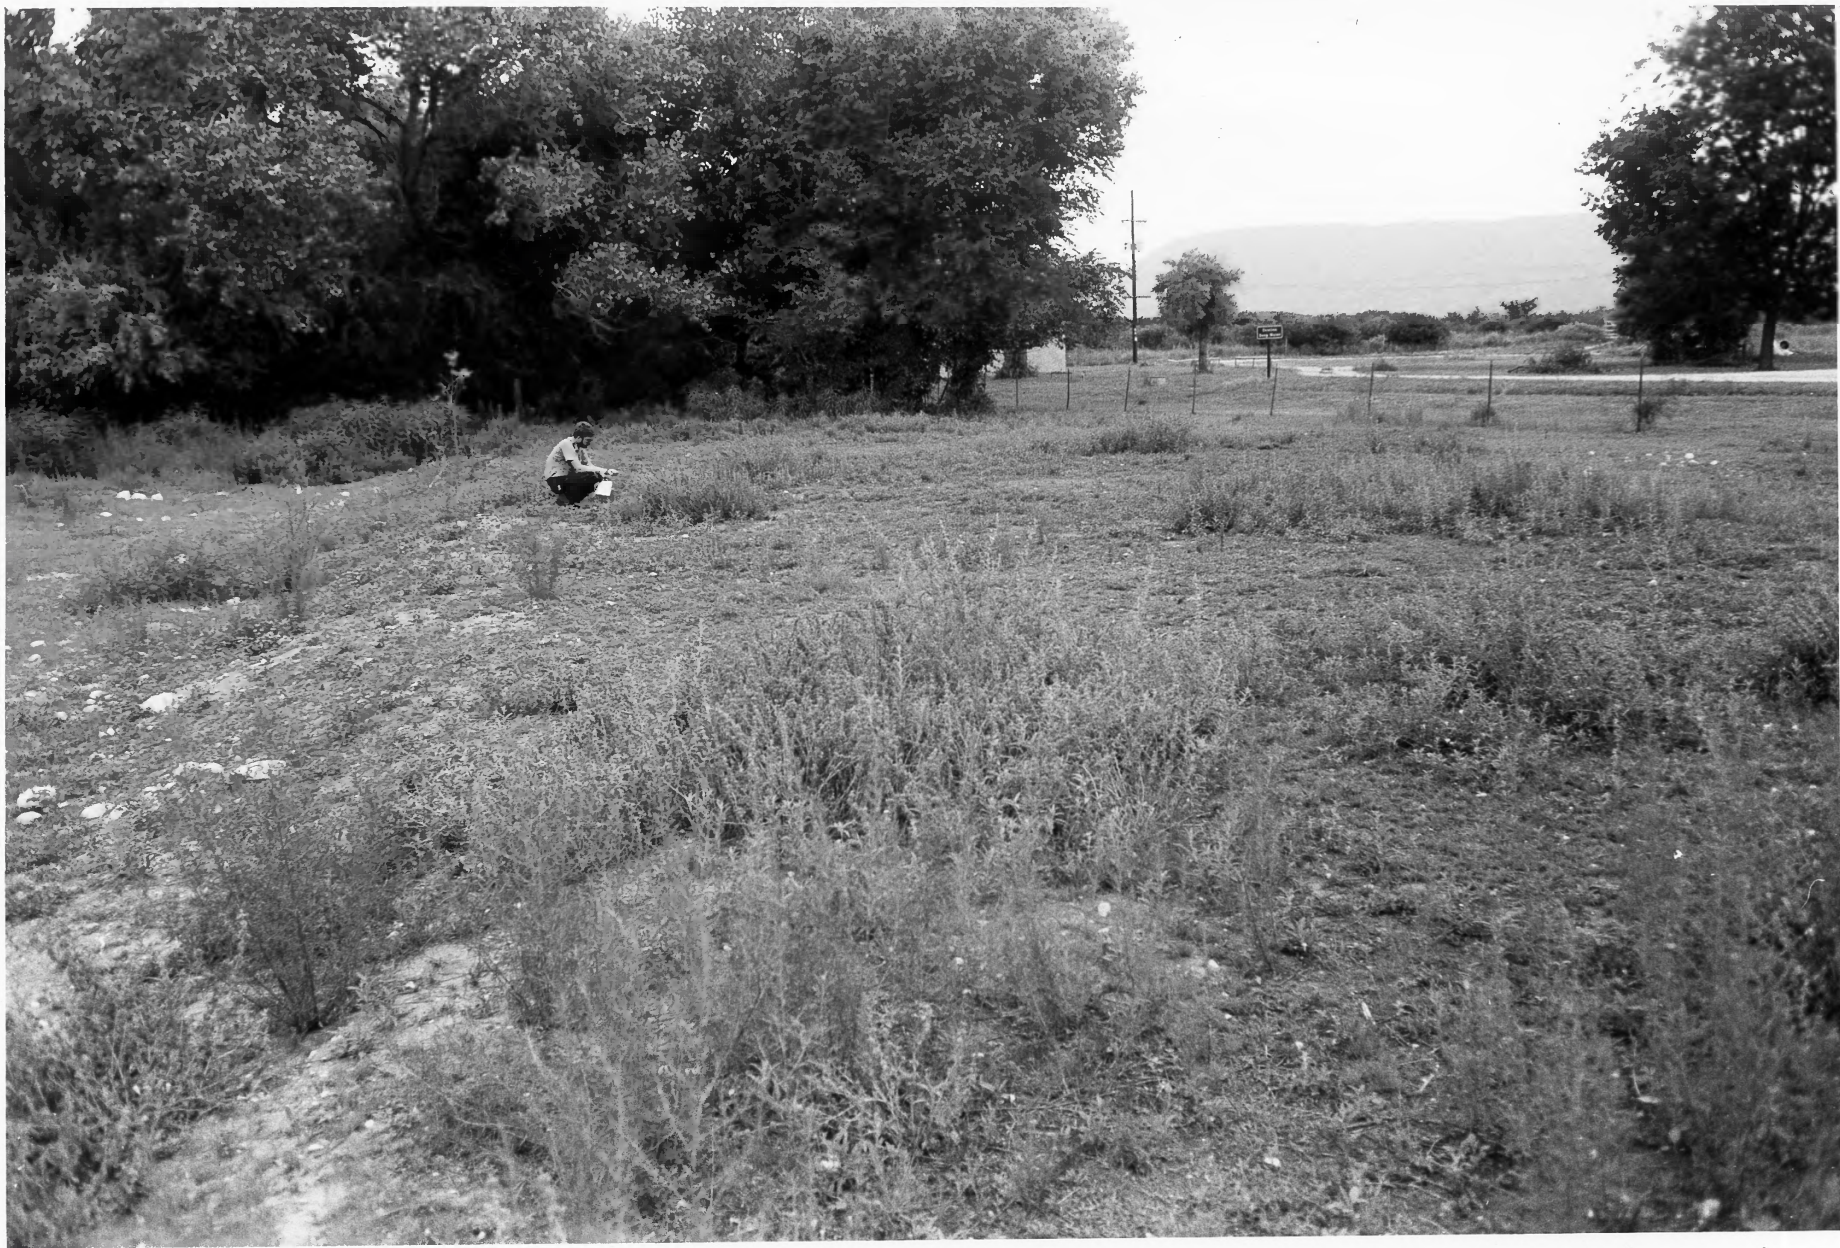
(8) Henry Harrison homestead house  
site, Ranger Kim Watson examin-  
ing artifacts, looking W. (C)

According to family tradition, two of Harrison's houses burned. Surface artifacts collected at the site were estimated by archaeologist Jake Ivey of the NPS Southwest Regional Office in Santa Fe to be domestic materials dating from about 1880 to about 1900.

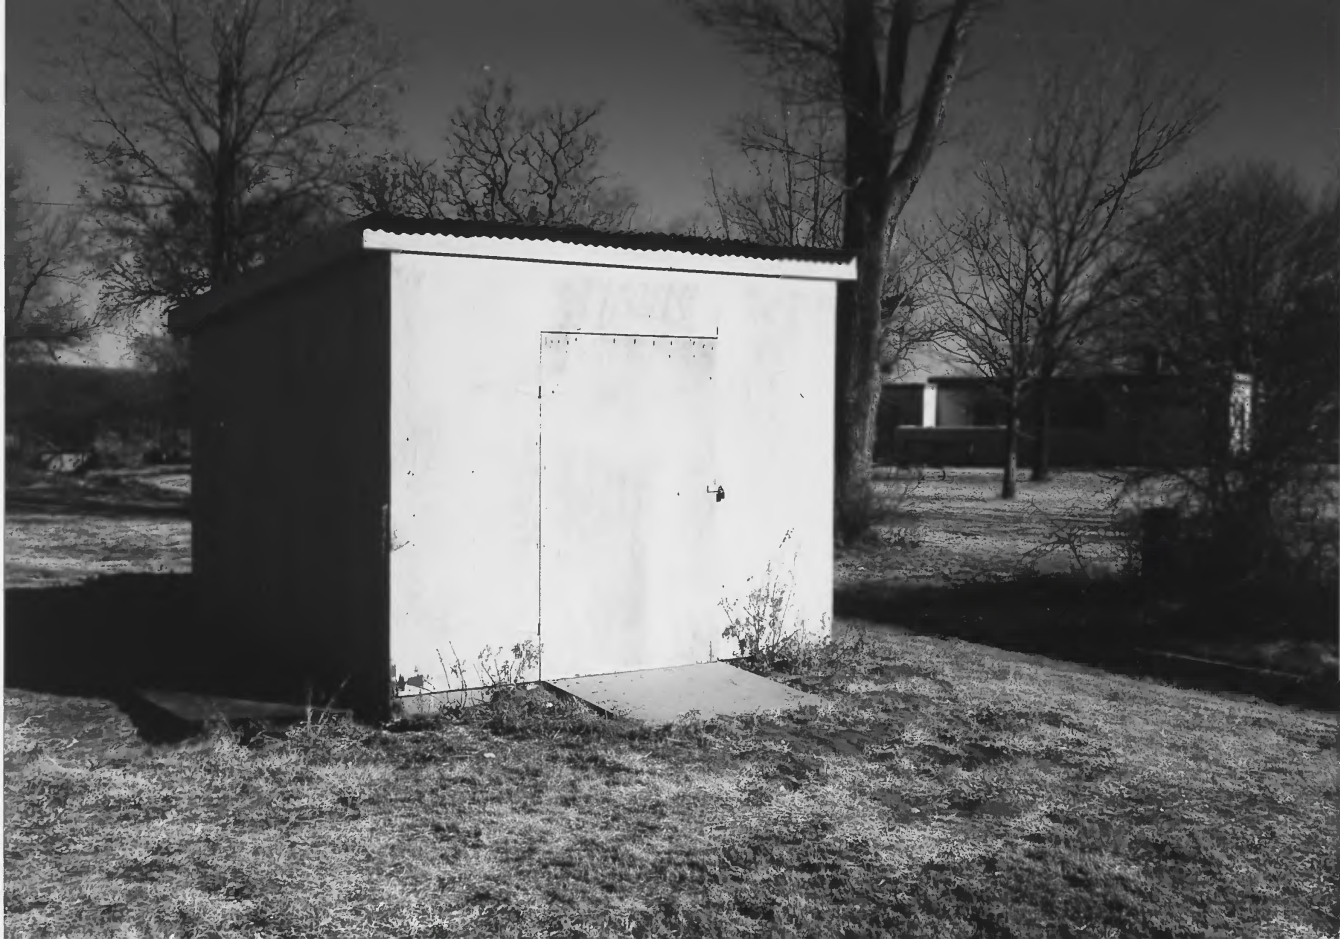
12. Storage shed, looking NE. (NC)

Square, measuring about 15 feet by 15 feet, slump block walls which imitate adobe brick, gabled roof covered with wood shingles, translucent plexiglass skylights in gables, metal doors, concrete floor and foundation.
