# Pueblo Bonito

CHACO CANYON NATIONAL MONUMENT  
NEW MEXICO

# PUEBLO BONITO

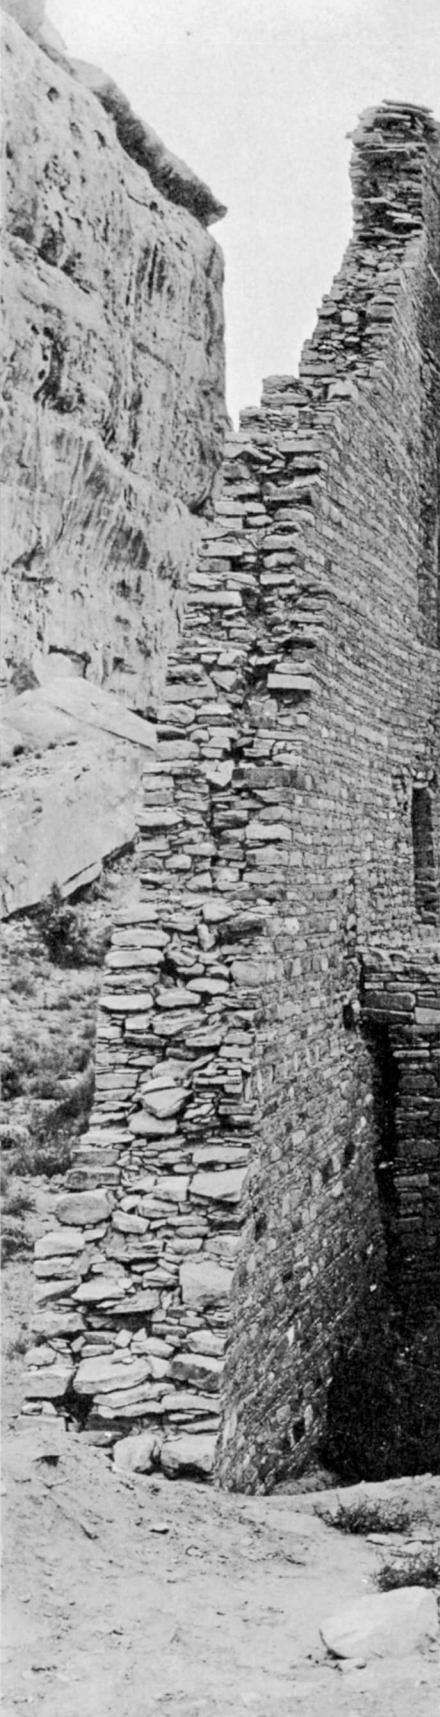
← *Wall Construction, Pueblo Bonito*

5. Notice the extreme thickness of the wall. This thickness provides strength to support multiple-storied construction. As walls grew higher and had less weight to carry, they were made thinner.

At this point you can also see that only the layers of stones on the outside and inside of the walls have been squared. The wall cores are made of rough, unshaped stones.

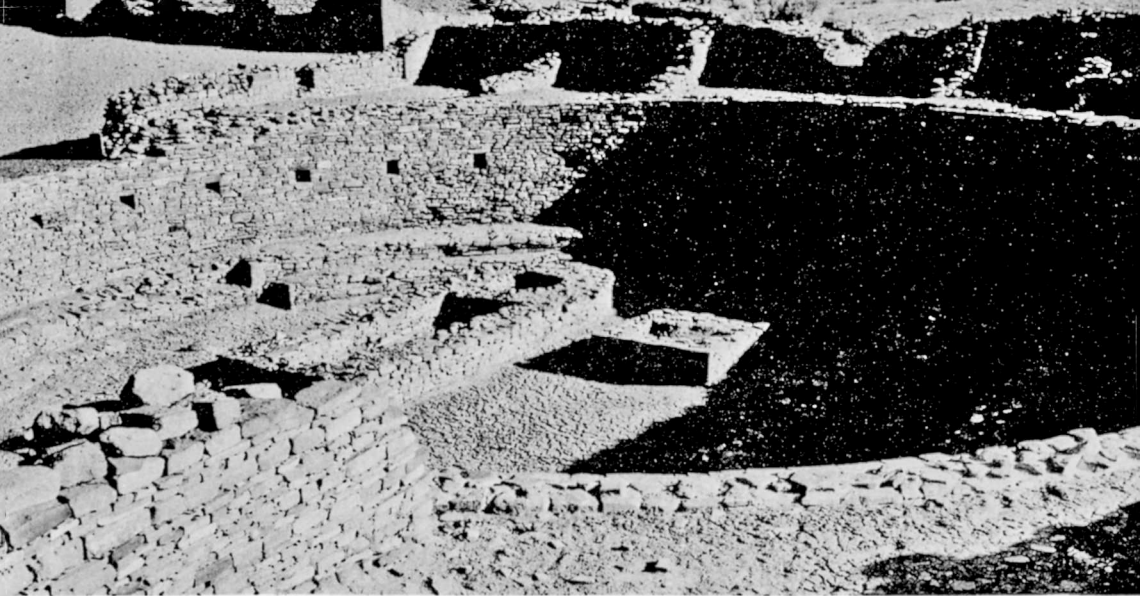
*One of the two Great Kivas in Pueblo Bonito*

9. The large circular room is known as a Great Kiva. It probably served as a ceremonial center for some of the residents of the pueblo. A more elaborate Great Kiva will be described for you at Marker 14.

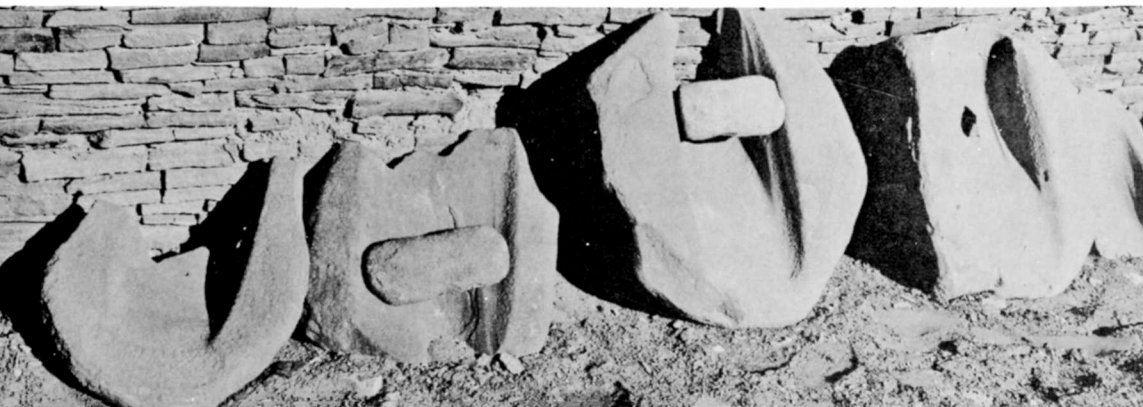
*Metates and manos, used for grinding corn and seeds*

**12.** The grooved stones along this wall are called metates (meh-TAH-tays). They and the handstones, or manos, were used by Pueblo Indians to grind corn and other seeds into flour. As the meal was being ground, a great deal of grit was unavoidably mixed with it. Through the years a diet of cornmeal and crushed sandstone eventually wore away the teeth, until in old age the Indians had little left but stubs. Examples of this can be seen in the Pueblo Bonito Contact Station exhibits.

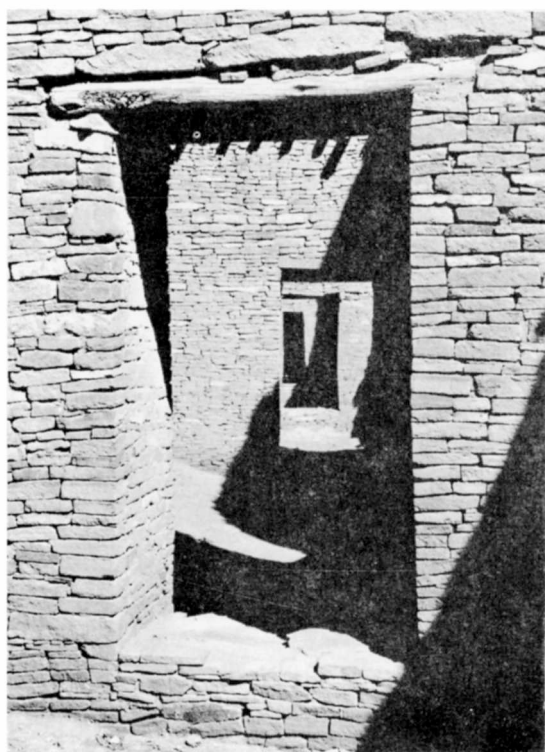
18. As you travel from room to room notice the small size of the doorways. The builders of the pueblo were no smaller than modern Pueblo Indians. Men averaged about 5 feet 4 inches in height and women 5 feet. Doorways were

made small to keep rooms warm and assure a strong wall above. To secure some privacy and to protect themselves against the cold, the Indians covered their doorways with a sandstone slab or blind made of reeds or peeled willows.

Those living in one of the rooms back of the courtyard enjoyed almost no privacy. There were no halls in the building. To reach the courtyard from a rear room, it was necessary to travel through the intervening rooms, or to go over the terraced roofs.

*This series of doorways demonstrates lack of privacy in the pueblo*

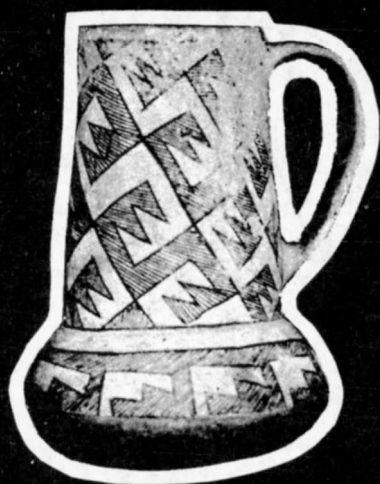
Trademarks of the  
ancient dwellers of Pueblo Bonito were  
the distinct patterns and unusual designs  
of their black-on-white  
pottery.
