# Pueblo del Arroyo

SOUTH MESA LOOP TRAIL

## Welcome to Pueblo del Arroyo

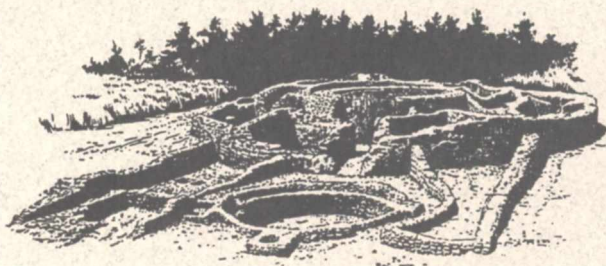
Multi-walled structure

**2** This triple-walled structure, called a “tri-wall,” is rare in the Chaco region. Most multi-walled structures are found further north in the San Juan River drainage and the Mesa Verde region of southern Colorado and Utah. The form of this structure, built with the softer sandstone, and the distinctive carbon painted black-and-white pottery that was found here are characteristic of sites built after A.D. 1100. The presence of this structure in Chaco lends support to the theory that ideas were being exchanged between the people of Chaco and northern population centers.

Archeologists are unsure how this tri-wall structure was used. However, the formal design, mass, size, and placement of this building indicate it had ritual significance. Among the multi-walled structures that have been excavated, most have enclosed kivas. When the central room of this tri-wall was excavated in 1926, researchers did not find any features typical of kivas such as wall niches or a fire hearth, but they did discover that the floor was partially paved with sandstone slabs.

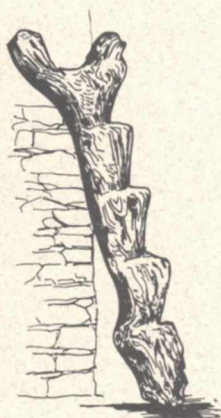
Carved ladder

**8** As you look down to the floor level of this three-story section, you might wonder how these rooms were reached during prehistoric times. Ladders, carved from logs, connected upper and lower story rooms, and also provided access to lower rooftops. Since the time the Chacoans left the canyon, these ladders have disappeared. Unaware of the consequences, archeologists and explorers who came through Chaco at the turn of the century used ladders and other building timbers for firewood. The few that remain are preserved in museums.

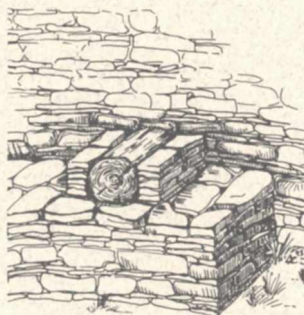
Pilaster

boxes called “pilasters,” each constructed by encasing a horizontal log in plastered masonry. On top of these pilasters rested the butts of logs which extended from pilaster to pilaster to encircle the chamber. Additional tiers of logs made circles of
