CRATER LAKE ADMINISTRATIVE COMPLEX, BANCER DORMITORY  
(William Steel Center, Steel Center)  
Monson Valley, Rim Drive off State Hwy. 62  
Crater Lake National Park  
Crater Lake  
Klamath County  
Oregon

HABS No. OR-<sup>142</sup>~~144~~-B

CRATER LAKE ADMINISTRATIVE COMPLEX,  
RANGER DORMITORY  
(HABS No. OR-144-B)  
(Page 1)

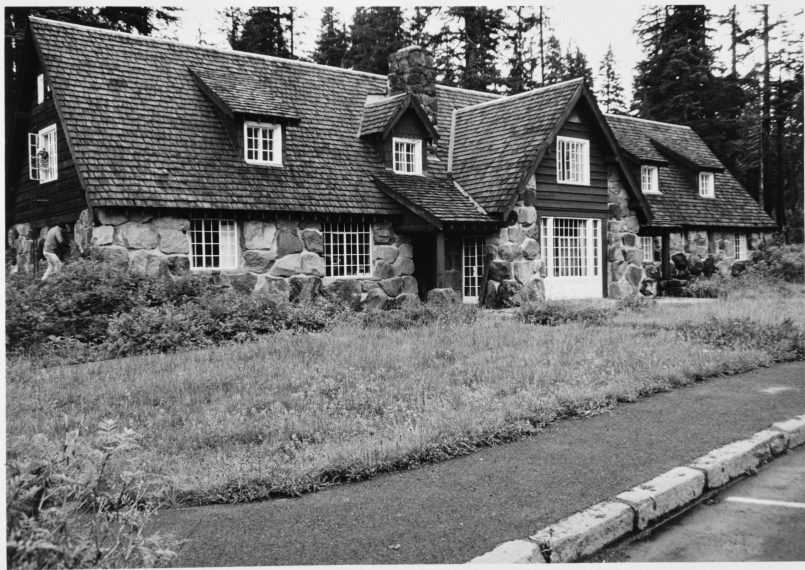
| OR- <sup>162</sup> 144-B-1 | VIEW OF EAST FACADE, LOOKING NORTHWEST |

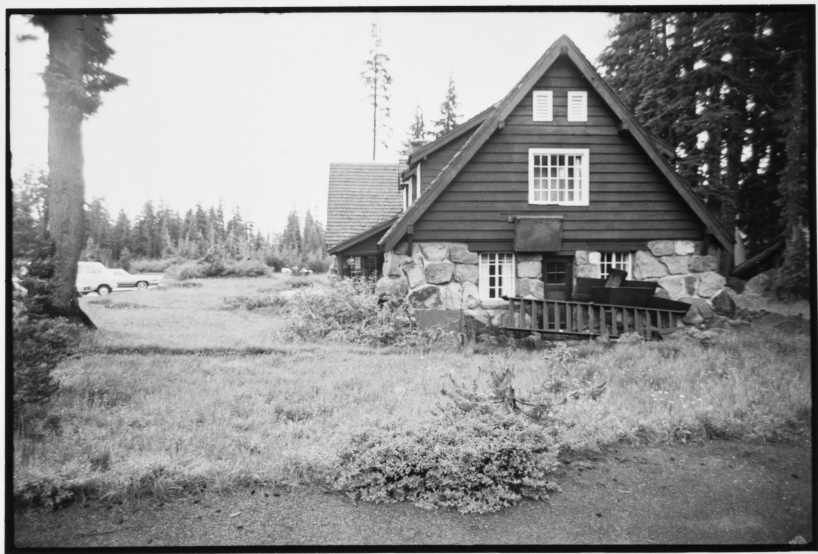
HABO No. OR-148-B-2.

| OR- <sup>162</sup> 144-B-2 | VIEW OF NORTH FACADE, LOOKING SOUTH |

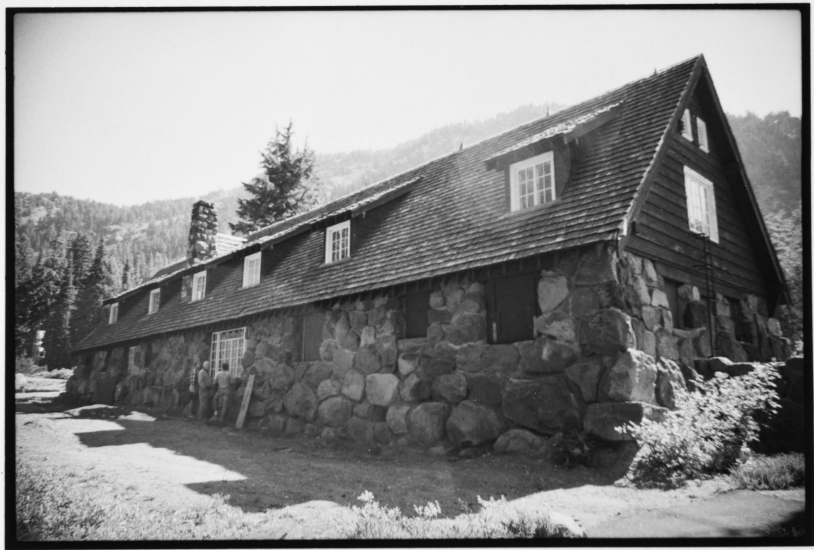
| OR- <sup>162</sup> 144-B-3 | VIEW OF WEST FACADE, LOOKING NORTHEAST |

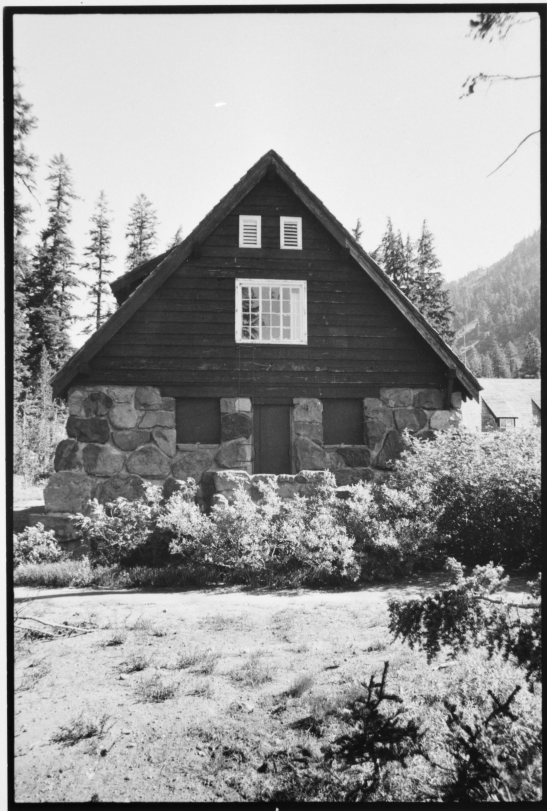
| OR- <sup>162</sup> 144-B-4 | VIEW OF SOUTH FACADE, LOOKING NORTHEAST |

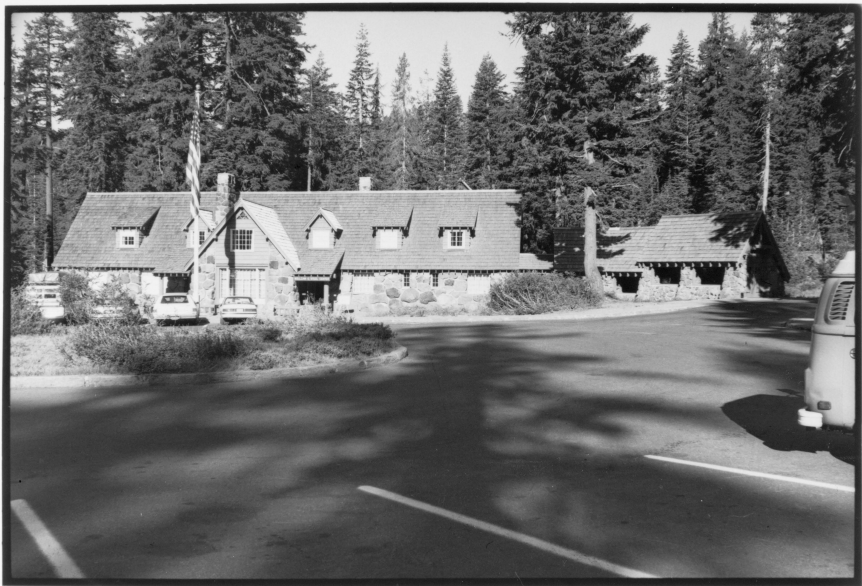
| OR- <sup>162</sup> 144-B-5 | VIEW OF EAST FACADE, LOOKING WEST |

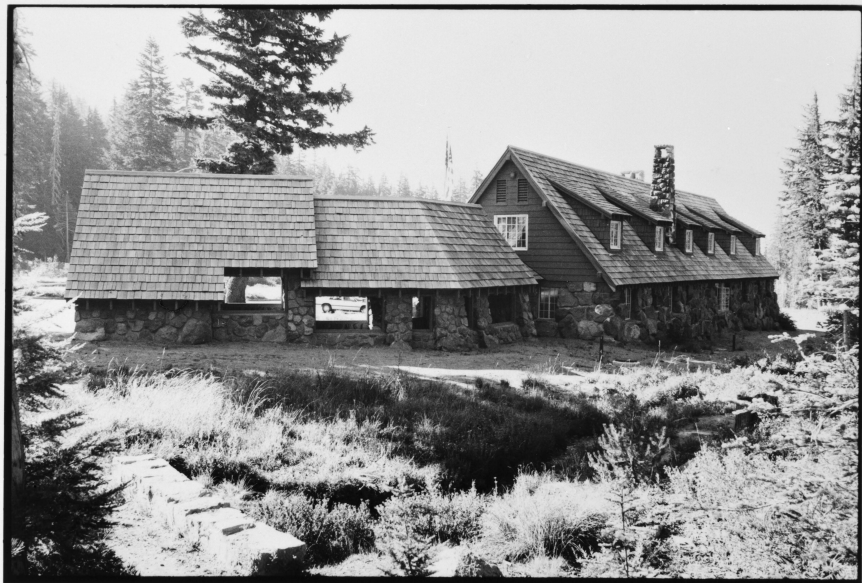
| OR- <sup>162</sup> 144-B-6 | VIEW OF WEST FACADE, LOOKING SOUTH |

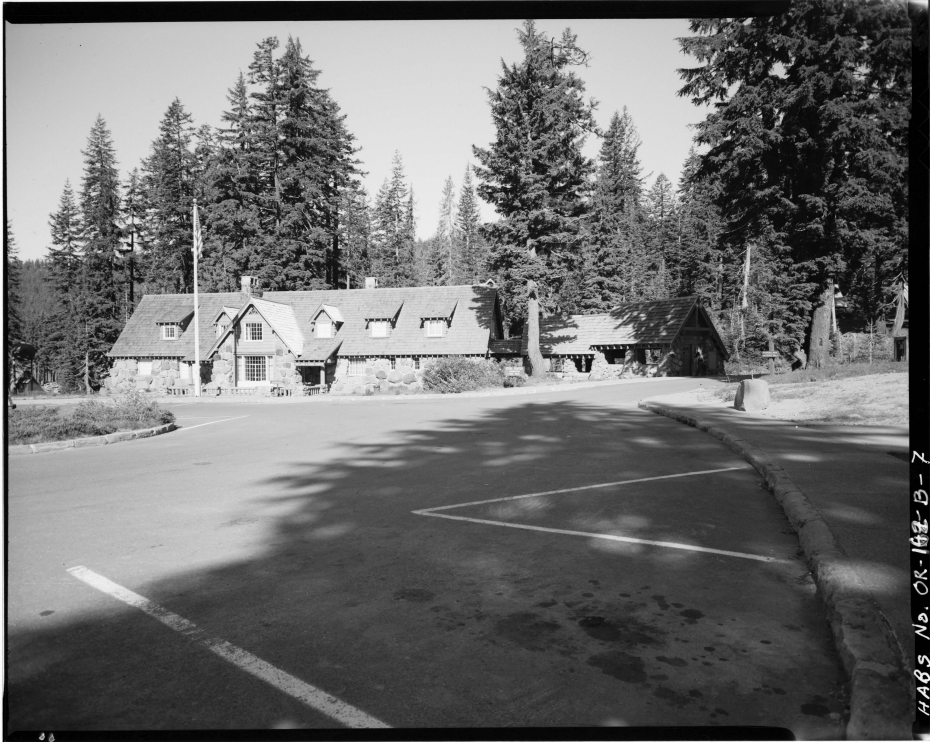
| OR- <sup>162</sup> 144-B-7 | VIEW OF EAST FACADE, LOOKING WEST |
