Rim Drive Historic District  
Property Name

# National Register of Historic Places Registration Form

Historic name Rim Drive Historic District

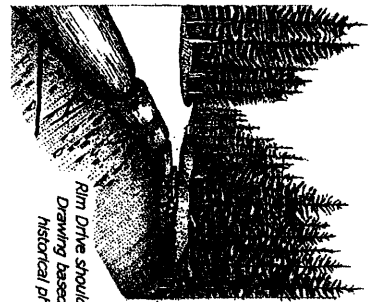
Rim Drive shoulders  
Drawing based on  
historical photo

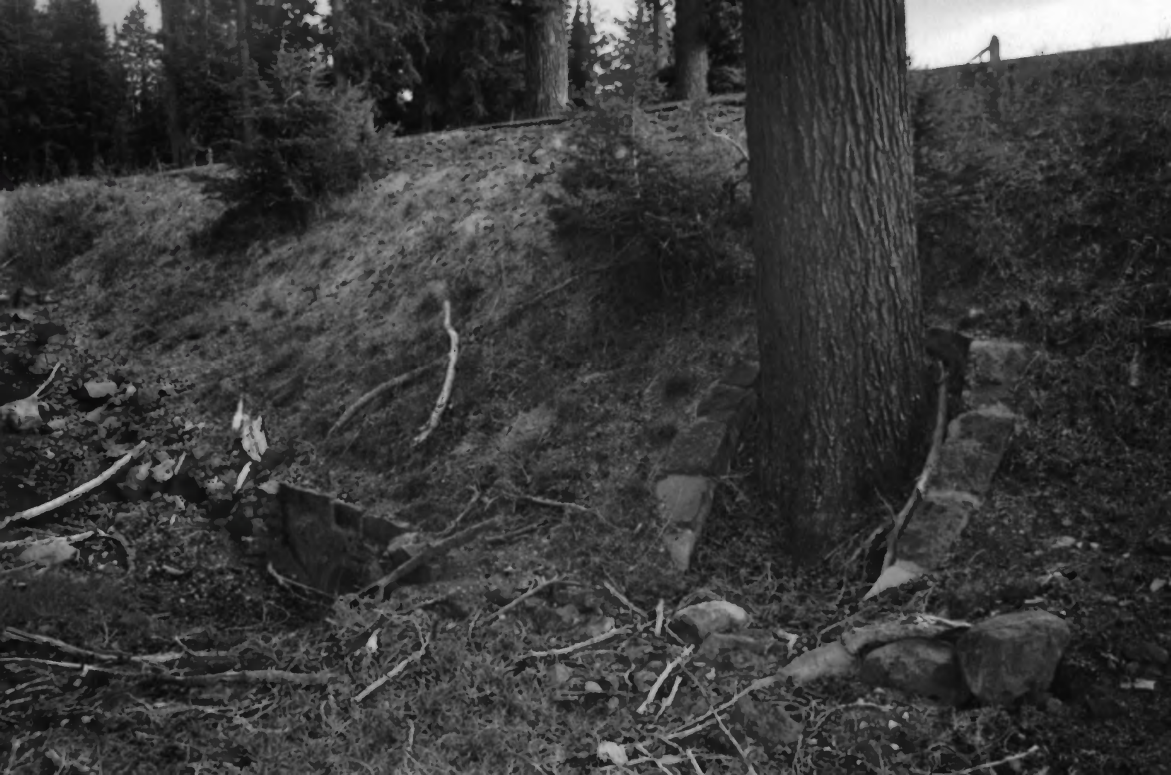
3. Culvert headwall (left) and masonry device to protect  
tree on fill (right) in road segment 7-A,  
Rim Drive Historic District  
Crater Lake National Park, Klamath County,  
Oregon

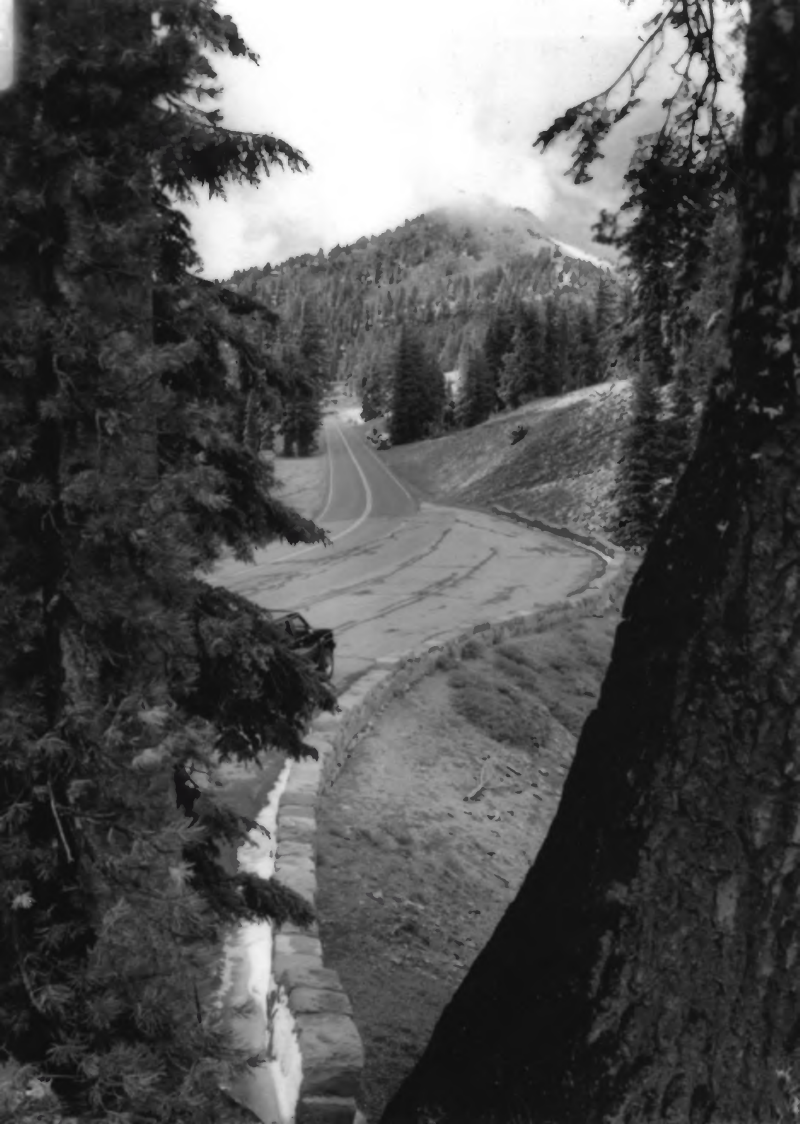
4. Substation 2-A delineated by  
masonry guardrail with road tangent  
and The Watchman in background,  
Rim Drive Historic District  
Crater Lake National Park,  
Klamath County, Oregon

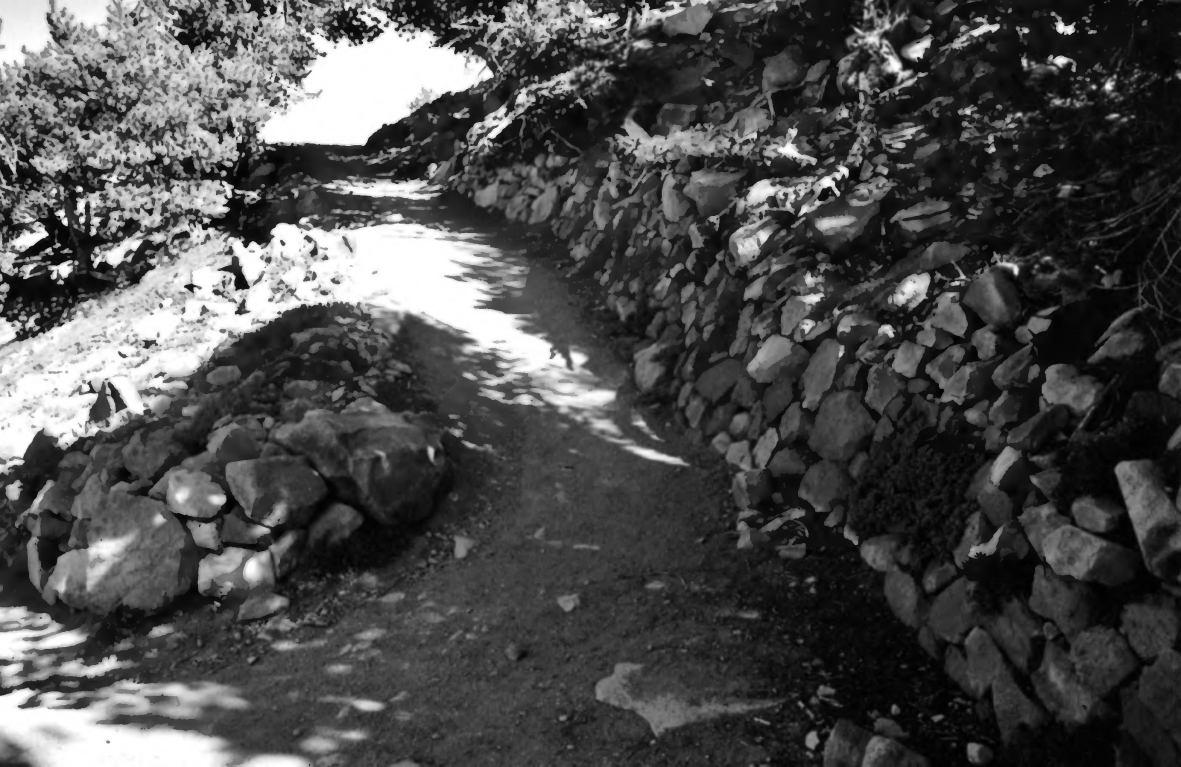
5. Dry laid retaining wall on Watchman Trail,  
Rim Drive Historic District  
Crater Lake National Park, Klamath County,  
Oregon

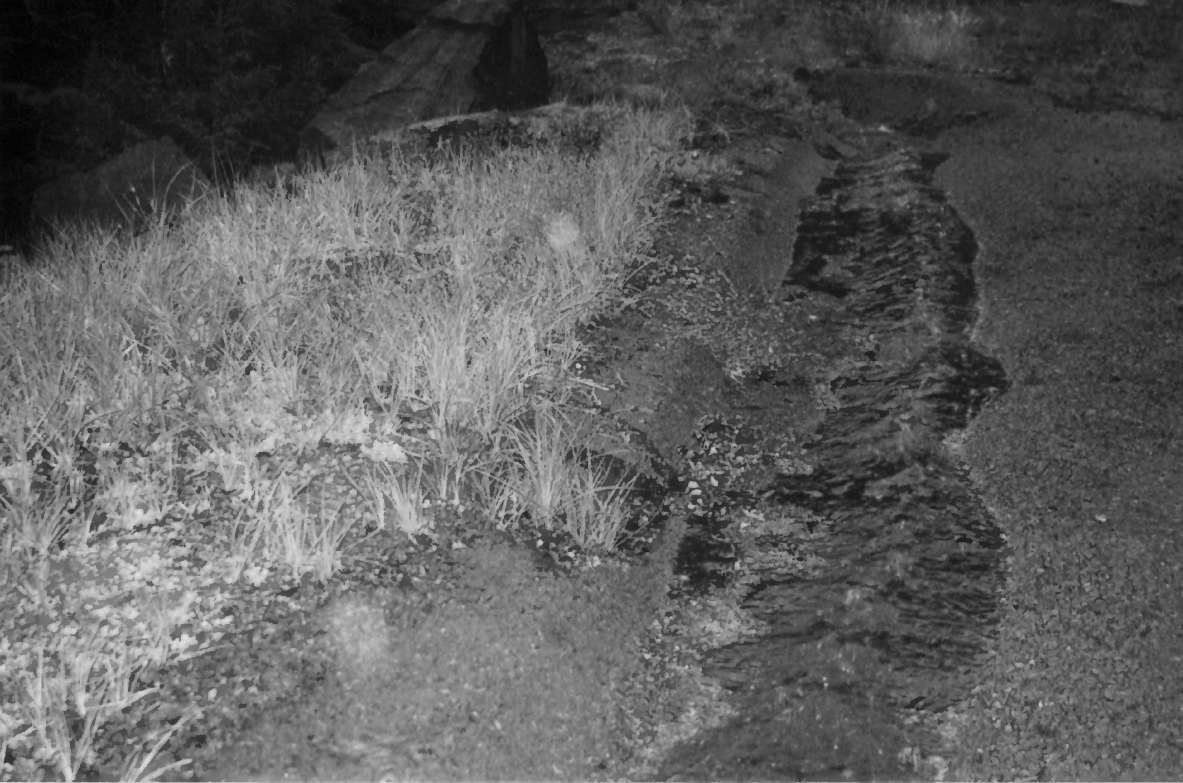
11. Rainwater flowing in paved ditch toward drop inlet  
in road segment 7-B, Rim Drive Historic District  
Crater Lake National Park, Klamath County,  
Oregon

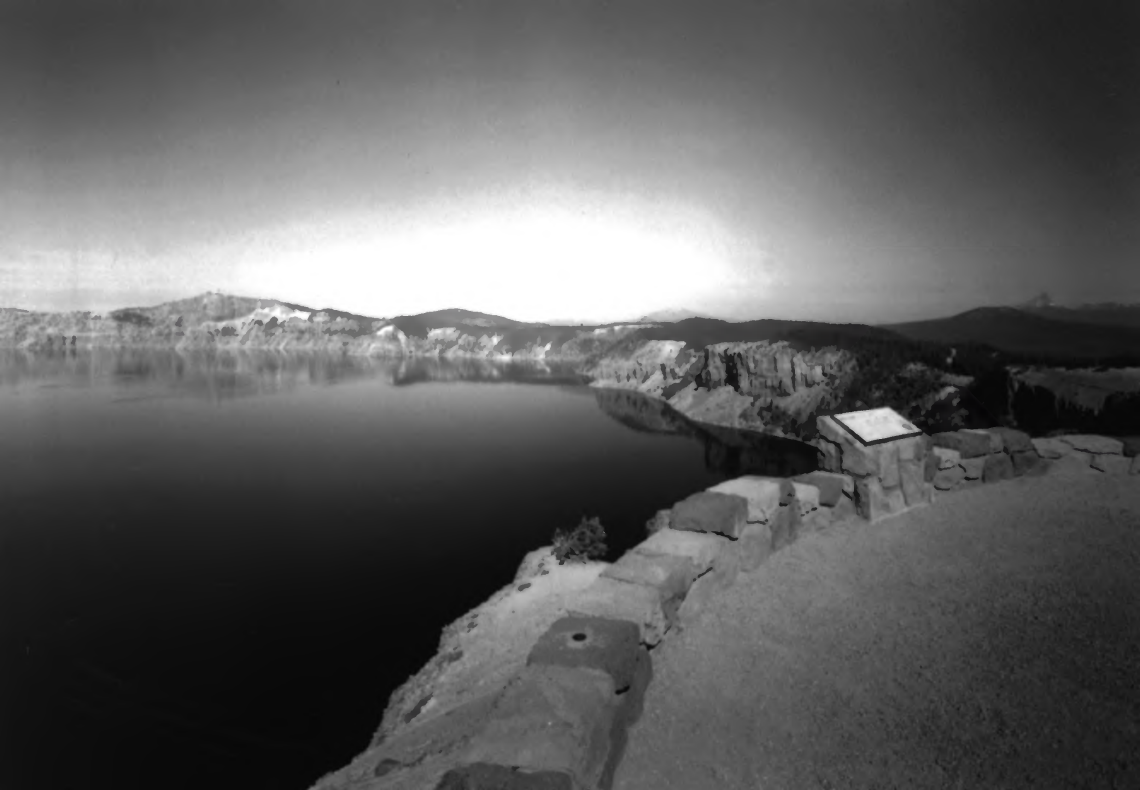
13. Walkway and parapet wall at Skull Head (observation station 6), Rim Drive Historic District  
Crater Lake National Park, Klamath County,  
Oregon

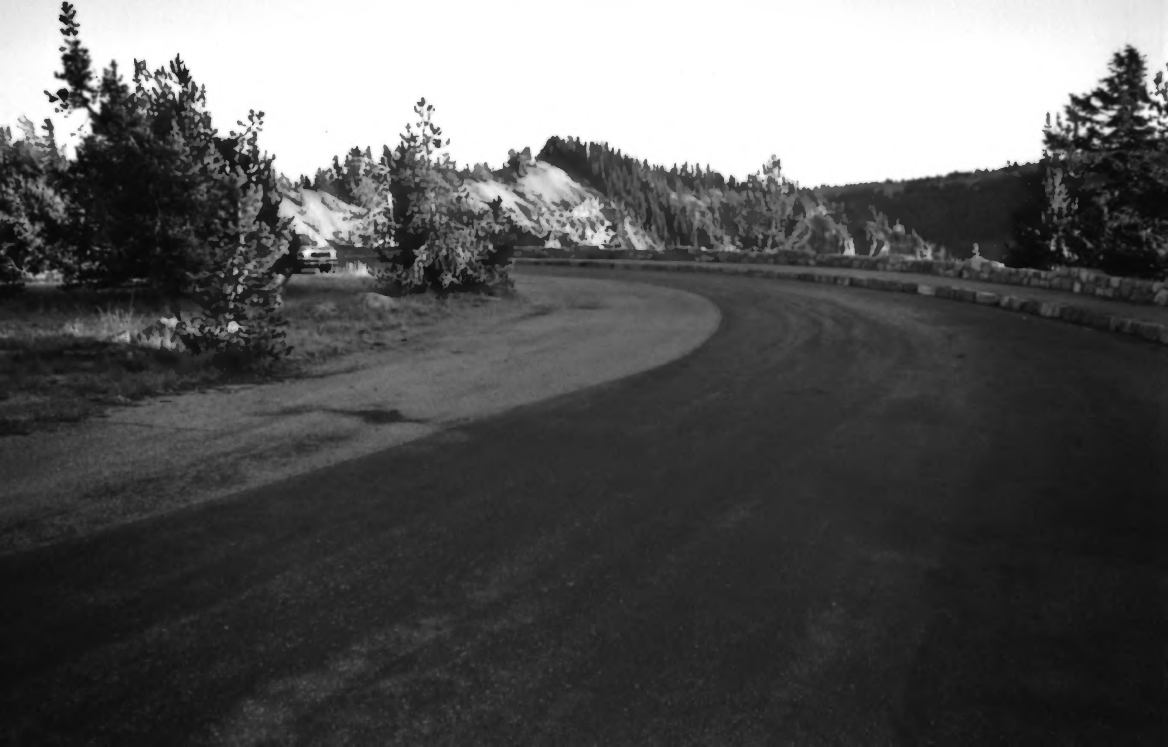
17. Planting bed, roadway, curb, walk, and masonry guardrail at Reflection Point Parking Overlook (substation 7-C), Rim Drive Historic District Crater Lake National Park, Klamath County, Oregon

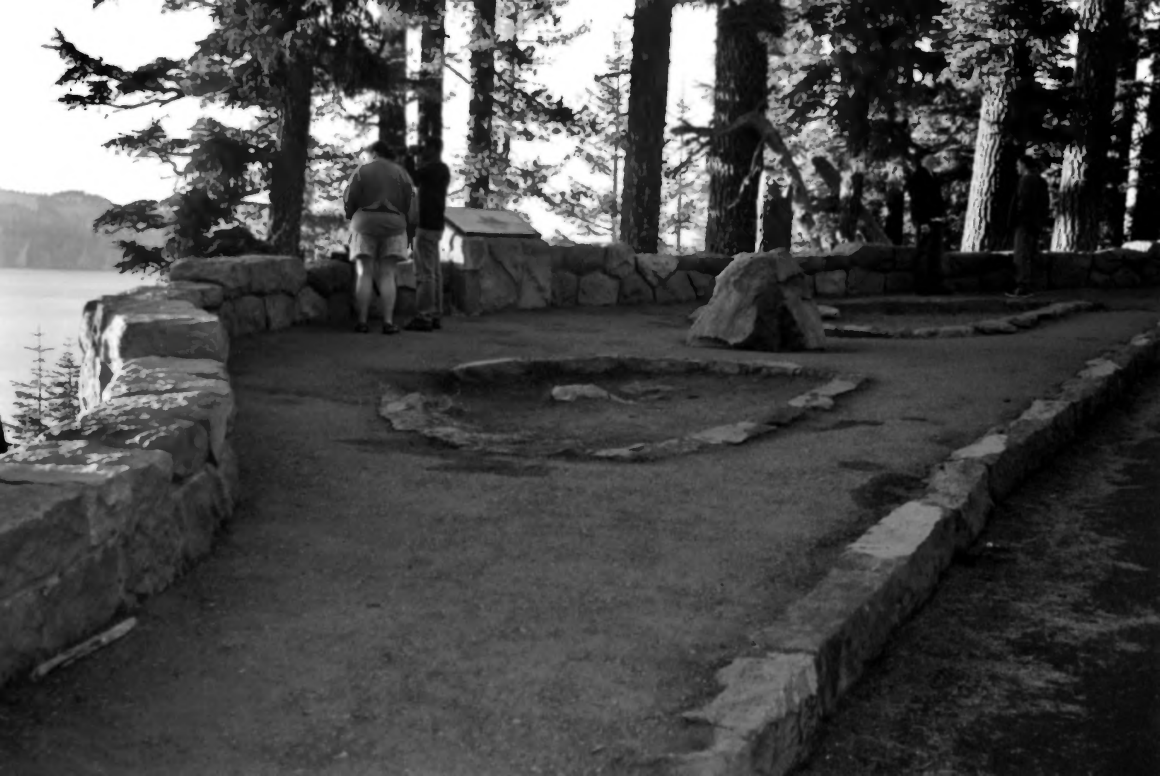
18. Parapet with planting beds, drinking fountain, and walk at Kerr Notch Parking Overlook (observation station 8), Rim Drive Historic District  
Crater Lake National Park, Klamath County,  
Oregon

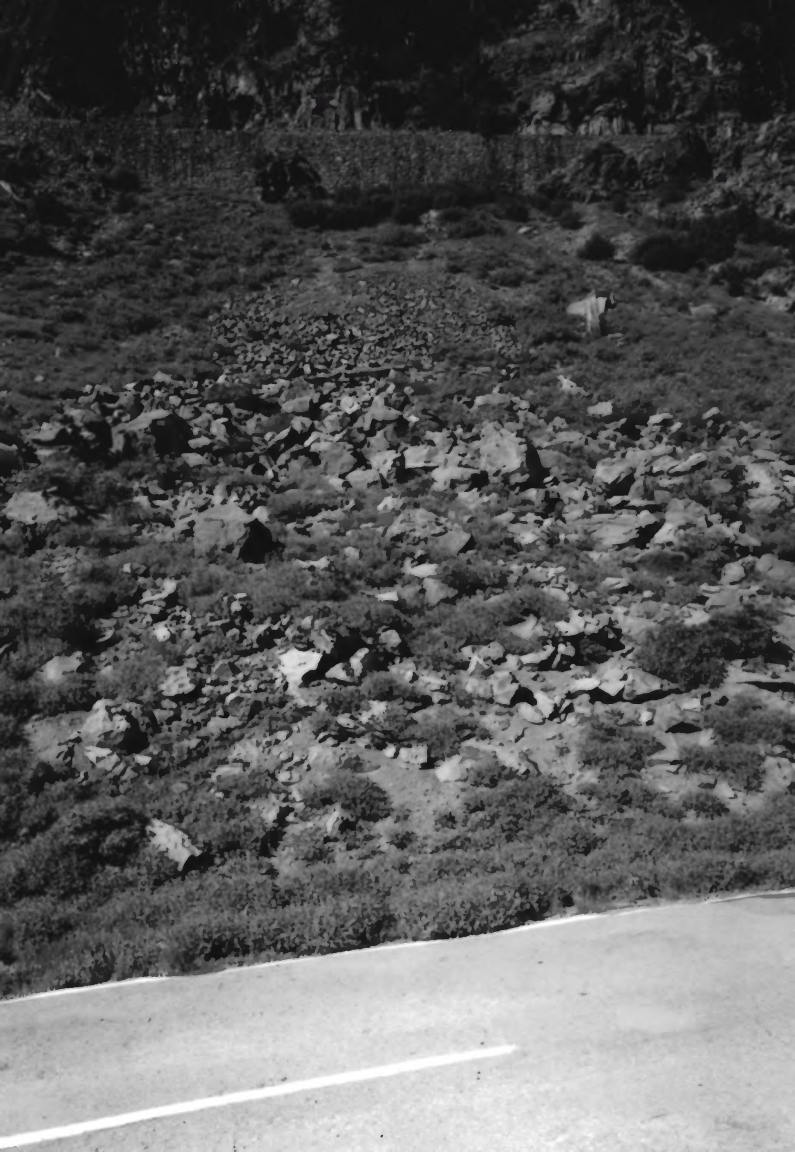
19. Retaining wall on the Dutton Cliff  
section of road segment 7-D, Rim  
Drive Historic District  
Crater Lake National Park, Klam-  
ath County, Oregon

Masonry guardrail has also undergone extensive repair on the west side of Dutton Ridge, about a half mile shy of the Sun Notch parking area. There remains, however, masonry guardrail in excellent condition where it was built away from steep slopes and rockfall areas. Several parking areas along this segment of Rim Drive still possess almost all original work and are located a mile or more south of Kerr Notch. One of the parking areas (there are no observation stations or substations in segment D) is situated high enough so that motorists who stop here can see Crater Lake to the north and portions of the Klamath Basin if they look south. Spectacular views of the basin and Klamath Marsh far to the east can be seen over the next mile or so to the road summit of Dutton Ridge where the southern panorama stretches to its widest point. The drive down the western side of the ridge to Sun Notch allows filtered views of Sun Meadow below the road and a ridgeline crowned by Applegate Peak to the west. None of the construction in this segment necessitated road obliteration because the old Rim Road followed an entirely different alignment located below Dutton Ridge where there is considerably less rockfall, but also far fewer vistas. The gradients encountered along the alignment of Rim Drive required designers to forsake paved ditches for cross drainage. They used stone masonry features called "spillways" instead to direct water coursing from seasonal springs and put it through culverts located underneath the road.

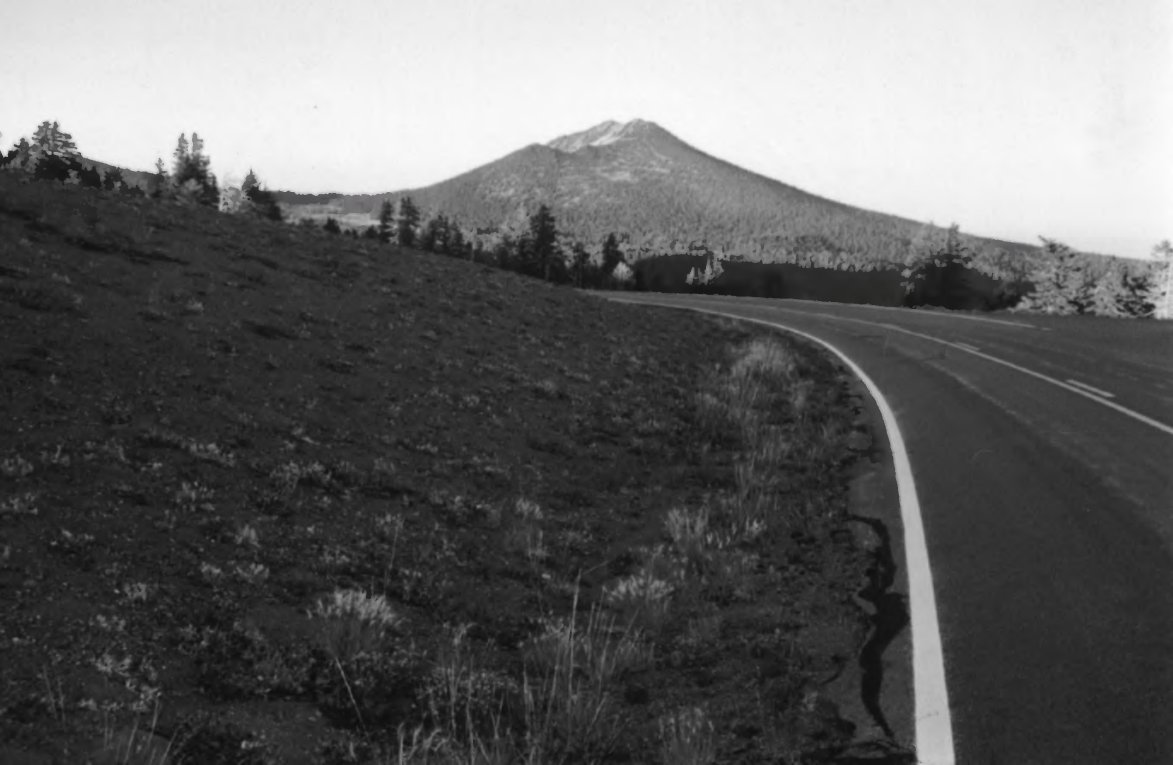
20. Rounded slopes on Dutton Ridge road summit,  
Mount Scott in background, Rim Drive Historic District  
Crater Lake National Park, Klamath County,  
Oregon

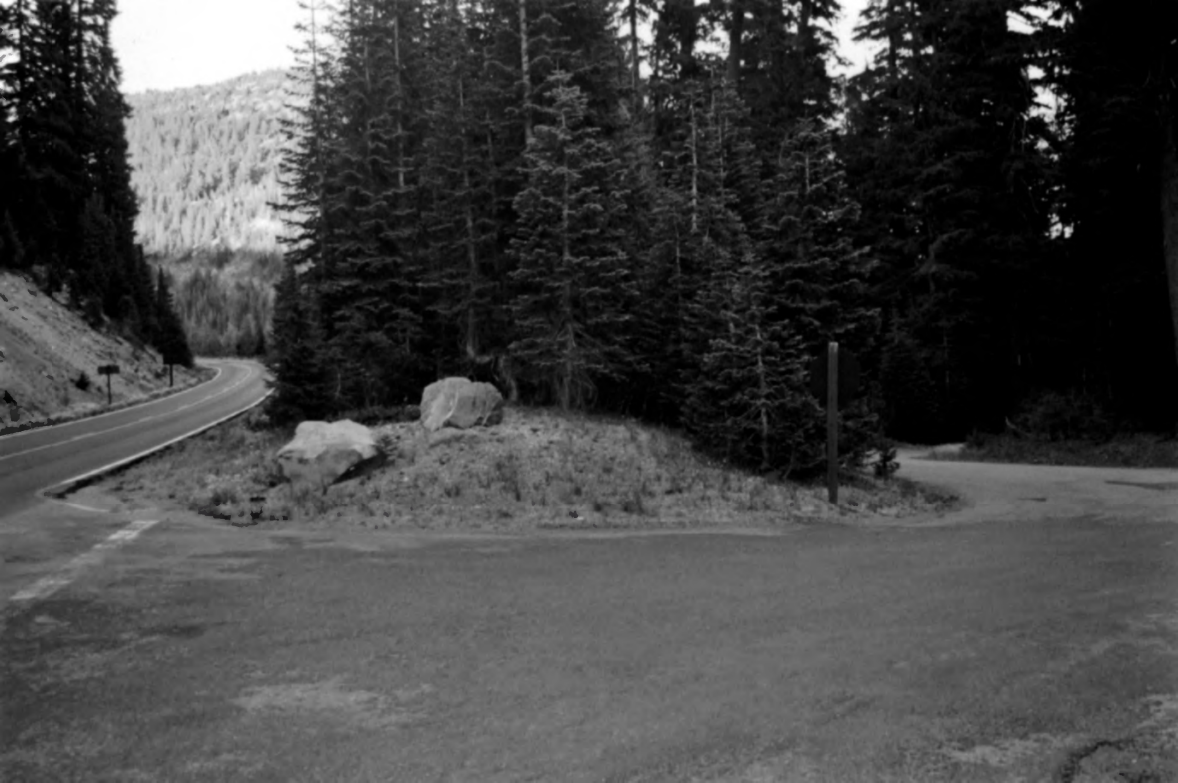
22. Banksloping used to separate Rim Drive (left) from  
Sun Creek Campground road near Vidau Falls  
parking area, Rim Drive Historic District  
Crater Lake National Park, Klamath County,  
Oregon

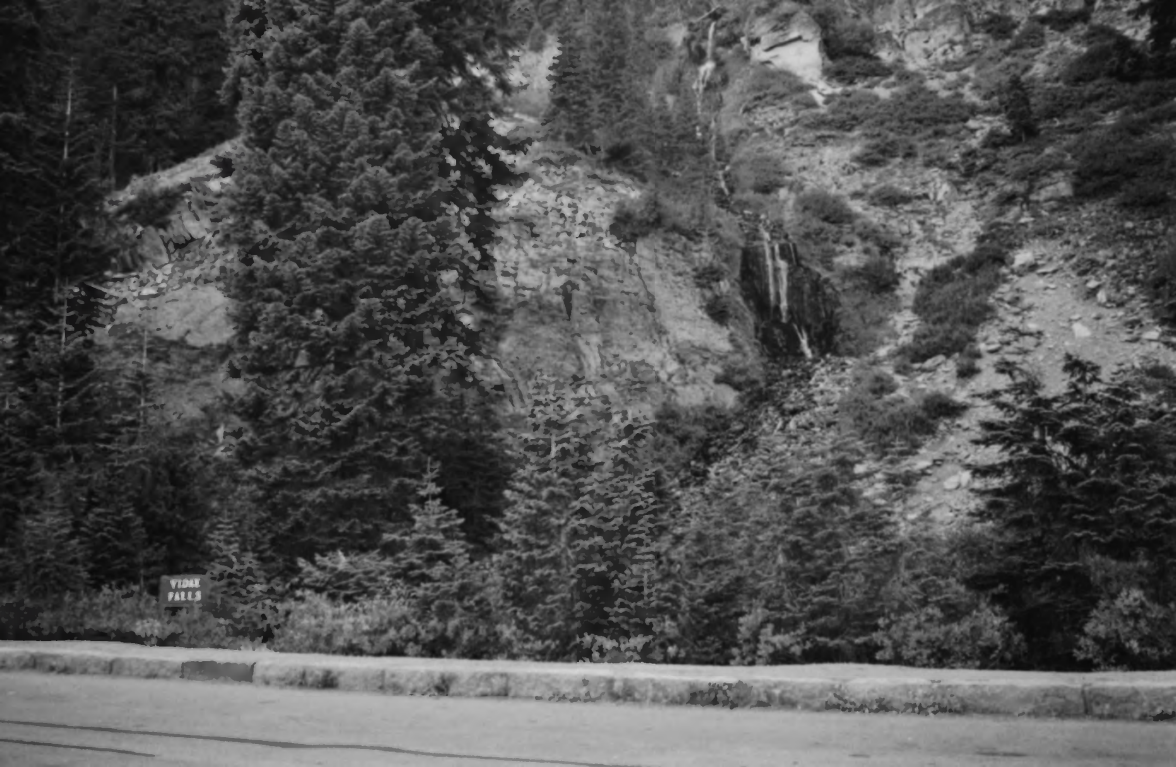
23. Part of Vidau Falls parking area with curb, original  
Civilian Conservation Corps sign, and plantings on  
fill, Rim Drive Historic District  
Crater Lake National Park, Klamath County,  
Oregon

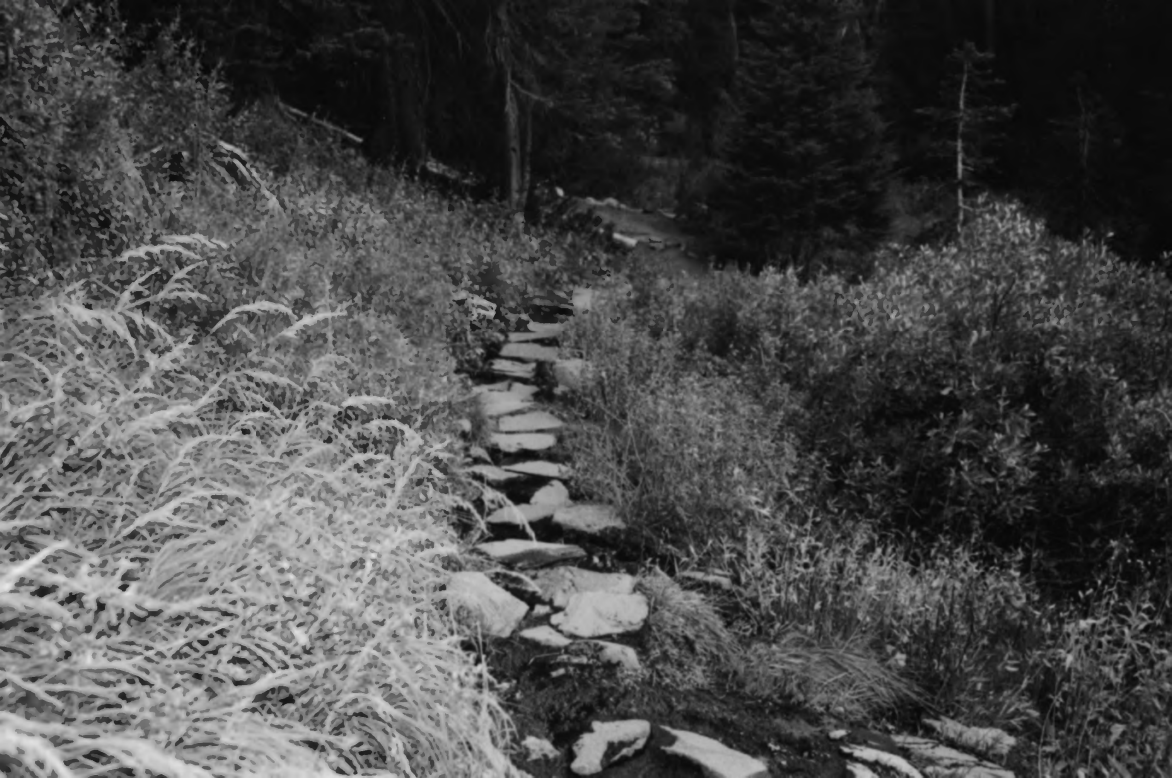
24. Stone steps on Castle Crest Wildflower Garden trail,  
placed to allow passage through wetland, Rim Drive  
Historic District

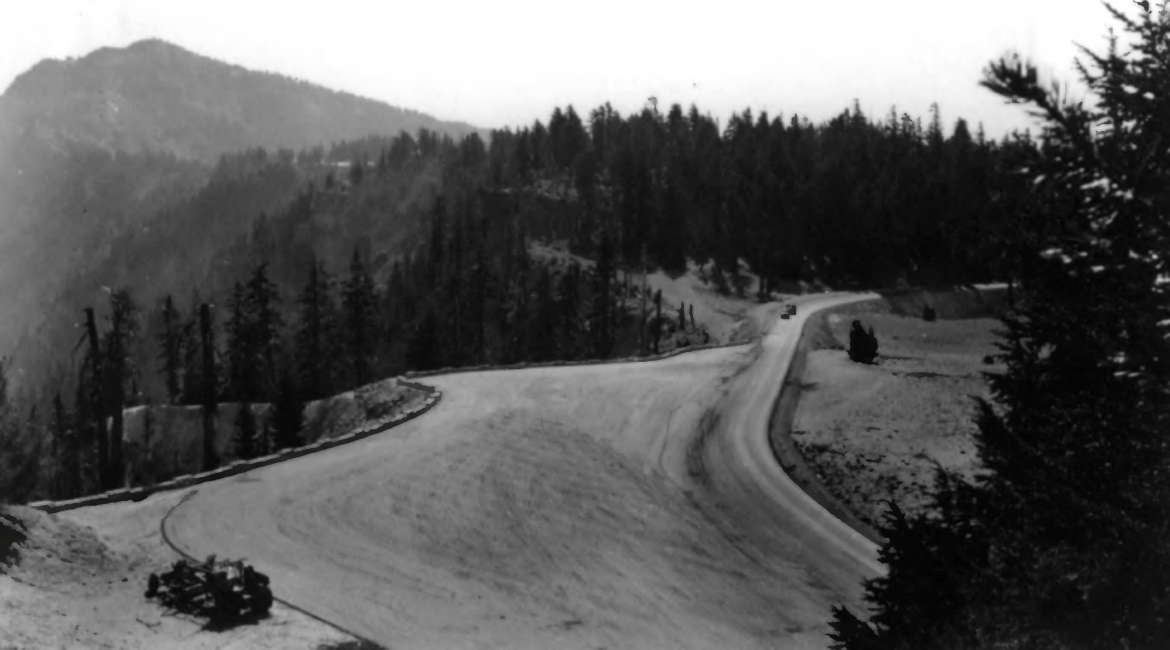
25. Paving Rim Drive (segment 7-A) at the Discovery Point  
Parking Area, Rim Drive Historic District (1935)  
Crater Lake National Park, Klamath County, Oregon

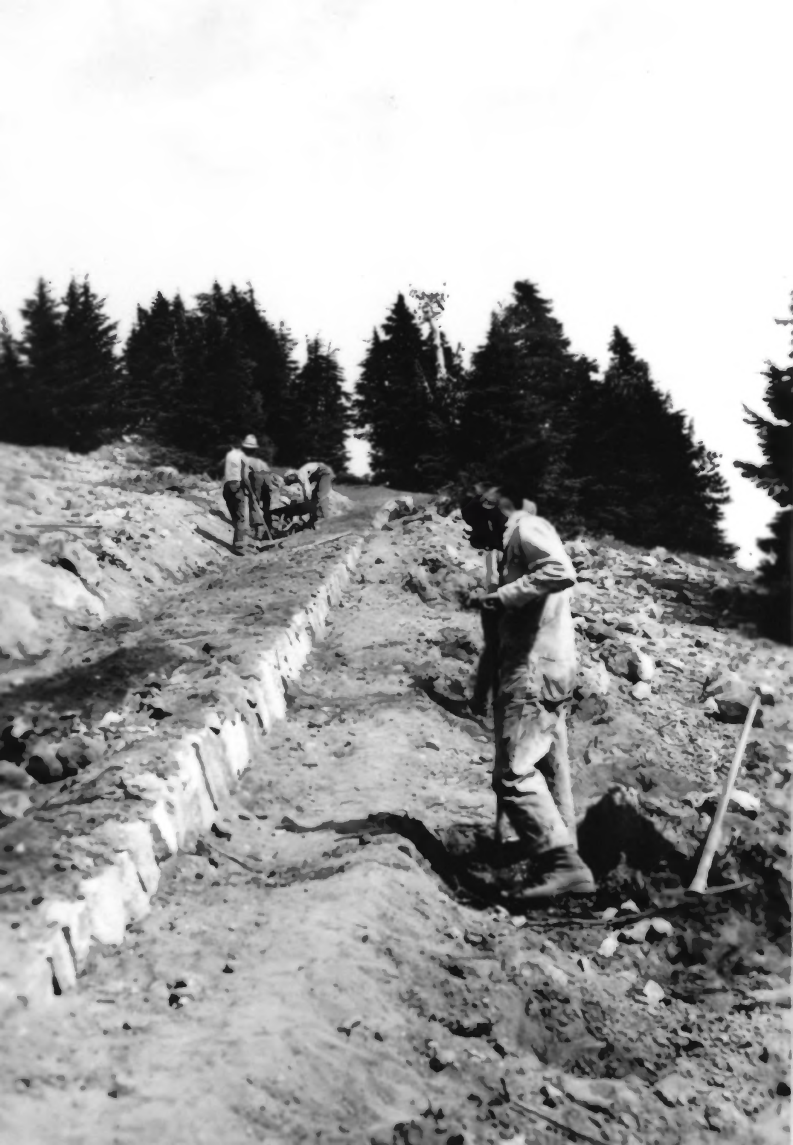
26. Crew building Watchman Trail,  
Rim Drive Historic District (1932)  
Crater Lake National Park,  
Klamath County, Oregon

This trail made use an existing road across Watchman Peak built by the Army Corps of Engineers as a segment of the old Rim Road, and a new footpath constructed by the NPS in 1932, so that park staff and visitors could reach a newly erected lookout structure. The two eras of construction are easy to distinguish as there is a considerable difference in width (twelve feet on the old road grade, as opposed to the four feet that reflect the NPS front country trail standards). At least one dry laid retaining wall can be found along the NPS trail section, whereas the lookout (a building dating from 1931 and previously listed on the National Register) was built of stone masonry. From the day it opened, this building was intended to serve a dual function of surveillance for forest fires and a museum, a combination which made the lookout's parapet into the third observation station for at least part of the 1930s.

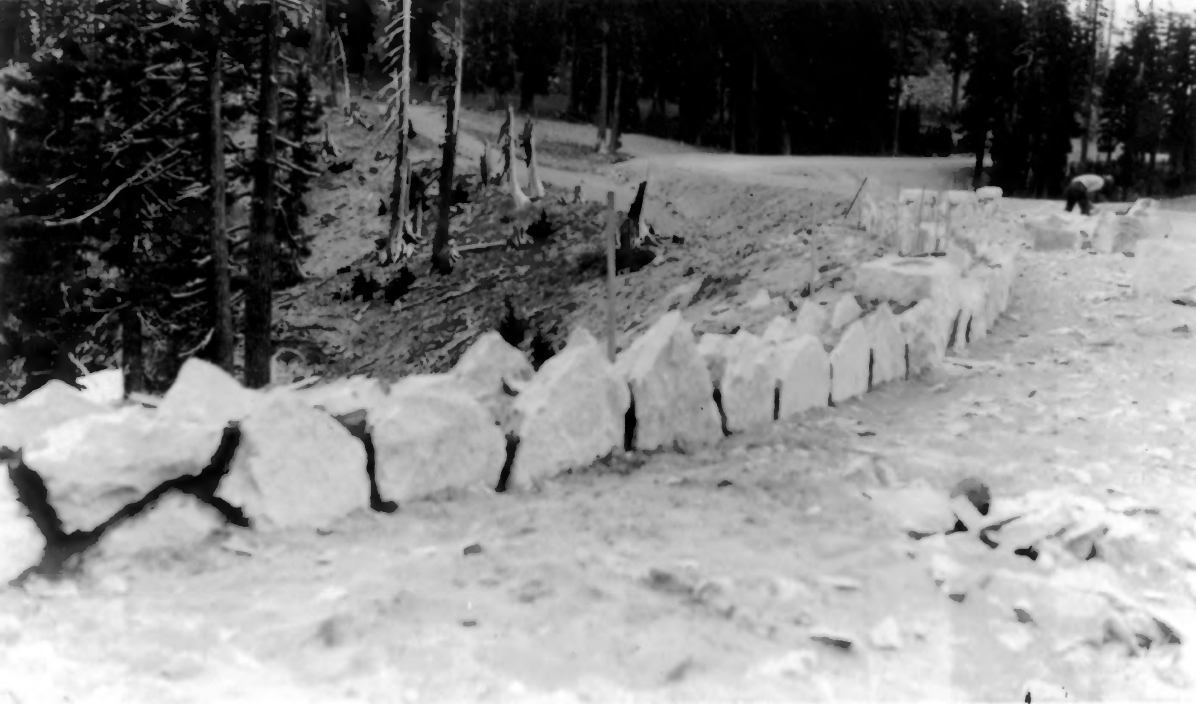
29. Building masonry guardrail near Pumice Point  
(observation station 5), Rim Drive Historic District  
(1934)

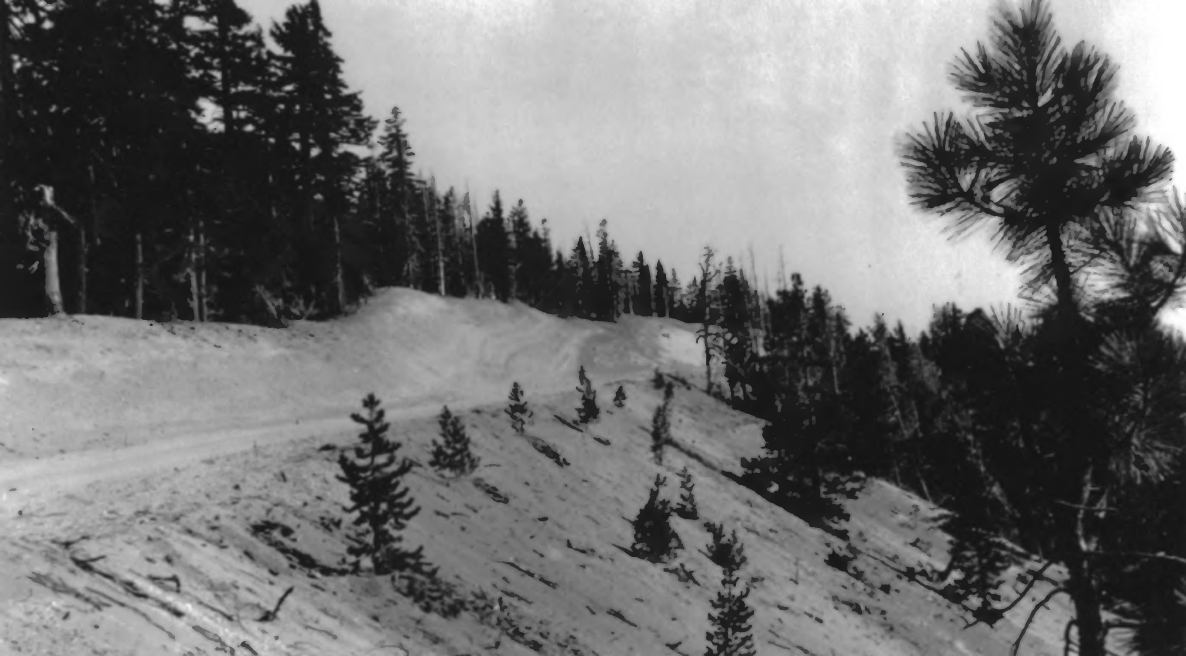
30. Trees planted to stabilize fill along road segment  
7-B, Rim Drive Historic District (1935)

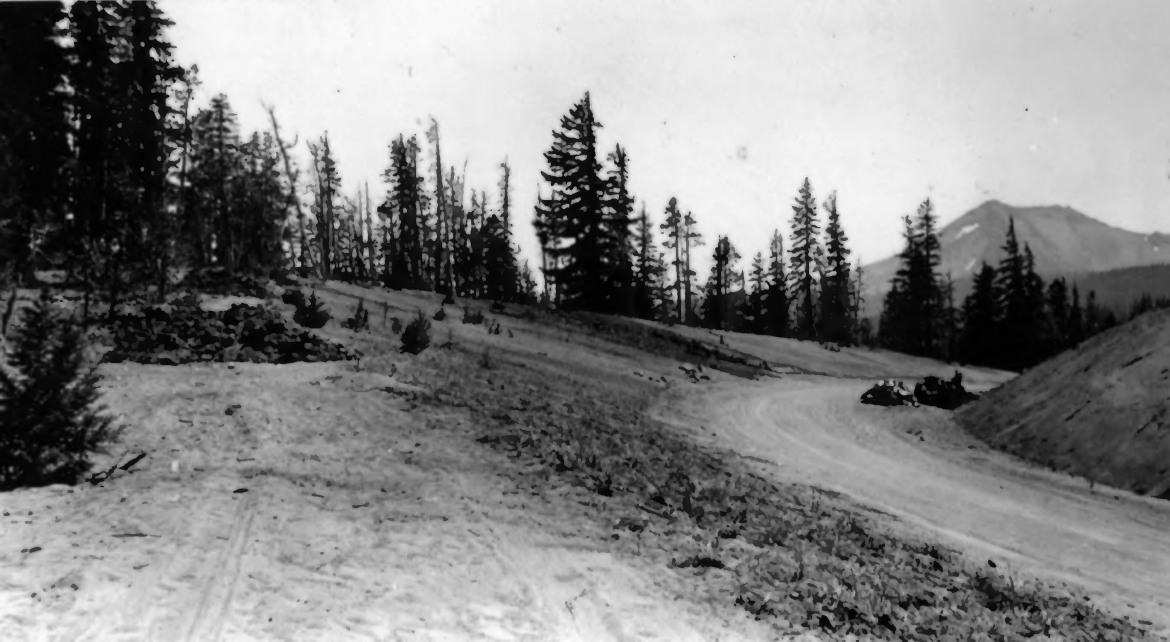
33. Planting daylighted slopes as a landscape treatment  
in road segment 7-C, Rim Drive Historic District  
(1935)

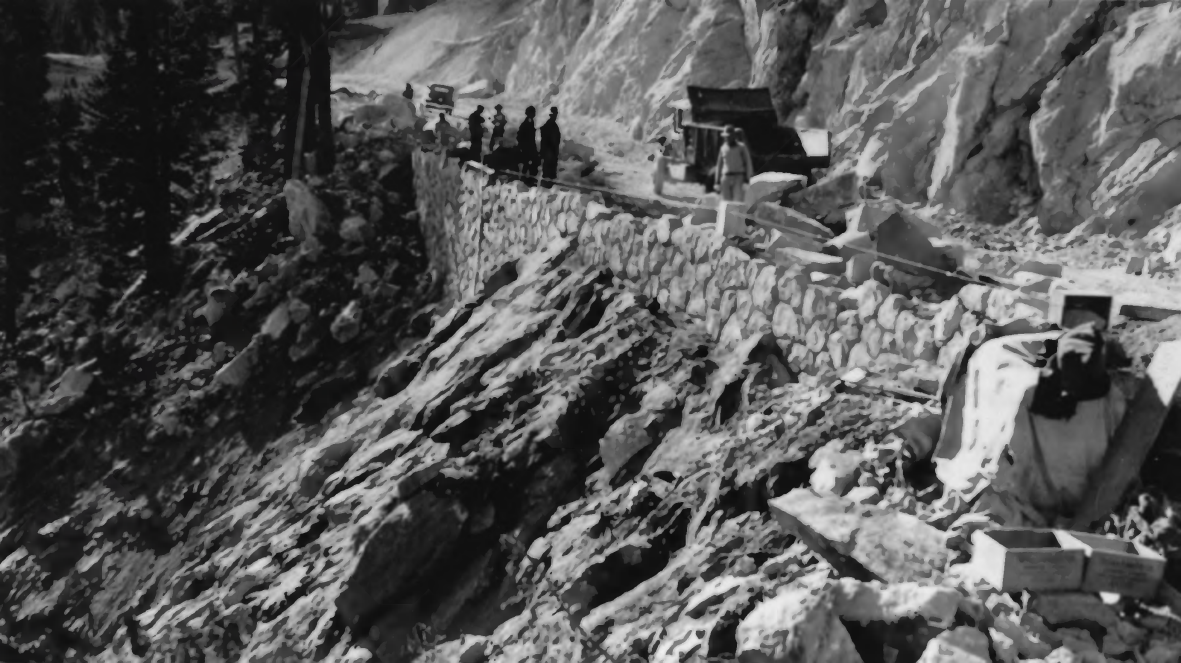
34. Crew building a retaining wall for the Scott Bluffs  
parking area, Rim Drive Historic District (1934)  
Crater Lake National Park, Klamath County.

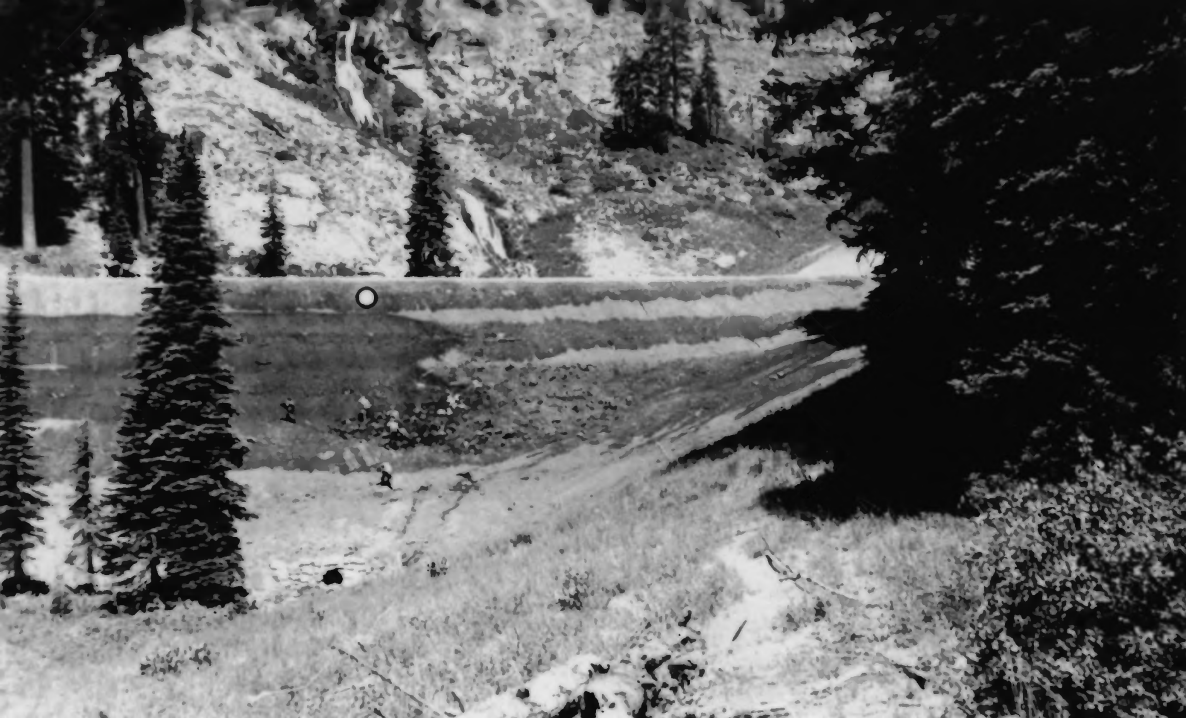
36. Crew planting the fill below Vidoe Falls, Rim  
Drive Historic District (1939)  
Crater Lake National Park, Klamath County,  
Oregon
