NATIONAL REGISTER OF HISTORIC PLACES
REGISTRATION FORM

historic name: Duffy, Michael, Farm

=====
Duffy, Michael, Farm
Peninsula, Ohio
Summit County

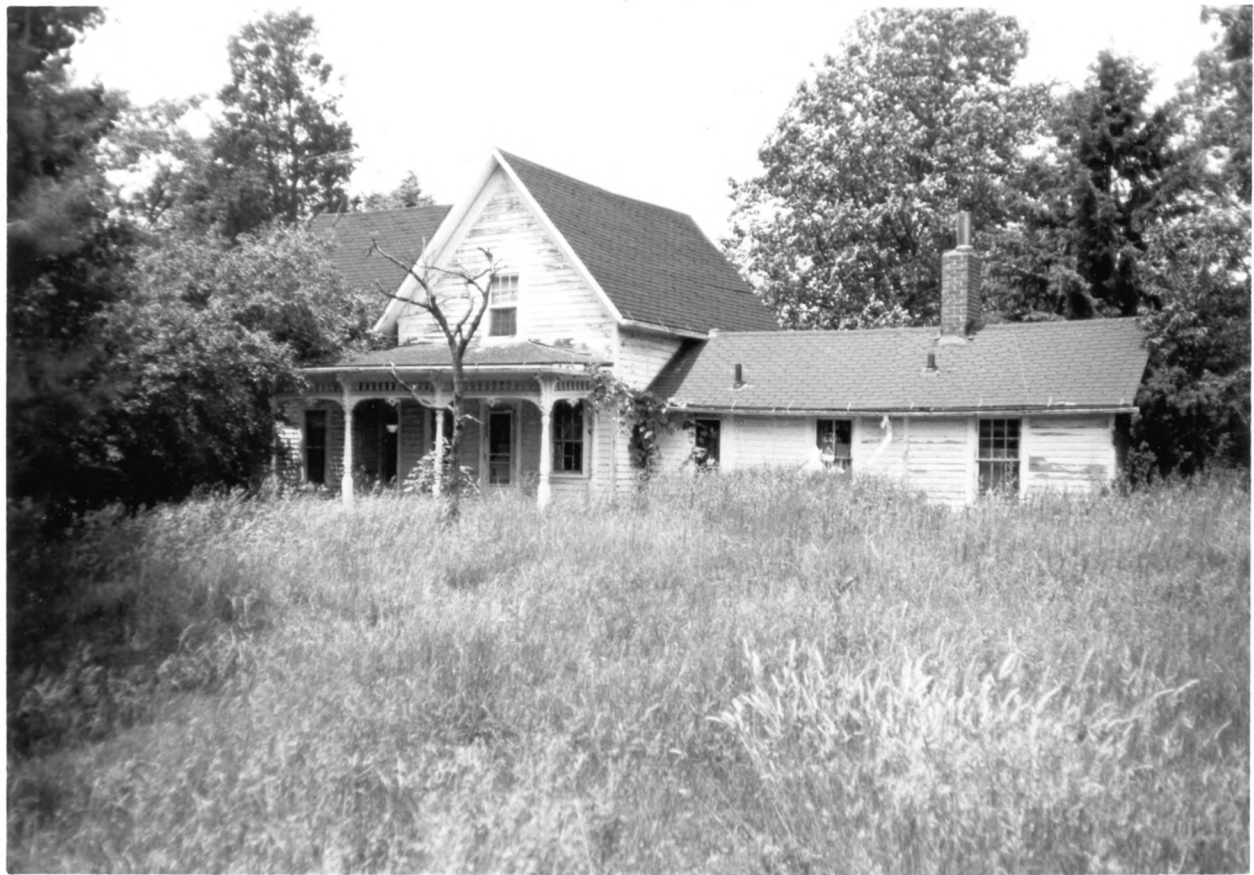
- 1) 1872 House, Michael Duffy Farm
- 2) Peninsula, Ohio
- 3) Melinda A. Campbell
- 4) June 8, 1987
- 5) U. S. Department of the Interior, National Park Service, Midwest Region, 1709 Jackson, Omaha, NE
- 6) Camera Direction: northwest
- 7) #1 on sketch map

The 1872 house is a T-plan structure with a single story porch with hip roof. The facade of the house is not oriented to the road, which is contemporary, or to a core grouping of outbuildings. The massing of the house is characteristic of the type: a half I-house with a perpendicular gabled wing. A one story rectangular massed addition with a central chimney is located on the northeast side of the house. The house sets on a sandstone block foundation, most of which has deteriorated.

The medium-pitch gable roof is covered with asphalt shingles. Walls are covered with wood siding that is either clapboard or drop-siding. Trim elements are limited to small cornerboards and a raked frieze board under the gable eaves. Evenly spaced windows are either 6/6, 4/2, or 2/2 sash. The core block is served by two entry doors located on the southeast facade. One is centered on the gabled section, while the half-I section's door is offset to the right, located in the crook of the porch's ell. The porch contains turned spindle posts with jigsaw-cut scrolled brackets separating a delicate spindlework frieze.

The side appendage is one story in height and has an asphalt shingle covered gable roof. A brick chimney stack is located astride the roof apex. The addition is covered with wood drop siding and is three bays wide and one bay deep. The southeast or facade elevation contains three evenly spaced openings--an entry door followed by two windows. The gable end contains another entry and window. Two additional windows are located on the rear elevation. All the openings have plain trim surrounds.

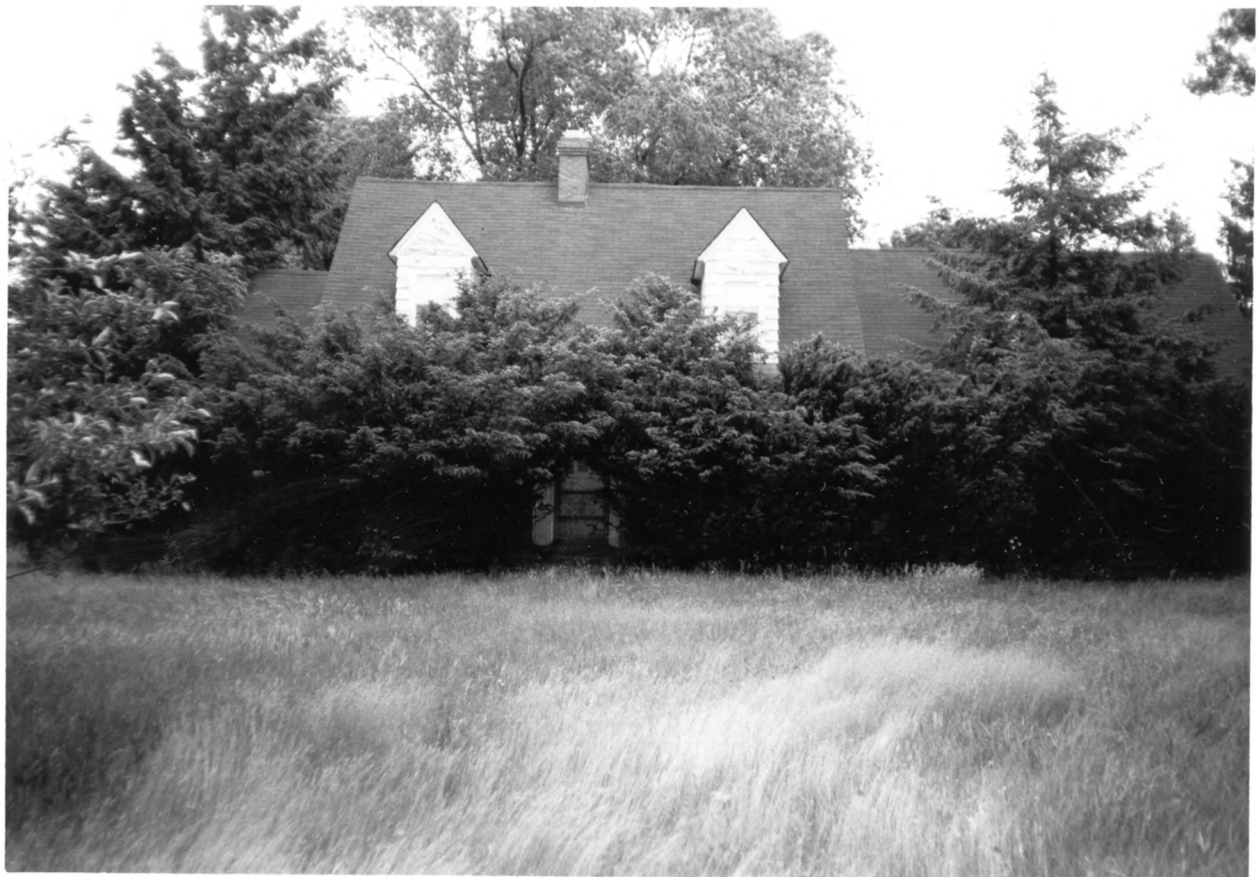
- 1) 1936 House, Michael Duffy Farm
- 2) Peninsula, Ohio
- 3) Melinda A. Campbell
- 4) June 8, 1987
- 5) U. S. Department of the Interior, National Park Service, Midwest Region, 1709 Jackson, Omaha, NE
- 6) Camera Direction: northeast
- 7) #2 on sketch map

The 1936 noncontributing house of Cape Cod style is faced with random ashlar stone veneer and wood siding. The asphalt shingle roof contains 2 gabled dormers. Parallel wings located on each gable-end house a sun porch and a garage.

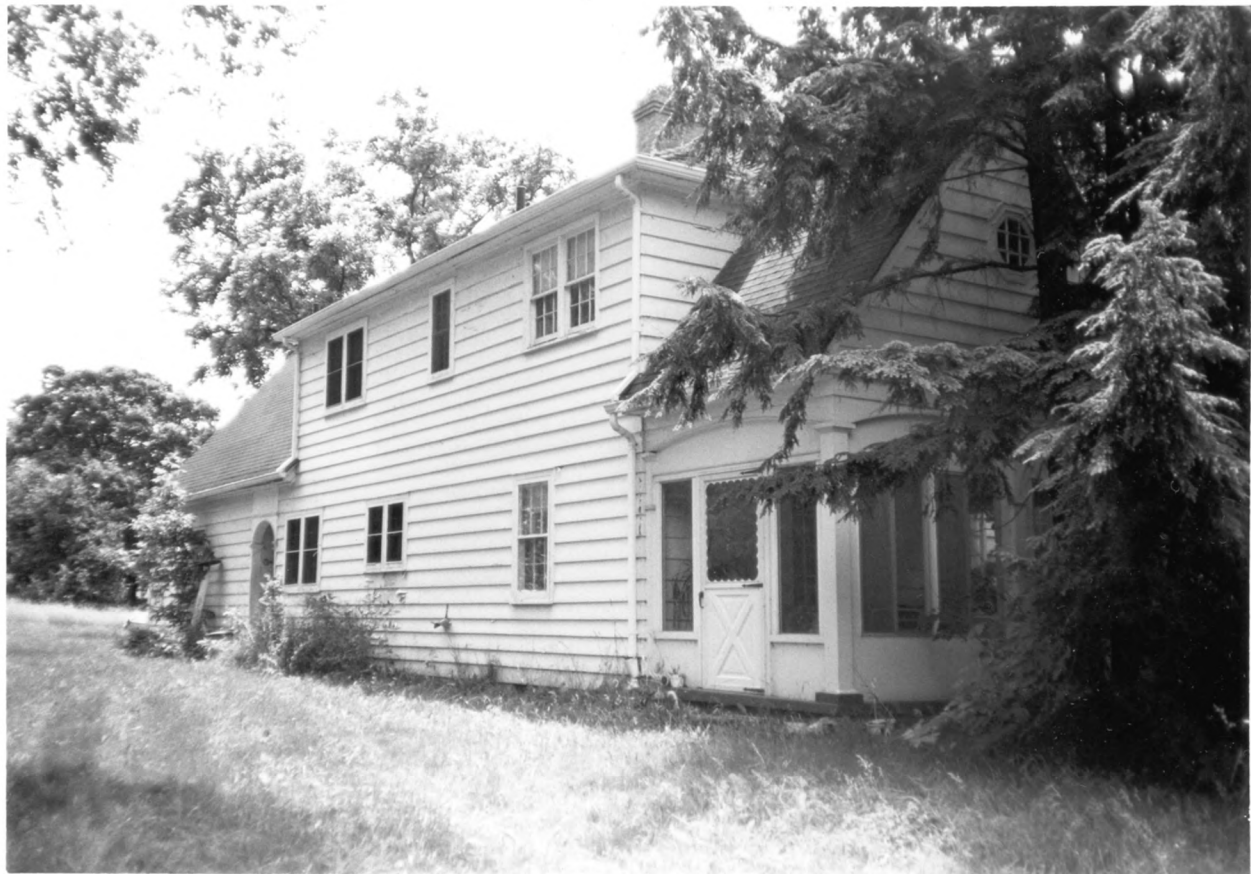
- 1) 1936 House, Michael Duffy Farm
- 2) Peninsula, Ohio
- 3) Melinda A. Campbell
- 4) June 8, 1987
- 5) U. S. Department of the Interior, National Park Service, Midwest Region, 1709 Jackson, Omaha, NE
- 6) Camera Direction: south
- 7) #3 on sketch map

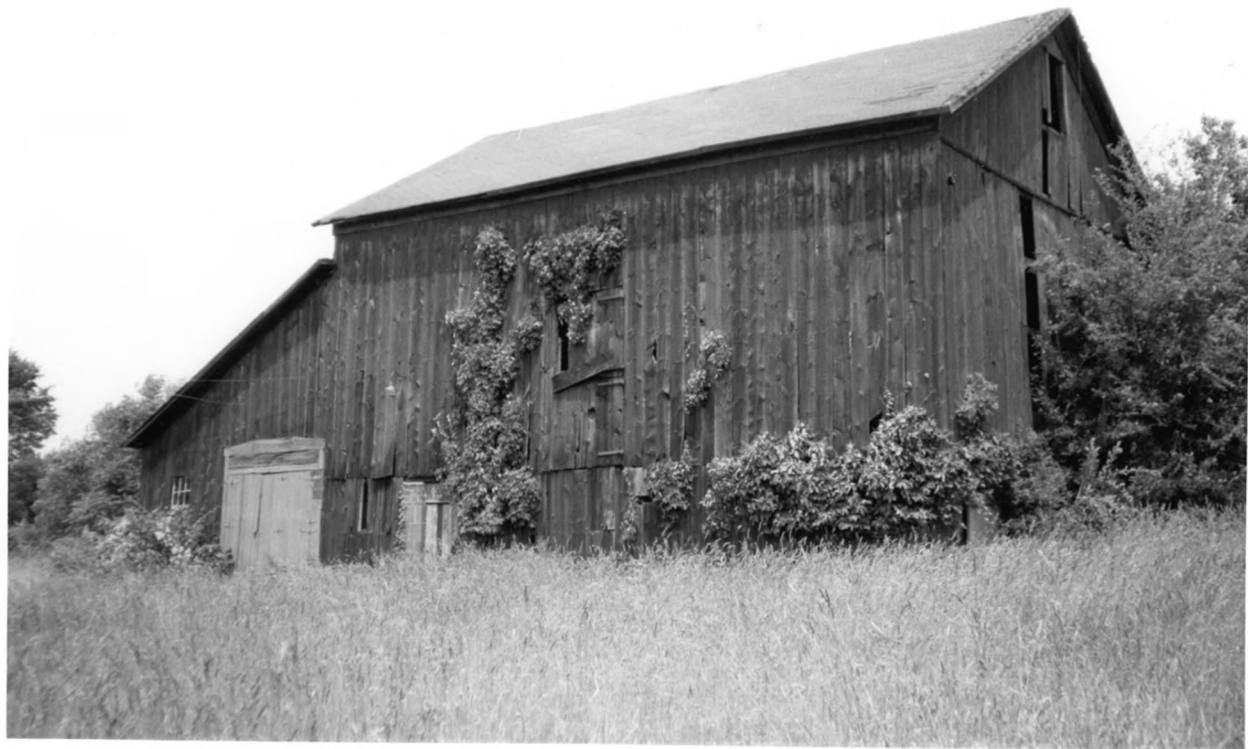
- 1) Barn, Michael Duffy Farm
- 2) Peninsula, Ohio
- 3) Melinda A. Campbell
- 4) June 8, 1987
- 5) U. S. Department of the Interior, National Park Service, Midwest Region, 1709 Jackson, Omaha, NE
- 6) Camera Direction: northeast
- 7) #4 on sketch map

The barn is a three-bay wide gable-roofed bank barn with a large shed appendage on the northwest gable end. The roof-wall junction of the core structure is marked by frieze board. The shed addition has a wide eave overhang. The barn rests on a sandstone base, and both the core and appendage are covered with vertical plank siding. Two entry doors have been cut into the southwest elevation.

A narrow vertical plank, double door with a heavy lintel beam is located on the shed roof addition. On the same elevation, a smaller door opening with hollow tile block surrounds is located on the lower level of core structure. Additional openings include a small 6/6 window adjacent to the shed door, a small hay door on the second floor of the barn's central bay, and a window opening in the southeast gable end. The earthen bank is located on the northeast side. The large sliding doors on the northeast elevation contain their original hardware.

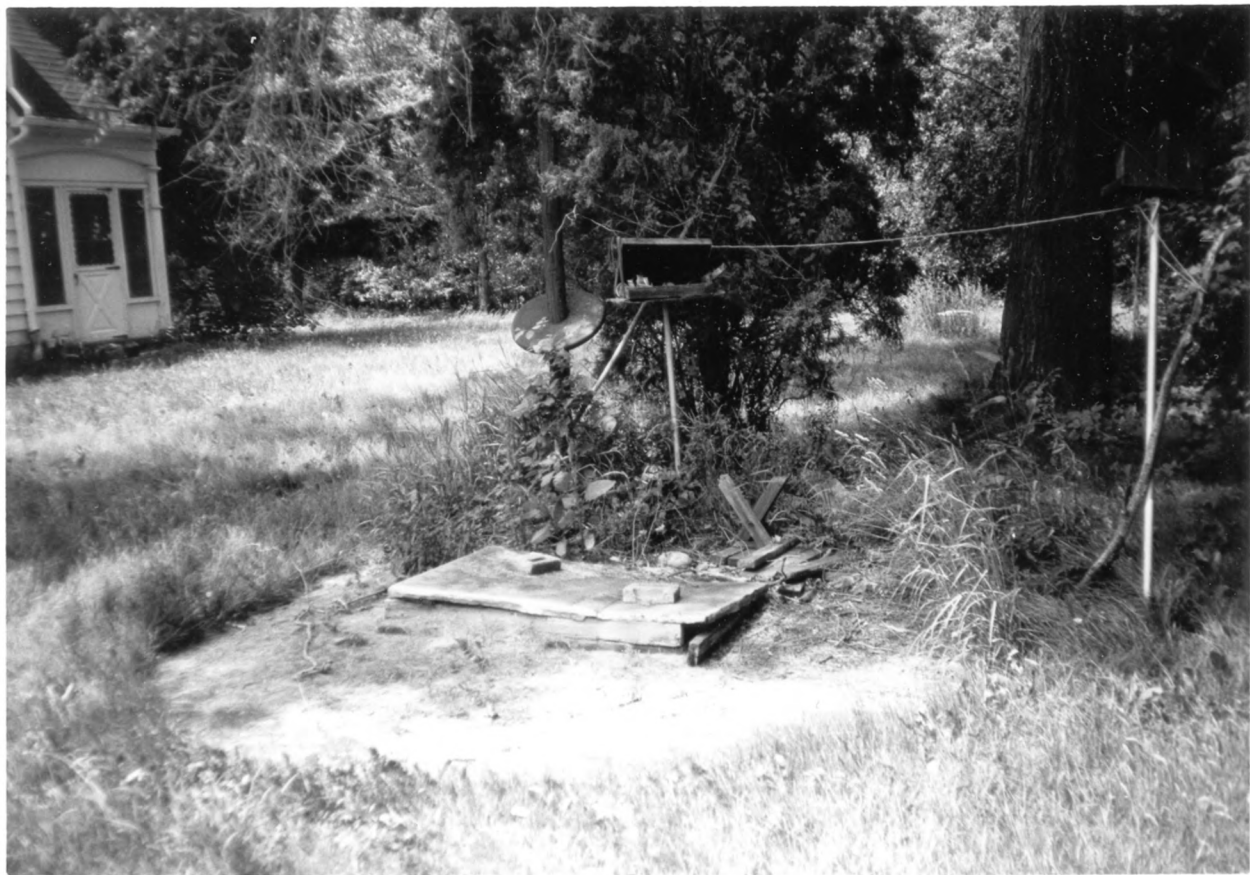
- 1) Well or Cistern (Springhouse floor?), Michael
Duffy Farm
- 2) Peninsula, Ohio
- 3) Melinda A. Campbell
- 4) June 8, 1987
- 5) U. S. Department of the Interior, National Park
Service, Midwest Region, 1709 Jackson, Omaha, NE
- 6) Camera Direction: west
- 7) #5 on sketch map

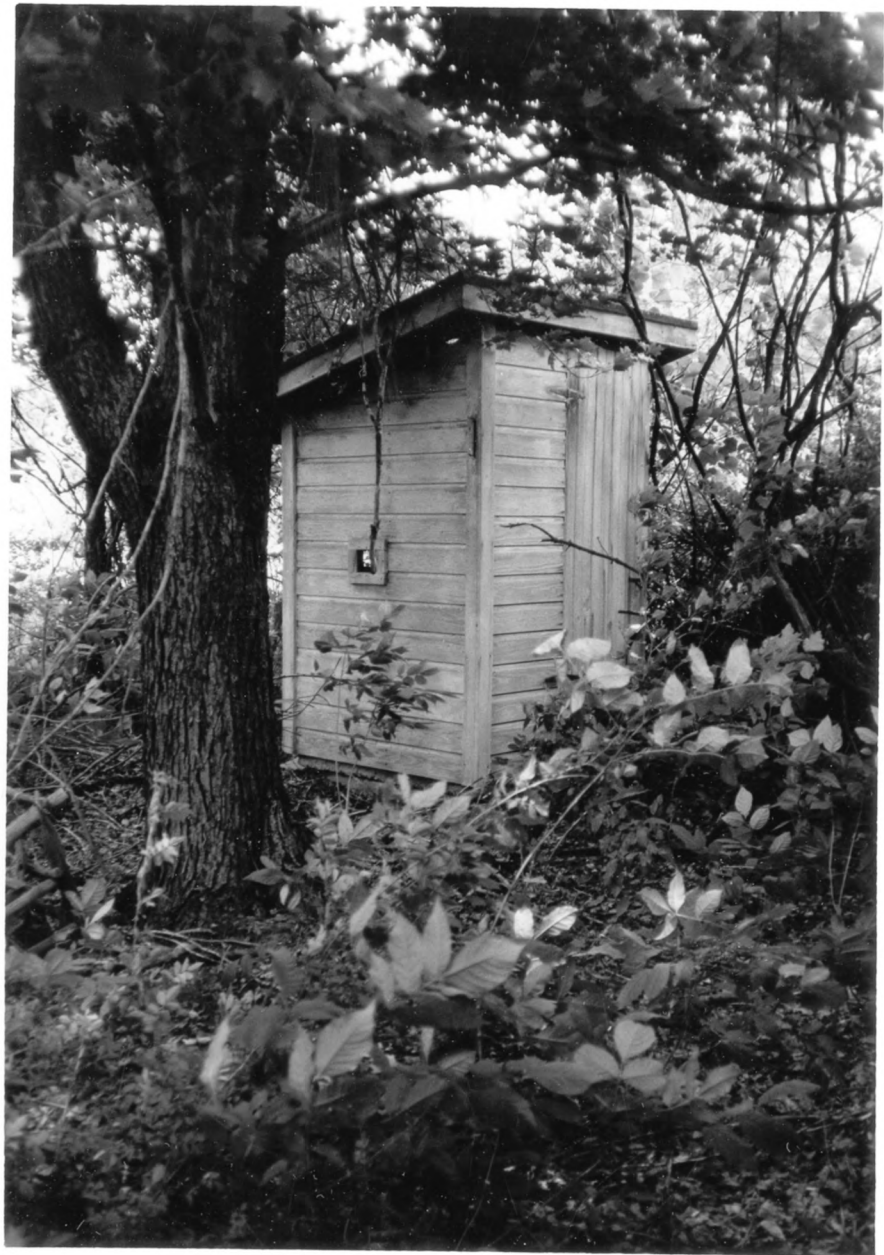
- 1) Outhouse next to 1936 House, Michael Duffy Farm
- 2) Peninsula, Ohio
- 3) Melinda A. Campbell
- 4) June 8, 1987
- 5) U. S. Department of the Interior, National Park Service, Midwest Region, 1709 Jackson, Omaha, NE
- 6) Camera Direction: east
- 7) #6 on sketch map

The two privies located on the farmstead have different roof profiles and different types of siding. The privy located closest to the house has a gable roof covered with rolled tarpaper, horizontal tongue-and-groove siding, a vertical plank door, and corner boards. The other privy has a shed roof, also covered with rolled tarpaper, horizontal drop siding, and vertical tongue-and-groove siding, and corner boards.

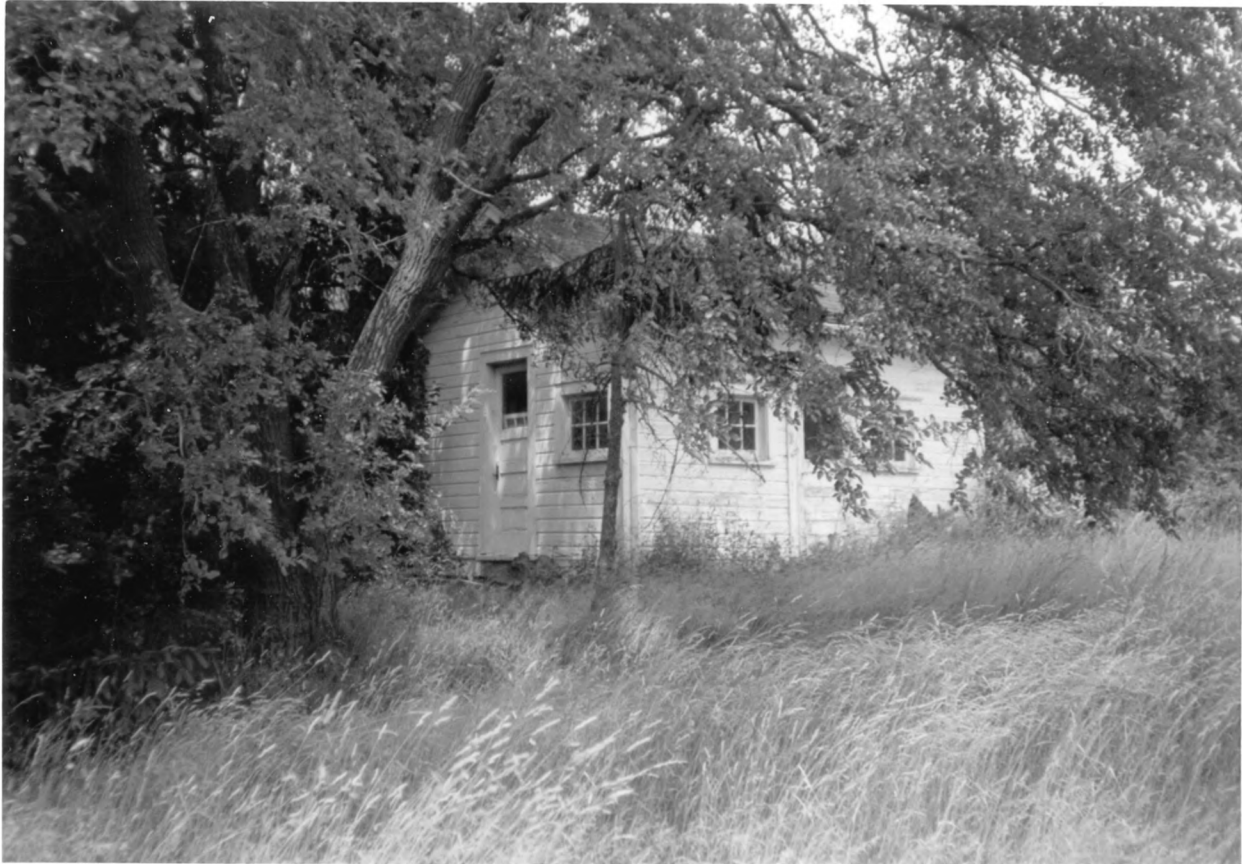
- 1) Fruit Stand, Michael Duffy Farm
- 2) Peninsula, Ohio
- 3) Melinda A. Campbell
- 4) June 8, 1987
- 5) U. S. Department of the Interior, National Park Service, Midwest Region, 1709 Jackson, Omaha, NE
- 6) Camera Direction: north
- 7) #7 on sketch map

The contributing outbuildings located on the farmstead include a fruit stand, a toolshed, and two privies. The fruit stand is a one story, gable roof structure. The roof is covered with composition sheeting and the walls are clad with wood drop siding. Openings include two doors, each with a glazed upper panel, and several small rectangular 6/6 fixed windows. A small wooden apple is located above the door. The toolshed is located approximately ten feet from the fruit stand and is similar in scale and massing to the fruit stand. Differences include narrower width tongue-and-groove horizontal siding and a fifteen light door. The toolshed also has a sawn-plank, lean-to addition with a plank door.

It is likely that Julius and Katherine Boehmer practiced truck farming during the 1920s when they owned the farm. The fruit stand located on the farm still has price list signs for several varieties of apples. Truck farming was one of the ways farmers survived during the Agricultural Decline and Economic Diversification period of farming in the valley.

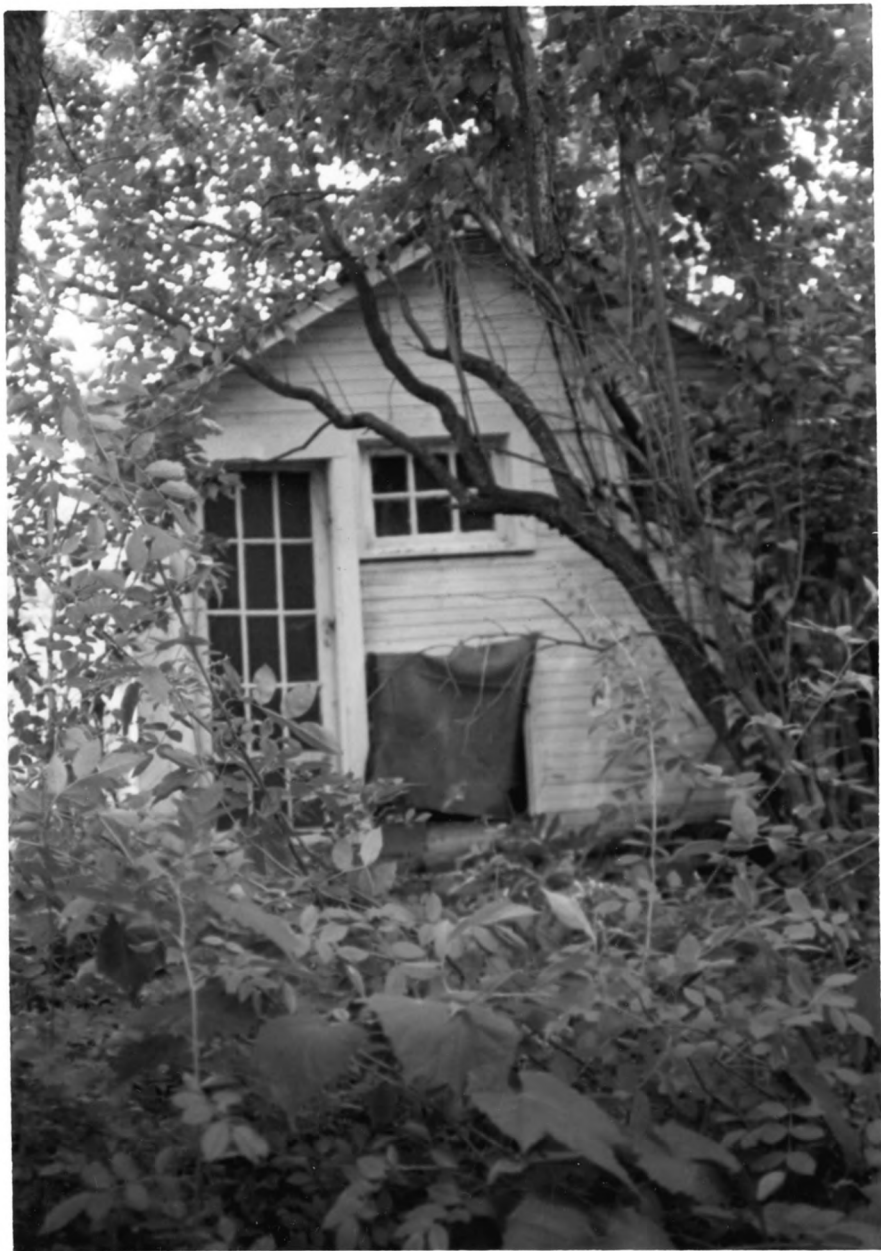
- 1) Chicken House, Michael Duffy Farm
- 2) Peninsula, Ohio
- 3) Melinda A. Campbell
- 4) June 8, 1987
- 5) U. S. Department of the Interior, National Park Service, Midwest Region, 1709 Jackson, Omaha, NE
- 6) Camera Direction: northeast
- 7) #8 on sketch map

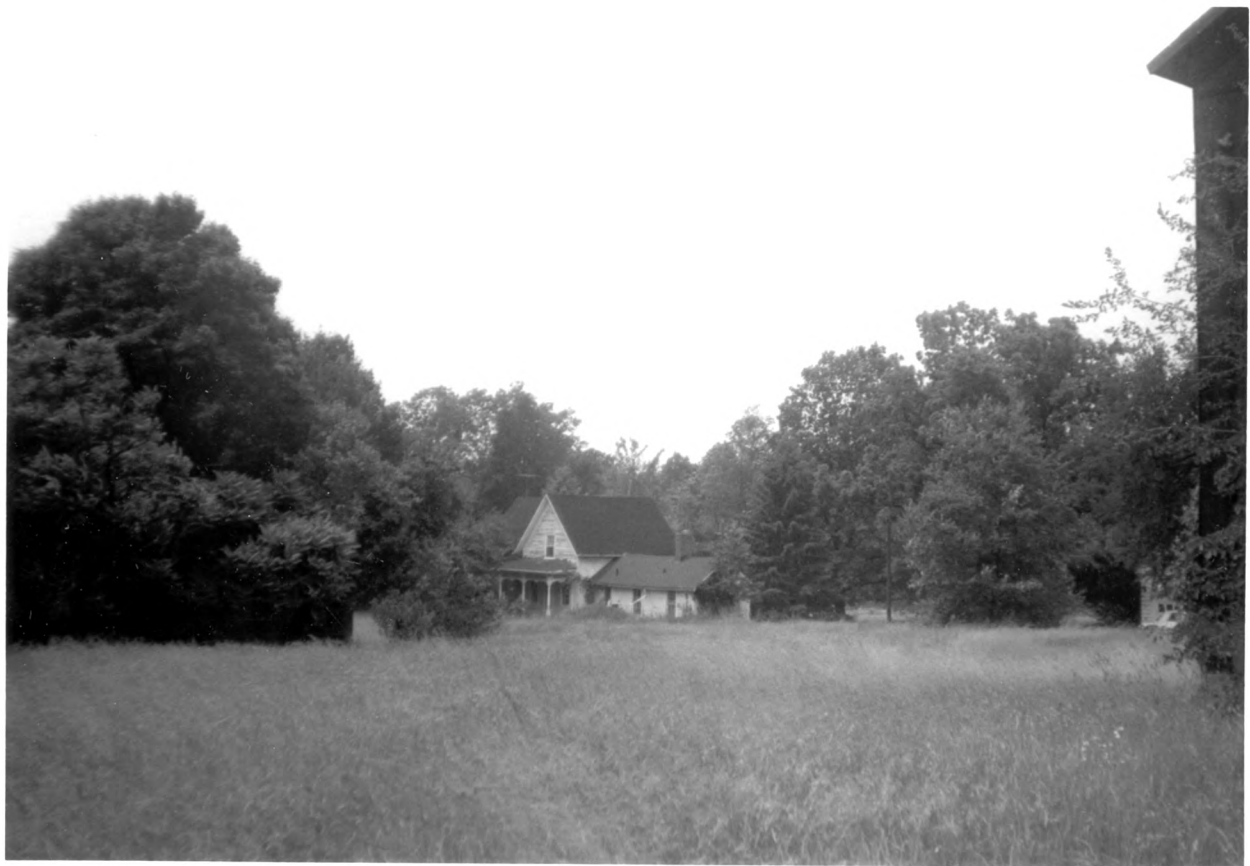
- 1) 1872 House/Landscape, Michael Duffy Farm
- 2) Peninsula, Ohio
- 3) Melinda A. Campbell
- 4) June 8, 1987
- 5) U. S. Department of the Interior, National Park Service, Midwest Region, 1709 Jackson, Omaha, NE
- 6) Camera Direction: west. Number on sketch map is approximate location of the camera.
- 7) #9 on sketch map

The adjacent fields are considered a contributing site. North and heading west from the 1872 house, the landscape changes from overgrown old fields, and becomes increasingly wooded. In this area there are a number of tall trees, but little undergrowth. The remains of an access road, which once connected fields near the house with fields in the north end of the property are apparent. The spruce and cherry trees which lined the road are extant, as are the remnants of a post and barbed wire fence. South and west of the farmstead is a cultivated field which is associated historically with the property.

Directly west of the house in a north/south line is a row of berry bushes, and parallel to this is a row of trees, including apple, cherry, and elm. These and other fruit trees and bushes throughout the property attest to the former truck farming operation.

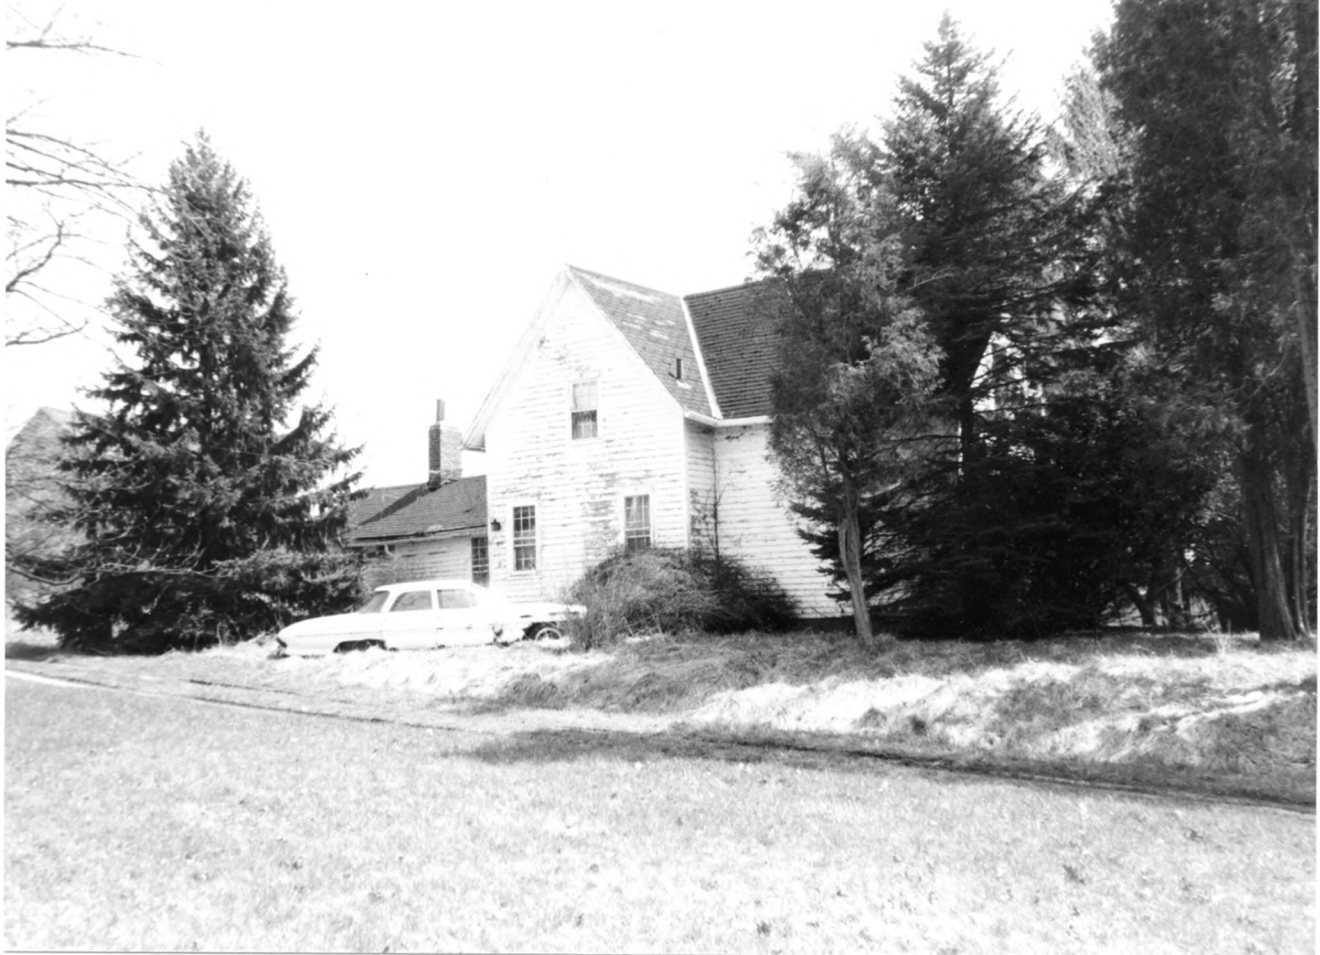
- 1) 1872 House, Michael Duffy Farm
- 2) Peninsula, Ohio
- 3) Paulette Oswick
- 4) April 9, 1990
- 5) U.S. Department of the Interior, National Park Service, Cuyahoga Valley Nat'l Recreation Area
- 6) camera direction: east
- 7) #10 on sketch map

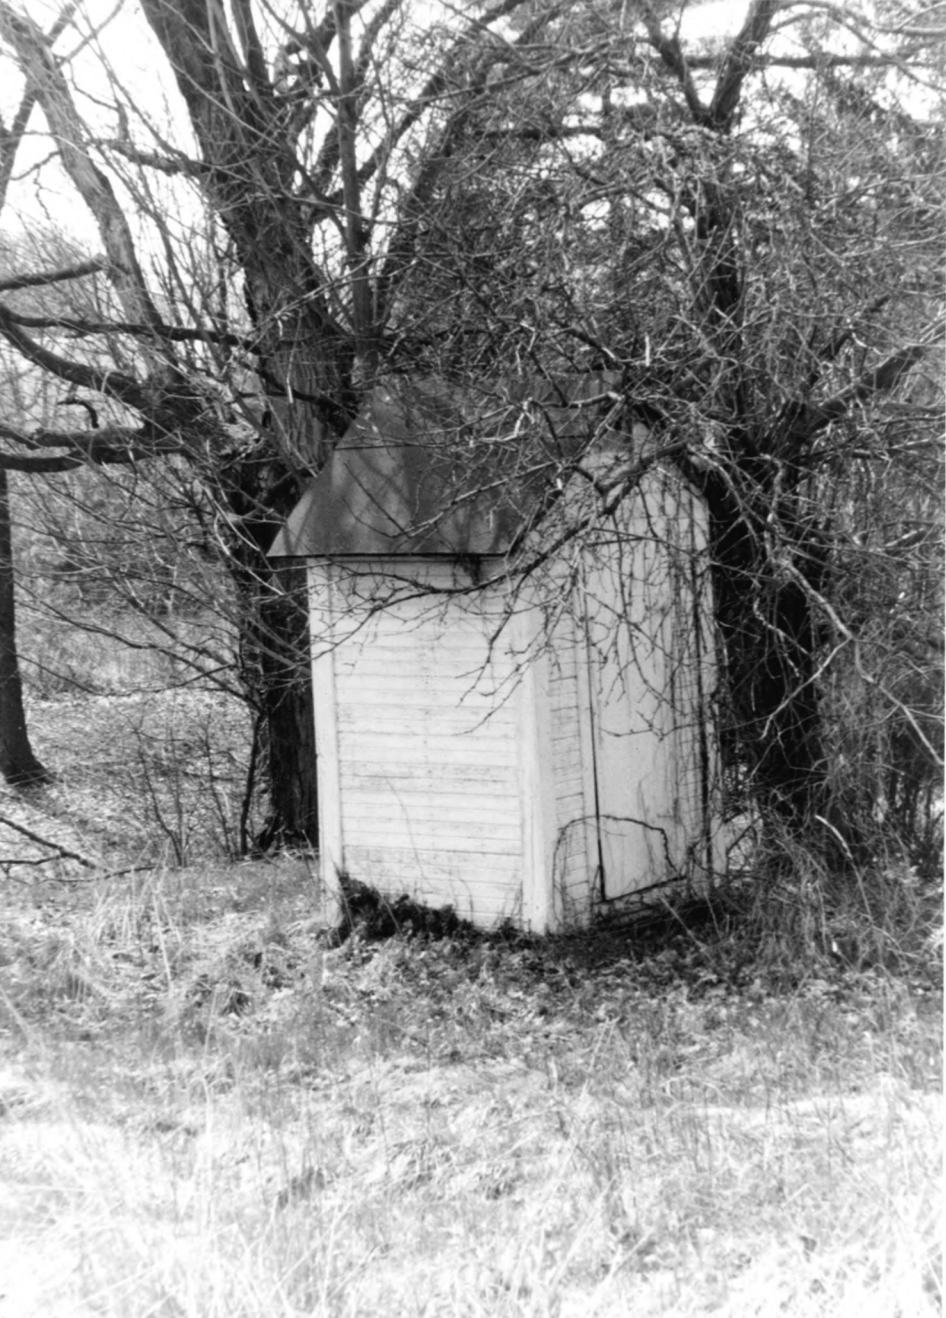
- 1) Privy next to 1872 House, Michael Duffy Farm
- 2) Peninsula, Ohio
- 3) Paulette Oswick
- 4) April 9, 1990
- 5) U.S. Department of the Interior, National Park Service, Cuyahoga Valley Nat'l Recreation Area
- 6) Camera Direction: southwest
- 7) #11 on sketch map
