# OHIO HISTORIC INVENTORY

1. No. <b>15</b>	4. Present Name(s) Lock No. 29 ("Peninsula Lock") and Aqueduct
2. County Summit	5. Other Name(s)
3. Location of Negatives OHS

15 Summit Lock No. 29 ("Peninsula Lock") and Aqueduct

Lock No. 29 ("Peninsula Lock") and  
Peninsula Aqueduct, Ohio and Erie  
Canal District, Cuyahoga and  
Summit Counties, Ohio

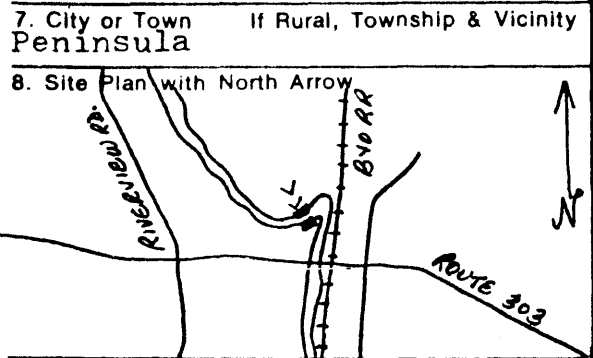
42. Further Description of Important Features  
Lock No. 29 and the abutments of the former canal aqueduct are both of cut stone construction. Lock is standard mitered gate type, measuring 90 X 15 feet within the lock chamber. Aqueduct was originally a two-span structure, acc. to Bishop. Center stone pier was removed when aqueduct was replaced with a single-span steel structure. The new aqueduct was destroyed by the great flood of 1913.

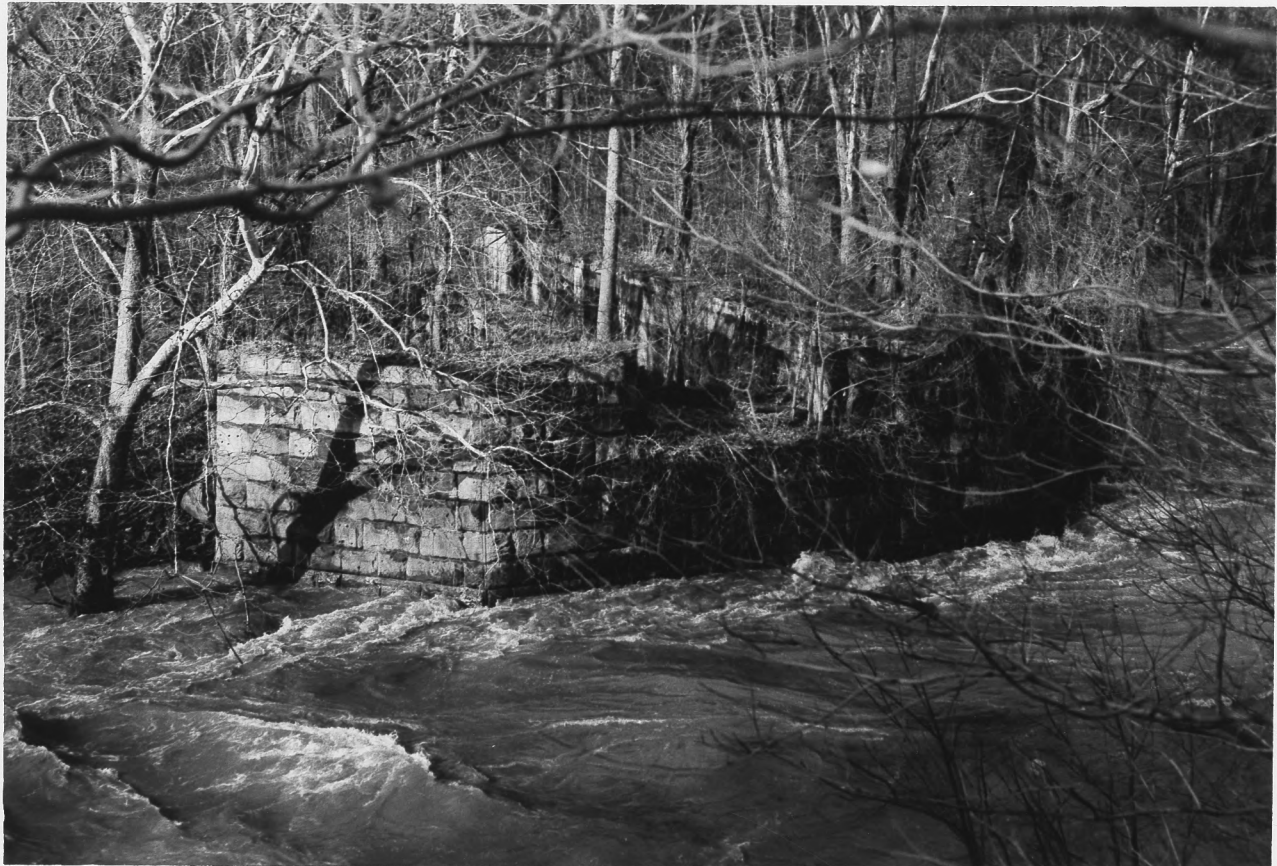
# 154/18

Photograph by Carol Poh Miller, April  
1976

View looking northwest.
