OHIO HISTORIC INVENTORY

1. No. 9	4. Present Name(s) Lock No. 33 ("Lost Lock")
2. County Summit	5. Other Name(s)
3. Location of Negatives OHS

Summit
Lock No. 33 ("Lost Lock")

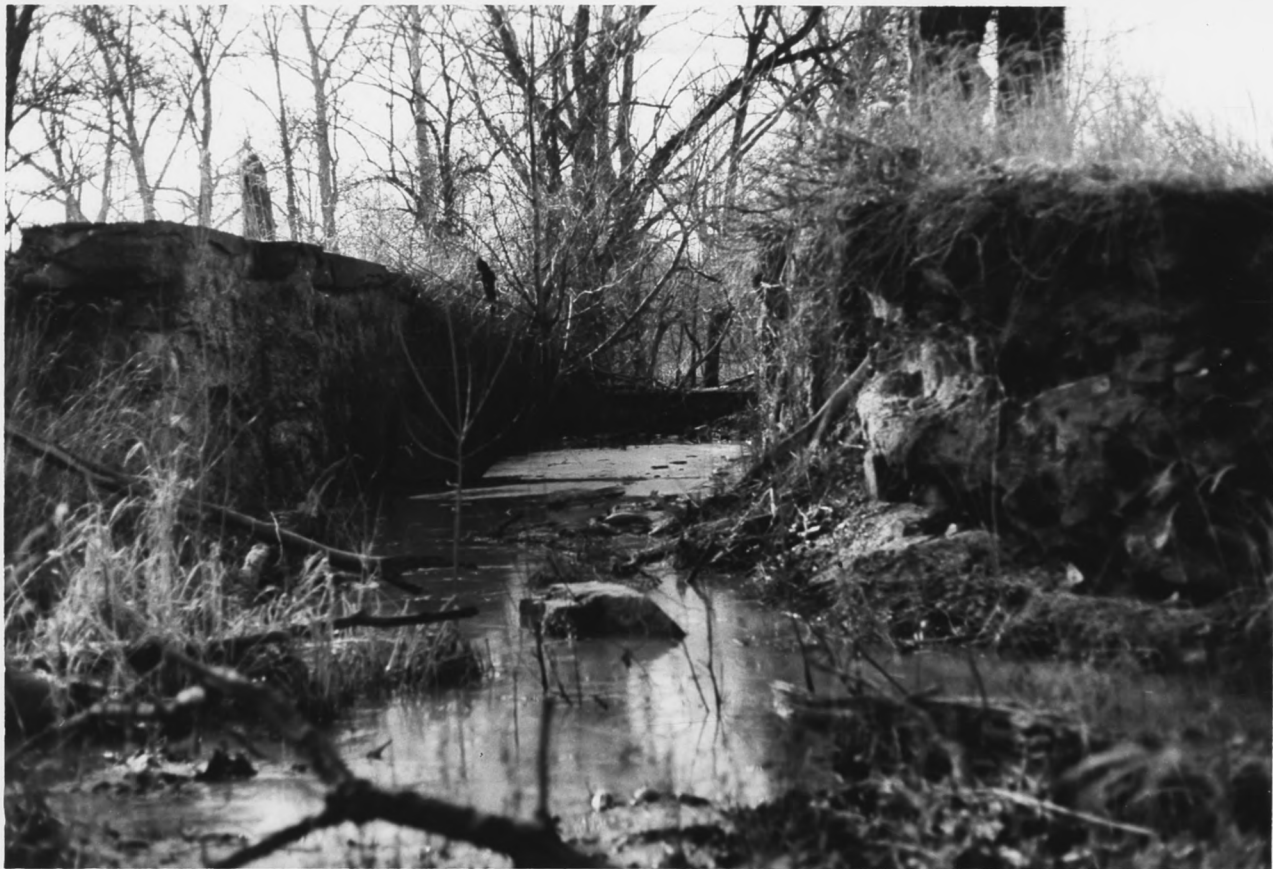
Lock No. 33 ("Lost Lock"), Ohio and
Erie Canal District, Cuyahoga and
Summit Counties, Ohio

View looking south.
