National Park Service  
Cultural Landscapes Inventory

Fort Wadsworth  
Gateway National Recreation Area

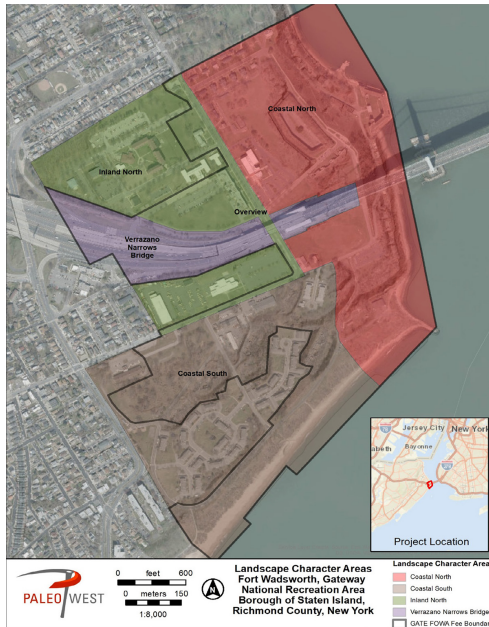
Figure 1. Landscape character areas of Fort Wadsworth. (Helen Juergens, Chris Baker, Ben DiBiase, and Steve Burns, “Cultural Landscape Report for Fort Wadsworth [hereafter CLR], 2022: 15)

Fort Wadsworth can be described by four landscape character areas based on historical development patterns: Coastal North, Coastal South, Inland North, and the Verrazzano-Narrows Bridge (Figure 1). Generally, the Coastal North area was the first to be developed for military defenses, and the oldest forts are located here. As the installation grew, various batteries were installed within the Coastal South area. The Inland North area was used historically for more administrative, supportive, and housing functions where sight lines or fields of fire were not the primary focus. The Verrazzano-Narrows Bridge area includes associated access roads. (CLR 2022: 15,166)

As presented in the 2022 CLR, documentation of existing conditions of the historic landscape is organized according to four Landscape Character Areas (see Figure 1). These landscape character areas are, Coastal North and Coastal South, which are characterized by their immediate adjacency and relationship to the coastline; the Inland North that has been interrupted by the Coast Guard presence; and the Verrazzano-Narrows Bridge with its associated access roads. (CLR 2022: 166)

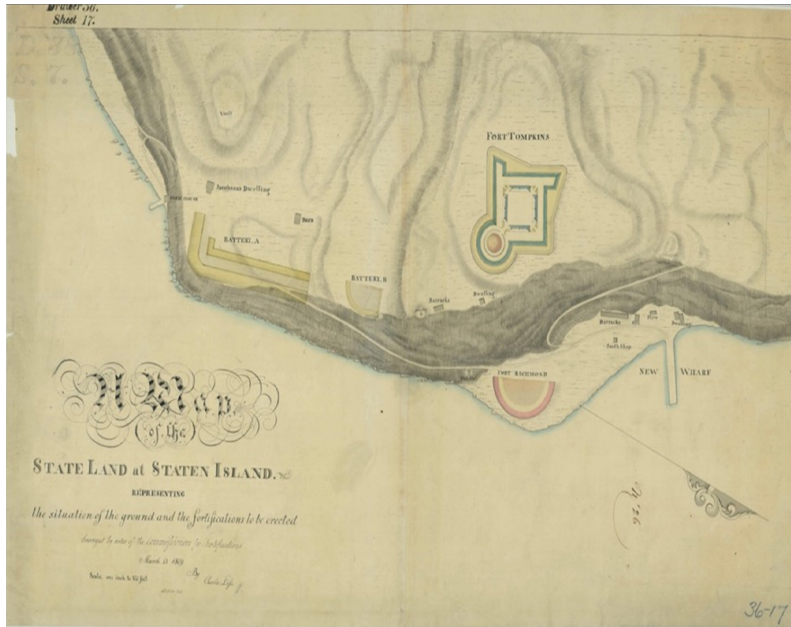
Figure 2. “Map of the State Land at Staten Island Representing the Situation of the Ground and Fortifications to be Erected, March 13, 1809.” The map shows state constructed fortifications near the water including Fort Richmond (now Battery Weed), small dwellings, and the proposed Fort Tompkins, the design of which was modified prior to construction; Battery A is Fort Hudson and Battery B is Fort Morton. (National Archives and Records Administration, from CLR 2022: 27)

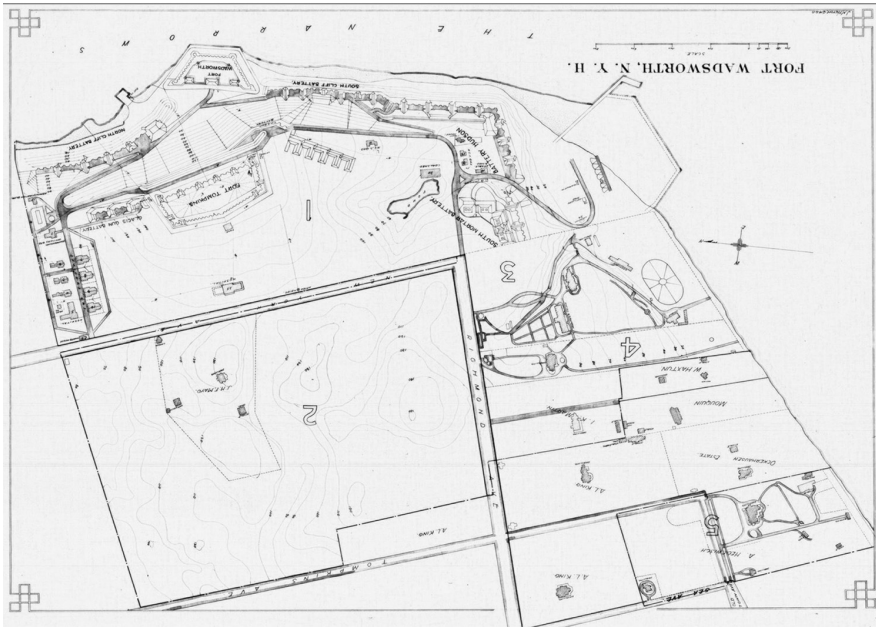
Figure 3. A map titled “Fort Wadsworth, N.Y.H.,” circa 1895. The map outlines the privately held land added to the western portion of the post. (National Archives and Records Administration, from CLR 2022: 50)

Development during this period occurred predominately in the Coastal North and Coastal South character areas with defensive fortifications spatially organized along the coastal perimeter and oriented towards the coastline and seaward approaches. Support buildings and structures occupied the Inland North area. The broad spatial organization remained consistent from the previous period, with fortifications occupying strategic locations on the landscape, a primary fort at the high point of the bluff, and batteries and redoubts below (Figure 3). (CLR 2022: 56)

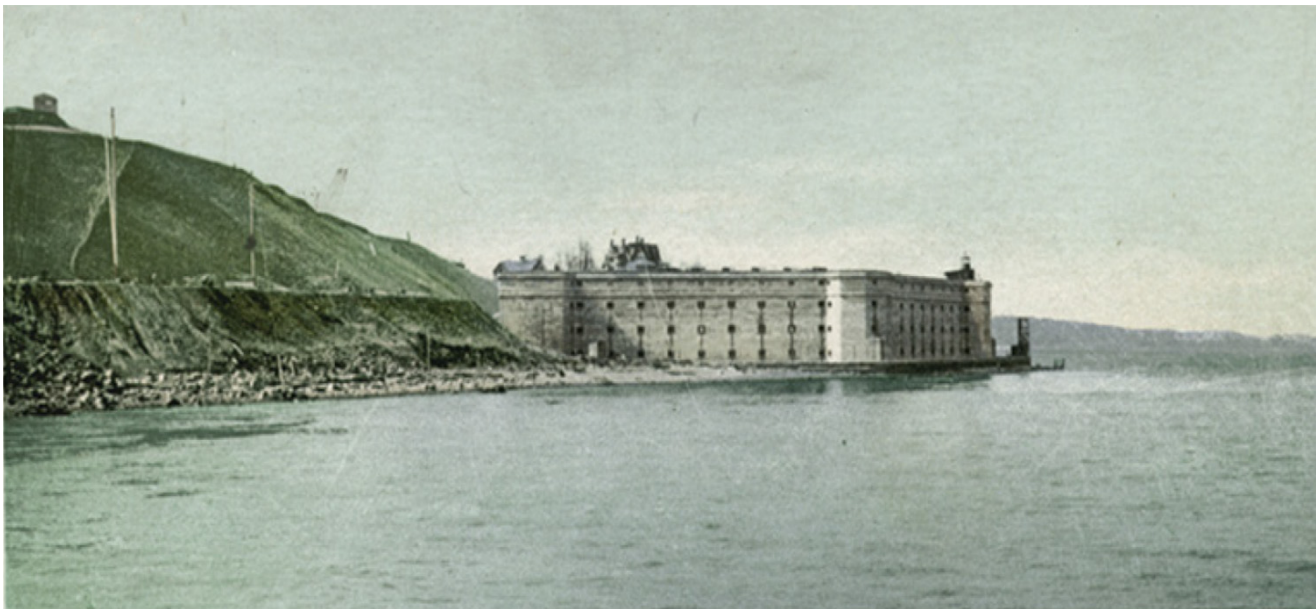
Figure 4. Photographic postcard by the Detroit Photographic Company titled “Fort Wadsworth, New York, 1903.” The postcard shows the cleared park-like landscape that the military required for defense and the public found desirable for recreation. Note the newly relocated Fort Wadsworth Light at Battery Weed. (New York Public Library, from CLR 2022: 55)

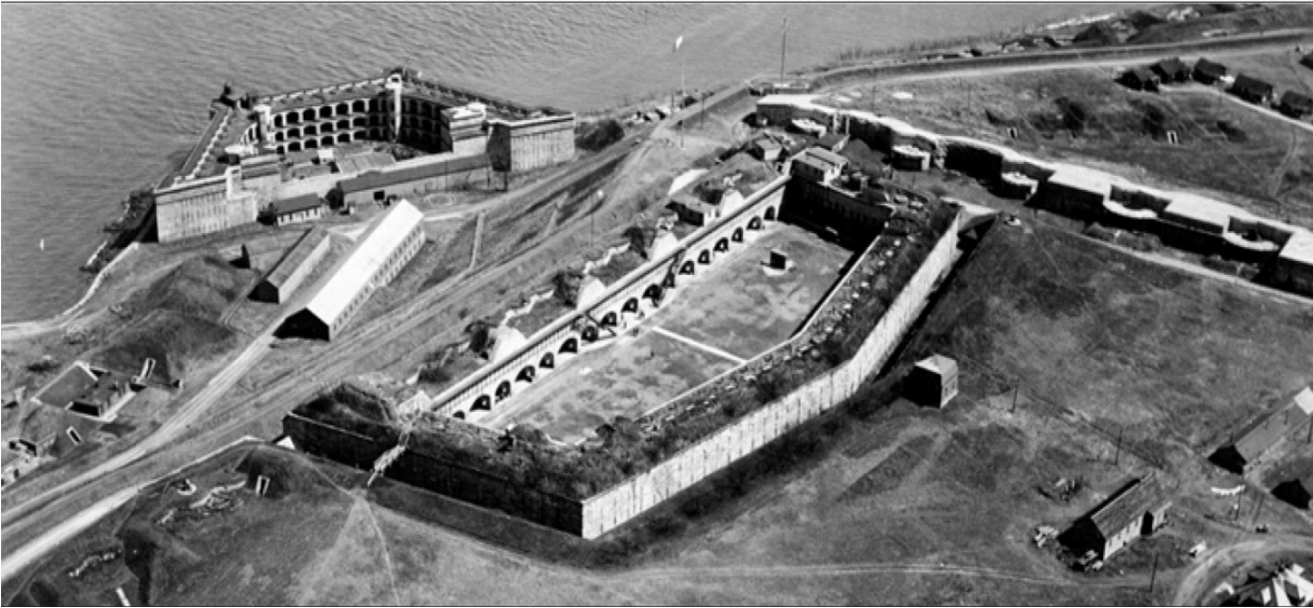
Figure 7. Oblique aerial photograph of Fort Tompkins and Battery Weed, early 1930s. Note the open, cleared landscape with roads and trails cross the grassy areas. (National Archives and Records Administration, from CLR 2022: 88)

The landscape was still defined by two monumental masonry buildings: Battery Weed projecting into the Narrows, and Fort Tompkins at the high point on the bluff (Figure 6). The topography between the two forts consisted of an engineered slope that was cleared of vegetation to provide views and vistas for open fields of fire (Figure 7). (CLR 2022: 91)

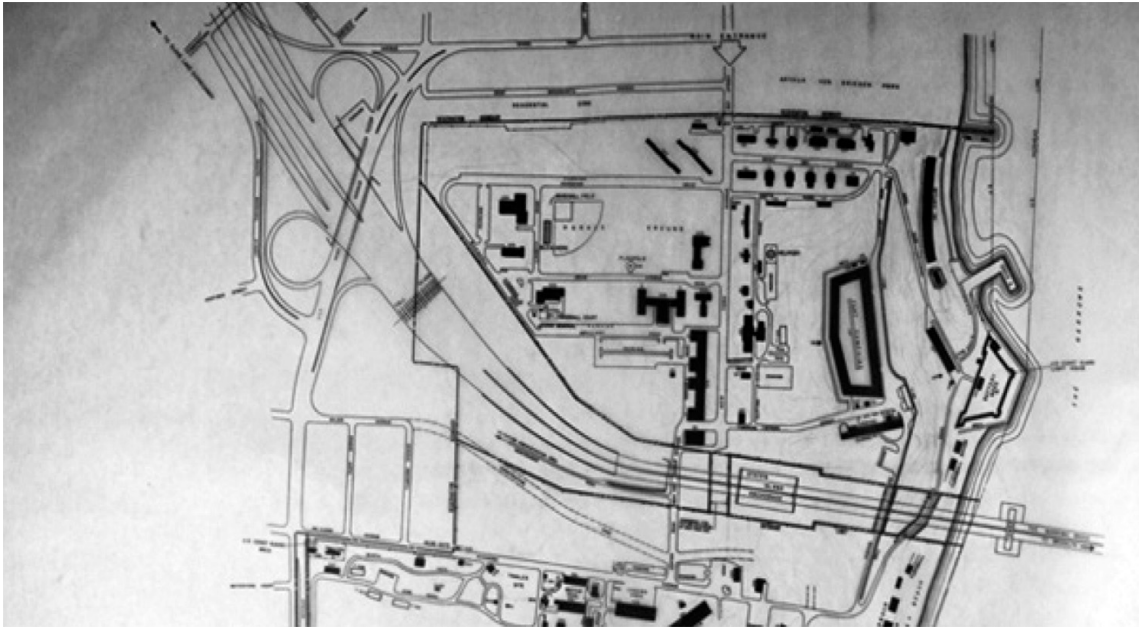
Figure 8. Detail of the Fort Wadsworth General Site Map, 1962. Note the bridge right-of-way (outgrant) cutting through the post. (Gateway NRA Collections, from CLR 2022: 107)

Fort Wadsworth did not play a major role in the Cold War, and the base served largely as an administrative processing center. The broad spatial organization remained consistent from the previous period, with fortifications occupying strategic locations on the landscape, a primary fort at the high point of the bluff, and batteries and redoubts below. However, this spatial organization was altered by the construction of the Verrazzano-Narrows Bridge, which dominated the views and vistas of the site (Figure 8 and 9). (CLR 2022: 113)

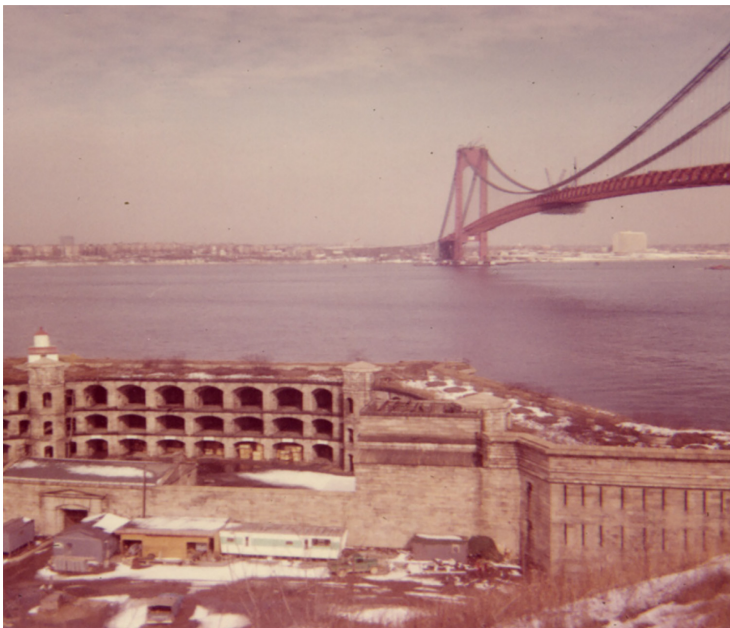
Figure 9. Photograph from Fort Tompkins looking towards Battery Weed, March 1963. Note the temporary buildings and construction staging along the western wall of Battery Weed; the fortification's interior was used for storage. (Gateway NRA Collections, Image 21915-3-64(3), from CLR 2022: 107)

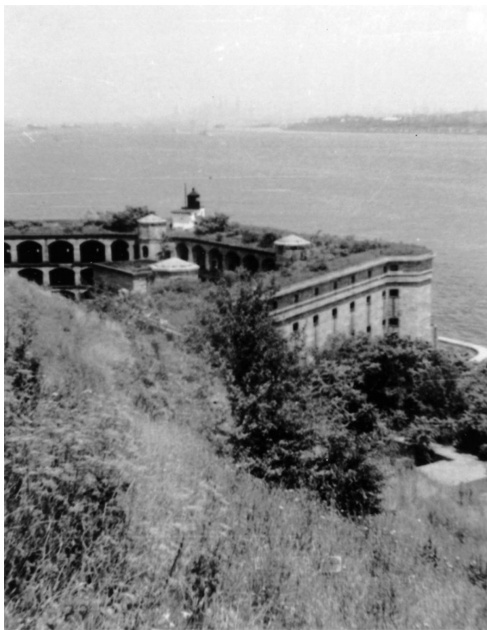
*Figure 10. Photograph of Battery Weed and the engineered slope between the forts, 1959. Note the woody vegetation and tall grass growing on the formerly cleared and mowed hillside; the roof of Battery Weed is shrouded in shrubs. (Gateway NRA Collections, Image 18698, from CLR 2022: 104)*

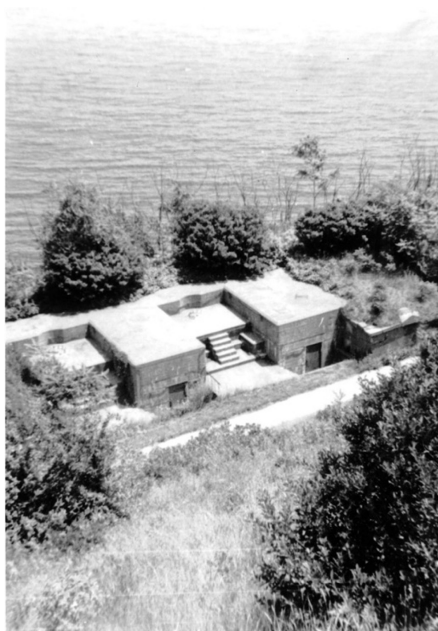
*Figure 11. Photograph of an Endicott-era Battery, 1949. Note the growth of young woody vegetation encroaching on the battery. (Gateway NRA Collections, Image 18699, from CLR 2022: 103)*

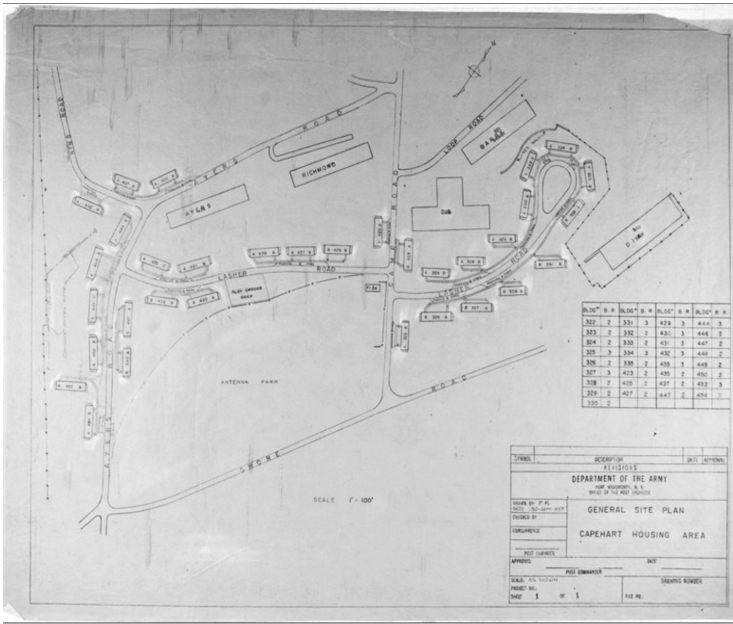
Figure 12. Map of Fort Wadsworth titled *General Site Plan Capehart Housing Area*, 1959. The proposed housing development included 66 buildings at the southwestern corner of the post. (Gateway NRA Collections, from CLR 2022: 102)

Buildings in the Coastal South area included military and family housing. The Capehart housing units spread across the Coastal South area south of the batteries (Figure 12). A pistol and rifle range occupied the southeast end of Range Road. Maintenance buildings formed the Seabee Complex south of Richmond Avenue, including four motor pool buildings (current Buildings 301–304) and an administration building (current Building 305). Utilitarian Building 310 stood at the intersection of Tennessee Road (formerly Camp Road) and Richmond Avenue, and a large warehouse was located south of Richmond Avenue. (CLR 2022: 113-114)

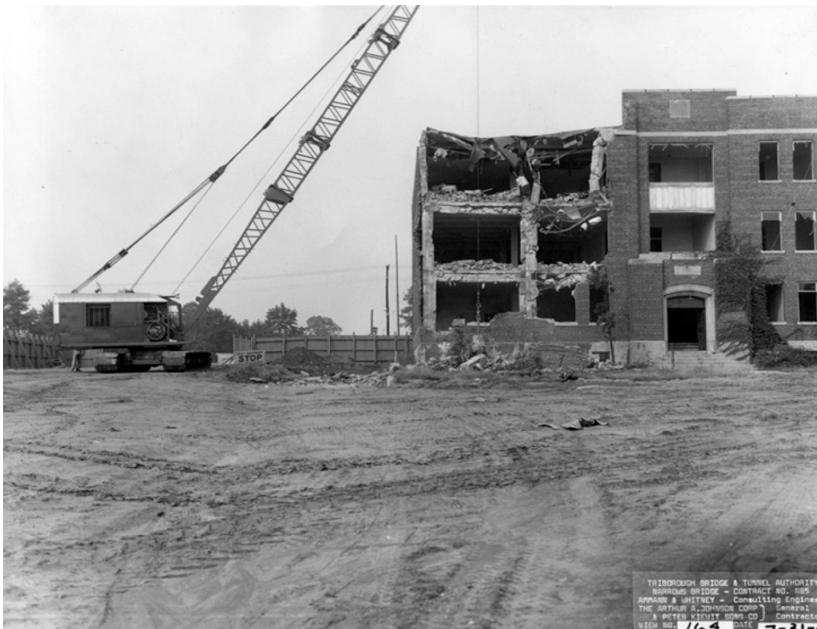
Figure 13. Photograph of the demolition of the 1931 Infantry Barracks at the southern end of Building 210, June 1961. (Courtesy of MTA Bridges and Tunnels Special Archive, Photo NB-5-164, from CLR 2022: 109)

Nearly fifty buildings and structures in the Coastal North and Inland North areas were removed in this period including one of the large infantry barracks, the Post Headquarters, Coast Guard housing and garage, Officer's Quarters, Non-Commissioned Officer's Quarters, the theater, the post exchange, the ordnance shop, garages, storerooms, handball courts, and a flagpole (Figure 13). (CLR 2022: 114)

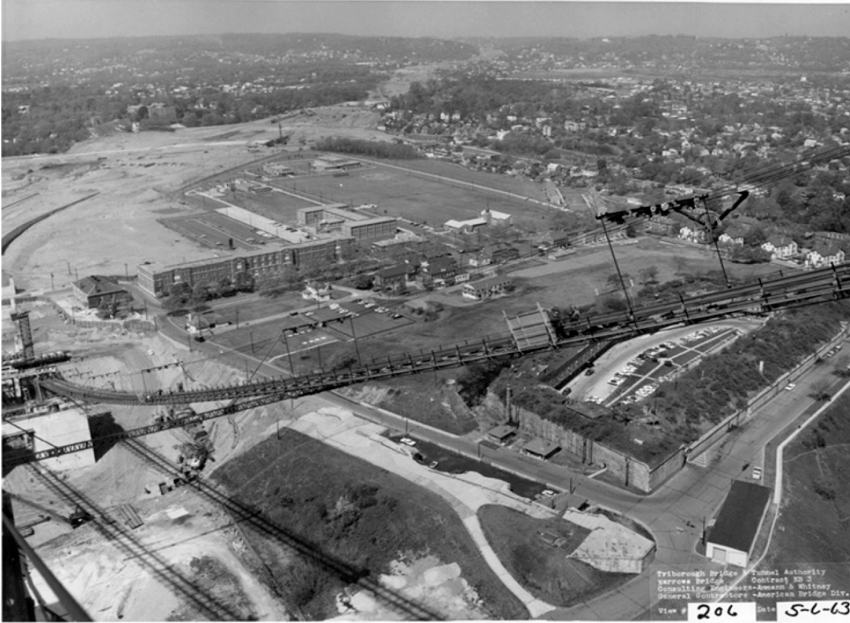
Figure 14. Aerial photograph depicting excavation for the bridge anchorage and clearing for the Verrazzano-Narrows Bridge approaches, May 1963. (Courtesy of MTA Bridges and Tunnels Special Archive, Photo NB-3-206, from CLR 2022: 108)

The Verrazzano-Narrows Bridge cut through Fort Wadsworth, creating the fourth Landscape Character Area: the Verrazzano-Narrows Bridge (Figure 14). The anchorages and approaches required considerable grading of the topography across a large section of the post. (CLR 2022: 114)

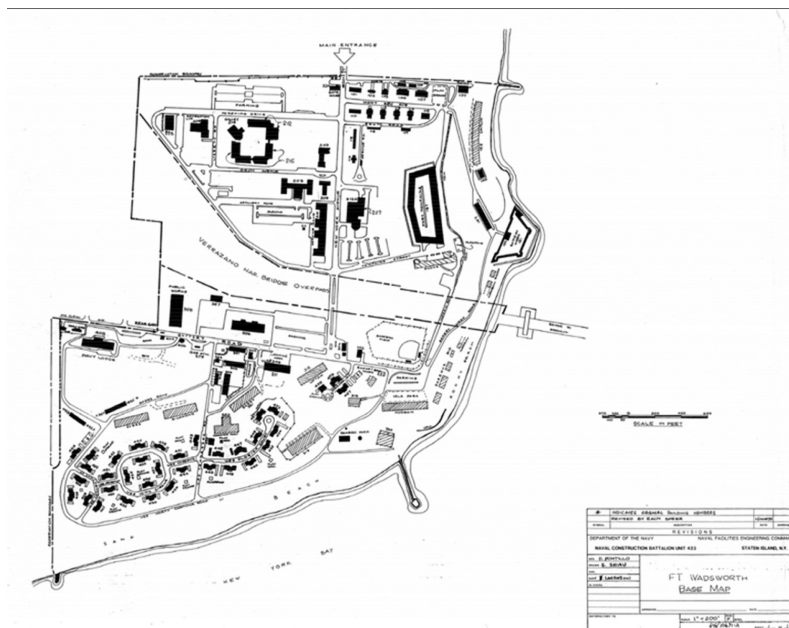
Figure 15. Fort Wadsworth Base Map, 1993. The map shows new Navy construction concentrated in the southern portion of the post. (National Park Service Technical Information Center, from CLR 2022: 128)

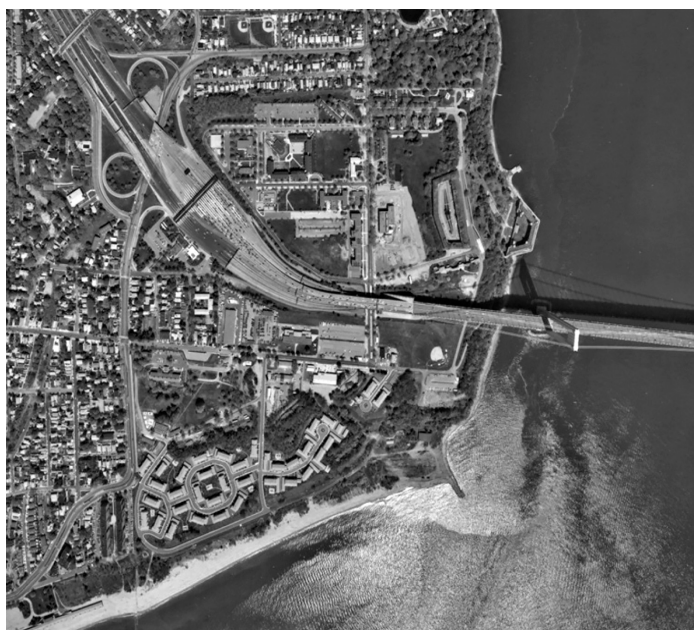
Figure 16. Aerial photograph of Fort Wadsworth, 1993. The photograph captures the late 20th-century alterations to the post prior to National Park Service acquisition. (Gateway NRA Collections, Image 30654, from CLR 2022: 132)

were subject to modern development. Changes occurred largely in the Coastal South and Inland North character areas, which remained in the control of the Department of Defense. Although largely unaltered during this period, a new postmodern administrative building on the east side of New York Avenue had a significant impact on the Coastal North area. The broad spatial organization remained consistent from the previous period, with fortifications occupying strategic locations on the landscape, a primary fort at the high point of the bluff, and batteries and redoubts below (Figure 15). The Verrazzano-Narrows Bridge dominated the views and vistas of the site, interrupting the original spatial organization (Figure 16). (CLR 2022: 133)

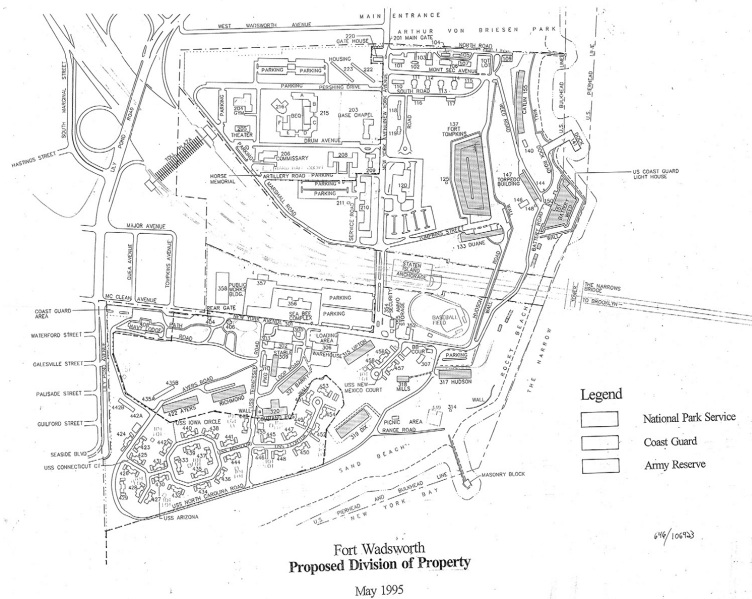
Figure 17. Map titled *Fort Wadsworth Proposed Division of Property, 1995*. The map illustrates the proposed boundaries between the National Park Service, Coast Guard, and Army Reserves. (National Park Service Technical Information Center, from CLR 2022: 131)

Fort Wadsworth entered a new phase in its history in 1995 (Figure 17). For the first time in two centuries, the primary land use for the property transitioned away from military use and toward a new mission of public use and resource protection. Fort Wadsworth was no longer an active military installation, which was its primary function since 1794. However, for much of its history, the post was also an area that attracted the general public for outdoor leisure. Under National Park Service management, this has become the fundamental use of Fort Wadsworth. In addition to general public use of the site, Fort Wadsworth provides the backdrop and staging for the start of the New York City Marathon each year and continues to host the finish of the Five Borough Bike Tour (Figure 18). Important characteristics of public use are the cultural landscape, historic harbor views, and historic buildings that served military and defensive purposes. (CLR 2022: 139)

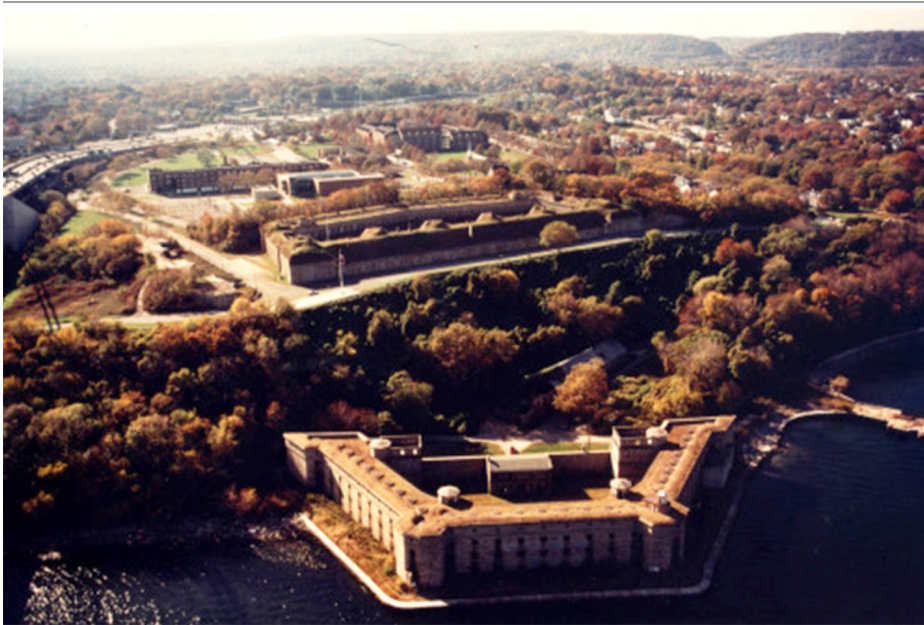
*Figure 19. Aerial photograph of Fort Wadsworth, 1995. Note the thick woody vegetation in the areas between Battery Weed and Fort Tompkins and West of Fort Tompkins. These areas were historically kept clear of trees and shrubs. (National Park Service, from CLR 2022: 142)*

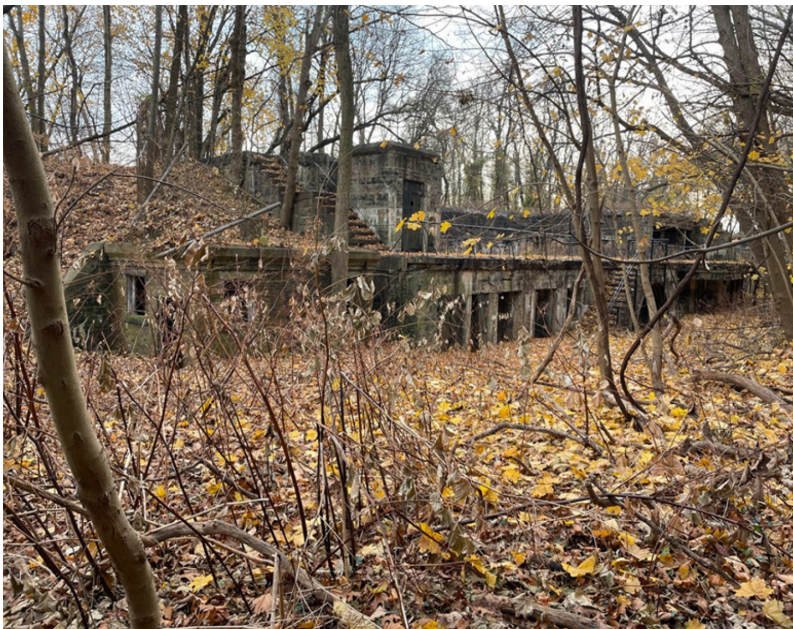
*Figure 20. Photograph of Battery Dix, the least deteriorated of the Endicott Era batteries, December 2021. (PaleoWest, from CLR 2022: 150)*

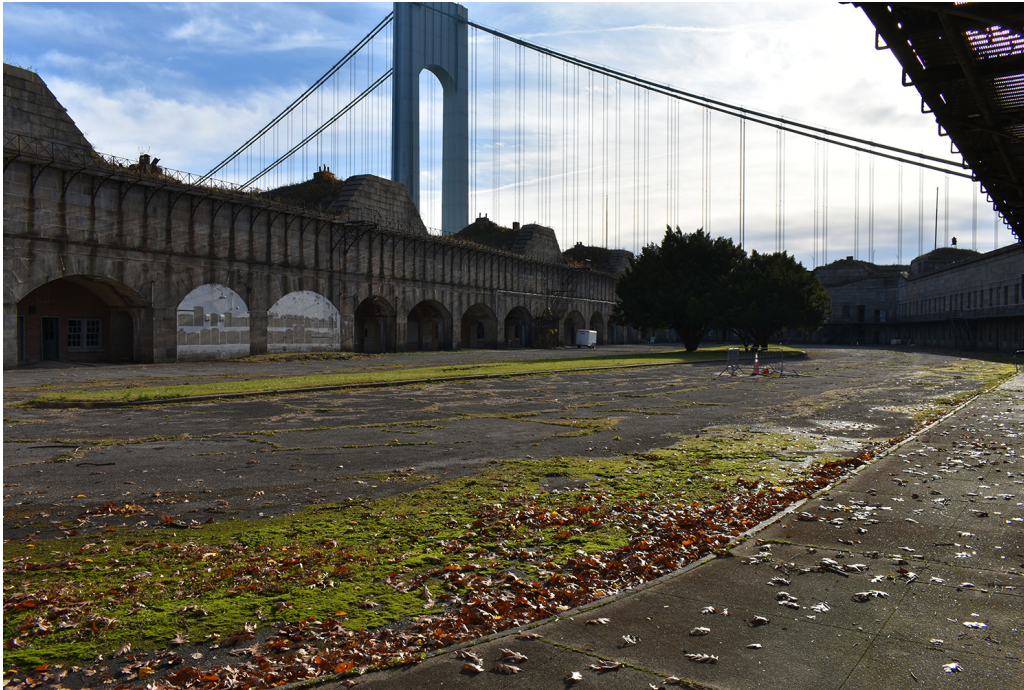
Figure 21. View looking southeast from Fort Tompkins interior quadrangle. (PaleoWest 2021, DES-1760)

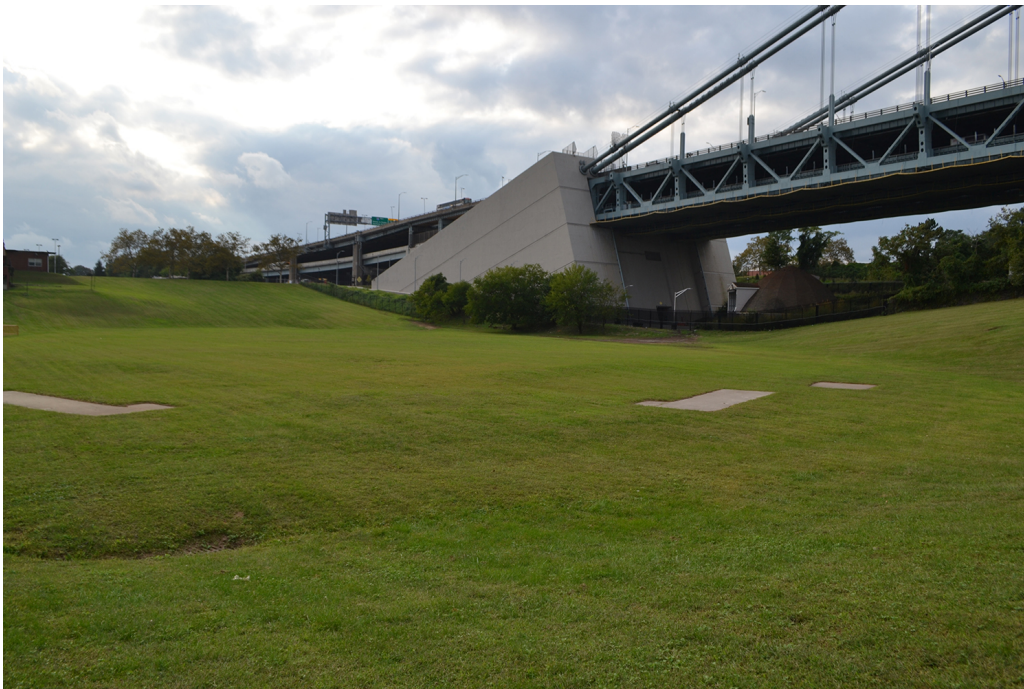
Figure 22. View looking northwest at the west bridge abutment. (Olmsted Center for Landscape Preservation--hereafter OCLP--2021, DSC-0984)

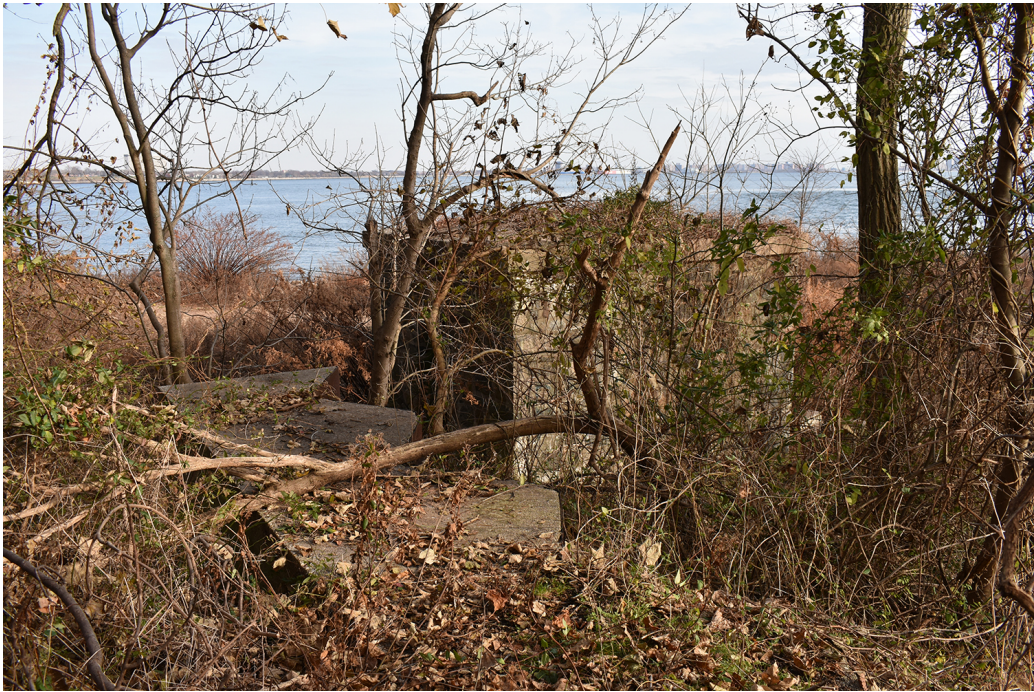
Figure 24. View looking southeast at the overgrown Experimental Battery. (PaleoWest 2021, DES-2273)

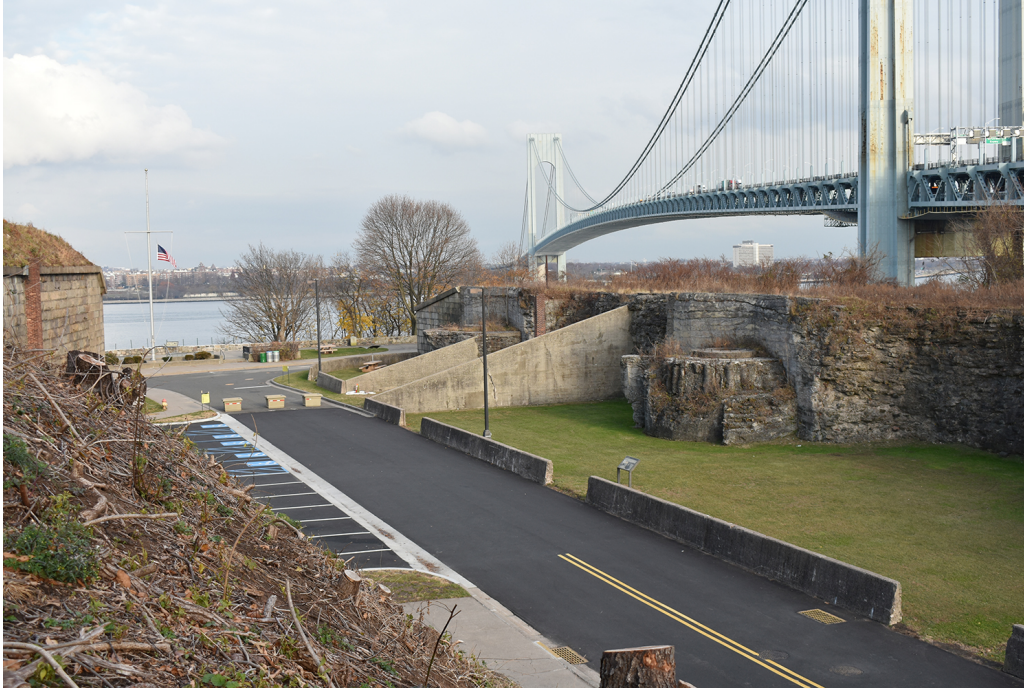
Figure 25. View looking southeast at recently cleared vegetation on the south side of Fort Tompkins and grass clearings at Battery Duane. (PaleoWest 2021, DES-1990)

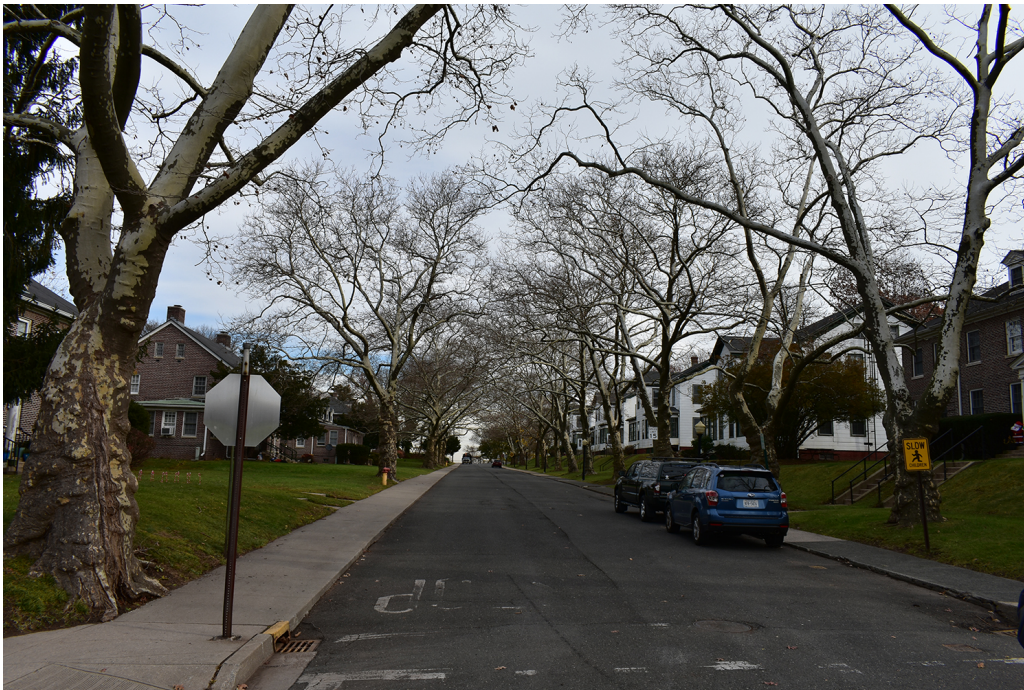
Figure 26. View looking east at London Plane trees and sidewalks on Mont Sec Avenue. The top of a historic lamppost is visible next to the blue car. (PaleoWest 2021, DES-1780)

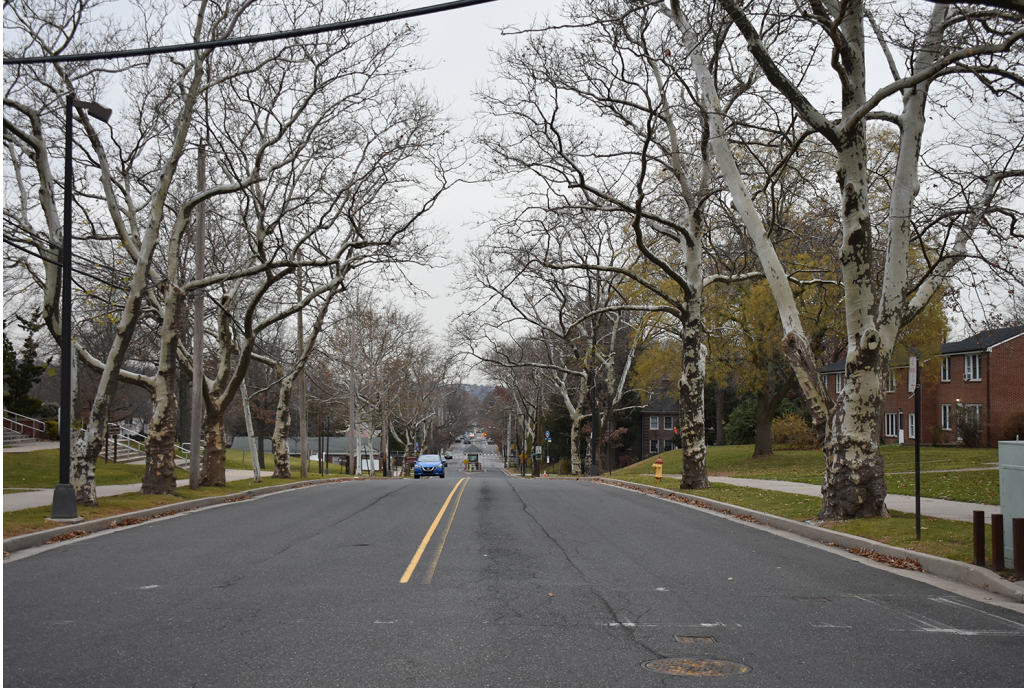
Figure 27. View looking north at London Plane trees on New York Avenue. (PaleoWest 2021, DES-1910)

Modern development and bridge construction has preserved much of the historic vegetation pattern. The notable exception is formal street tree plantings on New York Avenue in 1937 (Figure 27). There are also lawns and trees around the former barracks (Building 210), that now houses Gateway NRA headquarters. (CLR 2022: 234)

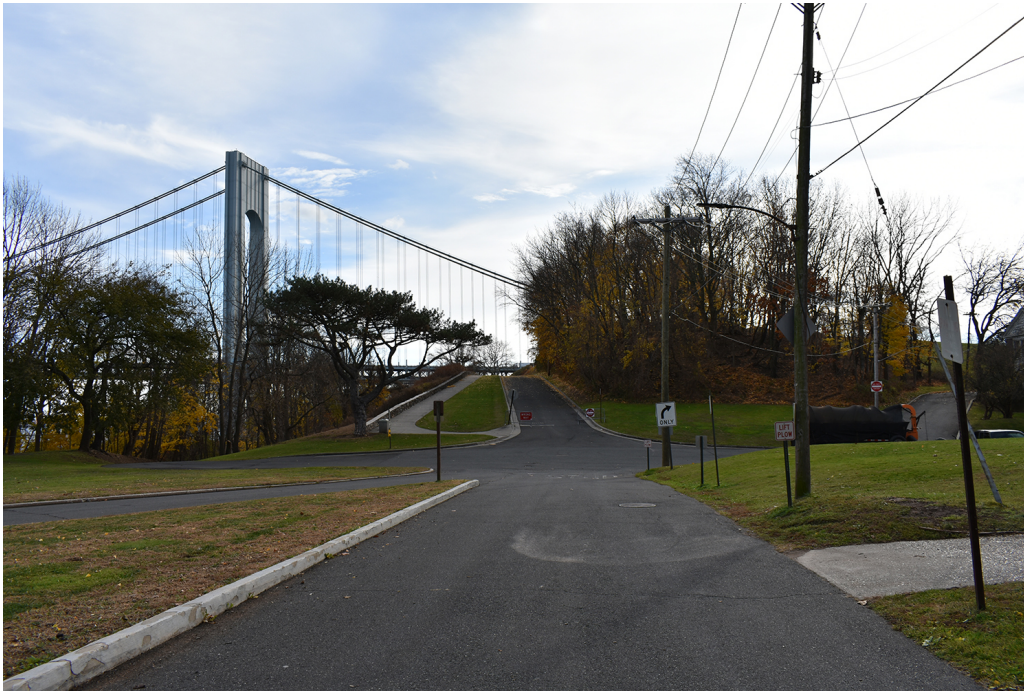
Figure 28. View looking south at the north end of Hudson Road, at intersection with the north end of Battery Weed Road (background left) and Mont Sec Avenue (background right). (PaleoWest 2021, DES-1794)

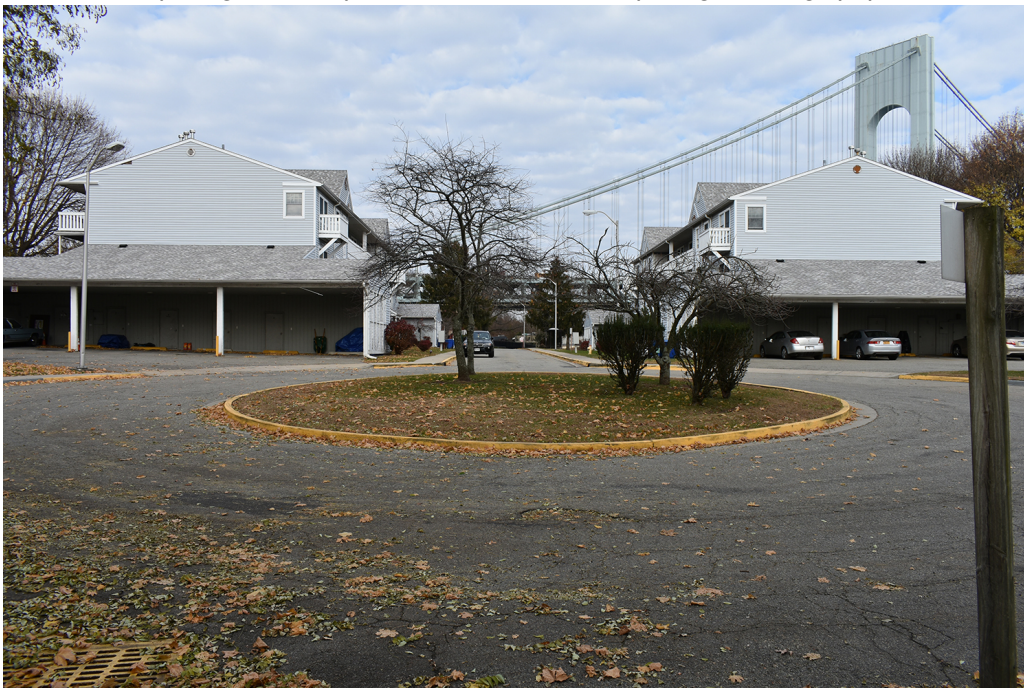
Figure 29. View looking northeast at USS New Mexico Court that accesses Junior Officers' Housing (Buildings 456 and 457). (PaleoWest 2021, DES-2262)

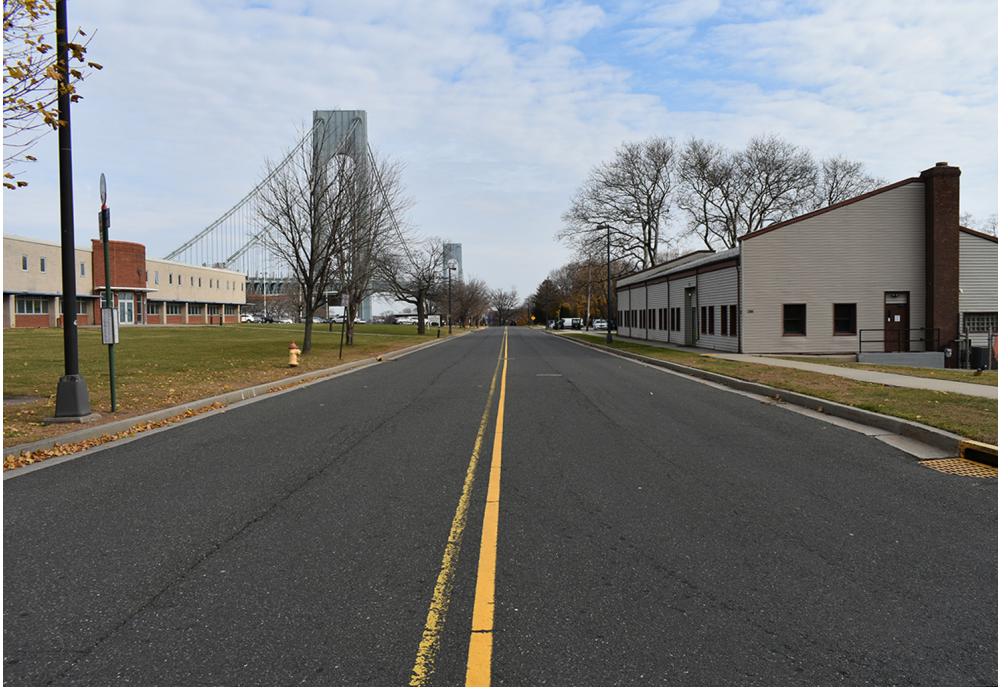
*Figure 30. View looking east from Battery Road. An Army Reserve building is visible on the left. The building on the right is one of the motor pool buildings (Building 201). (PaleoWest 2021, DES-2228)*

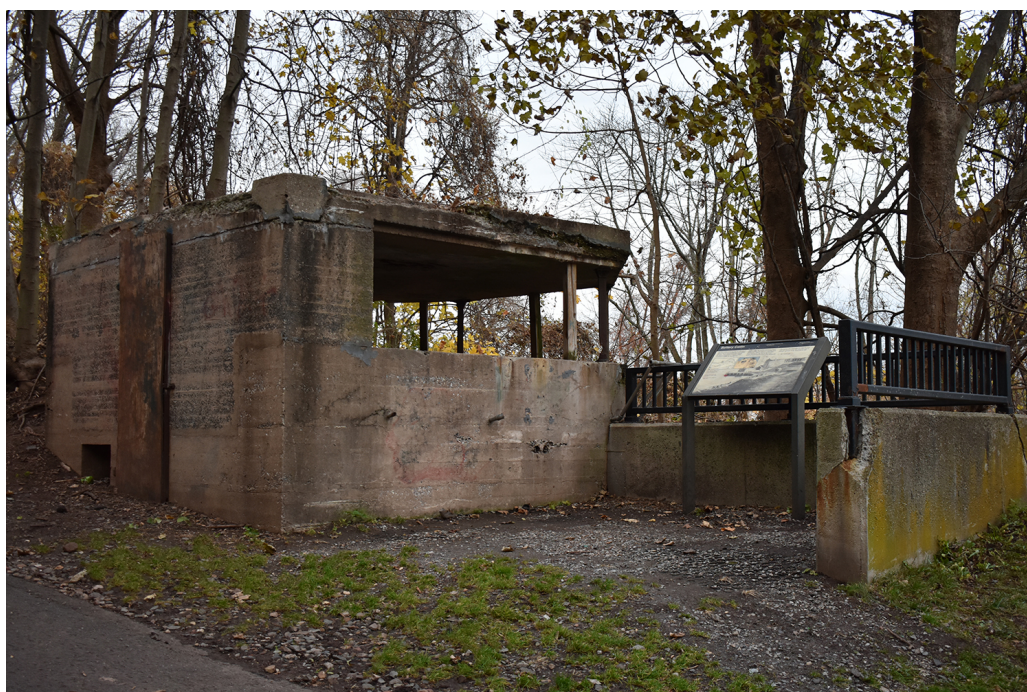
Figure 32. View looking north at the CRF station at Battery Catlin. (PaleoWest 2021, DES-2010)

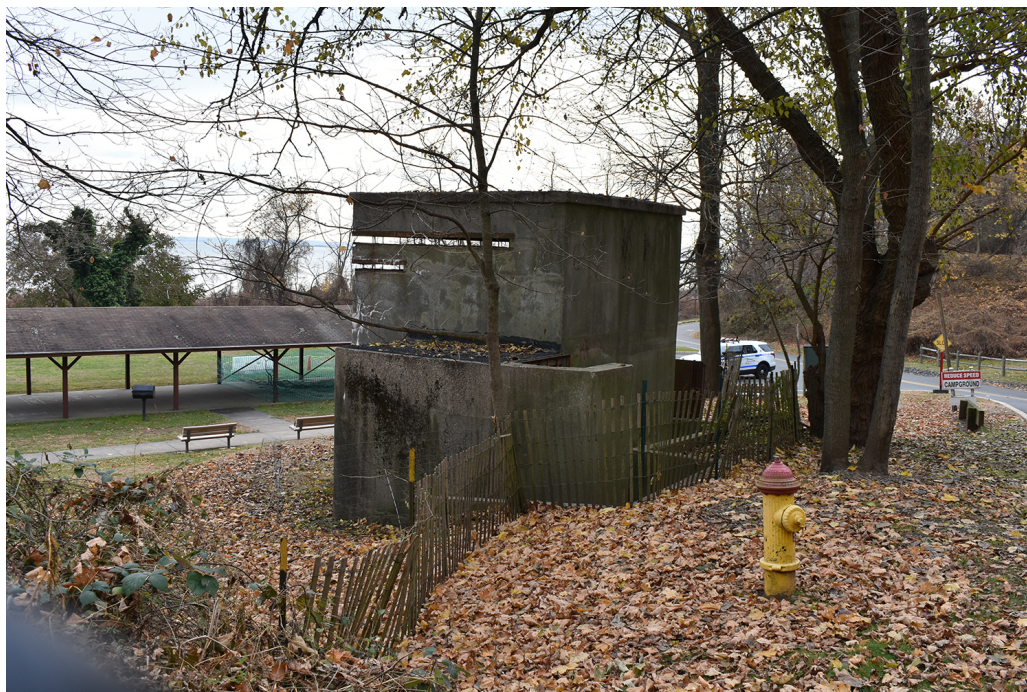
Figure 33. View looking southeast at the BC & CRF Station, with the pavilion in the background. (PaleoWest 2021, DES-2117)

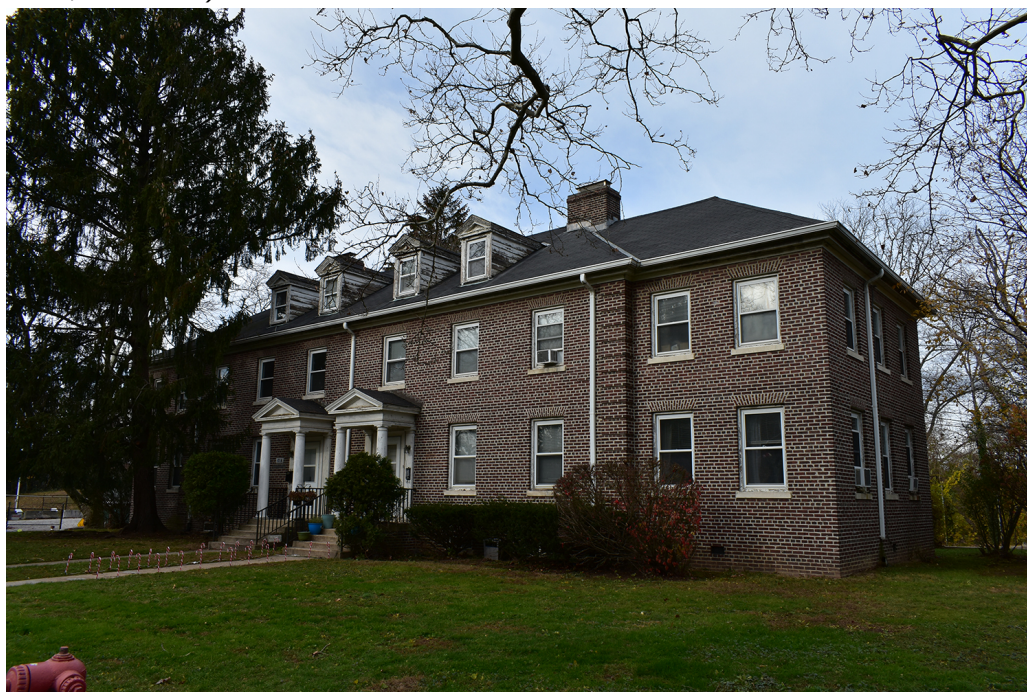
Figure 34. View looking at housing (Building 101) on Mont Sec Avenue. (PaleoWest 2021, DES-1782)

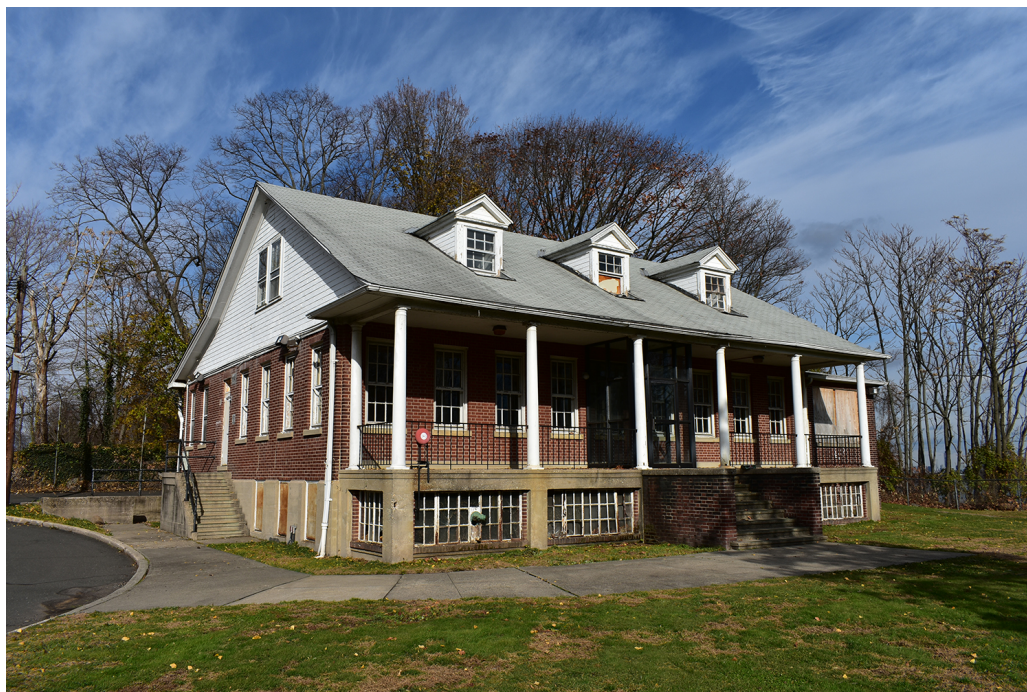
Figure 35. View looking north at the Administration/Officer's Club (Building 109). (PaleoWest 2021, DES-1797)

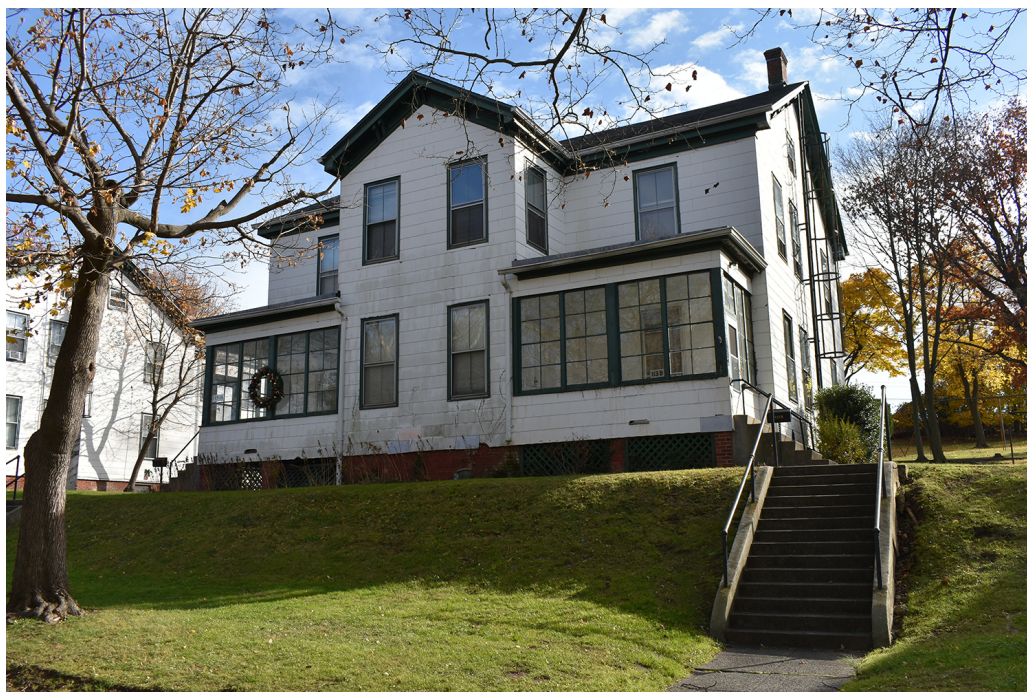
Figure 36. View of housing (Building 114) on Mont Sec Avenue. (PaleoWest 2021, DES-1810)

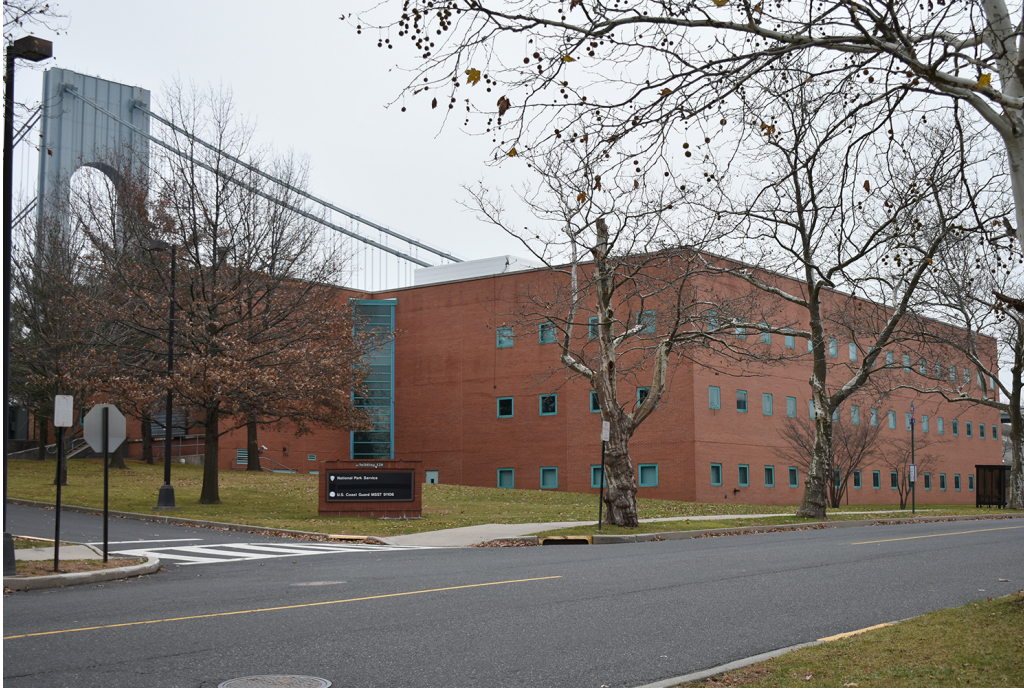
Figure 37. View looking southeast at the Offices, Administration, Visitor Center (Building 120). (PaleoWest 2021, DES-1931)
