National Park Service  
Cultural Landscapes Inventory

Fort Wadsworth  
Gateway National Recreation Area

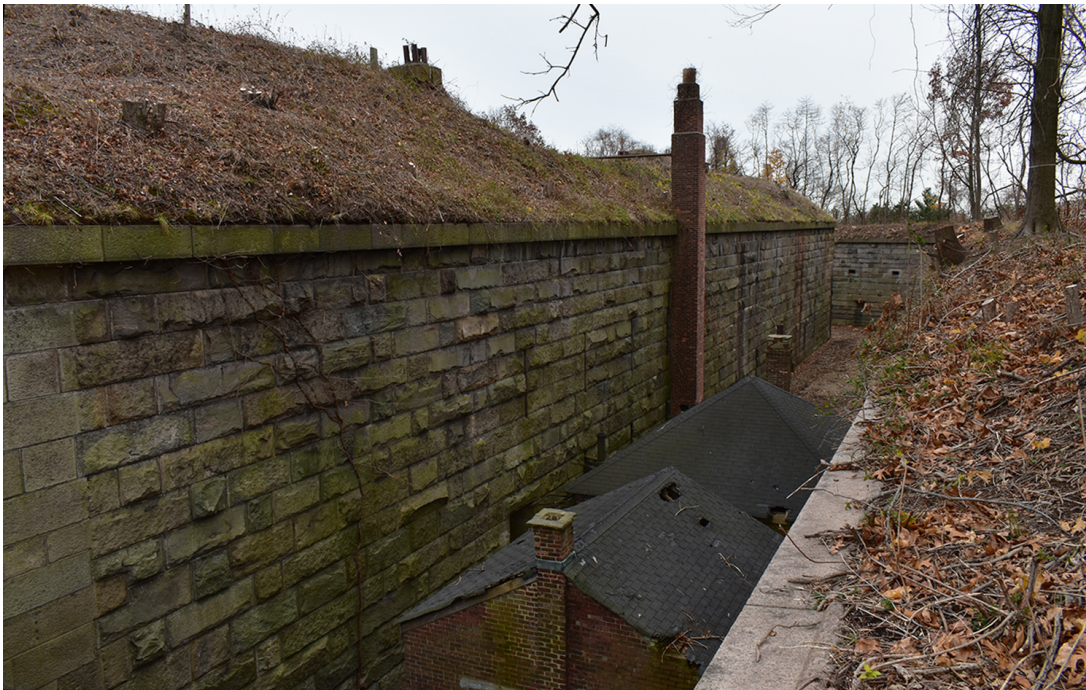
Figure 38. View looking south at Building 139 (foreground) and Building 138 (with chimney) within Fort Tompkins. (PaleoWest 2021, DES-1965)

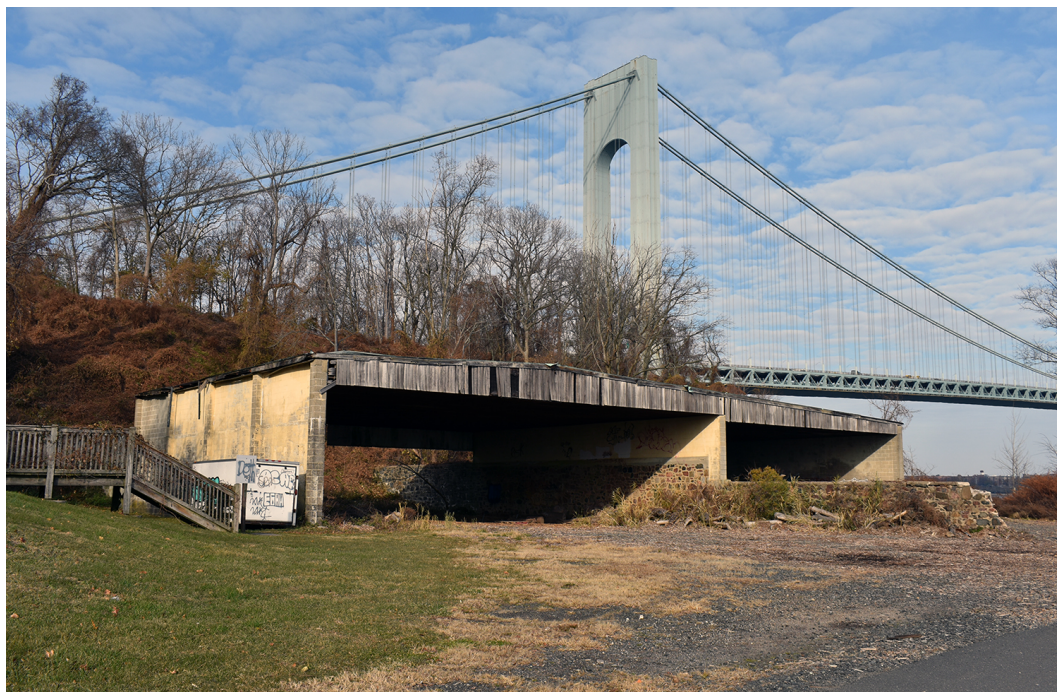
Figure 39. View looking northeast at the former Seaplane Hangar, then the Rifle and Pistol Range (Building 339). (PaleoWest 2021, DES-2268)

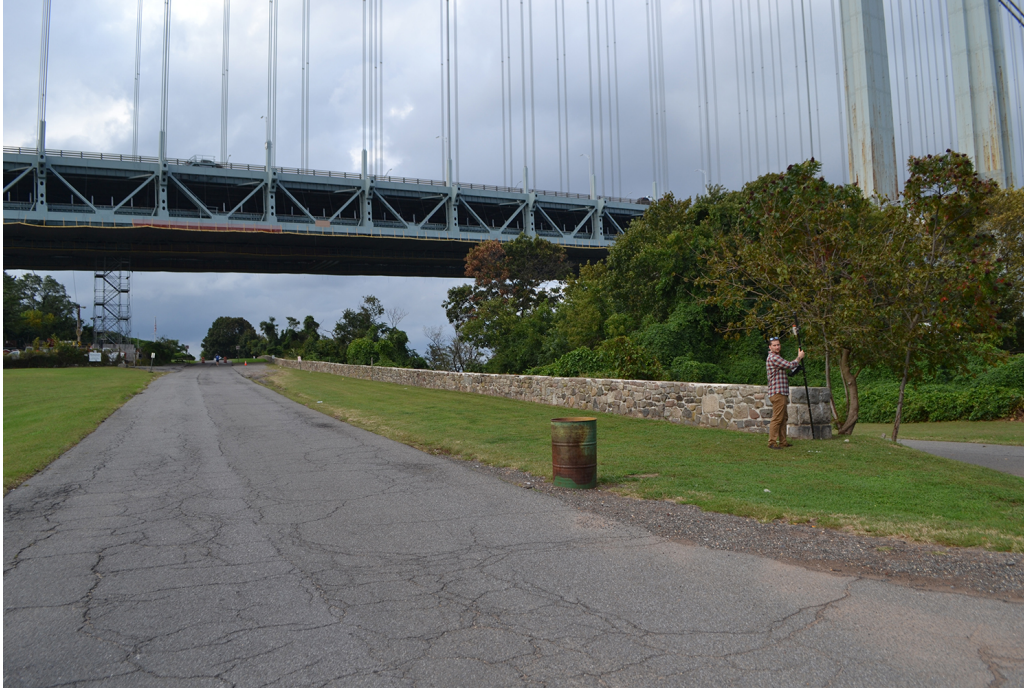
Figure 41. View looking north at the south end of the stone wall along Hudson Avenue. (OCLP 2021, DSC-0983)

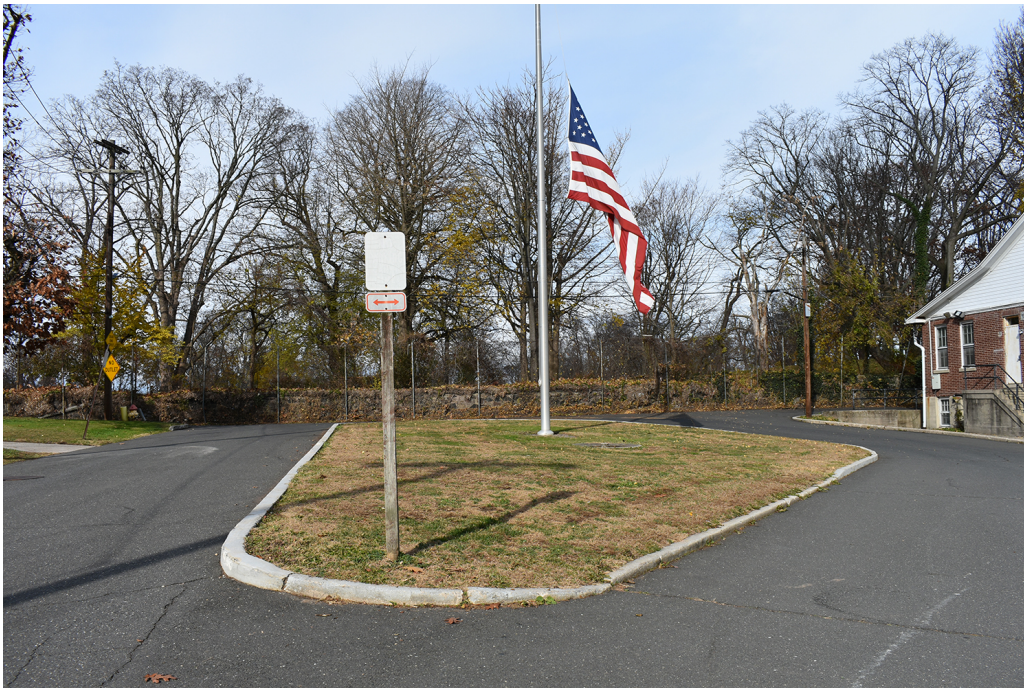
Figure 42. View looking north at the stone wall that stretches along the north side of North Road. (PaleoWest 2021, DES-1801)

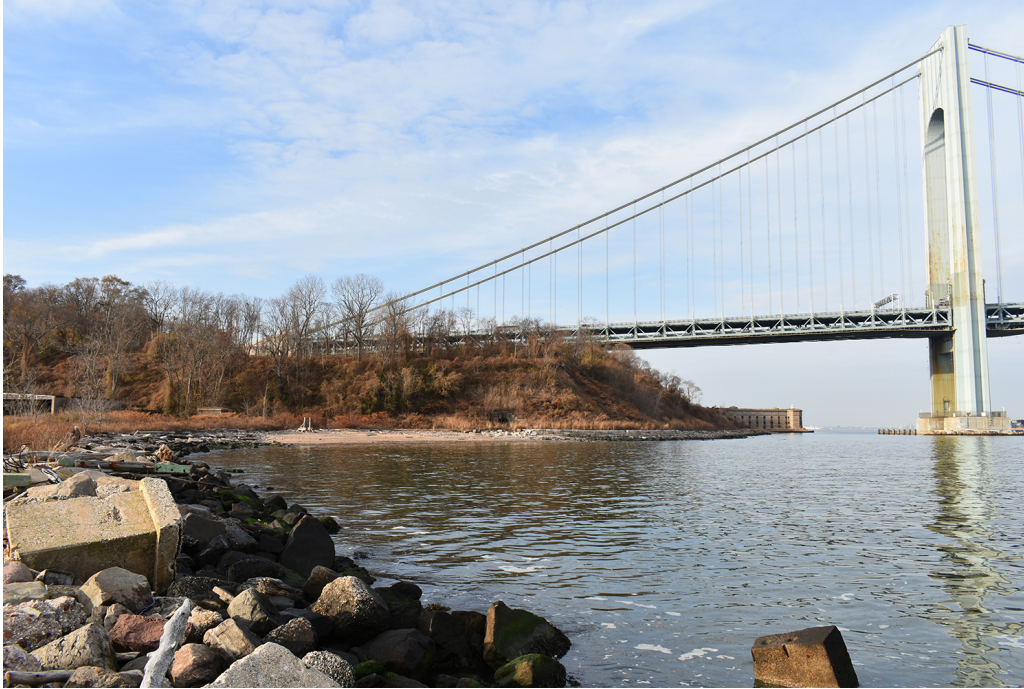
Figure 43. View looking north from the wharf/jetty. In the background is the Experimental Battery obscured by vegetation and Battery Weed just beyond the bridge. (PaleoWest 2021, DES-2285)

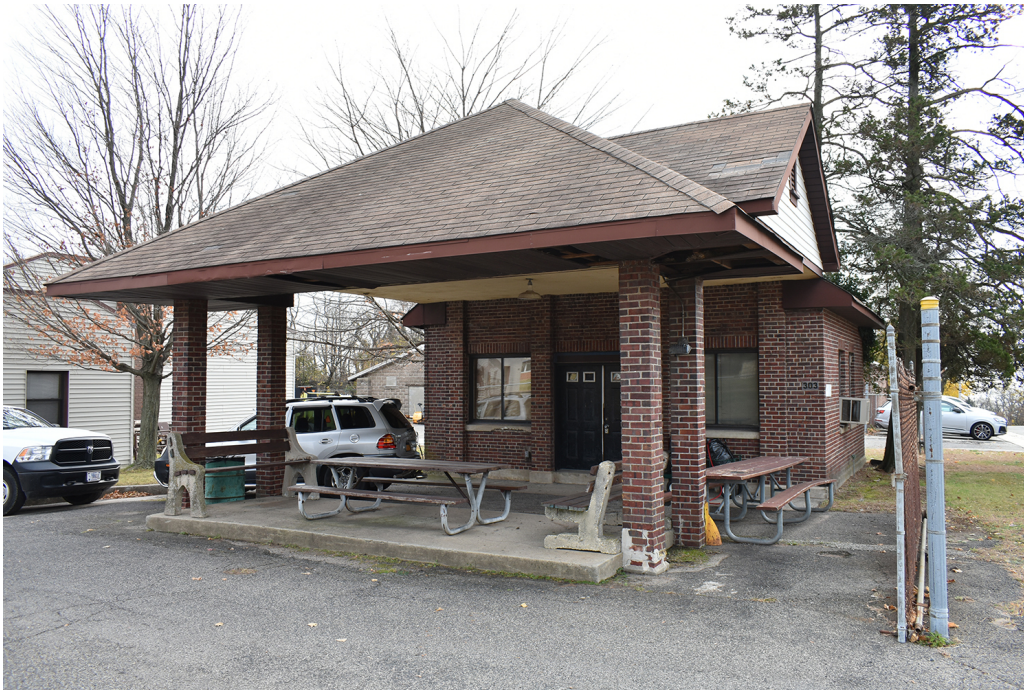
Figure 44. View looking south at the Motor Pool Office (Building 303/304). (PaleoWest 2021, DES-2211)

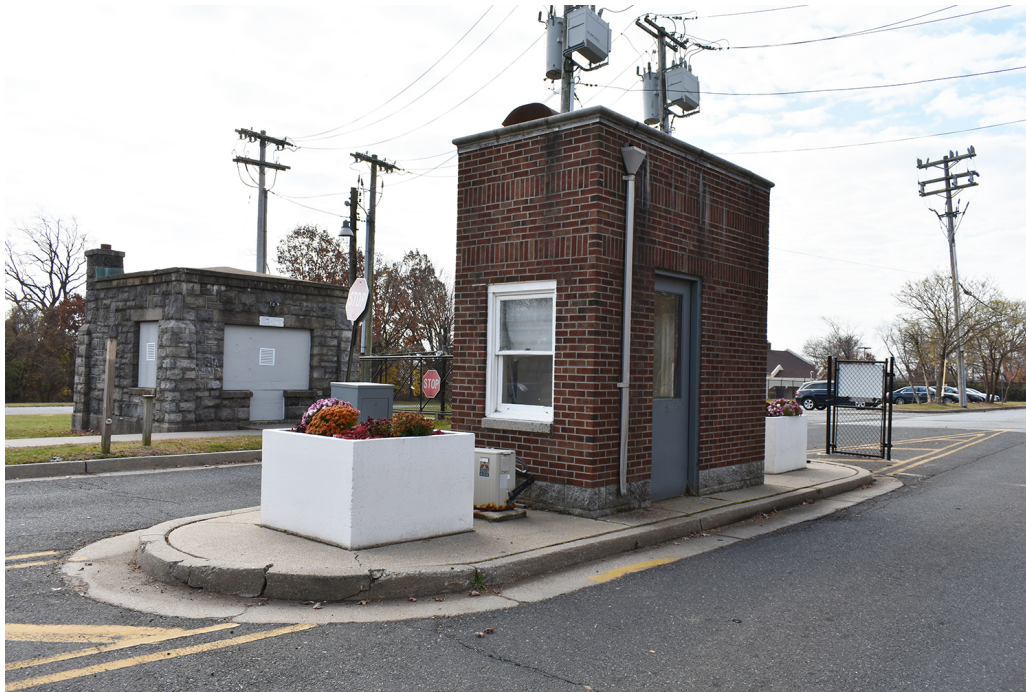
Figure 45. View looking southwest at the historic Gatehouse (Building 404) at image left and the non-historic West Guard Booth (Building 401) at image center. (PaleoWest 2021, DES-2234)

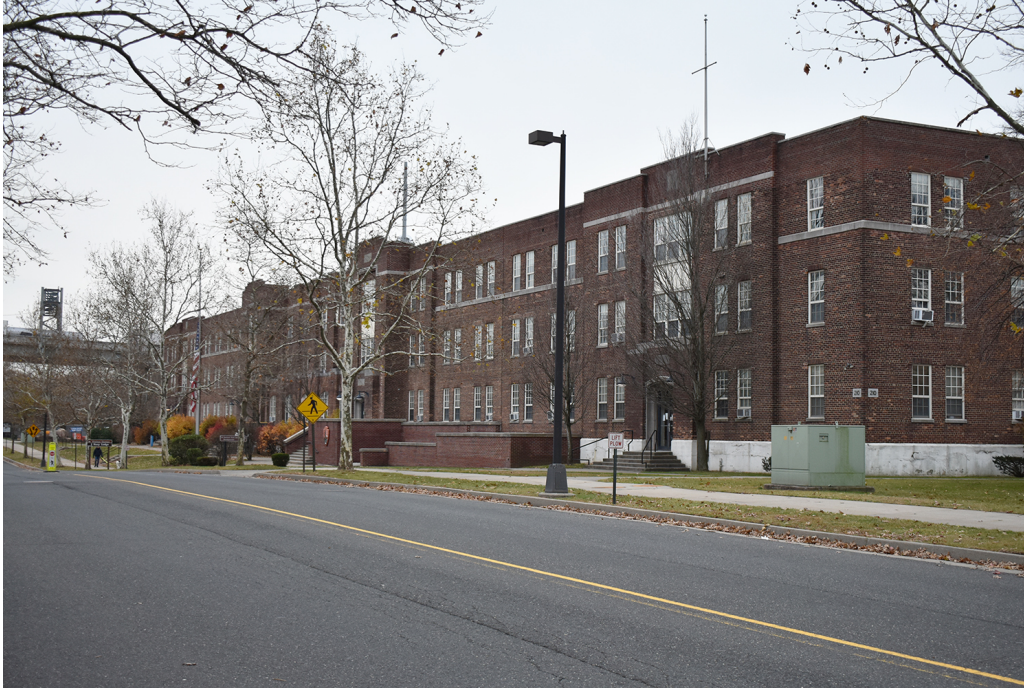
Figure 46. View looking south at the gate hut (Building 201) on New York Avenue, at the north boundary of Fort Wadsworth. The Gatehouse/Ranger Station (Building 220) is at image right. (PaleoWest 2021, DES-1779)

--Building 201--North Gate. Built in 1990 (Figure 46). A small hut set on a traffic island in the center of New York Avenue. (CLR 2022: 275)

--Building 220--Gatehouse/Ranger Station. Built after 1946 (see Figure 46). Brick building measures 74 feet by 30 feet, with two shallow projecting ells on the north façade.

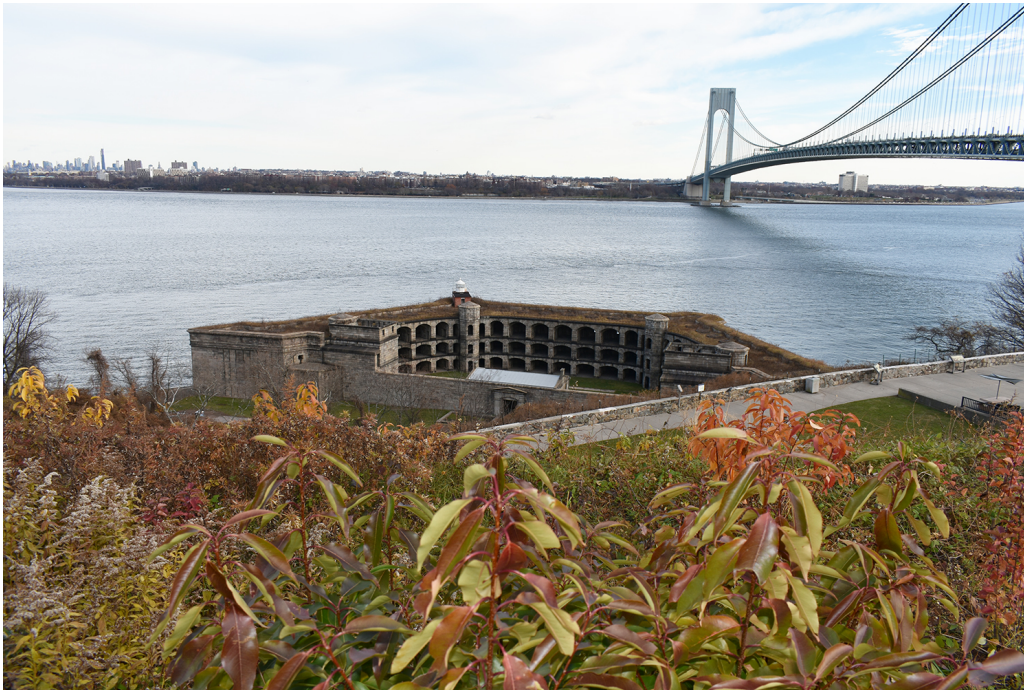
*Figure 48. View looking east from the top of Fort Tompkins toward Battery Weed and the Narrows. (PaleoWest 2021, DES-1772)*

As a military landscape whose primary purpose was the coastal defense of the Narrows and entry to New York Harbor, the most significant historic views in the Coastal North Area were from the clear fields of fire associated with the forts, batteries, and command and range finder stations (Figure 48). In contrast, in the west and northern portions of this area, support buildings and plantings along Mont Sec Avenue created framed interior views. Throughout the North Coastal Area, both the open and framed views were a scenic attraction that supported recreational uses at the fort. The construction of the Verrazzano-Narrows Bridge early in the 1960s overwhelmingly impacted nearly every view in consideration of the fort's historic military landscape (Figure 49). For that reason, the bridge is not discussed specifically for each significant historic view. (CLR 2022: 221)

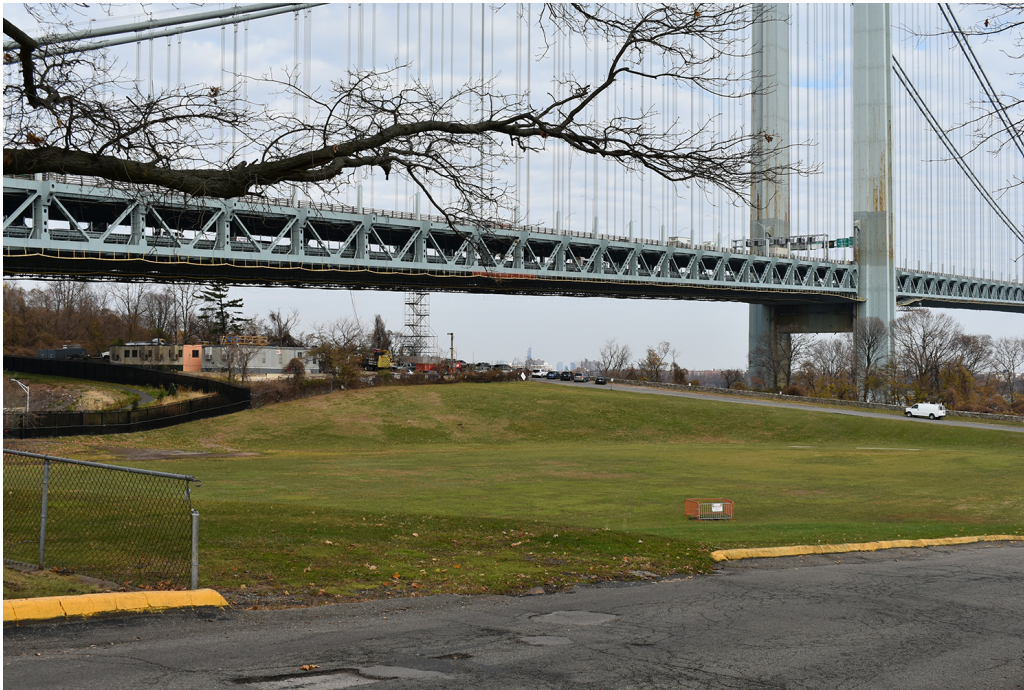
*Figure 49. View looking northeast at the former track and athletic field space. (PaleoWest 2021, DES-2250)*

There are no historic small-scale features extant within the Coastal North Area, except for the light poles on Mont Sec Avenue installed in 1885 to formalize and ornament the road. A tennis court dating to after 1956 stands just east of Building 123. An open-sided pavilion shelter with picnic tables was built in 1992 adjacent to Range Road, and later a gazebo at an unknown date (see Figure 33). In 1939 the CCC laid out a running track and athletic field adjacent to Hudson Road, replacing a natural pond seen in historic maps. The field went through numerous renovations after World War II, including addition of a baseball field with two concrete dugouts at the southeast end after 1956. The athletic field remains as an oval-shaped topographic remnant, with foundations slabs of the dugouts still visible (see Figure 49). (CLR 2022: 223,231,258,287,293; NR 2022, Sec.7: 24 and Sec.8: 52)
