United States Department of the Interior
National Park ServiceNational Register of Historic Places
Inventory—Nomination FormSee instructions in *How to Complete National Register Forms*
Type all entries—complete applicable sections

historic Fort Hancock and the Sandy Hook Proving Ground Historic District

and/or common Fort Hancock

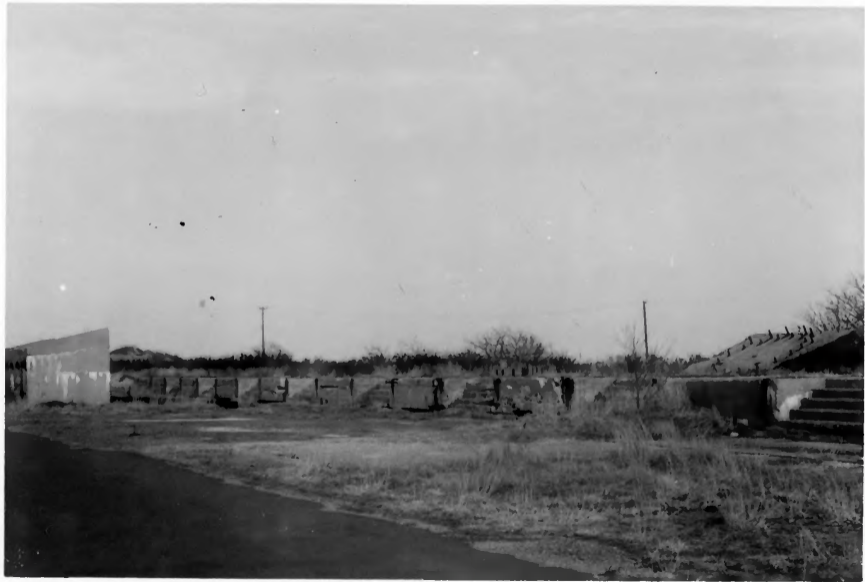
1. Proof Battery and Magazines (No. HS 174A)
Fort Hancock and the Sandy Hook Proving
Ground Historic District
2. Highlands, NJ
3. Photo: Richard Greenwood
4. Date: March, 1976
5. Negative: NARO, NPS, Boston, MA
6. View looking northwest
7. Photo no. 1 of 60

These four structures were directly involved with the test firings on the proof range. The proof battery itself (174A) and the foundations of two magazines (173 and 174) are on the second and final proof battery site

To the north of the proof battery were two large L-shaped concrete traverses, which formerly protected the ammunition magazine (173) built in 1905, and the constant temperature magazine (174) built circa 1914. Nothing but the concrete slab foundations remain of these two rectangular, single story, red brick buildings, which were demolished within the past decade.

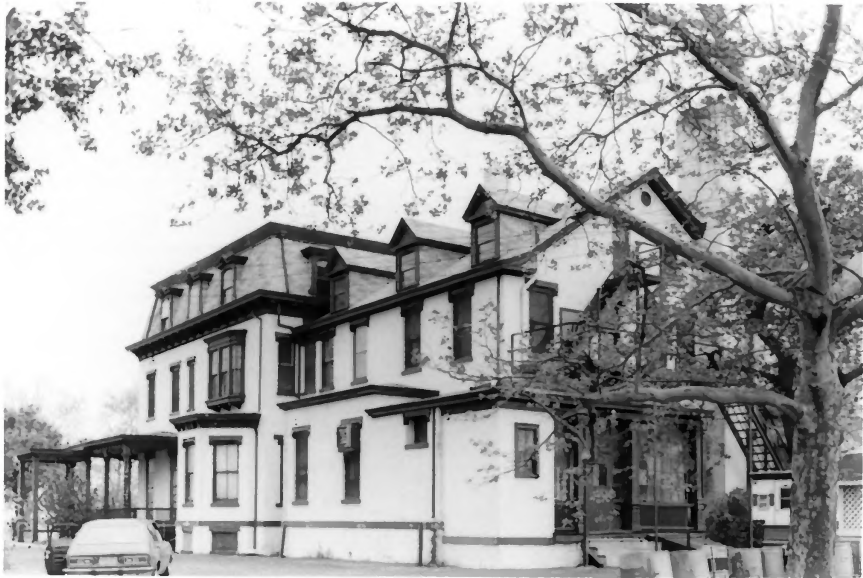
1. Officers' Club (No. HS 114)
Fort Hancock and the Sandy Hook Proving
Ground Historic District
2. Highlands, NJ *Monmouth Co.*
3. Photo: Anne Booth
4. Date: May 5, 1977
5. Negative: NARO, NPS, Boston, MA
6. View looking east showing northwest
(side) and southwest (back) facades
7. Photo no. 3 *of 60*

The wooden cornice is bracketed and extends along the perimeter of the house. The double hug sash windows and the doors are of wooden construction. The windows have stone sills and flat stone lintels. There are projecting demi-hexagonal bay windows in the center of the second story facades. The building has a partially raised basement and masonry foundations. The interior partitions are of plastered wood frame construction. The stairways and floors are wooden. The floors are covered with carpet and asphalt tile. The ceilings are stamped metal. the heating, plumbing, air conditioning and electrical systems are in good to fair operating condition. The building is equipped with a walk-in cooler as well. When the building was converted into the officers' club following the closing of the Proving Ground, the interior was altered somewhat, but such details as the stamped metal ceilings remain. A fire in 1938 damaged the upper part of the building.

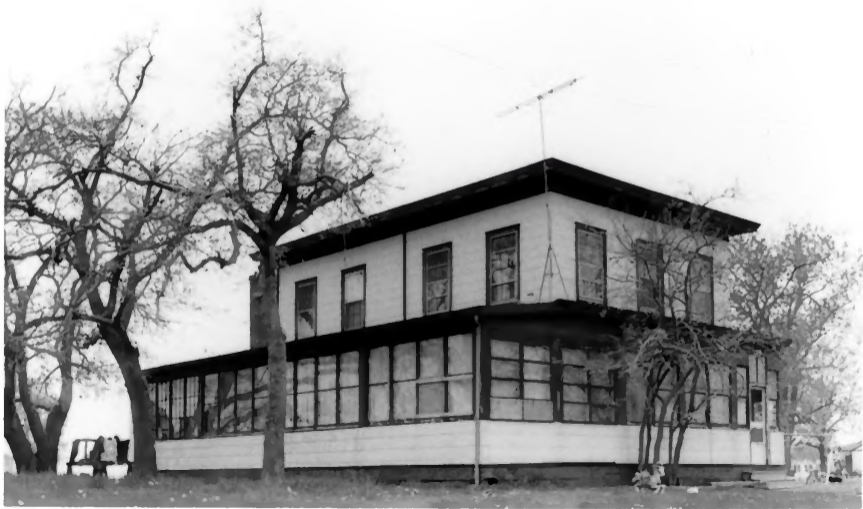
1. Master Workman's Residence (No. HS 112)
Fort Hancock and the Sandy Hook Proving
Ground Historic District *Monmouth co.*
2. Highlands, NJ
3. Photo: Anne Booth
4. Date: May 5, 1977
5. Negative: NARO, NPS, Boston, MA
6. View looking southwest from Canfield
Road showing north and east facades
7. Photo no. *4 of 60*

To the west of the Brick House, at the junction of Knox Road and Canfield Road, is this structure built in 1877, the oldest wooden structure extant on Sandy Hook. This L-shaped residence consists of a rectangular central structure, two stories tall with a flat roof and a single story, enclosed porch on its facade, and two wings, one of which extends to the north and the other to the west. Both wings are one story high; the north wing has a flat roof and the west wing has a low gable roof. There is a small extension built on the north end of the north wing. This attachment has concrete foundations, not the brick foundations of the rest of the house. The main house has a basement. The doors and the double hung sash windows are wood framed. The house is outfitted with aluminum storm windows. The interior is divided into eight rooms, four of which are bedrooms and one of which is a bathroom. The interior frame partitions and the ceilings are plastered. The floors and stairways are wood. The building was occupied as a residence on short-term lease to the Coast Guard from 1975-1977. It has been unoccupied since 1978, and is in need of major repairs.

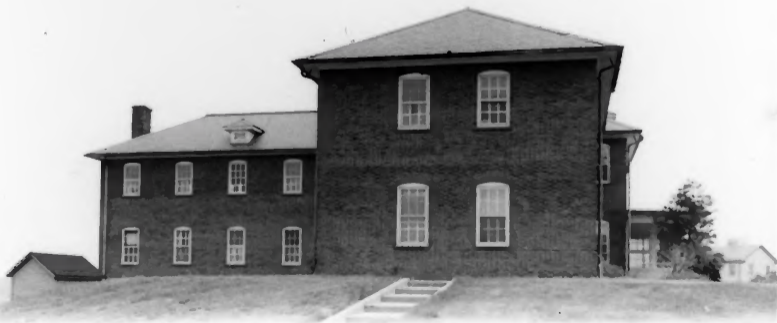
1. , Ordnance Barracks (No. HS 102)
Fort Hancock and the Sandy Hook Proving
Ground Historic District
2. Highlands, NJ *Monmouth Co.*
3. Photo: Anne Booth
4. Date: May 5, 1977
5. Negative: NARO, NPS, Boston, MA
6. View looking southeast, showing north-
west (side) facade
7. Photo no. 6 *0760*

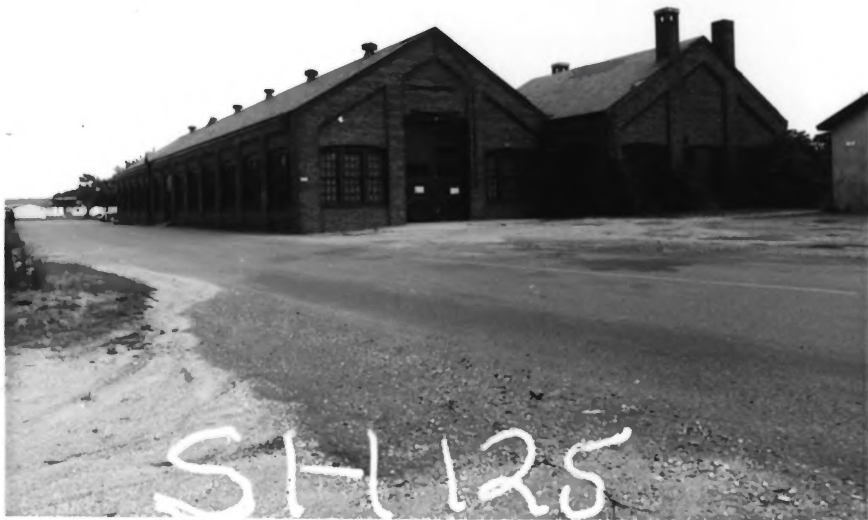
1. Machine and Blacksmith Shop (No. HS 125)
Fort Hancock and the Sandy Hook Proving
Ground Historic District *Monmouth Co.*
2. Highlands, NJ
3. Photo: Denver Service Center, NPS
4. Date: 1975
5. Negative: Denver Service Center, NPS
6. View from west showing southwest (front)
and northwest (side) facades
7. Photo no. 7 *860*

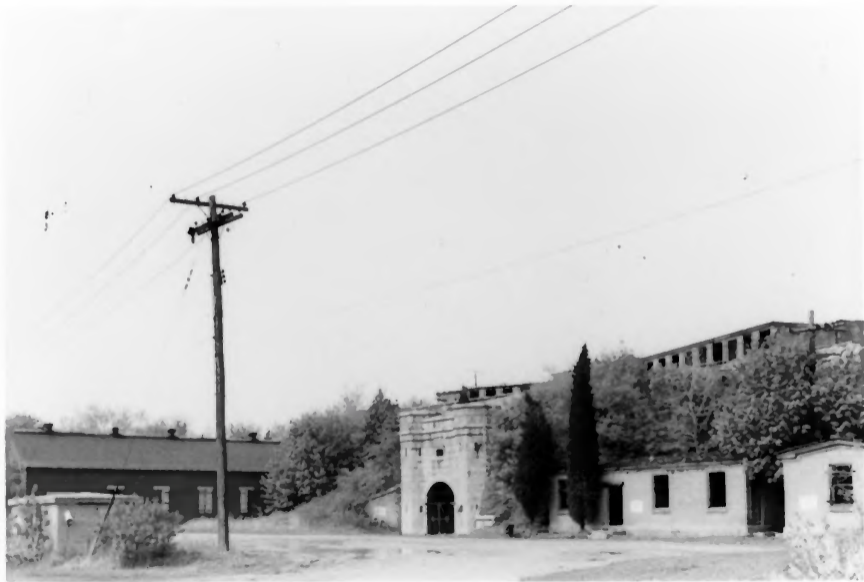
1. Battery Potter (No. HS 256-257)
Fort Hancock and the Sandy Hook Proving
Ground Historic District
2. Highlands, NJ *Monmouth Co.*
3. Photo: Anne Booth
4. Date: May 5, 1977
5. Negative: NARO, NPS, Boston, MA
6. View looking northeast from Hudson Drive
7. Photo no. 8 *of 60*

Several minor structures associated with Battery Potter--Storeroom (256), Storehouses (257-60), and Latrine (258) built of concrete masonry, concrete block masonry, and brick masonry, are in poor condition. Buildings 256 and 257 were telephone operator "rooms" linking the fire control stations atop Battery Potter with their respective gun batteries around Sandy Hook; these structures were built in 1907. Buildings 256 and 257 were telephone operator "rooms" linking the fire control stations atop Battery Potter with their respective gun batteries around Sandy Hook; these structures were built in 1907. Building 258 is a conduit hut for underground electrical wires; Building 259 (1901) is the powerhouse that generated electricity for Fort Hancock gun batteries and other post buildings; No. 260, next to 259, is the coal shed built in 1901. Battery Potter is the only one of its kind in the United States.

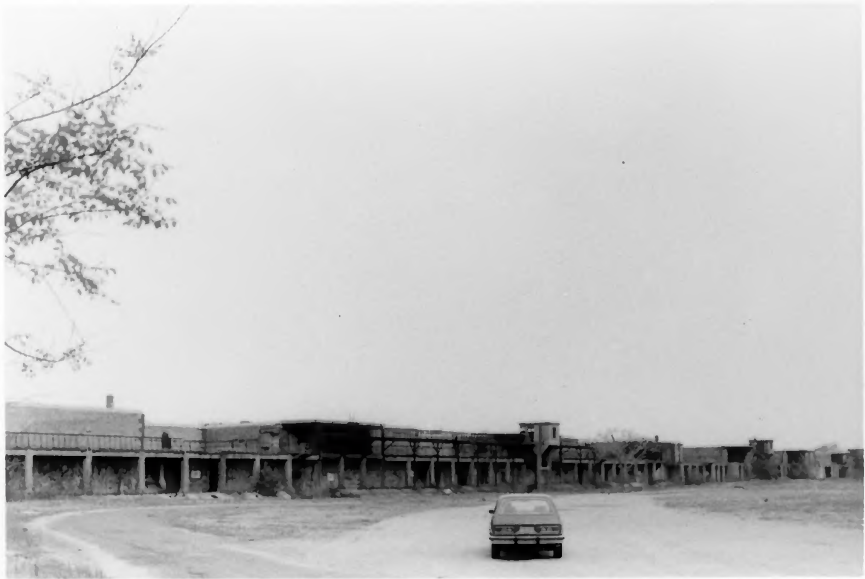
1. Batteries Alexander, Halleck, Bloomfield
and Richardson (No. HS 181)
Fort Hancock and the Sandy Hook Proving
Ground Historic District *Monmouth Co.*
2. Highlands, NJ
3. Photo: Anne Booth
4. Date: May 5, 1977
5. Negative: NARO, NPS, Boston, MA
6. View looking northeast
7. Photo no. 11 *of 60*

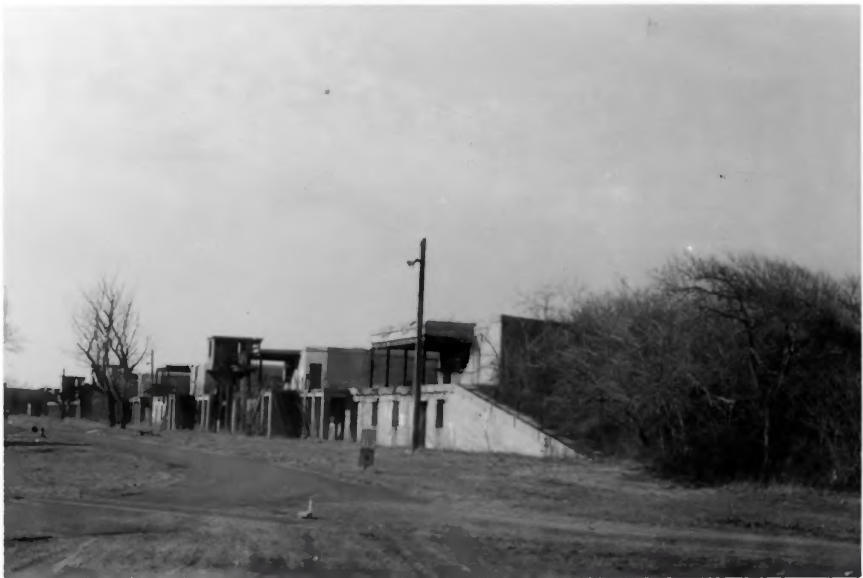
1. Batteries Alexander, Halleck, Bloomfield
and Richardson (No. HS 181)
2. Fort Hancock and the Sandy Hook Proving
Ground Historic District *Morrmouth Co.*
3. Highlands, NJ
4. Photo: Richard Greenwood
5. Date: March, 1976
6. Negative: NARO, NPS, Boston, MA
7. view looking north
8. Photo no. 12 *of 60*

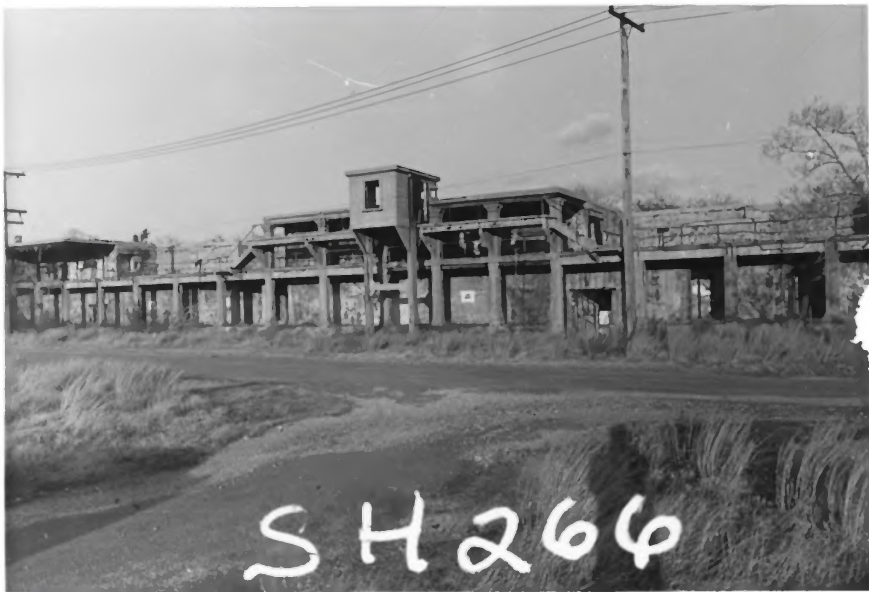
1. Eastern Shore Batteries: Battery Granger
(No. HS 266)
Fort Hancock and the Sandy Hook Proving
Ground Historic District *Monmouth Co.*
2. Highlands, NJ
3. Photo: Denver Service Center, NPS
4. Date; 1975
5. Negative: Denver Service Center, NPS
6. View looking northeast from Hudson Drive
7. Photo no. 13 *of 60*

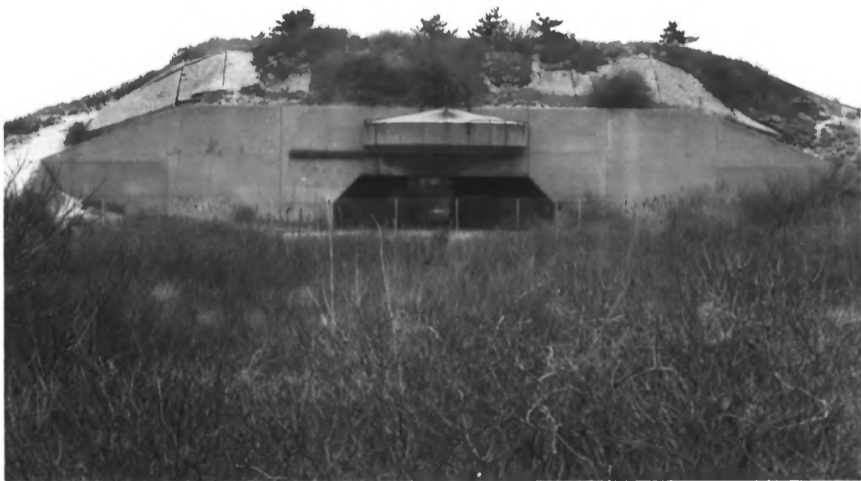
1. Battery Arrowsmith (No. HS 348)
Fort Hancock and the Sandy Hook Proving
Ground Historic District
2. Highlands, NJ
3. Photo: Richard Greenwood
4. Date: March, 1976
5. Negative: NARO, NPS, Boston, MA
6. View looking west
7. Photo no. 18
