# Geomorphic Processes and Aquatic Habitat in the Redwood Creek Basin, Northwestern California

U.S. GEOLOGICAL SURVEY PROFESSIONAL PAPER 1454

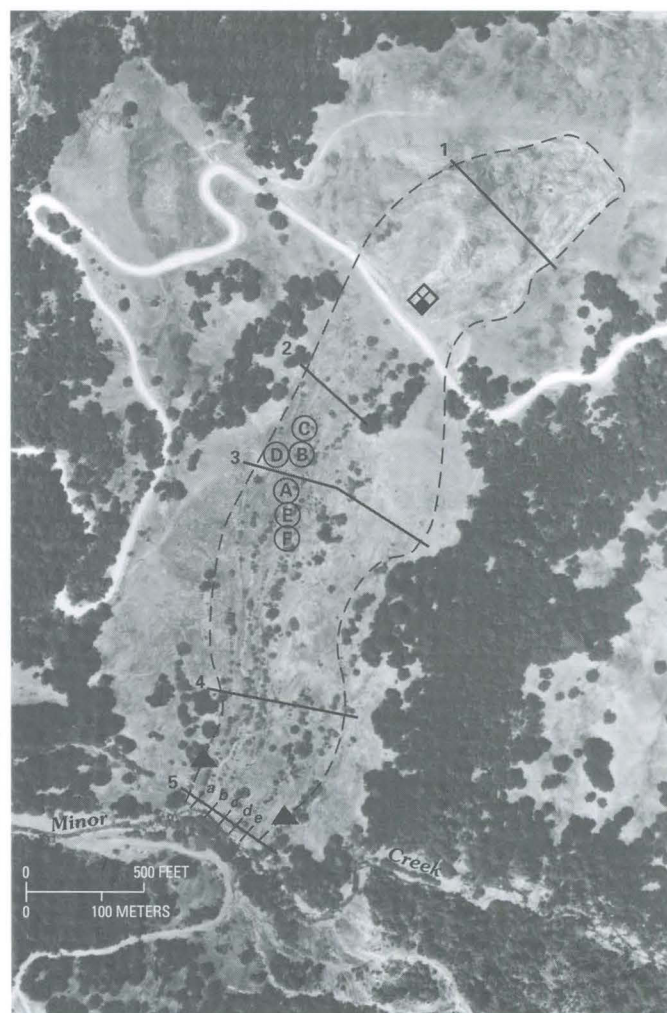
FIGURE 2.—Location of sampling and measurement sites on earthflow at study site 2. Aerial photograph taken July 14, 1979.

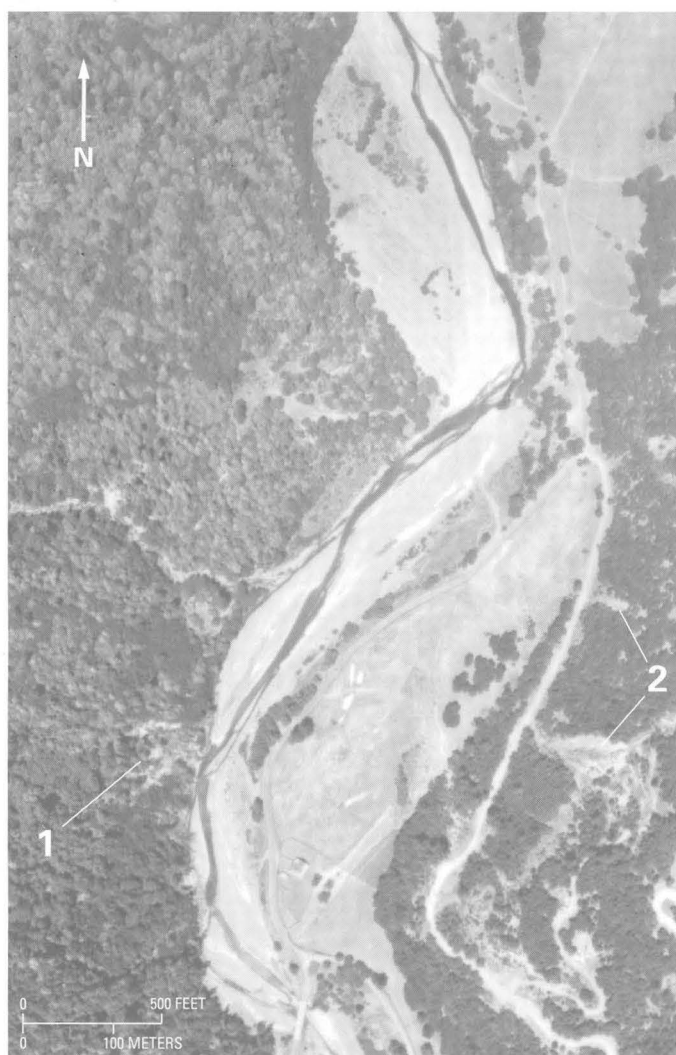
FIGURE 6.—Protective influence of flood plains on streamside hillslopes. Streamside landslides are numerous where Redwood Creek abuts hillslopes directly (1). On opposite bank, landslides (2) are separated from the active channel by a low flood plain. The photograph depicts the main channel of Redwood Creek immediately below the mouth of Minor Creek.

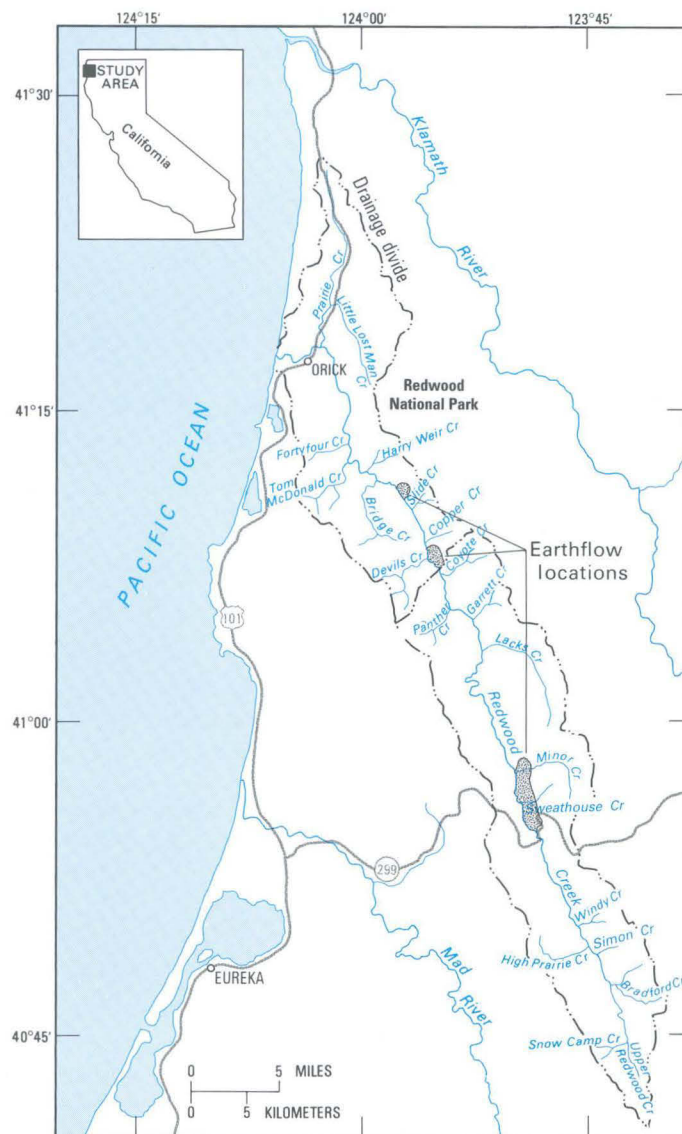
FIGURE 4.—Reaches where earthflows are abundant on the right bank of Redwood Creek (stippled areas). With one exception (the northernmost Counts Hill earthflow), the 16 earthflows occur along two distinct reaches of Redwood Creek.

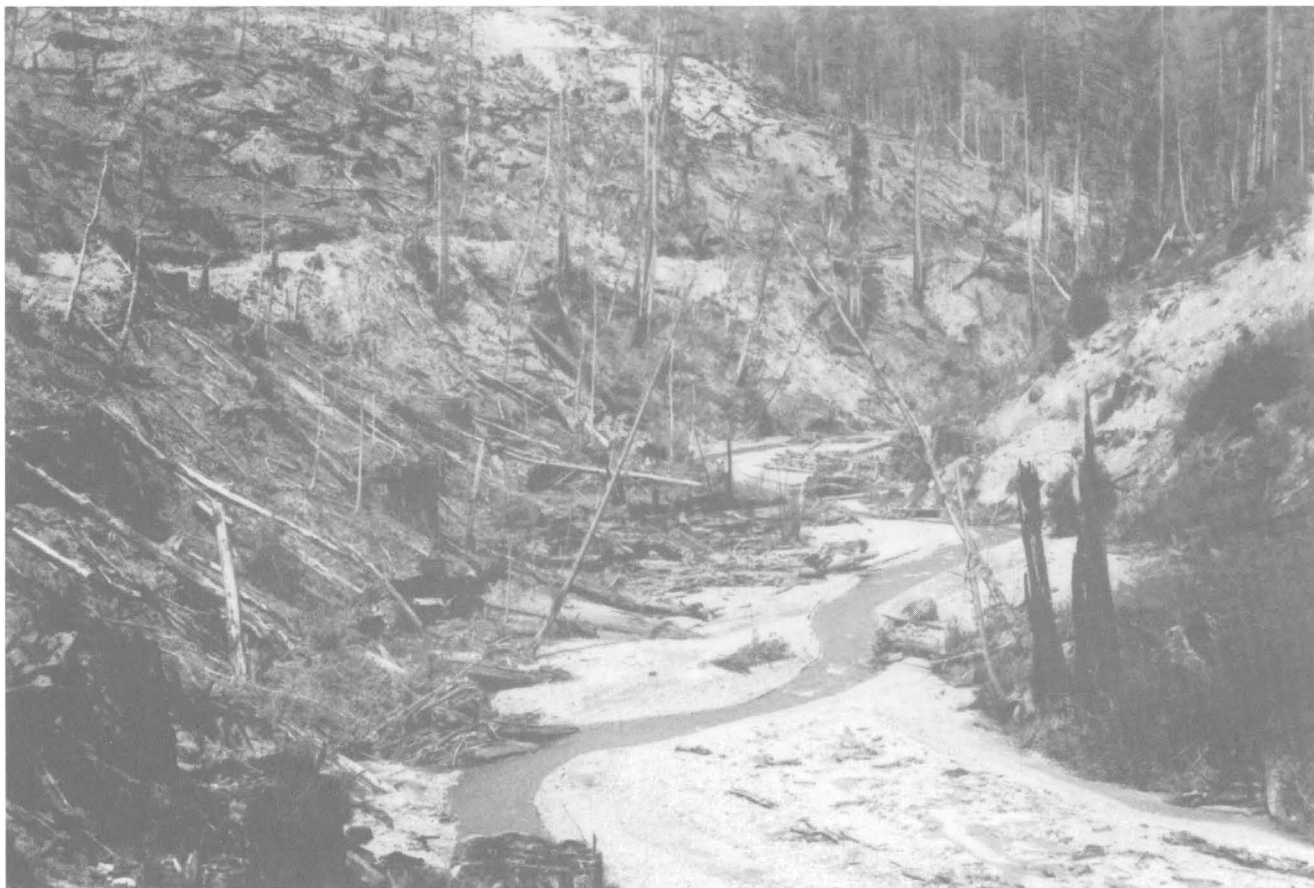
FIGURE 24.—Highly disruptive timber-harvest practices along lower reaches of Bridge Creek. Photograph taken April 1975.

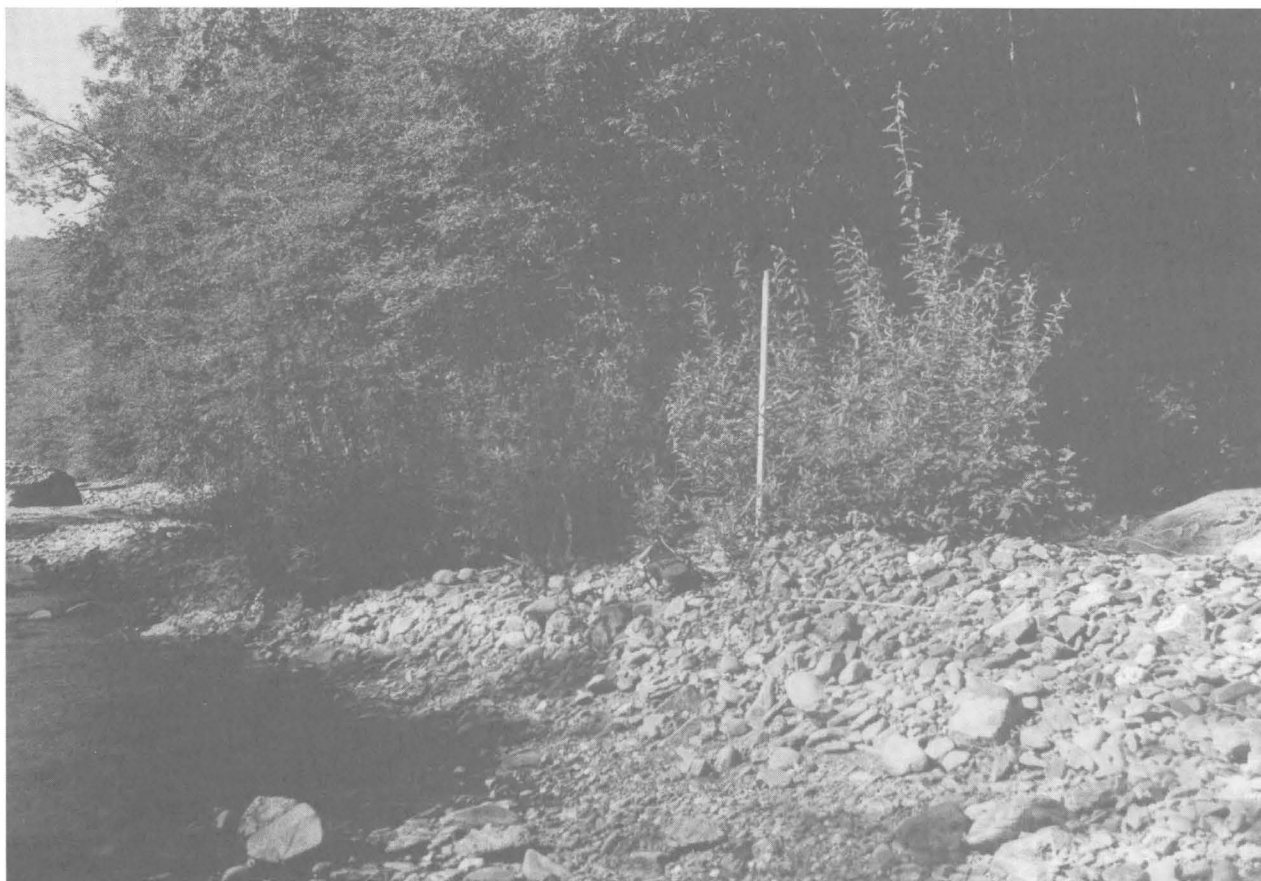
FIGURE 3.—Coarse lobate bar located at kilometer 30 in Redwood Creek (photographed in August 1983). Note thick growth of alder on bar surface, which dates from 1972. There is no evidence of recent movement of bar surface. Height of rod is 2 m.

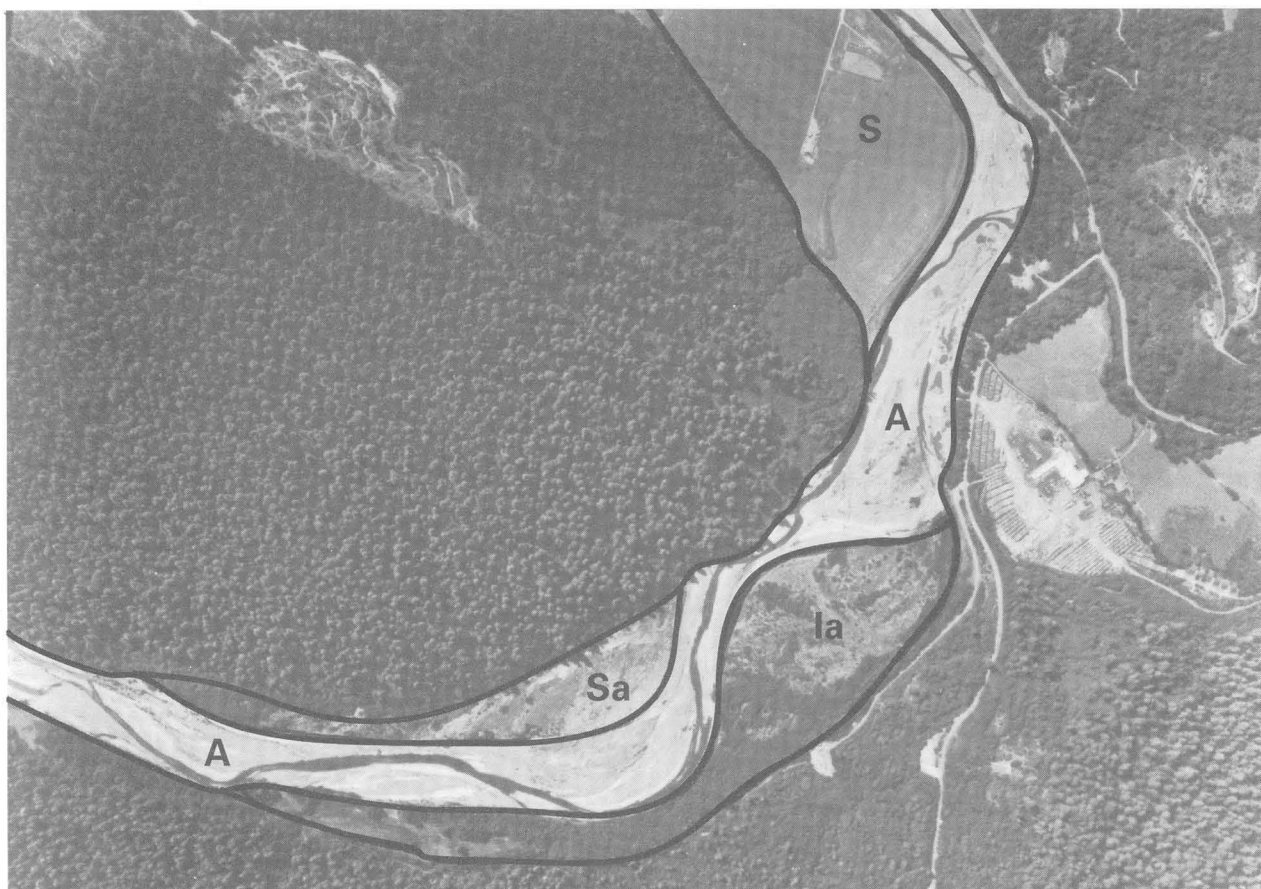
FIGURE 6.—Classification of sediment reservoirs shown on a vertical aerial photograph (1978; scale 1:6,000) of Redwood Creek, kilometer 100 near Orick; flow is from left to right. Classes are active (A), semiactive (Sa), inactive (Ia), and stable (S).
