GRAND CANYON NATIONAL PARK ROADS,  
VILLAGE LOOP DRIVE HEADWALL No. 2  
Grand Canyon National Park  
Grand Canyon Village  
Coconino County  
Arizona

HAER No. AZ-35-C

GRAND CANYON NATIONAL PARK ROADS,  
VILLAGE LOOP DRIVE HEADWALL NO. 2  
HAER No. AZ-35-C

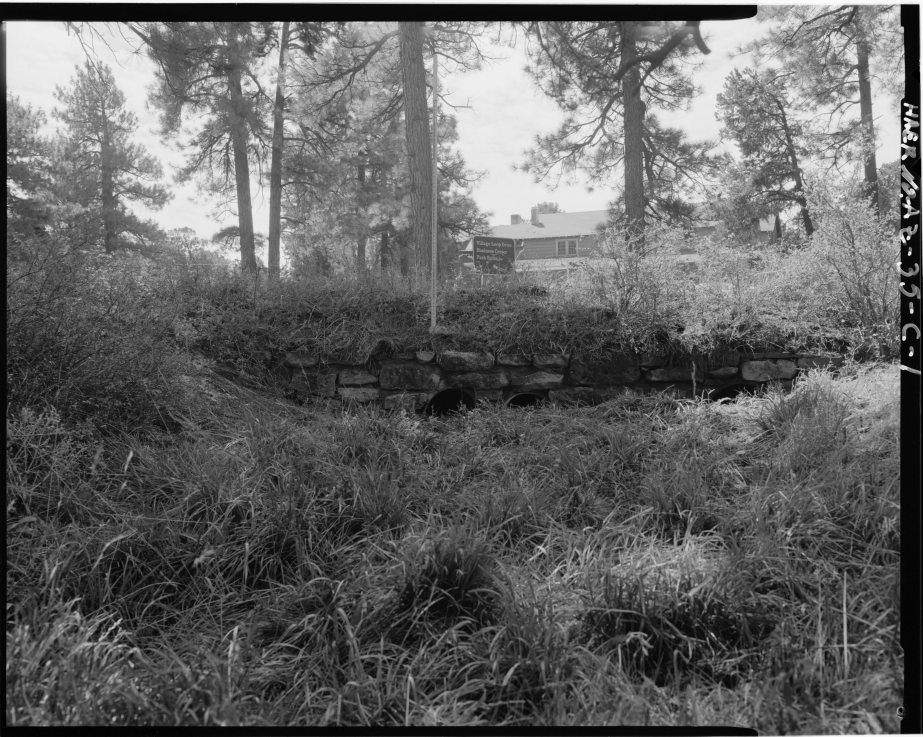
MSR 19A 2-35-C-1

AZ-35-C-1 DISTANT VIEW OF HEADWALL AS SEEN LOOKING TO THE  
SOUTH

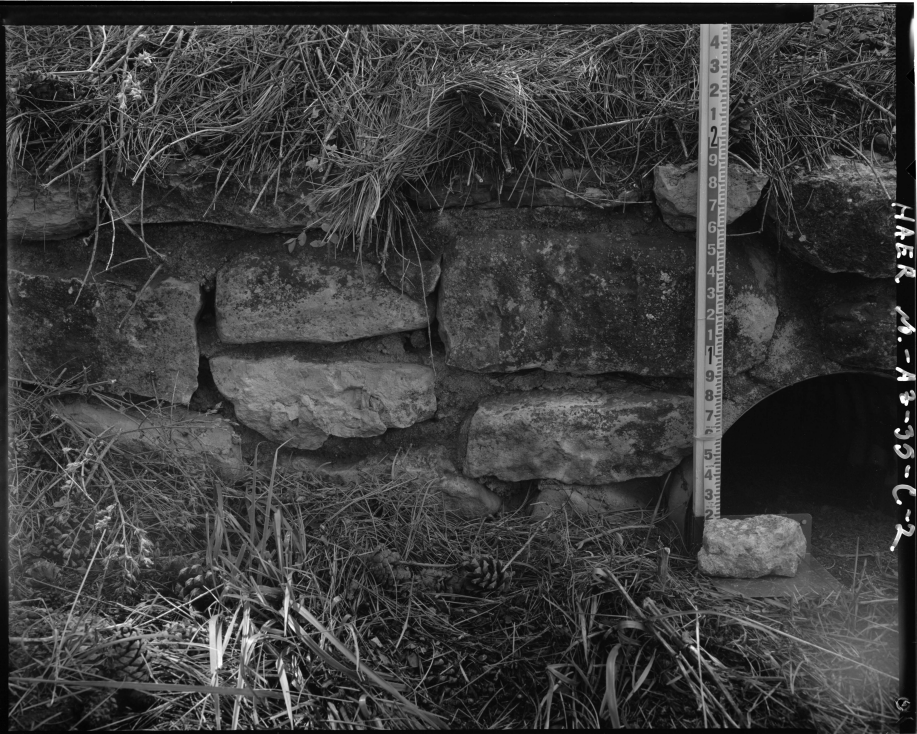
HAER M.-A-3-30-C-2

Village Loop Drive Headwall No. 2 is partially buried by silt, gravel, and pine needles. The exposed portion of the wall is approximately 17' long and 2' high at its highest point. It is of undressed, flat, rectangular blocks of sandstone and limestone, collected or quarried locally and crudely mortared. The roadway's asphalt wearing course is approximately 18" above the top of the headwall and several feet south of the headwall. It is in good condition, showing no signs of bulging, buckling nor cracking. The only signs of aging are a uniform darkening of the rock face, lichen growth, some deterioration of the mortar, and its partial burial. The two 18" C.M.P. culverts--side-by-side to the east and apart from the 24" C.M.P.--carry storm water from the west side of Center Road north beneath Village Loop to the large drainage ditch south of the railroad tracks. The 24" C.M.P. culvert carries storm water which runs east along the south side of Village Loop Drive to the large drainage ditch south of the tracks.

AZ-35-C-2 DETAILED VIEW OF MASONRY WORK OF THE HEADWALL  
LOOKING TO THE SOUTH
