CULTURAL LANDSCAPE REPORT FOR THE  
JACKSON LAKE LODGE  
NATIONAL HISTORIC LANDMARK DISTRICT  
PART II: TREATMENT  
FINAL REPORT

Jackson Lake Lodge  
National Historic Landmark District  
Cultural Landscape Report

Final  
June, 2015

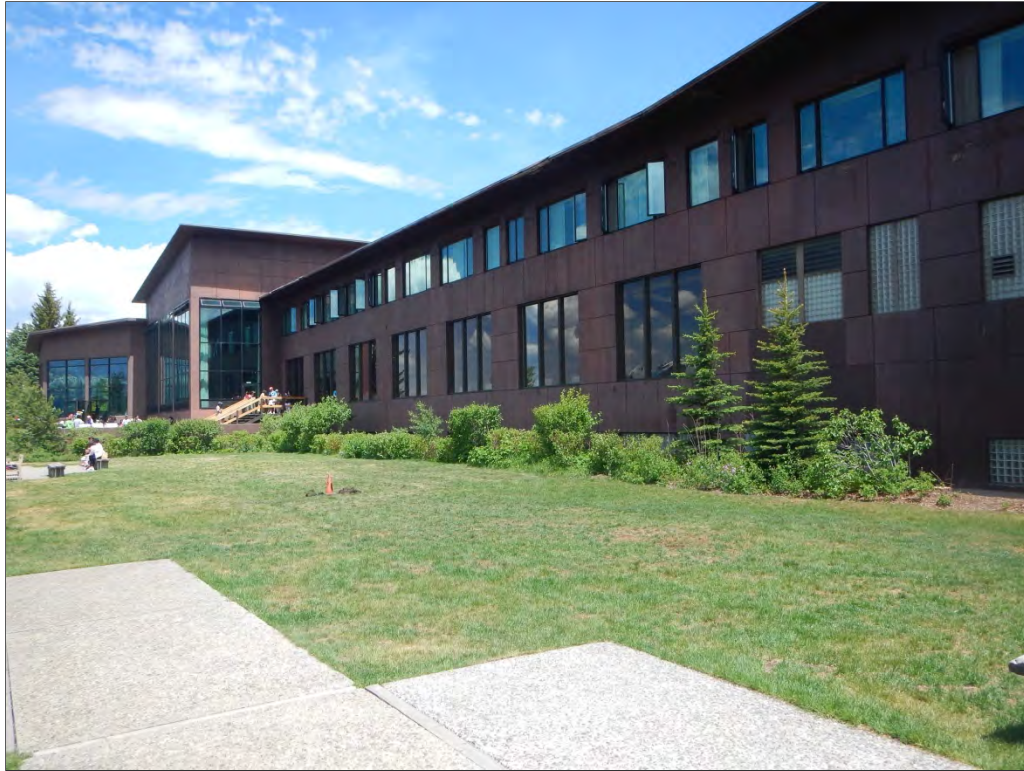
Photograph 1.1. Western façade of the lodge, facing northeast, 2014 (Source: Logan Simpson).

The predominantly International style lodge is perched on the edge of a natural terrace and provides expansive views of Jackson Lake, the Teton Range, and Willow Flats to the west (Photograph 1.1 and Photograph 1.2). The building is accessed via a two-lane paved entrance road that originates at US 89/191 and continues west-southwest past a service station and parking lot before looping beneath an overhanging porte-cochere on the lodge's eastern facade. A series of driveways extend to the north and south of the main entrance road and provide access to a rectangular parking lot, which consists of six rectangular areas and

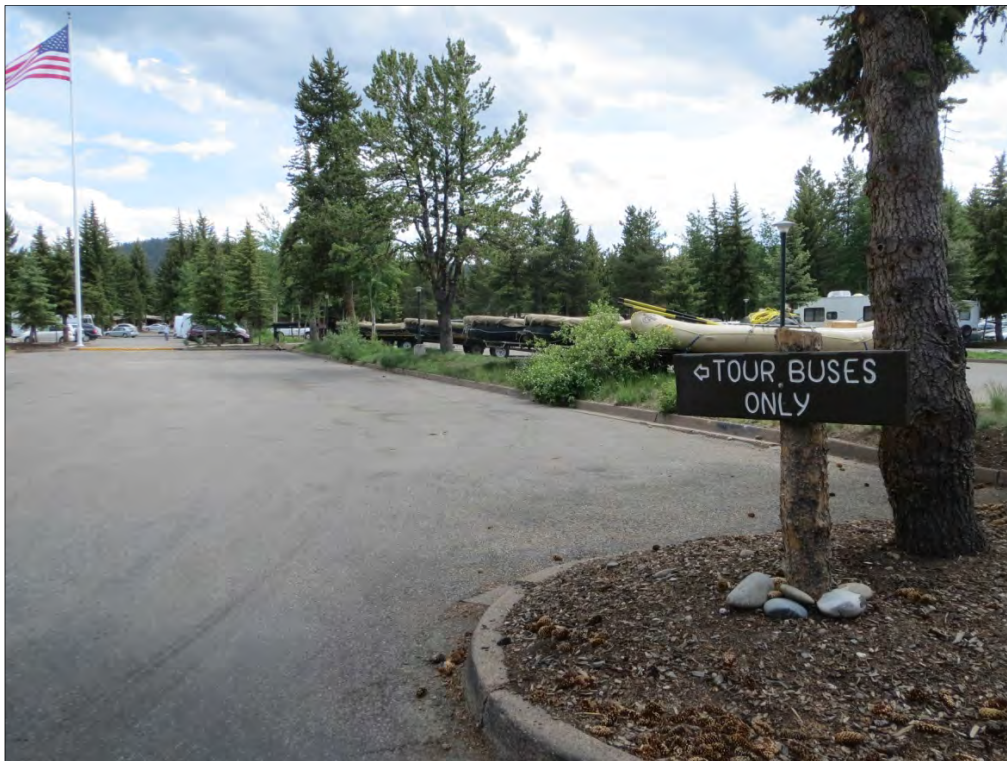
Photograph 1.3. Overview of the parking lot, showing concrete islands, signage, and native vegetation, facing southwest, 2014 (Source: Paula Reed, Paula S. Reed and Associates, Inc.).

provides parking for approximately 750 vehicles (Photograph 1.3). The six parking areas are delineated by concrete islands containing native vegetation and outdoor lighting. Towards the center of the parking lot, these islands widen to create a central pedestrian walkway. Large wooden sign posts once displaying a numbering system for the parking areas and modern trash receptacles line the walkway on its northern and southern sides.

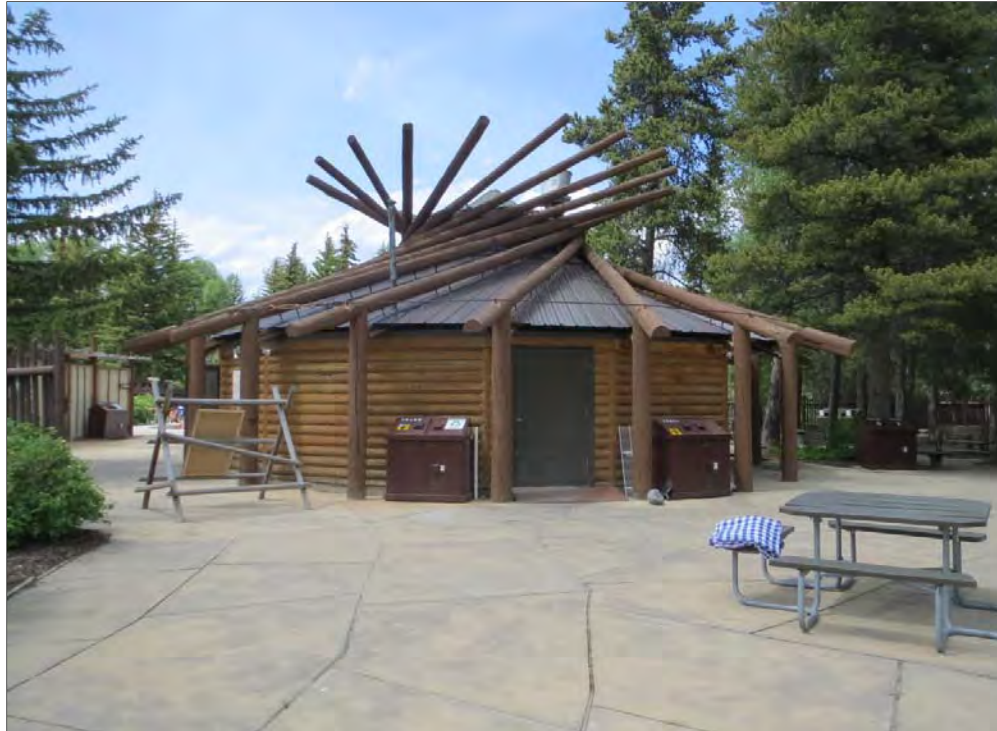
Photograph 1.4. Interior of the pool complex, showing the pool house (JL-21) (center) and maintenance shed (JL-21) (left center), facing east, 2014 (Source: Paula Reed, Paula S. Reed and Associates, Inc.).

A pool complex, consisting of a rectangular-shaped swimming pool, pool house, and storage shed, was added at the east end of the main parking lot in 1964 (Photograph 1.4). During construction of the pool complex, the easternmost parking area was altered to create a small flagpole plaza in the center of the pedestrian walkway. With the exception of these additions, the parking lot and area to the east of the lodge retains much of its original 1950s design.

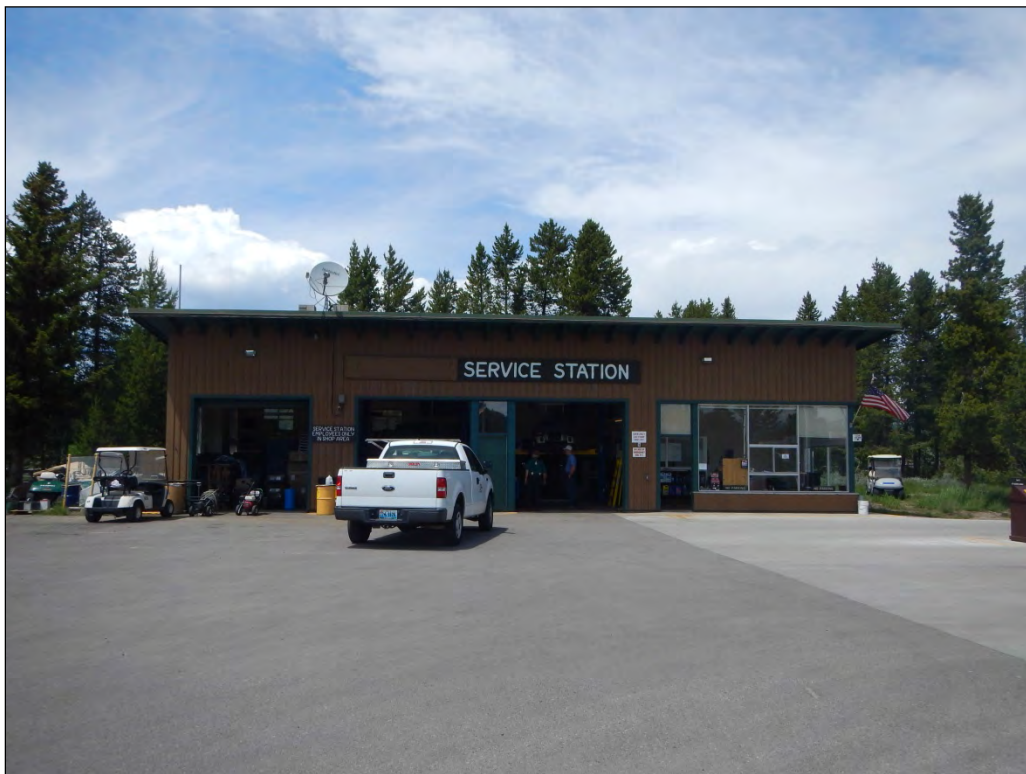
Photograph 1.8. Service station (JL-18), facing west, 2014 (Source: Logan Simpson).

The remaining buildings and structures of the lodge complex are located to the east of the pool complex along a two-lane paved road which branches southeast from the main entrance road. Known collectively as the complex service area, these buildings and structures consist of a service station, corral, telephone building, and medical clinic. Of these buildings, only the service station and corral were built within the period of significance (1953 through 1960) (Photograph 1.8 and Photograph 1.9).

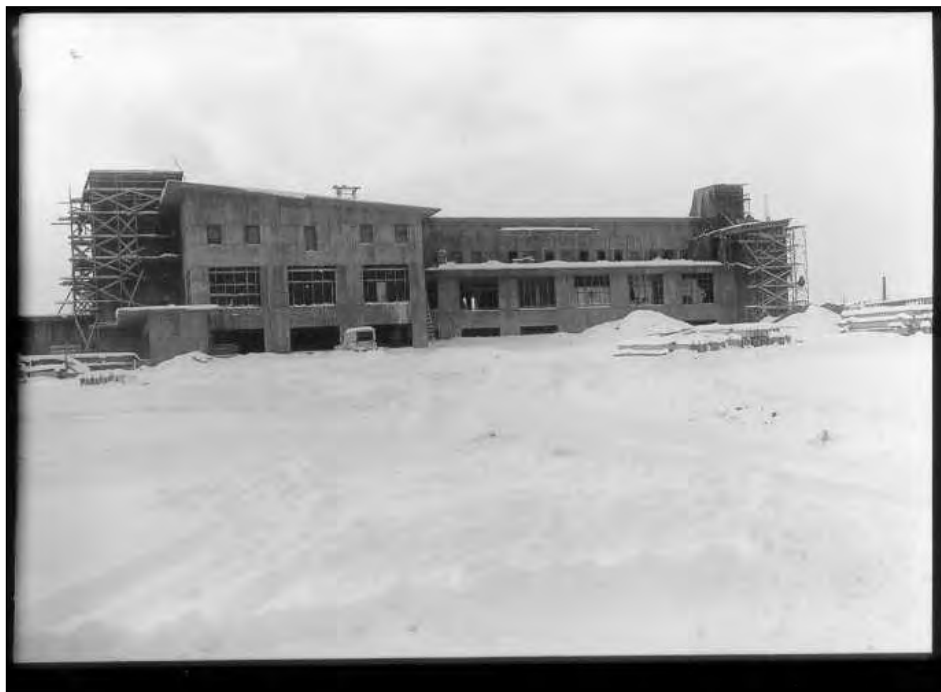
Figure 1.2. Eastern elevation of Jackson Lake Lodge, showing the initial construction, ca. 1954 (Source: GTLC Archives, Jackson Lake Lodge).

The lodge complex was constructed between 1953 and 1955 (Figure 1.2). In addition to the lodge building, the initial master plan consisted of six dormitories and four residences for employees, a recreation center, a northern and southern cottage area (each with three rows of guest cottages), a parking lot, a stable/corral, and a service station (Figure 1.3). An effort was made to retain existing mature trees surrounding the lodge; additionally, native vegetation including local conifers and hedges were planted throughout the site, and native pine and aspen trees were planted in landscape islands in the parking lot.<sup>14</sup> In 1956, for example, approximately 3,400 shrubs were planted.<sup>15</sup> Infrastructure improvements to the site also included circulation features. Paved walkways were constructed to wind between the guest cottages and a paved interpretive trail was constructed from the rear viewing terrace of the lodge to a scenic overlook atop Lunch Tree Hill.

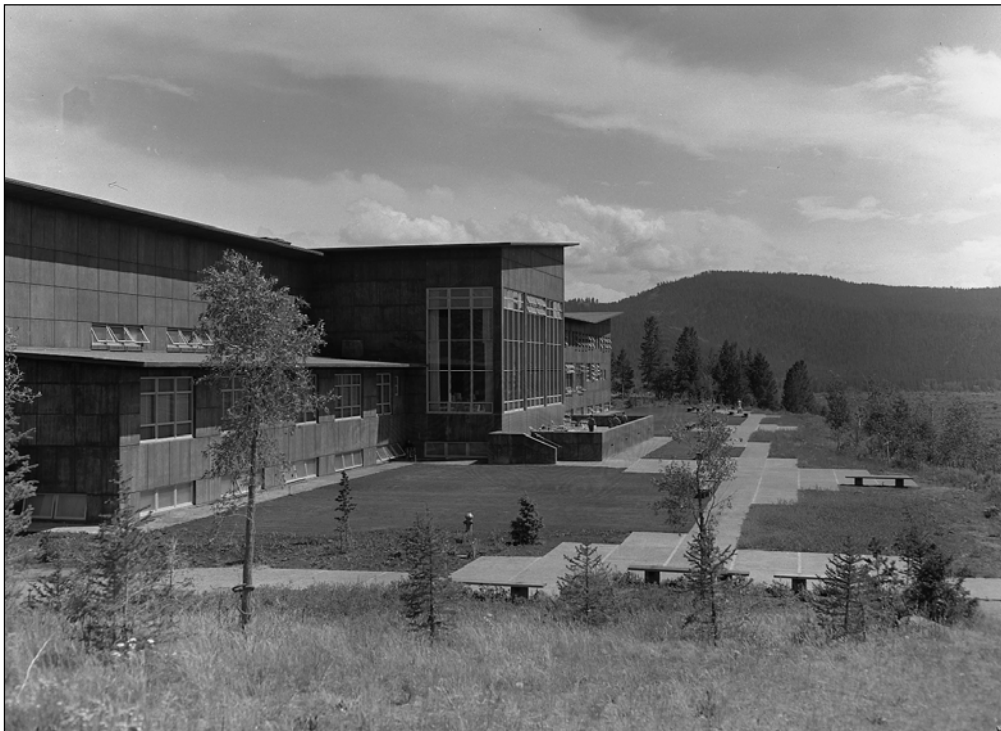
Figure 1.4. Western elevation of Jackson Lake Lodge, depicting the geometric concrete promenade with north and south terrace lawns, ca. 1960 (Source: GTLC Archives, Jackson Lake Lodge).

The landscape plan that Spencer & Lee created for the Jackson Lake Lodge in 1958 encompassed the lodge proper, the guest cottages, and parking lot. The plans show existing improvements, which likely date to the original construction, including the large planting beds to the south of the porte-cochere which contained lawns toward the central walkway and natural groundcover and trees to the north and south. Existing clusters of trees are also depicted on either side of the lodge entry and to the south of the South Terrace and south and east of the South Court. Ted Spencer also recommended the installation of more mature native tree species, ranging between 10 feet and 20 feet in height to better screen the lodge.<sup>21</sup> The plans also called for the concrete paving of the bordering promenade. The concrete, poured in square forms, created a geometric design accommodating both a walkway and seating areas (Figure 1.4).

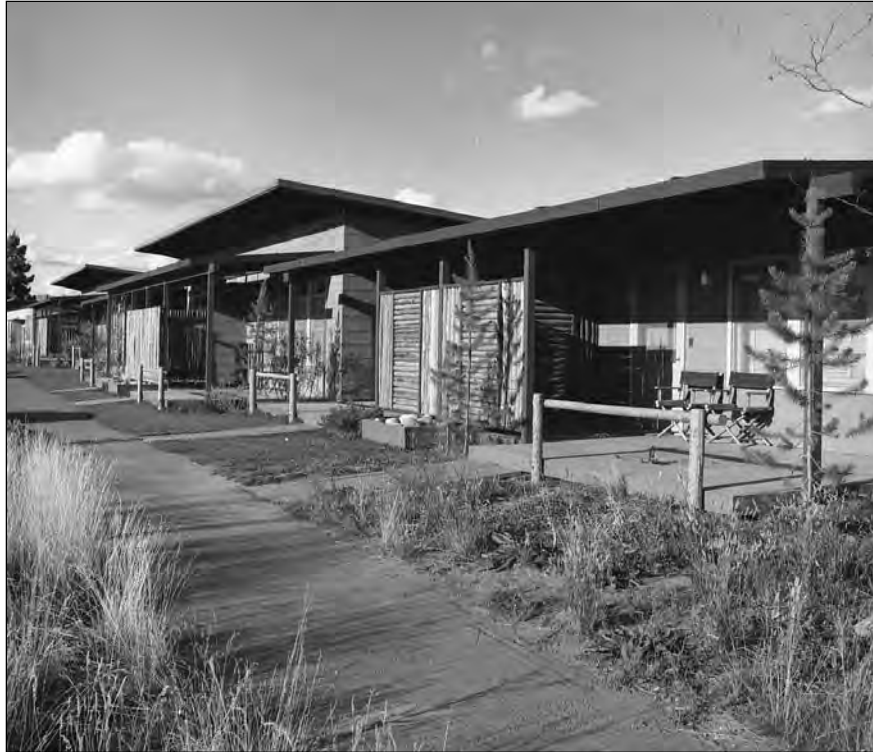
Figure 1.5. Landscape design at guest cottages depicting natural vegetation and strips of lawn at entrances, date unknown (GTLC Archives, Jackson Lake Lodge).

Plans for the north and south guest cottages included the installation of large areas of natural cover surrounding the buildings with lawns placed immediately in front of the entrances and rock mulch strips bordering the east to west trending access streets. Native shrubs were to be planted in the planting strips of the parking area to fill in the vegetation and minimize the appearance of the 277-car lot.<sup>22</sup> These improvements were carried out in 1960 (Figure 1.5).

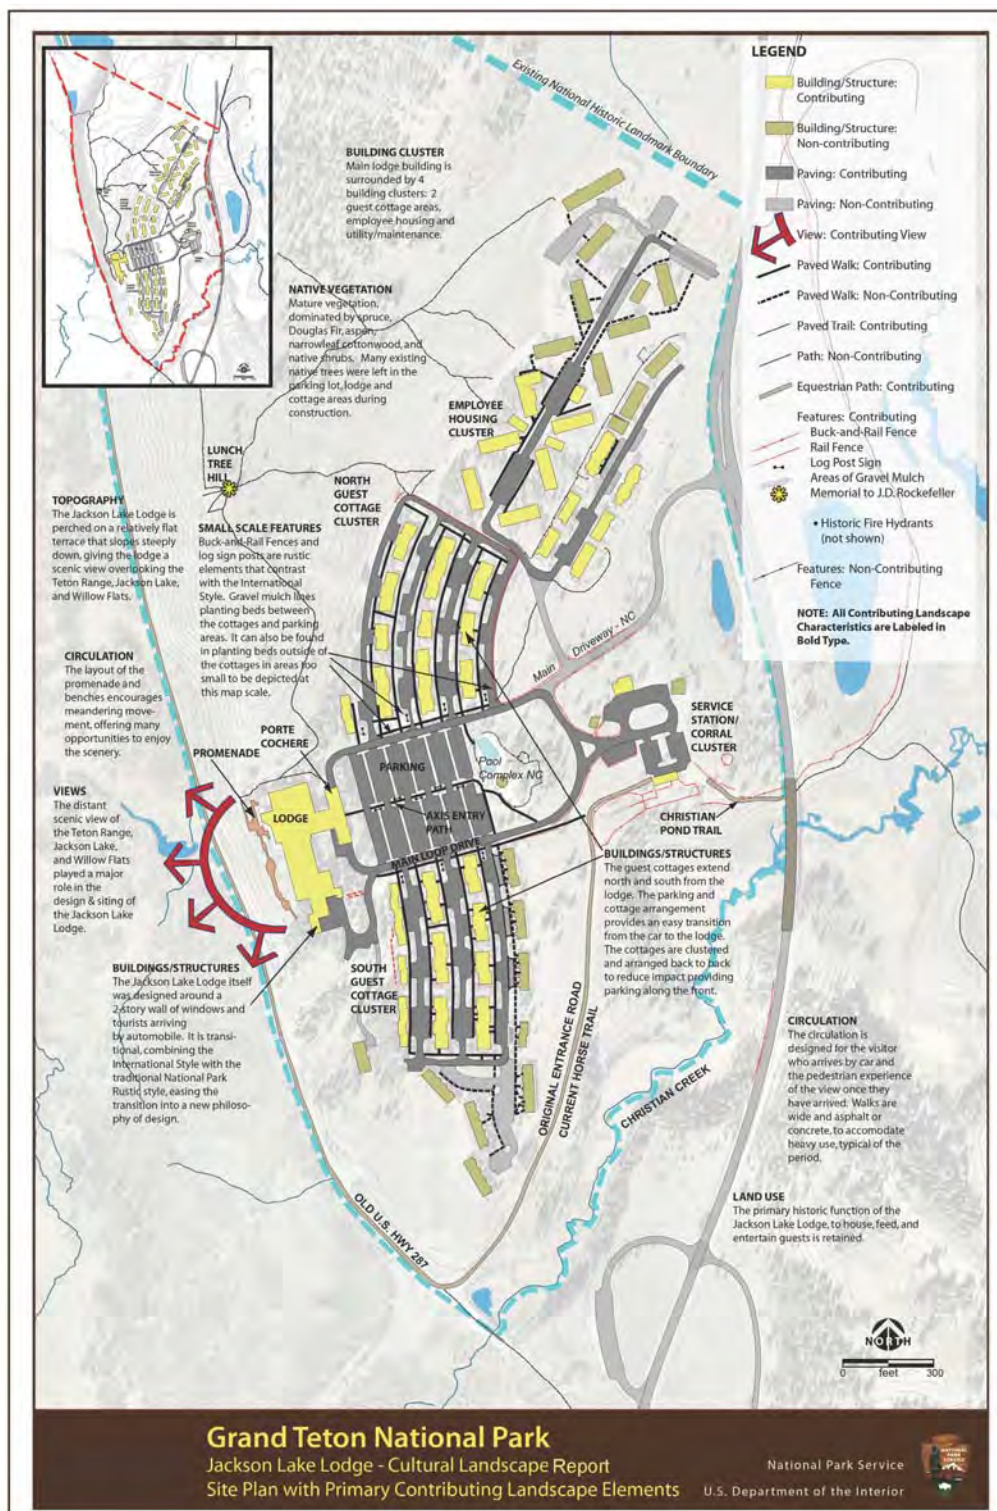
Figure 2.1. Site plan with contributing landscape elements, identified by Shapins Associates for the 2007 CLI (CLR Part I) and updated by Logan Simpson for the Part II CLR.

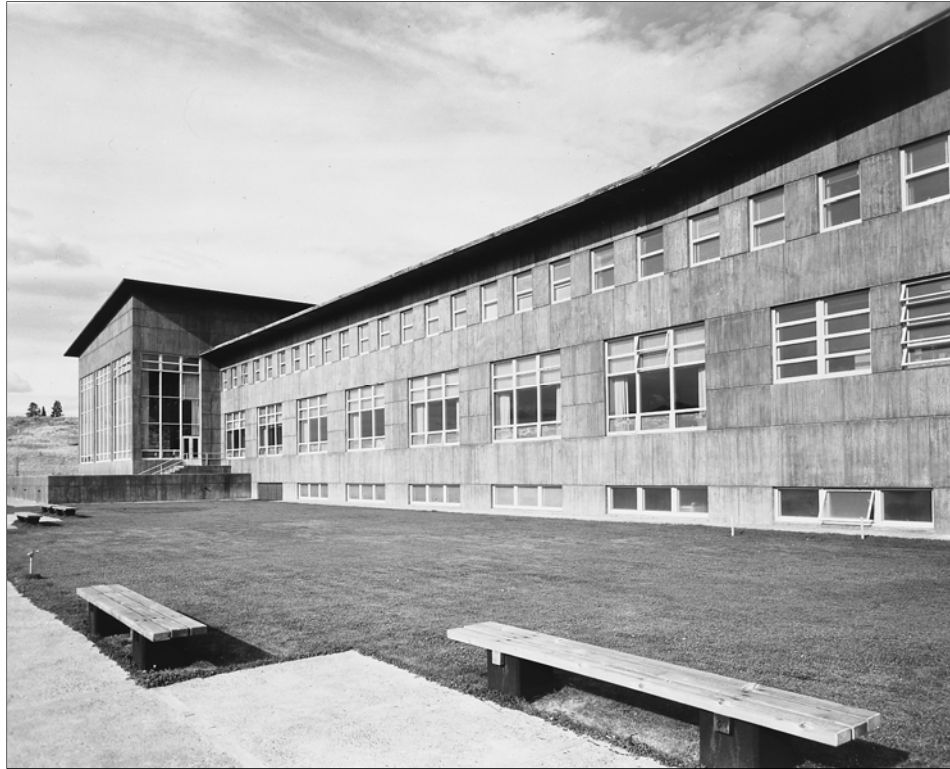
Photograph 2.1. Western (rear) façade of the Jackson Lake Lodge, facing northeast, ca. 1955 (Source: GRTE Archives, Jackson Lake Lodge.).

The first major exterior modification to the lodge building occurred in 1960 and included replacement of the original double-hung, louvered, and hinged windows on the western (rear) façade with wider 3-part hinged windows along the upper story and 3-part fixed windows on the lower story (Photograph 2.1 and Photograph 2.2). As is evident today, several of the glass panes in the basement and lower story windows were replaced with glass block some time after the lodge's original construction (see Photograph 2.2). Additional alterations were made at the northern end of the building in the late 1980s and late 1990s. These include the addition of the Blue Heron Lounge to the northwest corner of the building and expansion of the existing convention facilities, completed in 1989 and 1998 respectively (see Photograph 2.2). All of these modifications are noted in the 2003 NHL nomination, but they are not discussed in the 2007 CLI.<sup>4</sup>

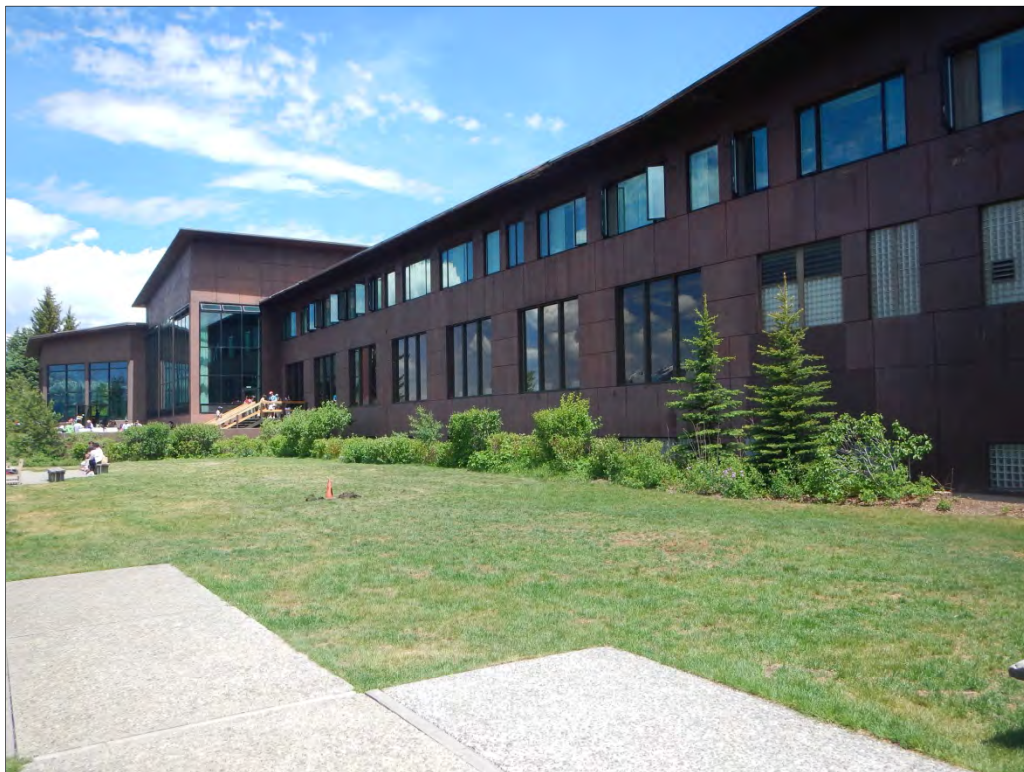
Photograph 2.2. Same view of the lodge, taken in 2014 (Source: Logan Simpson). Note the replacement windows and the northwestern Blue Heron Lounge addition.

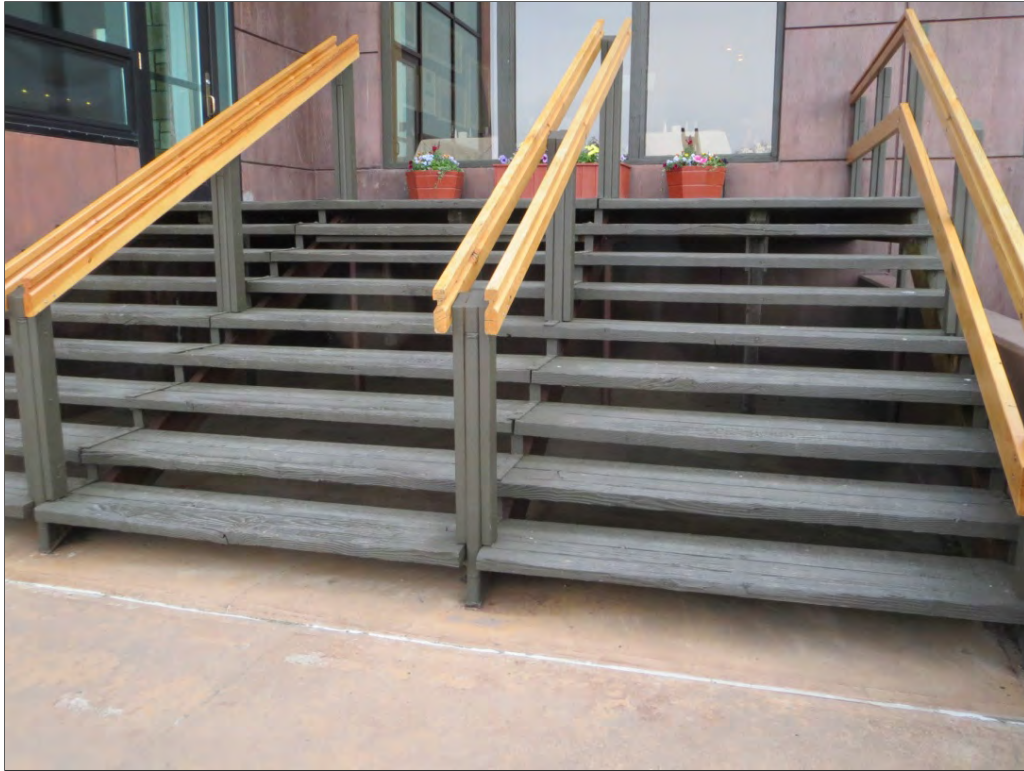
Photograph 2.3. Wooden stairway leading to the lodge's rear terrace, facing east, 2014 (Source: Paula Reed, Paula Reed & Associates Inc.).

Additional modifications to the lodge building were noted by Logan Simpson during the background research effort and 2014 field inventory. These include re-staining of the lodge's reinforced concrete exterior due to tree damage, and recent reconstruction of a wooden stairway leading from the interior lounge area to the western viewing terrace (Photograph 2.3). A review of historic photographs also suggests that the windows and doorways on the upper story of the eastern façade have been reconfigured. The date for this modification is unknown; however, it is likely that this change occurred following relocation of the lodge's original bar to the Blue Heron Lounge addition in 1988. Although some of the lodge's character-defining features have been compromised by these alterations, the building continues to retain a high level of integrity as its principal visual elements (e.g., horizontal rows of windows, the overall form of the building, and the experience of the vista it overlooks) remain intact.<sup>5</sup>

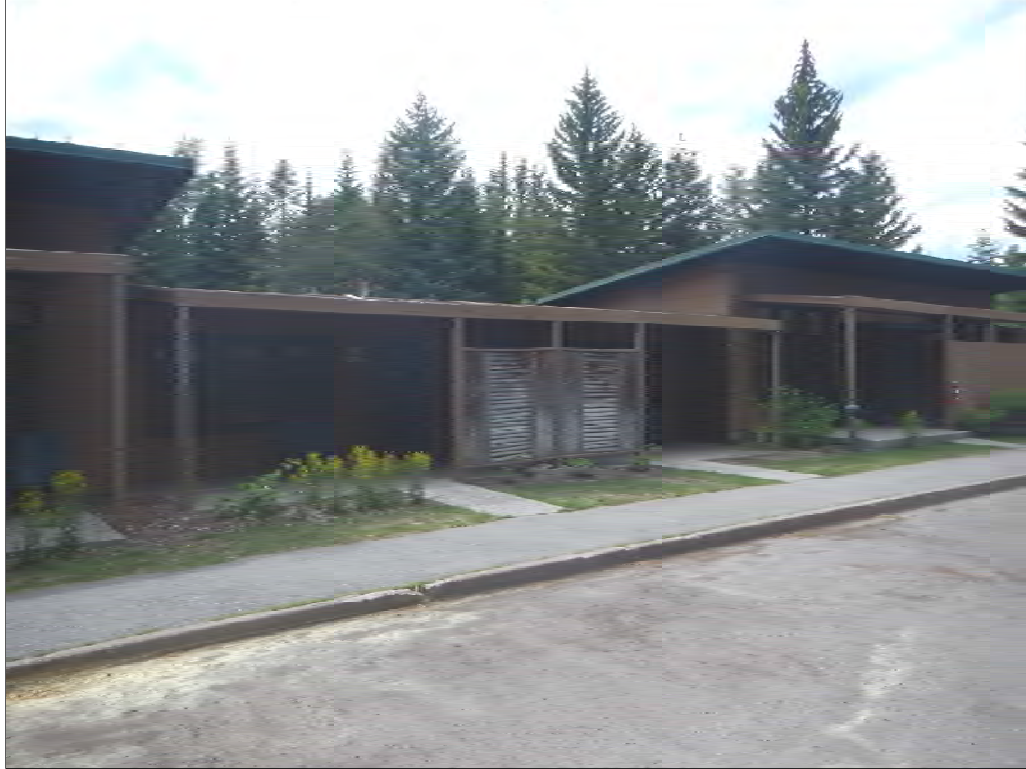
Photograph 2.4. Combined vertical and horizontal lodgepole pine screening panels outside of rooms 304-309 (JL-9), facing west-northwest, 2014 (Source: Logan Simpson).

As noted in the CLI and observed by the Logan Simpson team in 2014, the outdoor terraces of the guest cottages are partially enclosed by three different types of wooden screening panels; these include vertical lodgepole pine screening panels, combination panels comprised of vertical and horizontal lodgepole pine poles, and panels constructed of vertical wooden boards (Photograph 2.4, Photograph 2.5, and Photograph 2.6). Both the vertical and combination lodgepole pine screening panels consist of 2-inch-diameter poles encased in wooden frames. At least one variation in the vertical screening panels—the presence of a 2 x 4 wooden brace above the framing—was observed at some of the southern guest cottages during the 2014 field inventory (see Photograph 2.5); the purpose or age of the bracing is unknown. Historic photographs and architectural drawings suggest that both the vertical and combination lodgepole pine pole screening panels were erected by Spencer & Lee in the late 1950s or early to mid-1960s as part of a larger landscape improvement project, and because of this, the screening panels constructed of lodgepole pine poles are treated and managed as historic by the NPS. In recent years, many of the lodgepole pine poles have been replaced with vertical wooden boards; however, replacement of the screening panels does not impact the overall integrity of the guest cottages.

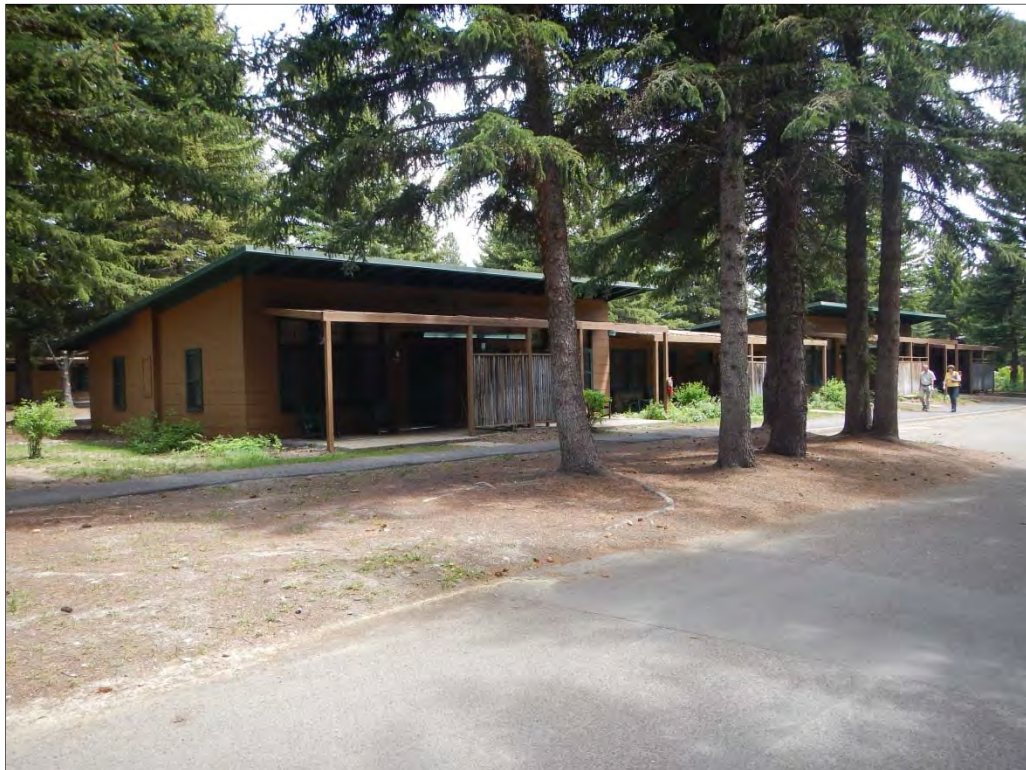
Photograph 2.5. Vertical pine screening panels outside of rooms 129-143 (JL-5), facing southeast, 2014 (Source: Logan Simpson).

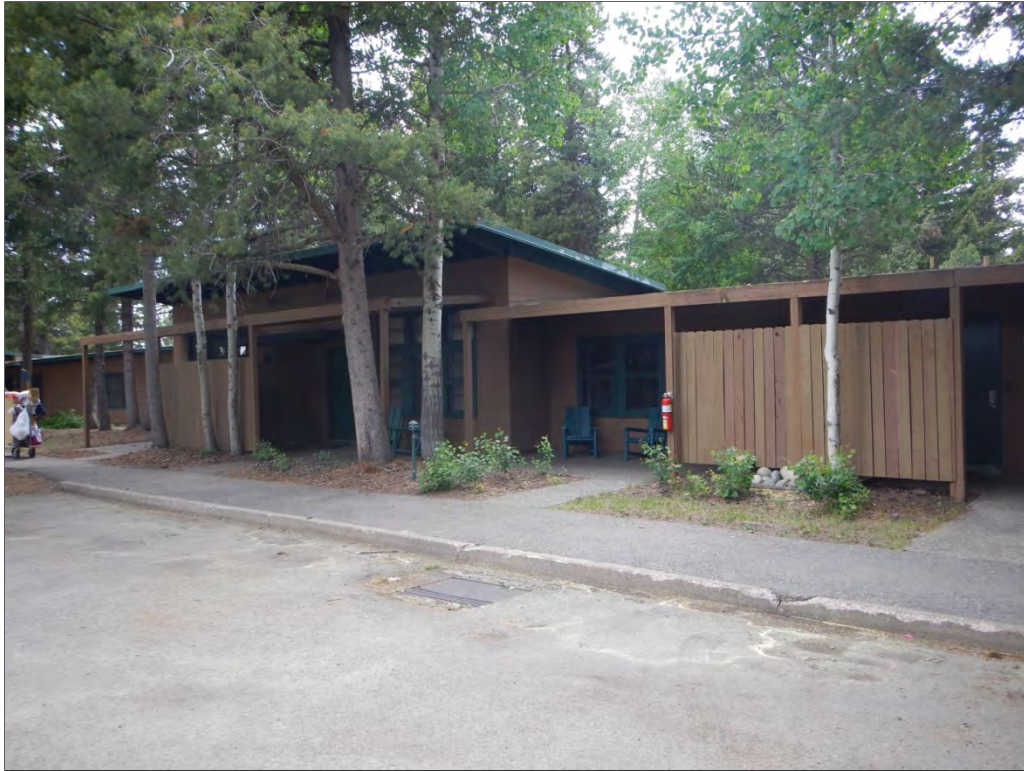
Photograph 2.6. Screening panels comprised of vertical wooden boards outside of room 531 (JL-324/529), facing southwest, 2014 (Source: Logan Simpson).

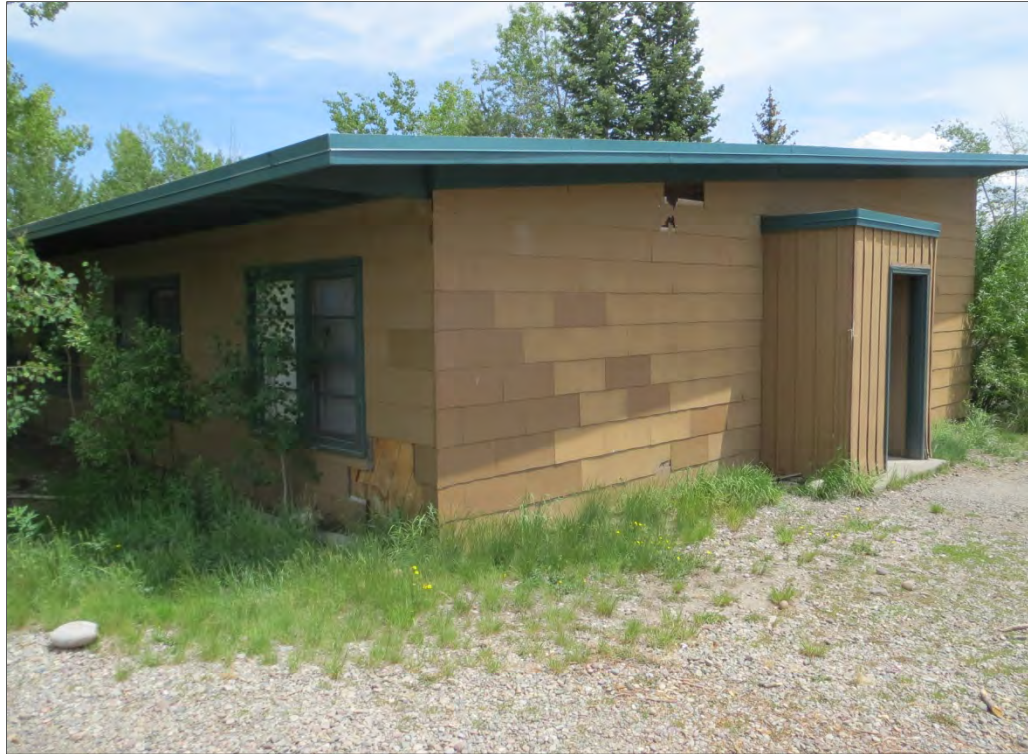
Photograph 2.7. Rear façade of Dorm #7 (JL-36), showing the replacement of original asbestos shingle siding with modern siding, facing east, 2014. Note the additional loss (visible at bottom left) and the warping of siding near the base of the projecting entry (Source: Logan Simpson).

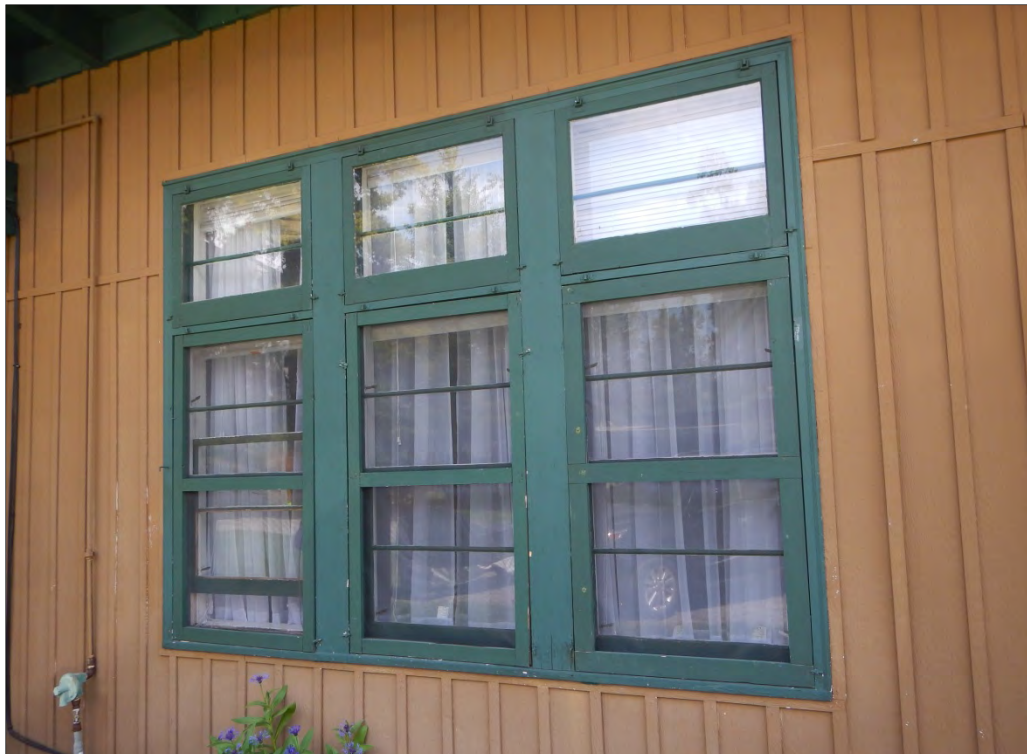
Photograph 2.8. Original wood frame windows on Staff Housing no. 8 (JL-42) in the employee housing area, facing east, 2014 (Source: Logan Simpson).

*Materials.* Integrity of materials is considered largely the same, with concrete, wood, and asphalt remaining the prevalent materials of the district. Some replacement of historic materials due to weathering and deterioration has occurred. Notable examples include the recent and ongoing replacement of the lodgepole pine screening panels of the guest cottages with screening panels constructed of modern wooden boards; window replacement in the employee housing area; and replacement of asbestos shingle siding on the dormitories and multi-housing units along Dorm Street. The NPS and GTLC are currently considering several modern products that resemble the original historic materials but are environmentally safe, more durable, or cost effective. At the time of the 2014 field inventory, for instance, several of the houses on Staff Street were undergoing or had recently undergone window replacement using modern windows that had been specially manufactured to resemble the appearance of the original wood frame windows (see Photograph 2.8 and Photograph 2.9).

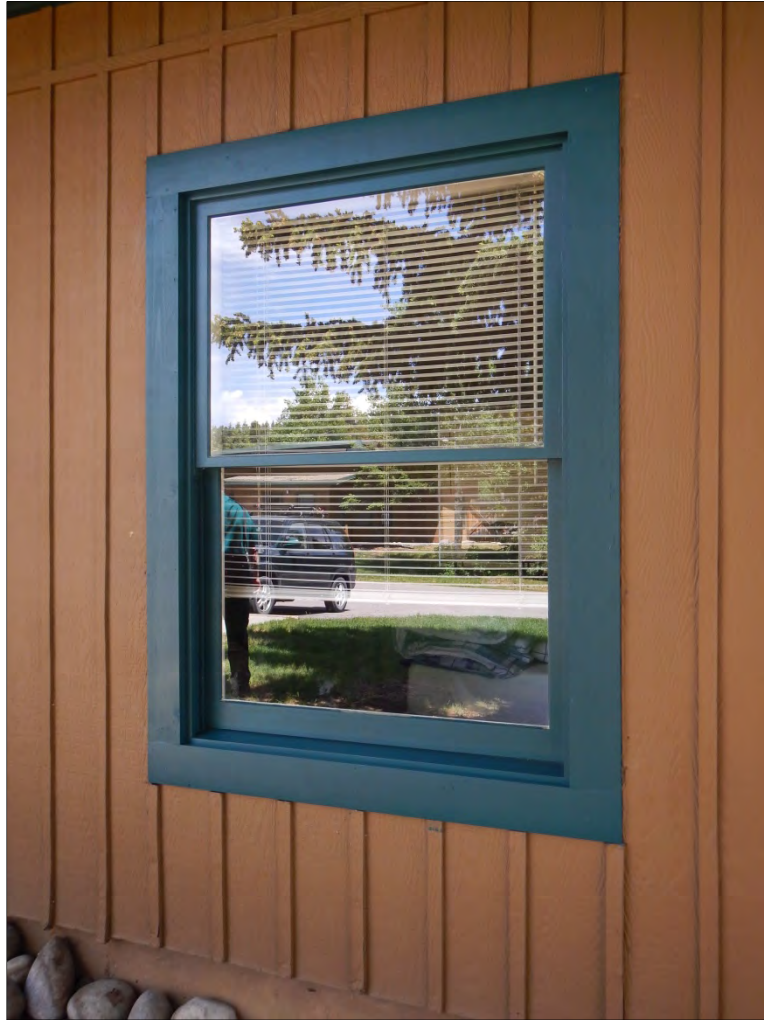
Photograph 2.9. Modern replacement window on Staff Housing no. 10 (JL-43) in the employee housing area, facing east, 2014 (Source: Logan Simpson).

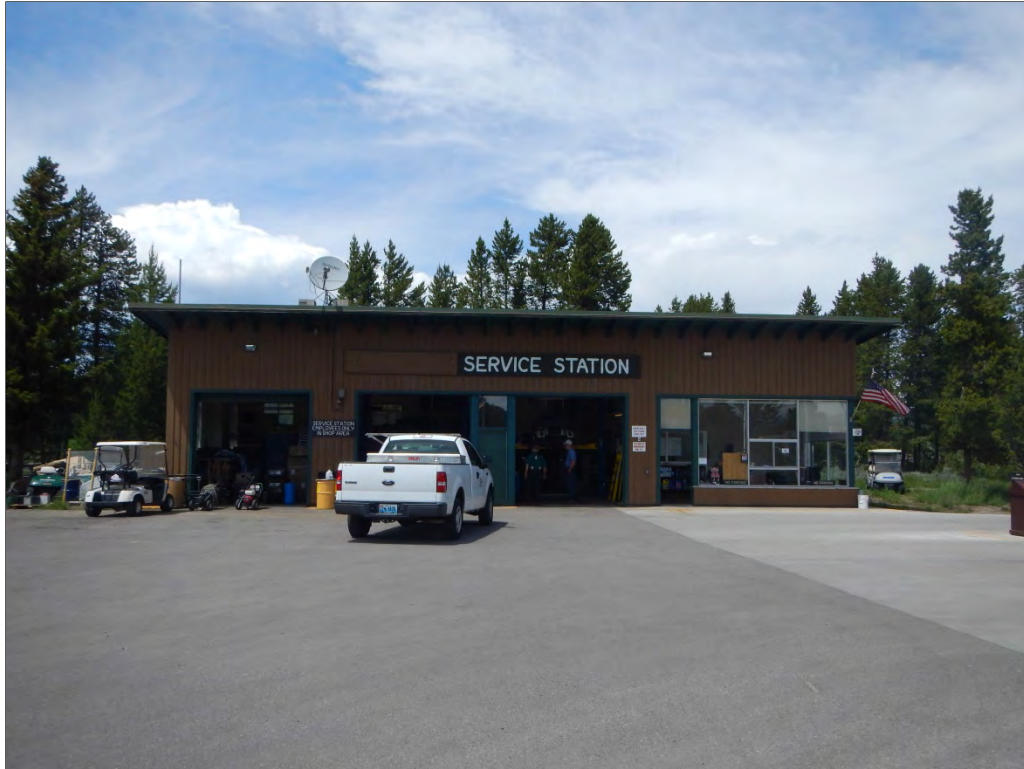
Photograph 2.10. Service station (JL-18), facing west, 2014 (Source: Logan Simpson).

Other contributing buildings identified in the 2007 CLI include the service station, corral, and 13 employee housing units (incorrectly cited as “15 employee housing units”). All of these buildings are recognized on the GRTE LCS as having architectural significance. The 2007 CLI did not identify any modifications to the corral, employee residences, or service building, and Logan Simpson did not note any significant structural alterations to these buildings as part of the 2014 field inventory. However, the condition of certain historic materials has degraded, which has led to damage and/or loss of integrity of materials. For instance, weathering of asbestos shingle siding on employee housing has resulted in the loss of shingles and replacement with modern, non-asbestos, material shingles. Similarly water damage has caused warping of vertical siding at several of the housing entrances (Photograph 2.7). Historic windows in poor condition are also actively being replaced on the permanent employee housing buildings on Staff Street (Photograph 2.8 and Photograph 2.9). It is also likely that fencing materials at the corral have been replaced over time as needed. Despite some loss of integrity in historic materials, the contributing employee buildings, service station (Photograph 2.10), and corral continue to retain their character-defining features.

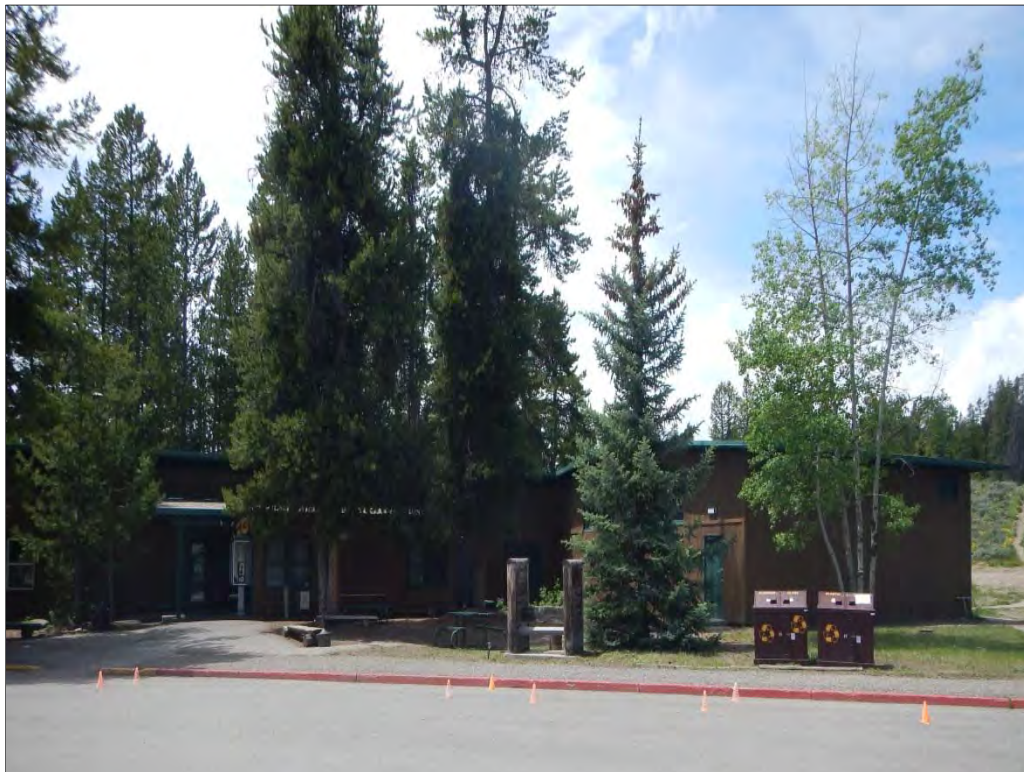
Photograph 2.11. Recreation center (JL-46), facing west, 2014 (Source: Logan Simpson).

The CLI identifies the recreation center/employee lounge building on Dorm Street as non-contributing. However, the building was constructed as part of the original lodge complex in 1955, is included on the lodge’s LCS, is identified in the NHL nomination as contributing, and is currently maintained by the NPS according to the Secretary of the Interior’s Rehabilitation Standards. As such, it continues to retain its character-defining features and has been added as a contributing building to the district’s cultural landscape in this document (Photograph 2.11).

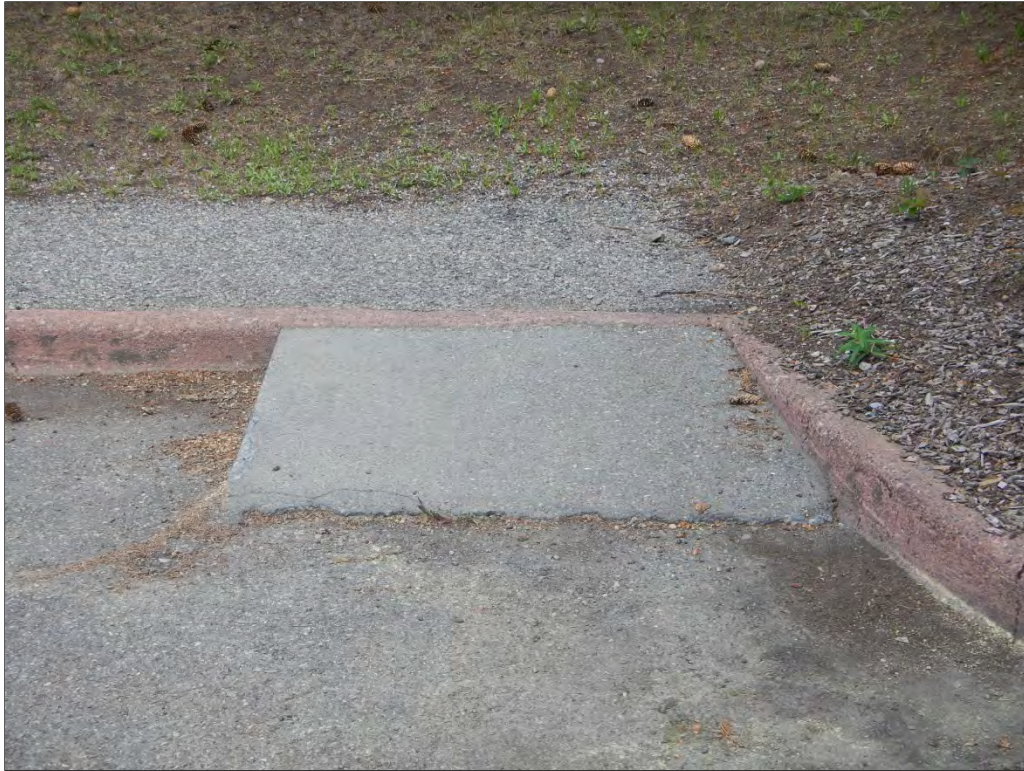
Photograph 2.12. Concrete ramp in the south guest cottage area, facing east, 2014 (Source: Logan Simpson).

In addition to the former entrance road and old alignment of US 287, the CLI identifies the following features as walkways and trails: the central pedestrian walkway in the parking lot, the asphalt walkways paralleling the drives in the north and south cottage areas, the "beaten" paths or "desire lines" leading throughout the lodge landscape created by guests and/or employees, and the Christian Pond and Lunch Tree Hill trails.<sup>8</sup> With the exception of the employee/guest paths which are considered non-contributing, all of these features are identified by Shapins Associates as contributing. Very few changes were observed to these features during the 2014 survey; however, the addition of asphalt ramps and curb cuts along several of the walkways in the guest cottages areas was noted by Logan Simpson (Photograph 2.12). These ramps, which were likely installed for accessibility purposes, are predominantly located along the corners of the drives near accessible parking stalls and provide access to guest cottages.

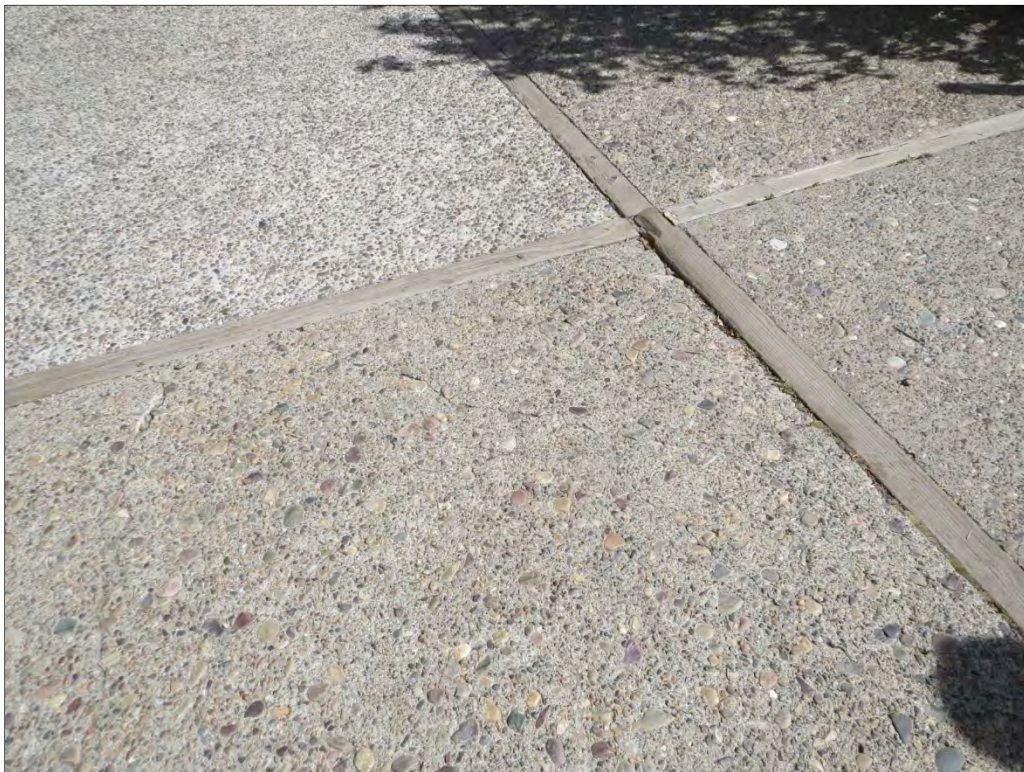
Photograph 2.13. Close-up of the promenade showing a replaced paver (at left), facing southwest, 2014 (Source: Paula Reed, Paula S. Reed and Associates, Inc.).

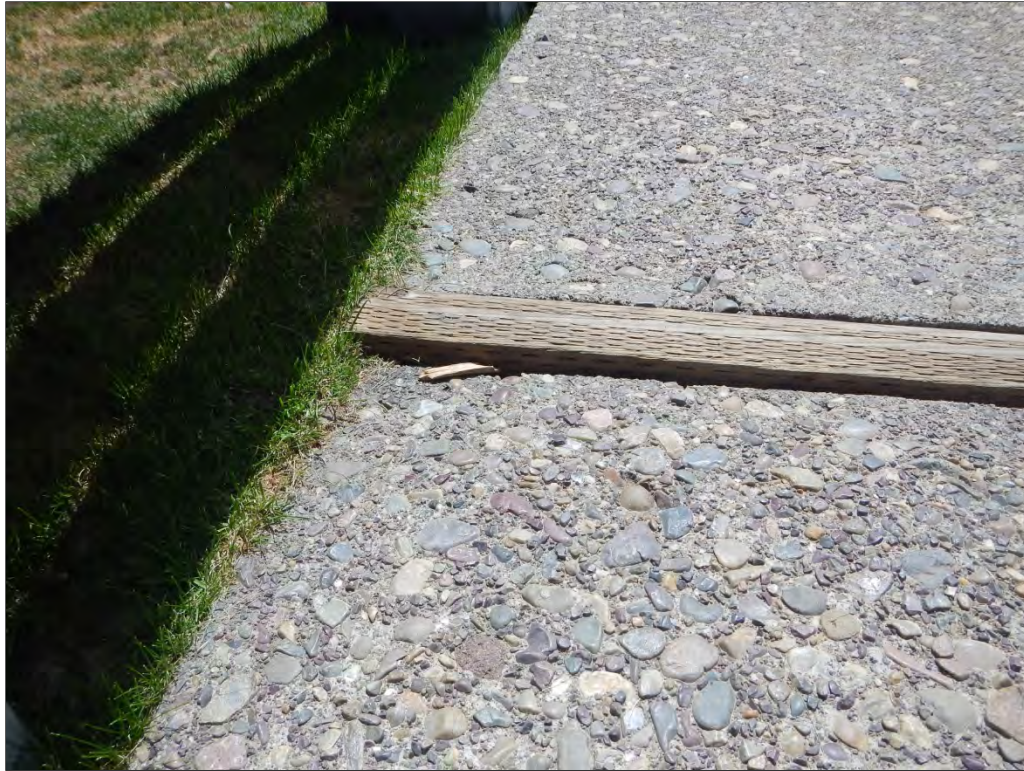
Photograph 2.14. Close-up of the promenade showing original wood band replaced with pressure treated lumber, facing south, 2014 (Source: Logan Simpson).

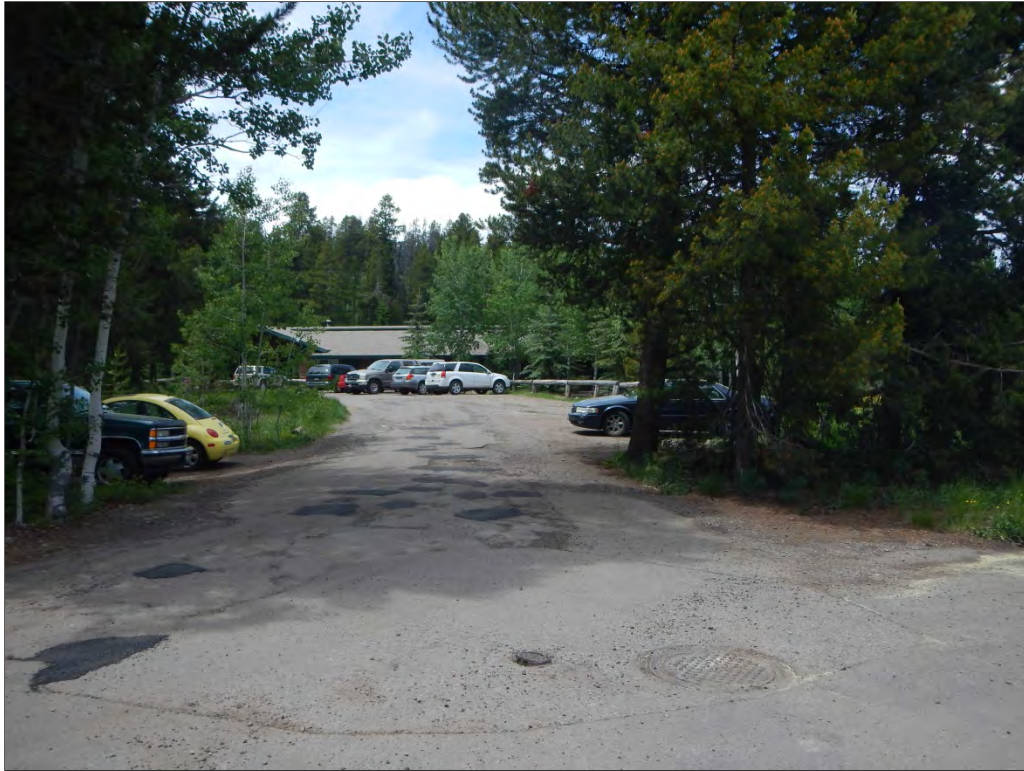
Photograph 2.15. Potholes and patched pavement near the northern end of Dorm Street, facing northwest, 2014 (Source: Logan Simpson).

Although additional changes have not been made to the circulation features since 2007, numerous condition issues were observed by Logan Simpson in 2014. These include many potholes and areas of patched asphalt along Dorm and Staff Streets, in the parking lot, and along the drives in the north and south cottage areas (Photograph 2.15); damaged concrete curbing along the drives in the guest cottage areas and in the main parking lot, particularly along the islands (Photograph 2.16) replacement of concrete curb with wooden logs (Photograph 2.17); the addition of curb cuts in the existing concrete curb for ADAAG accessibility (Photograph 2.18); and the poor construction of concrete steps on the viewing terrace to the north of the Blue Heron Lounge (Photograph 2.19).
