CULTURAL LANDSCAPE REPORT FOR THE  
JACKSON LAKE LODGE  
NATIONAL HISTORIC LANDMARK DISTRICT  
PART II: TREATMENT  
FINAL REPORT

Jackson Lake Lodge  
National Historic Landmark District  
Cultural Landscape Report

Final  
June, 2015

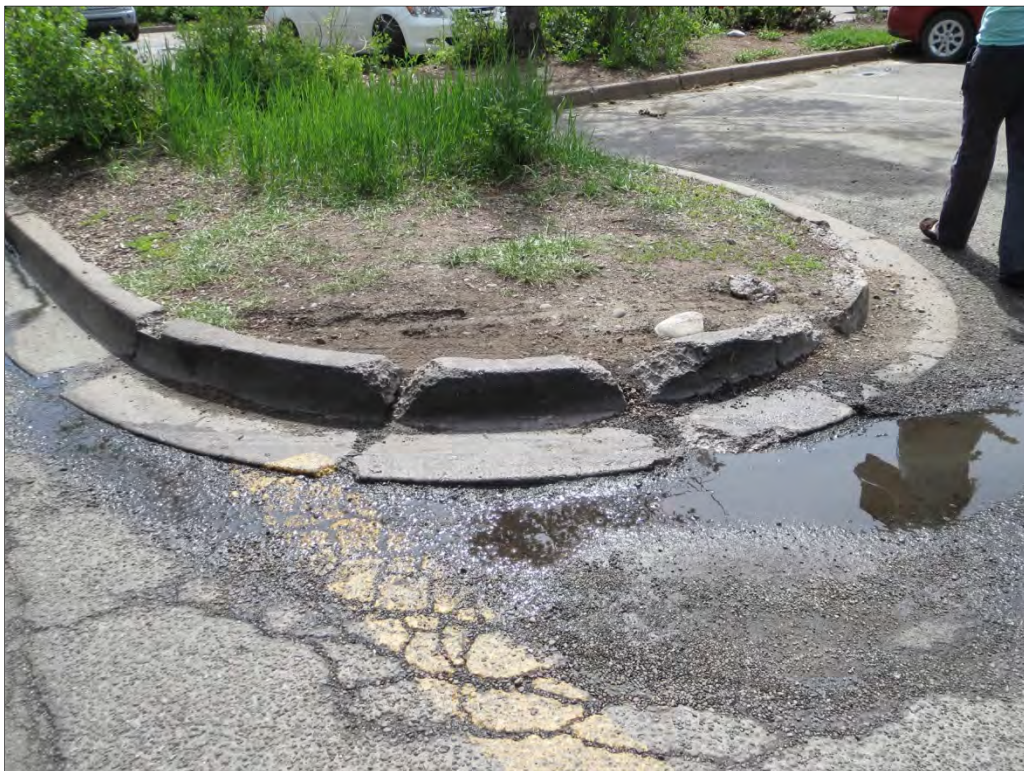
Photograph 2.16. Damaged concrete curb along one of the islands in the parking lot, facing southeast, 2014 (Source: Logan Simpson).

Although additional changes have not been made to the circulation features since 2007, numerous condition issues were observed by Logan Simpson in 2014. These include many potholes and areas of patched asphalt along Dorm and Staff Streets, in the parking lot, and along the drives in the north and south cottage areas (Photograph 2.15); damaged concrete curbing along the drives in the guest cottage areas and in the main parking lot, particularly along the islands (Photograph 2.16) replacement of concrete curb with wooden logs (Photograph 2.17); the addition of curb cuts in the existing concrete curb for ADAAG accessibility (Photograph 2.18); and the poor construction of concrete steps on the viewing terrace to the north of the Blue Heron Lounge (Photograph 2.19).

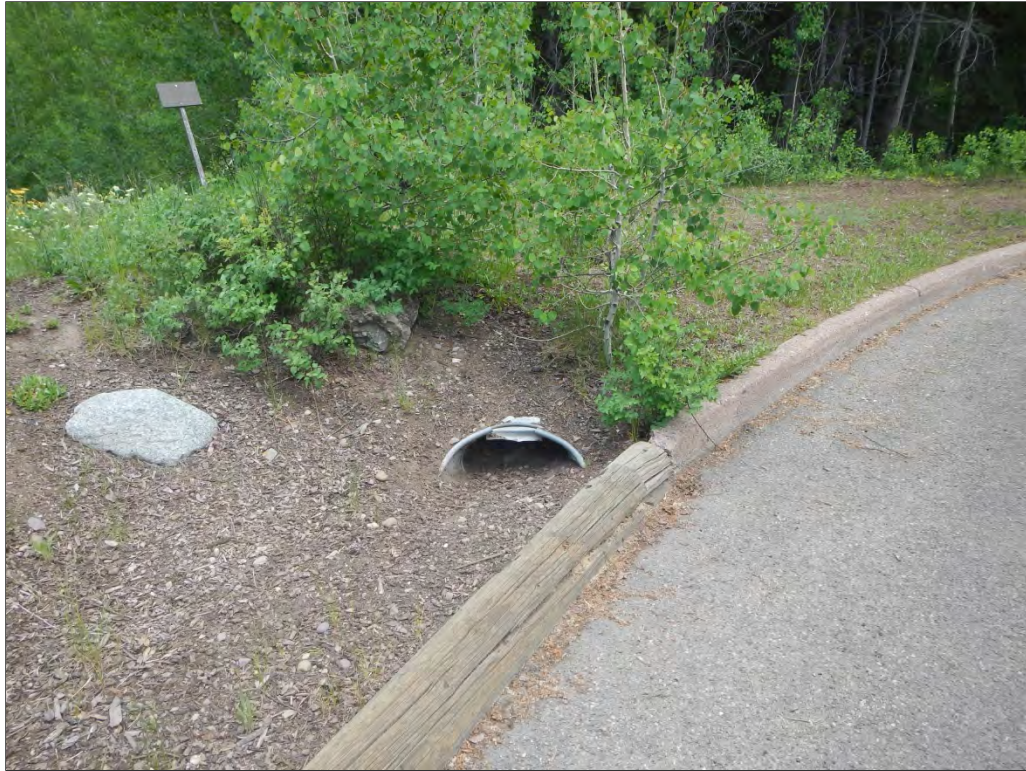
Photograph 2.17. Replacement of concrete at the southern end of the south guest cottage area with wooden logs, southeast, 2014 (Source: Logan Simpson).

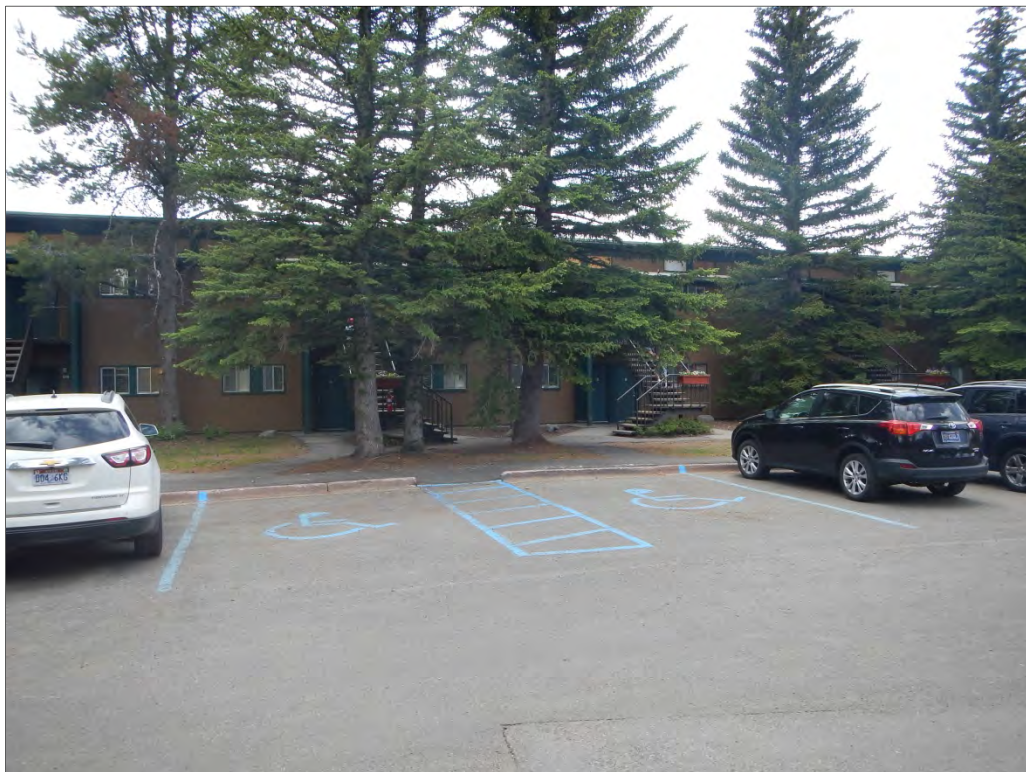
Photograph 2.18. Curb cut to create ADA accessible ramp in front of rooms 560–579 in the south guest cottage area, facing southwest, 2014 (Source: Logan Simpson).

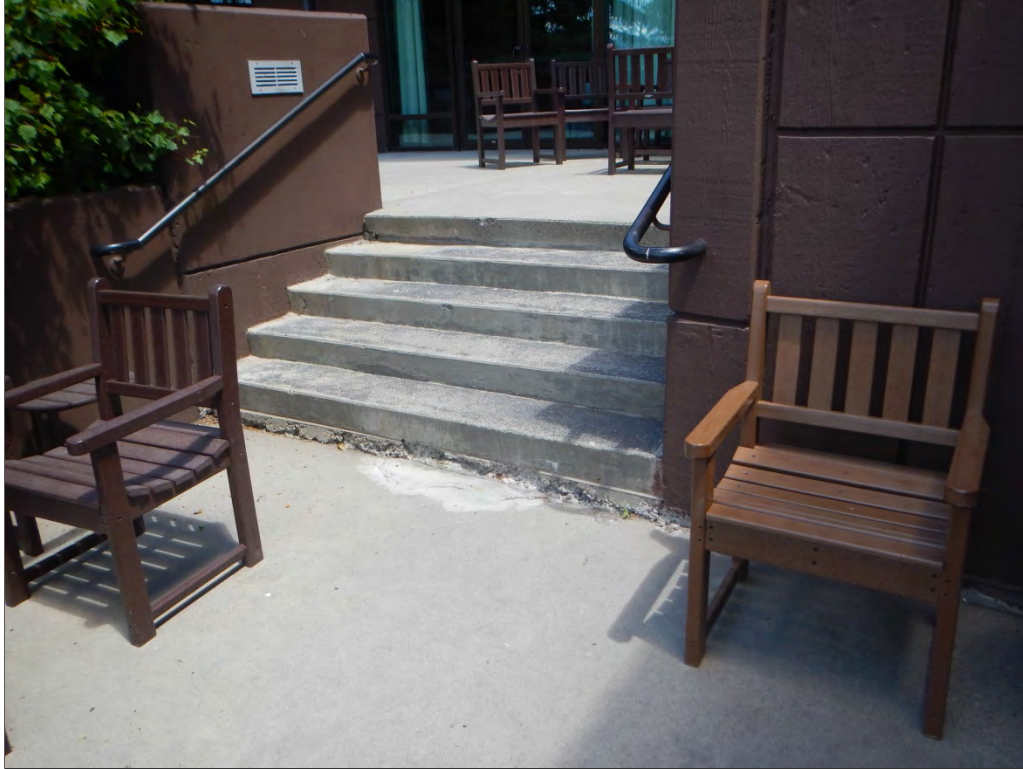
Photograph 2.19. Deteriorating concrete stairway outside of the Blue Heron Lounge, facing northeast, 2014 (Source: Logan Simpson).

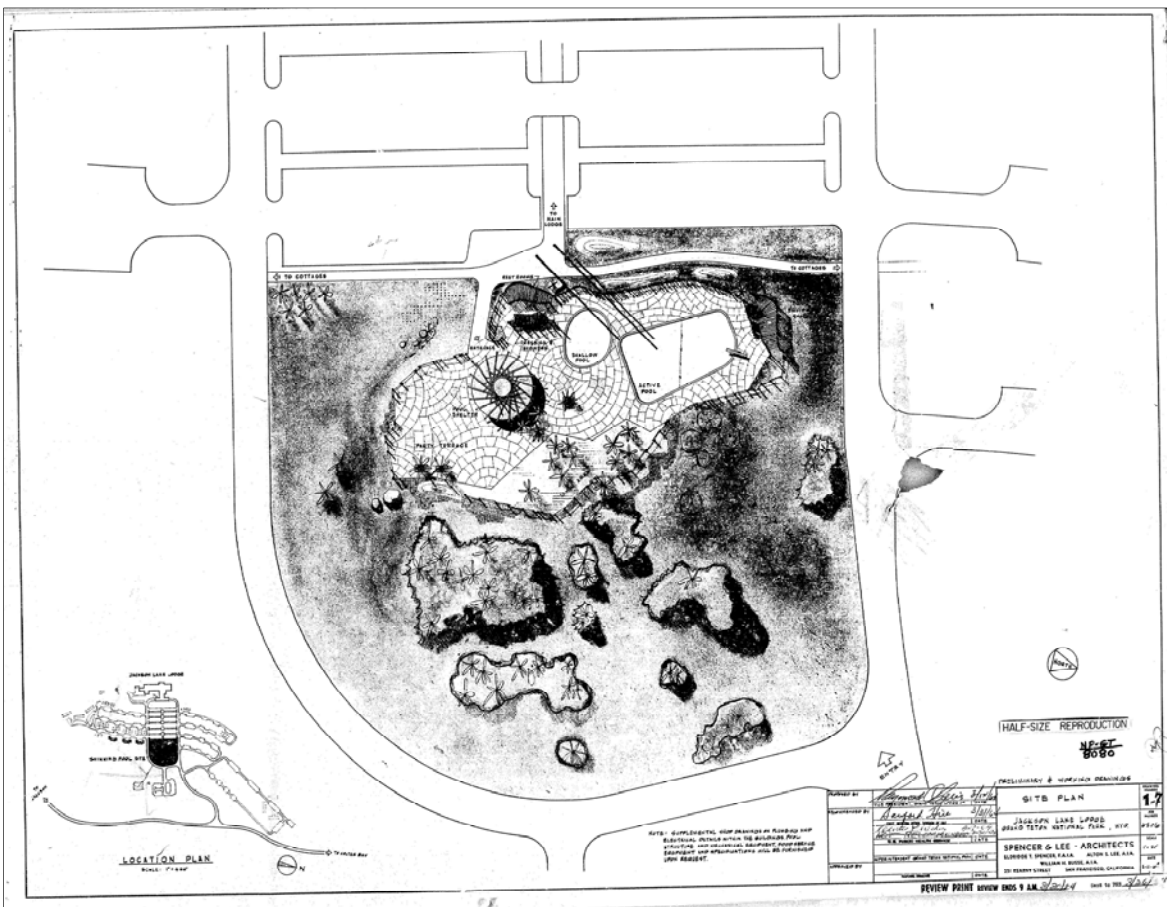
Figure 2.3. Architectural rendering of the proposed pool complex (G.T.-N.P.8080) done by Spencer & Lee Architects in March 1964 (Source: NPS Archives, Denver, CO.).

One additional type of fencing is present within the cultural landscape but was not included in the CLI. This fencing, which consists of vertical lodgepole pine logs, encircles the pool complex (Photograph 2.22). A plan drawing for the pool complex drafted by Spencer and Lee Architects indicates that a fence was planned for that location as part of their 1964 design (Figure 2.3). Because the fence is constructed of native materials and blends with the surrounding landscape and other buildings and structures of the district but was built outside the period of significance, it has been added as a non-contributing, compatible small scale feature in this document.

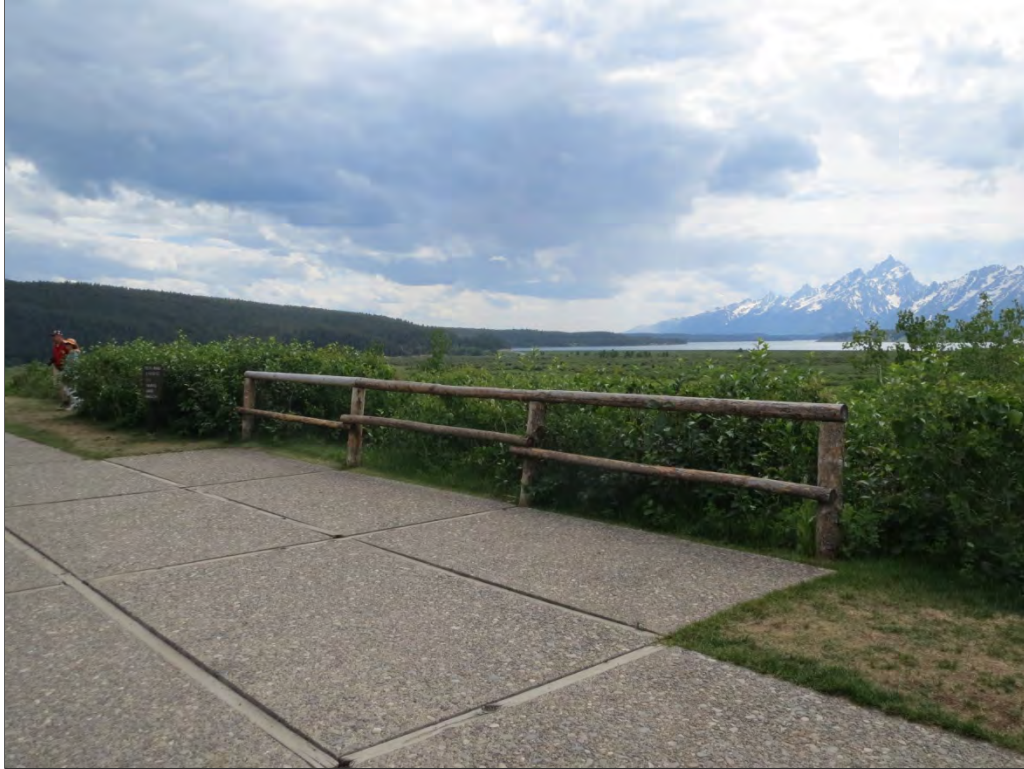
Photograph 2.21. Split rail fencing along the promenade to the rear of the lodge building, facing southwest, 2014 (Source: Paula Reed, Paula S. Reed and Associates, Inc.).

Other fence types, including high log rail fencing and plank fencing, were also noted in the CLI as forming a portion of the corral. High log rail fencing was also identified by Logan Simpson along the promenade to the rear of the lodge building (Photograph 2.21). These features do not appear on any of the 1950s era landscape plans, which suggest that they were used to expand the corral and delineate the edge of the lodge's rear promenade sometime after the district's period of significance. Because their materials and design are compatible with the buck-and-rail fencing installed within the lodge complex during the period of significance, these fence types are considered to be non-contributing, compatible features of the district's cultural landscape.

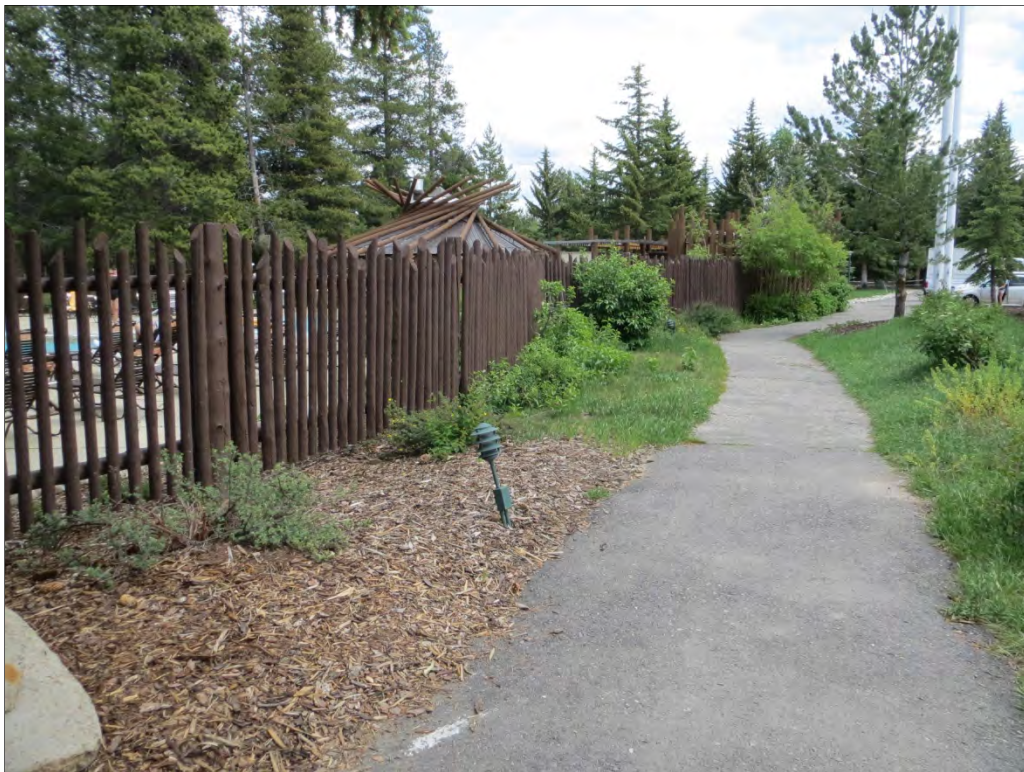
Photograph 2.22. Fence encircling the pool complex, facing south, 2014 (Source: Paula Reed, Paula S. Reed and Associates, Inc.).

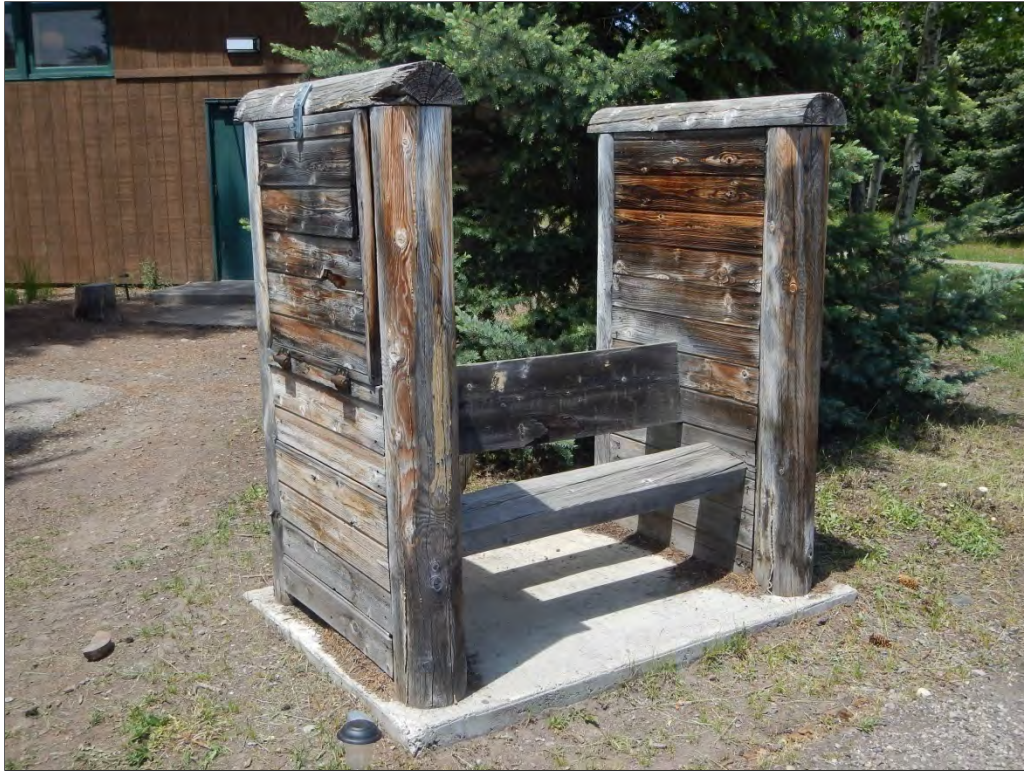
Photograph 2.23. One of two permanent wooden benches located within the employee housing area to the east of the recreation hall, facing north, 2014 (Source: Logan Simpson).

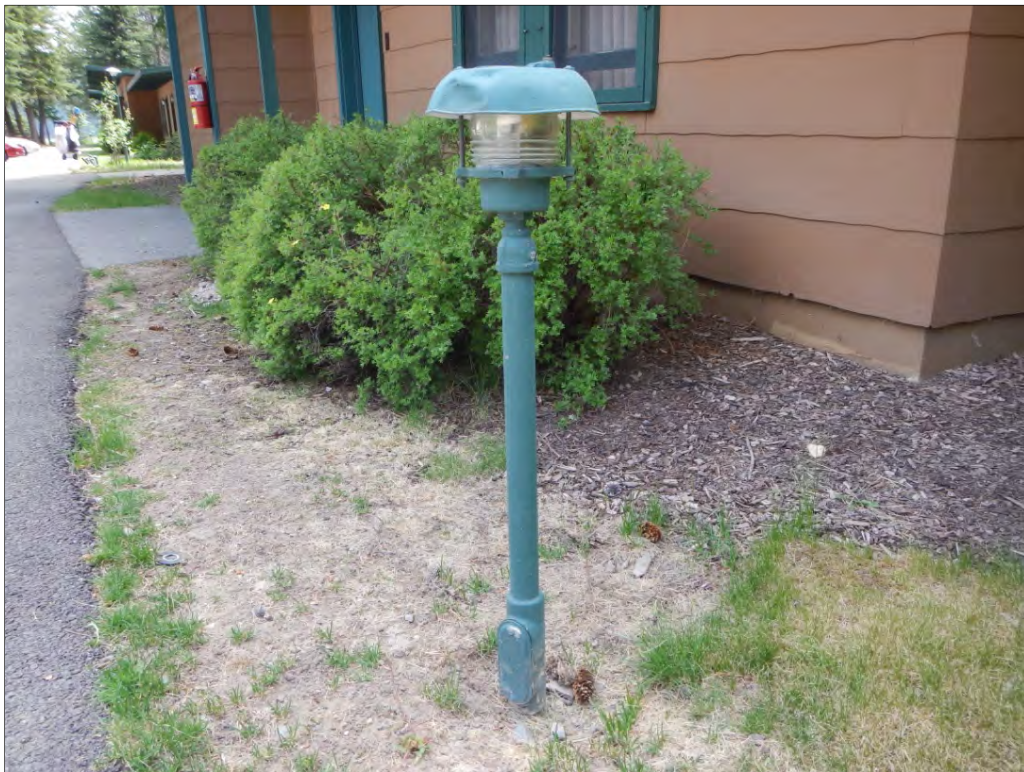
Photograph 2.24. Example of path light along a walkway in the south guest cottage area, facing southwest, 2014 (Source: Logan Simpson).

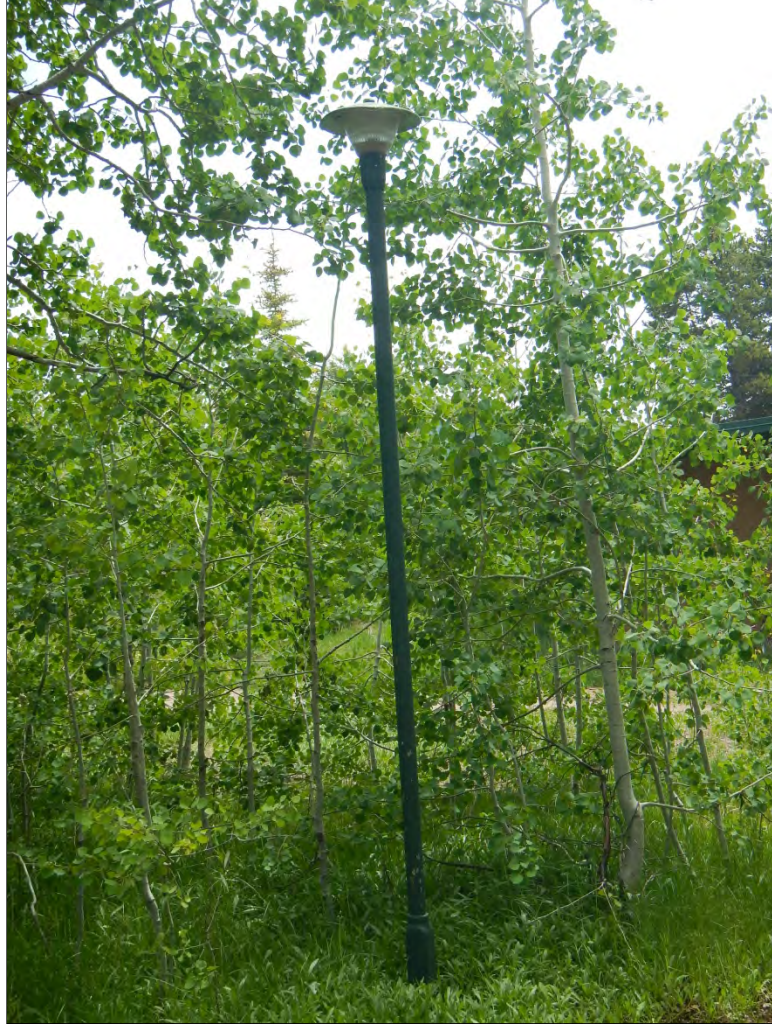
Photograph 2.25. Streetlight along Dorm Street, facing southeast, 2014  
(Source: Logan Simpson).

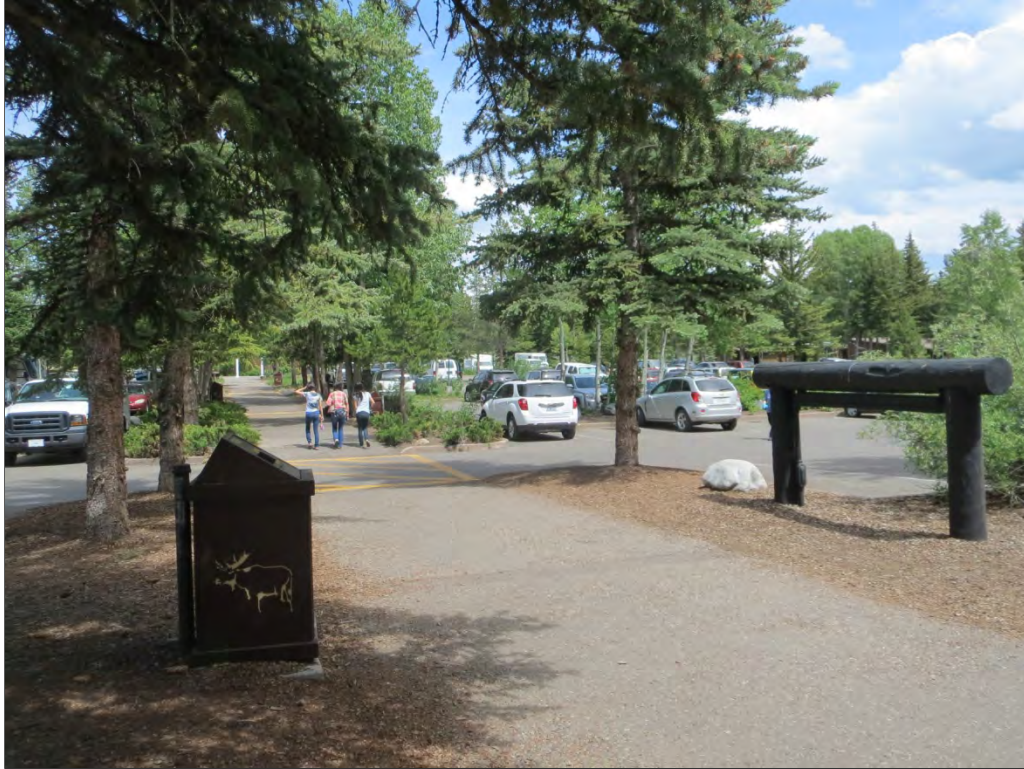
Photograph 2.26. Animal-resistant trash cans along the central pedestrian walkway in the main parking lot, facing northeast, 2014 (Source: Logan Simpson).

Various types of animal-resistant trash cans are present in numerous locations throughout the lodge landscape. These receptacles are typically brown or green in color and contain either a single can or two cans depending on their location (see Photograph 2.11; Photograph 2.26; and Photograph 2.27). Receptacles for the disposal of cigarettes are also present in several areas around the lodge and in the employee housing area.

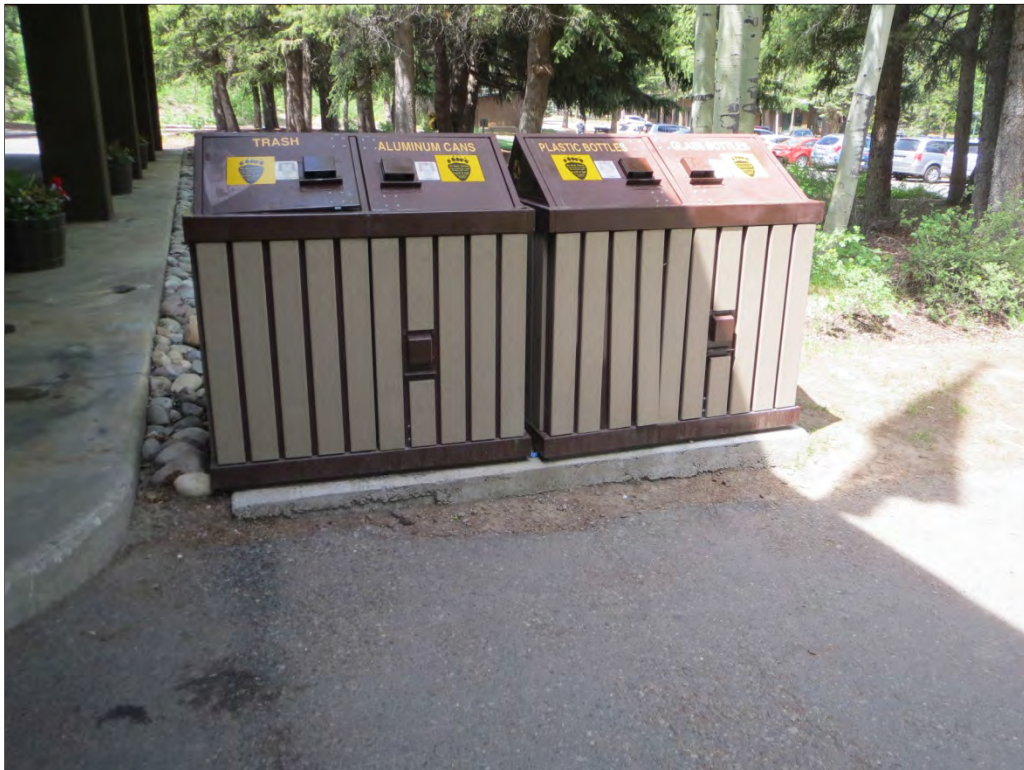
Photograph 2.27. Animal resistant trash cans to the east of the porte-cochere, facing northwest, 2014 (Source: Paula Reed, Paula S. Reed and Associates, Inc.).

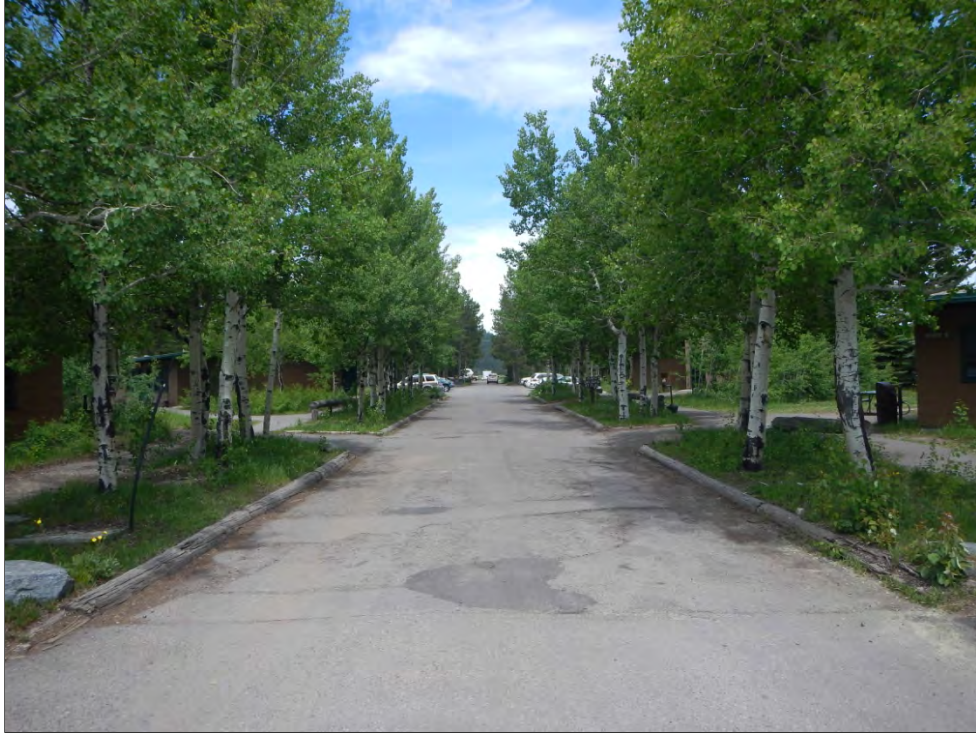
Photograph 2.28. View of Dorm Street, taken in 2014 (Source: Logan Simpson). Note the pavement condition and dense aspen colony.

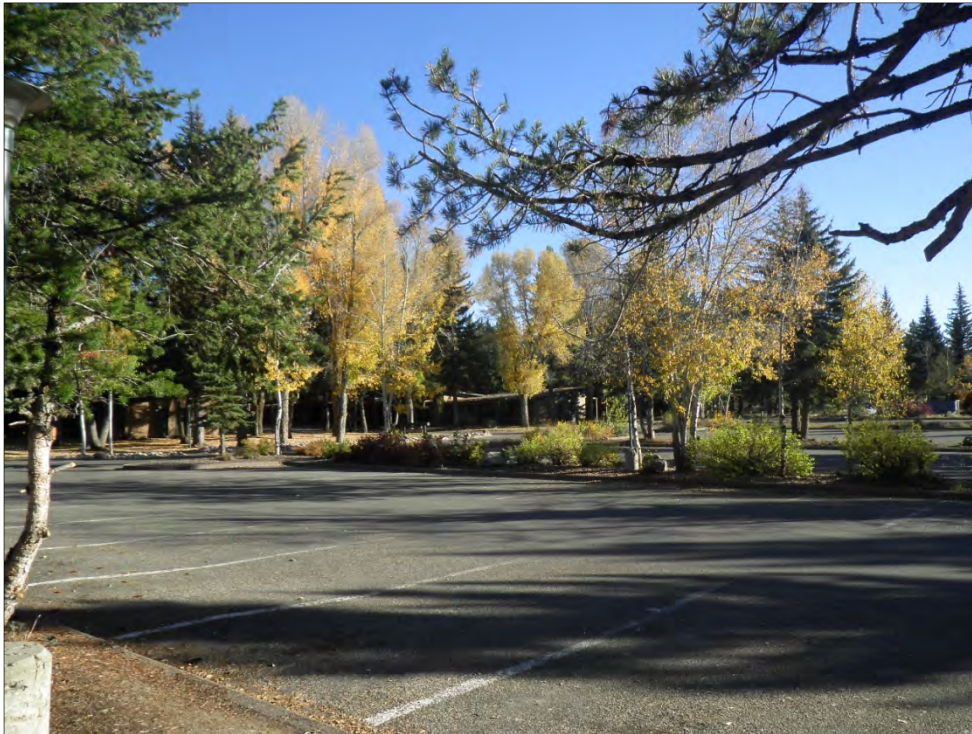
Photograph 2.29. View of main parking area, taken in 2014 (Source: Logan Simpson). Note the combination planting of trees, shrubs, and grasses in parking islands.

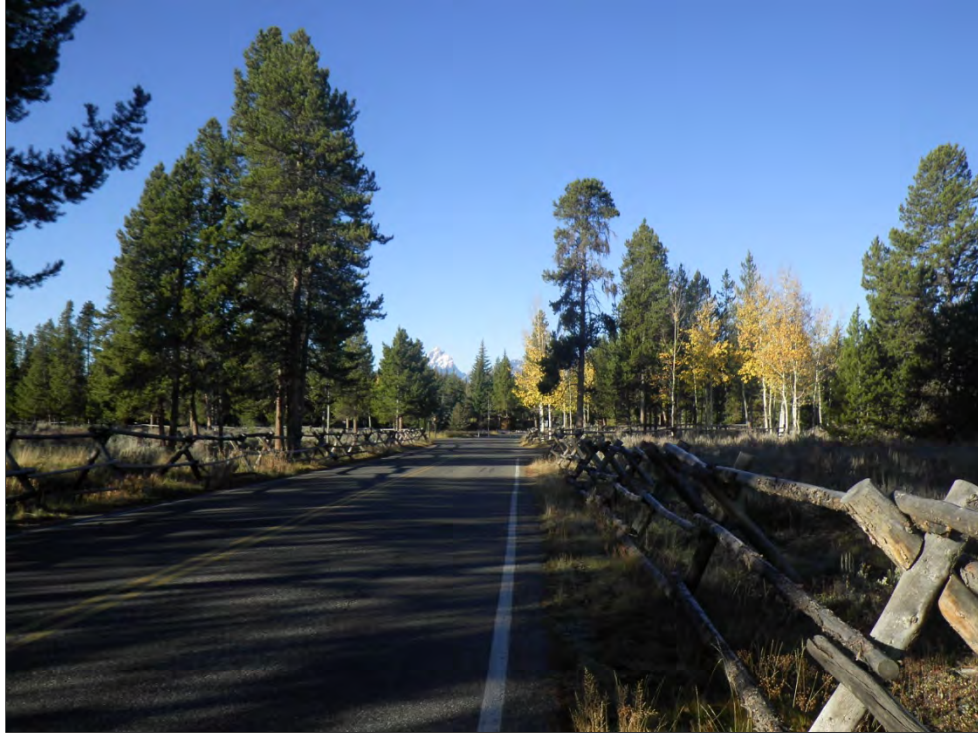
Photograph 2.30. View of main parking area from entry road, taken in 2014 (Source: Logan Simpson.). Note the mature vegetation screening the parking lot from view.

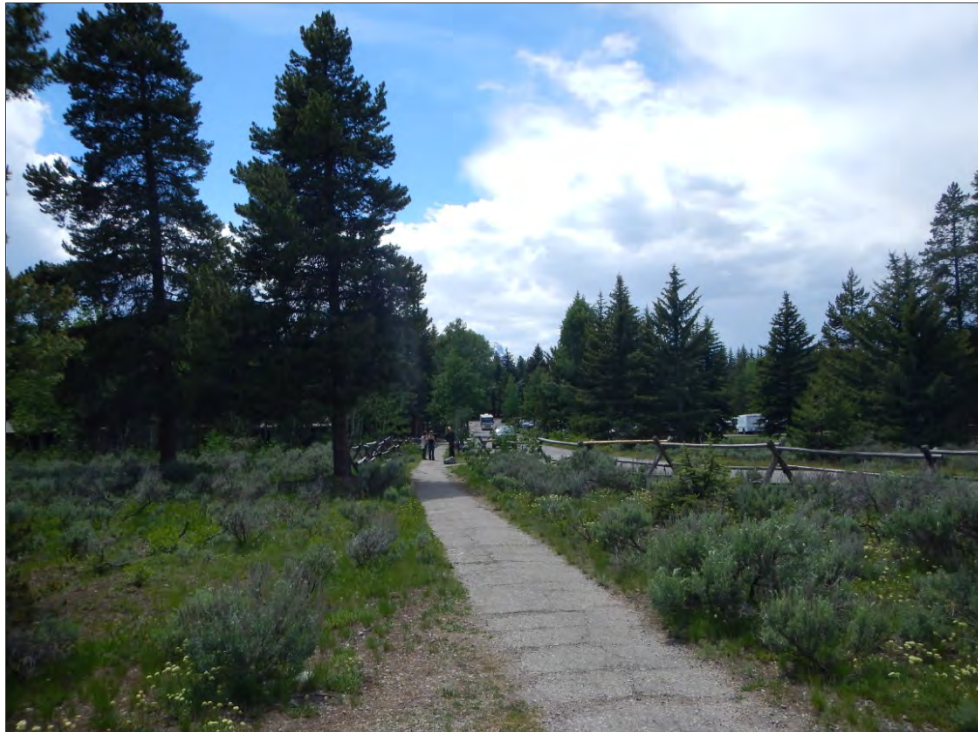
Photograph 2.31. View of parking area (right), taken in 2014 (Source: Logan Simpson). Note the mature plantings screening the parking lot from view.

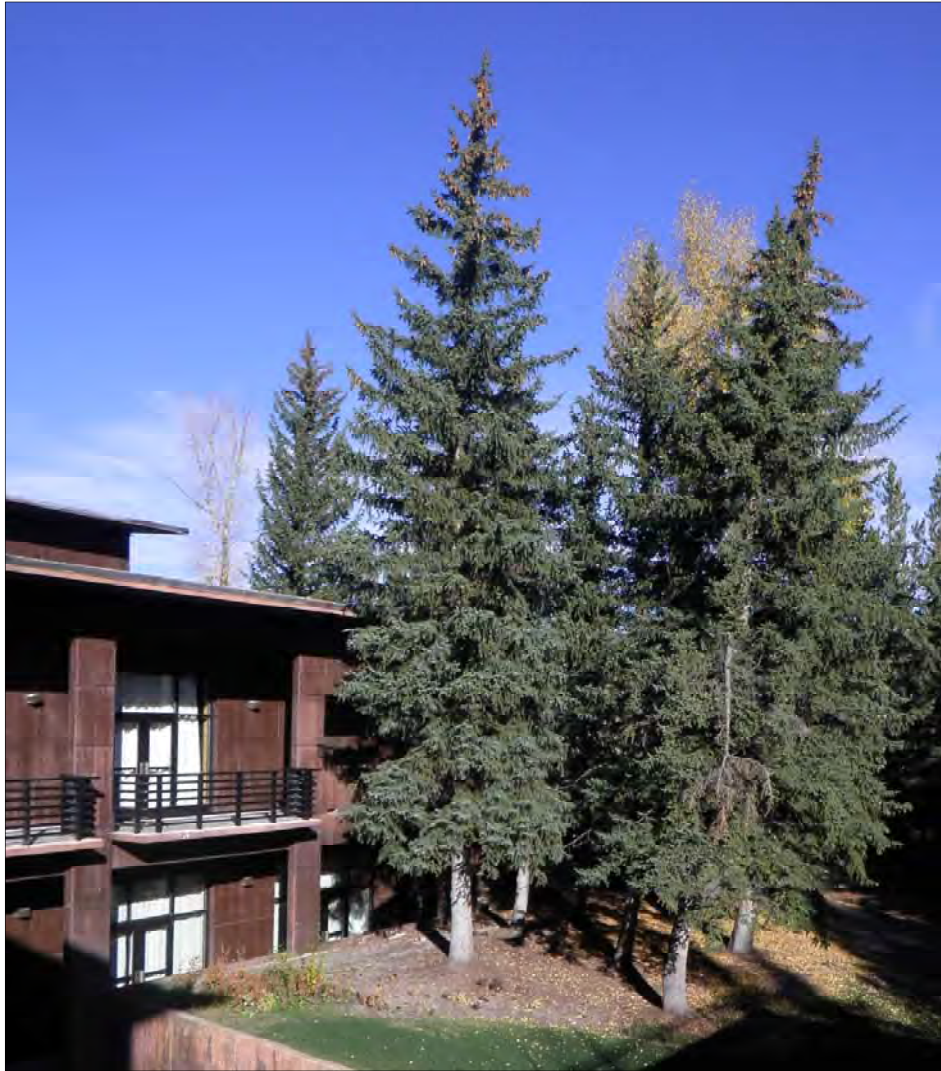
Photograph 2.32. View of mature trees encroaching on the lodge, taken in 2014 (Source: Logan Simpson).

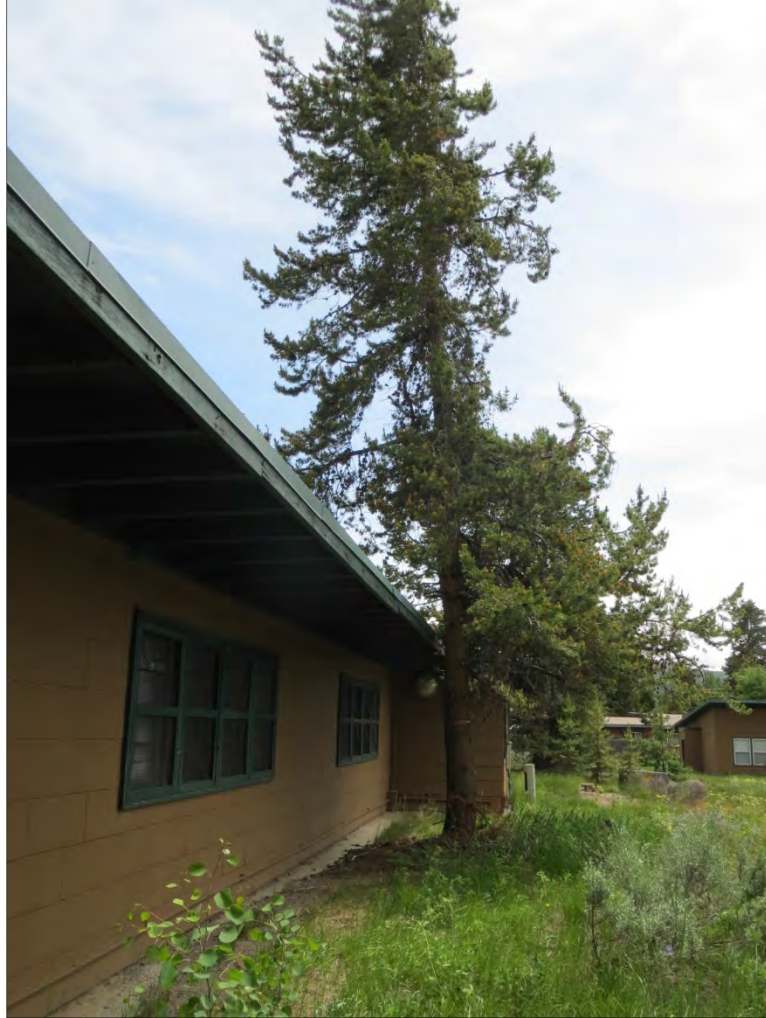
Photograph 2.33. View of mature tree encroaching on employee housing unit, taken in 2014 (Source: Logan Simpson).

that the view of the lodge from the main parking area—and vice versa—is almost totally obscured, just as the designers intended. However, the maturation of these trees has come at a cost. Aspen, which spread through rhizomatous rootstock, have colonized throughout parking islands, along sidewalks and near buildings, resulting in pavement buckling and damage to underground utilities. In other areas, evergreen trees have encroached onto buildings, damaging roofs and exterior siding (Photograph 2.33).

The 2007 CLI documented aspens and chokecherries growing on the slope to the west of the terrace and observed the potential for these elements to interfere with highly significant views of the Tetons, if not maintained by the GTLC staff (Photographs 2.33 and 2.34). NHL nomination co-author and member of the Logan Simpson project team Paula Reed noted during the 2014 field inventory that this trimmed hedge of aspens and chokecherries was not present in 2002. The 2014 field inventory and a review of aerial photography also found that the aspen and chokecherries are likely benefitting from nearby irrigation of the lawn and ornamental plantings; the majority of the remaining west-facing slope, where irrigation is not present, is dominated by sagebrush-grass communities.

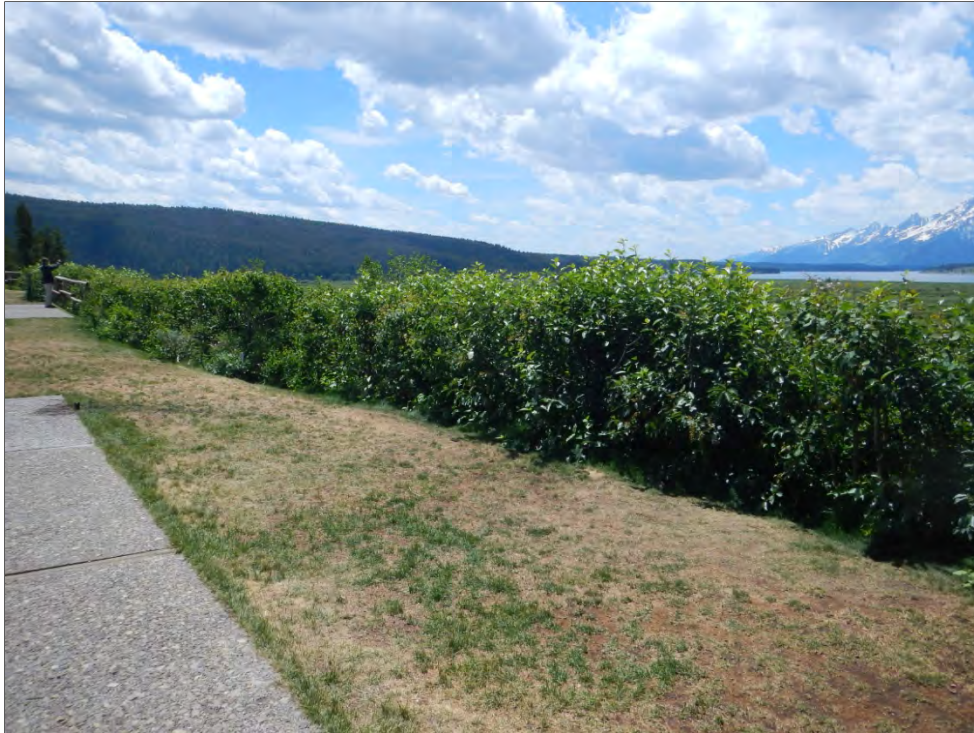
Photograph 2.34. View of promenade, taken in 2014 (Source: Logan Simpson).

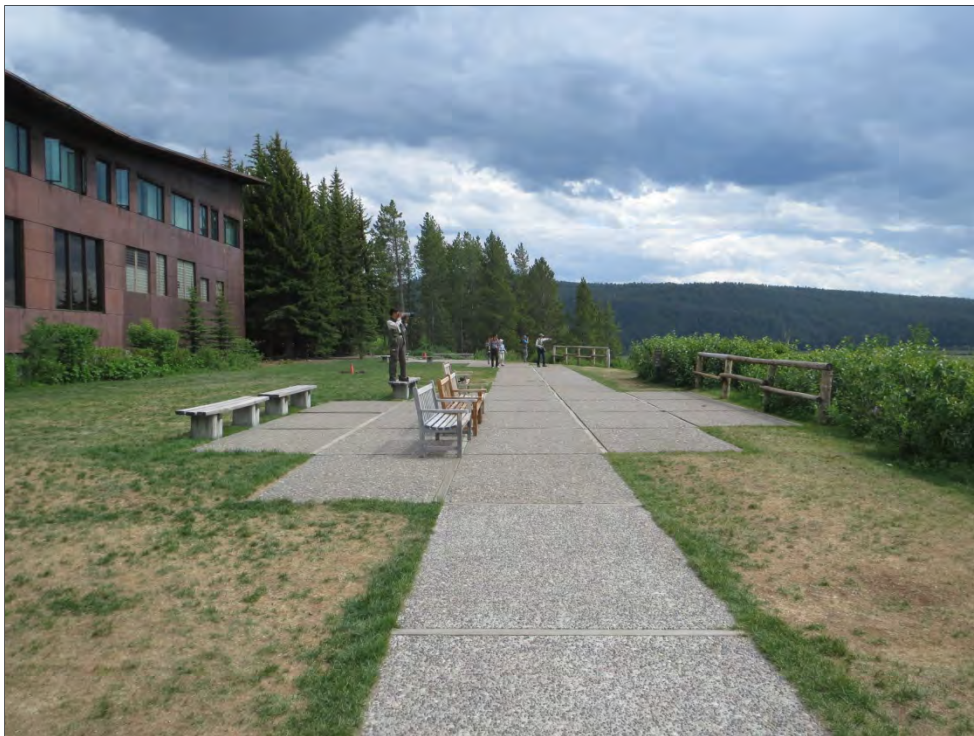
Photograph 2.35. View of promenade, taken in 2014 (Source: Logan Simpson). Note the visitor standing on a bench to overcome the aspen/chokecherry hedge to photograph the view.

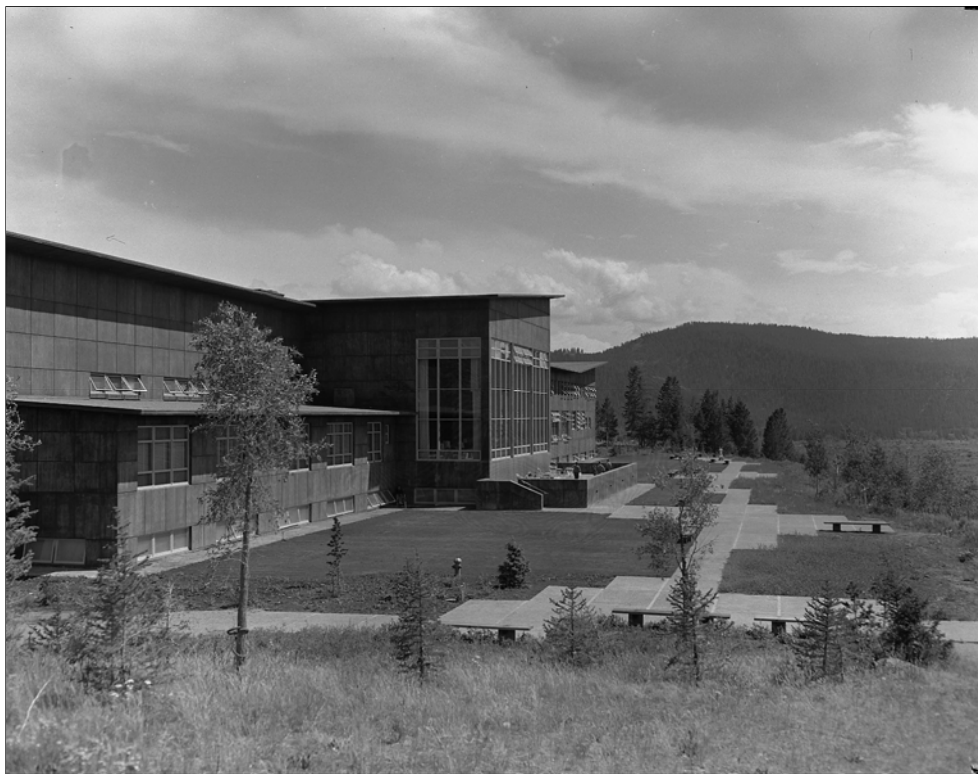
Photograph 2.37. View of the lodge from the bottom of Lunch Tree Hill, ca. 1960s (Source: GRTE Archives, Jackson Lake Lodge).

The view from the top of Lunch Tree Hill is also considered a contributing feature of the district's cultural landscape. It was on top of this hill that John D. Rockefeller, Jr. picnicked with his family and made his decision to purchase acreage for the purpose of expanding GRTE so the view from that location could be preserved for perpetuity. Today, visitors electing to hike the short trail to its summit experience a nearly 360-degree-view of the Teton Range, Willow Flats, and Jackson Lake to the west and the surrounding rolling wooded hills to the east. As the highest point within the district, Lunch Tree Hill also provides an overview of the lodge complex to the south and east. The view of the lodge from the top of the hill is somewhat diminished by the maturation of natural vegetation and native shade and ornamental trees planted along the northern edge of the promenade (Photograph 2.36). The diminished view is particularly evident at the base of the trail where the lodge is completely shielded from view. The diminishment over time is particularly evident when historic and modern photographs taken from the same vantage point along the trail are compared (Photograph 2.37 and Photograph 2.38).

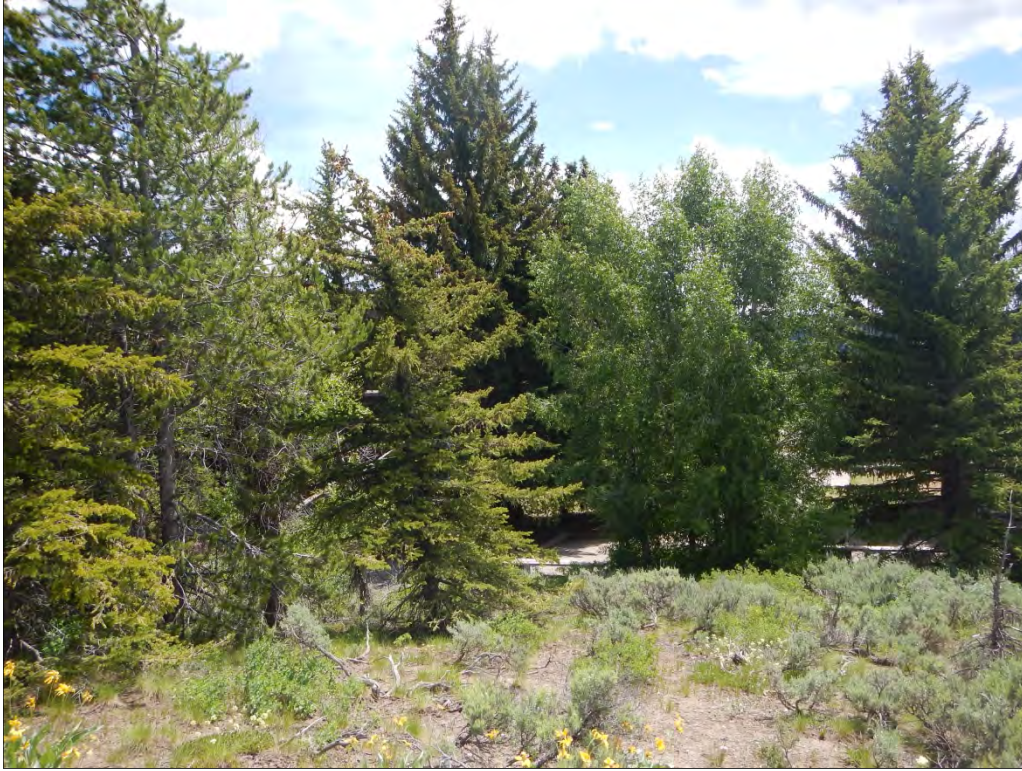
Photograph 2.38. Modern view of the lodge from the bottom of Lunch Tree Hill, facing south, 2014 (Source: Logan Simpson).

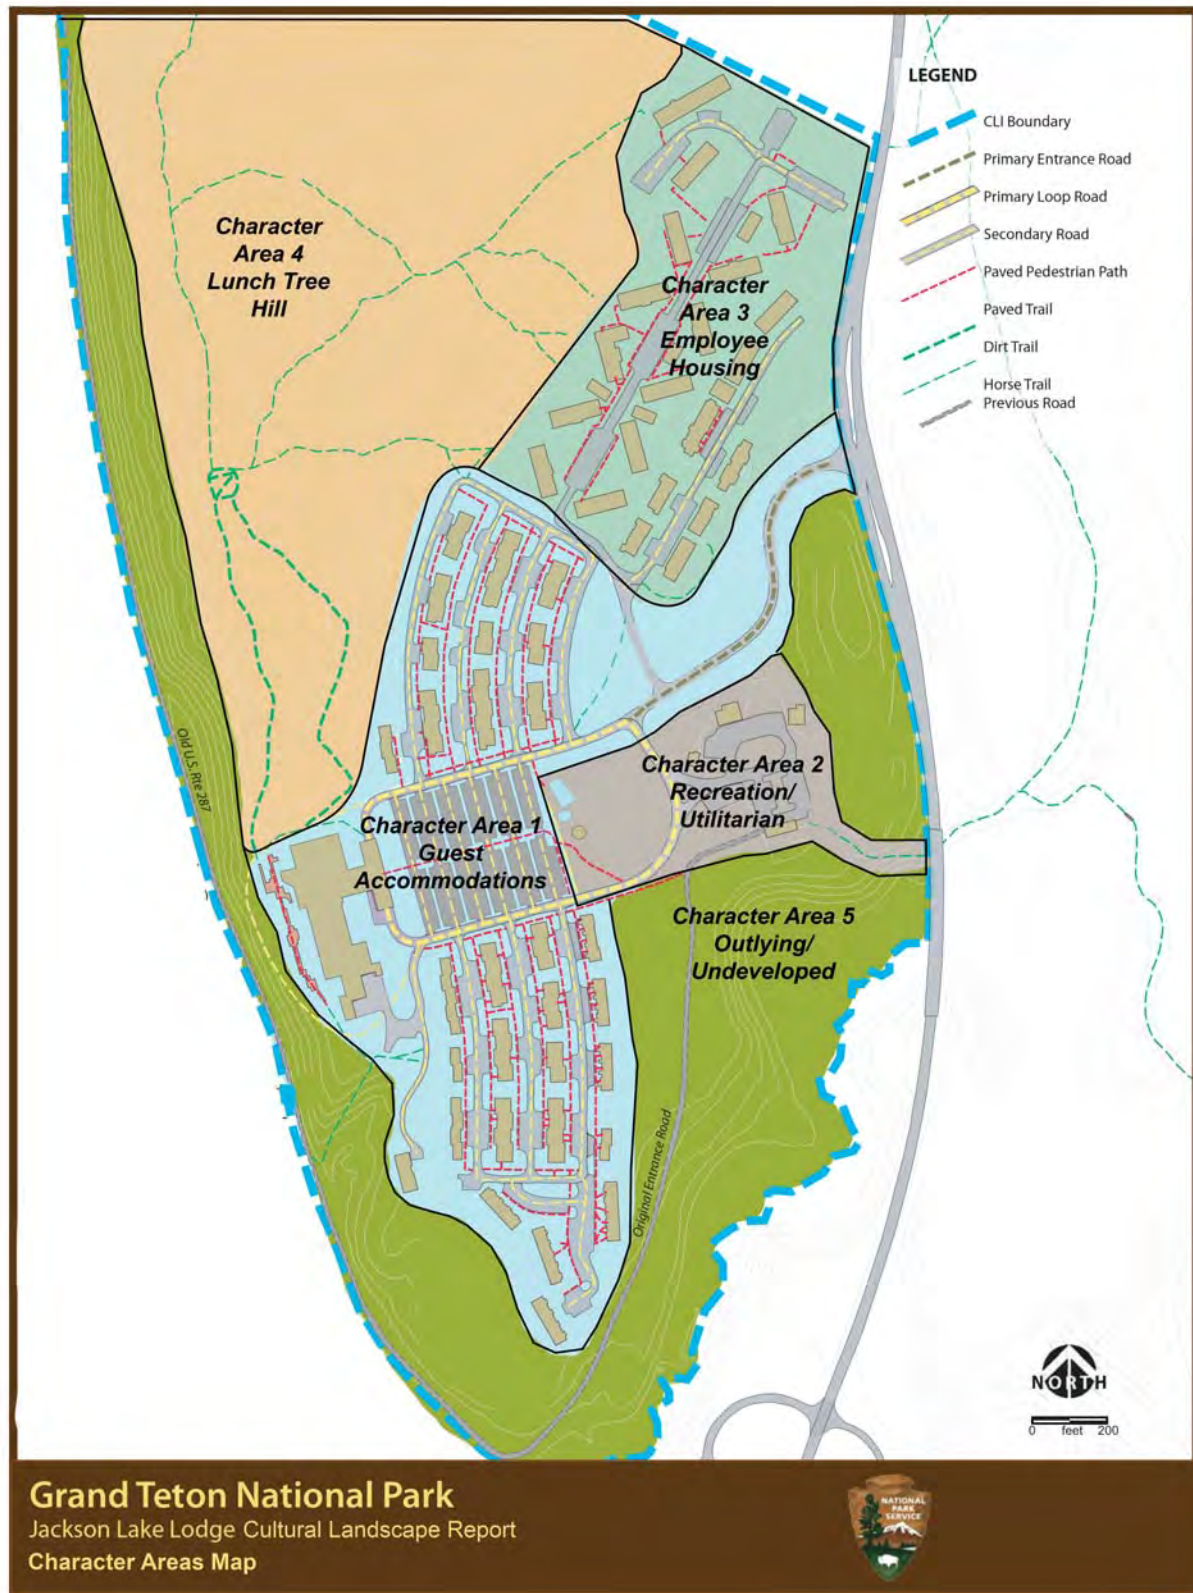
Figure 2.4. Character areas developed by Logan Simpson for the district's cultural landscape.

Treatment guidelines and tasks in the following chapters are organized by five character areas based on function and their shared design characteristics—guest accommodations, recreation/utilitarian, employee housing, Lunch Tree Hill, and outlying/undeveloped (Figure 2.4). These character areas are adapted from those developed in the 2007 CLI for the district (CLR Part 1), which identified seven clusters (e.g., lodge, north guest cottages, south guest cottages, Lunch Tree Hill, employee housing, service station/corral, and pool complex) within the landscape (Figure 2.5). For the purposes of this document, the north and south guest cottage and lodge clusters have been combined into a single area—the guest accommodations character area—due to their similar function. The pool complex and service station/corral clusters have also been consolidated into the recreation/utilitarian character area for the same reason. The Lunch Tree Hill character area has remained the same. Descriptions of the six character areas are included below.

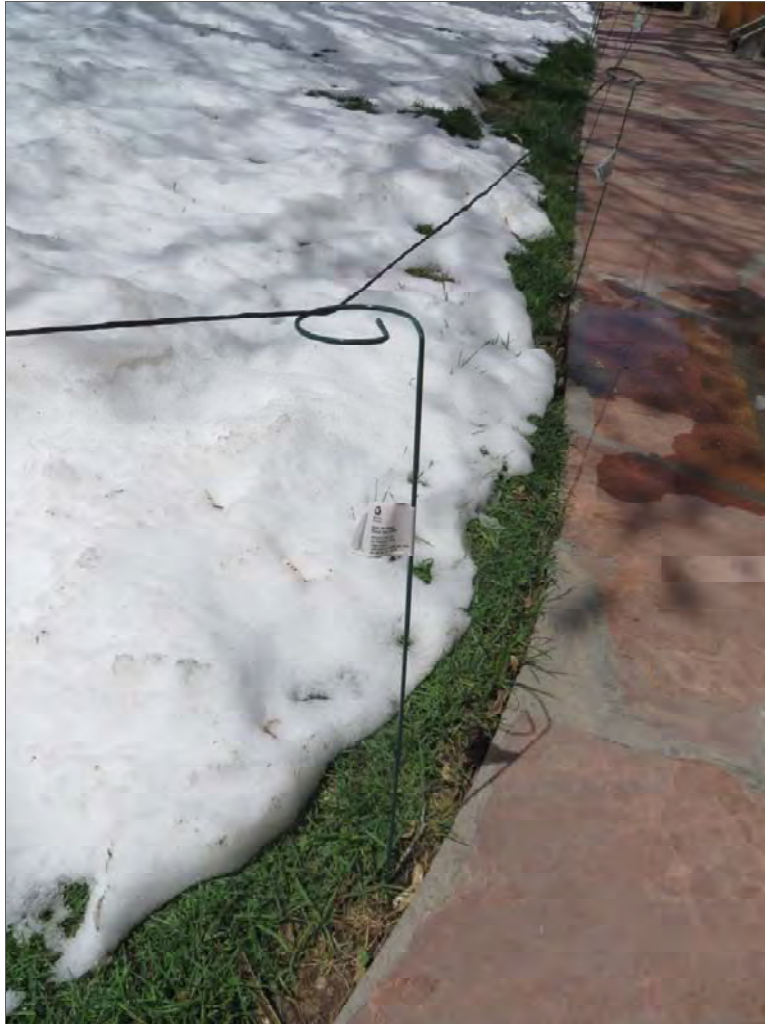
Photograph 4.1. Example of temporary low fencing to deter foot traffic, 2014 (Source: Logan Simpson).

- In more confined locations, such as the promenade, consider implementing temporary, non-intrusive low fencing to deter foot traffic (Photograph 4.1).
