CULTURAL LANDSCAPE REPORT FOR THE  
JACKSON LAKE LODGE  
NATIONAL HISTORIC LANDMARK DISTRICT  
PART II: TREATMENT  
FINAL REPORT

Jackson Lake Lodge  
National Historic Landmark District  
Cultural Landscape Report

Final  
June, 2015

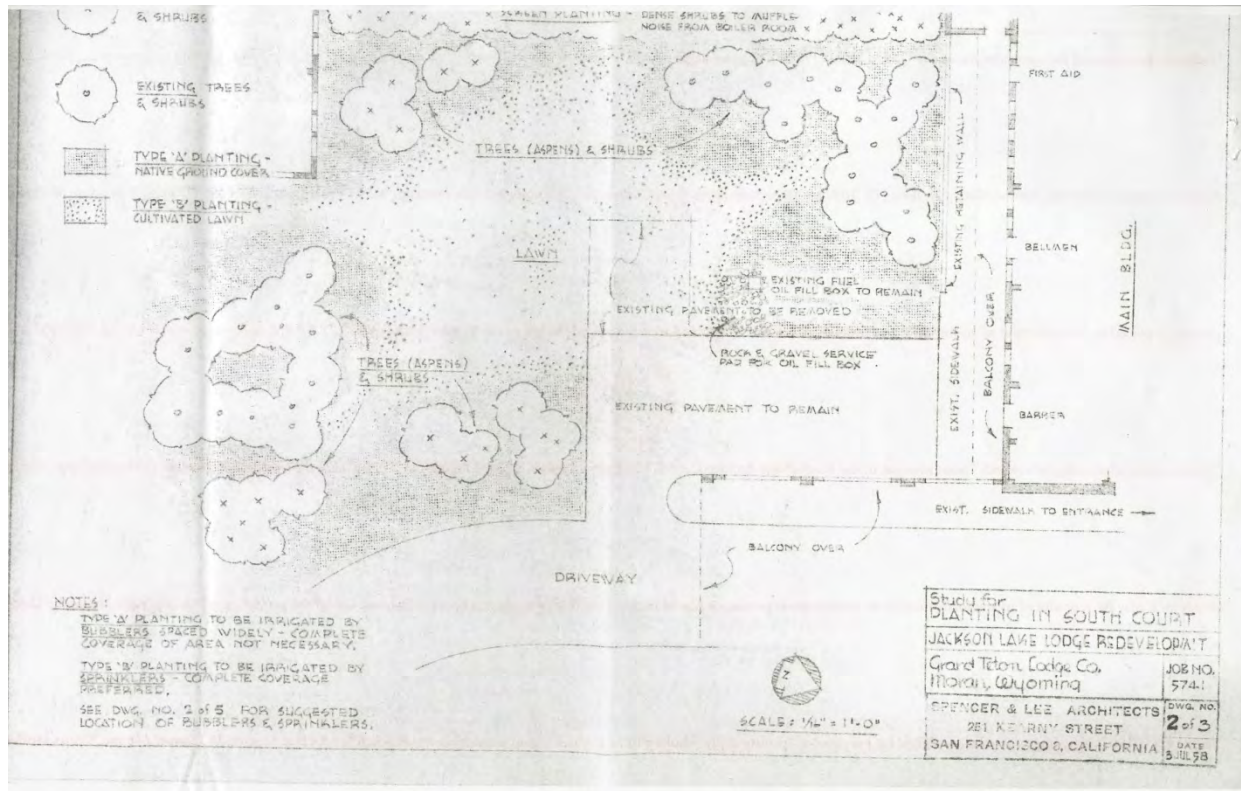
Figure 4.1. Scan of the South Court of the Jackson Lake Lodge in the 1957 Spencer and Lee landscape plans. Note no species list and quantity information are provided and the singular plant symbol drawn in a uniform scale to delineate proposed trees and shrubs (Image provided by NPS). Complete plans can be found in Appendix 1B.

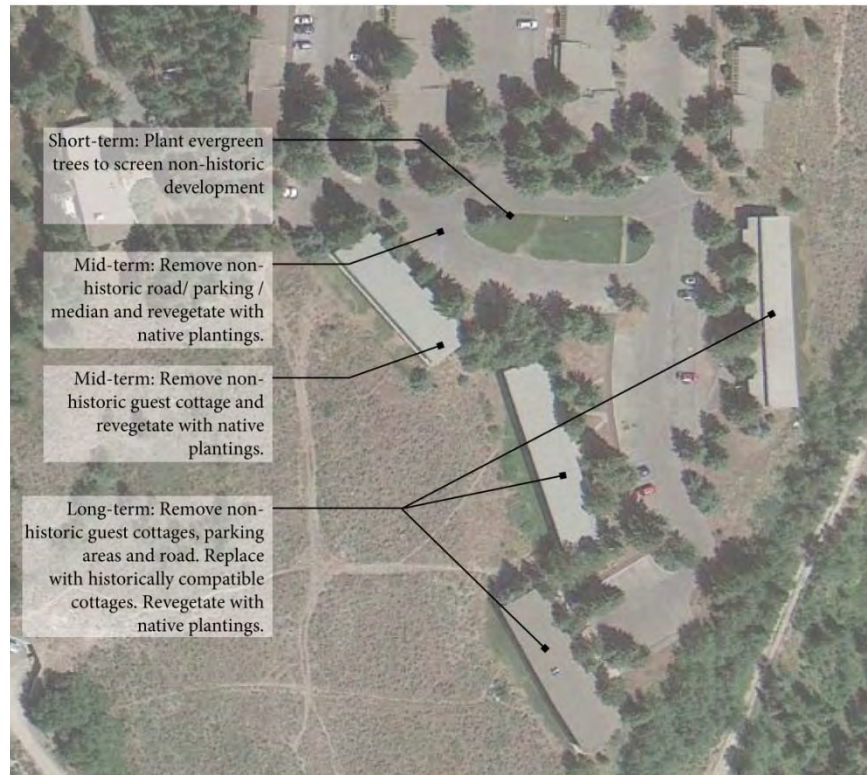
Figure 4.3. Treatment recommendations for south guest cottage area. See Figure 4.2 for recommended plant list. (Source: Logan Simpson).

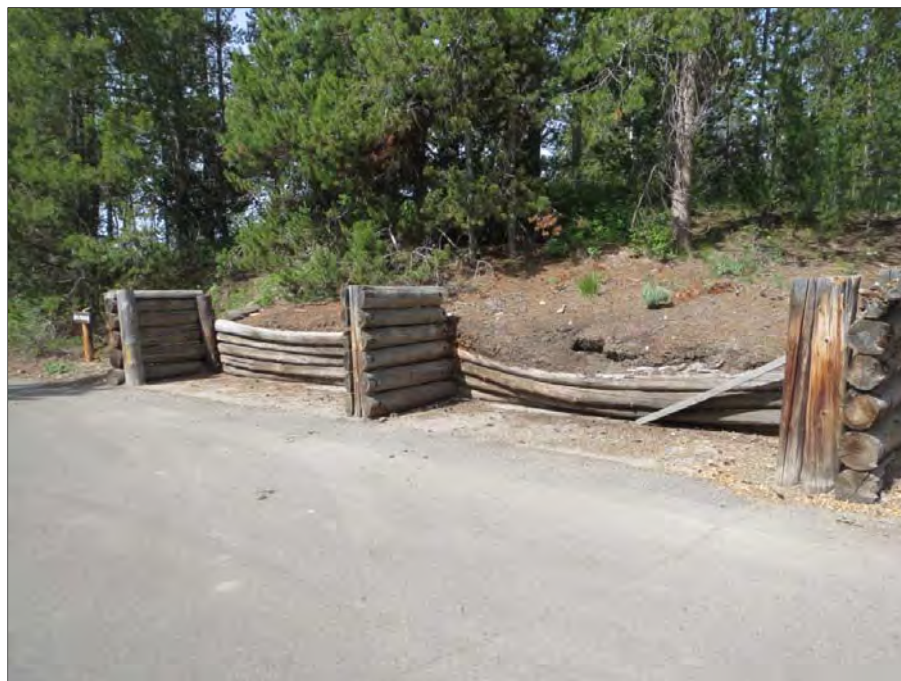
Photograph 4.2. Non-historic firewood storage units no longer in use, facing west-southwest, 2014 (Source: Logan Simpson).

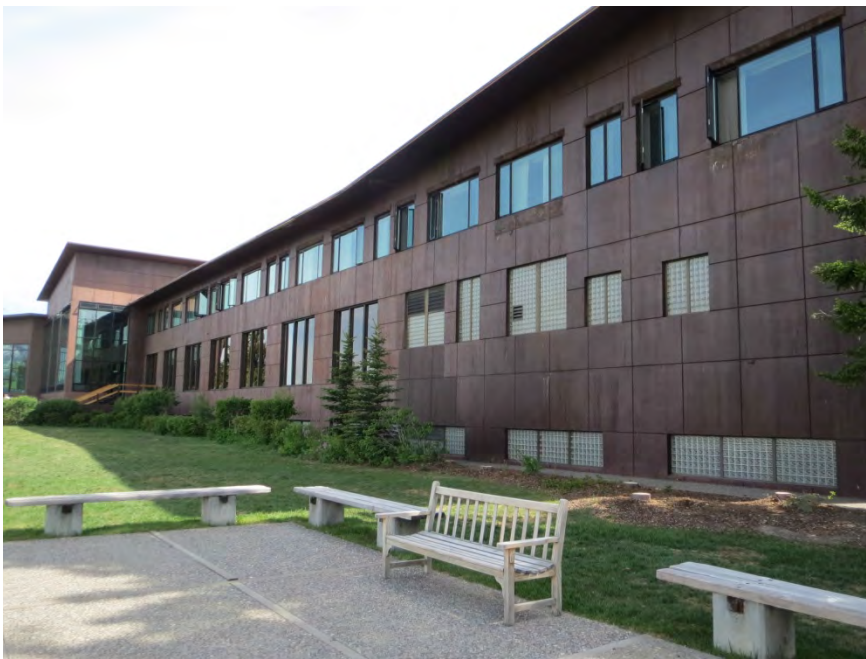
Photograph 4.3. Non-historic landscaping along the lodge's western foundation (Source: Logan Simpson).

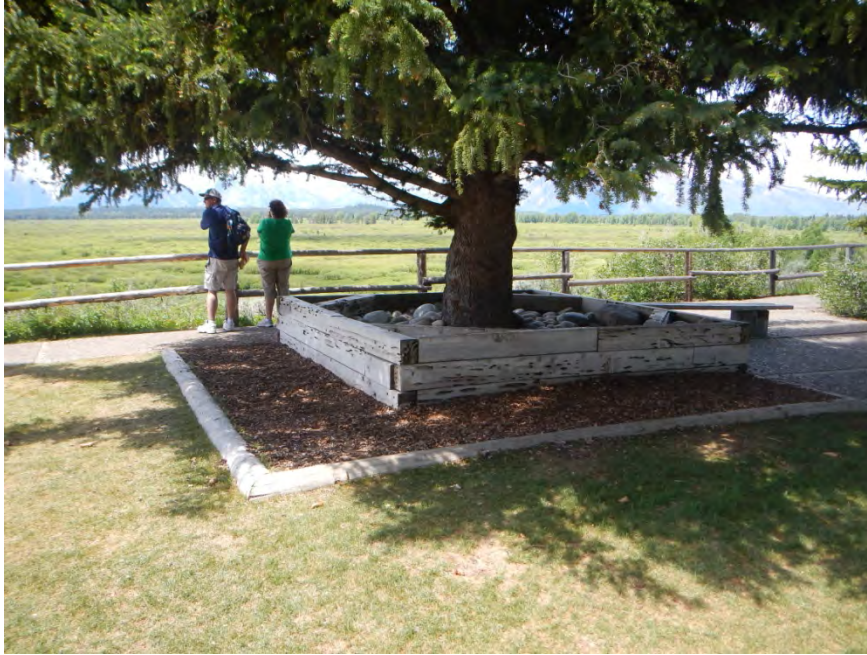
Photograph 4.4. Non-historic landscape planters at viewing terrace (Source: Logan Simpson).

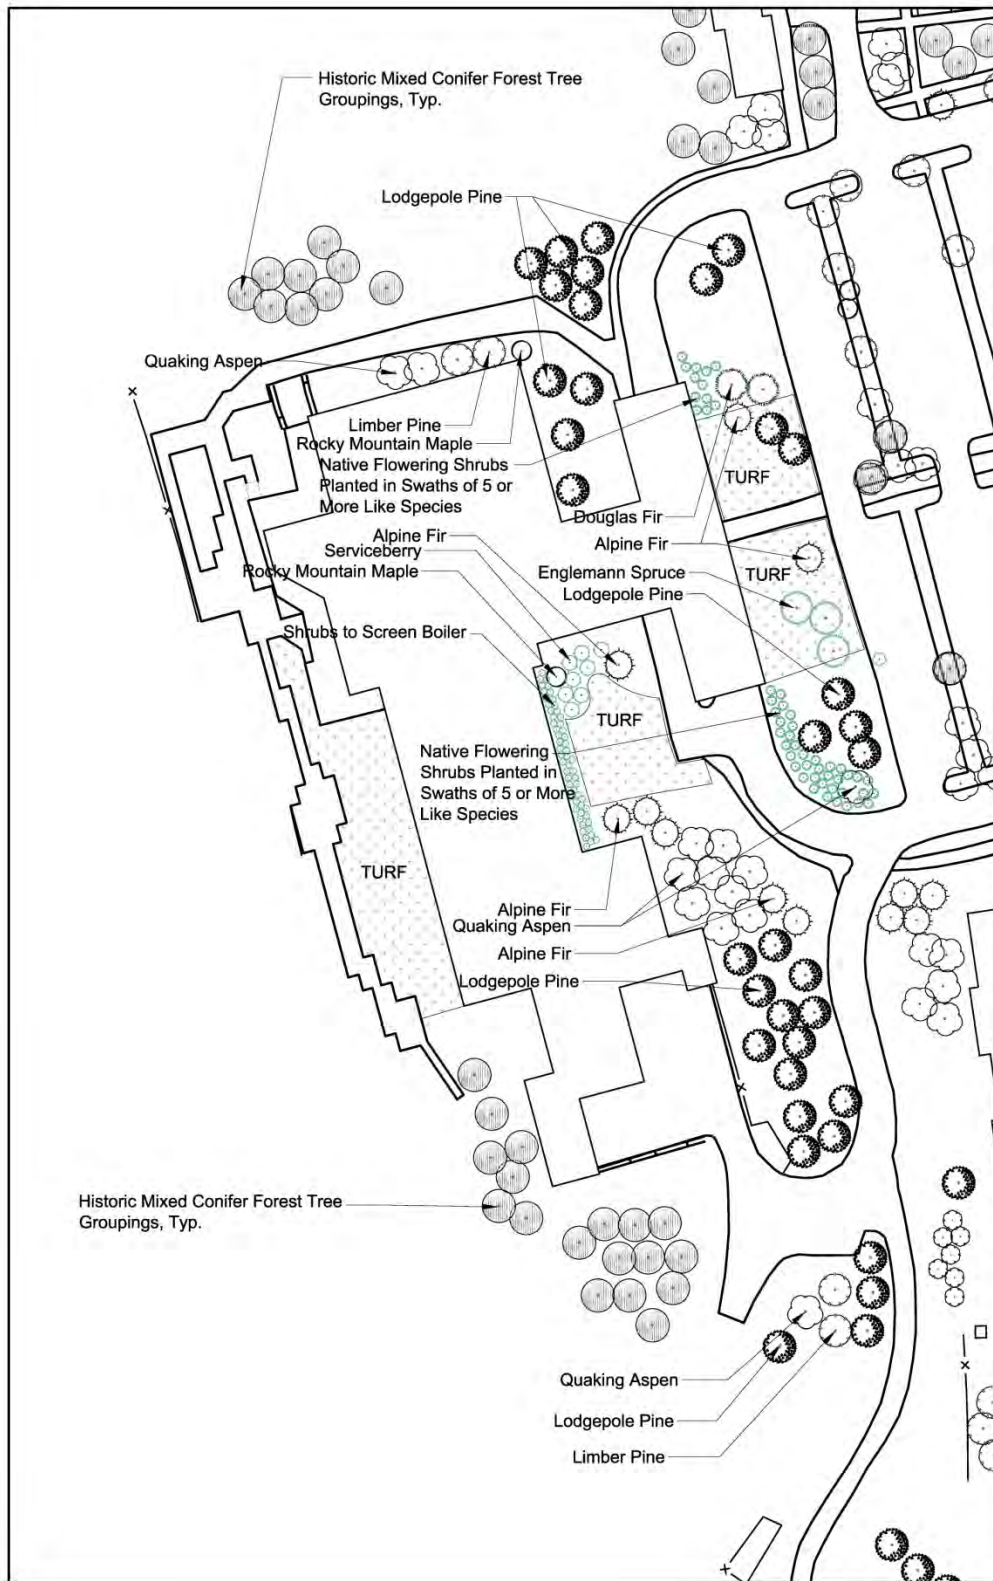
Figure 4.4. Recommended vegetation treatment for the lodge, based on 1957 Spencer and Lee historic landscape plans and historic photography, with turf areas called out. See Figure 4.2 for the recommended plant list (Source: Logan Simpson).

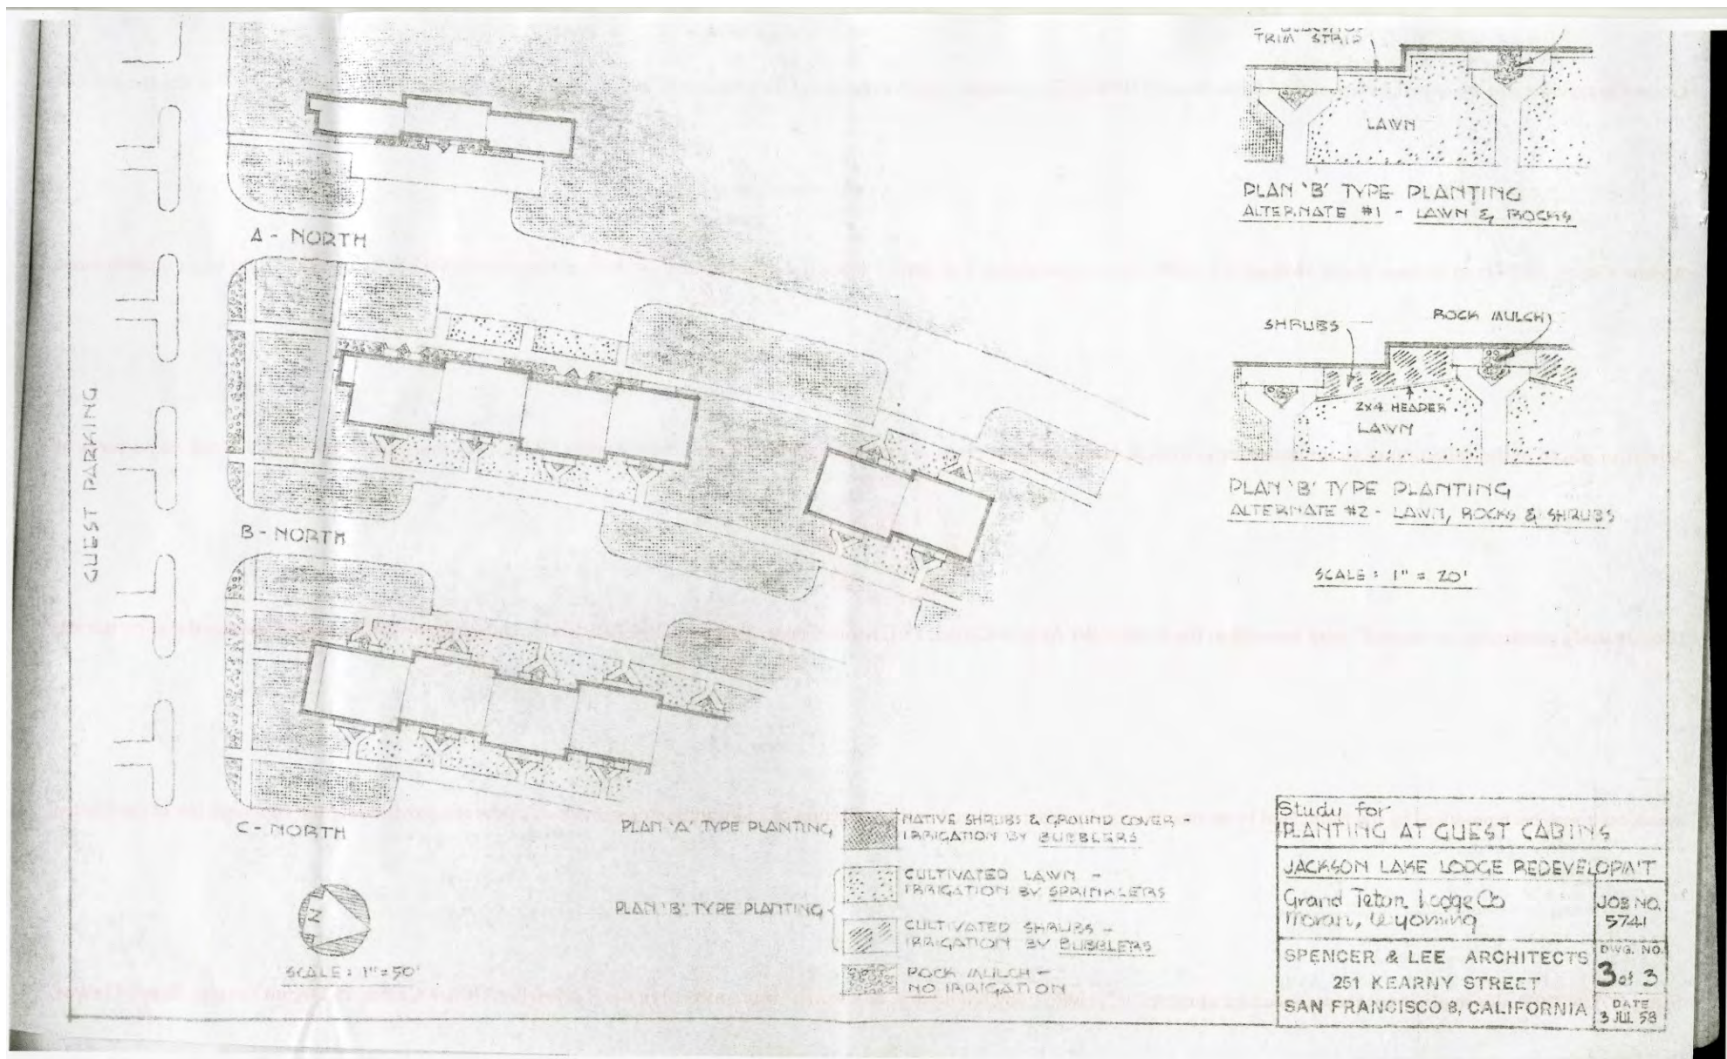
Figure 4.6. Recommended groundcover and two shrub planting schemes for Guest Cottage areas which is based on 1957 Spencer and Lee historic landscape plans and historic photography. Note turf areas denoted on plan. See Figure 4.3 for recommended species list. (Source: NPS).

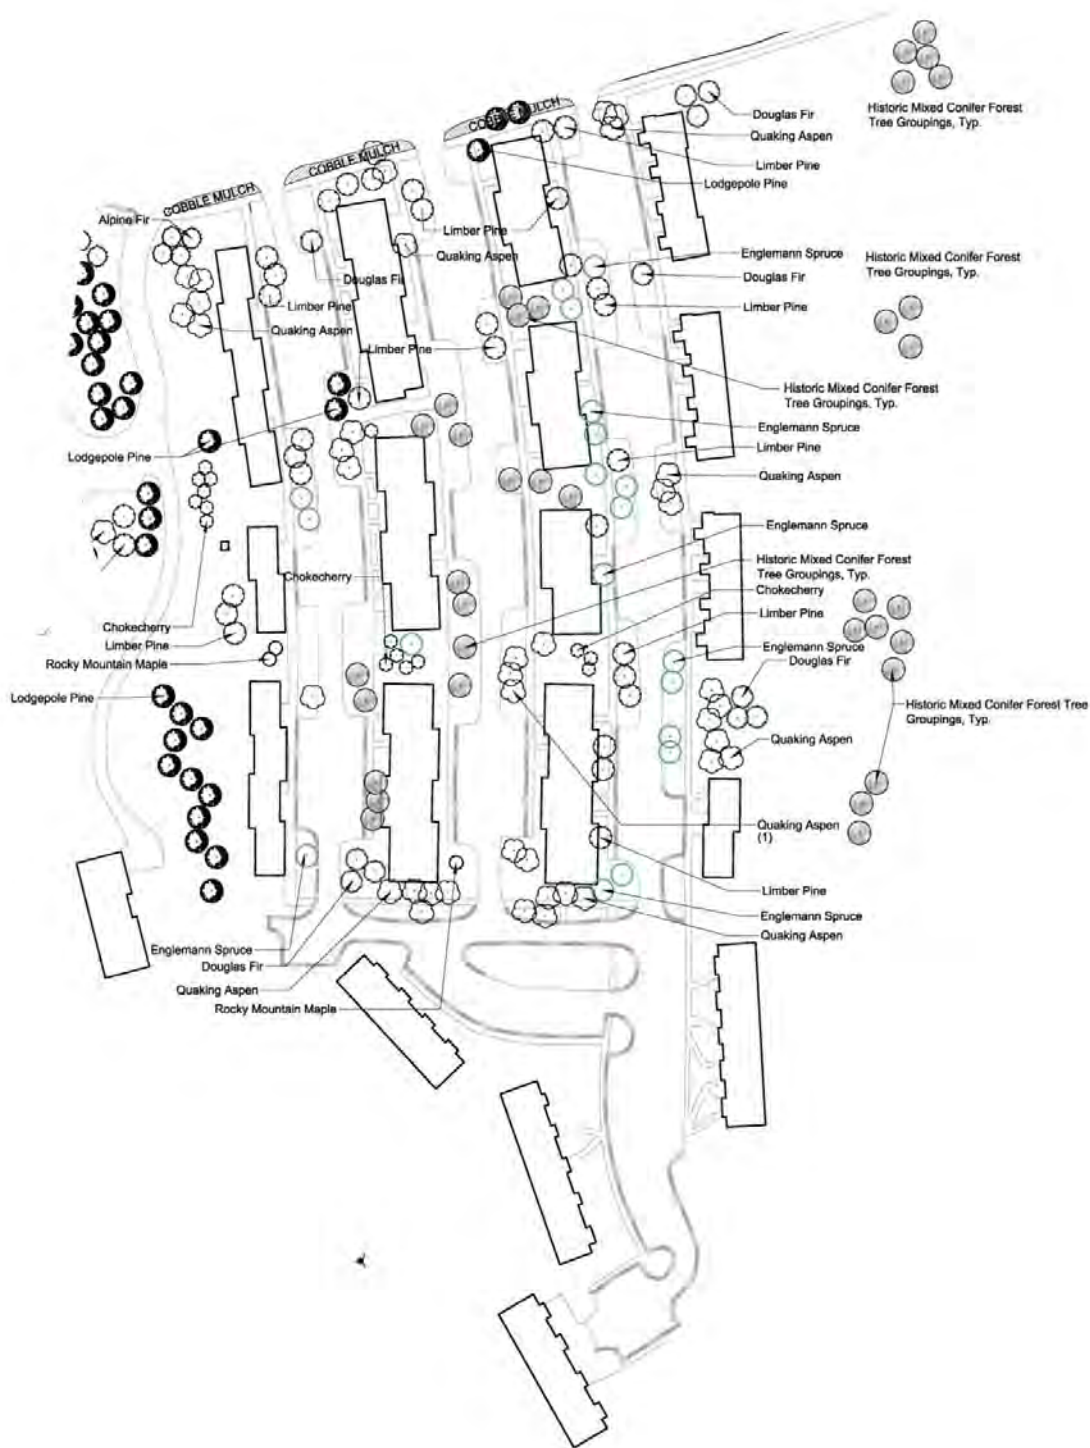
Figure 4.7. Recommended tree landscape treatment for the South Guest Cottages which is based on historic photography and the 1955 Mortimore and Wirth landscape plan, as no information related to trees or shrubs was provided in Spencer and Lee landscape plans. Refer to Figure 4.3 for recommended areas to be screened and Figure 4.2 for recommended plant list. Refer to Figure 4.6 for historic groundcover and shrub plantings. (Source: Logan Simpson).

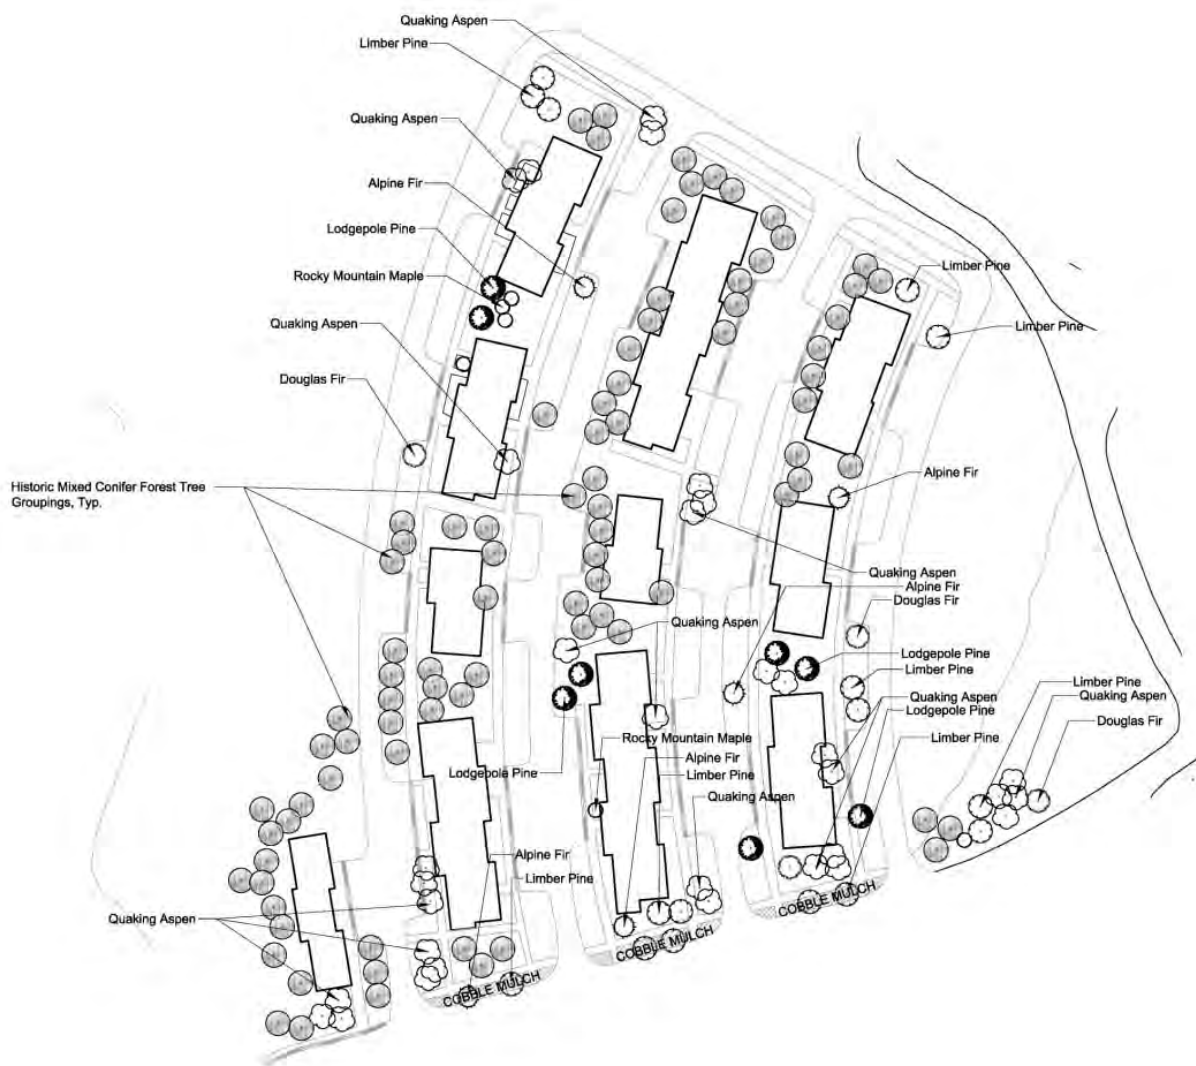
Figure 4.8. Recommended tree landscape treatment for the North Guest Cottages which is based on historic photography and the 1955 Mortimore and Wirth landscape plan, as no information related to trees was provided in Spencer and Lee landscape plans. Refer to Figure 4.6 for historic groundcover and shrub plantings (Source: Logan Simpson).

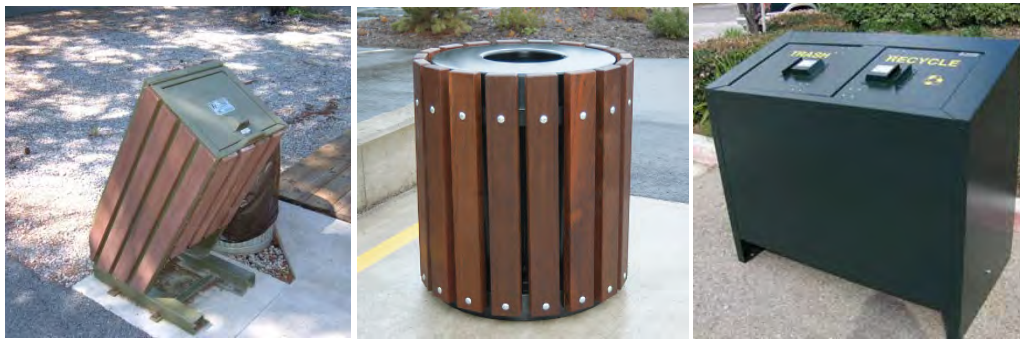
Figure 4.9. Above are some examples of possible trash receptacle styles. (Source: Chicagomutual.org; FairWeather Site Furnishings; globalindustrial).

- Trash receptacles should be uniform in style throughout the site in a single, unobtrusive style. See Figure 4.9 for examples of styles.
- Replace wood curbs with exposed aggregate concrete curb and gutter stained to match historic curb and gutter throughout the district, such as the one at the southern end of the south guest cottage area.

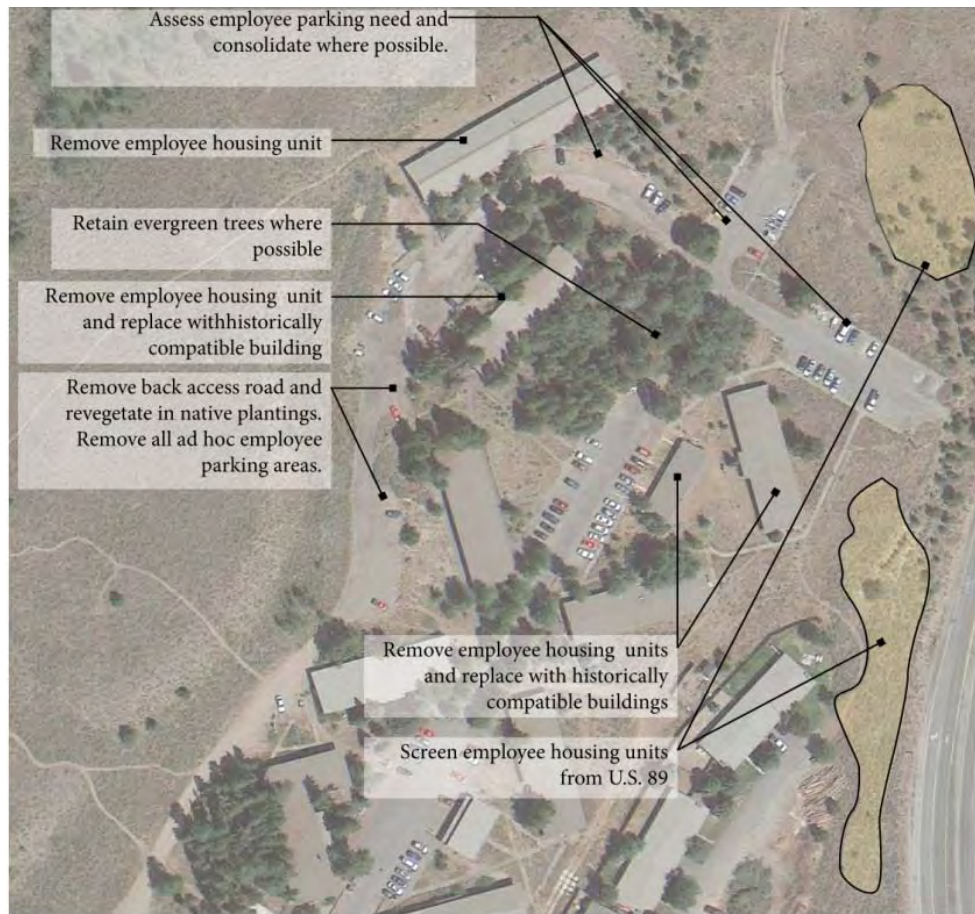
Figure 4.10. Treatment recommendations for the employee housing area. (Source: Logan Simpson).

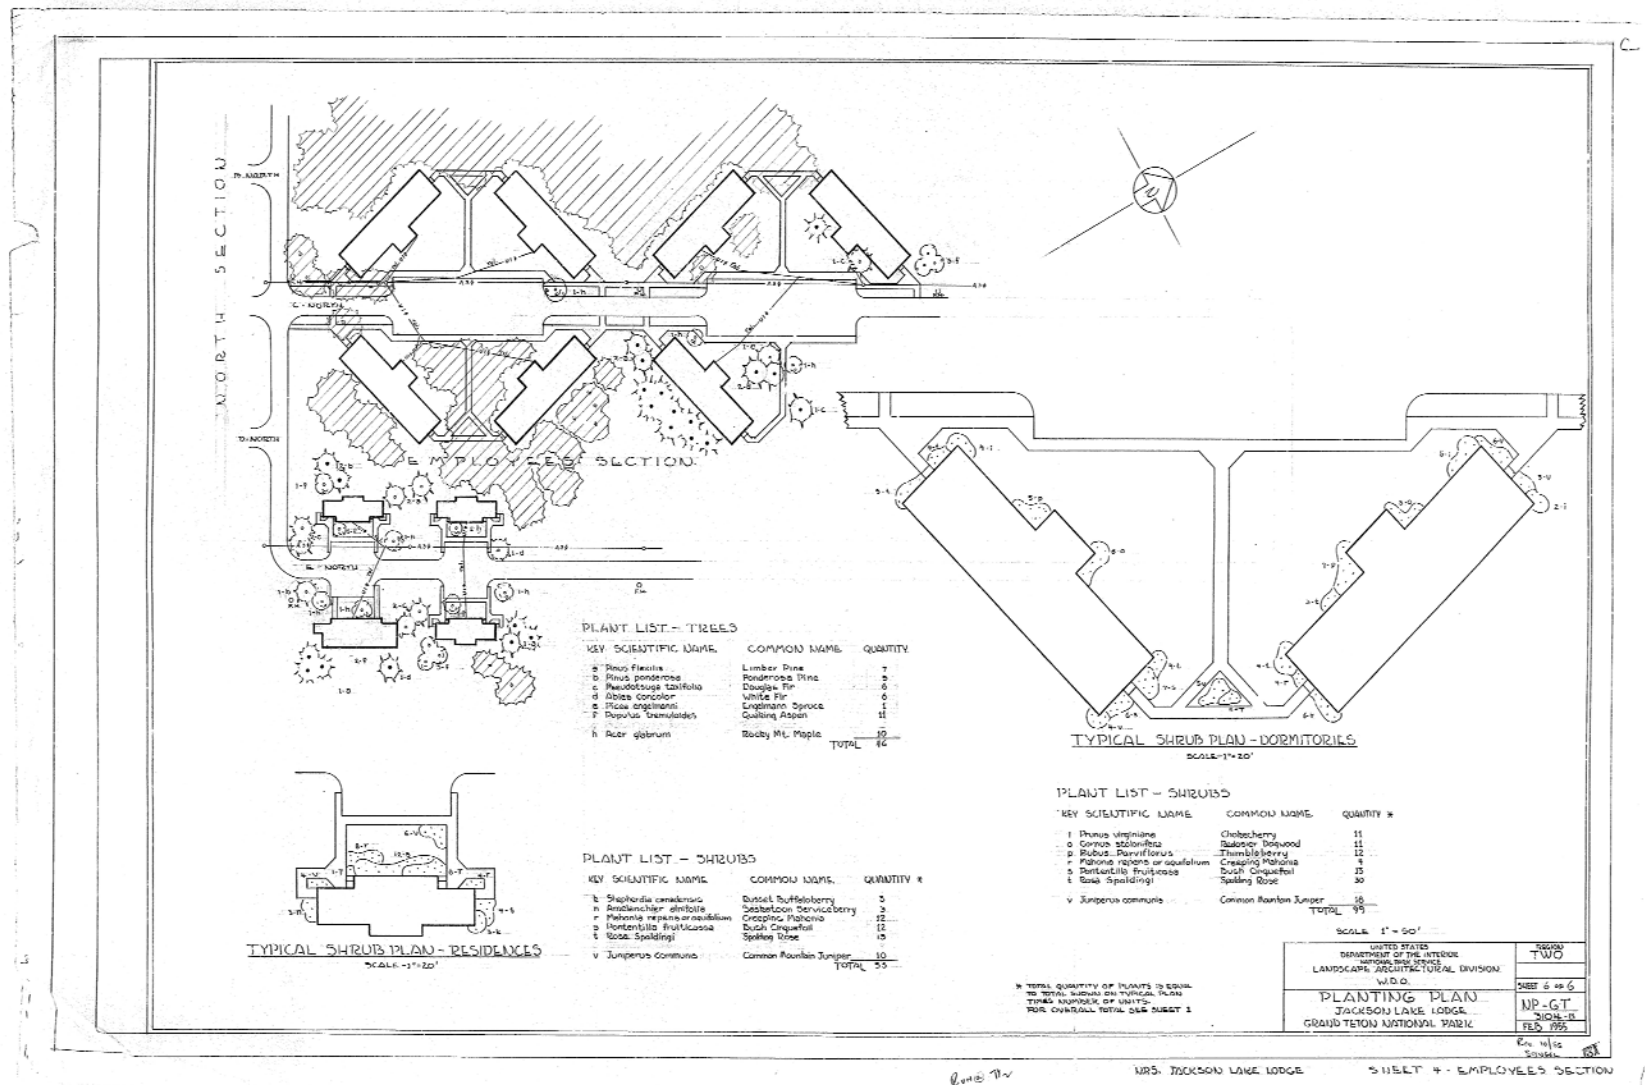
Figure 4.11. Recommended landscape treatment for the employee housing area which follows the 1955 Mortimore and Wirth landscape plan, as no information is provided in the 1957 Spencer and Lee plan. See Figure 4.3 for species selection and Figure 4.10 for recommended areas to screen. Note hatch pattern delineates historic lodgepole pine trees preserved during construction (Source: NPS).

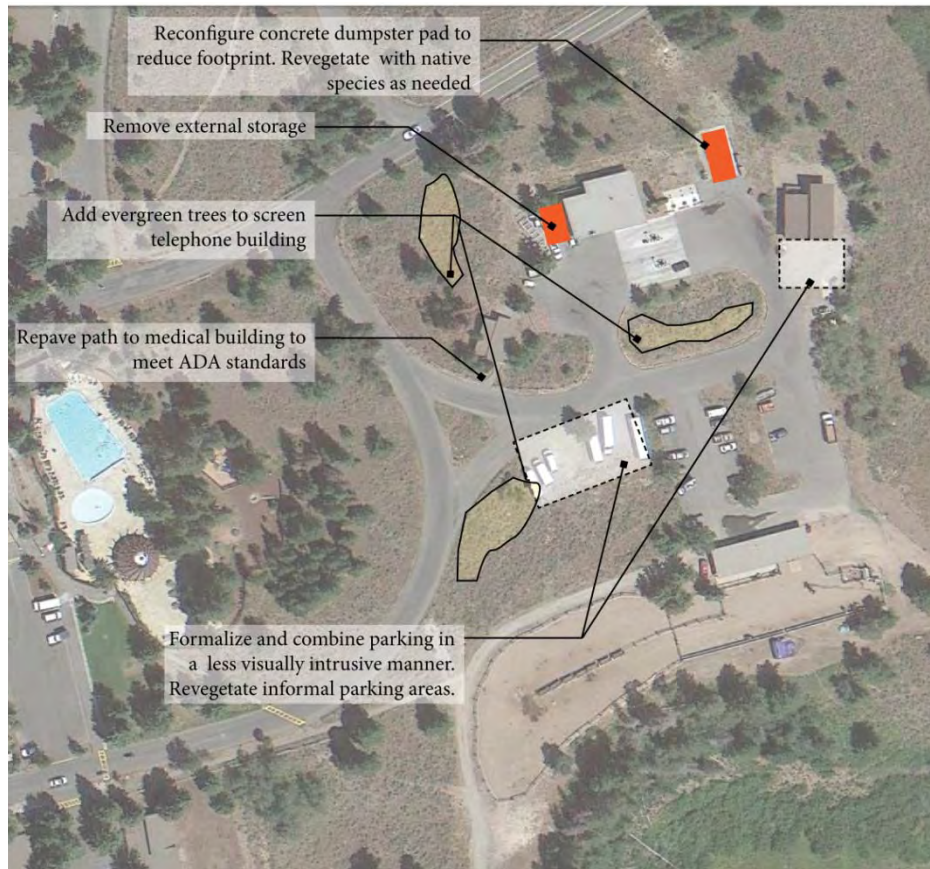
Figure 4.12. Treatment recommendations for the recreation/ utilitarian character area (Source: Logan Simpson).

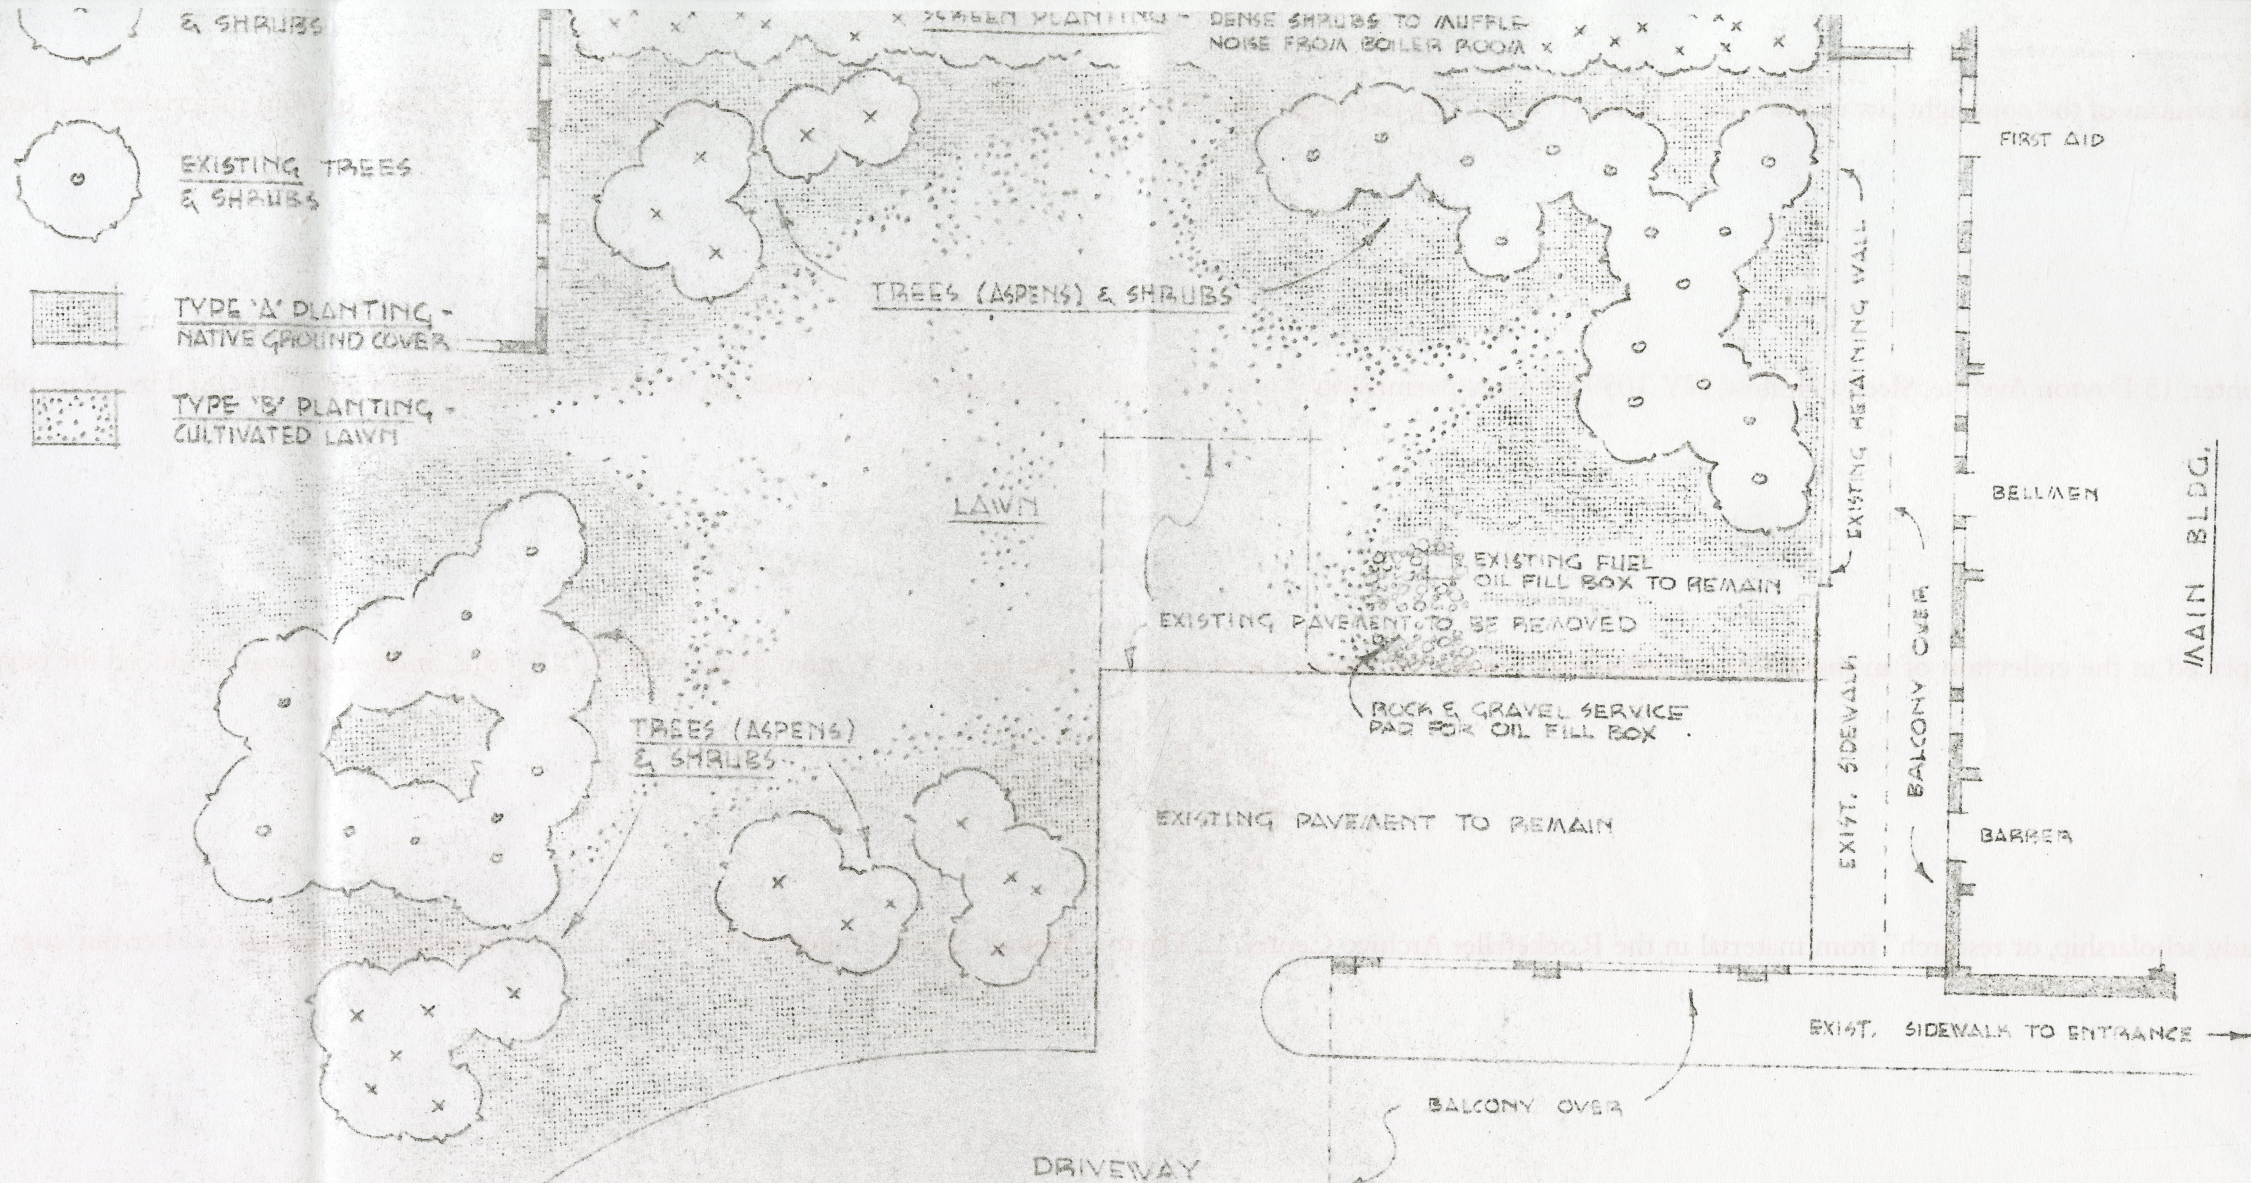
TYPE 'B' PLANTING -  
CULTIVATED LAWN

TYPE 'A' PLANTING TO BE IRRIGATED BY BUBBLERS SPACED WIDELY - COMPLETE COVERAGE OF AREA NOT NECESSARY.

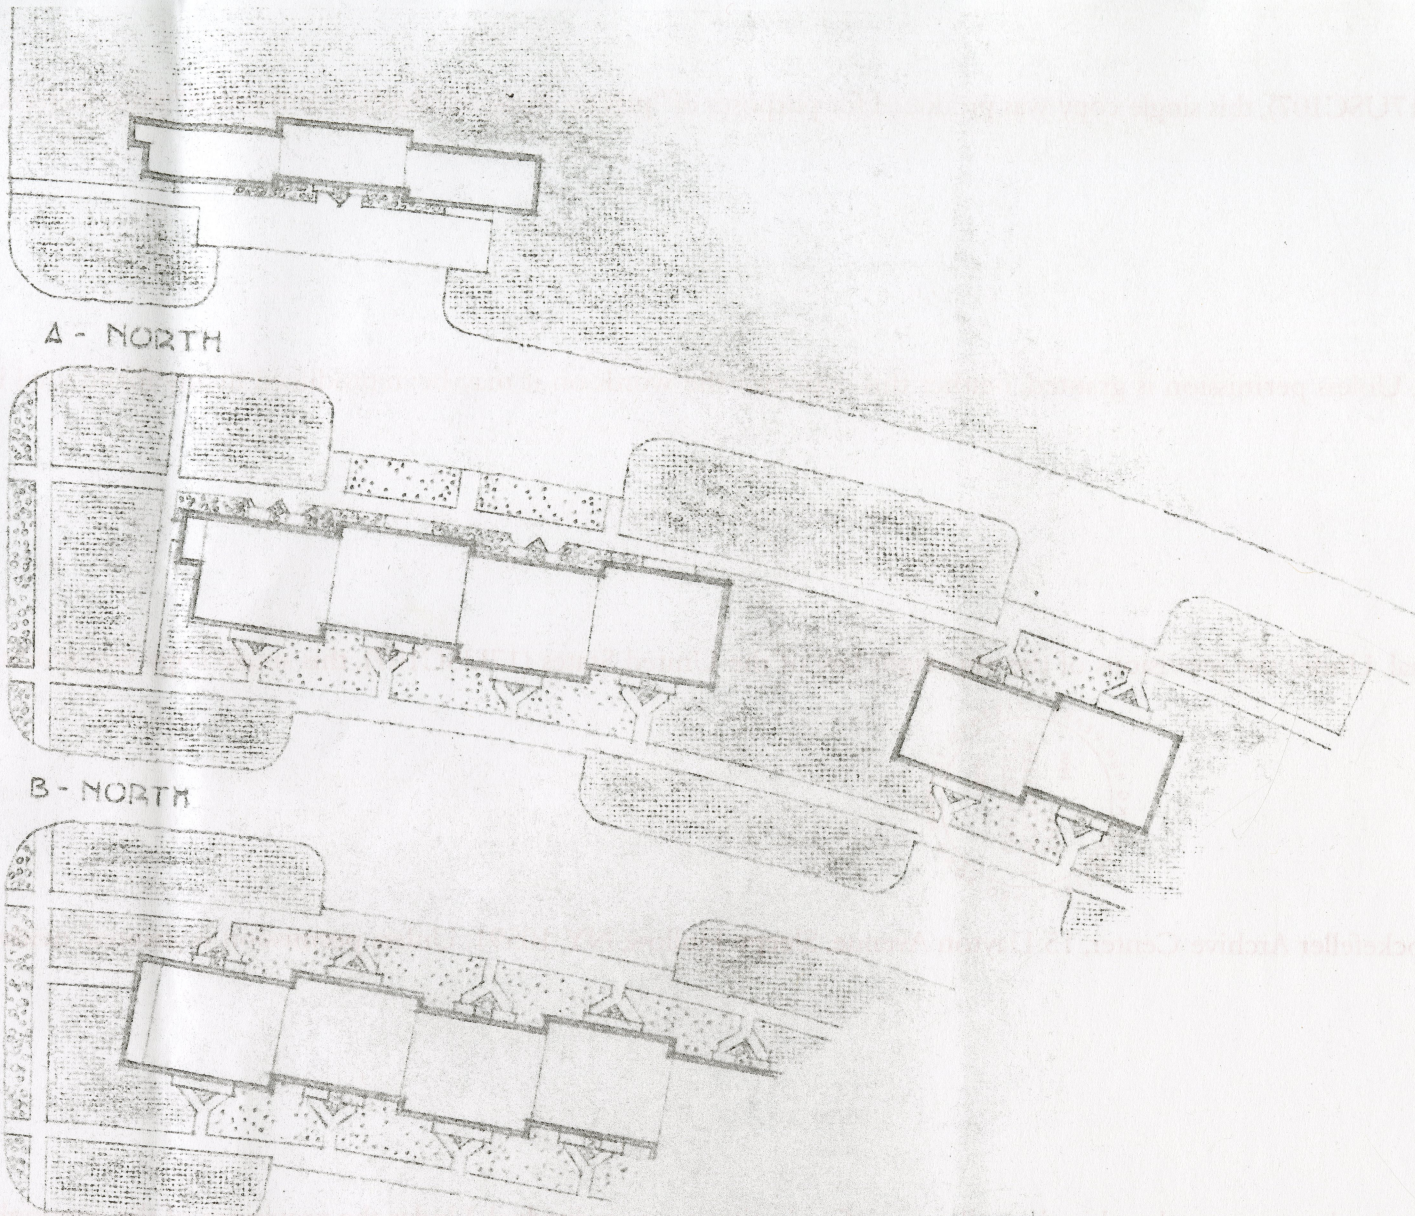
PLAN 'B' TYPE PLANTING

- NATIVE SHRUBS & GROUND COVER - IRRIGATION BY BUBBLERS
- CULTIVATED LAWN - IRRIGATION BY SPRINKLERS
- CULTIVATED SHRUBS - IRRIGATION BY BUBBLERS
- ROCK MULCH - NO IRRIGATION

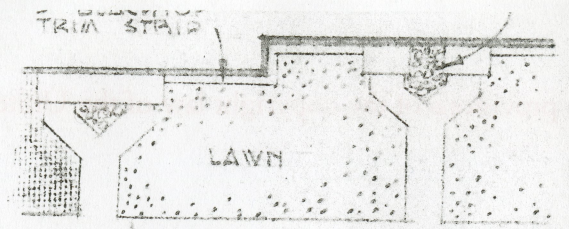
PLAN 'B' TYPE PLANTING  
ALTERNATE #1 - LAWN & ROCKS

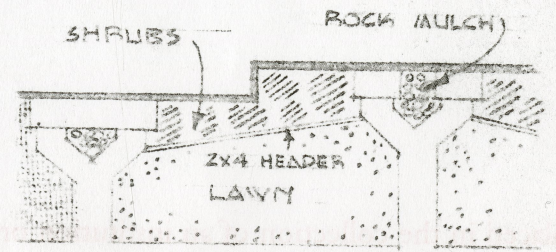
PLAN 'B' TYPE PLANTING  
ALTERNATE #2 - LAWN, ROCKS & SHRUBS
