Cunningham Cabin  
Moose  
Grand Teton National Park  
Wyoming

HABS No. WYO-25

CUNNINGHAM CABIN

Grand Teton National Park, Moose, Wyoming

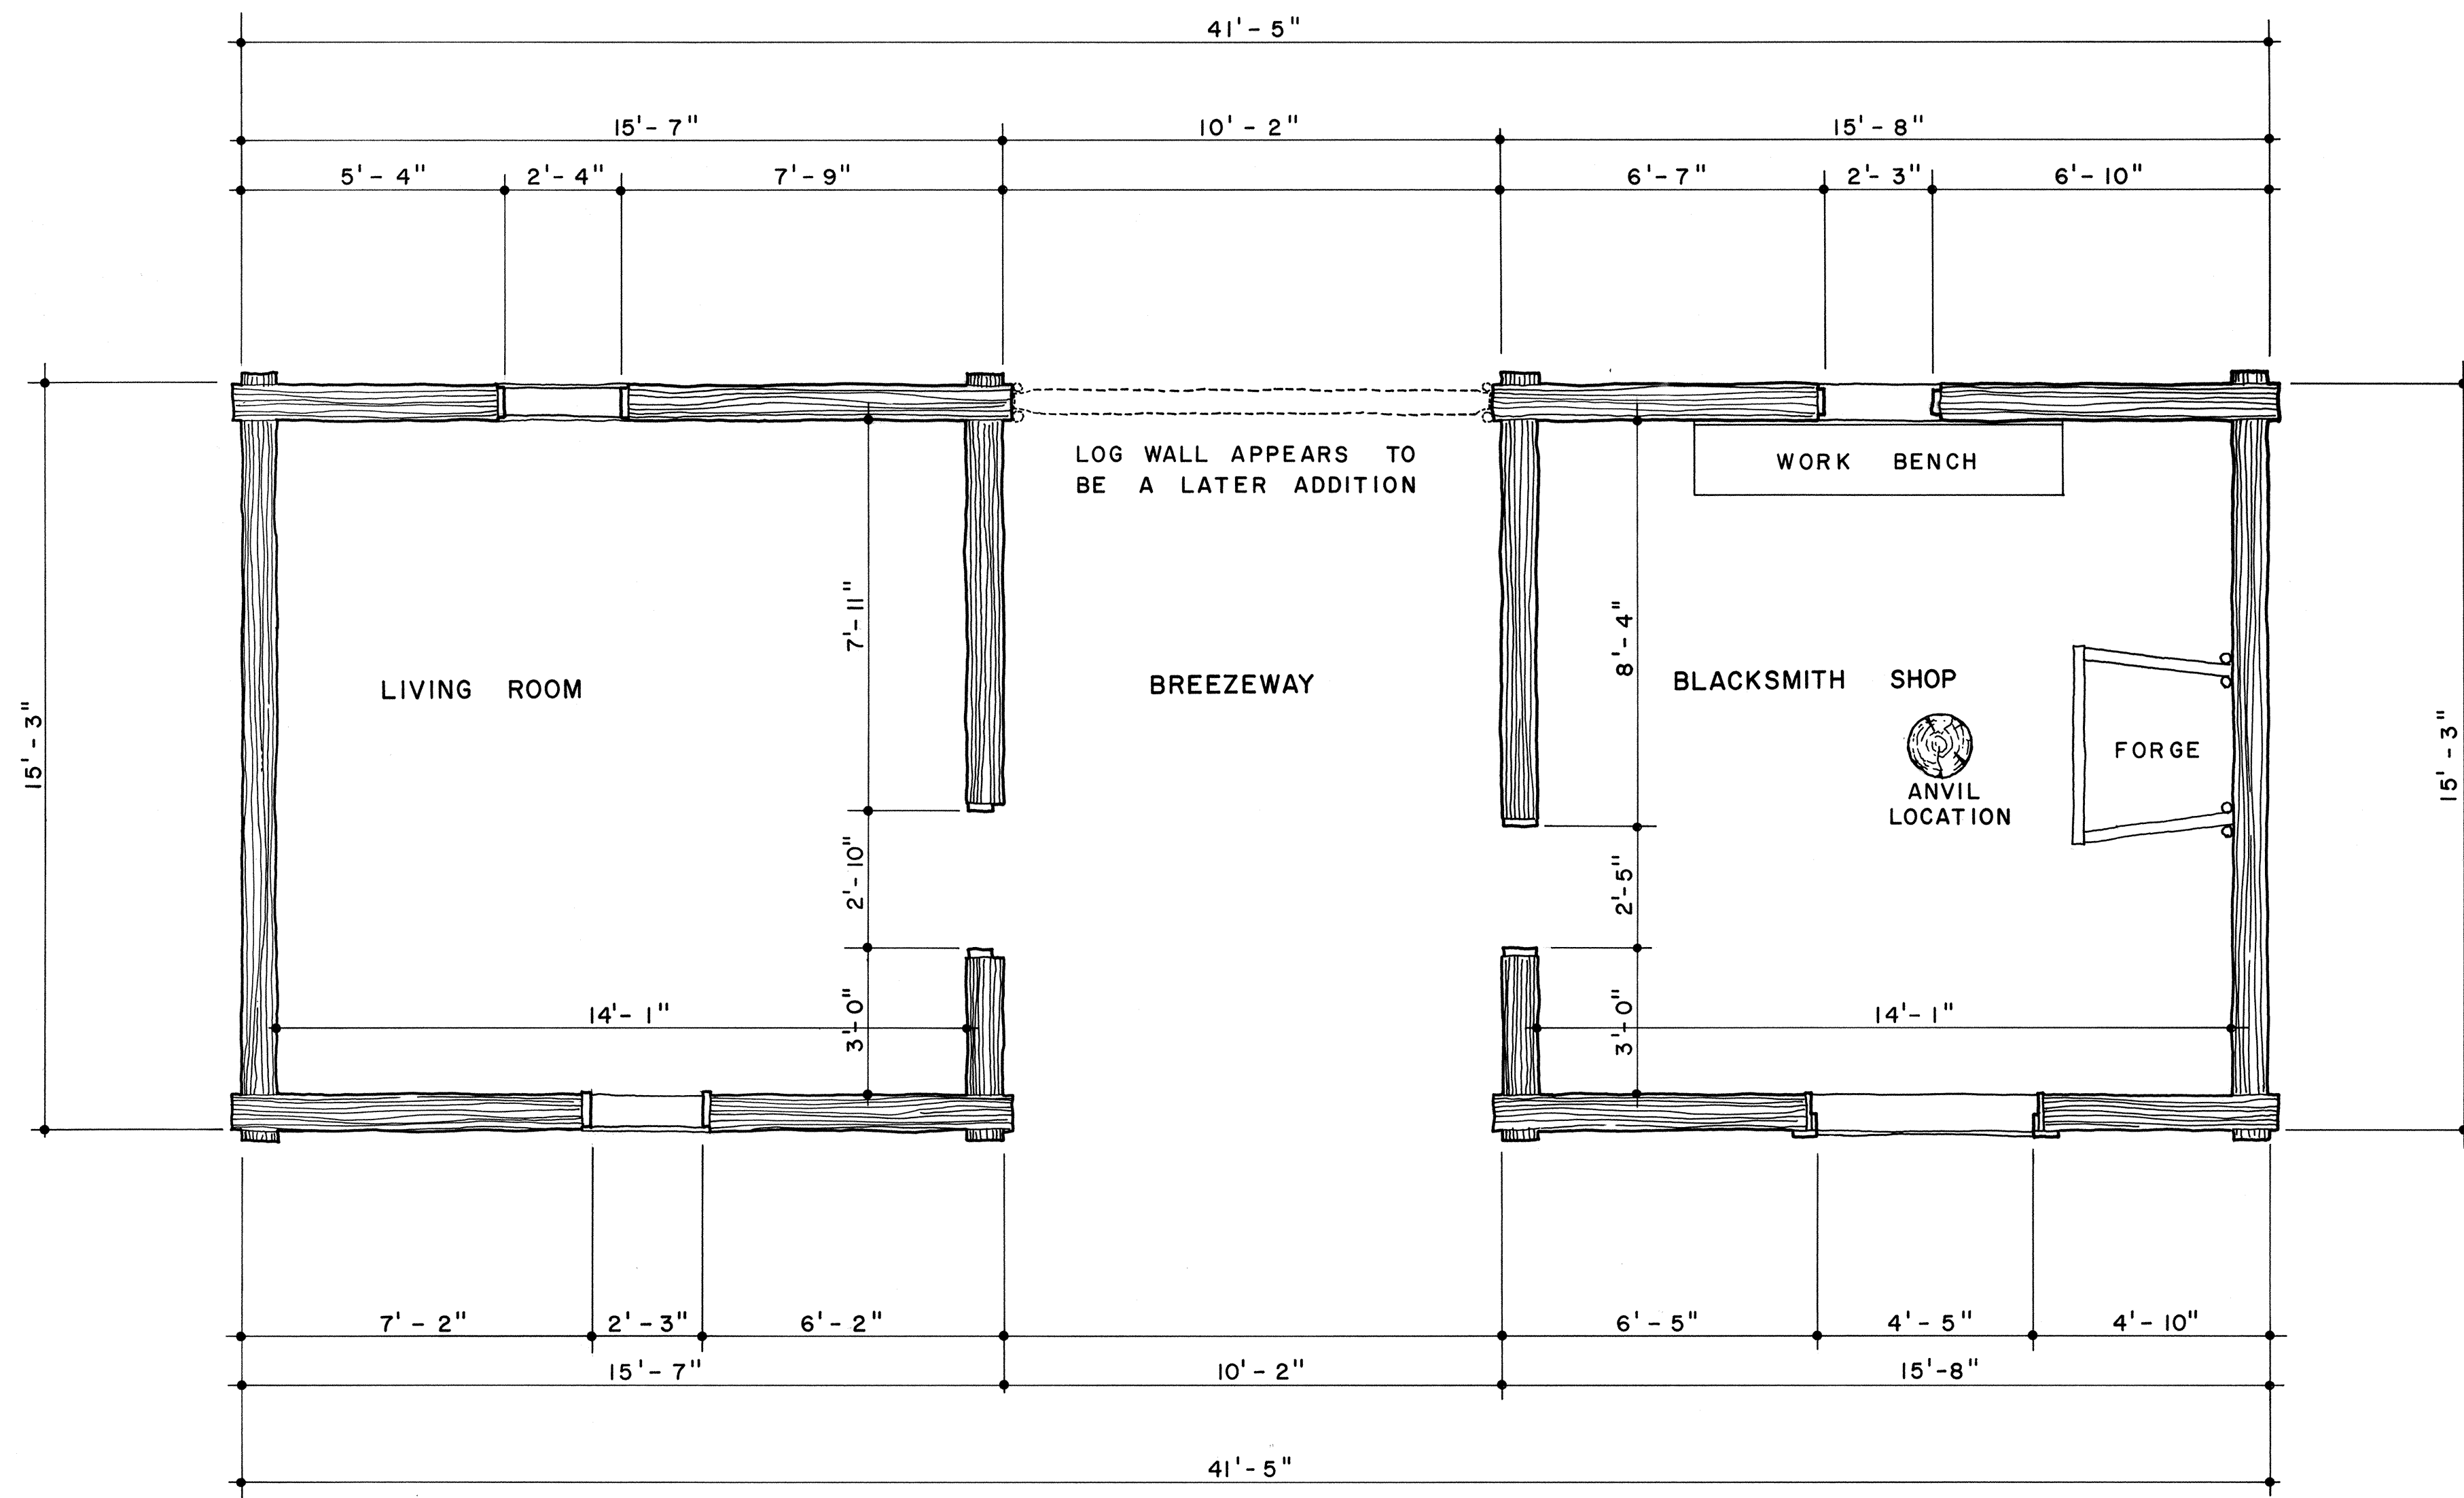
# FLOOR PLAN

Floor Plan - Two rooms approximately square and of the same size with a single doorway for each opening onto a breezeway. The south room has an interior dimension of 14'-1" x 13'-10" and the north room measures 14'-1" x 13'-9". The southern room was living quarters, the north room a blacksmith shop. A work bench, forge and anvil remain today.

NOTE :  
CABIN COMPLETELY  
RESTORED IN 1956.

Overall Dimensions - 41'-5" x 15'-3"; two rooms separated by an open breezeway under a single roof.

Openings - Entrances: each of the two rooms has a single doorway opening onto the breezeway and opposite each other. The door to the south room is 2'-10" x 5'-4" and the door to the north room is 2'-5" x 5'-5".

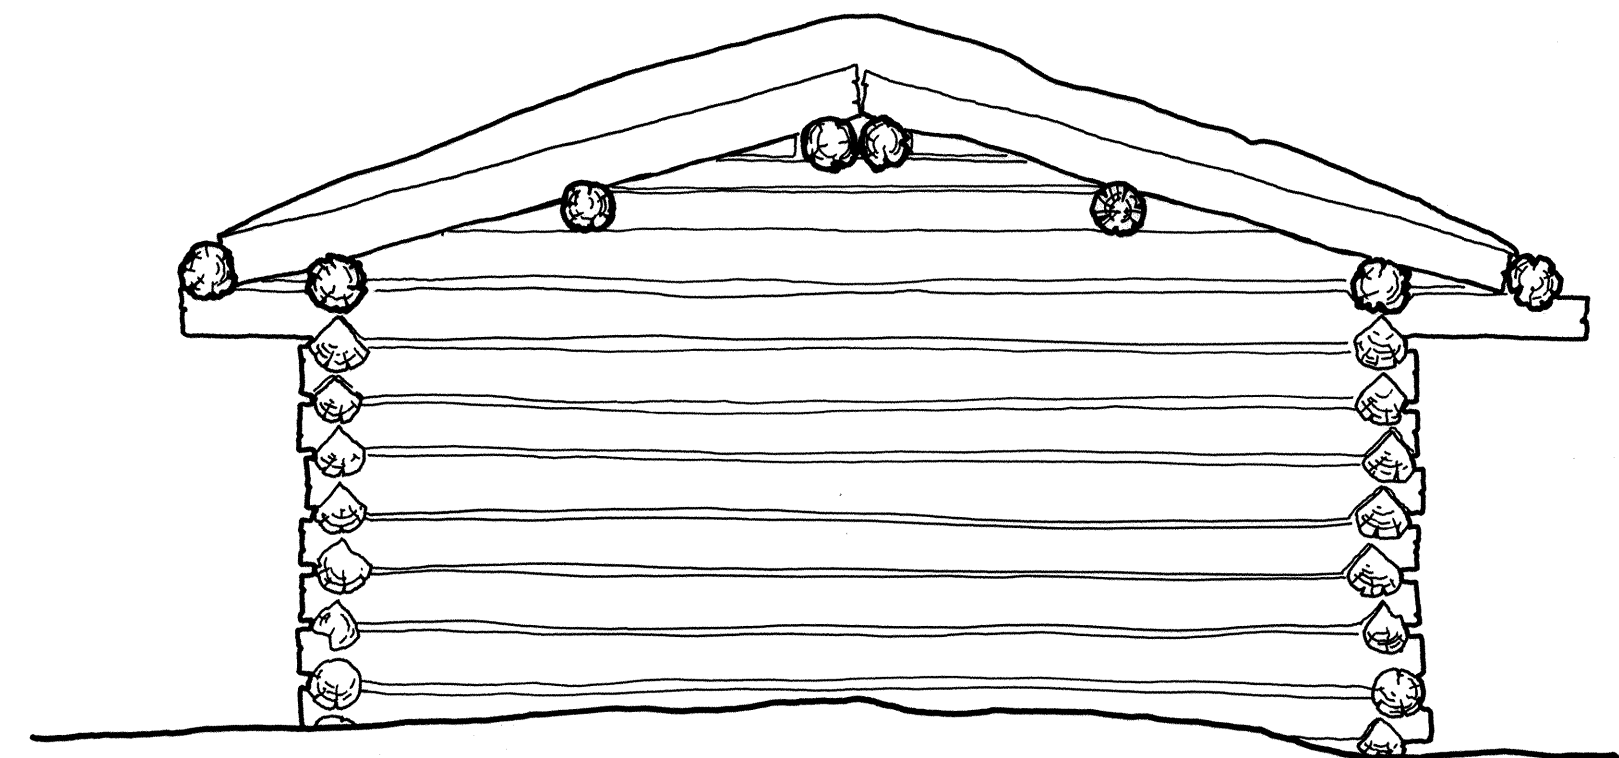
N O R T H E L E V A T I O N

NOTE:  
OPENING WAS WALLED UP WITH LOGS  
AT A LATER DATE.
