# NATIONAL REGISTER OF HISTORIC PLACES INVENTORY -- NOMINATION FORM

HISTORIC Bateria de San Antonio

Bateria de San Antonio/Battery San Antonio/Fort San Carlos (de Barrancas)

Bateria de San Antonio, Pensacola, Fla.

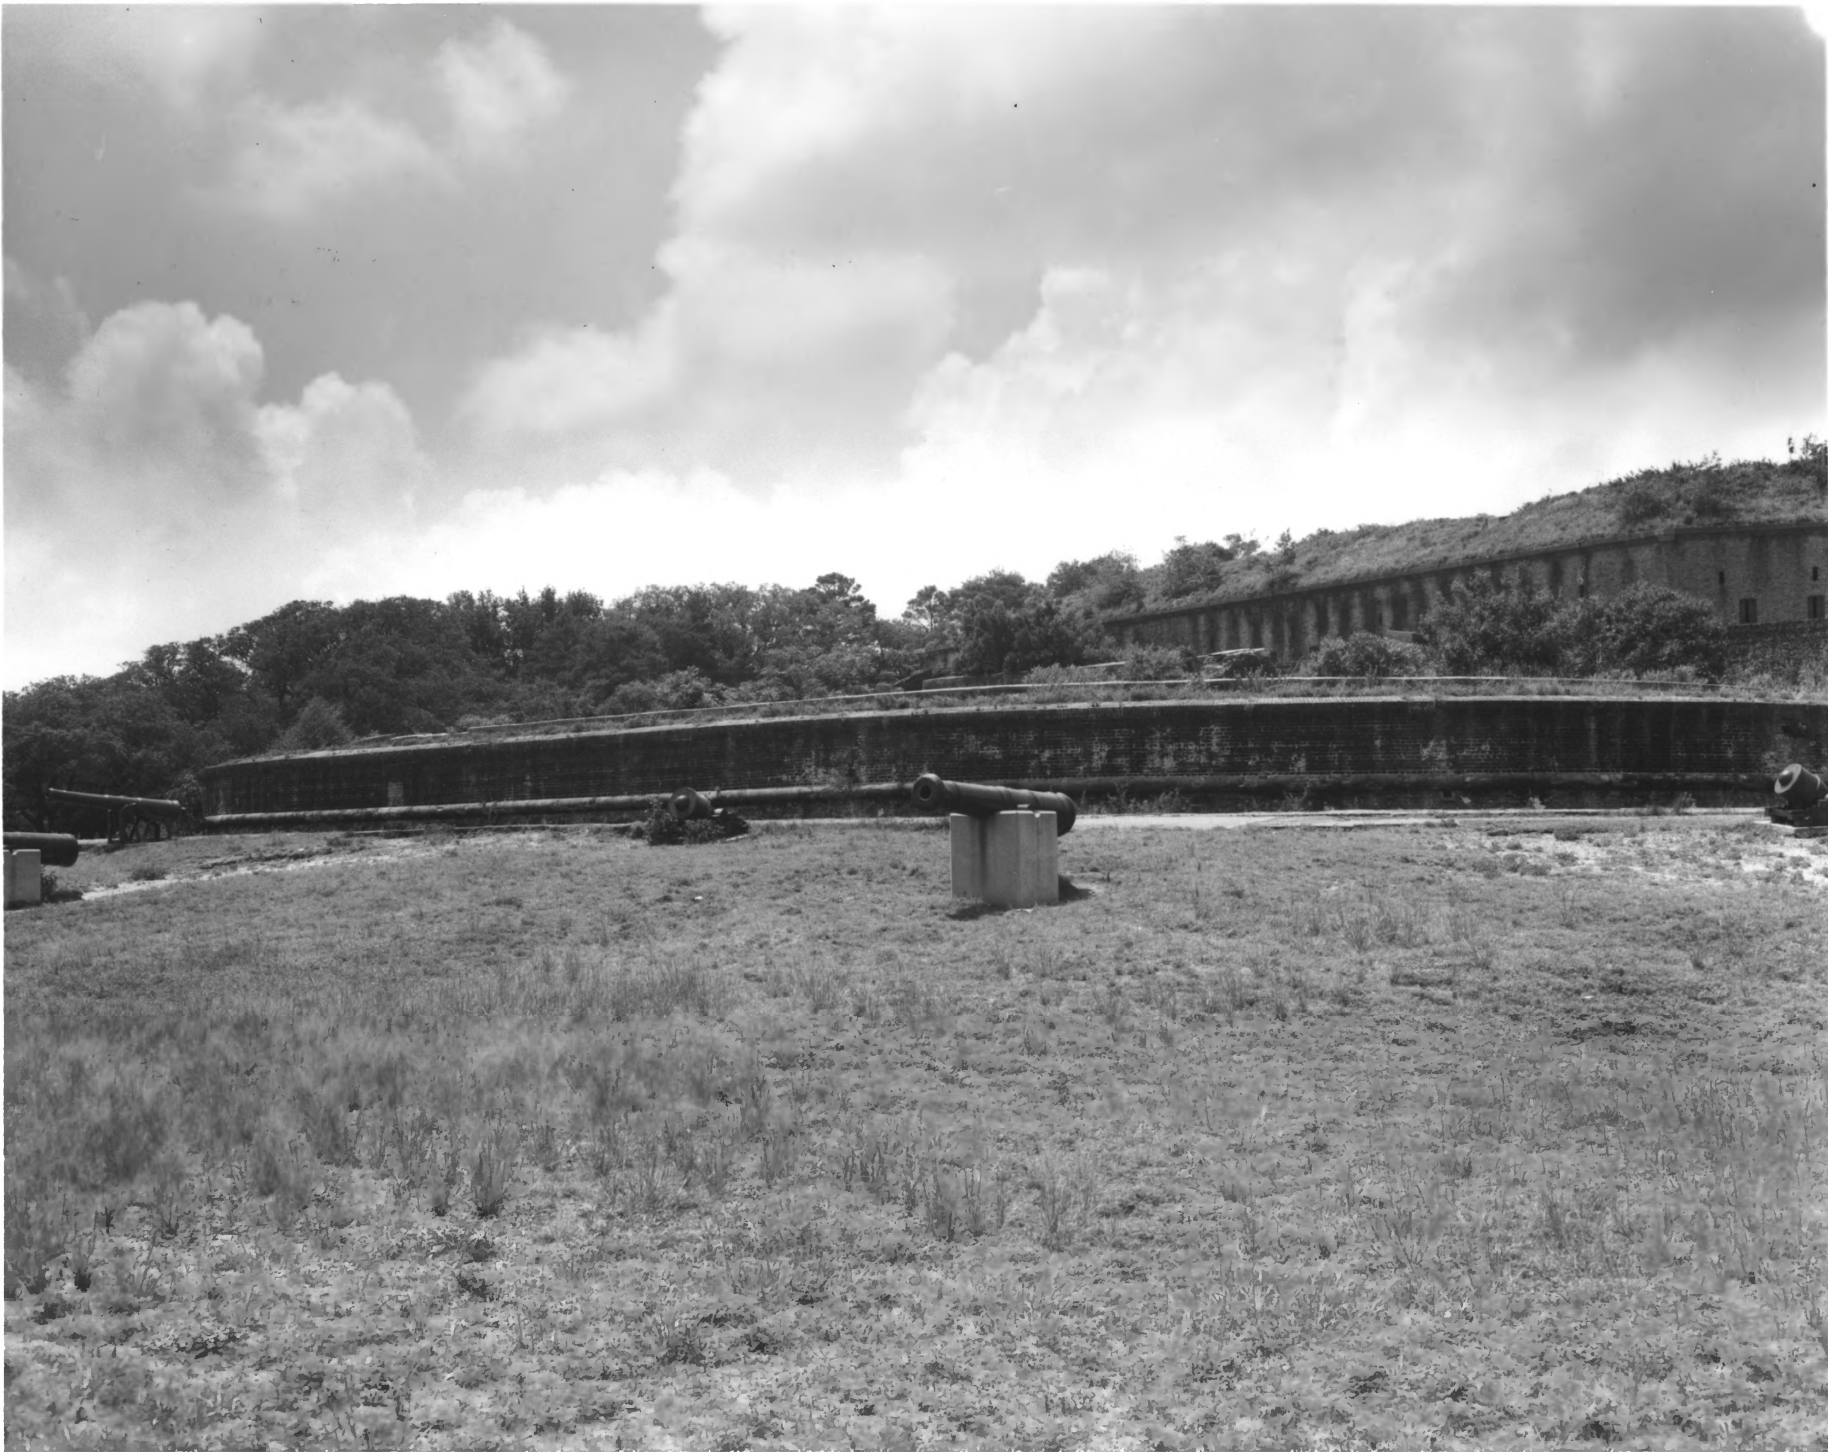
Looking northeast toward Fort Barrancas

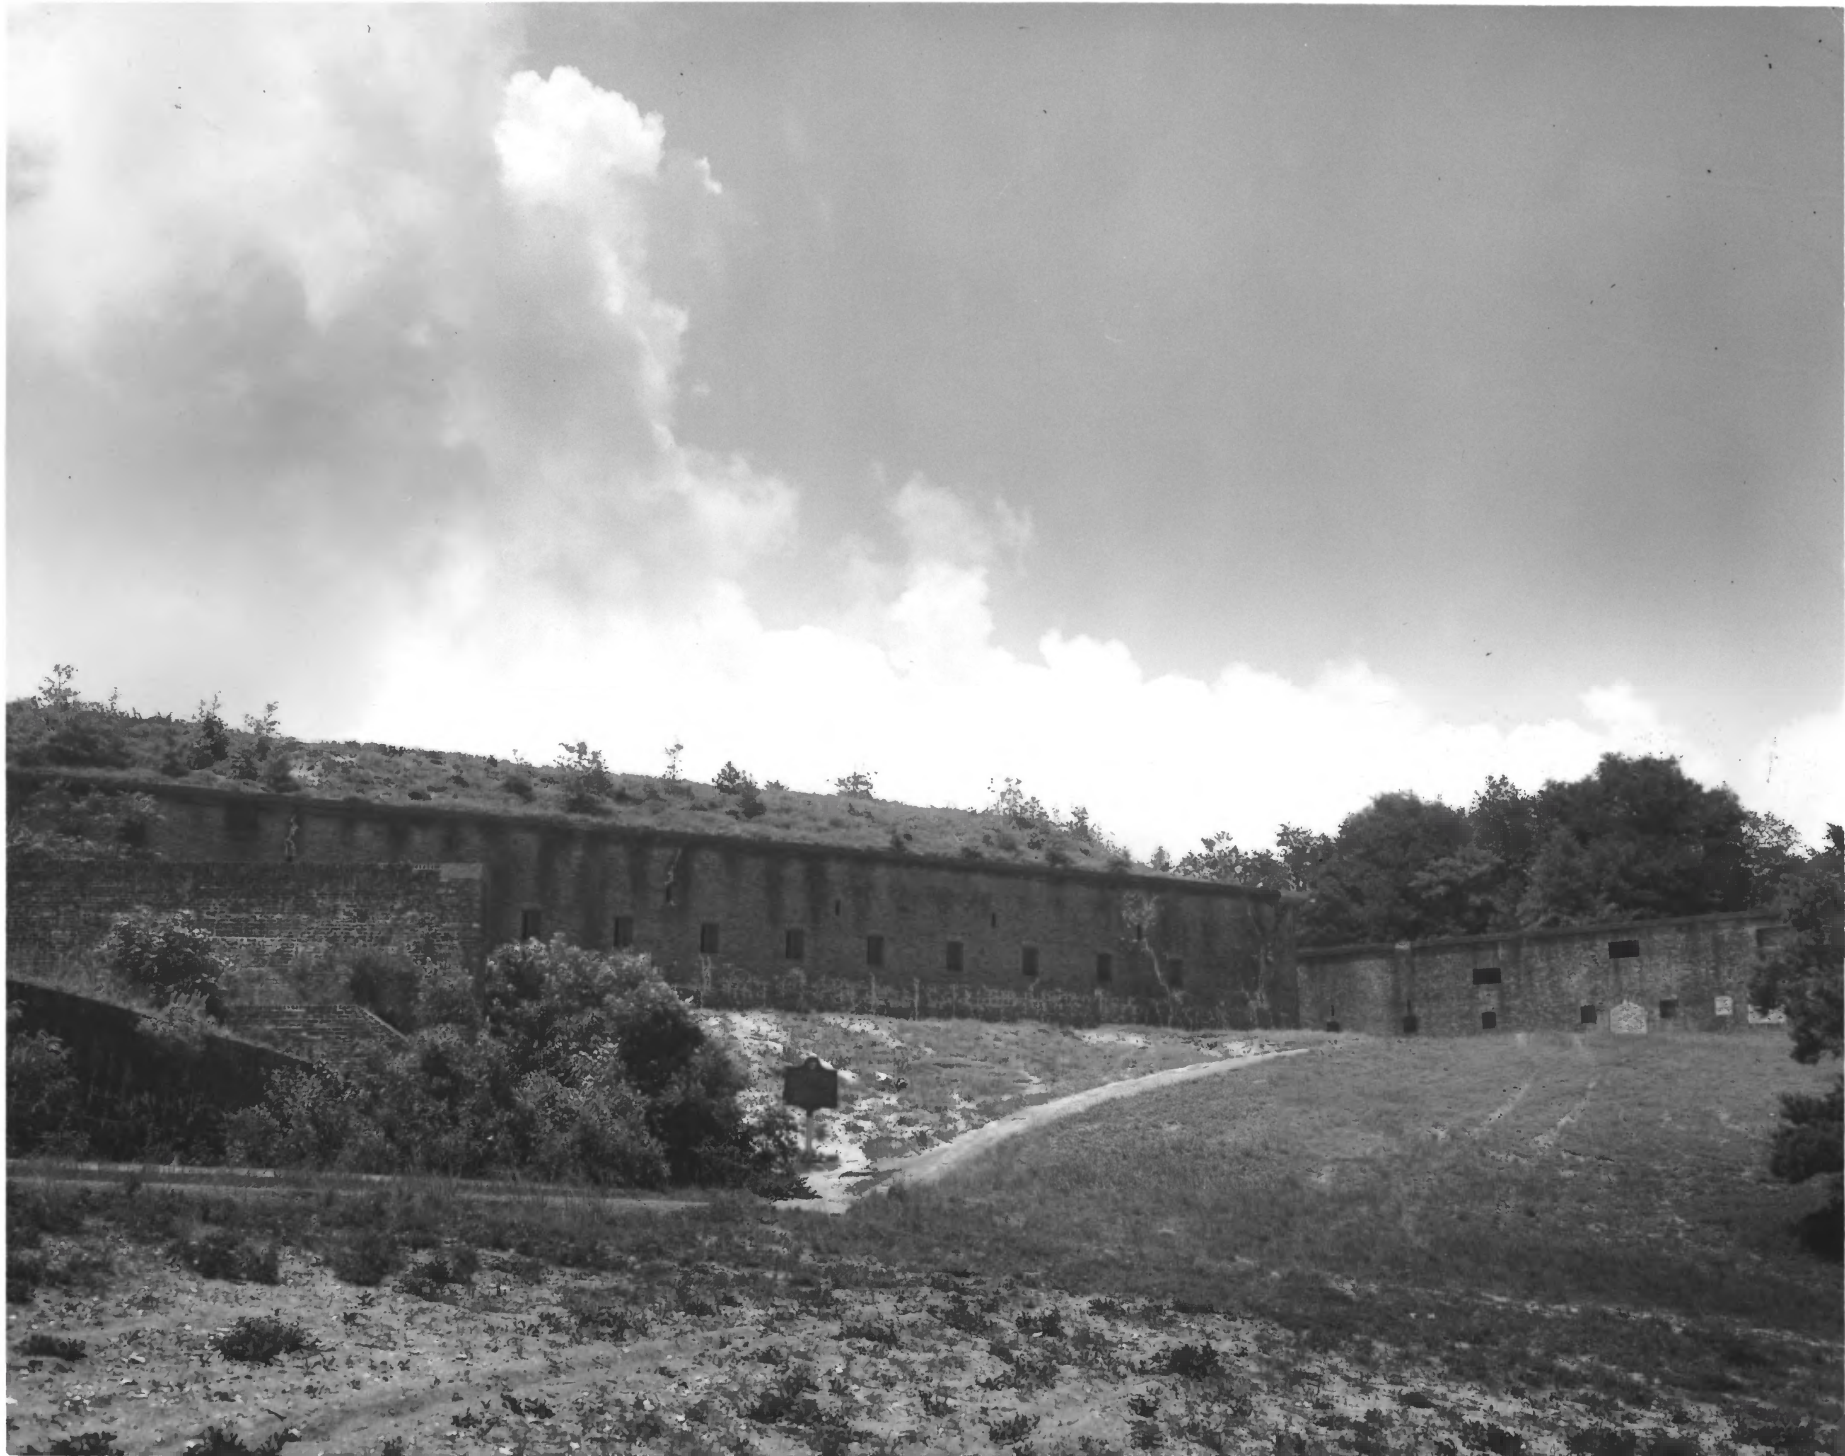
View of the front of Fort Barrancas, with the counterscarp wall on the extreme right. Looking toward the northwest.

In the four years since this photograph was taken much of the vegetative cover has been removed and ~~the~~ interpretive signs installed. The fort will be stabilized during 1978-79

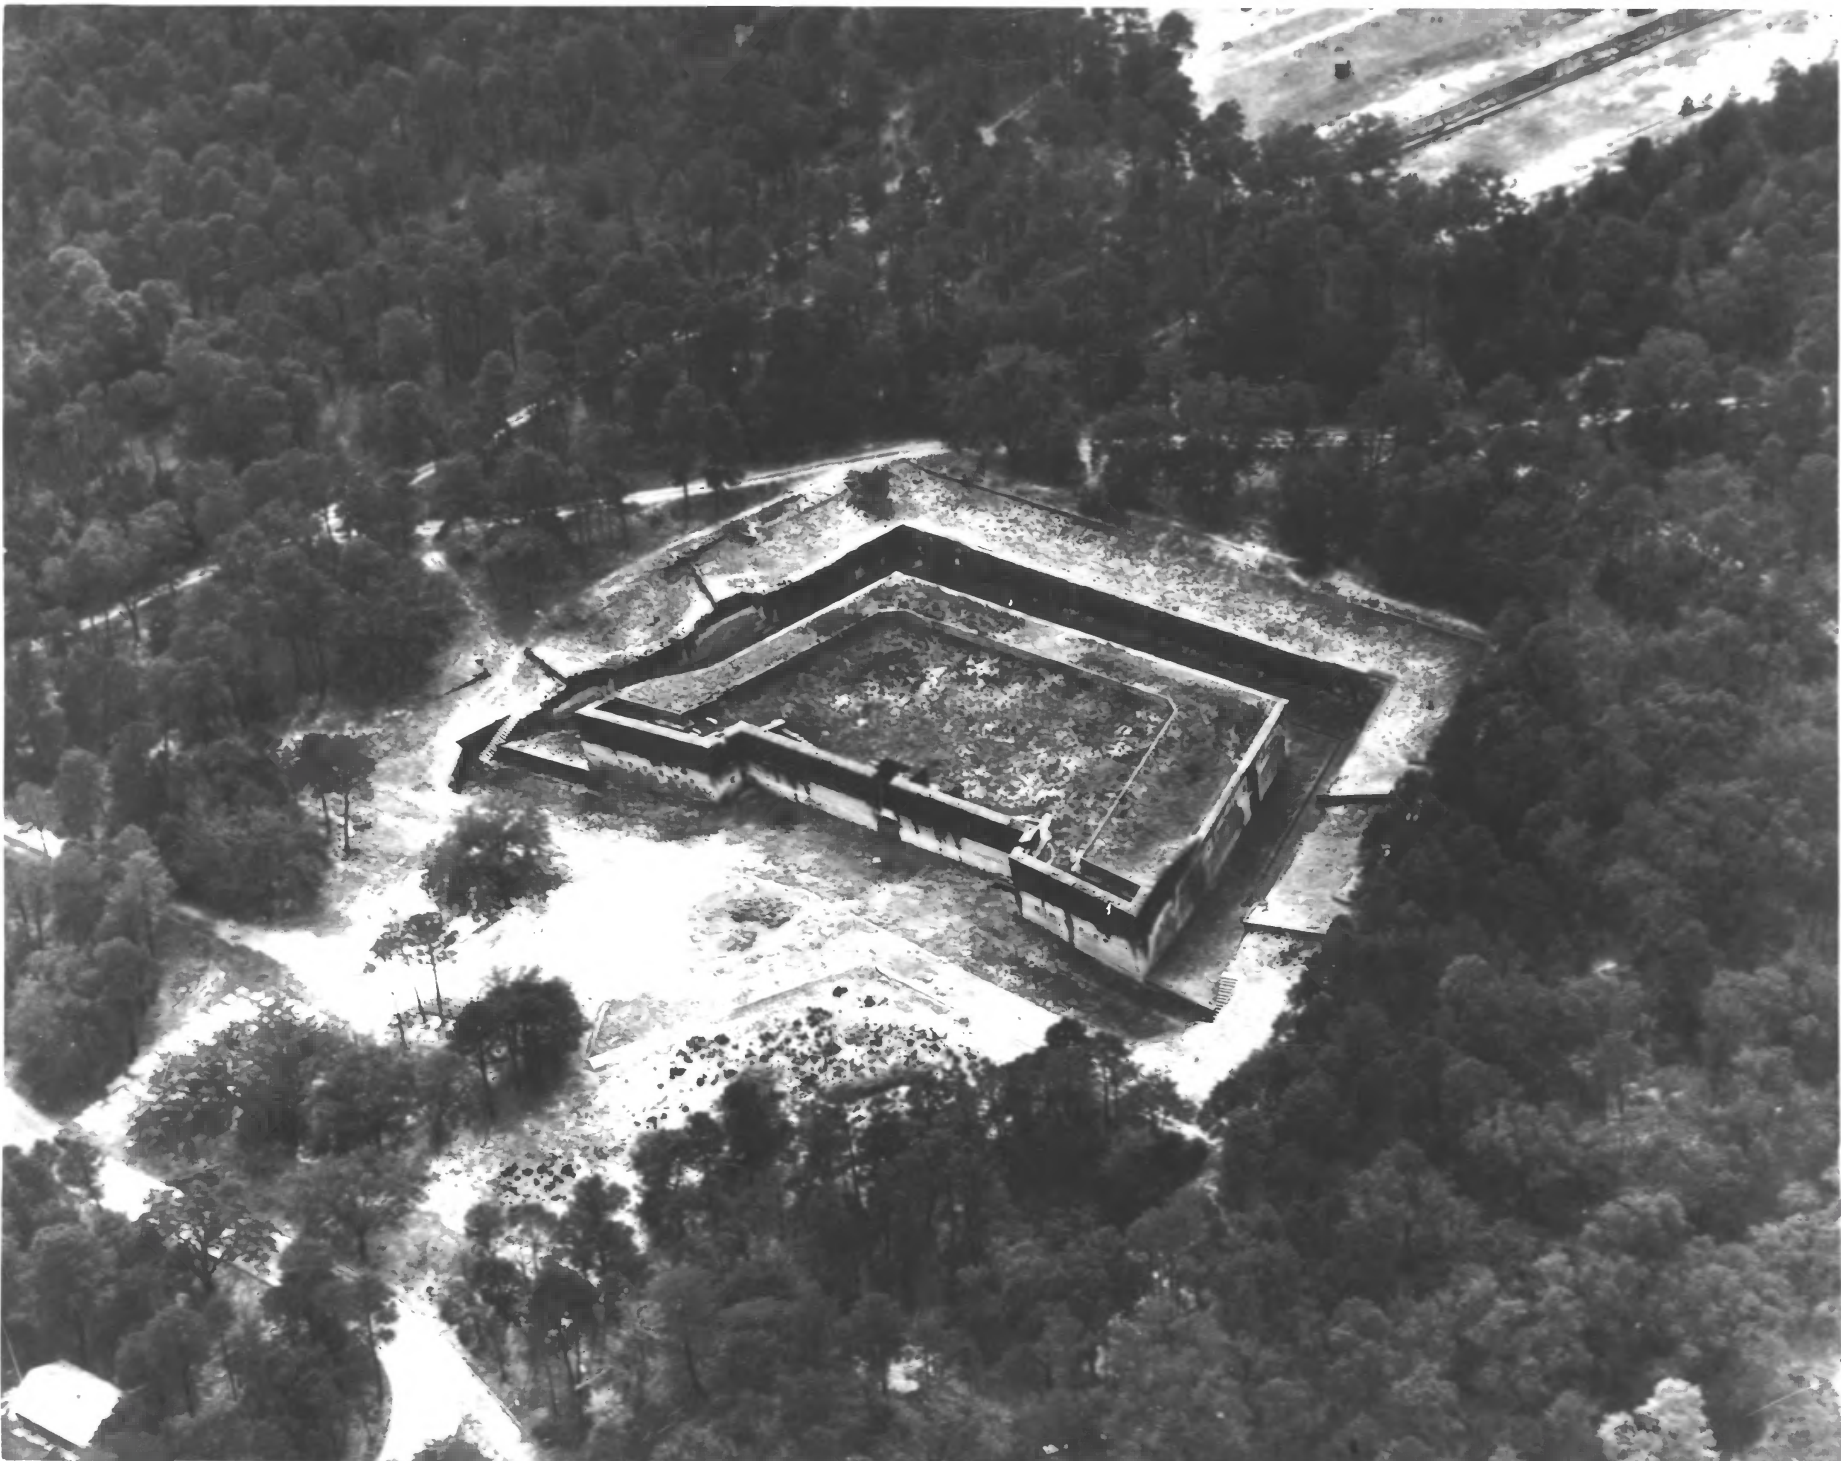
1.

Looking north at Battery San Antonio (foreground)  
and Ft. Barrancas

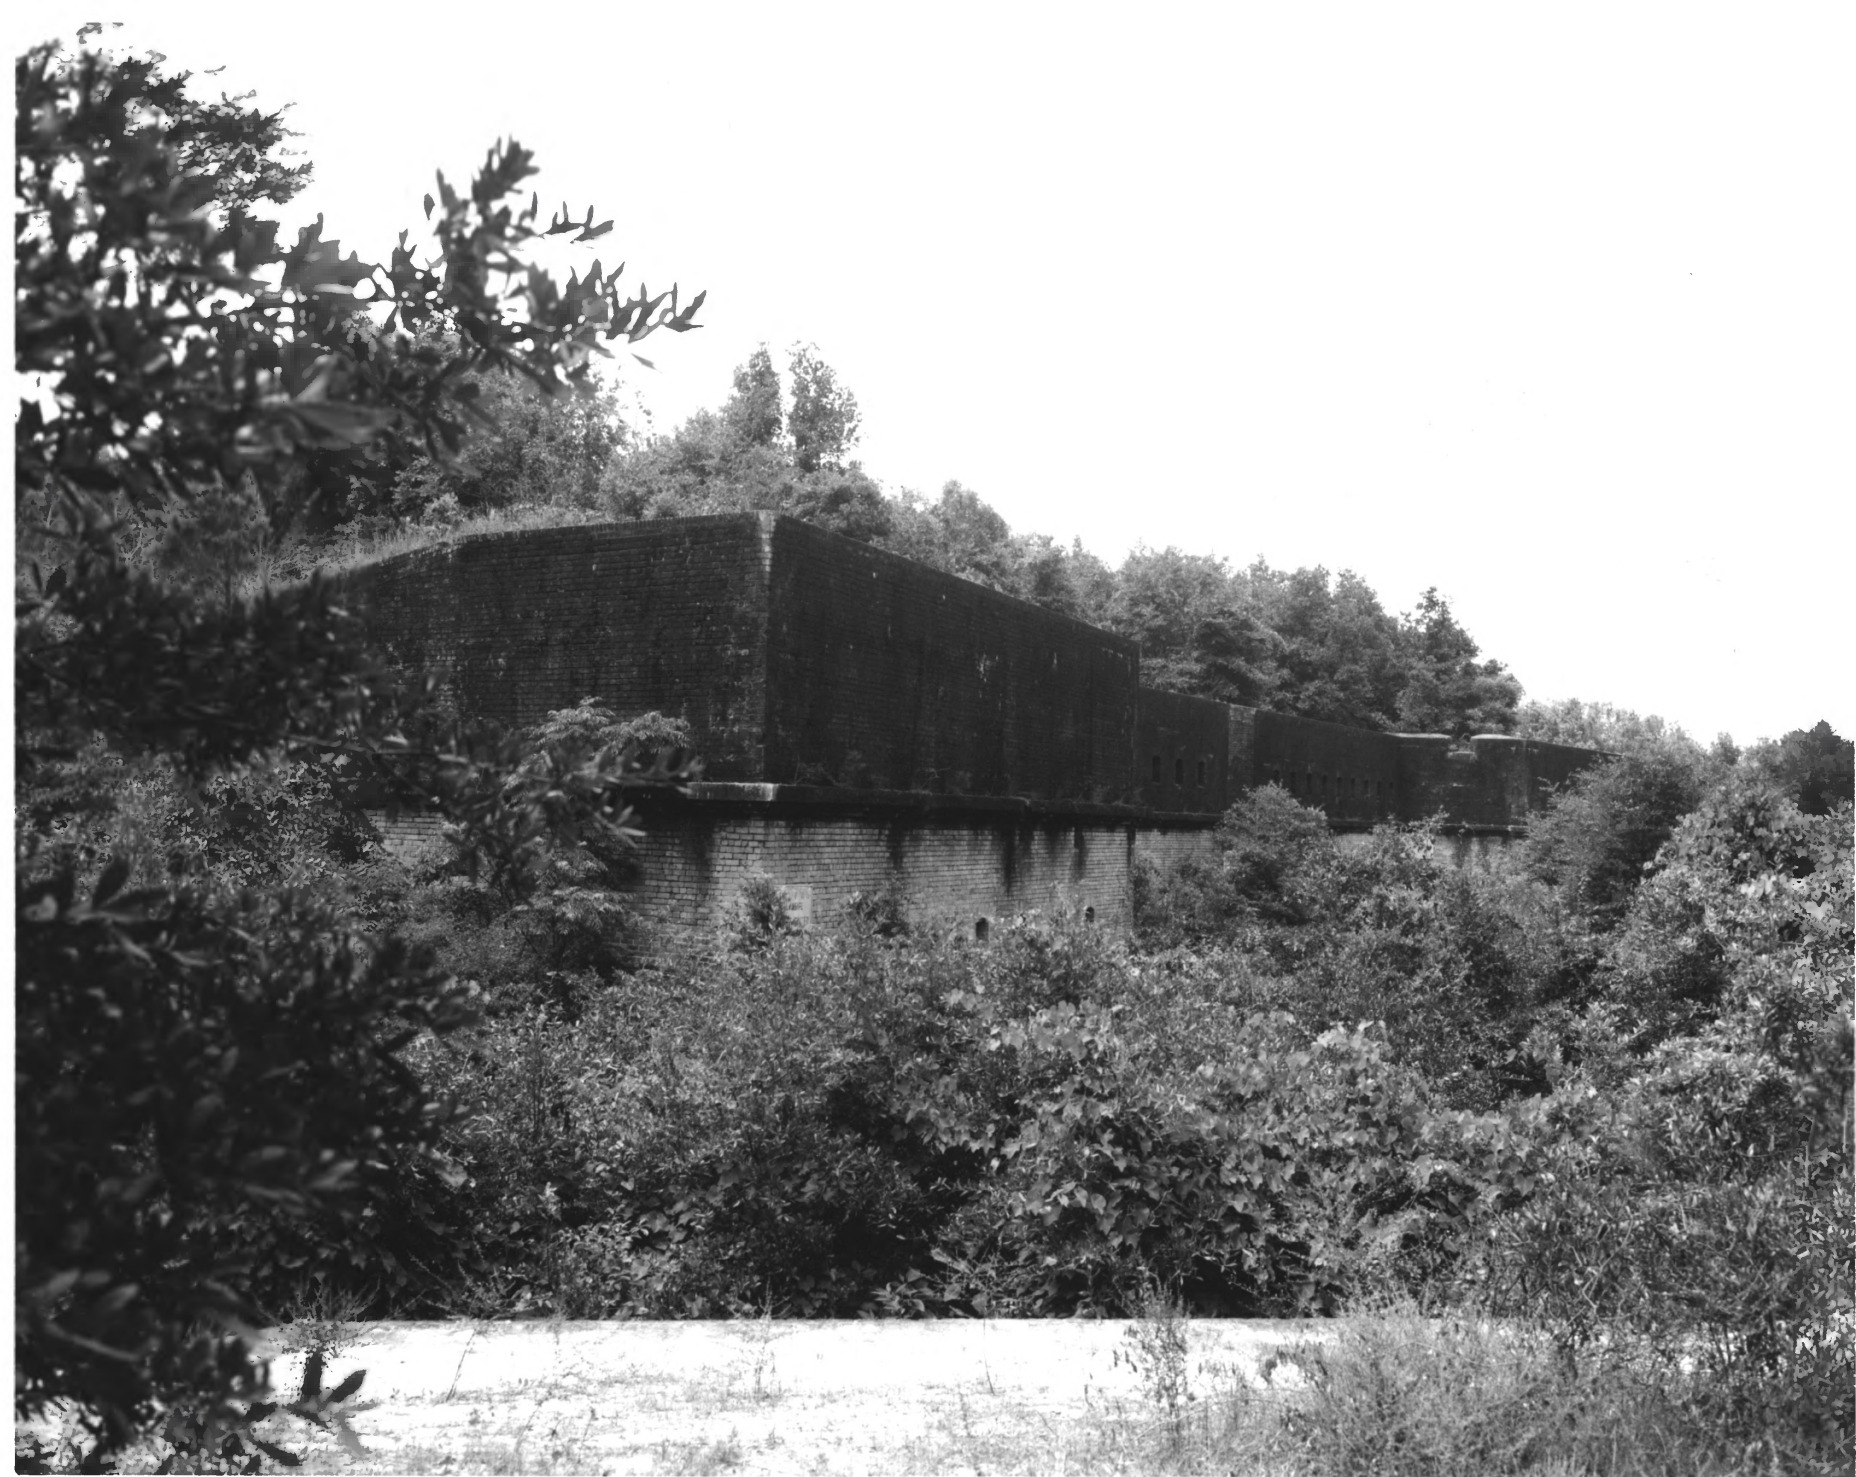
2.

Looking west at the Advanced Redoubt
