National Park Service  
Cultural Landscapes Inventory  
2008

Haleakala Highway  
Haleakala National Park

## HALEAKALA NATIONAL PARK : Haleakala Highway

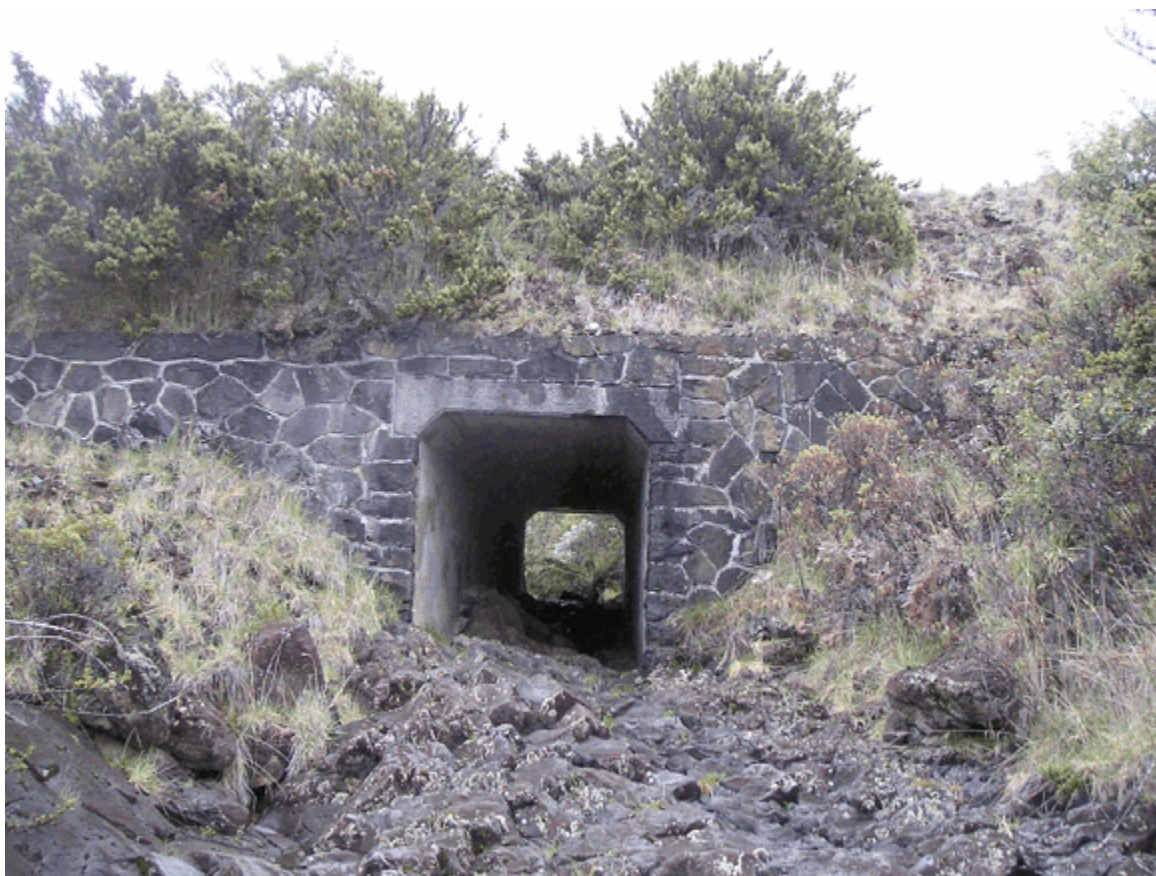
*Example of a historic box culvert with a random course pattern along the Haleakala Highway. (PWRO 2006)*

The design of the 10.6-mile section of Haleakala Highway within the national park exhibits many characteristics of the naturalistic and rustic design styles, including the simple appearance of the road that belies the amount of engineering involved, the lack of guard rails so as not to impede views of the dramatic landscape below, the curvilinear alignment that hugs the natural topography of the slope and ravines, the "naturalization" of road shoulders, rock cuts, and fill slopes, the construction details for box culverts, small culverts, and the bridge, and the careful alignment of the road to maximize views and minimize the road's intrusion on the landscape. NPS landscape ideals are reflected in the road's relatively easy grades and curves, as well as in its harmony with surrounding terrain. Despite the fact that the road traversed open brush country, which is practically treeless due to over 100 years of ungulate browsing, careful alignment and landscaping during and after construction reduced or obliterated road scars. NPS landscape architect Merel S. Sager noted that the terrain itself was "not particularly interesting," but observed that the road provided beautiful panoramic views of the central Maui isthmus, West Maui, and other Hawaiian islands. Sager described the auto climb above the clouds as "inspiring" and claimed that the sunrise or sunset views over the clouds were "an experience long to be remembered" (Sager, December 10, 1935). Notable rustic structures and features along the road include the White Hill Observatory, White Hill trail, 11 box culverts, a bridge, and many small culverts with stone headwalls.

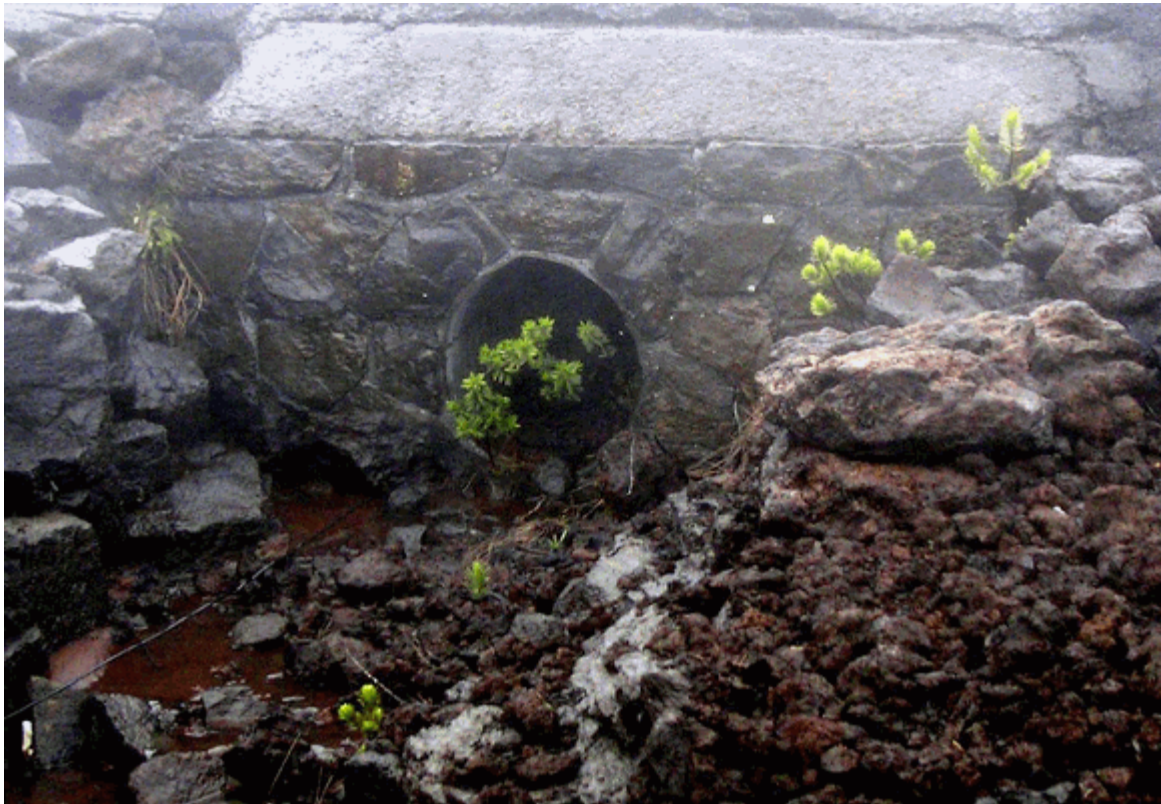
*Historic culvert with a random course pattern along the Haleakala Highway. (PWRO 2006)*

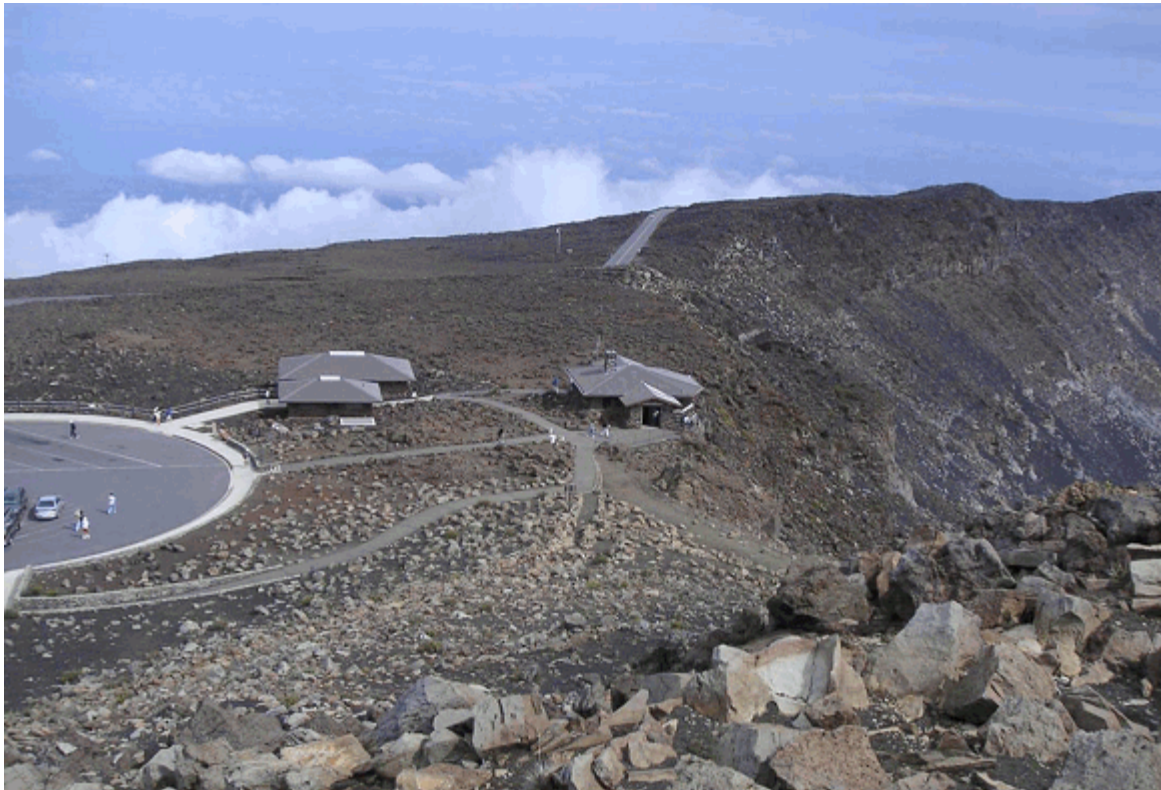
*White Hill walkways. (PWRO 2006)*

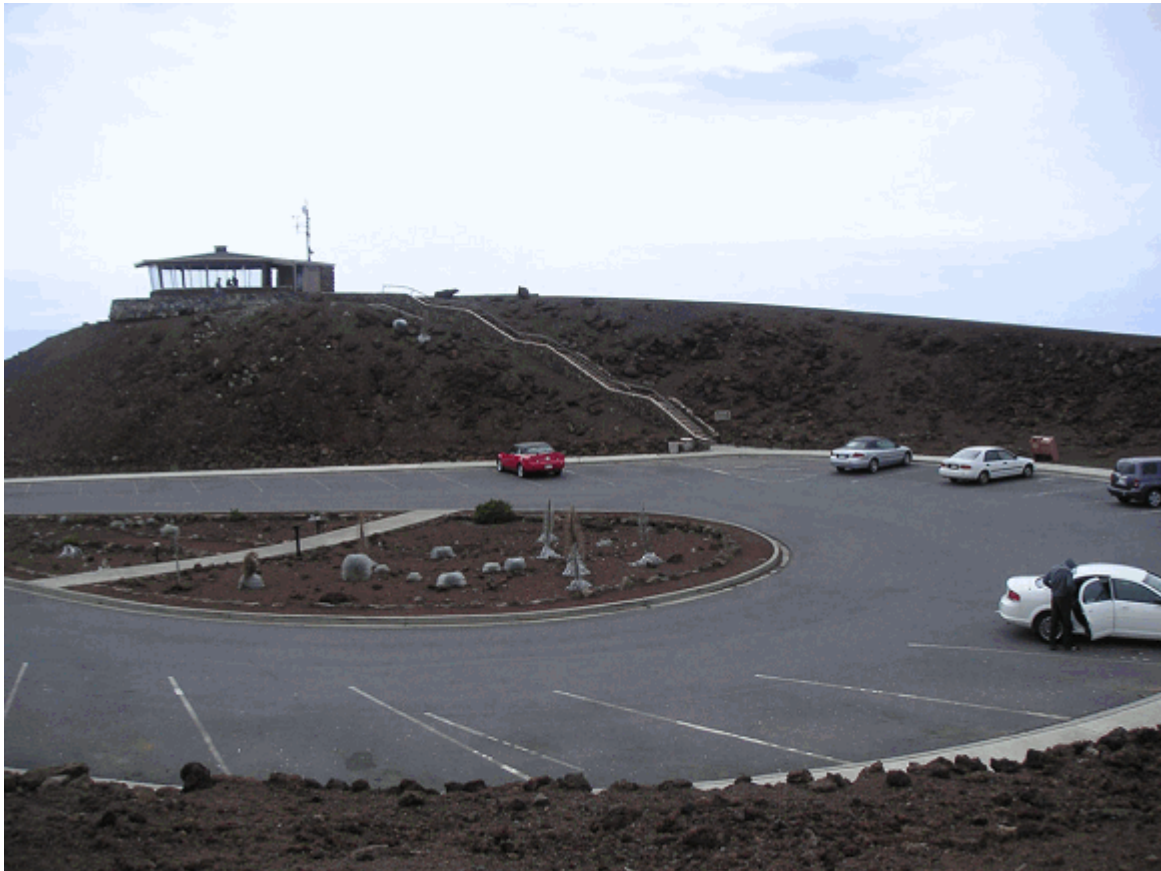
*Red Hill parking lot, sidewalks, and stairs. (PWRO 2006)*

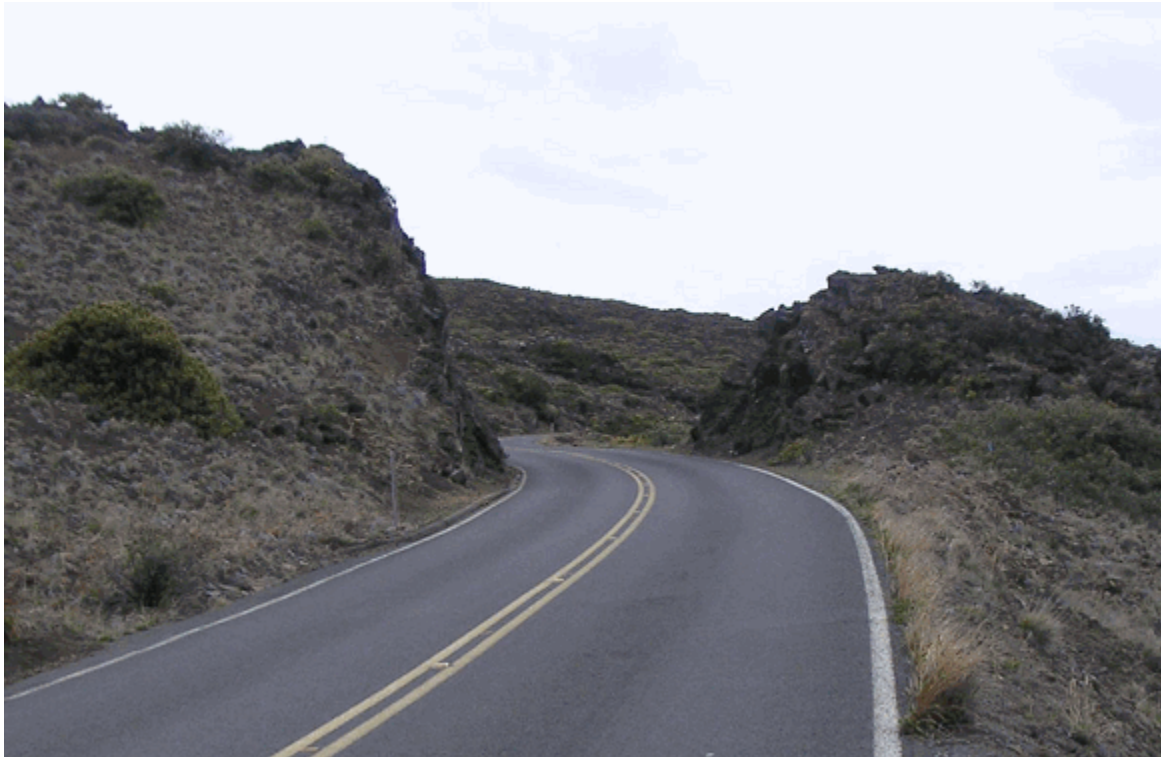
*Road alignment winding through a rock cut. (PWRO 2006)*

accommodate road widening, cuts and fills are still characteristic of the Haleakala Highway today. They continue to be the main engineering technique that characterizes the cross-section of the road as it winds up the steep slope of the volcano.
