Historic Furnishings Report

FORDYCE BATHHOUSE

THE FORDYCE BATHHOUSE

HOT SPRINGS NATIONAL PARK
Arkansas

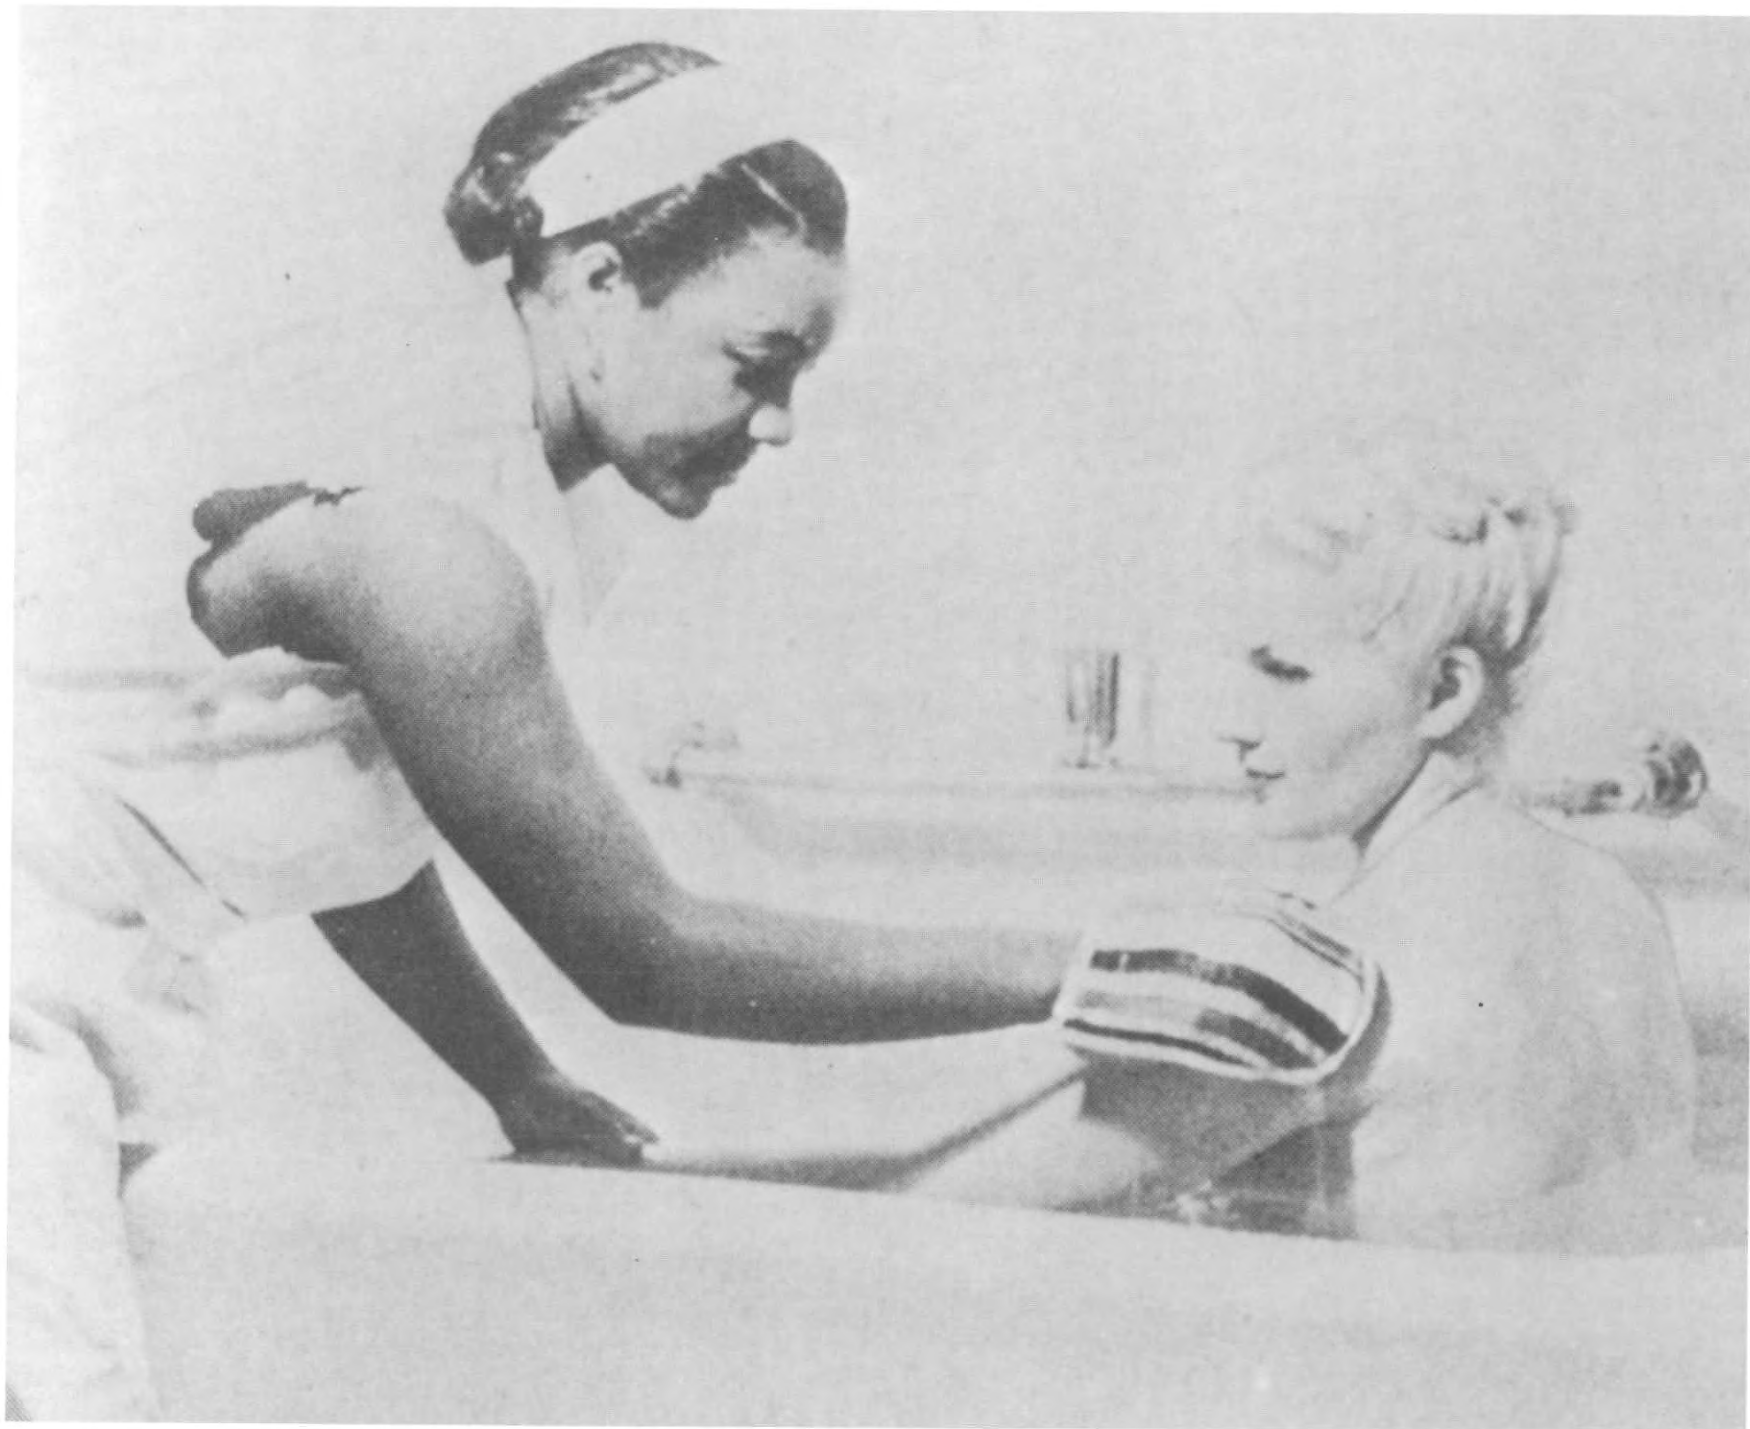
Figure 26. Sitz bath in the ladies' bath hall. The caption includes:
"The Sitz bath is part of the modern Fordyce equipment. This bath
is indicated in infectious and benign hypertrophy of the prostate
and in chronic rectal and genitourinary diseases."

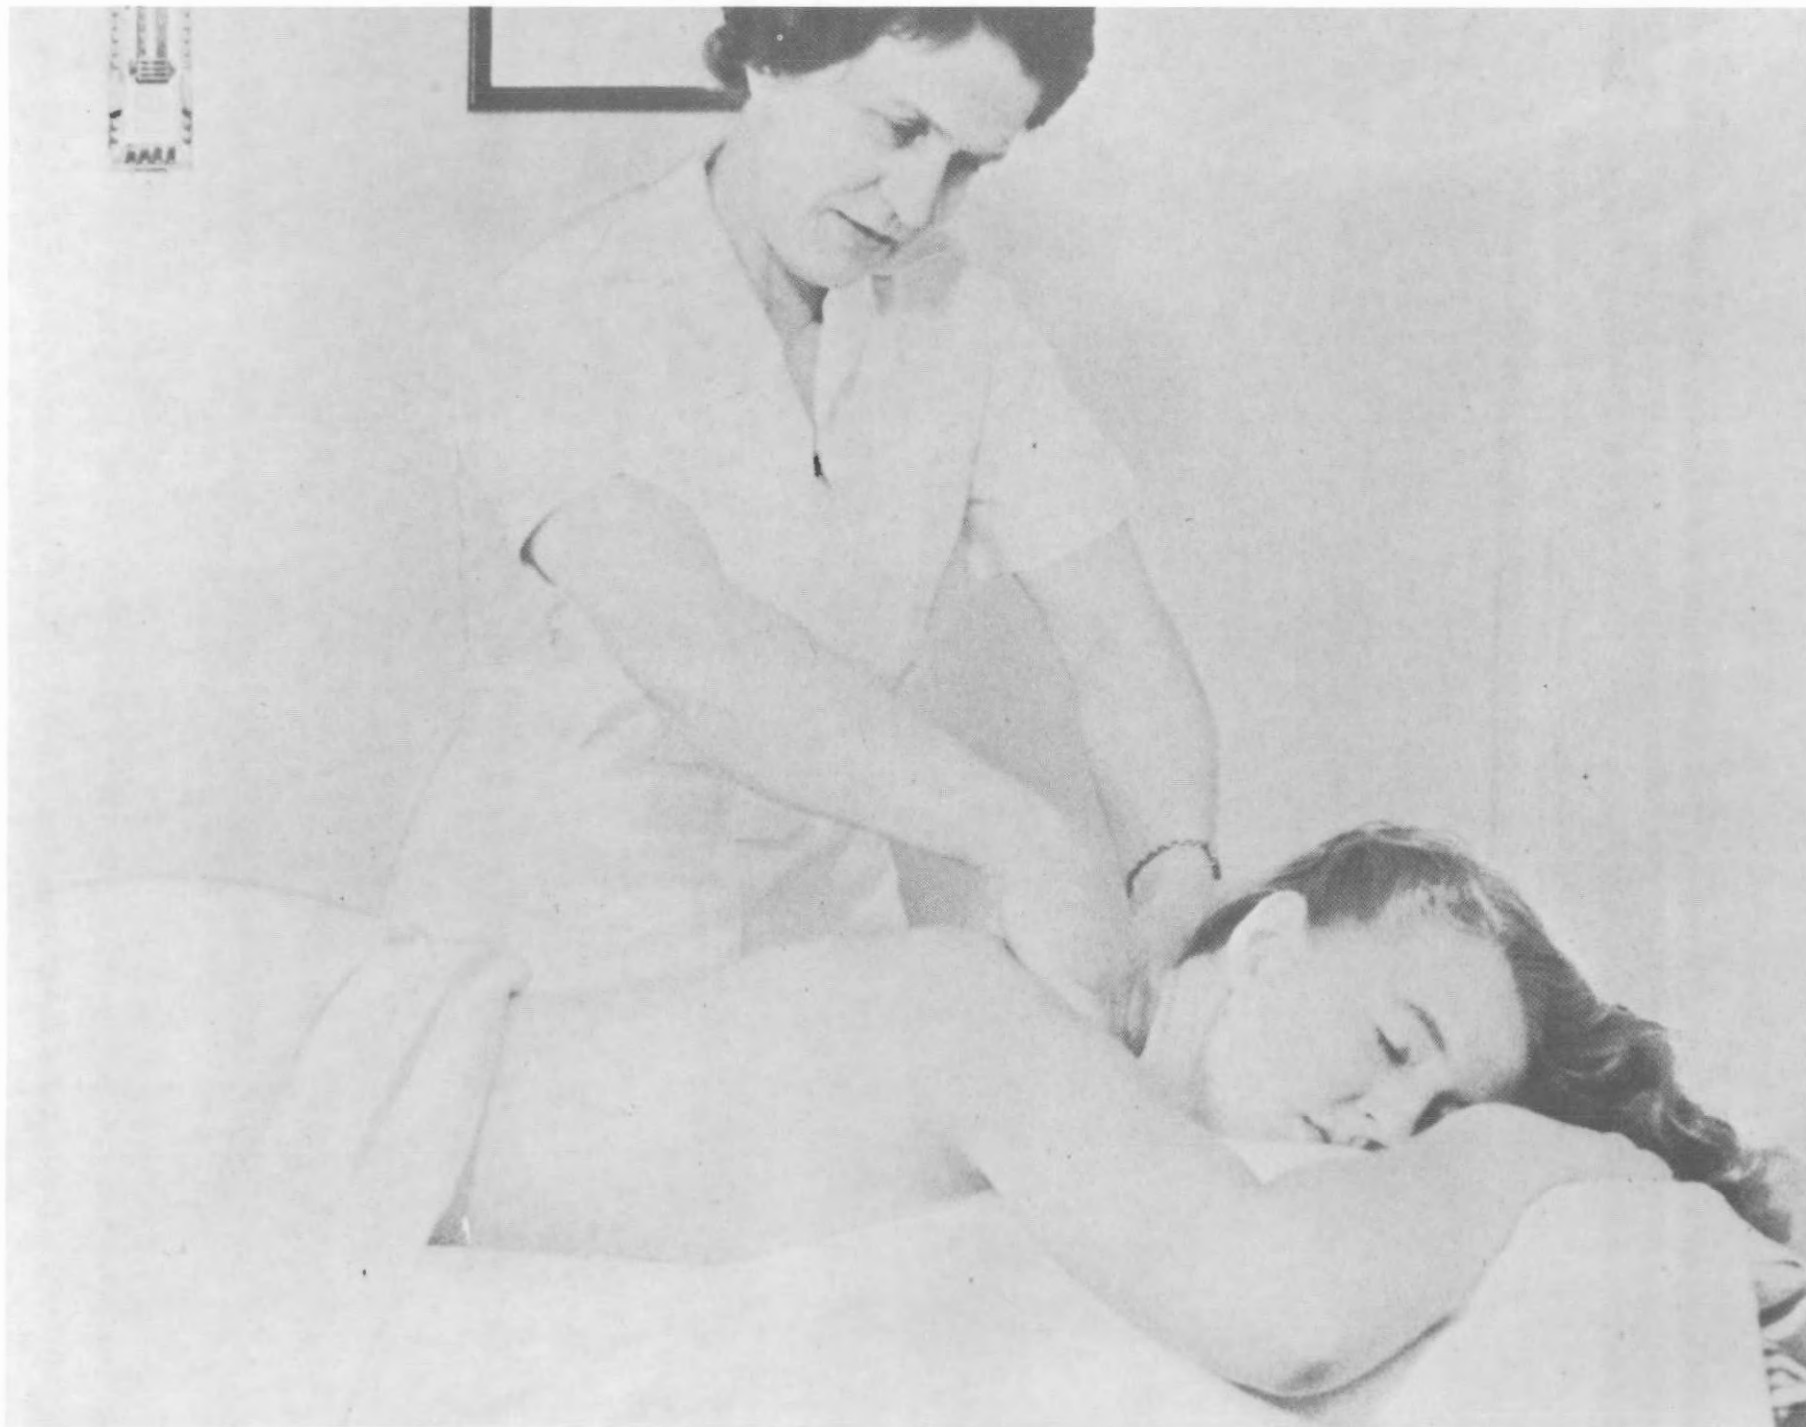
Figure 45. Mechanotherapy department, Fordyce Bathhouse. The items have been identified as fully as possible. Compare with figures 74 and 75, the electricity and massage department at the Palace Bathhouse. The tissue oscillator and the static machine were clearly from the Palace. Electrical vibrators similar to those used at the Palace can be seen in the Fordyce mechanotherapy room.

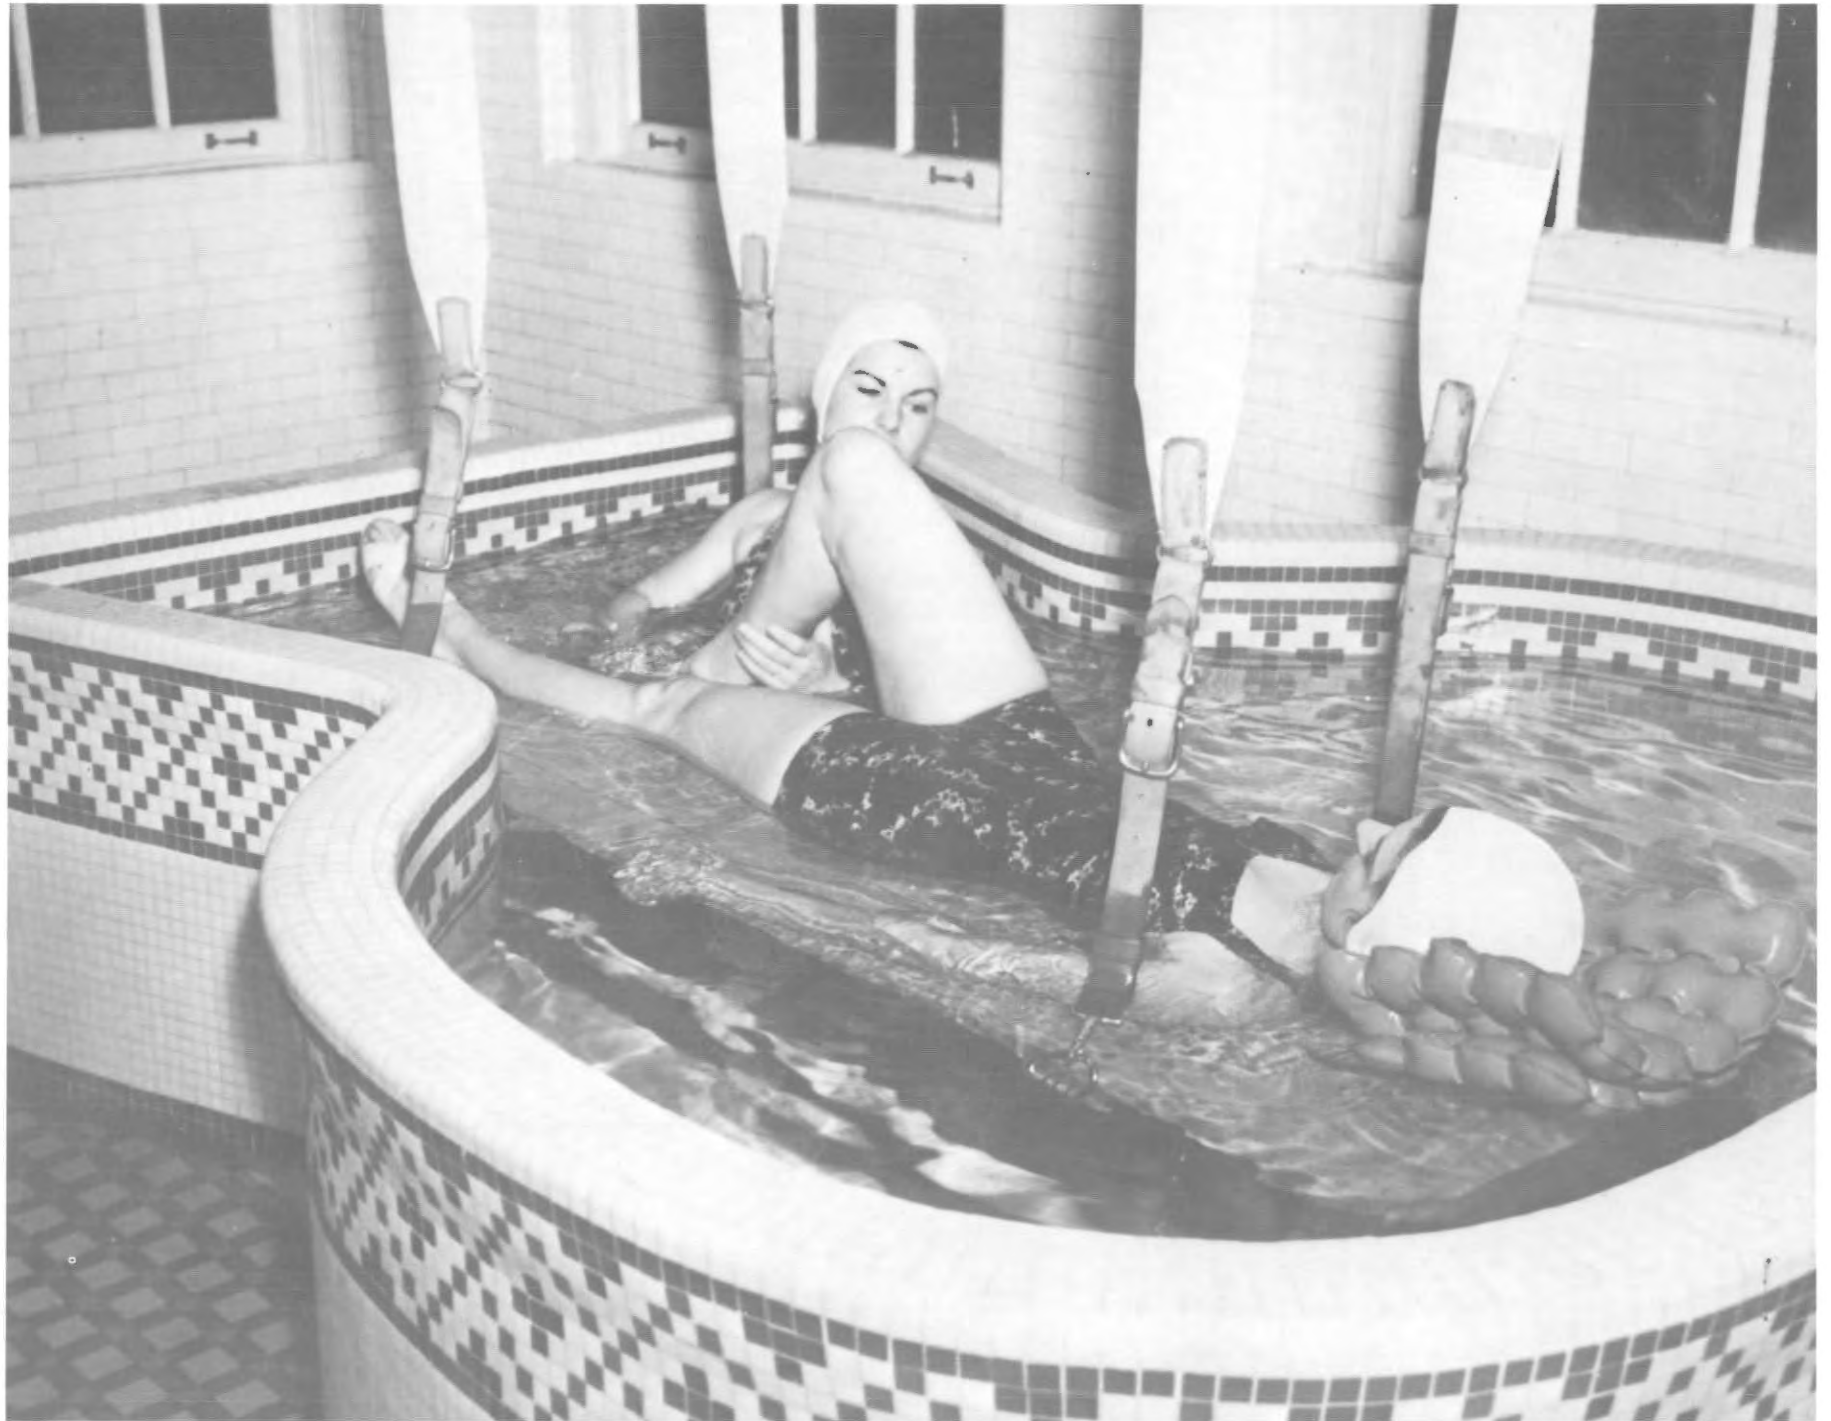
Figure 64. Hubbard tub, Fordyce Bathhouse. Stamped on reverse "DeLuxe Studio/Mar 1 1939/Hot Springs, Ark." The buoyancy of the water and the handrails enabled the patient to retrain muscles for walking.

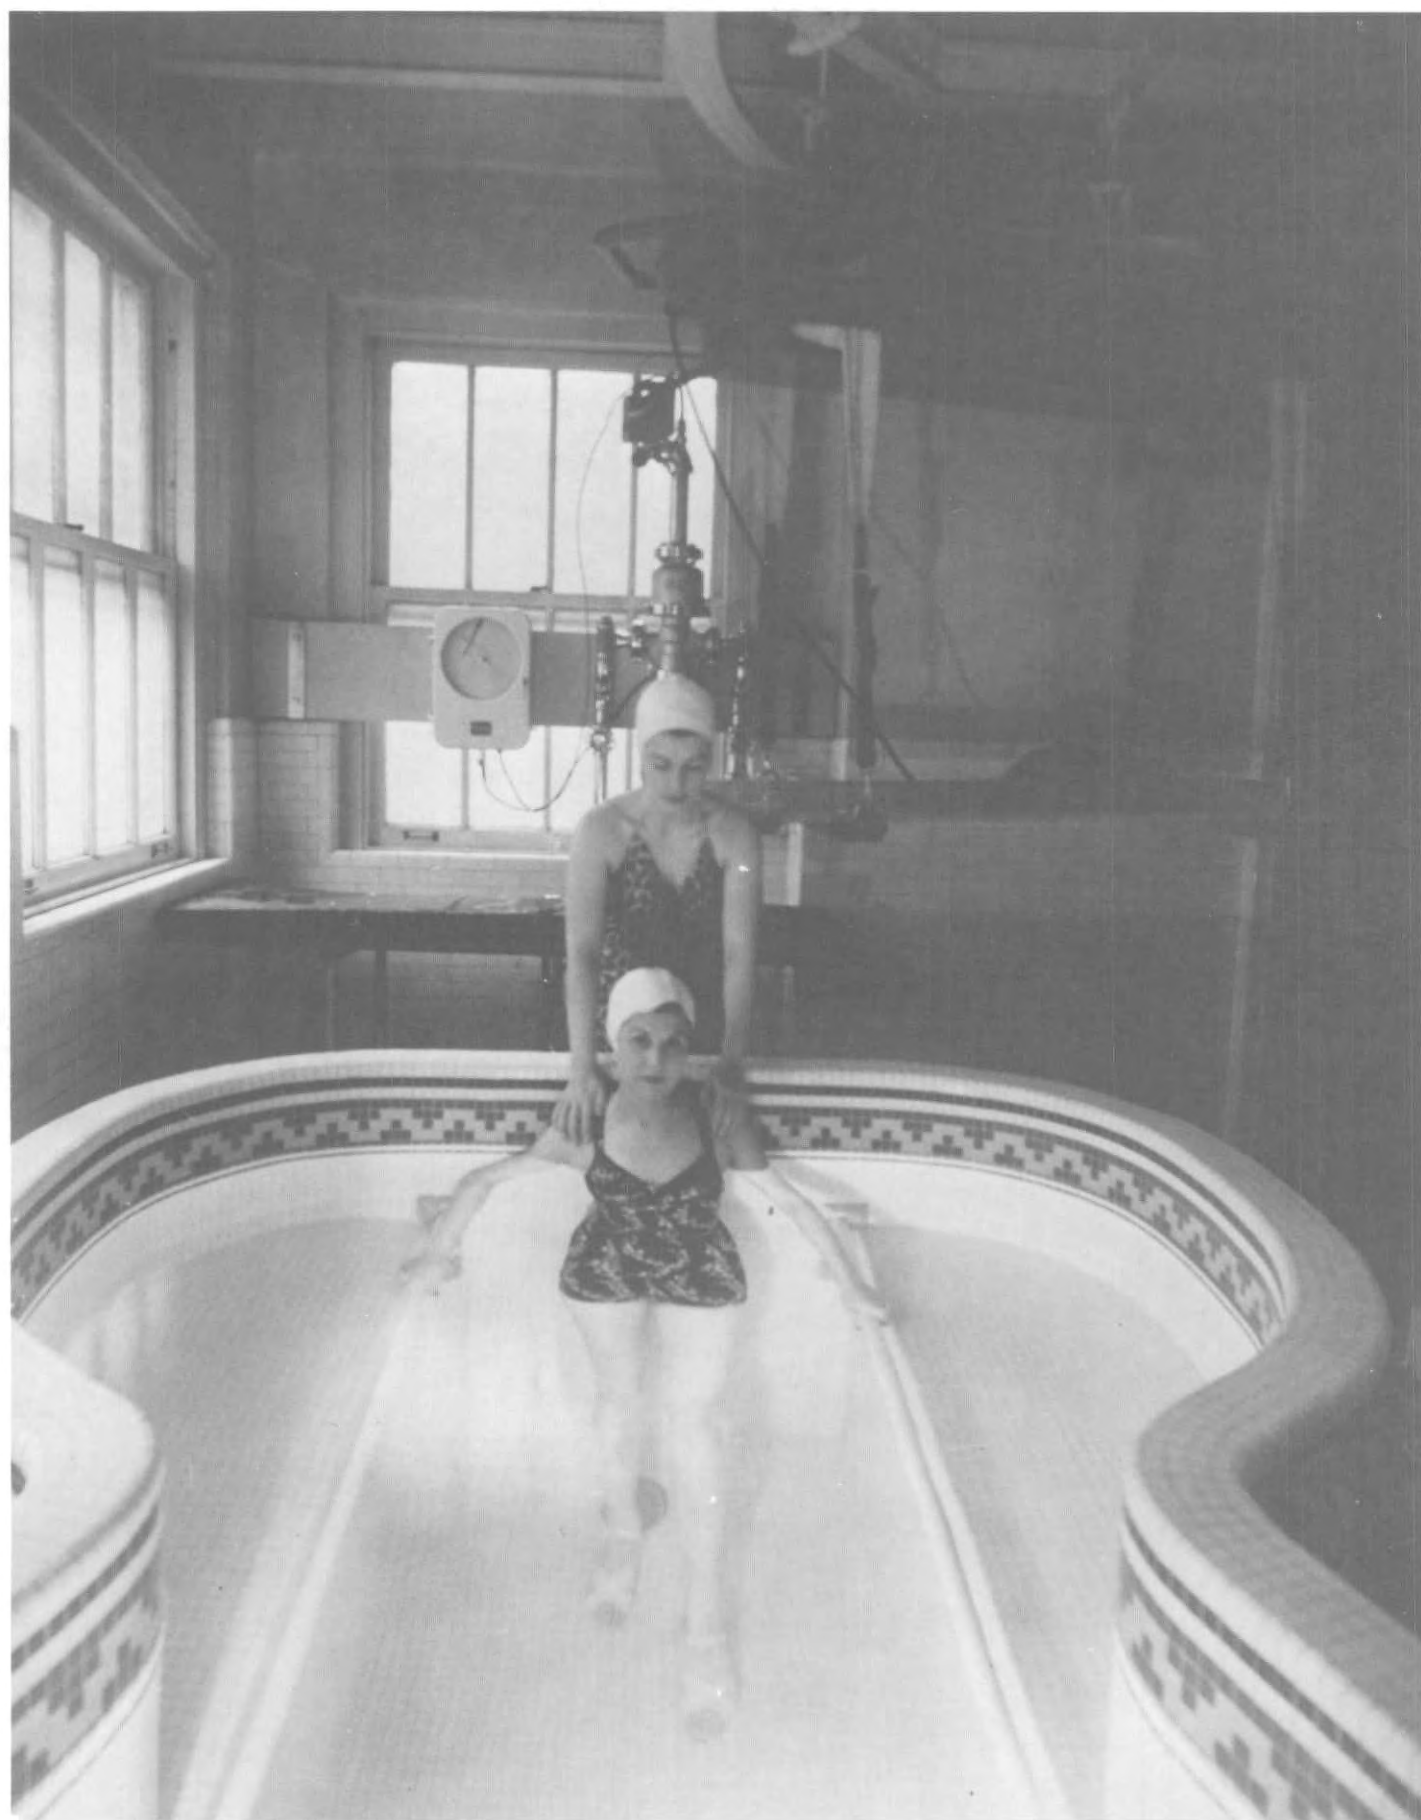
Figure 65. Hubbard tub, Fordyce Bathhouse. Stamped on reverse "DeLuxe Studio/Mar 1 1939/Hot Springs, Ark." This photograph does not show the tub being used therapeutically but does clearly show the overhead stretcher system.

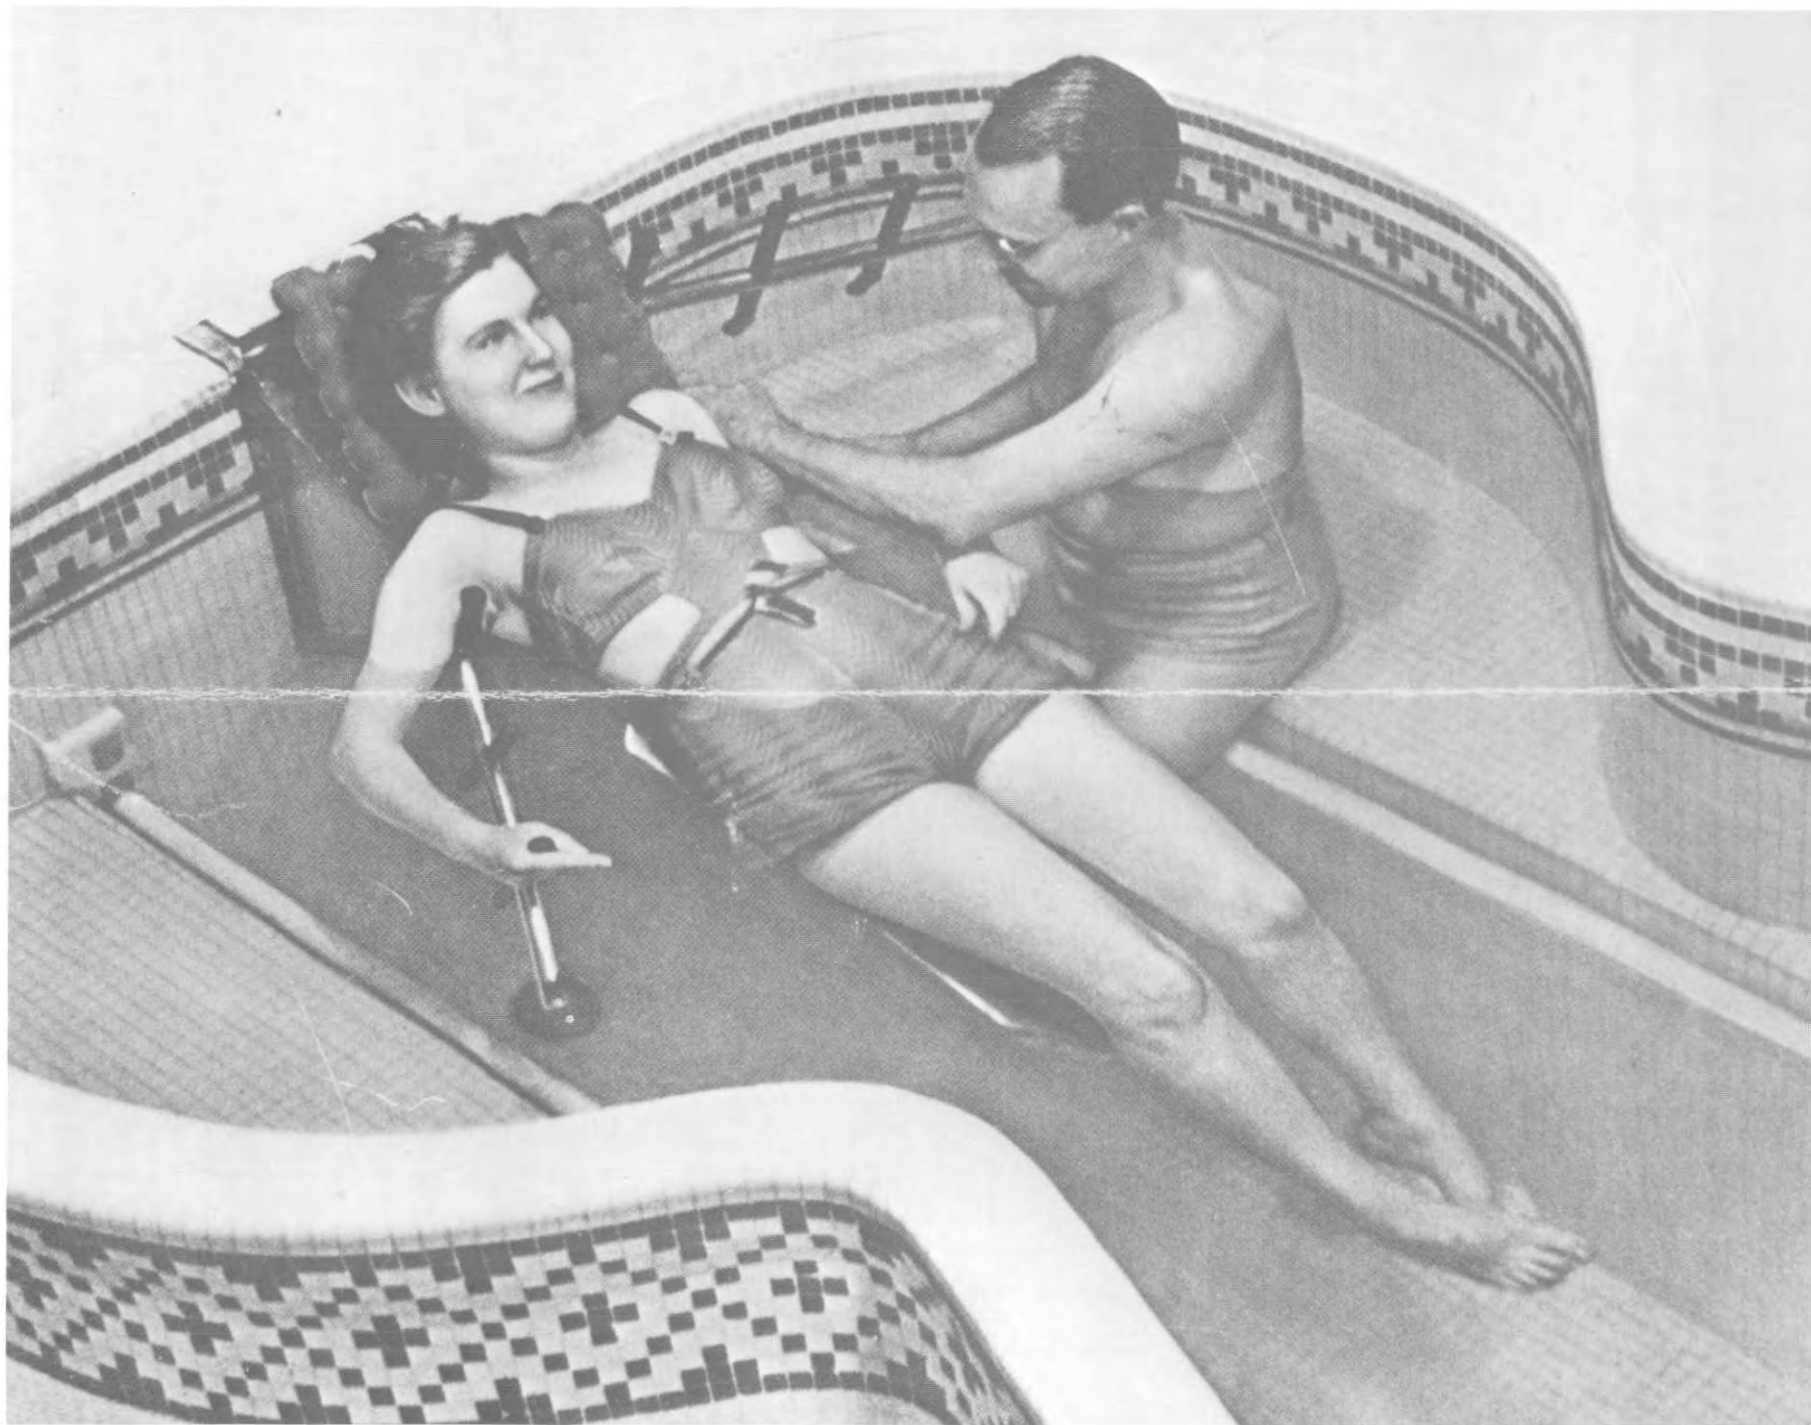
Figure 69. Hubbard tub, Fordyce Bathhouse. Pictorial evidence indicates that it was much more common for the physiotherapist to provide treatment while in the tub with the patient. The position pictured here seems uncomfortable and unwieldy.
