The Well In The Entrance Hall  
Of *Independence Hall*  
Independence National Historical Park

Archaeologist: Charles I. Wilson, Jr.  
Excavated: September, 1967  
Submitted: December, 1967  
Purchase Order: 391-220

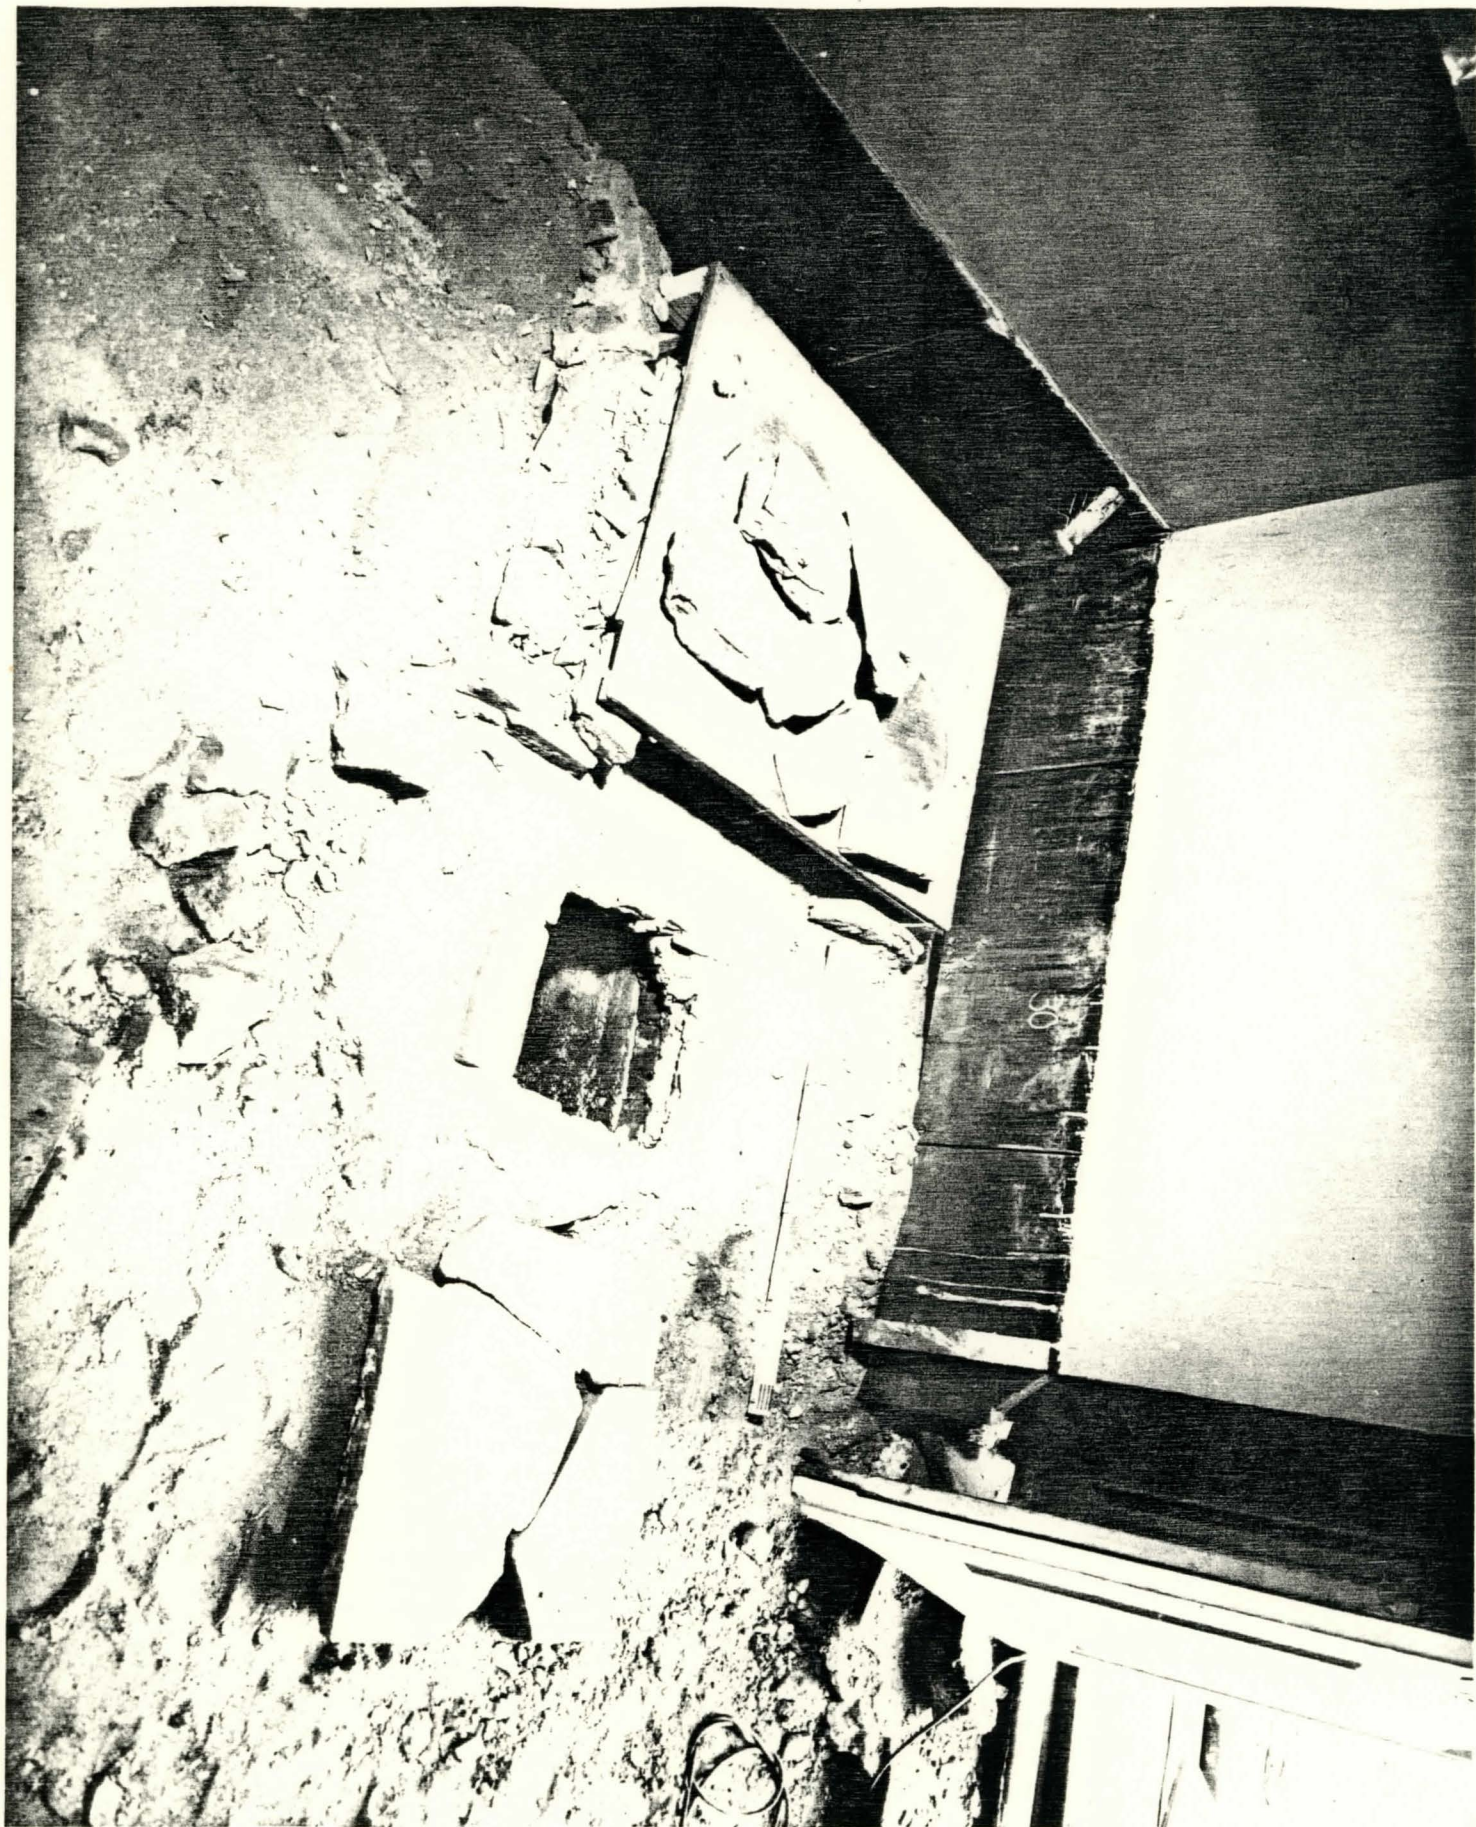
The well is located in the Northwest corner of the Entrance Hall of Independence Hall. It was covered with a red sandstone cap (shown to the right of the opening). Descent into the well was made through this opening.\*

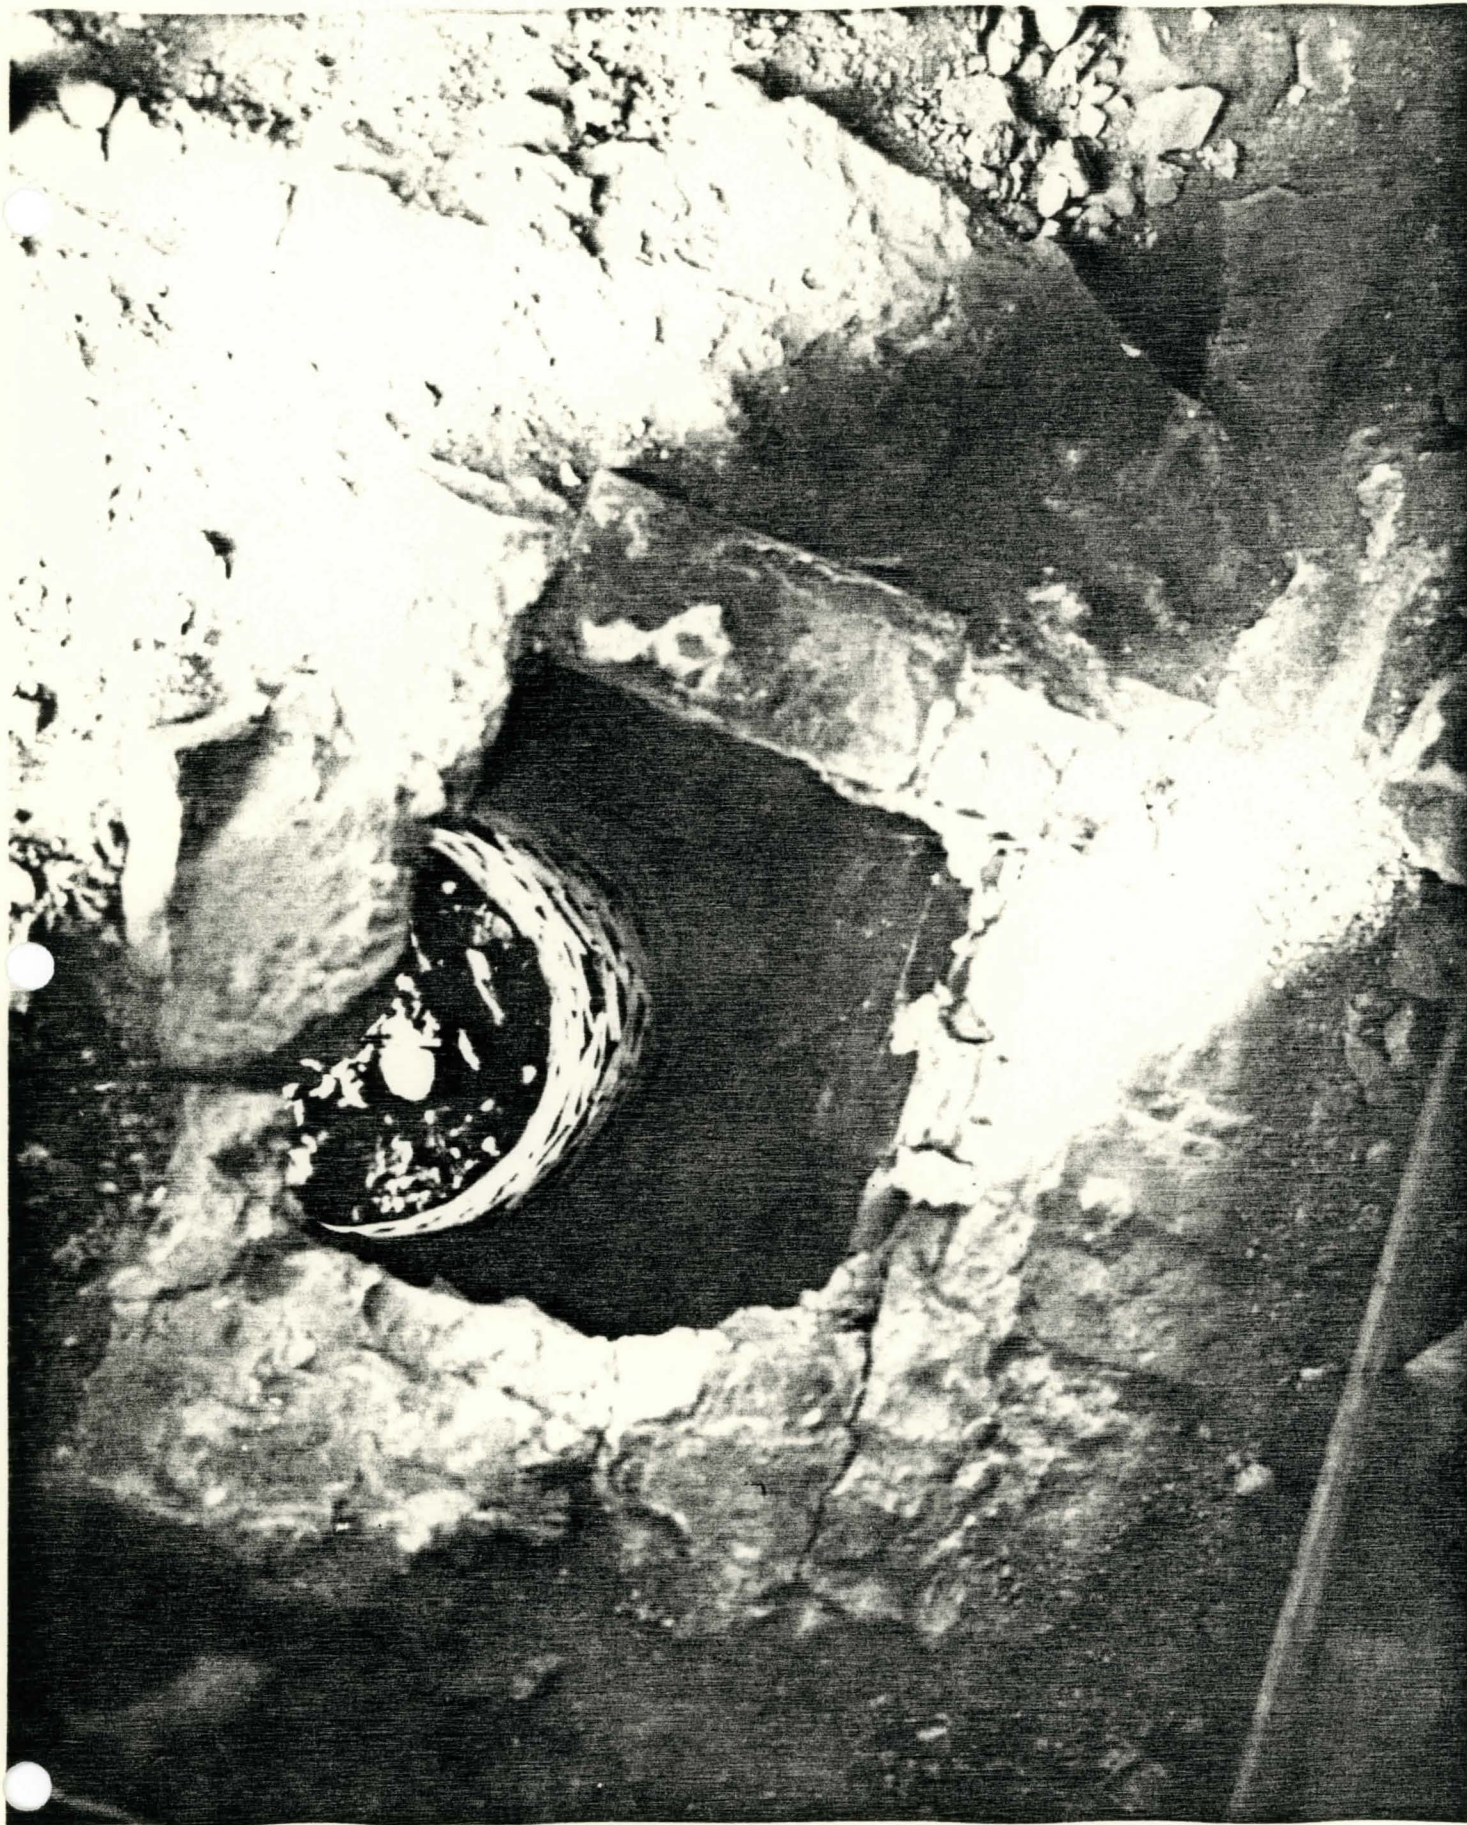
PHOTOGRAPH 3  
SITE #1  
LOCATION Below Entrance Hall  
SUBJECT Corbeling

This is the top of the corbeling that was placed above the well. The interior was laid up in order to make a 14" x 14" opening. Below are the bricks (stretchers) that comprize the well casing.

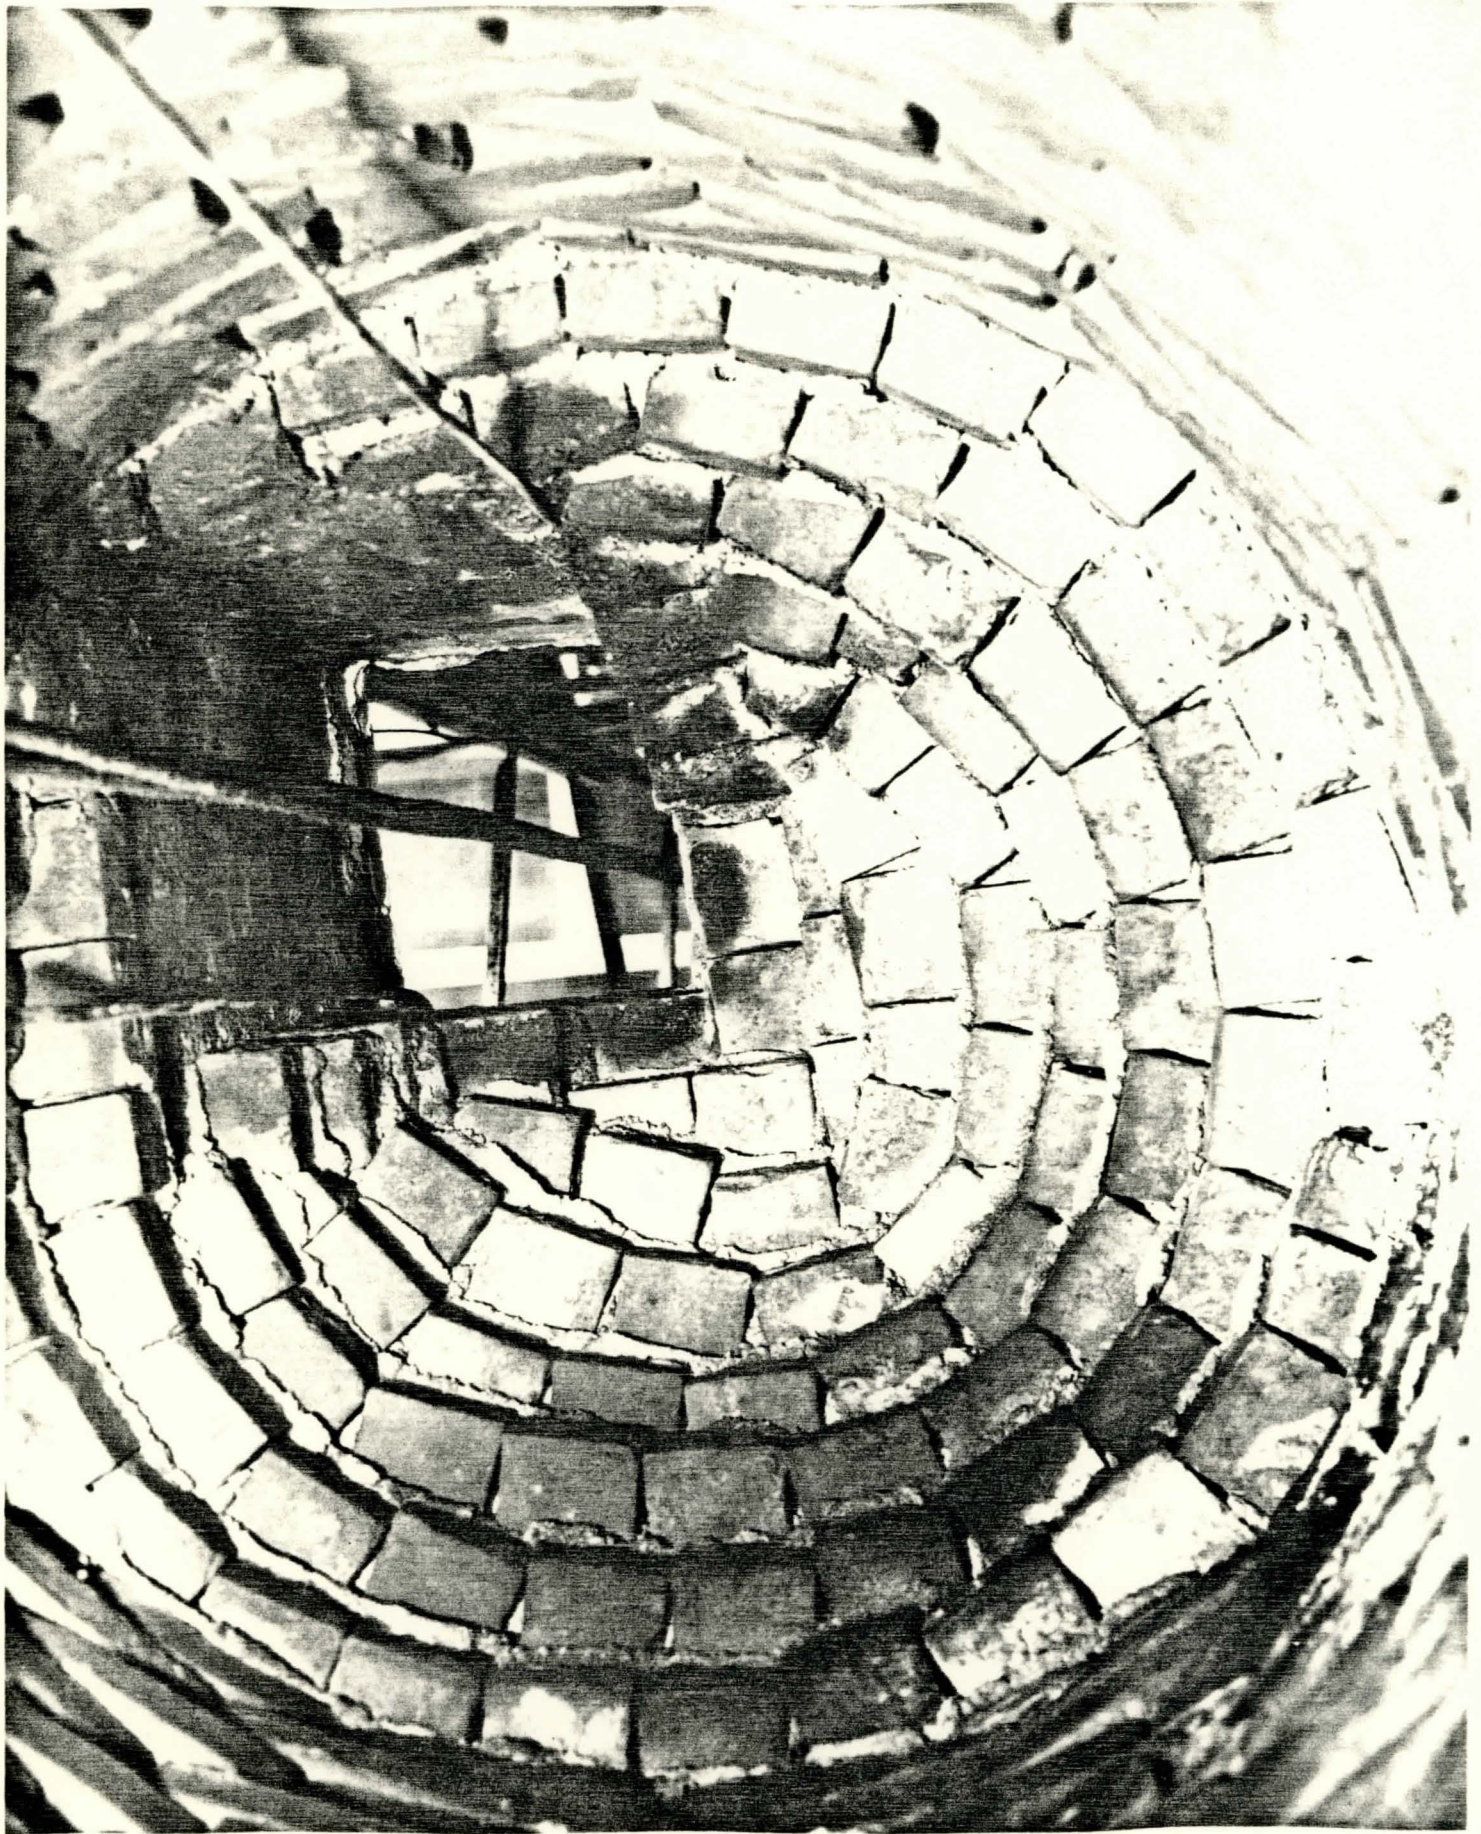
PHOTOGRAPH 4  
SITE #1  
LOCATION Below Entrance Hall  
SUBJECT Bottom of Well

The corbeled section of the well is a magnificent piece of workmanship. It is comprised of headers fitted not only in a circular pattern, but also fitted to form the opening. The mortar that was found in these joints was also found along with brick fragments at the bottom of the well.

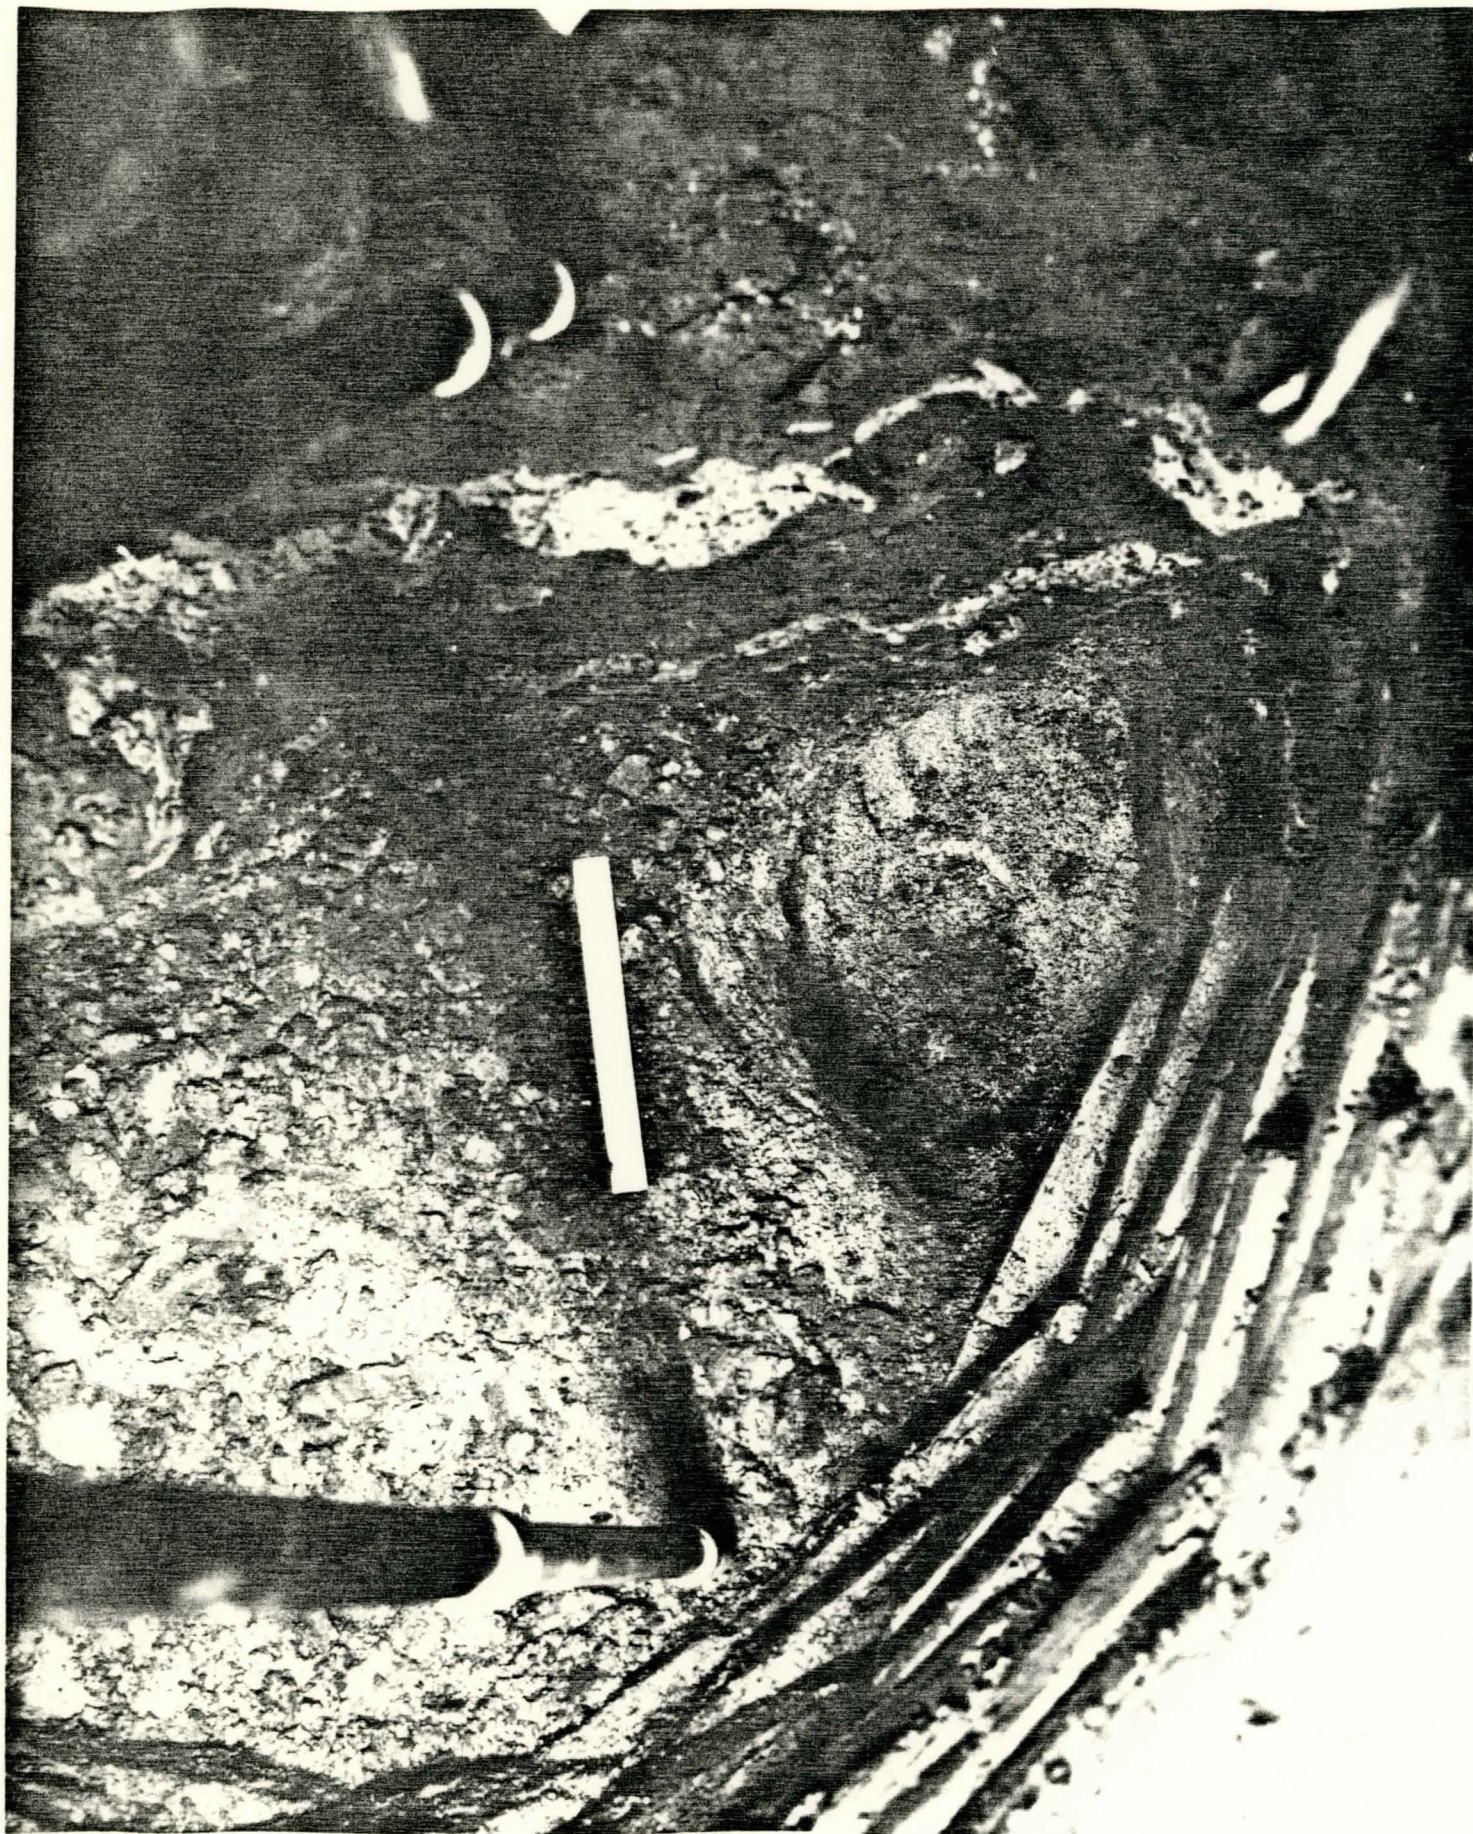
PHOTOGRAPH 5  
SITE #2  
LOCATION Entrance Hall  
SUBJECT Well Casing and Mandible

The bottom of the well was set in coarse sand. At this point it was 32" wide. Cramped quarters made photographing the interior of the well quite difficult. The area between the survey pin and the foot of the tripod is a vertical profile of alternating stratum of loam clay and dark brown sand. (Rule = 6")

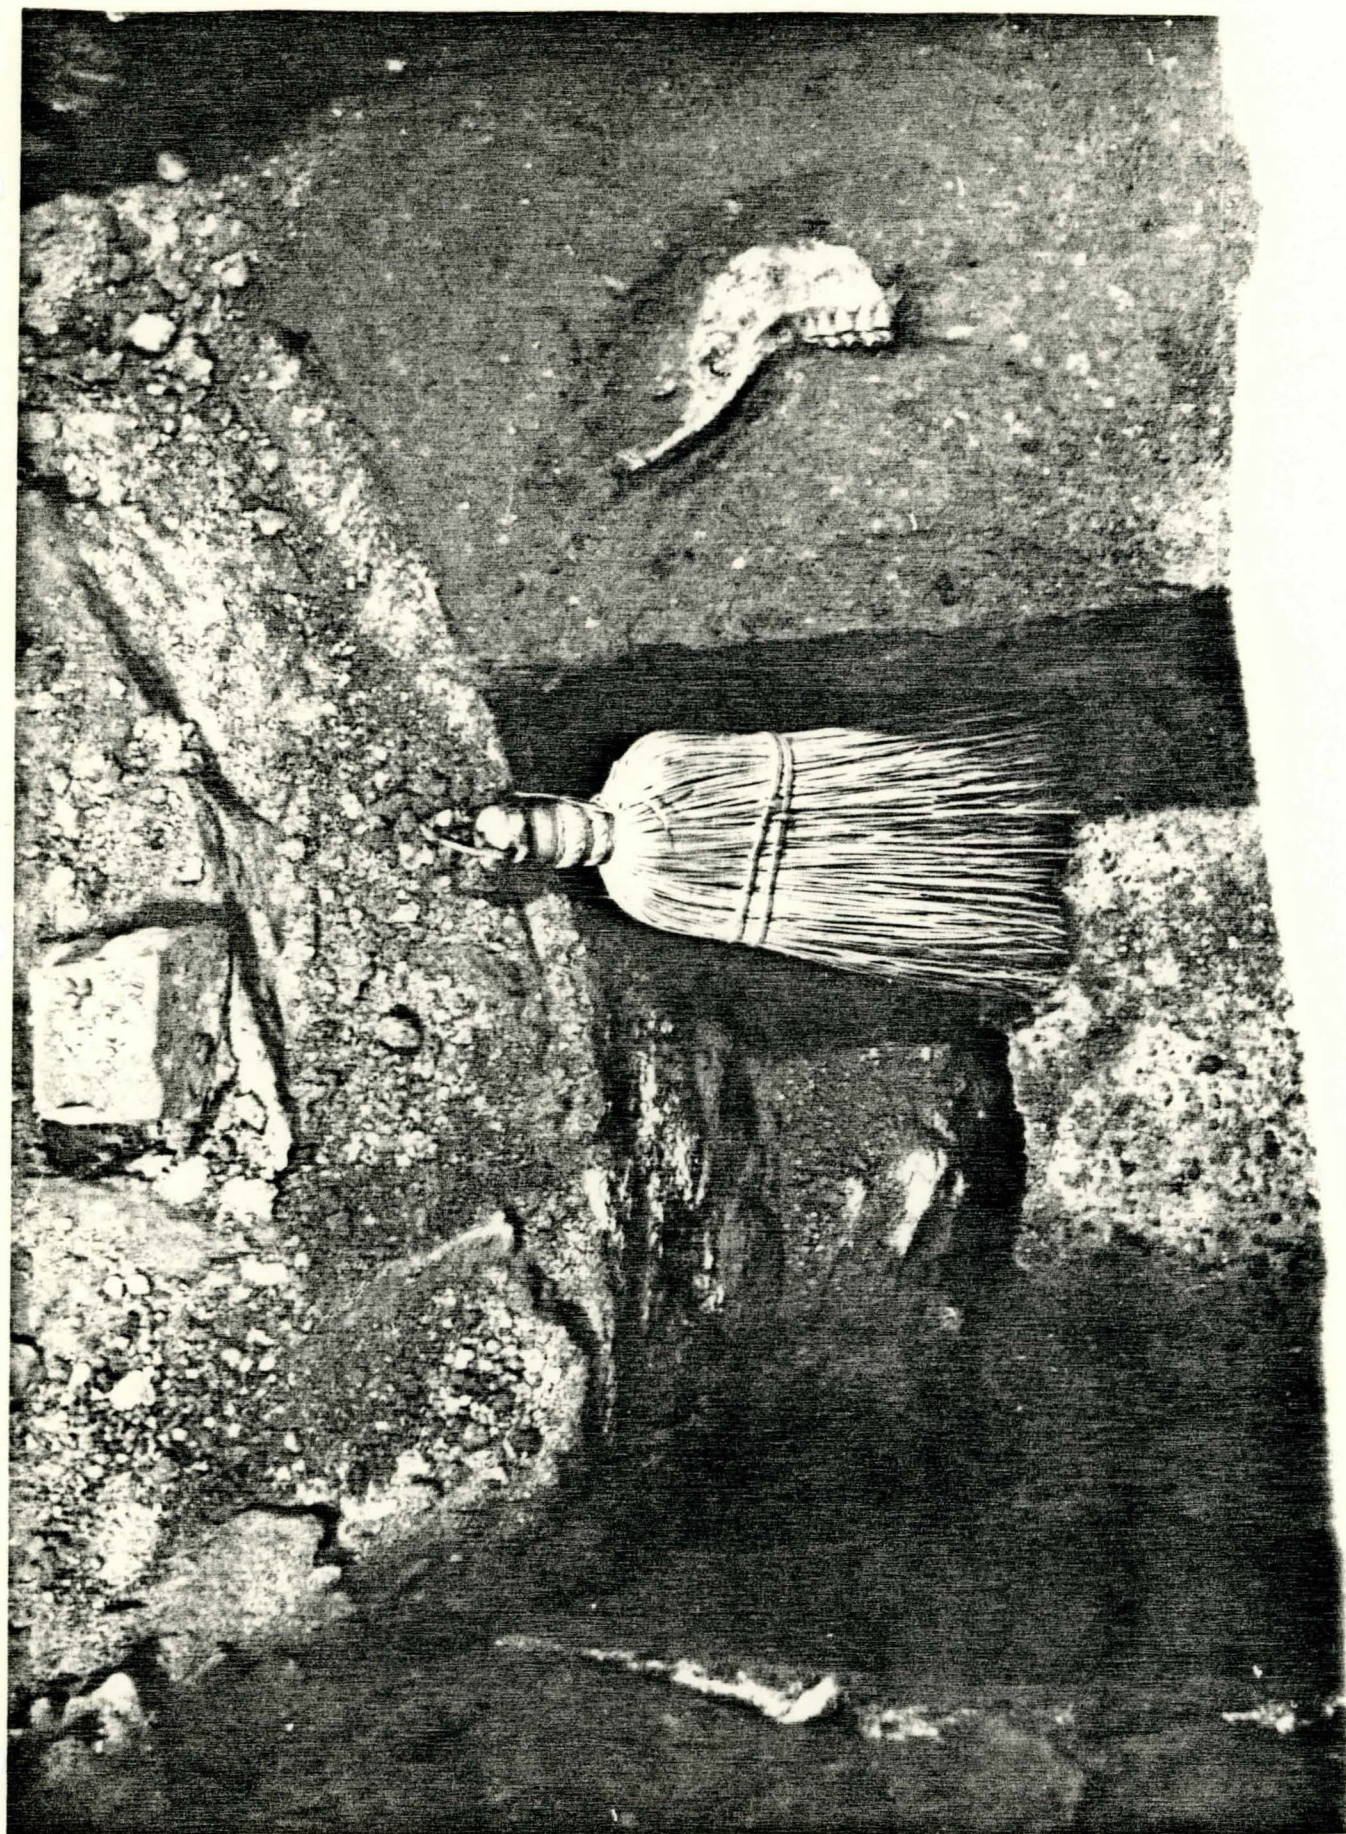
PHOTOGRAPH 6  
SITE #2  
LOCATION Entrance Hall  
SUBJECT Bricks

The mandible of a deer was found in the old humus. It was in association with 18th century artifacts. No artifacts were found in the cavity created between the humus and the well casing. The entire undisturbed area was dotted with small holes.

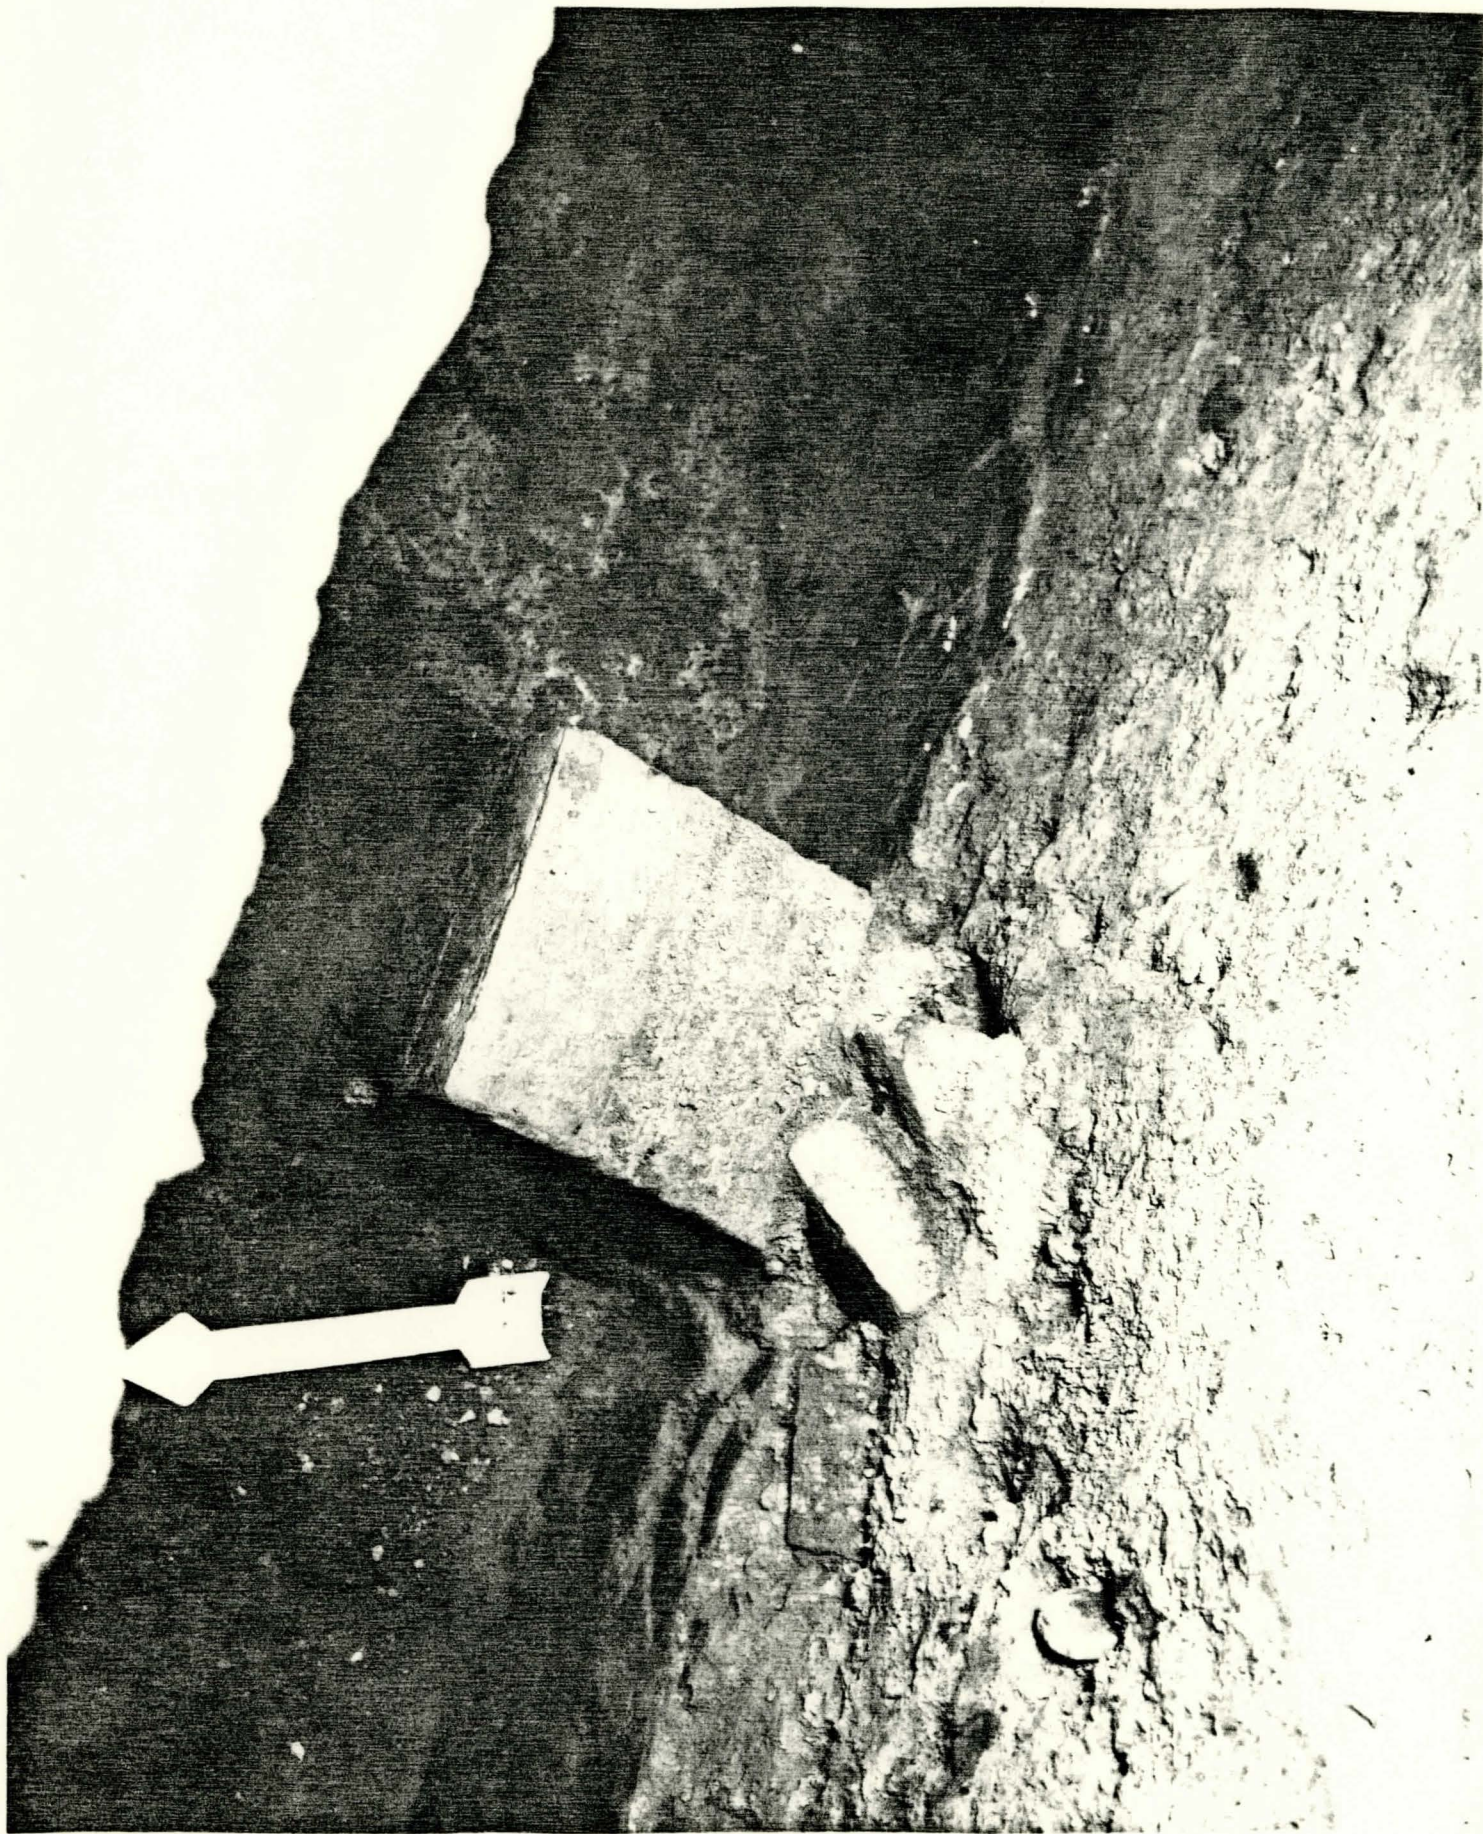
These are two of three bricks ( $8\frac{1}{2} \times 4\frac{1}{4} \times 2\frac{3}{8}$ ) that were found on top of the humus.\* There occurrence in this spot would indicate that they were of the type used in the construction of the State House. They are 5 to 6' from the wood paneling and feet from the west wall.

\*Third was to the north of those shown; there were none to the south.

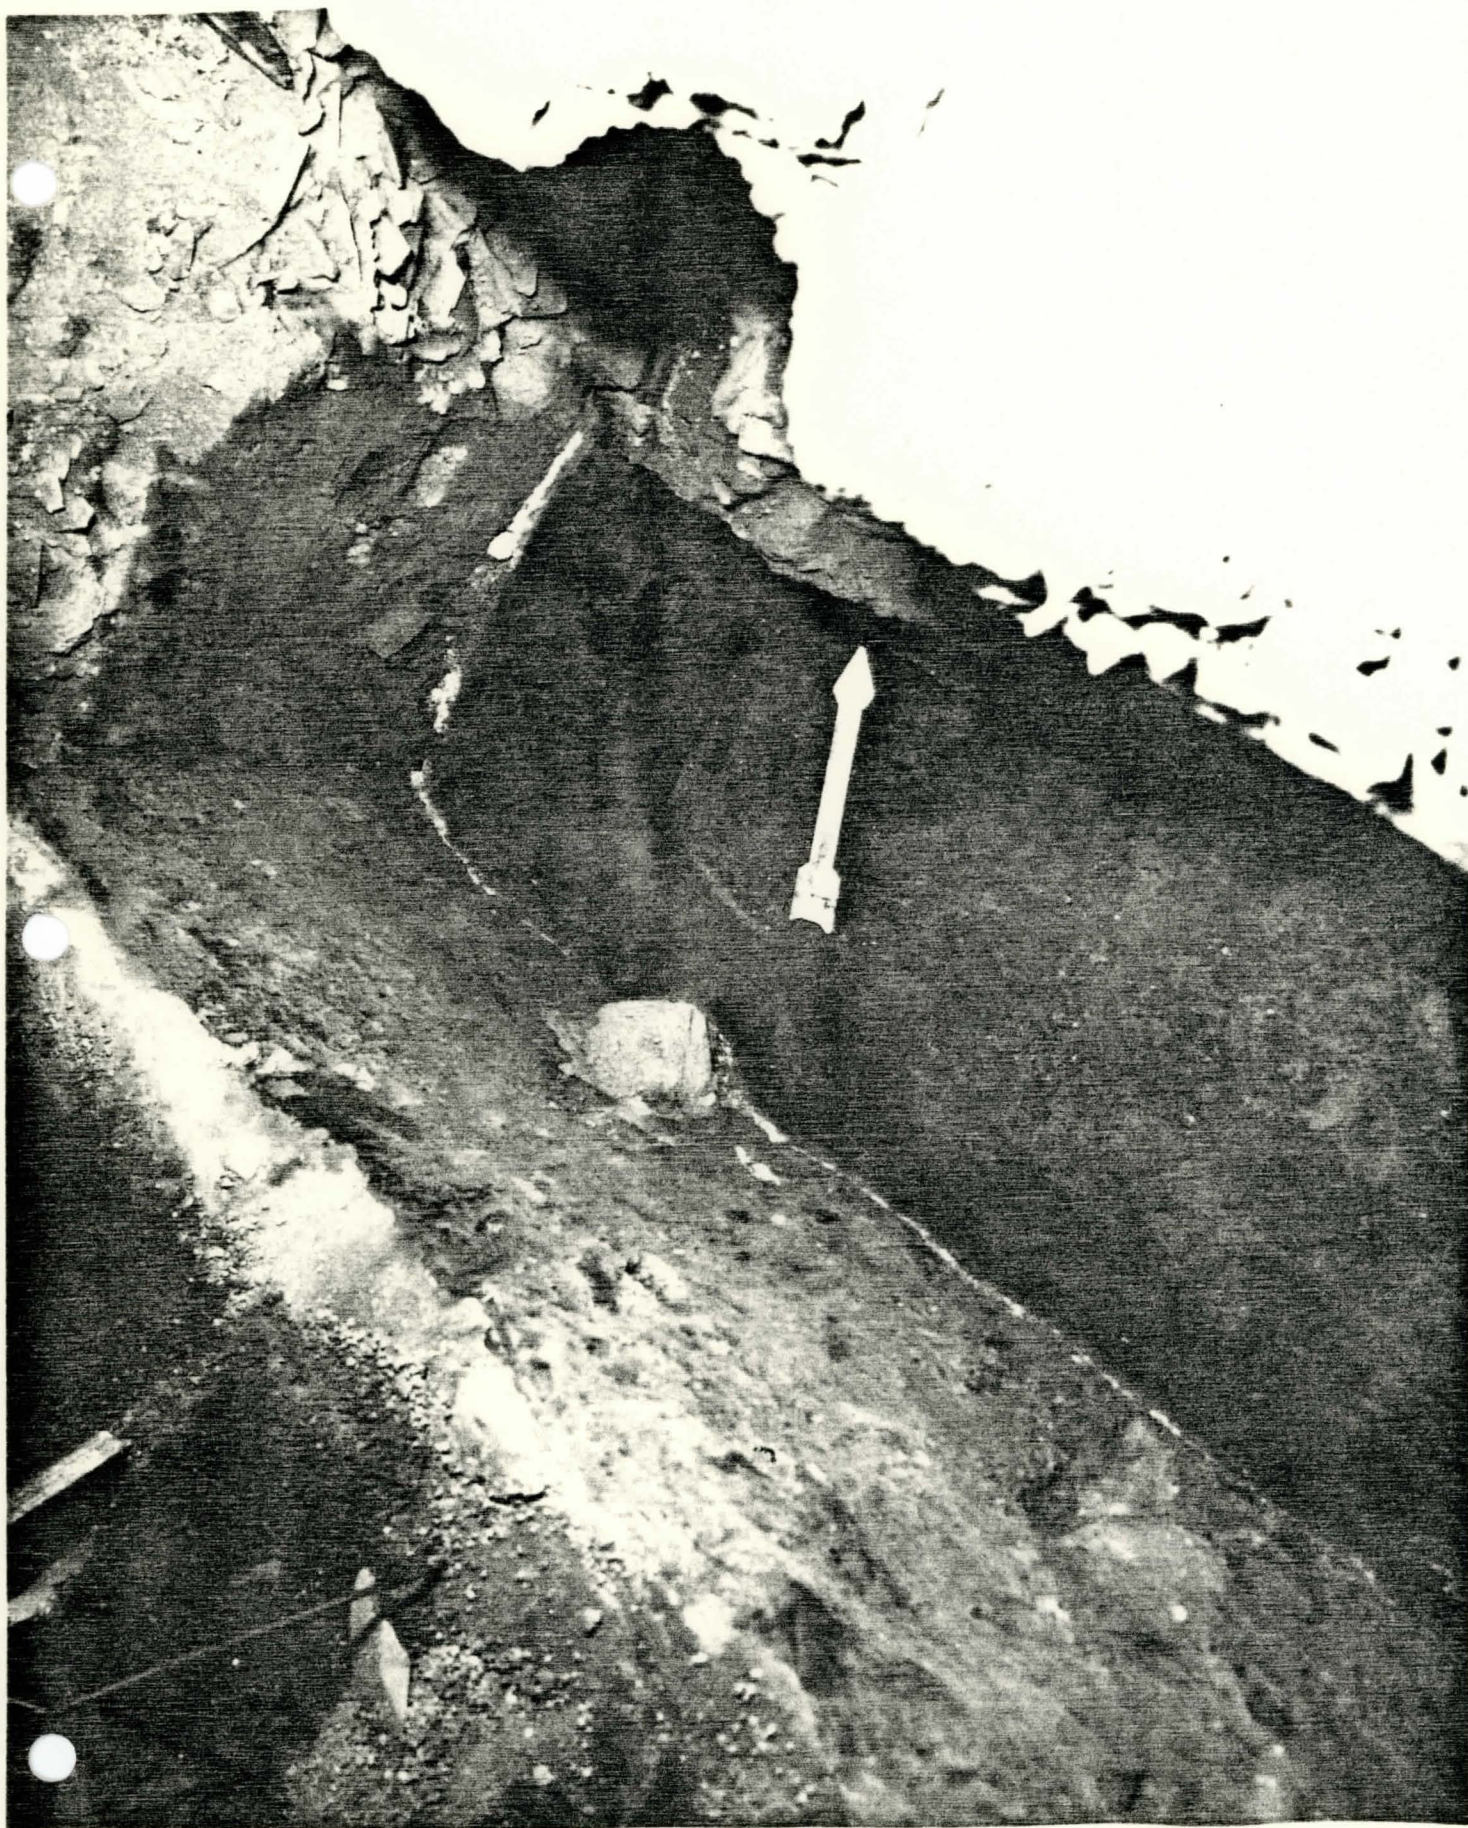
PHOTOGRAPH 8  
SITE #2  
LOCATION Entrance Hall  
SUBJECT South West Corner of Trial Trench

There are five strata in the trench. The uppermost is refill that was placed there when the State House built. The lime lens was from craftsman working on the building. Below this is a lens of yellow sand ( not noticeable in this picture). The humus pre dates the completion of the building. It contains 18th century material, but in all probability extends over a period of several hundred years. The loam clay below the humus contained no artifacts.

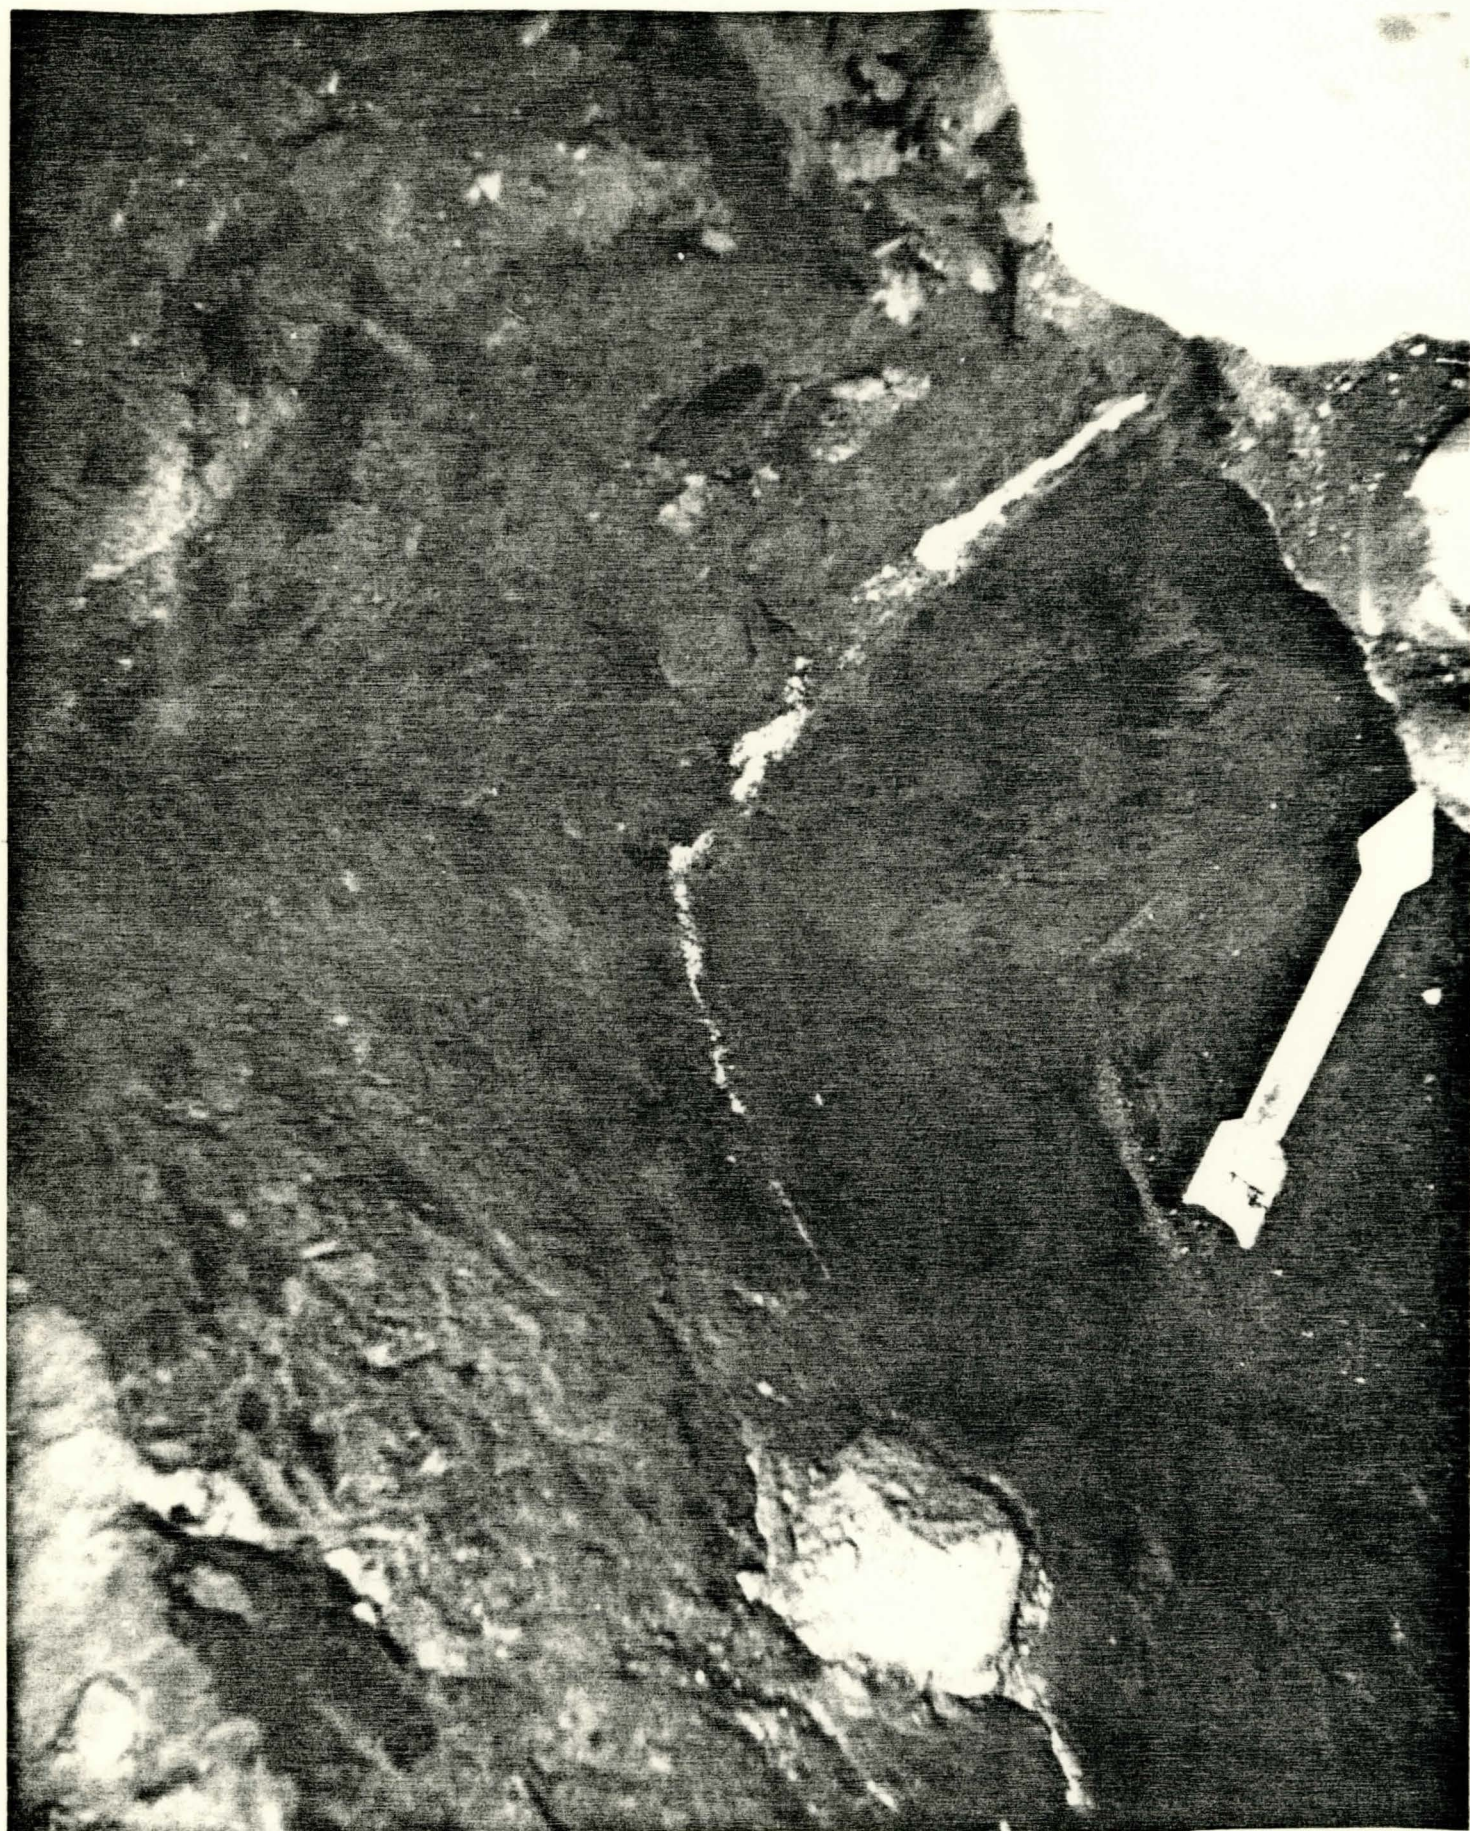
PHOTOGRAPH 9  
SITE #2  
LOCATION Entrance Hall  
SUBJECT Junction of Well and Old Humus

The humus in this trench has a definite association with the well. They are contemporary.

No trees or large root systems were in evidence. The sub-soil was well full of minute holes. These were verticle and often extended the entire depth of the loam clay that was excavated.
