The Well In The Entrance Hall  
Of *Independence Hall*  
Independence National Historical Park

Archaeologist: Charles I. Wilson, Jr.  
Excavated: September, 1967  
Submitted: December, 1967  
Purchase Order: 391-220

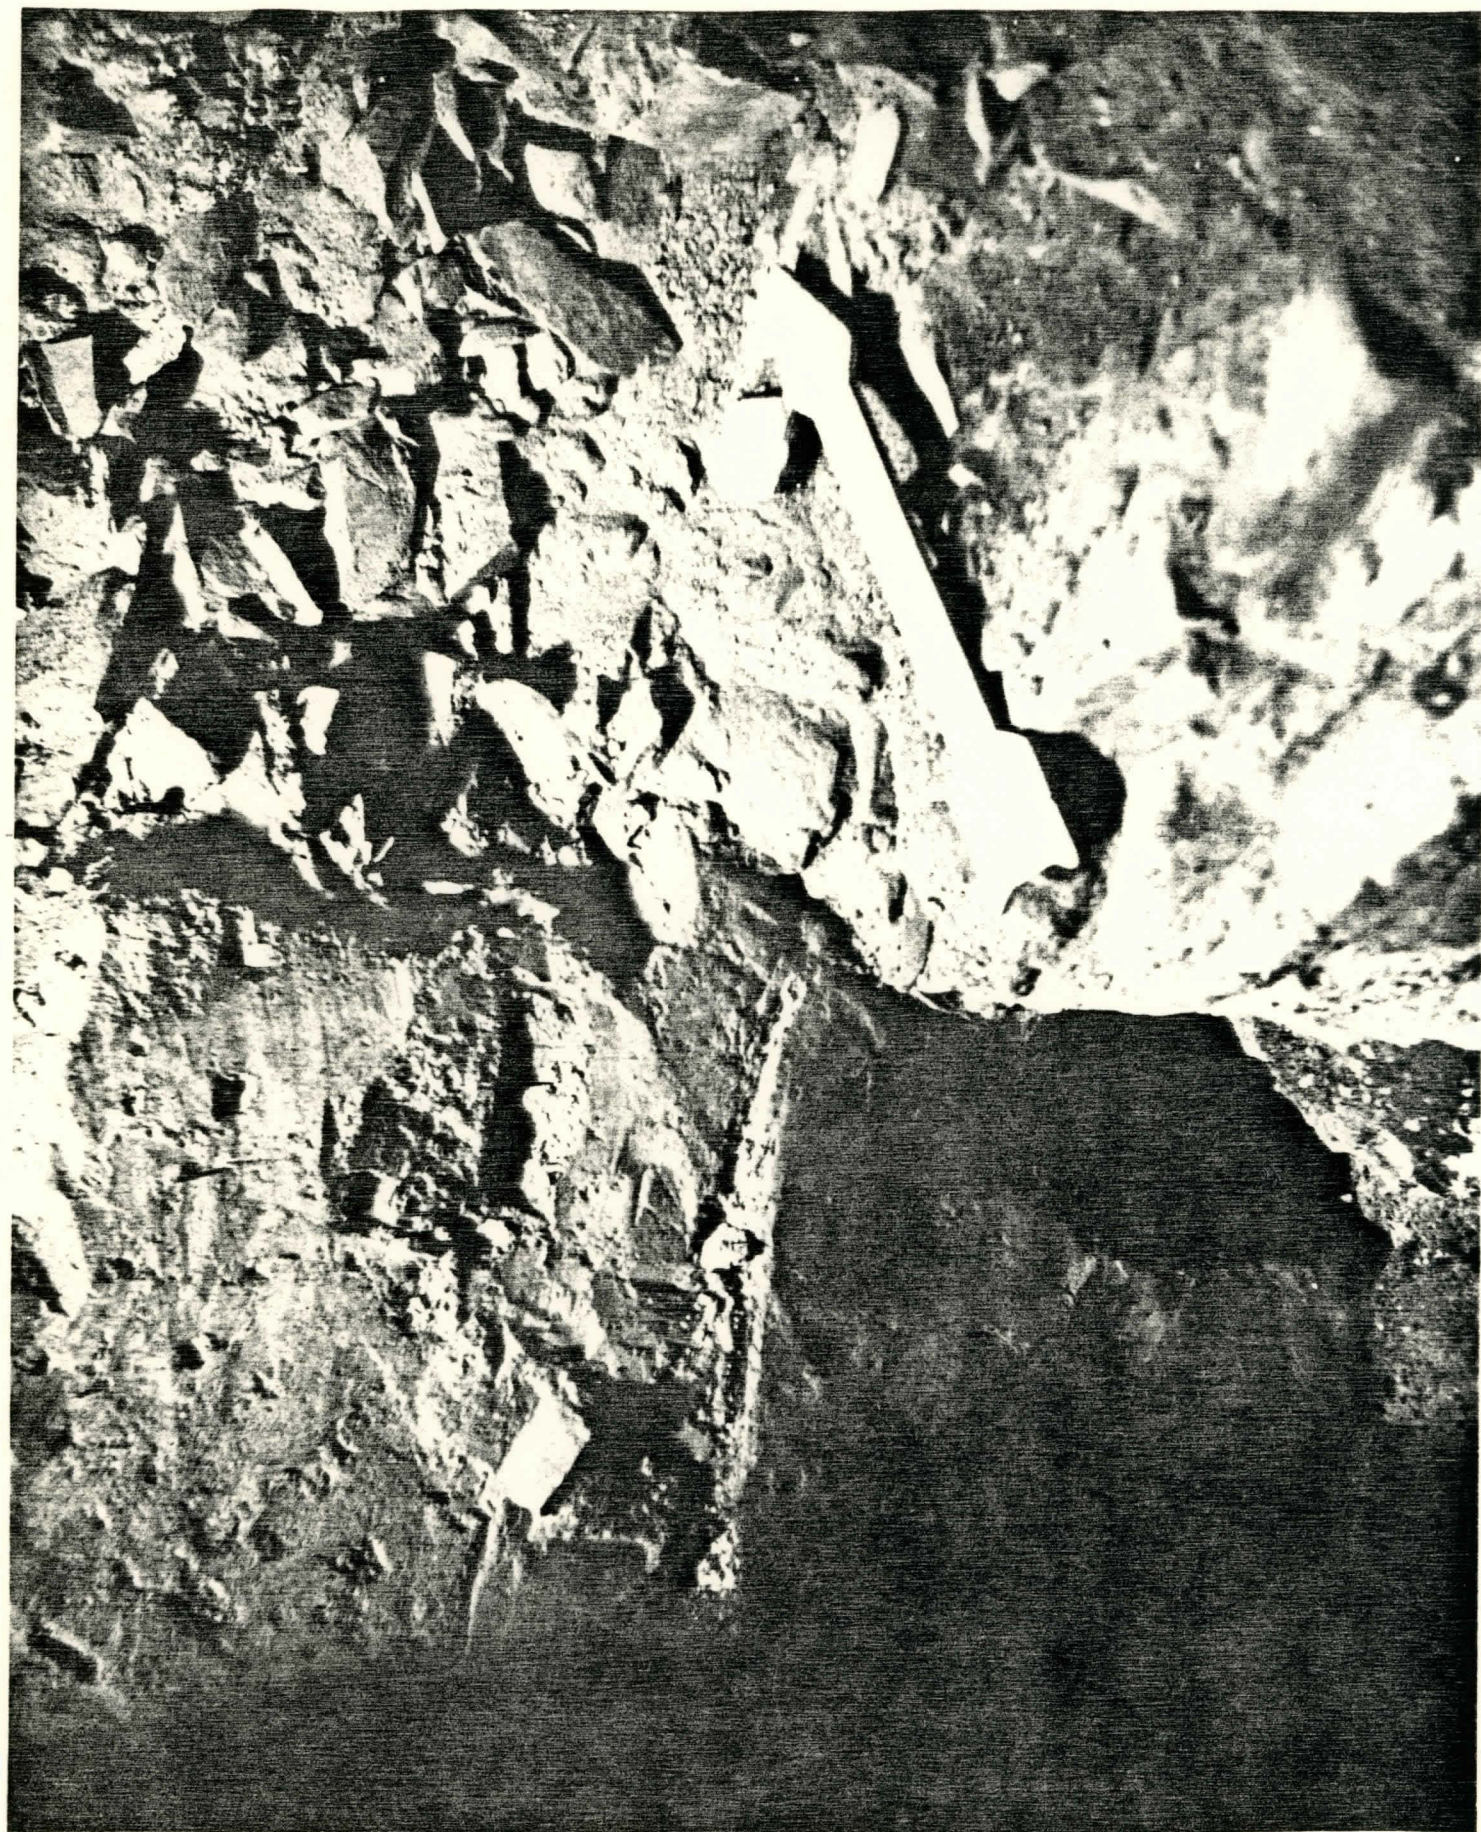
PHOTOGRAPH 10  
SITE #2  
LOCATION Entrance Hall  
SUBJECT Well Casing and Corbeling

This is the west end of the trial trench. To the right of the photograph are the red sandstones chips that were used to refill the area above the well casing. To the left above the lime is the refill that was placed in the Entrance Hall when the State House was built. Below the lime there is a lens of yellow sand. These two lenses are continuous throughout the trial trench. Each lens varies from 1/2" to a trace. They were in all probability deposited when the State House was built. The downward curve of the lime lens has in part been caused by the caving in of the area surrounding the well casing. Note the relationship of the lime lens to the top of the brick. The humus is seven inches thick. It yielded only 18th century artifacts. (17th century material may be found when the artifacts are further studied.)

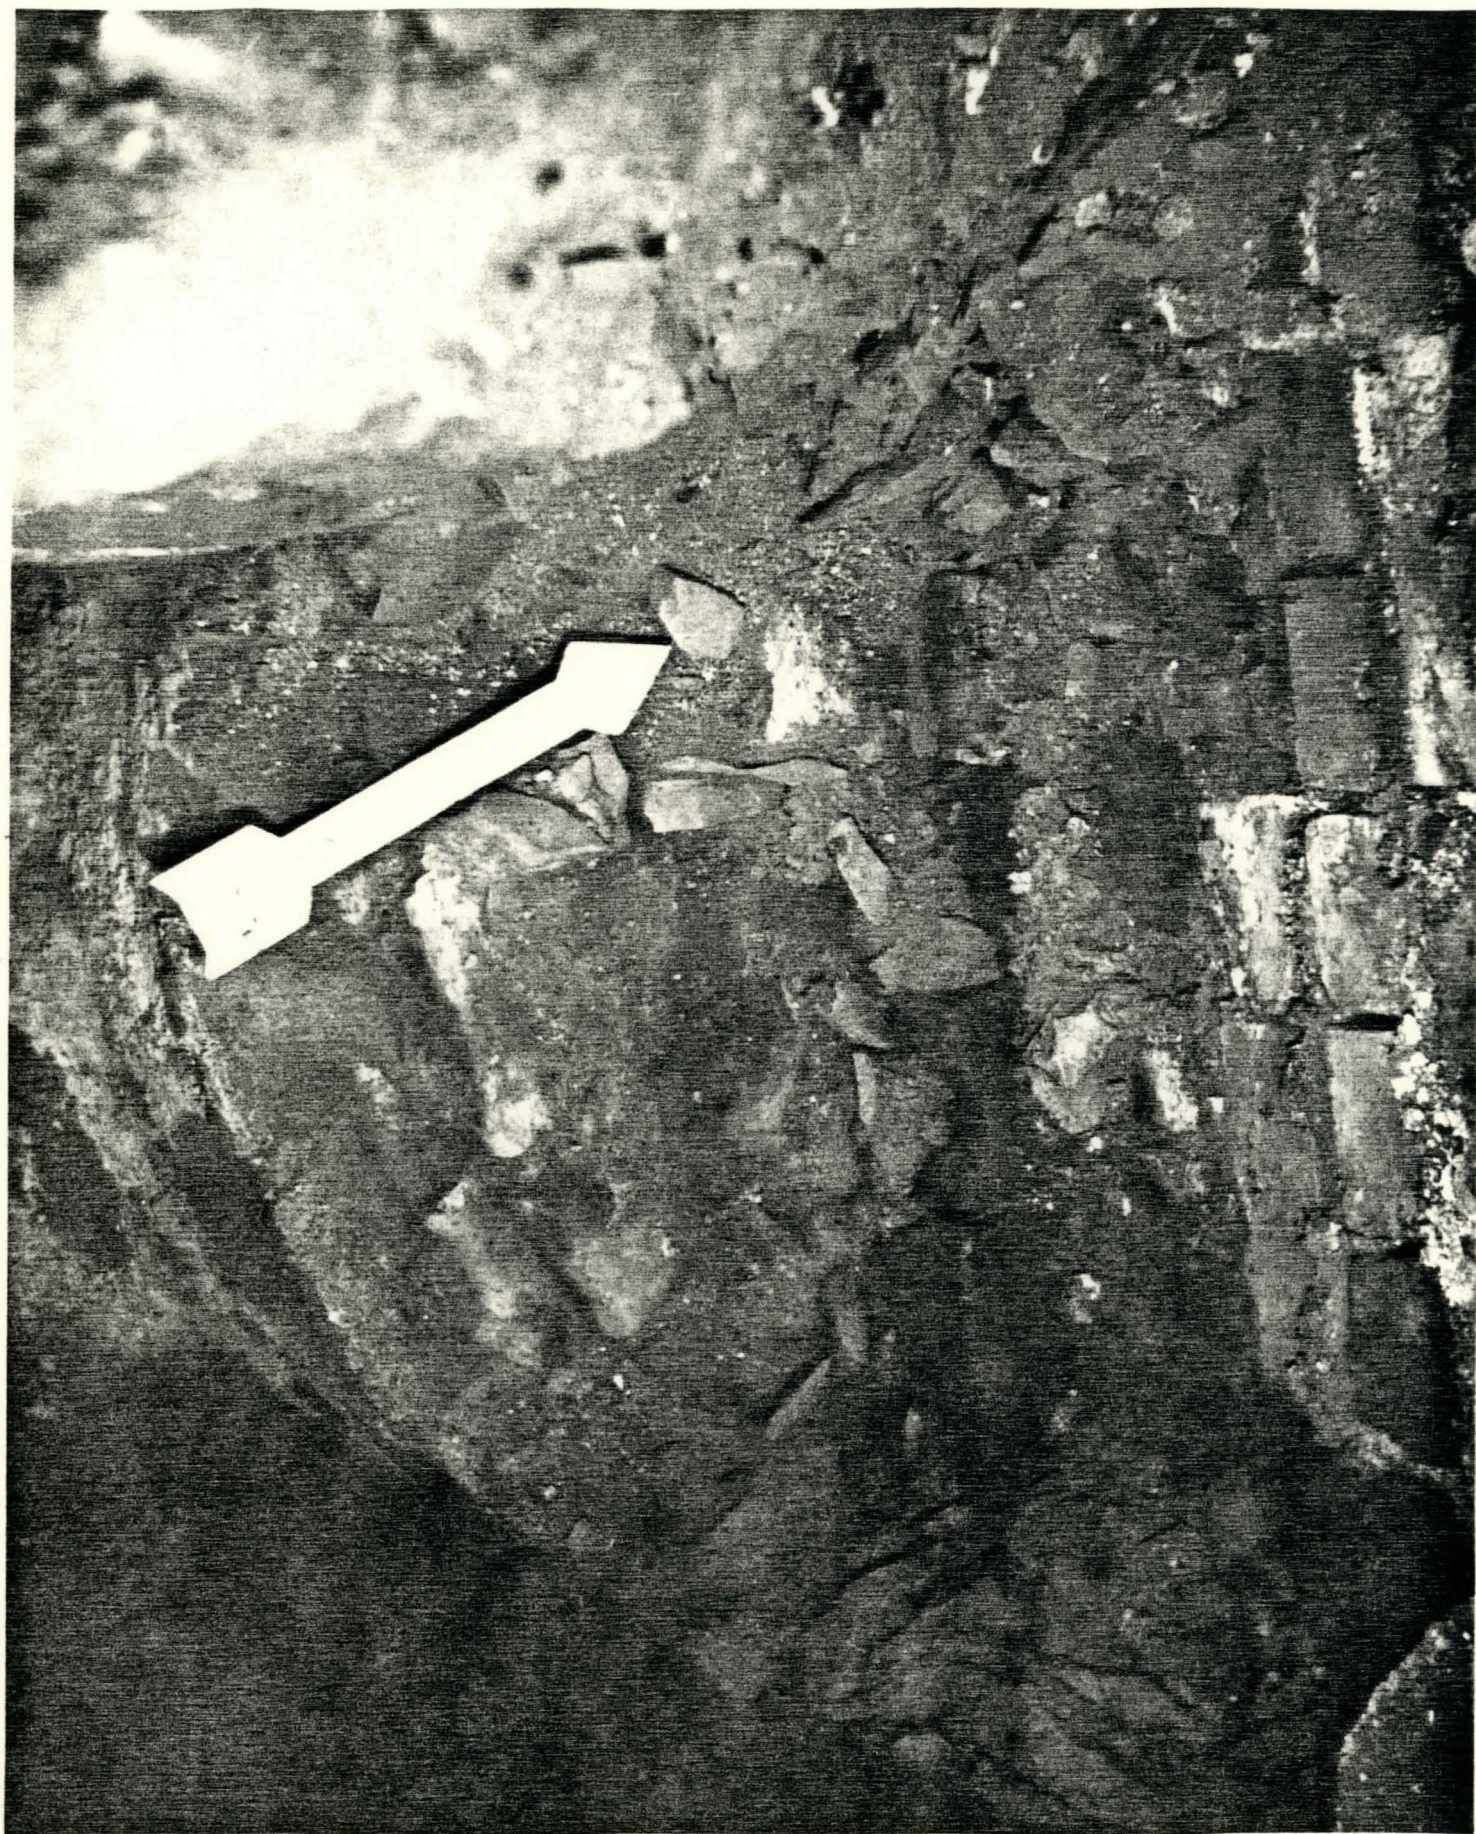
PHOTOGRAPH 11  
SITE #3  
LOCATION North Entrance - Independence Hall  
SUBJECT Void In Steps

Well casing was mortar covered at this level in order to retain corbeled area above. The bricks in the upper part of the picture are those that were found around the 14" x 14" opening. To both sides are the red sandstone chips that were used to fill in around the well casing.

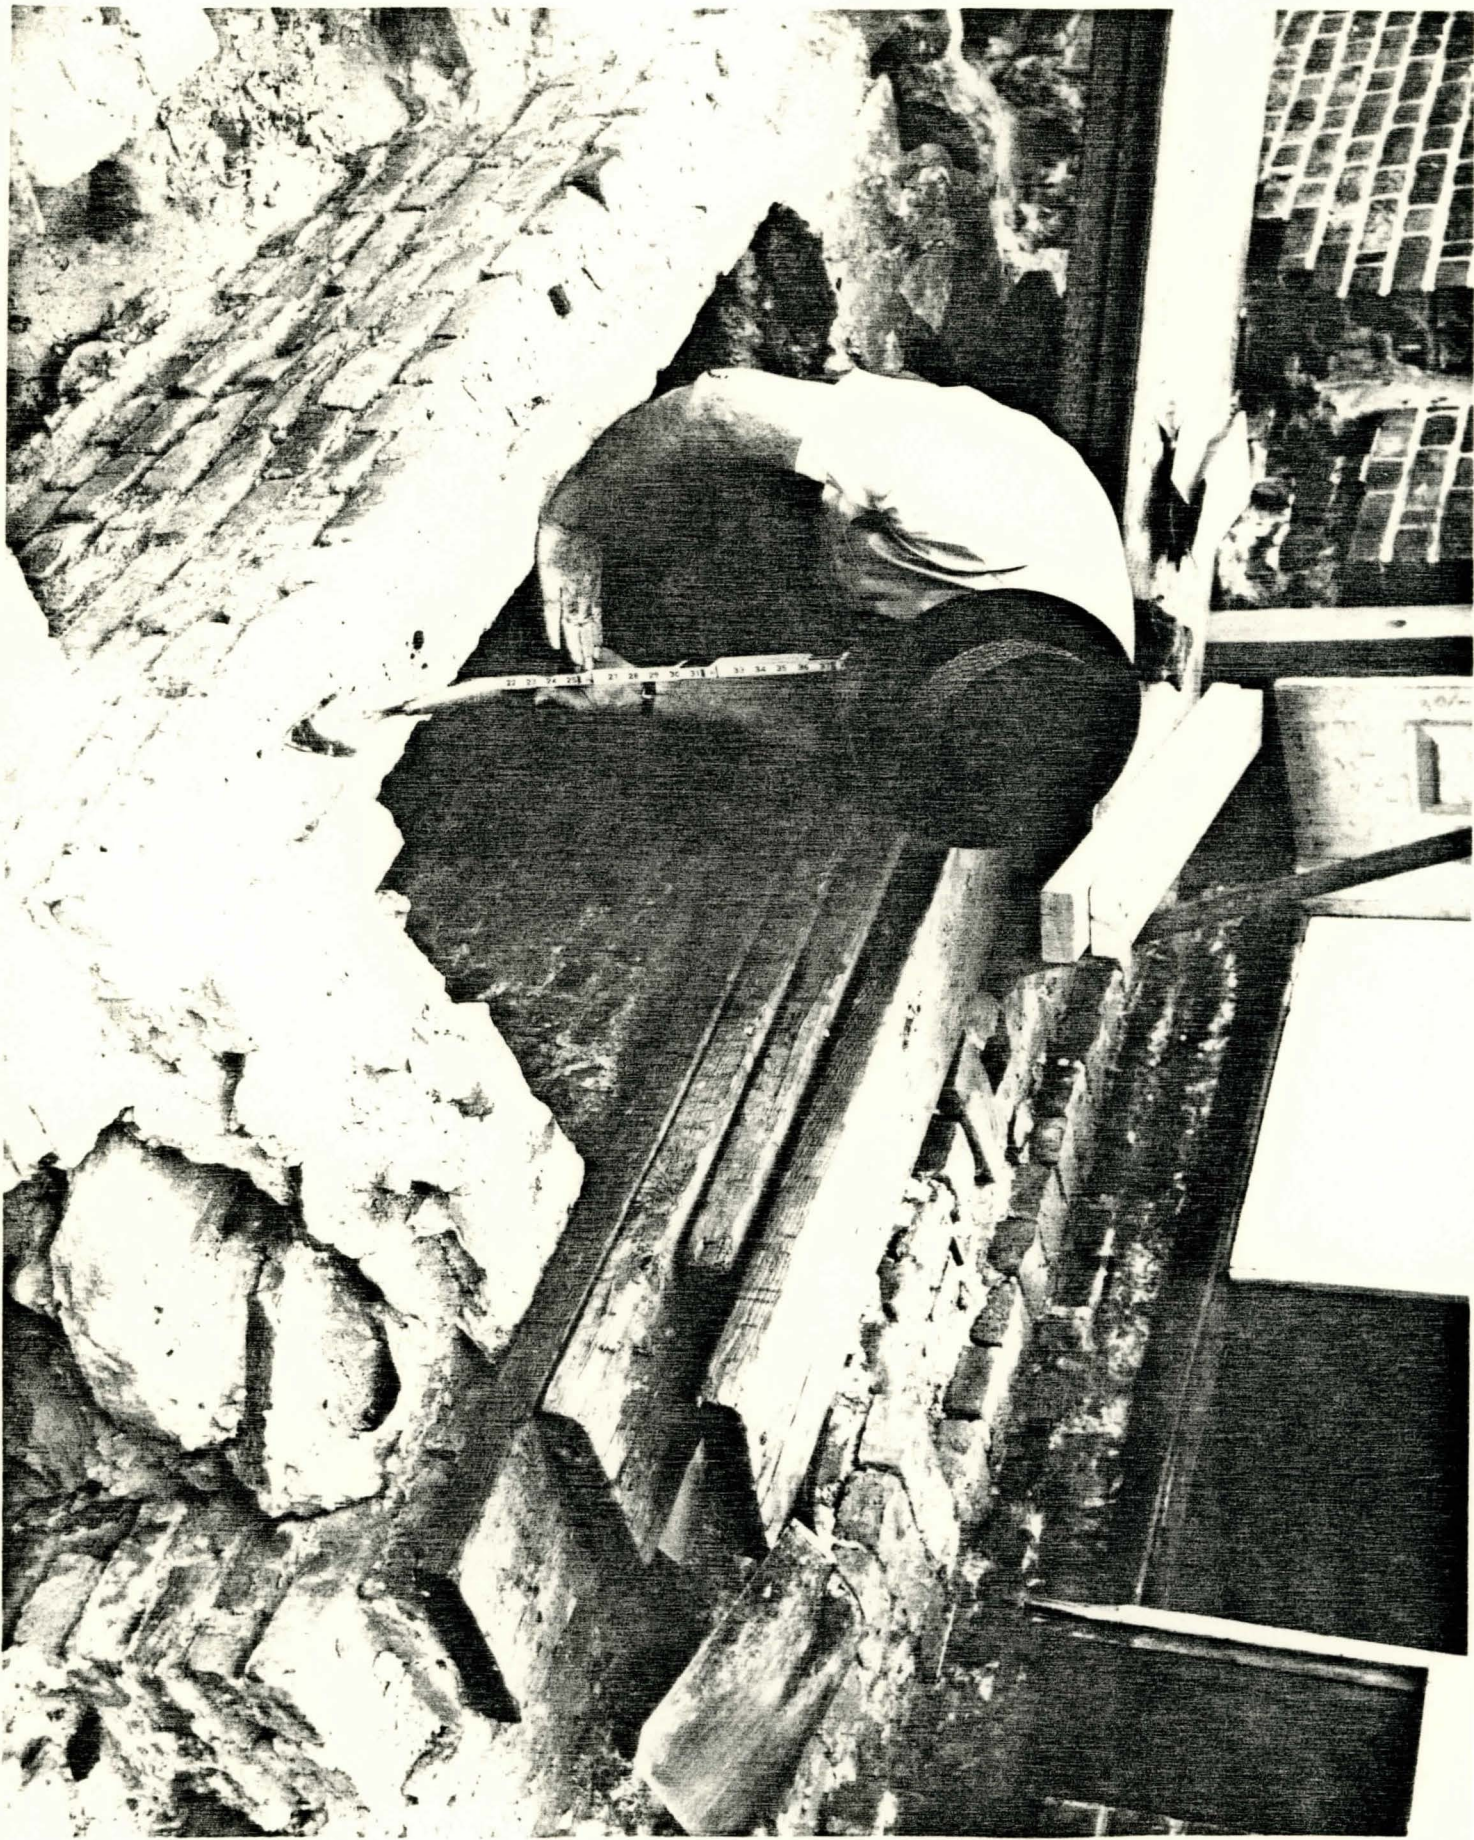
PHOTOGRAPH 12  
SITE #3  
LOCATION North Entrance - Independence Hall  
SUBJECT Void In Steps

Ruler indicates depth of void before work  
began on Zone A.

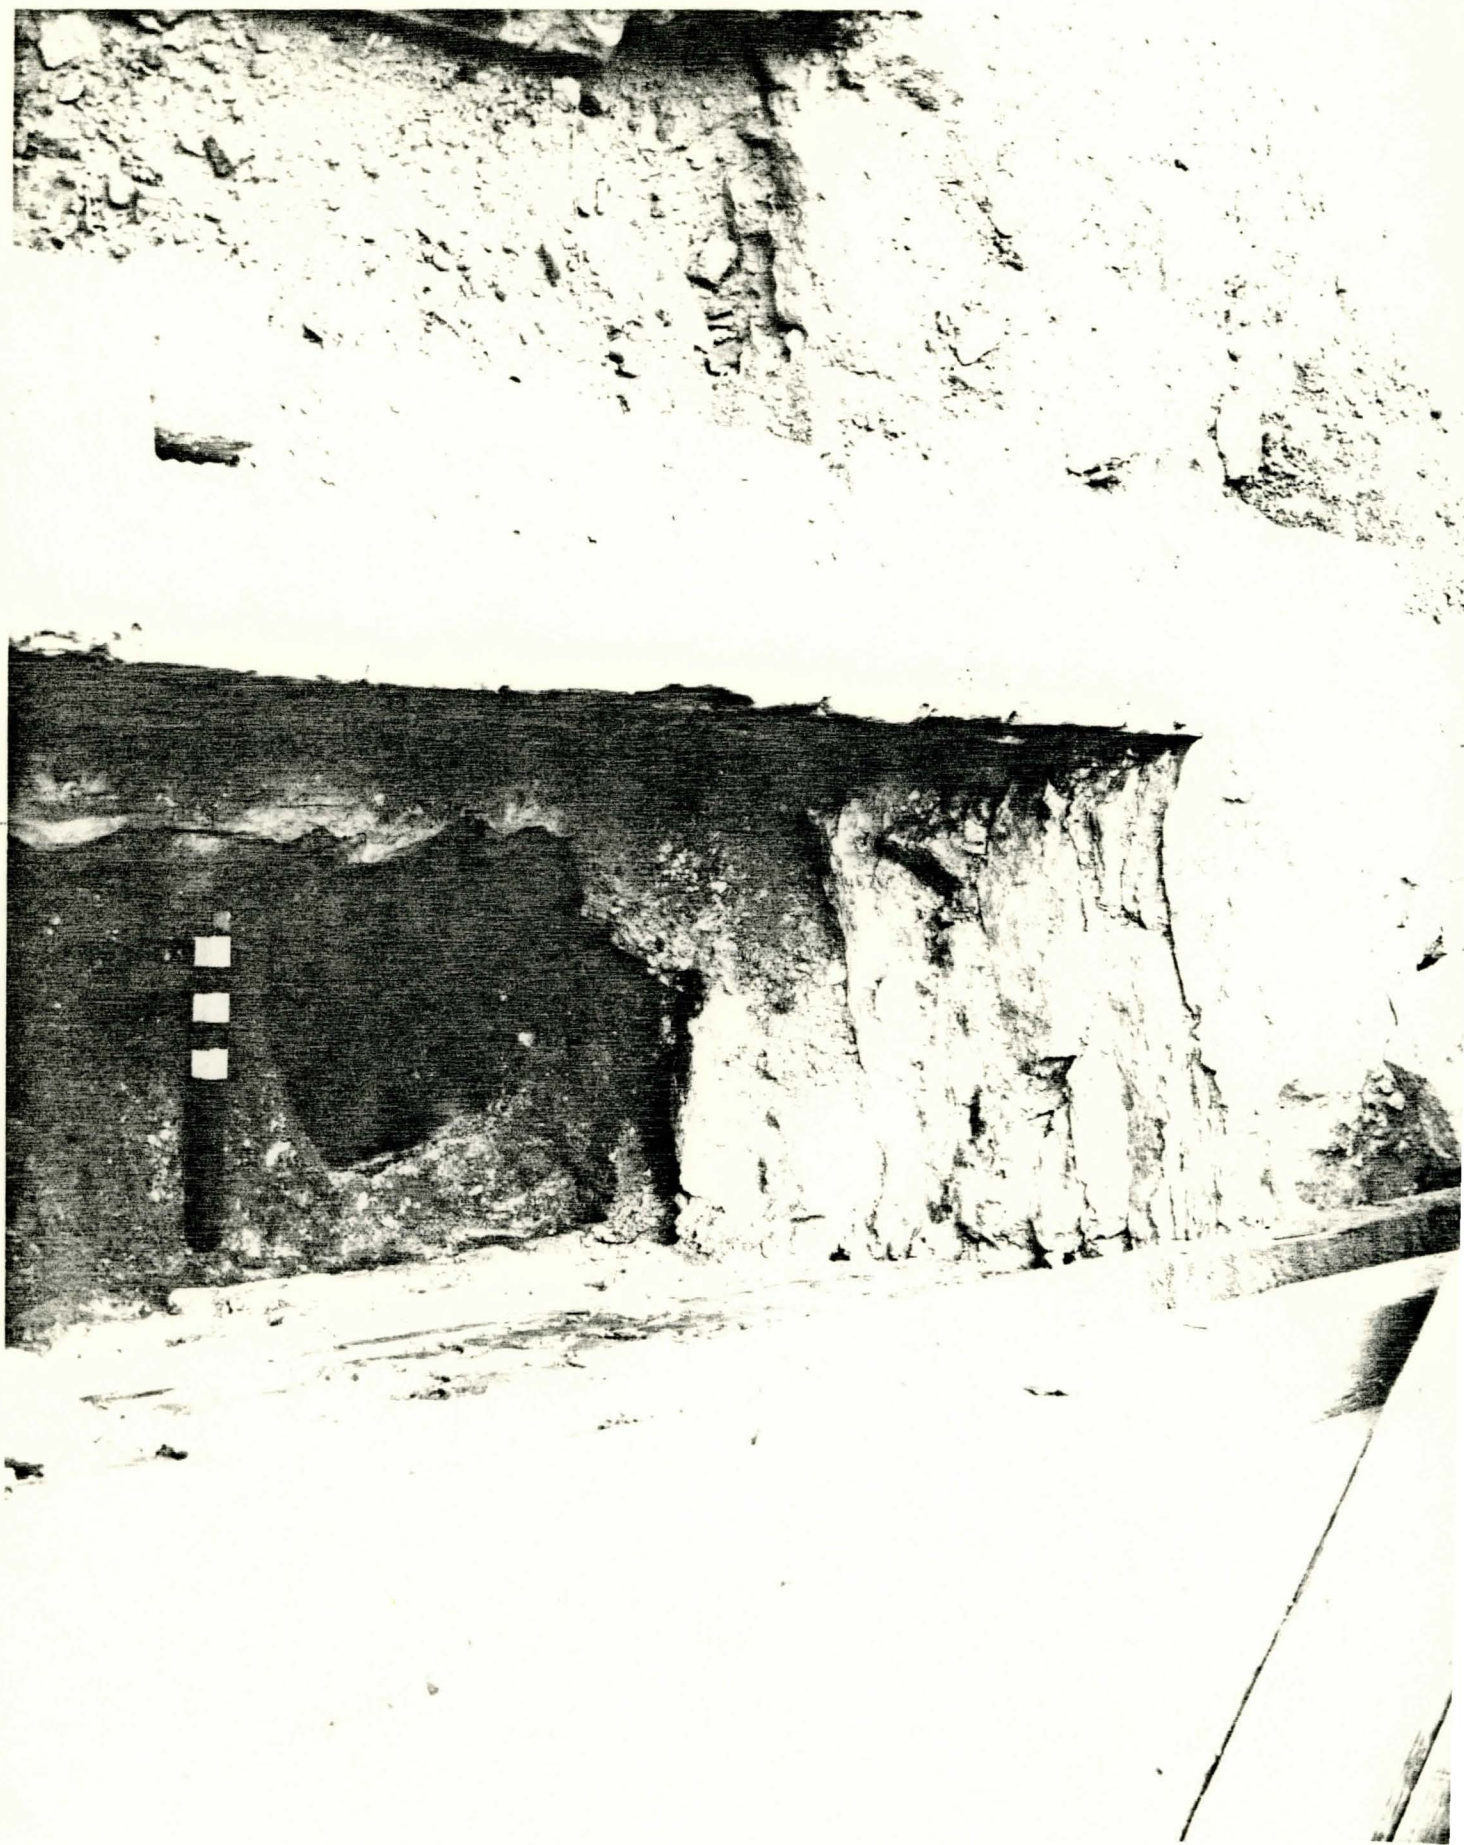
Test hole dug in eastern end of void in order to determine depth to undisturbed earth. Undisturbed earth encountered at 132" below datum. Nineteenth century rubble and artifacts in void. Eighteenth century artifacts in Zones A and B. Zone C was undisturbed earth. Void was filled with concrete before steps were rebuilt.

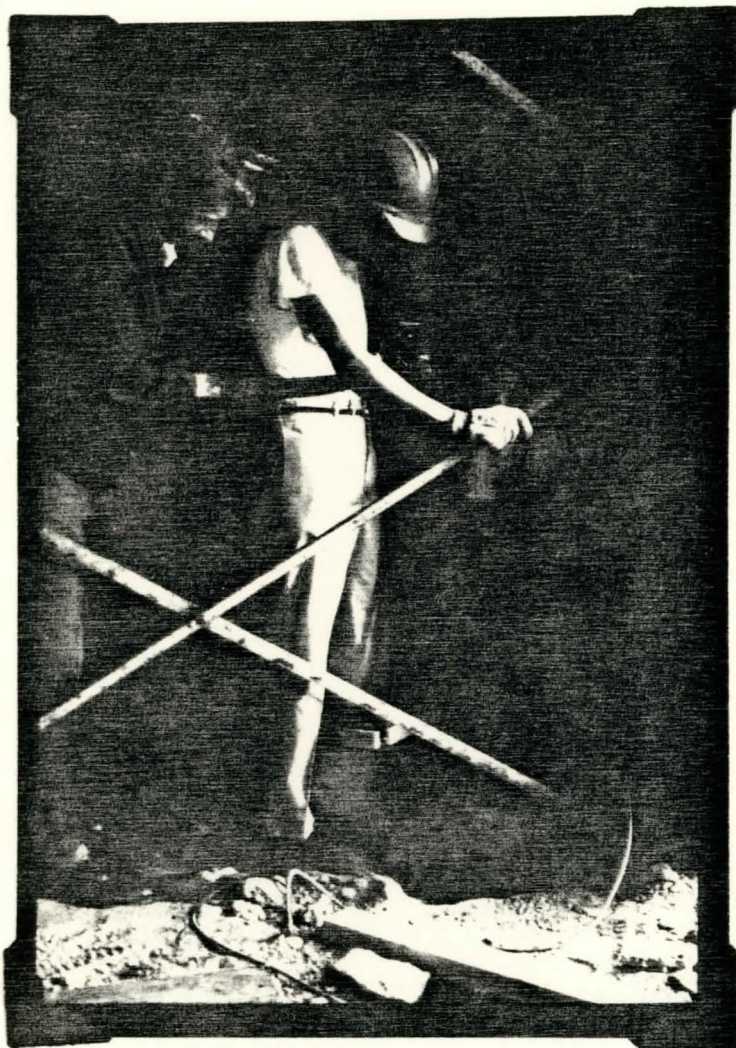
| PHOTOGRAPH | 13 |

| LOCATION | Intrance Hall |
| SUBJECT | Well |

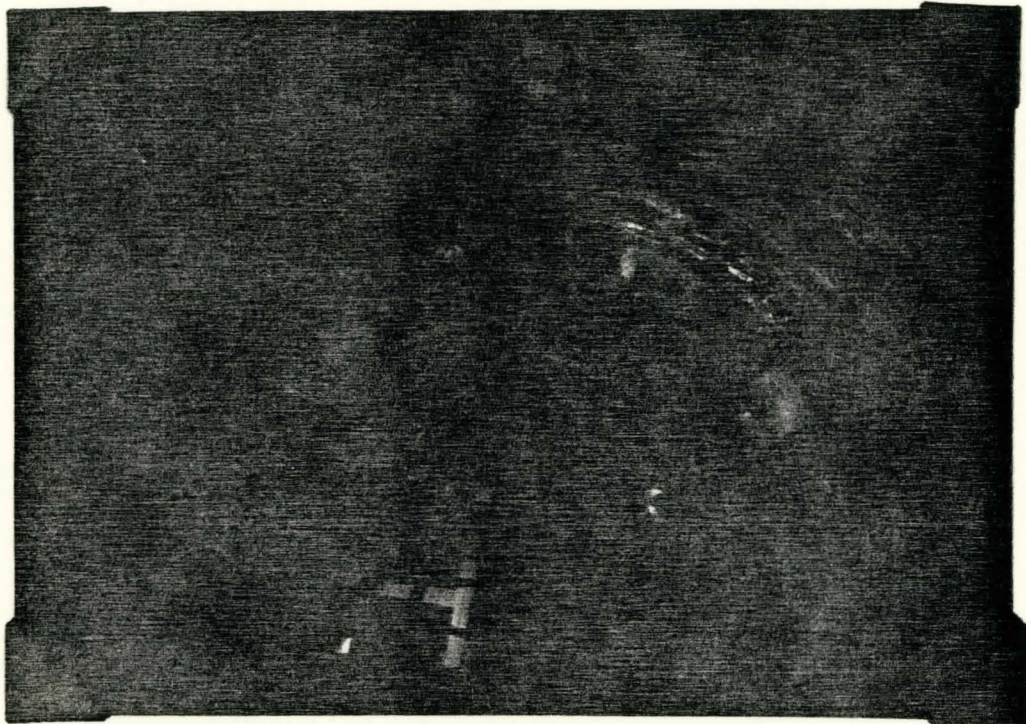
The corbeling was built in concentric circles of brick to the point where the opening was begun. Then the brick continued as a square until it was capped. The original cap had been replaced with a piece of red sandstone. The date of this replacement has not yet been determined.

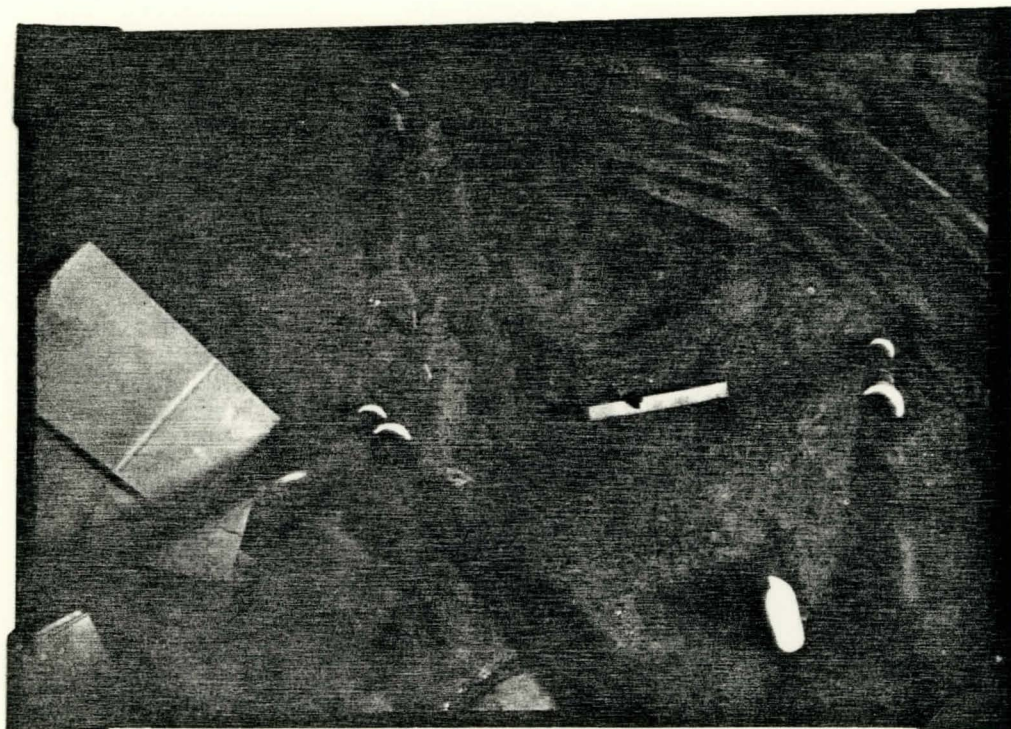
The entire well is dry set.  
The lowest brick is 17' 2"  
below the bottom of the cap.  
(Pule = 6")

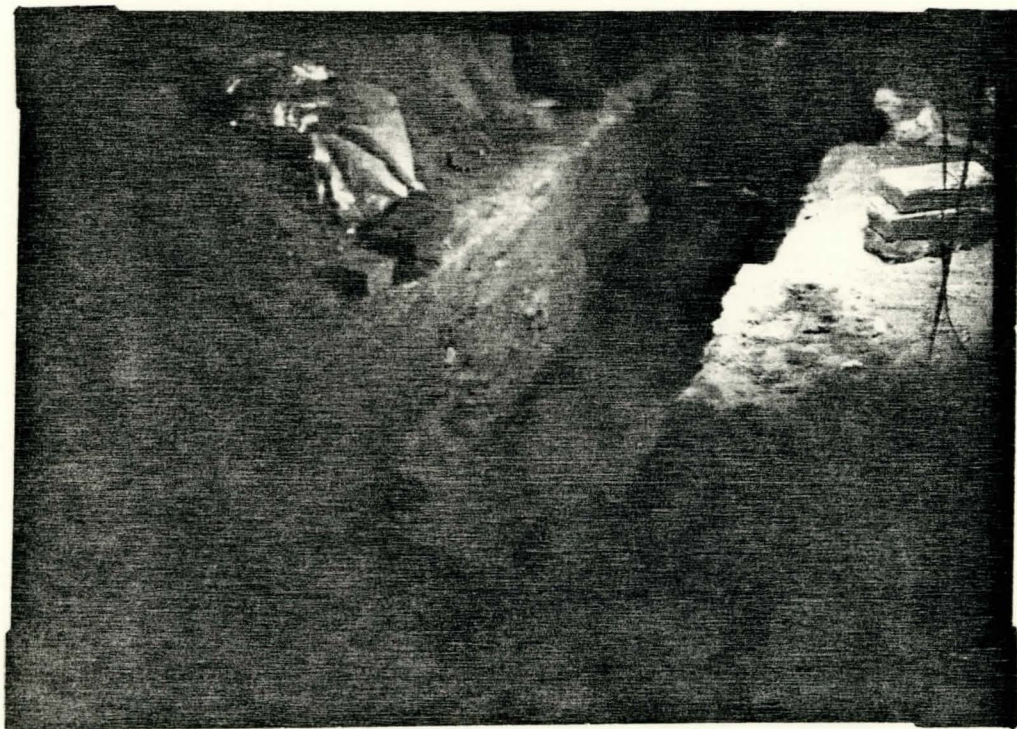
The refill above the humus was removed with the aid of a shovel and pick by Independence Hall National Park workmen. The area around the bricks and the humus strata were excavated by the archaeologist.

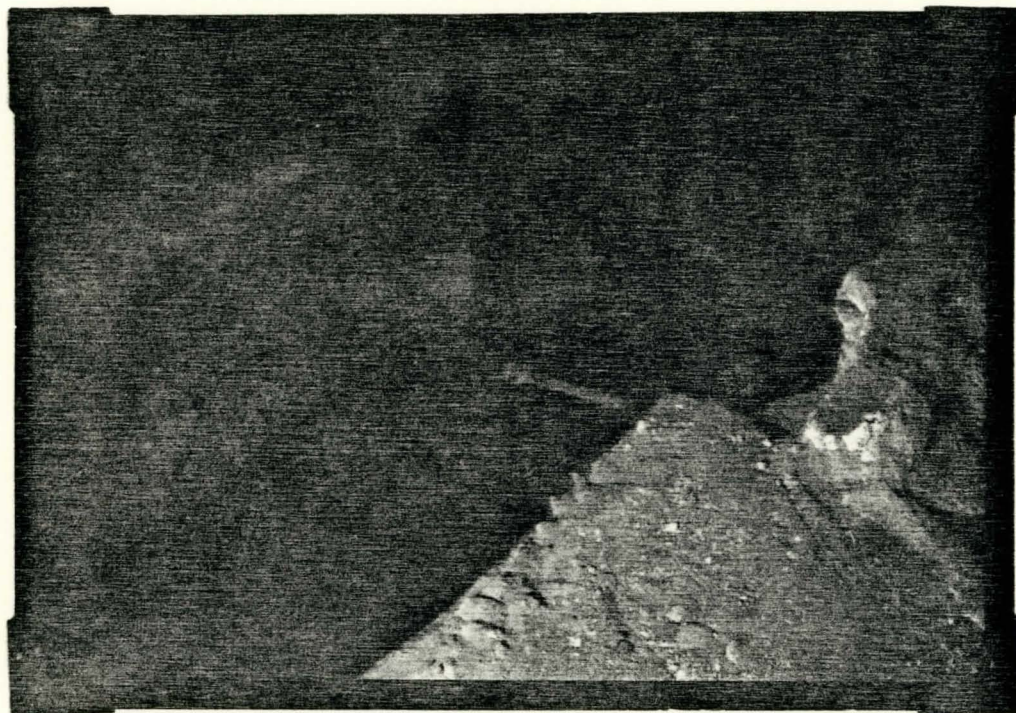
The humus below the lens of lime contained many bones, bottle glass and window-light fragments. Both stoneware and earthenware fragments were found also.

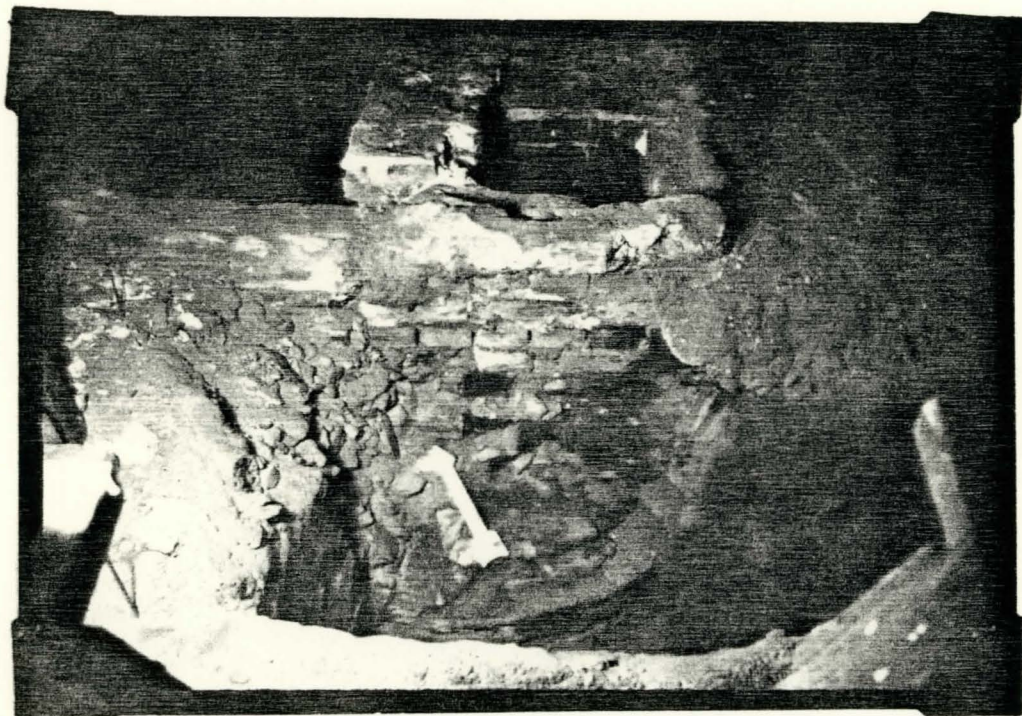
The upper part of the corbeling was broken apart just above the outer casing of the well. The red sandstone chips were placed over the corbelled area at the same time the cap was replaced.

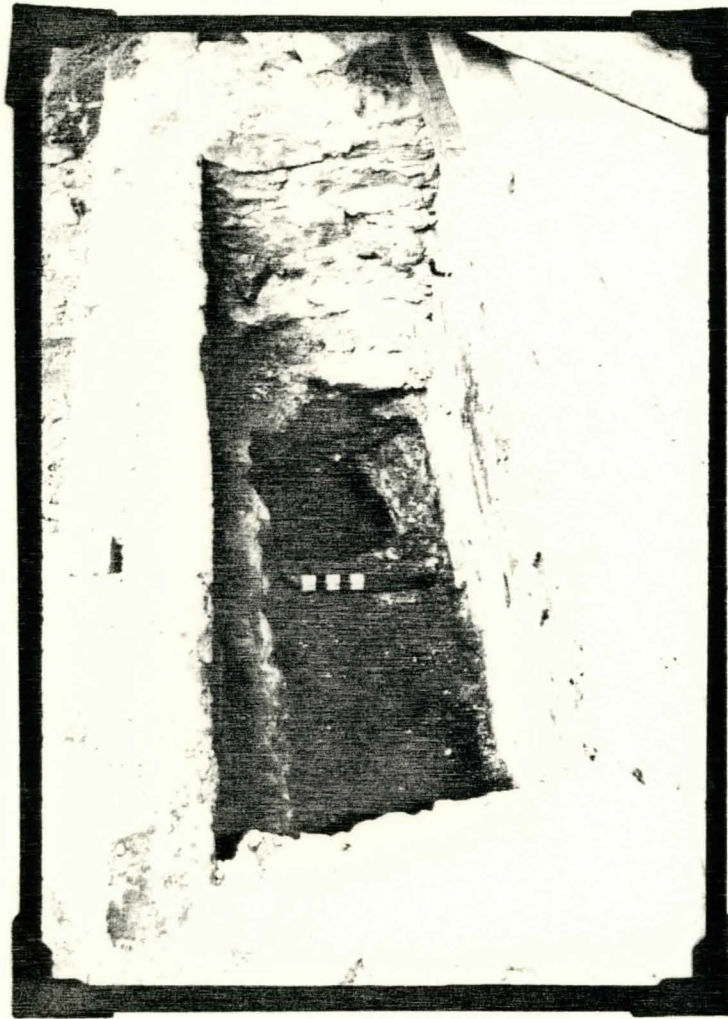
| PHOTOGRAPH | 19 |

| SUBJECT | Corbeling and Well Opening |

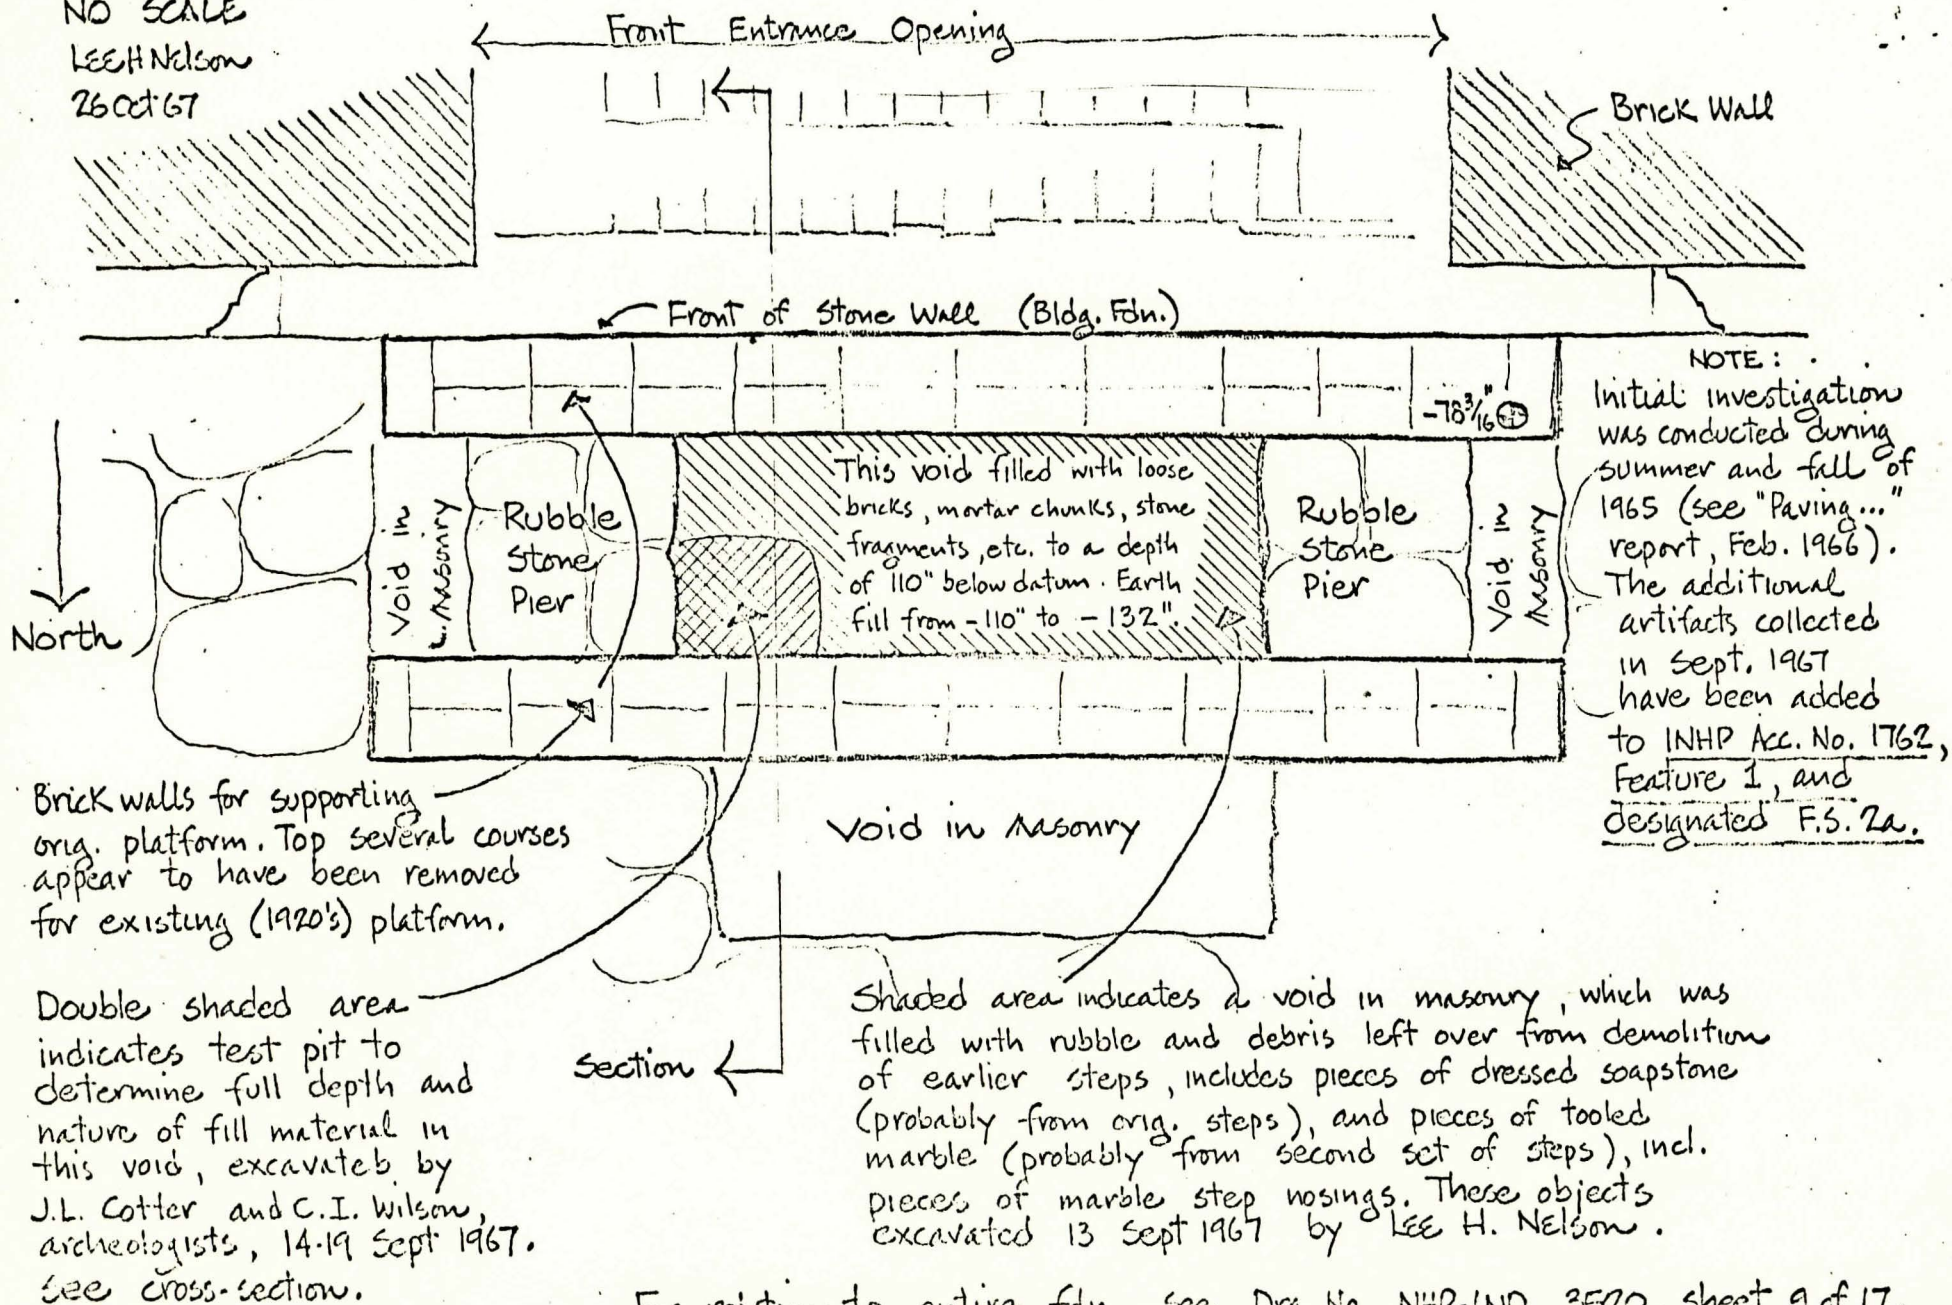
# SKETCH SECTION SHOWING ADDITIONAL EXCAVATIONS AT FRONT ENTRANCE • IND. HALL

SECTION LOOKING EAST • NO SCALE

Rubble-filled void excavated by Lee H. Nelson - fill consisted of mortar chunks, pieces of broken soapstone and marble steps + artifacts.

Test Pit excavated by J.L. Cotter and C.L. Wilson, 14-19 Sept. 1967.

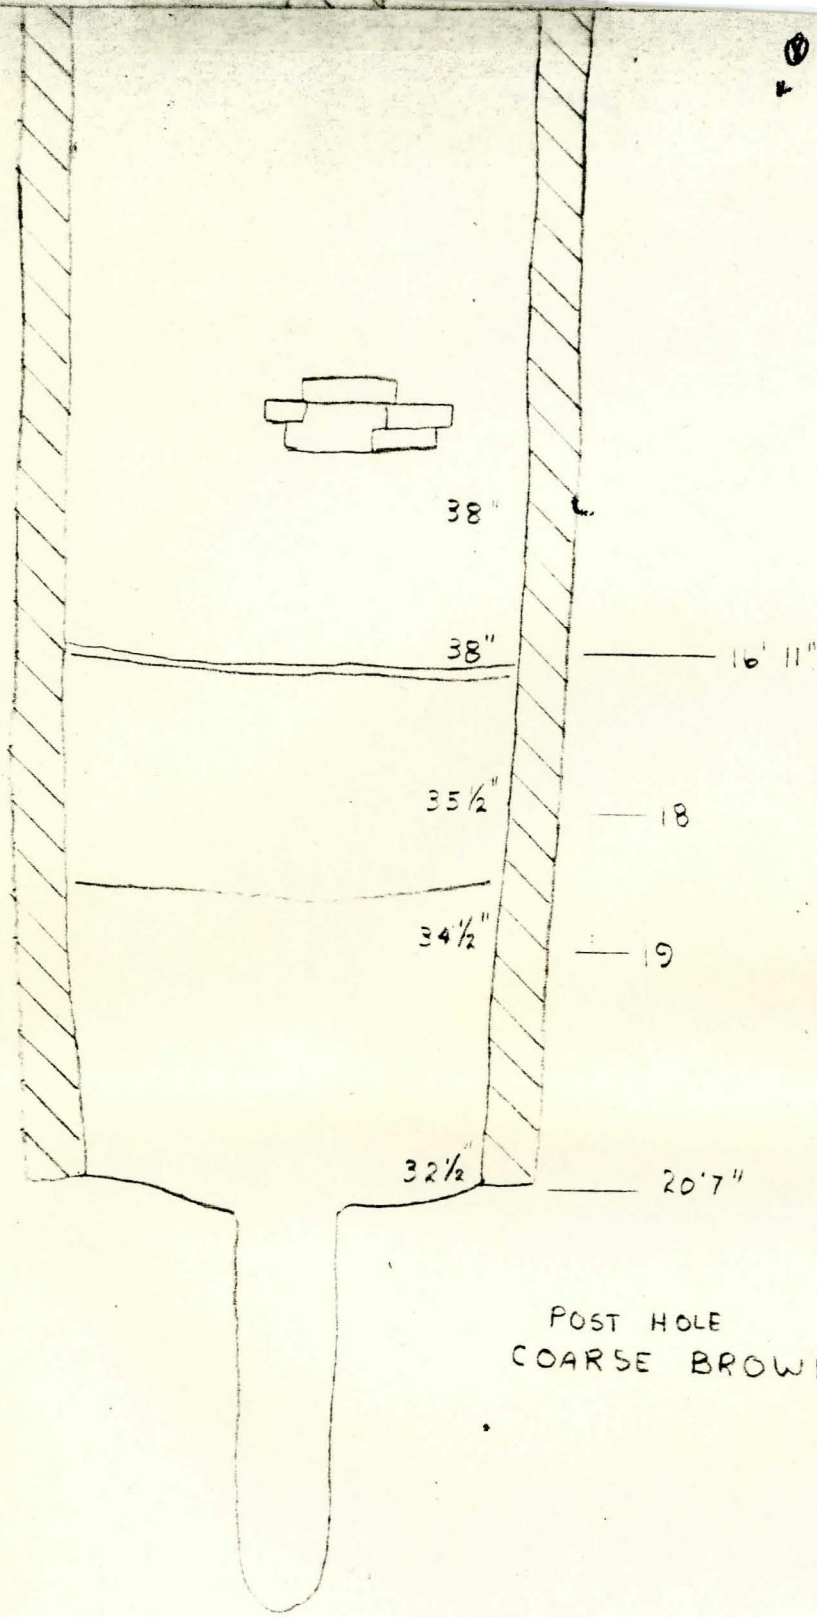
THE VOID OTHER SMALL ARTIFACTS, COULD BE RE-DEPOSITED.

THE CLAY, EXCEPT FOR THE FOUND BELOW THE BRICK, CONTAINING NO ARTIFACTS, IT WAS WASHED FROM BEHIND THE CASING. BRICK FRAGMENTS AND AT THE BOTTOM OF THE WELL FROM THE CORBELED AREA. CLAY BELOW THE BRICK FRAGMENT CONTAINED THREE POTTERY FRAGMENTS OF POSSIBLE 17-18th CENTURY ORIGIN.

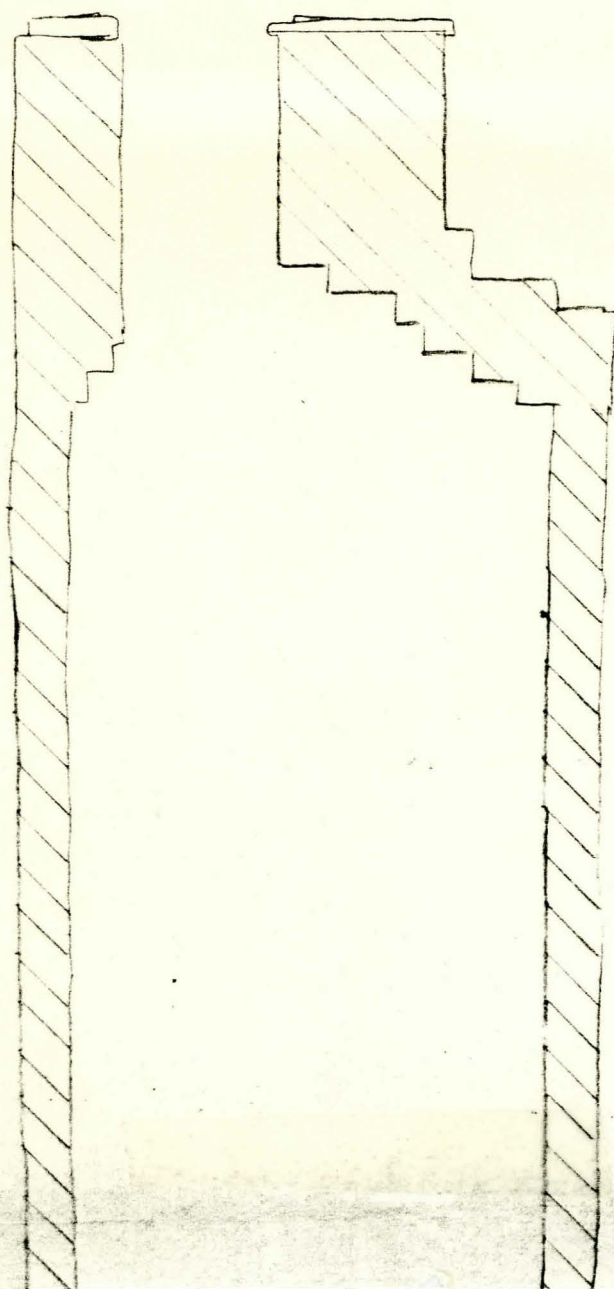
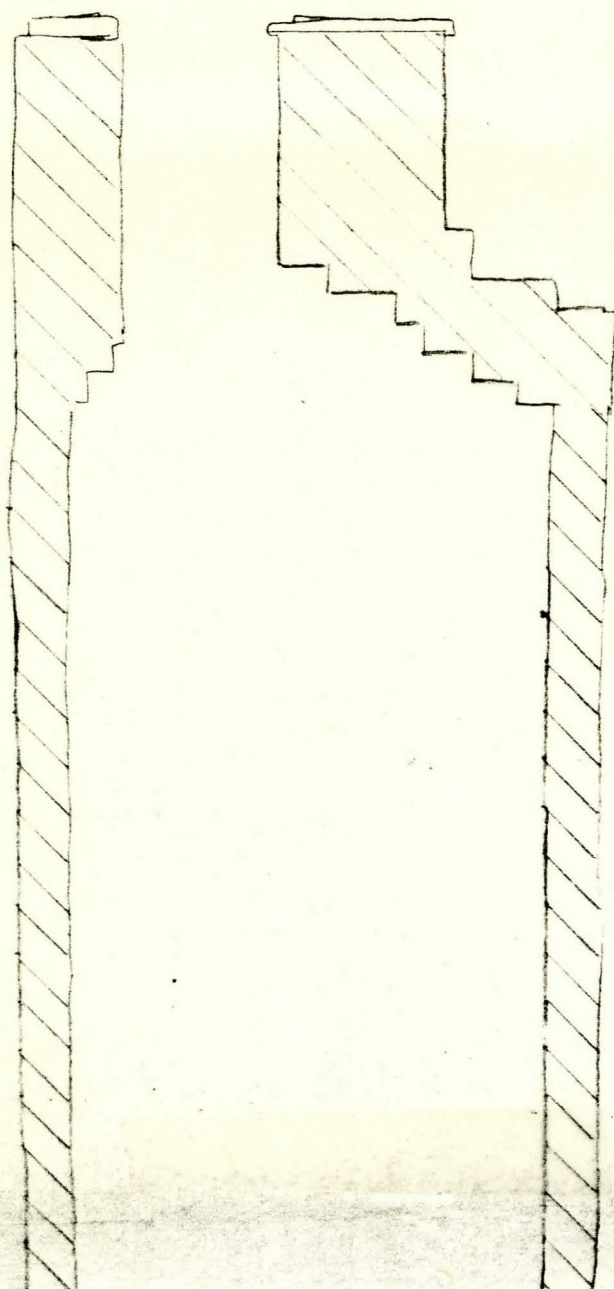
CHAIR-RAIL LINE 17 5/8" BELOW D

BRICK CURB- LINE

ARCHAEOLOGICAL EVIDENCE  
DETERMINED THAT THE FILL IN  
WELL ACCUMULATED DURING  
MID TO LATE NINETEENTH  
URY, THAT THE WELL WAS  
AT AN EARLY DATE, POSSIBLY  
IT WAS DUG. THE SIZE OF  
ARTIFACTS PROVE THAT MOST  
ALL OF THEM WERE DROPPED  
THE VOID. OTHER SMALL  
ARTIFACTS COULD BE DROPPED

THE MATERIAL ABOVE THE  
HUMUS CONTAINED WITH THE  
BUILDING OF THE STATE HOUSE  
THE RED SANDSTONE CAP  
AND SANDSTONE CHIPS WERE MOST  
LIKELY PLACED AROUND THE  
GORELING AT THE TIME THAT THE  
BAILEY FLOE WORK WAS PLACED IN  
THE BUILDING
