The Well In The Entrance Hall  
Of *Independence Hall*  
Independence National Historical Park

Archaeologist: Charles I. Wilson, Jr.  
Excavated: September, 1967  
Submitted: December, 1967  
Purchase Order: 391-220

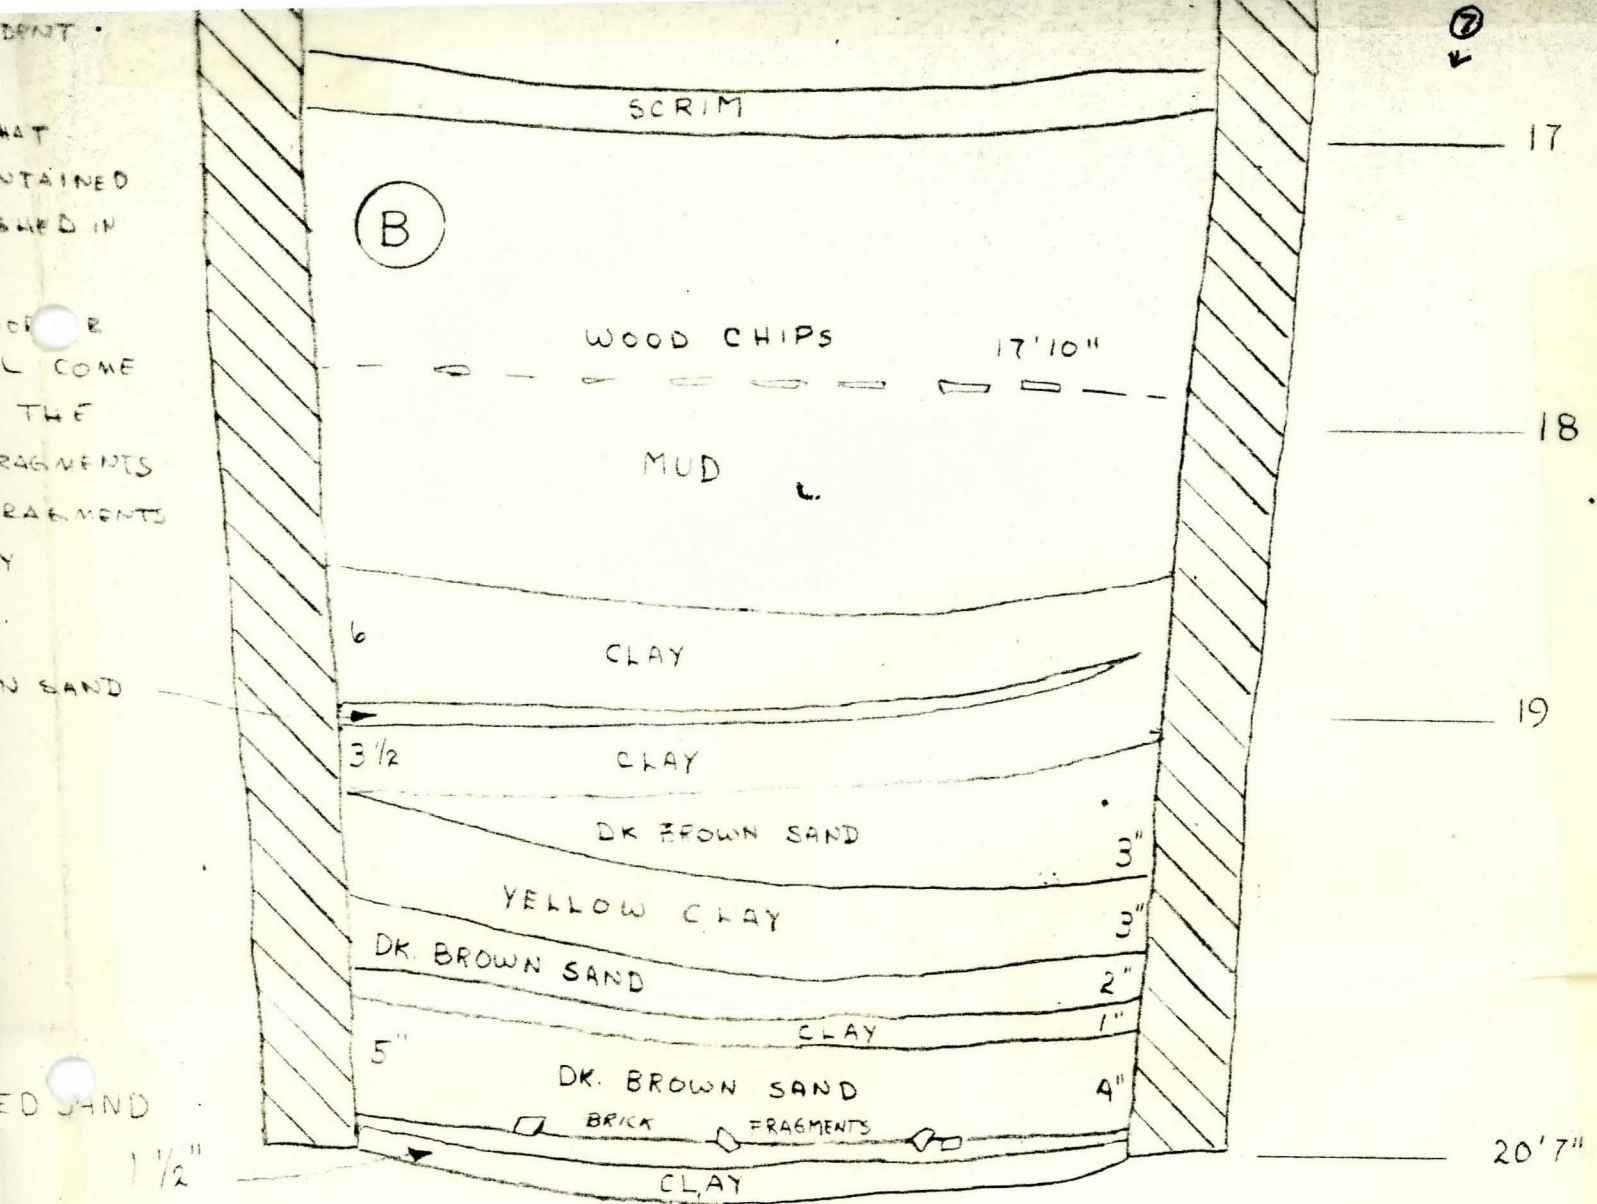
ENLARGED PORTION OF WELL  
 SCALE 1 1/2" = 1' 0"

THE MATERIAL ABOVE THE  
HUMUS CONTAINED WITH THE  
BUILDING OF THE STATE HOUSE  
THE RED SANDSTONE CAP  
AND SANDSTONE CHIPS WERE MOST  
LIKELY PLACED AROUND THE  
GORELING AT THE TIME THAT THE  
BAILEY FLOE WORK WAS PLACED IN  
THE BUILDING
