# NATIONAL HISTORIC LANDMARK NOMINATION

National Register of Historic Places Registration Form

Historic Name: Skagway and White Pass District

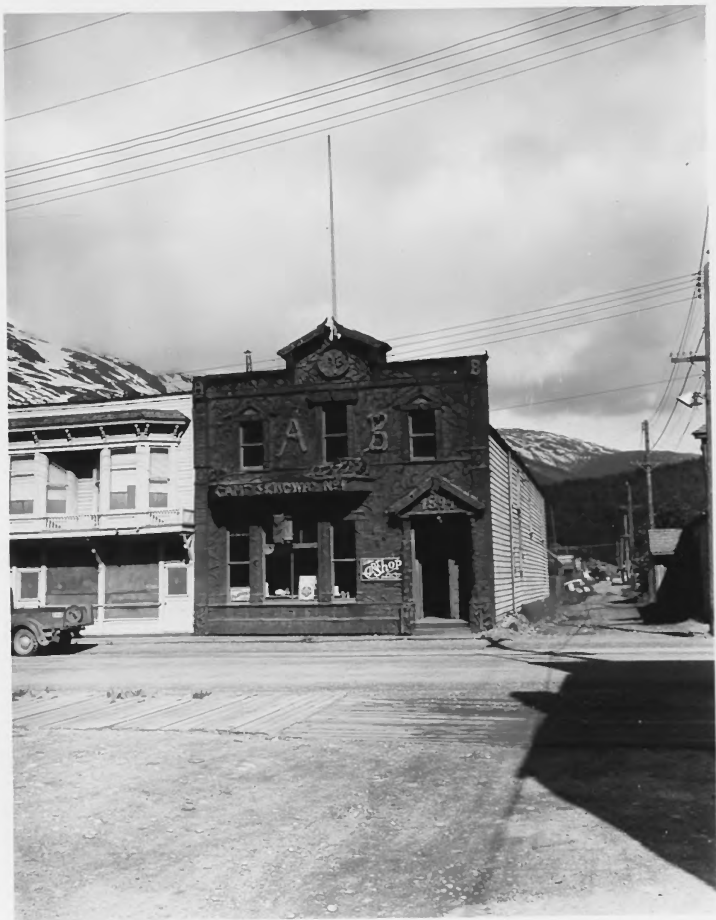
Alaskan Brotherhood Bldg.  
built in 1899

309. Arctic Brotherhood Hall, 1899. Two-story frame fraternal hall, gable roof, stick and driftwood checkerboard-pattern veneer nailed on east facade. Veneer contains high degree of architectural detailing, including balcony, frieze, cornice, broken pediment and recessed doors flanked by fluted pilasters. Drop siding on remaining facades, shed addition.

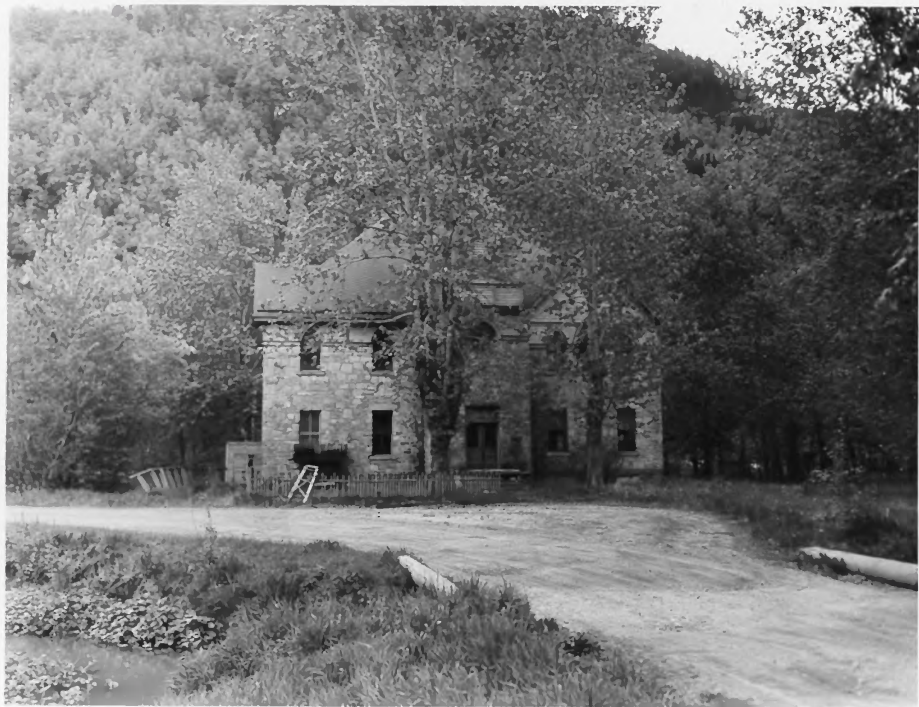
Old Federal Courthouse

386. McCabe College/Federal Courthouse, 1899. Two and one-half story, hip main roof with gabled extensions and a gabled tower, stone foundation, granite walls up to center of second floor, upper five feet of wall clapboard siding. Round and diamond-shaped wood shingles at gable ends, tower has clapboard siding above second floor windows.

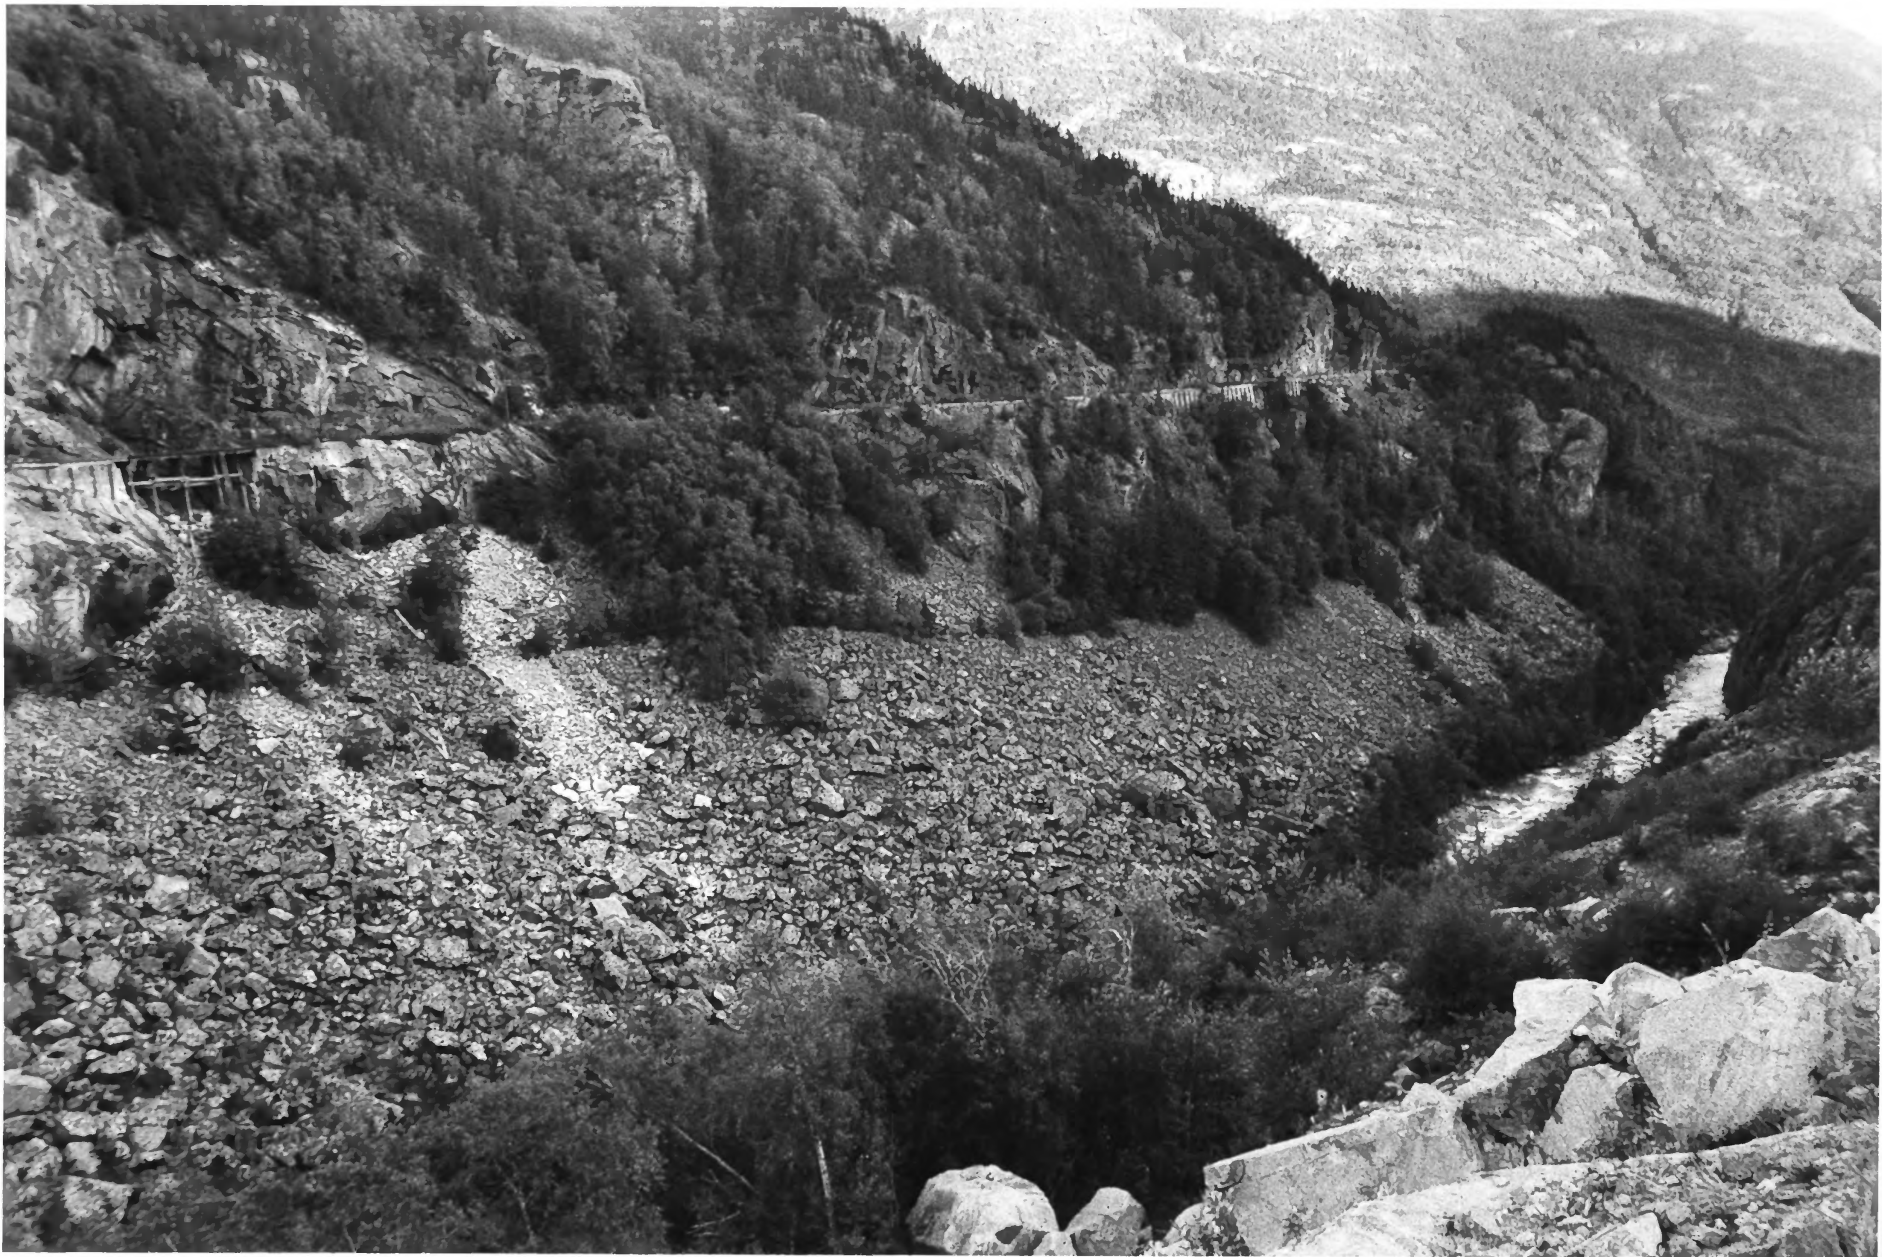
WP&Y railroad grade with Brackett  
Wagon Road visible below with tree  
growth. Skagway River Canyon at right

Much remains of the wagon road and sled-road extension today. In 1940, the WP&YR railroad took over the first several miles, south of its crossing of the East Fork of the Skagway River. Between the East Fork Bridge site and the seven-mile post of the railroad, the condition of the route is unknown, but between the seven-mile post and White Pass City the route is almost entirely visible. Its route in this area is a well-defined pathway between the Skagway River and the WP&YR right-of-way. Its condition is fair: forest growth has obscured only small portions of the route; rockslides have obliterated a few areas; and some bridges and corduroy areas have been swept away or have decayed. Immediately north of White Pass City, the condition of the sled road is unknown, but north of the Ford (see below) it becomes increasingly easy to identify as it nears timberline. Near the top of White Pass, it can be easily spotted from the railroad tracks. An interpretive sign in this area calls attention to the so-called "Trail of '98."

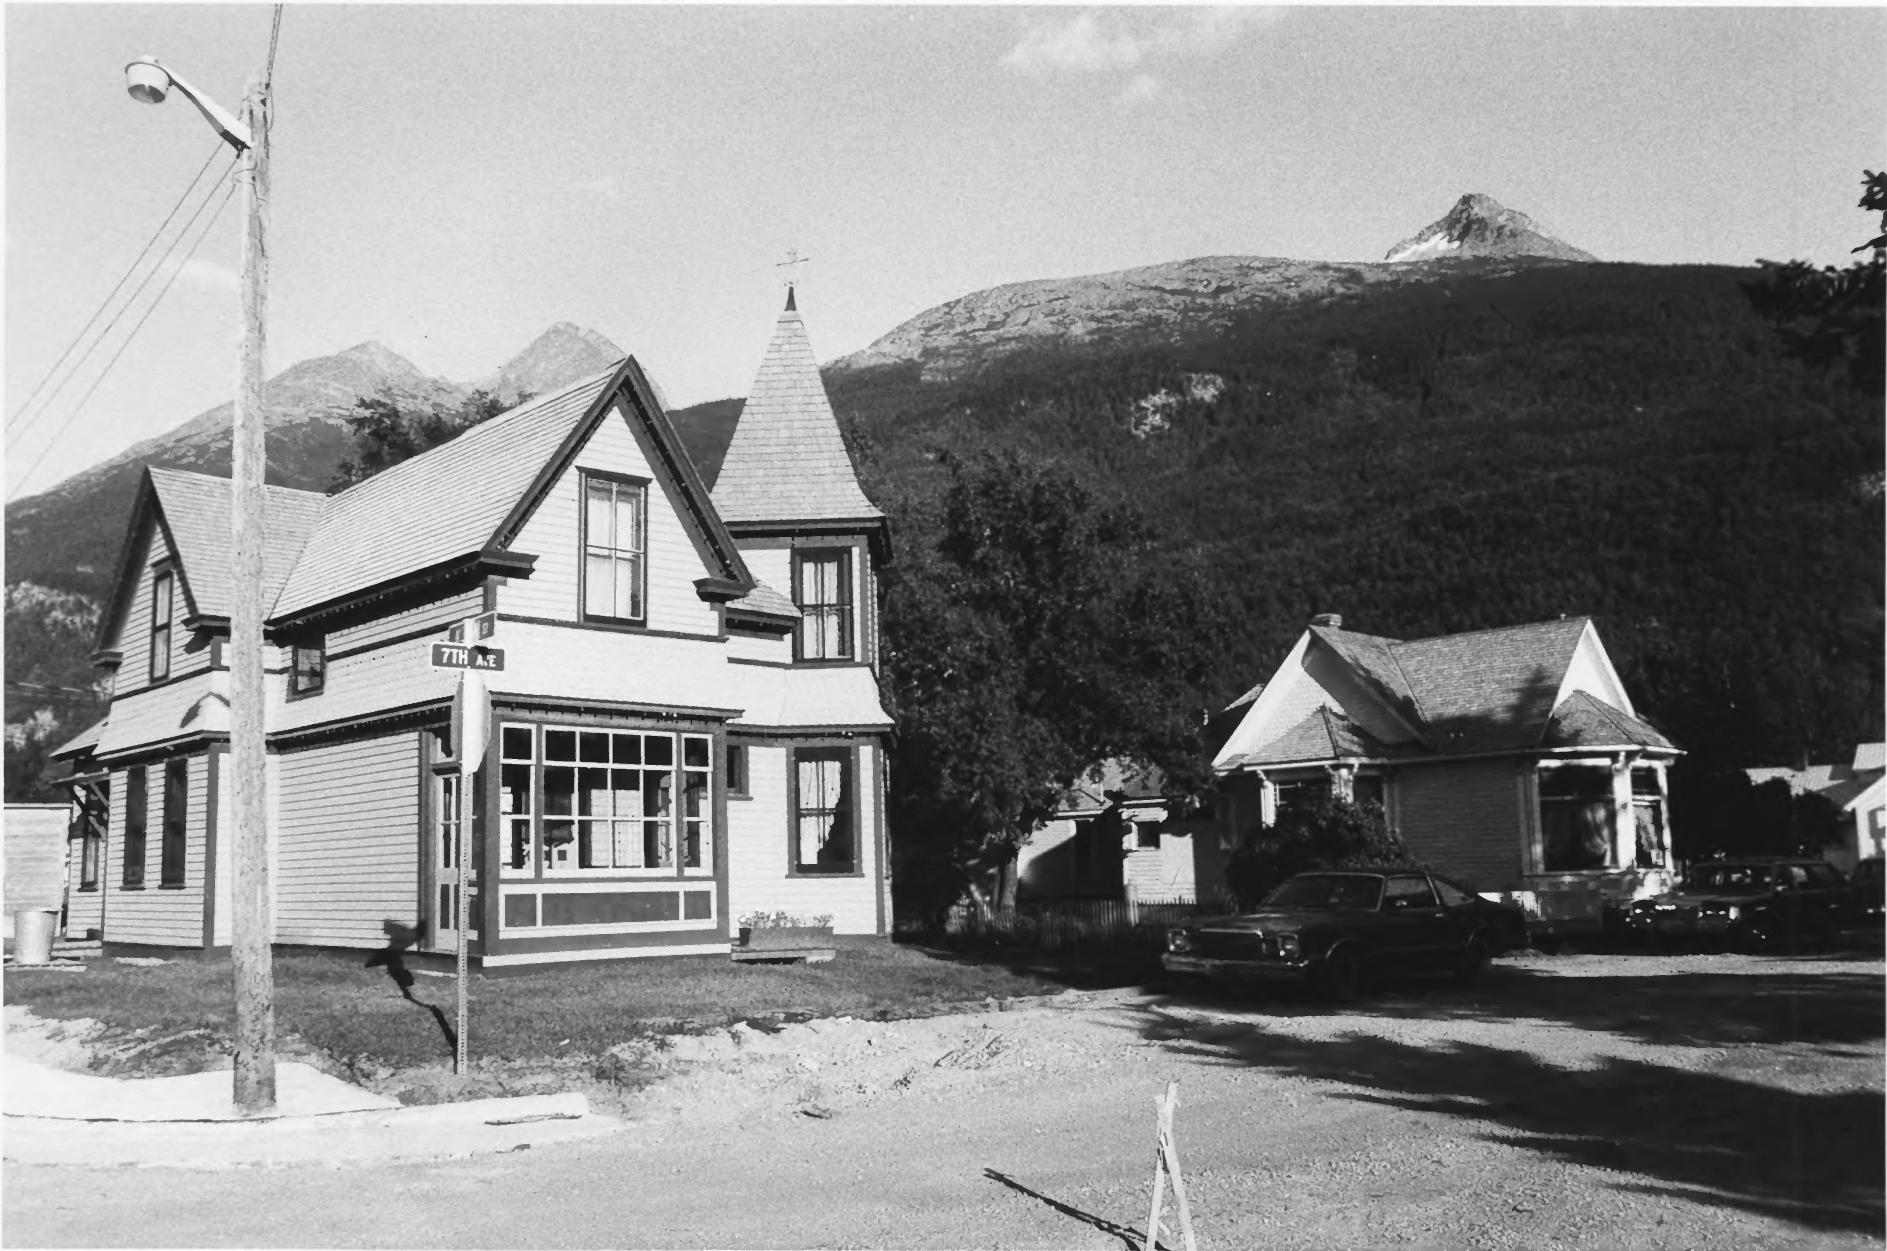
Case/Mulvihill House (#54) and Nye/  
Roehr House (#53), 7th Ave., Skagway.

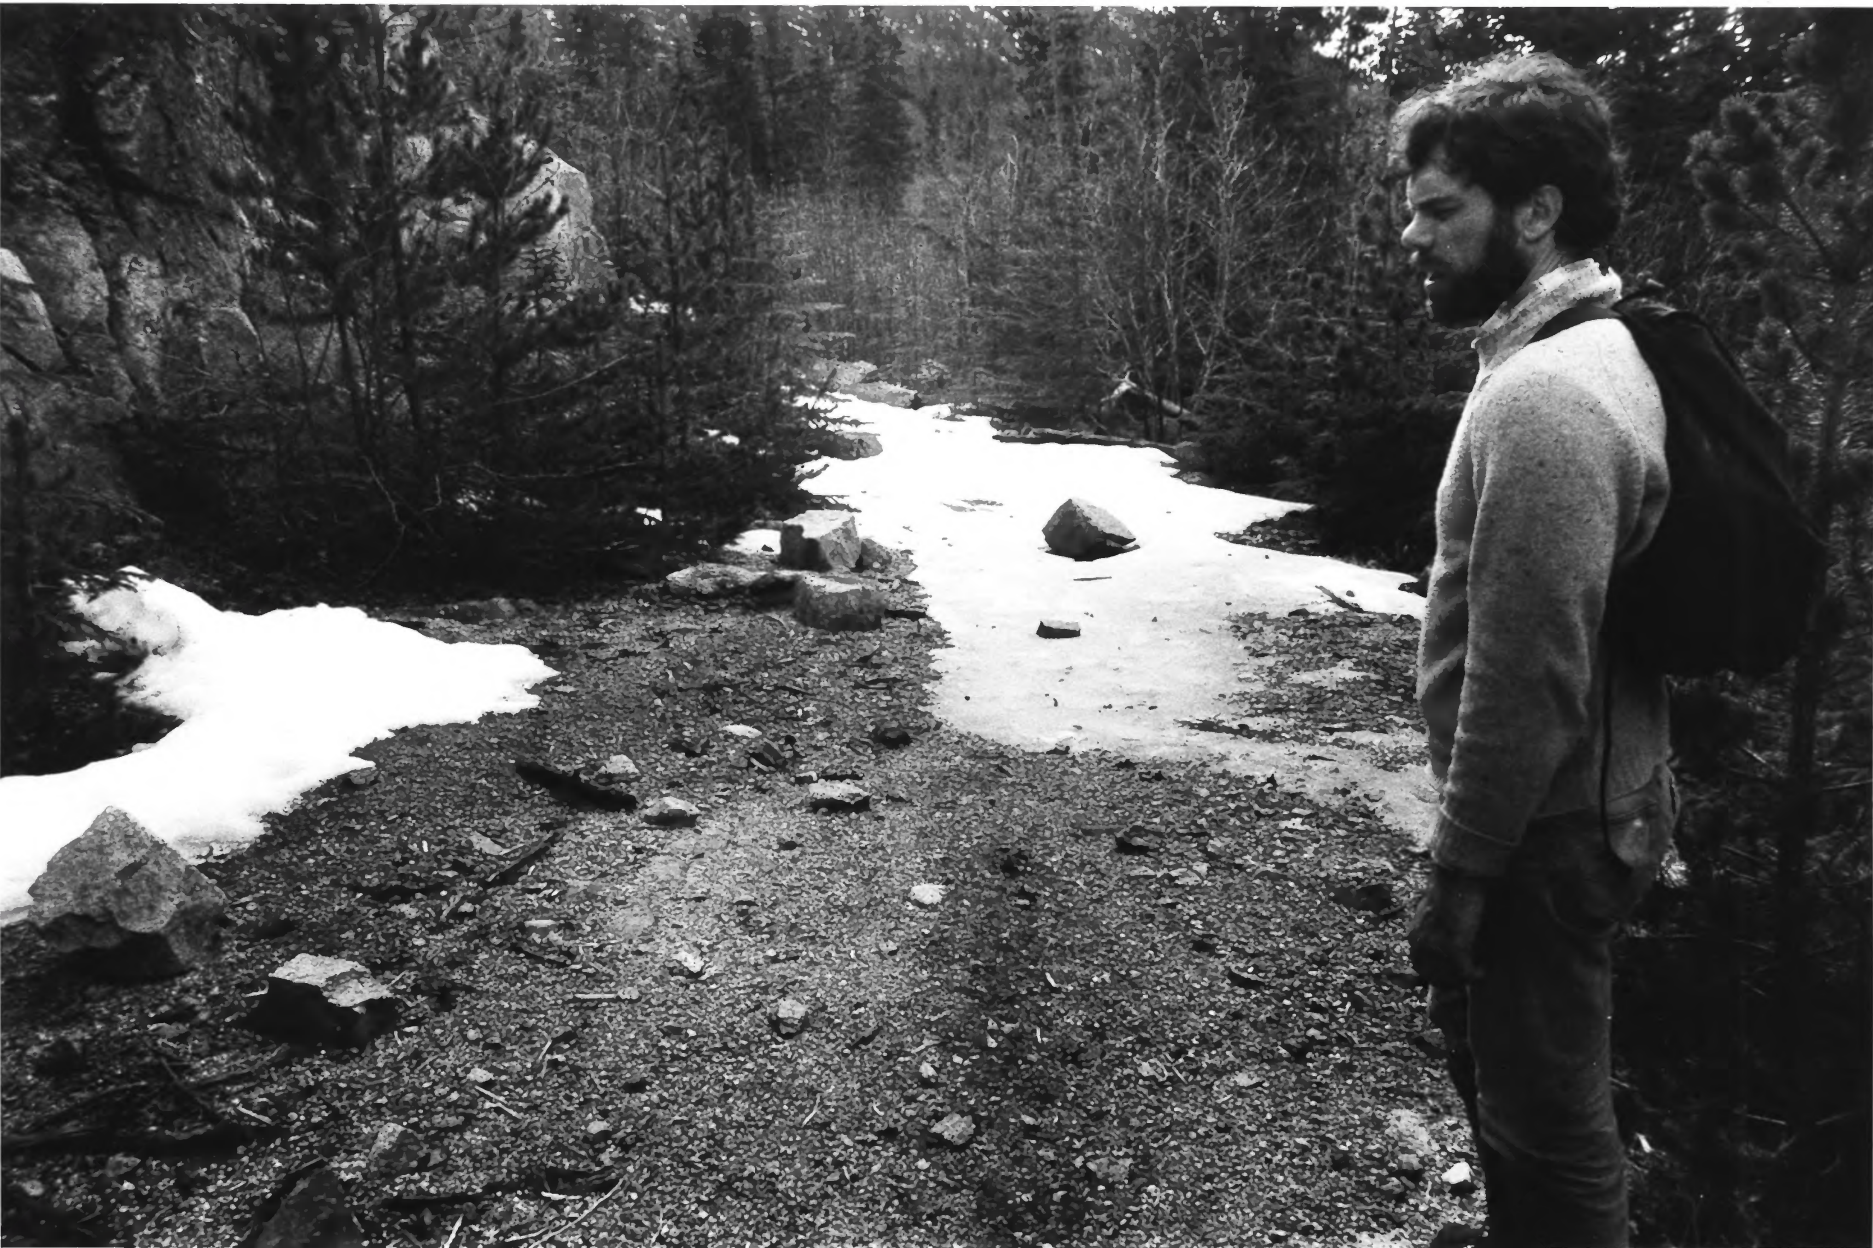
Remnant of the Brackett Wagon Road,  
Skagway River Valley.
