Manzanita Lake Naturalist's  
Services Historic District  
Property Name

# NATIONAL REGISTER OF HISTORIC PLACES REGISTRATION FORM

historic name: Manzanita Lake Naturalist's Services Historic District

**Additional Documentation: Current Condition Photographs (original photographs attached)**

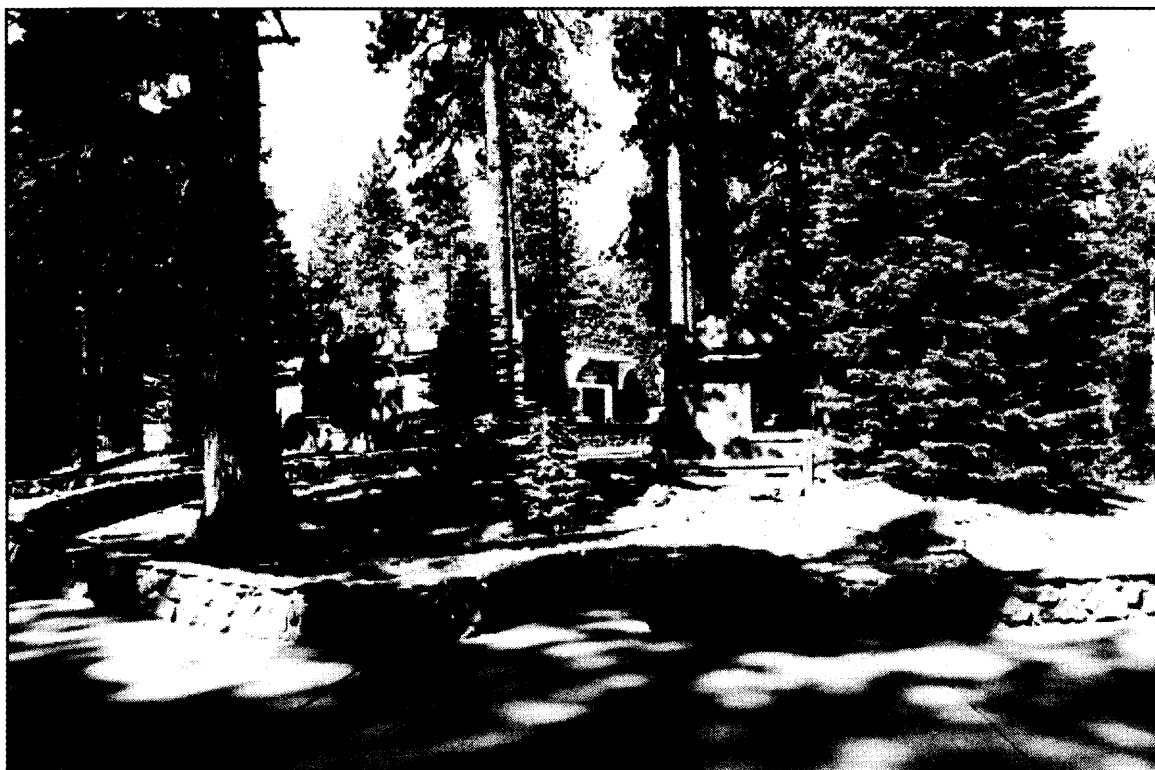
Photo 1: Overview of Museum Area (view to SW). Note stone wall.

The museum is surrounded at the front and sides by a low stone wall (*contributing structure*). The wall consists of square rubble columns topped with concrete caps alternating with lower lengths of mortared stone. A stone-edged concrete sidewalk runs parallel to the outside edge of the wall on its northeast and northwest sides. An opening in the wall opposite the museum entrance provides access from the sidewalk to the museum.

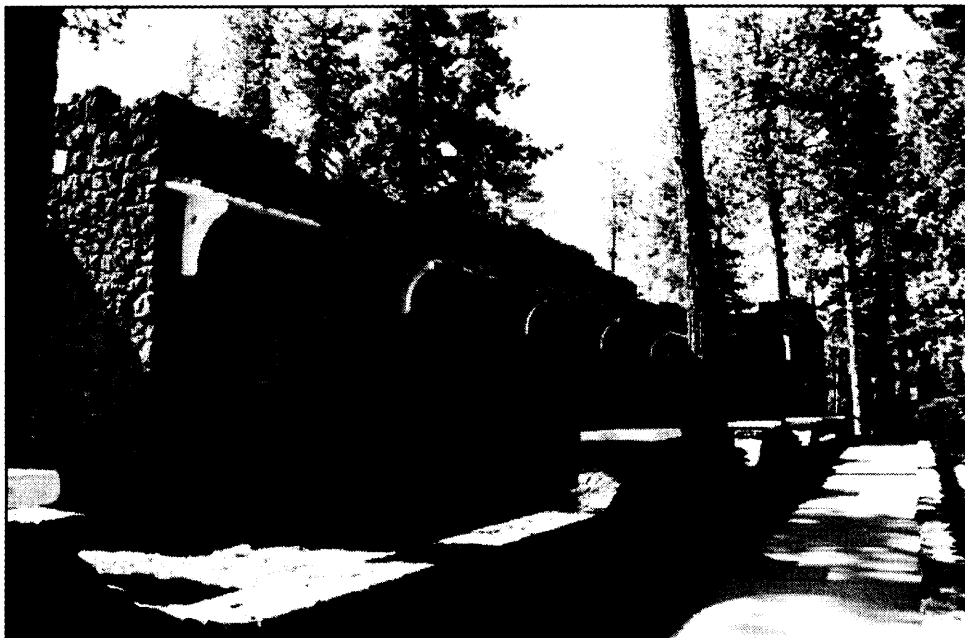
Photo 3: Loomis Museum- West and South Elevations

*Loomis Museum (HS-43, contributing building, previously listed):* The Loomis Museum is a one-story, stone masonry building constructed on a concrete foundation. The building has an inverted T-shaped plan and a vaulted roof with a stepped stone parapet. The exterior walls are random rubble except at the door and window openings and at the corners of the building, where the native stone has been dressed and laid in courses. The front of the building faces northeast and contains a central arched entryway with a pair of copper-clad glazed doors. A fixed fanlight is located above the entrance. A shallow, shed-roofed awning above the arch shelters the entrance. The overhang is supported by concrete brackets and is topped with half-rounds of formed concrete, making the roof of the overhang appear to be made of tile. Stamped cement tiles placed in the parapet above the overhang spell the word "museum." A bronze plaque with a dedication to the Loomis' daughter is affixed to the base of the wall adjacent to the north side of the entrance. Another plaque dedicated to Stephen T. Mather, is affixed to the wall on the south side of the entrance.

The two side elevations each have an arched window opening at the north end of the wall. The openings contain four-over-one-light wood sash windows. Awnings similar to that over the front entrance run the length of the side elevations, marking the wall – parapet juncture. A second entrance with a flush metal door is located near the rear of the building in the northwest side elevation. The only architectural detail on the rear of the building is a bracketed awning at the wall – parapet juncture.

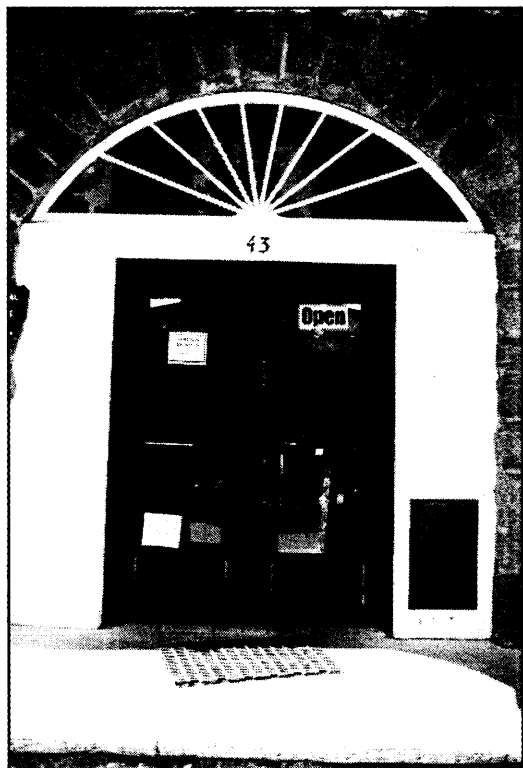
Photo 4: Loomis Museum- Detail Doors & Entrance – Copper Clad Door.

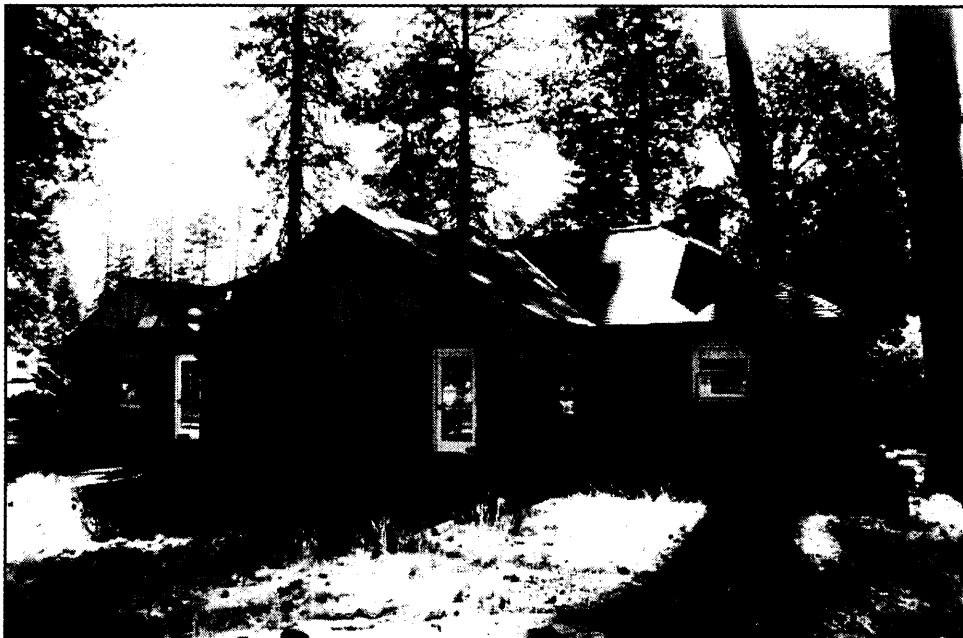
Photo 7: Loomis Residence and Studio, West Elevation

*Loomis Residence and Studio (HS-39, contributing building):* The Loomis residence is a one-story stone building with a rectangular plan constructed on a concrete foundation. The building is currently used for park service administrative purposes. The exterior walls are constructed of a locally available pink dacite. The foundation is enhanced with a stone veneer consisting of the same material. The hipped roof is covered with red asphalt shingles and has exposed pole rafter ends and an interior stone chimney with a metal hood. The window openings contain wooden sashes – creating unusually proportioned vertical lights - and have stone sills.

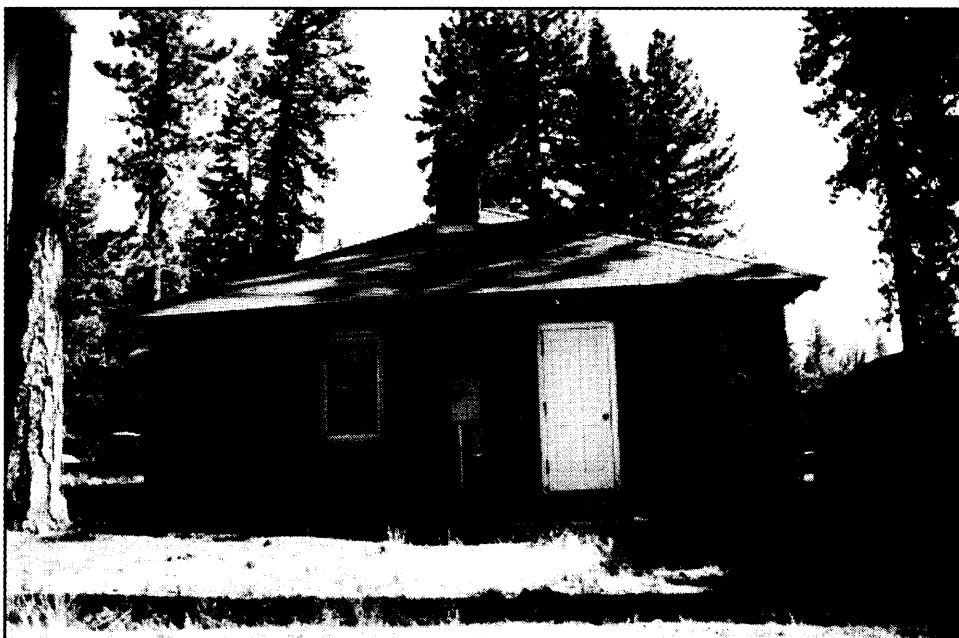
Photo 9: Loomis Residence and Studio, South Elevation

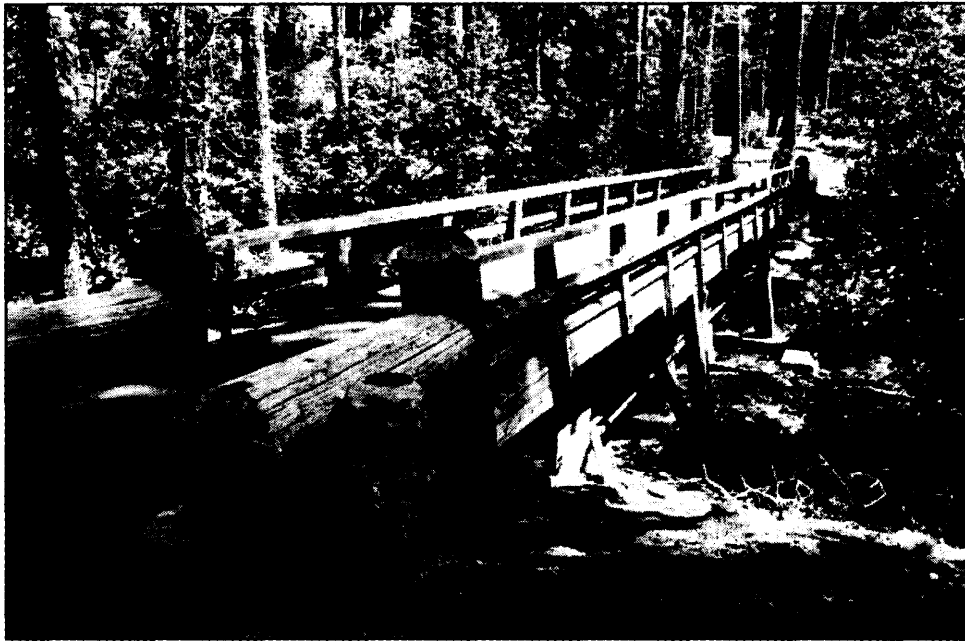
Photo 14: Bridge over Manzanita Creek.

*Manzanita Creek Footbridge (no number assigned, noncontributing structure):* This simple rustic footbridge, designed in 1951 and built soon thereafter, spans Manzanita Creek in the vicinity of the Museum. The bridge is constructed of log stringers secured to stone abutments. Gravel surfaces the milled-lumber decking. The railing is constructed of chopper-cut log posts and milled-lumber horizontal elements.

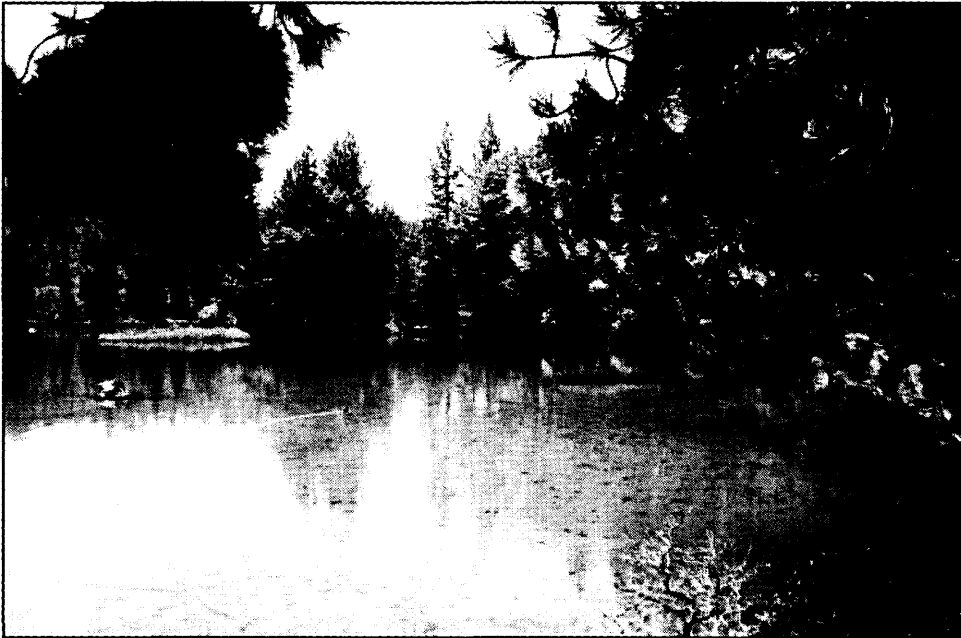
Photo 16: Manzanita Lake Dam.

At Manzanita Lake an earthen dam (about 10 feet high and 469 feet long) was constructed across its natural outlet, raising the capacity of the impounded reservoir to roughly 500 acre-feet. At maximum pool, the lake covers an area of roughly 175 acres. A concrete spillway, ten feet in width, is located at the north end of the reservoir. A cleared area with a beach made of imported sand is located at the south end of the lake and functions as a day-use picnic area.
