Rosemary Inn, Dresmerie Cabin (Bldg. No. 374)  
Olympic National Park  
Harnes Point, Lake Crescent  
Port Angeles Vicinity  
Clallam County  
Washington

HABS No. WA-185-C

HISTORIC AMERICAN BUILDING SURVEY  
ARCHITECTURAL DATA FORM

ROSEMARY INN, DREAMERIE CABIN (Bldg. No. 374)  
HABS No. WA-185-C (page 2)

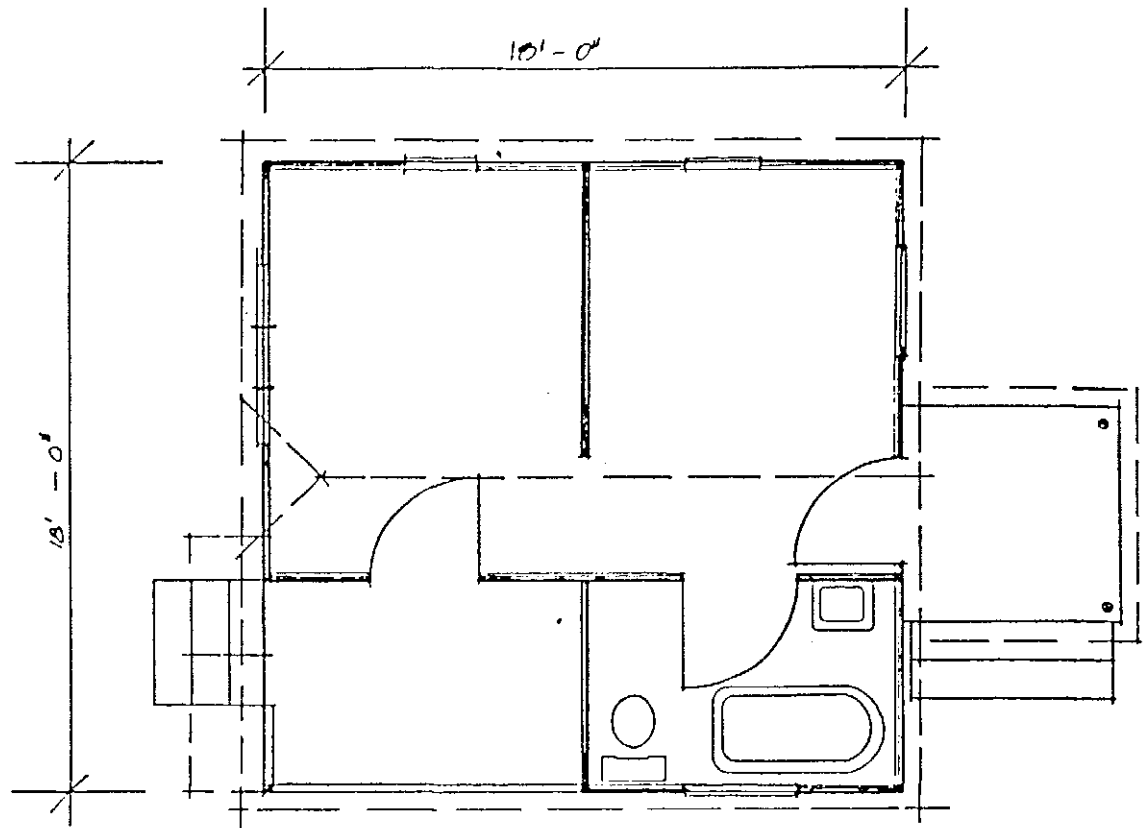
Dreamerie Building #374

| SHAPE AND DIMENSIONS OF STRUCTURE (sketched floor plans on separate sheet acceptable)<br>Square: 19' x 19' | | |
| INTERIOR FEATURES OF NOTE (describe floor plans if not sketched)<br>Bathroom construction original; painted floor boards; 2 sleeping rooms divided by partition; vertical wood board wainscoting with 3 1/4" bevelled siding above (painted). | | |
