Rosemary Inn, Alabam Cabin (Bldg. No. 376)  
Olympic National Park  
Earnes Point, Lake Crescent  
Port Angeles Vicinity  
Clallam County  
Washington

HABS No. WA-185-E

HISTORIC AMERICAN BUILDING SURVEY  
ARCHITECTURAL DATA FORM

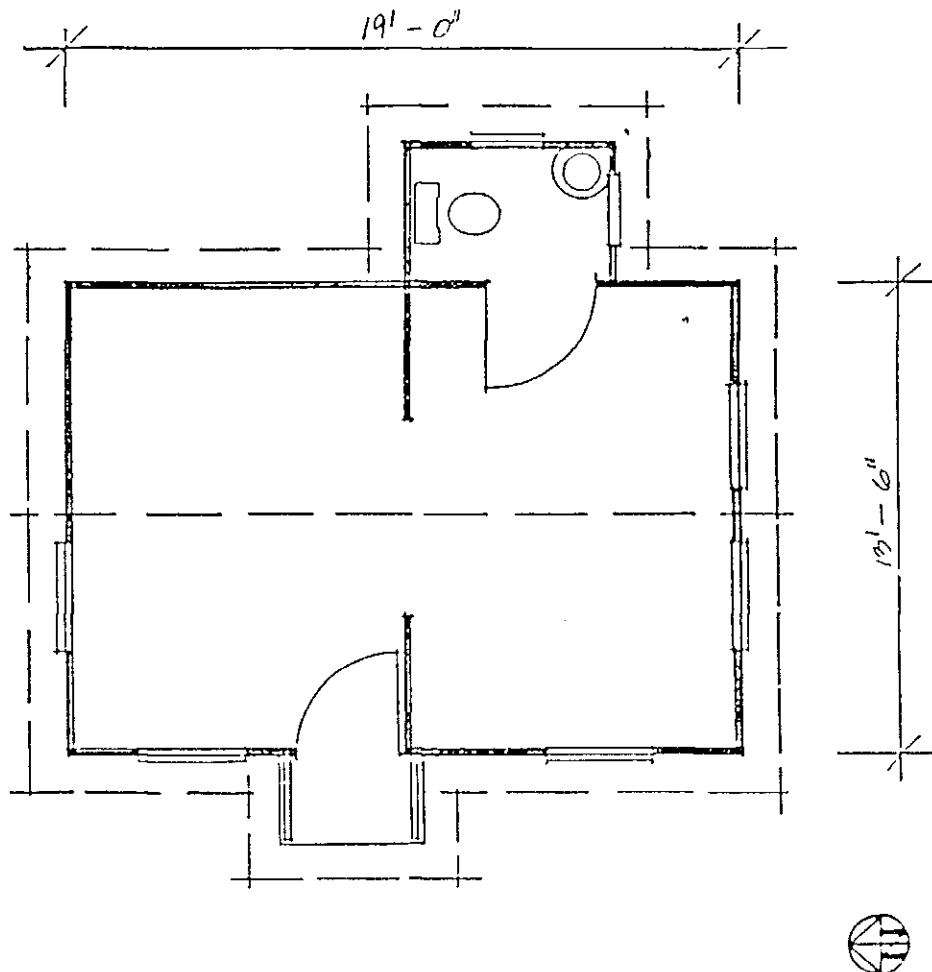
Alabam Building #376

| MATERIAL OF CONSTRUCTION (include structural systems)<br>Wood-frame construction set on 6 x 6 wood posts on concrete piers and blocks. | | |
| SHAPE AND DIMENSIONS OF STRUCTURE (sketched floor plans on separate sheet acceptable)<br>Rectangle: 14' x 19' with shed-roofed extension (bathroom) off east facade. | | |
| EXTERIOR FEATURES OF NOTE<br>1 story; wood-shingled gable roof with slightly clipped gable ends, extended eaves and exposed rafter ends; wood shingle siding with narrow vertical wood boards at gable ends; multi-paned, casement and hinged sash; off-center entry on west; shed roof overhang with exposed log rafters supported by knee braces; peeled log railing on stoop; plain fascia board. | | |
