Rosemary Inn, Honeyeuckle Cabin (Bldg. No. 377)  
Olympic National Park  
Barnes Point, Lake Crescent  
Port Angeles Vicinity  
Clallam County  
Washington

HABS No. WA-135-F

HISTORIC AMERICAN BUILDING SURVEY  
ARCHITECTURAL DATA FORM

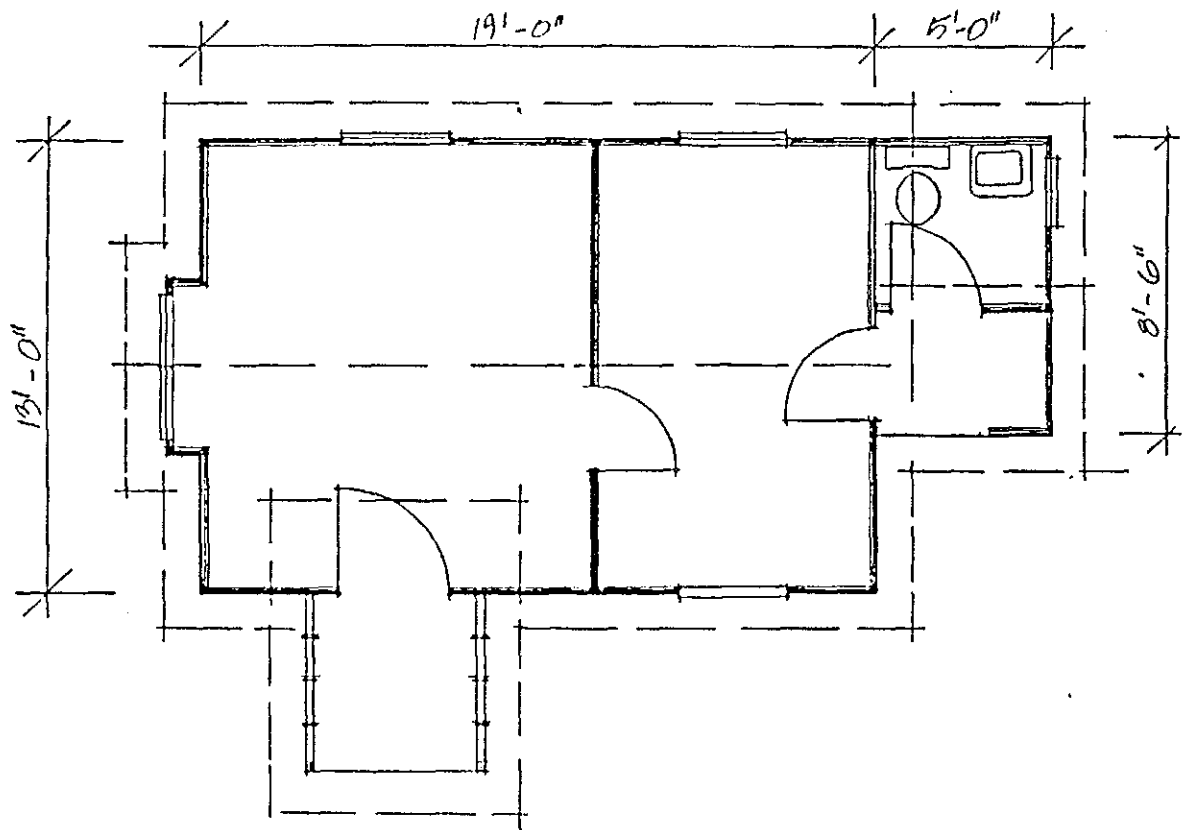
Honeysuckle Building #377

| SHAPE AND DIMENSIONS OF STRUCTURE (sketched floor plans on separate sheet acceptable)<br>Irregular: approx. 13' x 19' with a 5' x 9' addition on east facade. | | |
| EXTERIOR FEATURES OF NOTE 1-story; wood-shingled gable roof with exposed rafter ends and slightly extended eaves; shed-roof extension off south facade forms entry overhang supported by peeled logs; wood shingle siding with vertical wood boards at gable ends; hip-roofed bay window on west has tri-partite diamond pane casement sash supported by 3 knee braces; multi-paned casement and hinged sash with plain surrounds; horizontal wood skirting; plain fascia boards; entry has boxed wood shingle rail and lattice as screening. | | |
