Rosemary Inn, Red Wing Cabin (Bldg. No. 330)  
Olympic National Park  
Barnes Point, Lake Crescent  
Port Angeles Vicinity  
Clallam County  
Washington

HABS No. WA-185-H

HISTORIC AMERICAN BUILDING SURVEY  
ARCHITECTURAL DATA FORM

ROSEMARY INN, RED WING CABIN (Bldg. No. 380)  
HABS No. WA-185-H (page 2)

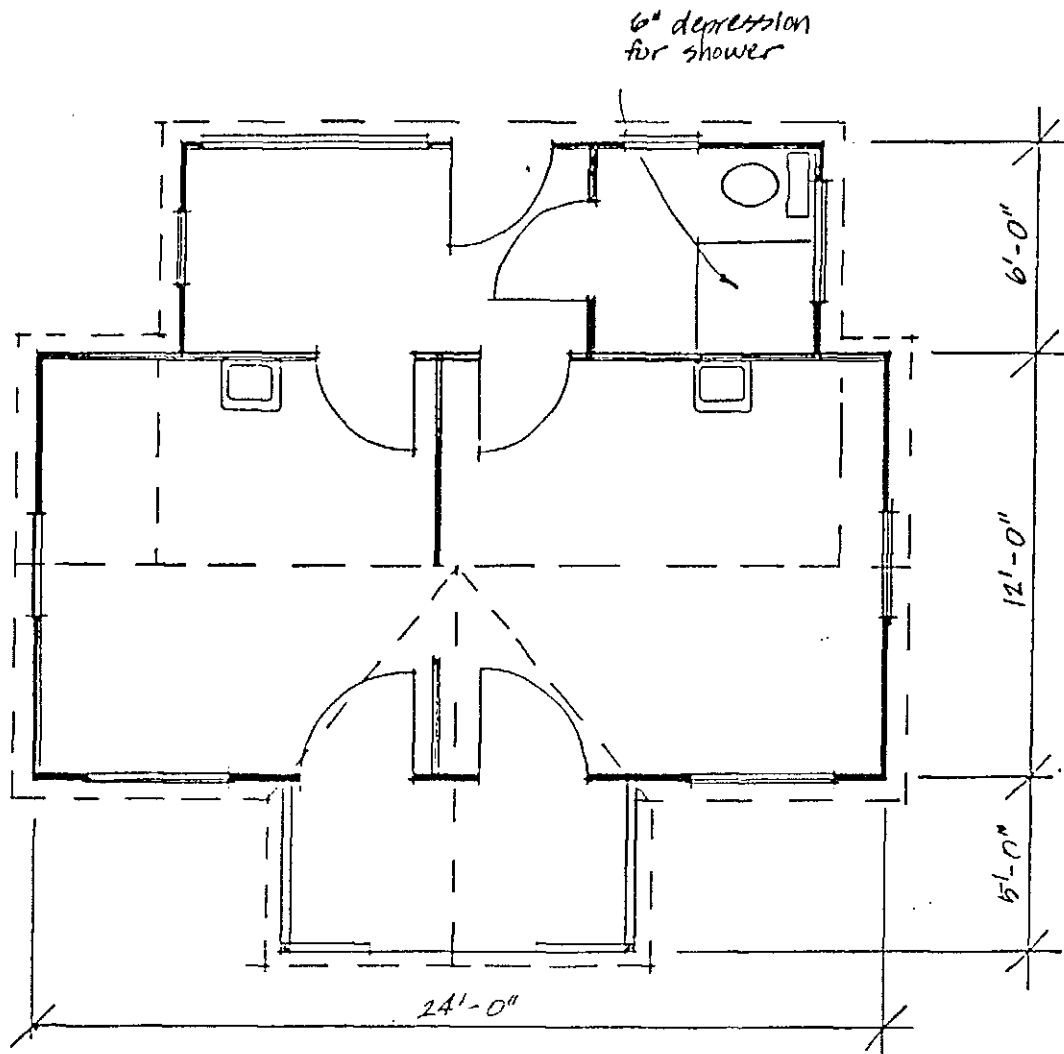
Red Wing Building #380

| SHAPE AND DIMENSIONS OF STRUCTURE (sketched floor plans on separate sheet acceptable)<br>Irregular: overall dimensions approx. 24' x 23' | | |
| INTERIOR FEATURES OF NOTE (describe floor plans if not sketched)<br>Painted floor boards; bevelled board siding; vertical board wainscoting on walls; sinks in each sleeping room. | | |
