HABS No. WA-105-N

HISTORIC AMERICAN BUILDING SURVEY  
ARCHITECTURAL DATA FORM

| HISTORIC NAME OF STRUCTURE (include source for name)<br>Rosemary Inn, "Dardenella" Cabin | | HABS NO.<br>WA-185-N |

INDEX TO PHOTOGRAPHS

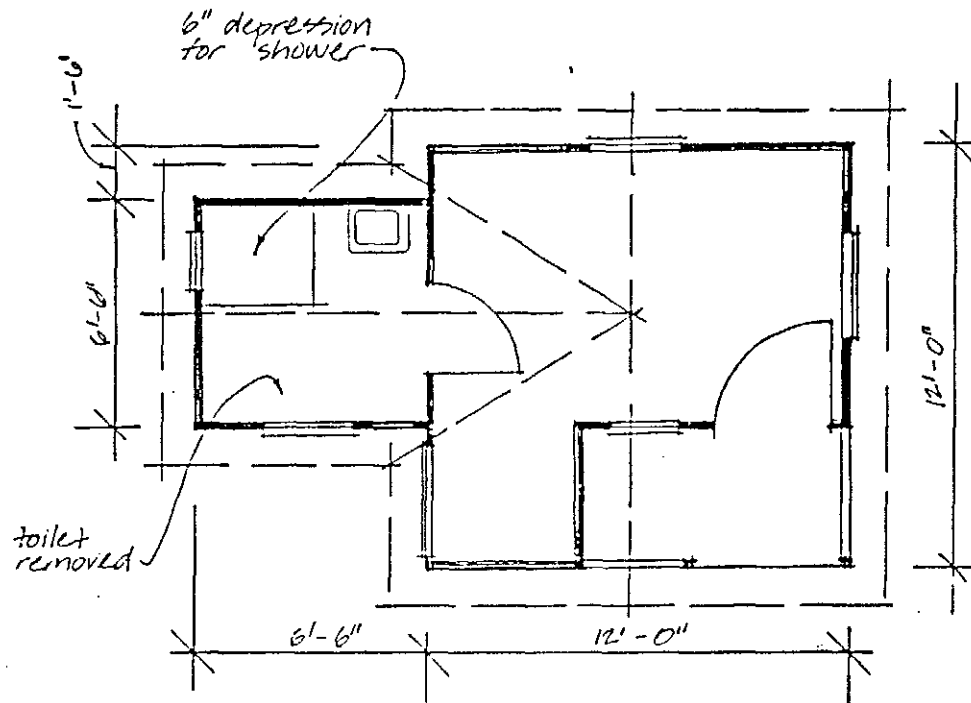
Dardanella Building #388

| SHAPE AND DIMENSIONS OF STRUCTURE (sketched floor plans on separate sheet acceptable)<br>L-shape: approx. 12' x 18'6" | | |
