Rosemary Inn, Inglebrook (Fireplace Shelter,  
Building No. 398)  
Olympic National Park  
Barnes Point, Lake Crescent  
Port Angeles Vicinity  
Clallam County  
Washington

HABS No. WA-185-0

HISTORIC AMERICAN BUILDING SURVEY  
ARCHITECTURAL DATA FORM

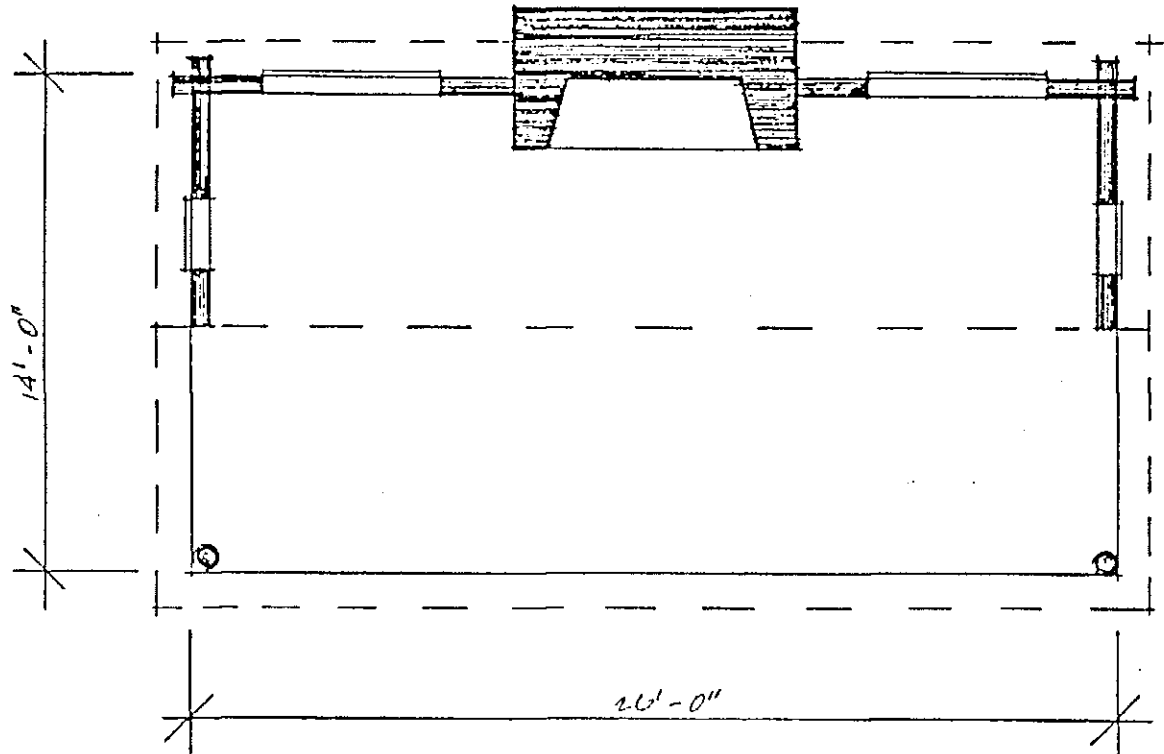
Fireplace Shelter Building #398

| SHAPE AND DIMENSIONS OF STRUCTURE (sketched floor plans on separate sheet acceptable)<br>Rectangle: 12' x 18' | | |
| EXTERIOR FEATURES OF NOTE<br>3-sided shelter: galvanized metal gable roof supported by log posts at open end (south);<br>extended eaves, exposed log rafters and joists, and log fascia; multi-paned fixed sash with<br>plain surrounds; log ends bevelled; vertical board and batten siding on gable ends above logs;<br>massive exterior rough-cut stone chimney and fireplace on north. | | |
| INTERIOR FEATURES OF NOTE (describe floor plans if not sketched)<br>Massive, stepped, rough-cut stone fireplace; flagstone floor; chairs cut from a single log. | | |
