Singer's Lake Crescent Tavern (Lake Crescent Lodge),  
Employees/Boys Dormitory (Storage Bldg., Bldg. No. 657)  
Barnes Point, Lake Crescent  
Olympic National Park  
Port Angeles Vicinity  
Clallam County  
Washington

HABS No. WA-186-G

# PNRO INVENTORY

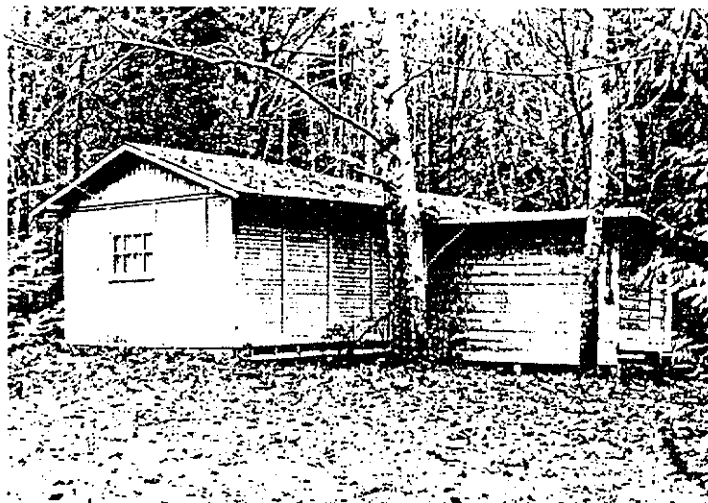
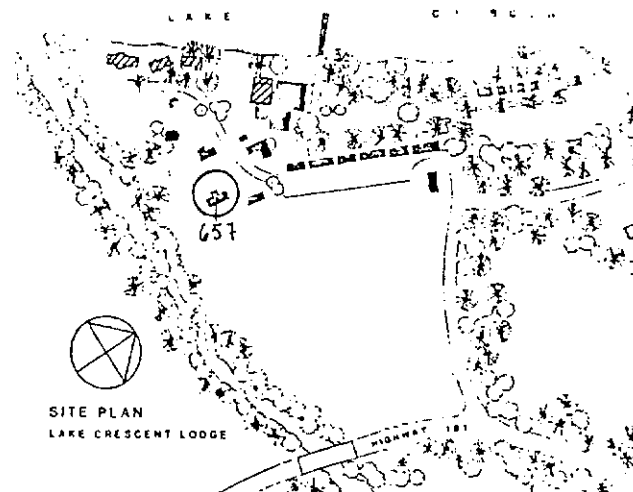
NEG. 37:3

Rectangular in shape with square addition on north elevation; measures 34' x 14' with 13' x 8' addition; 1 story; wood-frame wall construction with channel drop siding, interspersed with panels of vertical board siding where, perhaps, two doors were once located; gabled roof with composition rolled roofing material; foundation basically post and pier, except on north elevation; horizontally placed logs with diameters of 10' support the cabin. Four-light, horizontal, sliding casement windows; vertical board door with "Z" bracing. Boardwalk leads to cabin. Alterations: addition on north elevation; replacement of sections of siding; possibly moved from original site. Siting: located in wooded area; part of the Singer's Tavern building ensemble.

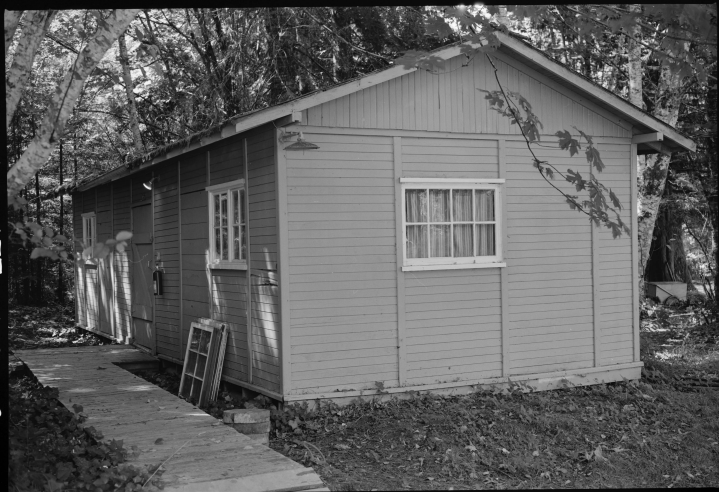
HABS NO. WA-136-G-1

WA-186-C-1 NORTHEAST FACADE, LOOKING SOUTHWEST
