Singer's Lake Crescent Tavern (Lake Crescent Lodge),  
Storage Building/Garage (Bldg. No. 1268)  
Barnes Point, Lake Crescent  
Olympic National Park  
Port Angeles Vicinity  
Clallam County  
Washington

HABS No. WA-186-M

WRITTEN HISTORICAL AND DESCRIPTIVE DATA

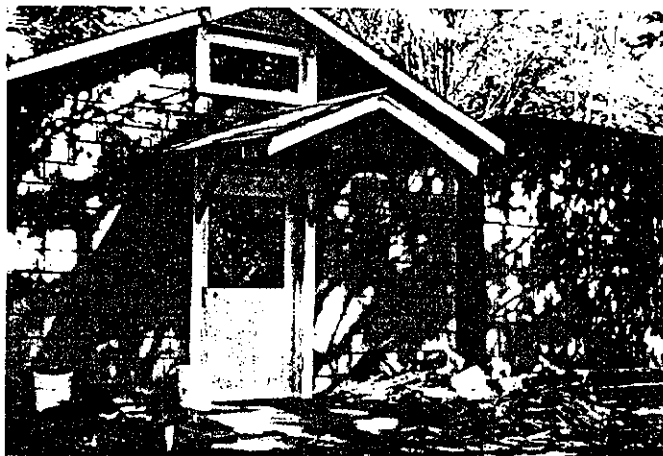
NEG. 2:9

Rectangular in shape; measures approx. 14' x 20'; 1 story; wood-frame wall construction with wood shingle siding; gable roof with exposed rafters and sheathed with wood shingles; gable roof porch, supported by braces, projects from main (north) facade; concrete slab foundation; horizontal single-light windows in gable ends; wood door with single glass pane in upper portion. Alterations: possibly moved; new foundation; new roofing (1982). Siting: at the edge of forest near small creek; small shake-clad building 1' from west wall; near other storage and employee quarters buildings; part of the Singer's Tavern Group.

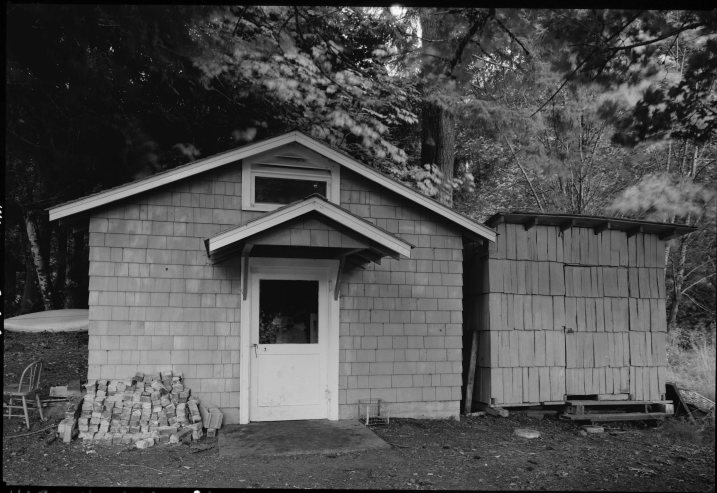
HABS NO. WA-186-M-1

WA-186-M-1 NORTH FACADE, LOOKING SOUTHWEST
