# VICTORIA MINE

Historic Structures Report  
Organ Pipe Cactus National Monument  
ARIZONA

## Historic Structures Report, Parts I & II Organ Pipe Cactus National Monument ARIZONA

HISTORIC STRUCTURES REPORT  
PARTS I AND II  
ARCHITECTURAL DATA SECTION  
ON  
VICTORIA MINE  
Organ Pipe Cactus National Monument  
Arizona

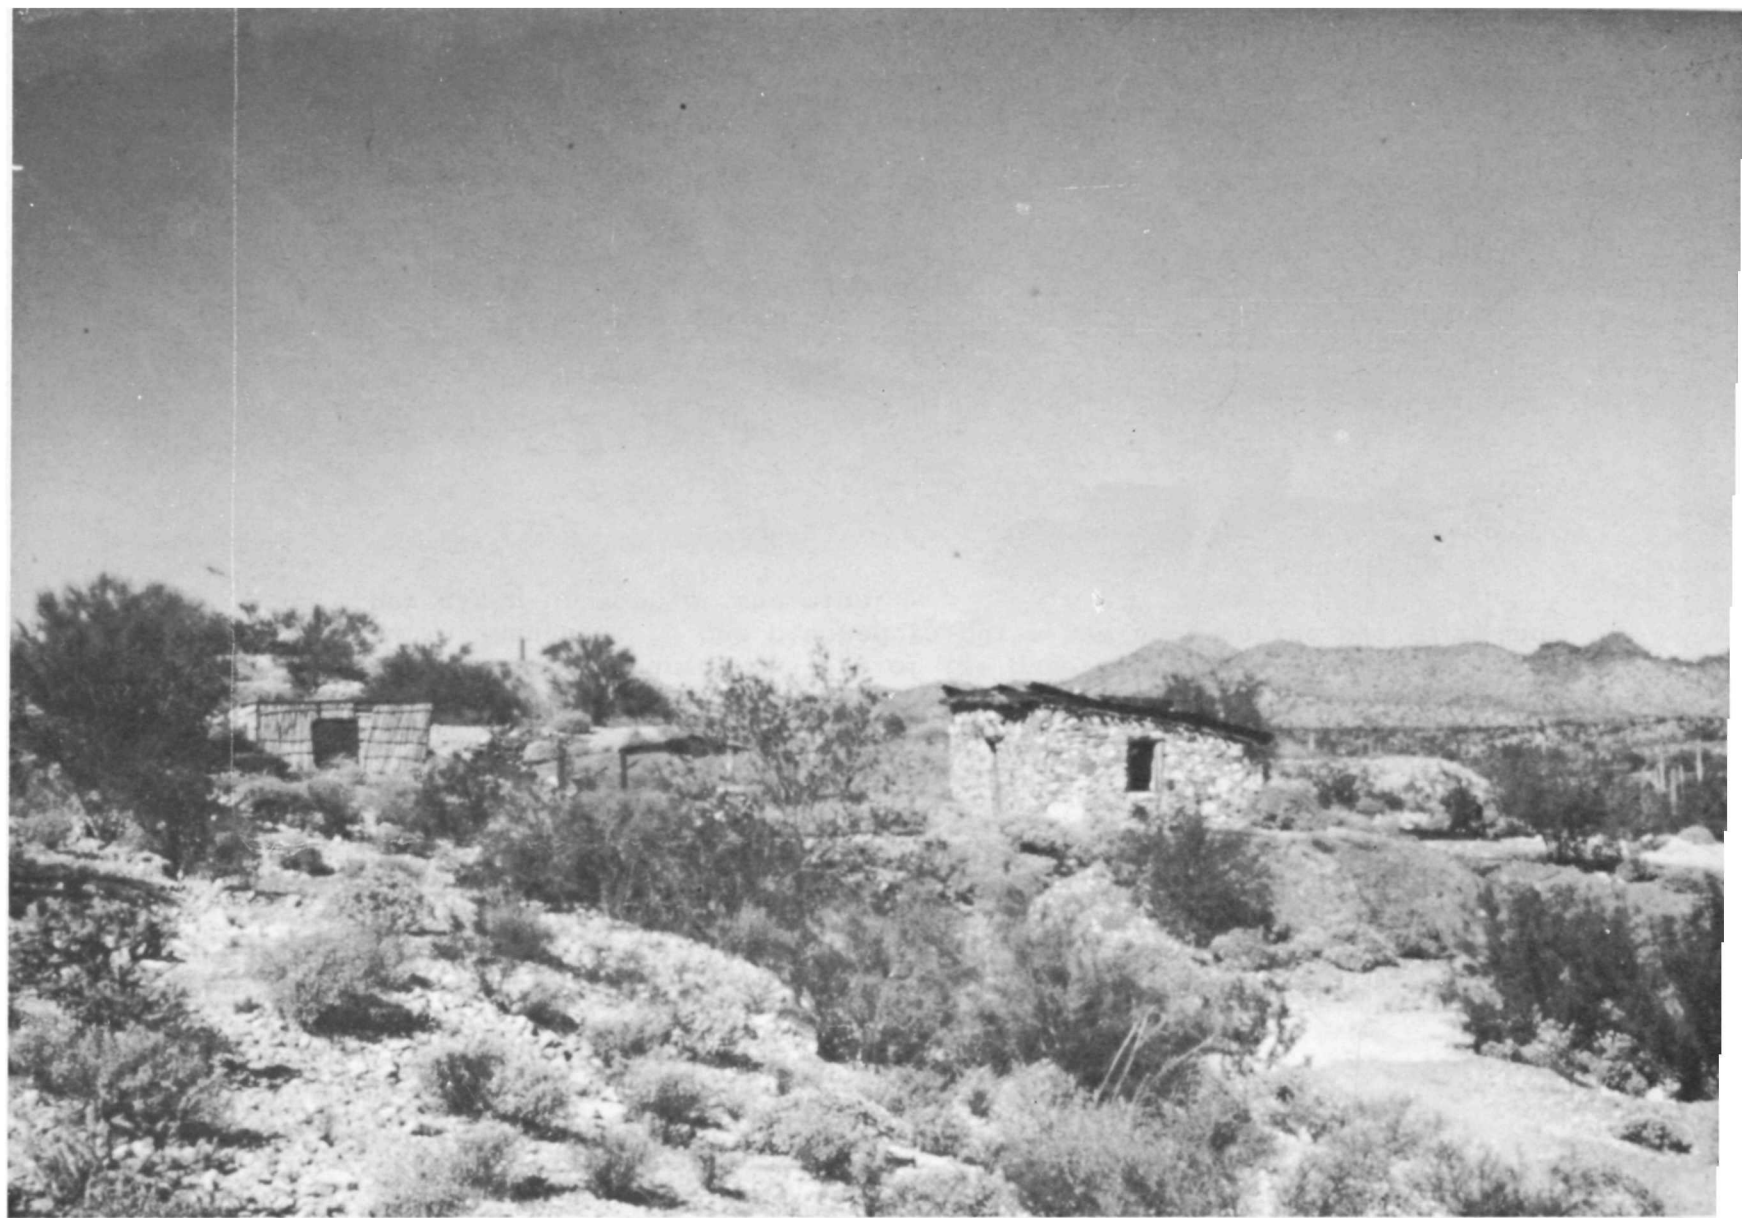
2. Stone House and debris at Victoria Mine, April 1967. Photograph taken by William E. Brown, Regional Historian, Southwest Region, National Park Service. Note that the house still has a dilapidated roof on it at this time. The roof is now gone, removed in January 1968 by Bob Chapman and Terry Traflinger. Chapman was one of the owners of the mining claim. Chapman in January 1968 had planned to put a new roof on the building and do other clean-up work at the mine.

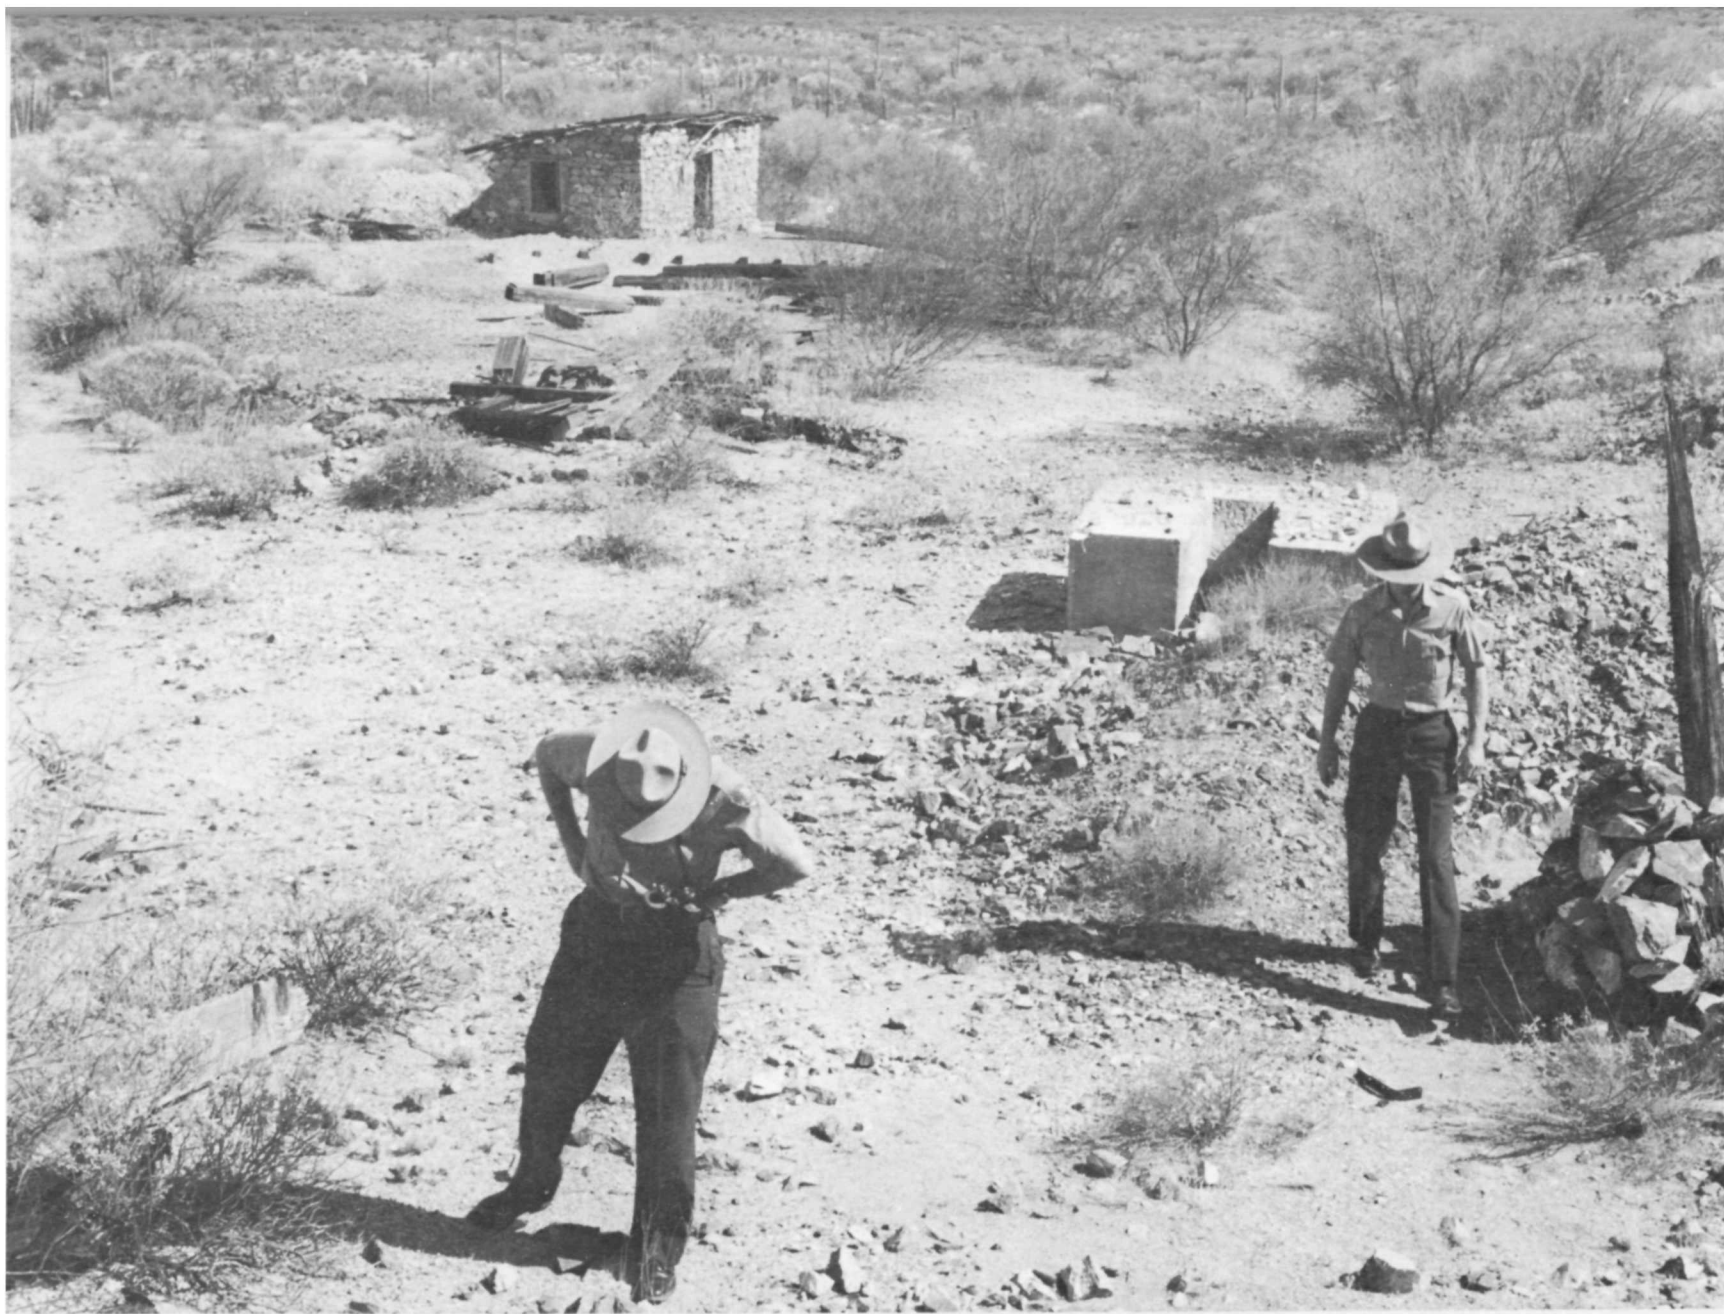
3. View of the Stone House and general area of the Victoria Mine. Mine shaft hidden from view by house. This general area is dotted with glory holes, prospector diggings, and much debris from the Victoria Mine. This picture shows the dilapidated condition of the roof before it was removed in January 1968 by Chapman and Traftlinger. Note that a corner of the Stone House has fallen in. The stone work indicates the roof at one time was flat, but that one side was built up to give a slight slope to the roof line. This is the only structure standing at the Victoria Mine. The best speculation, based on some evidence, is that M.G. Levy built it about 1900. Foundations and stone walls of several structures are visible at the site. Photo taken in April 1967 by William E. Brown, Regional Historian, Southwest Region, National Park Service.

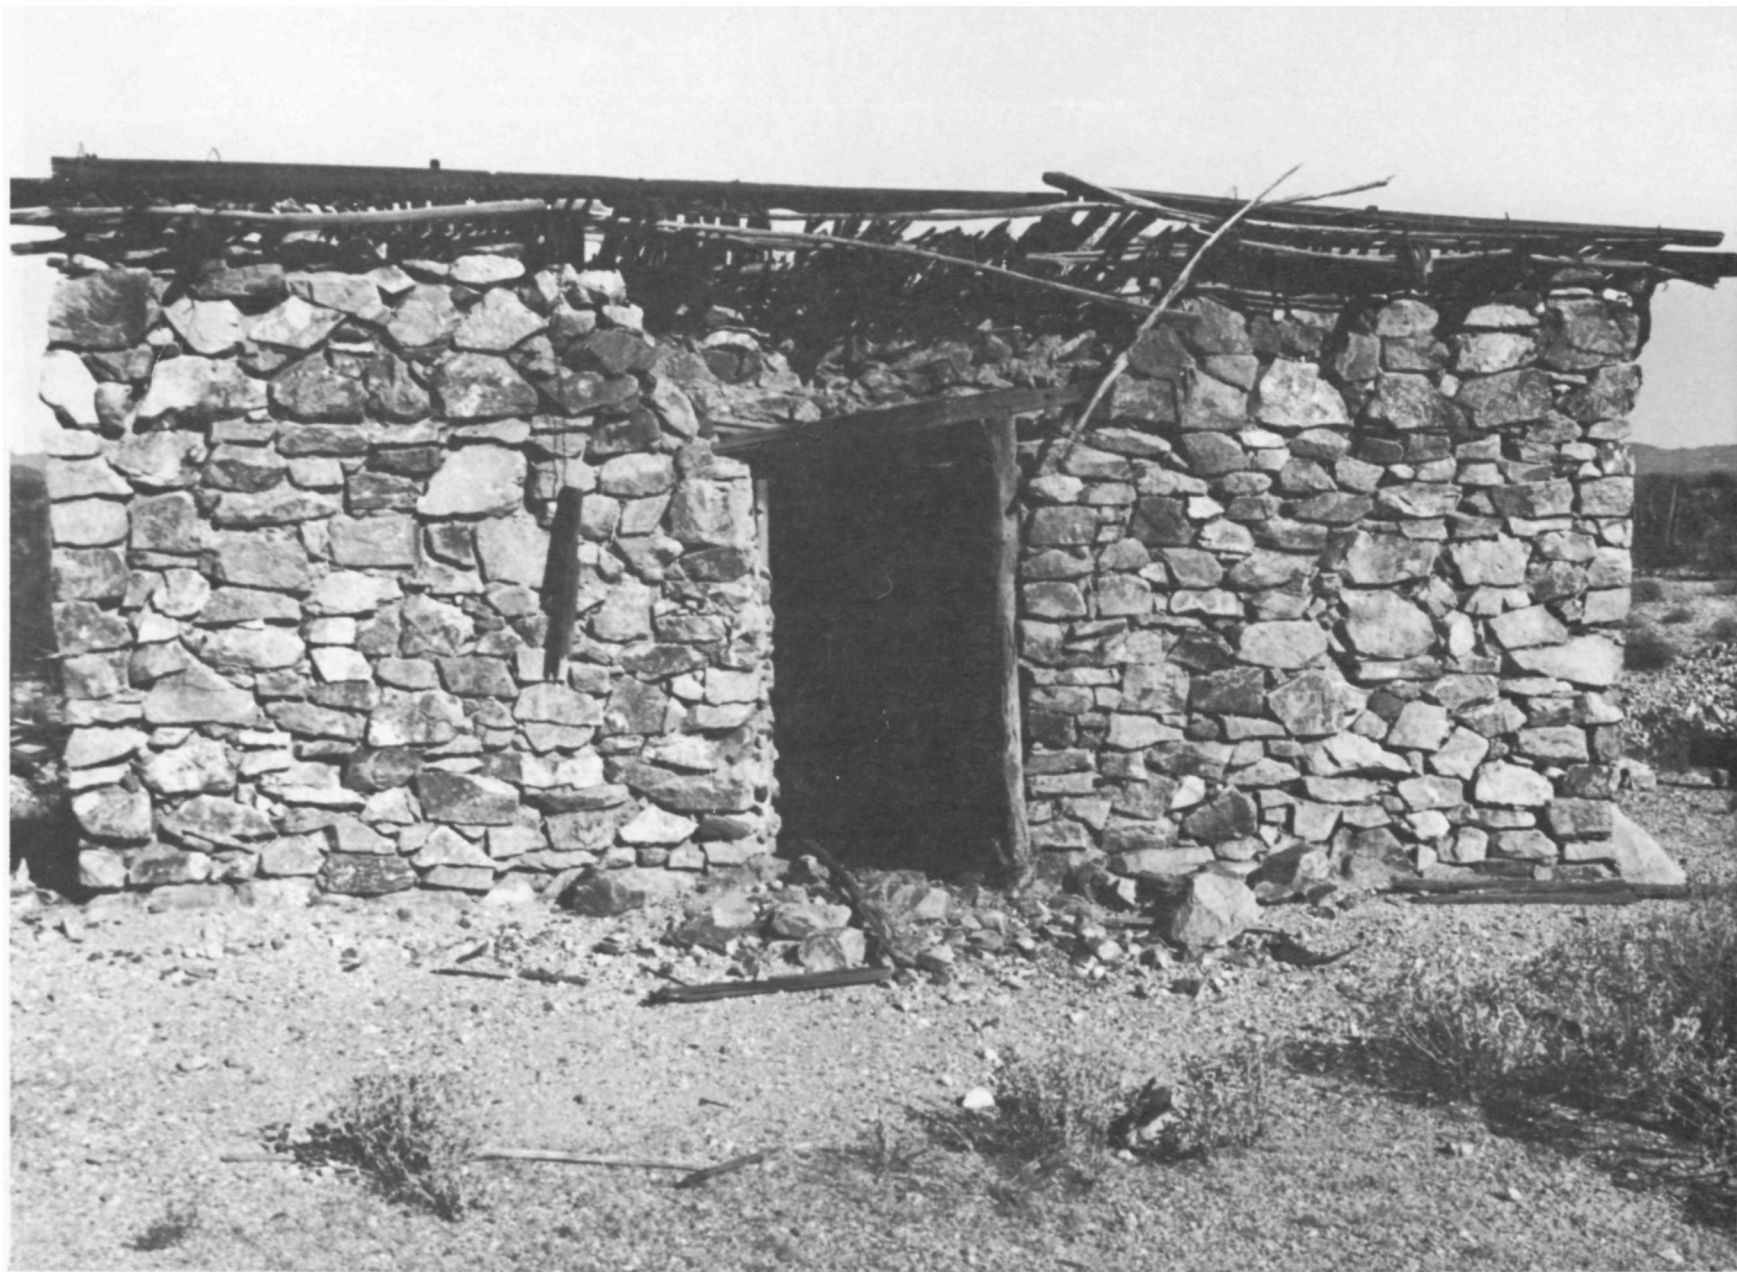
PLATE I

Front View of Headquarter Building Showing Condition of Structure,  
October 1967.

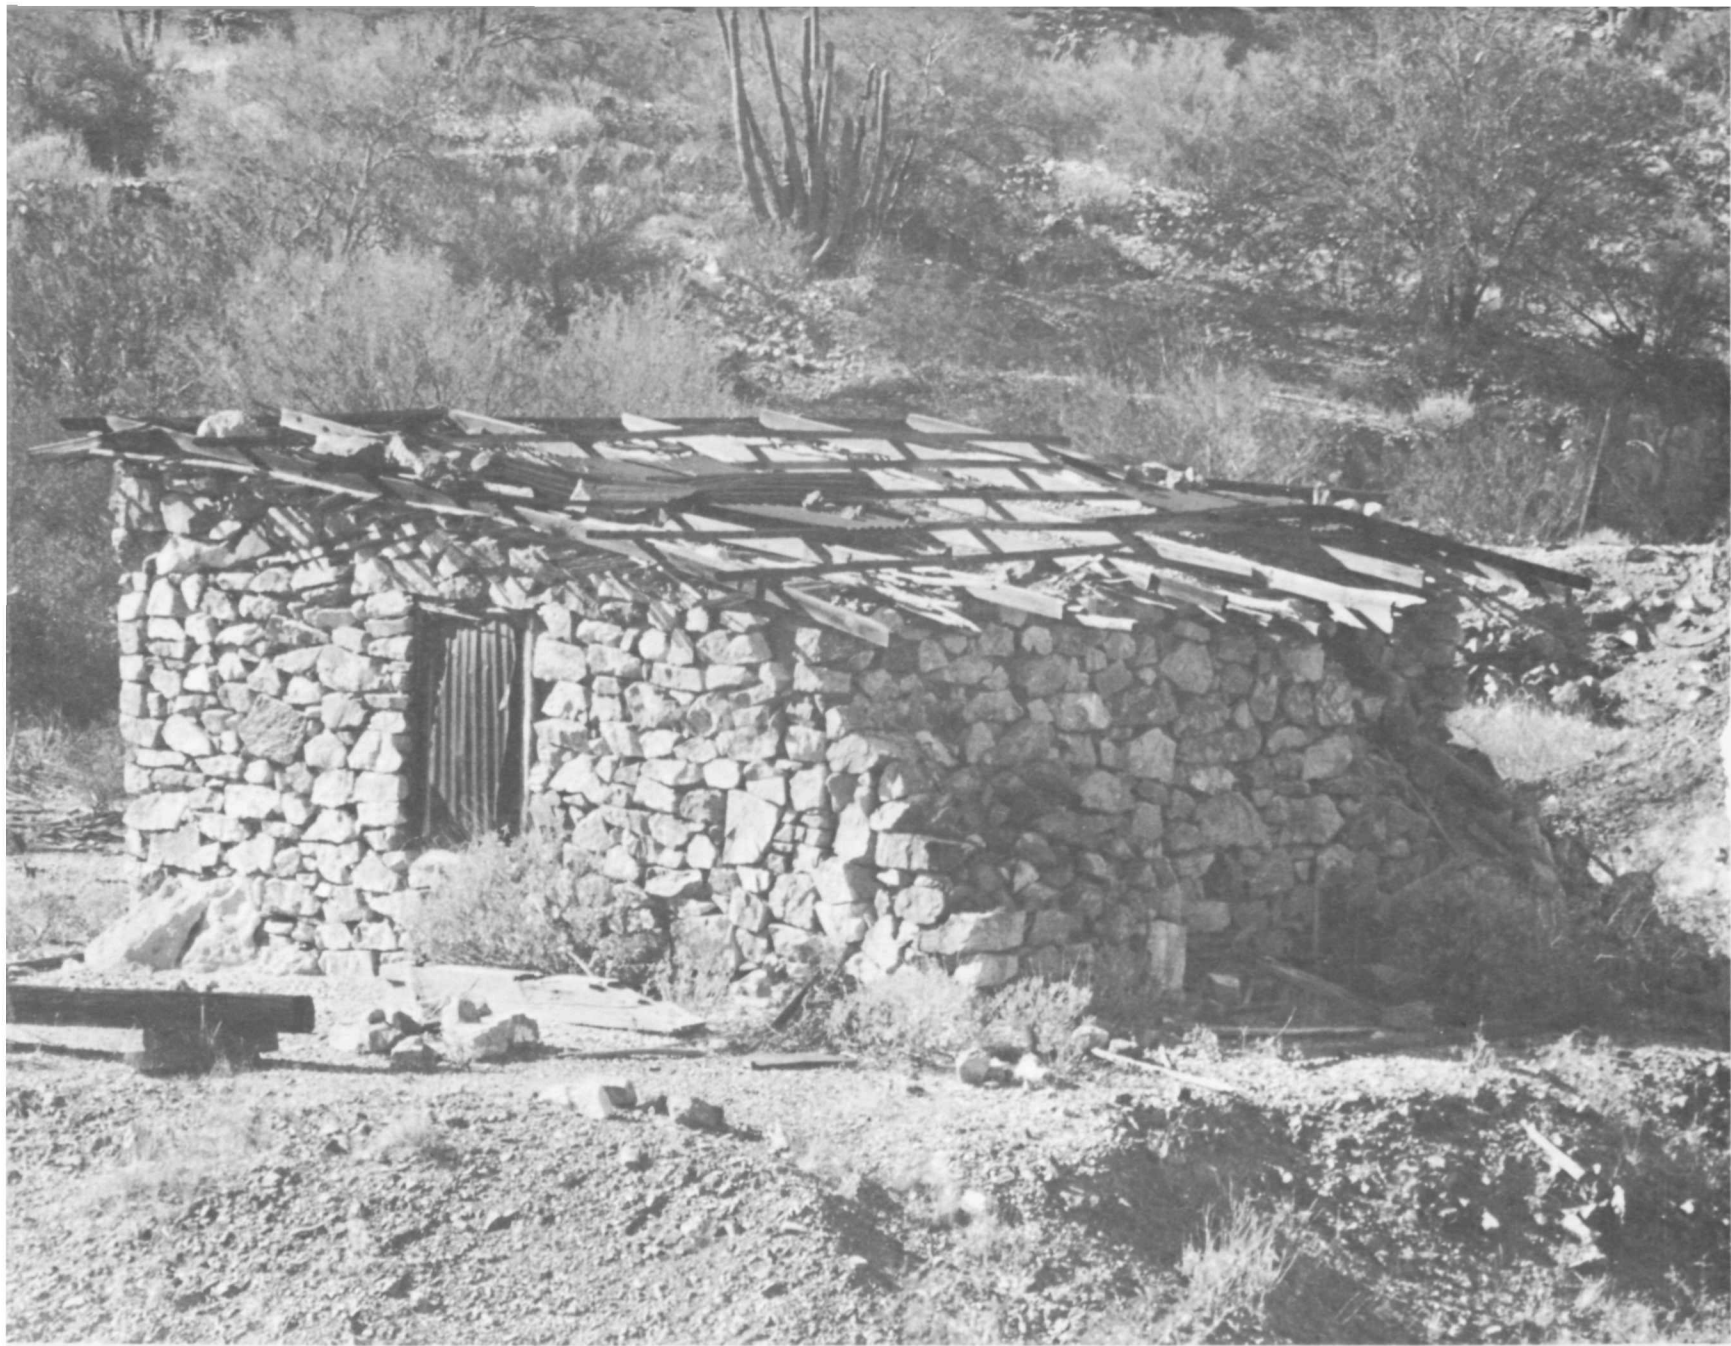
PLATE II

View from the Southwest Showing Condition of Roof, October 1967.

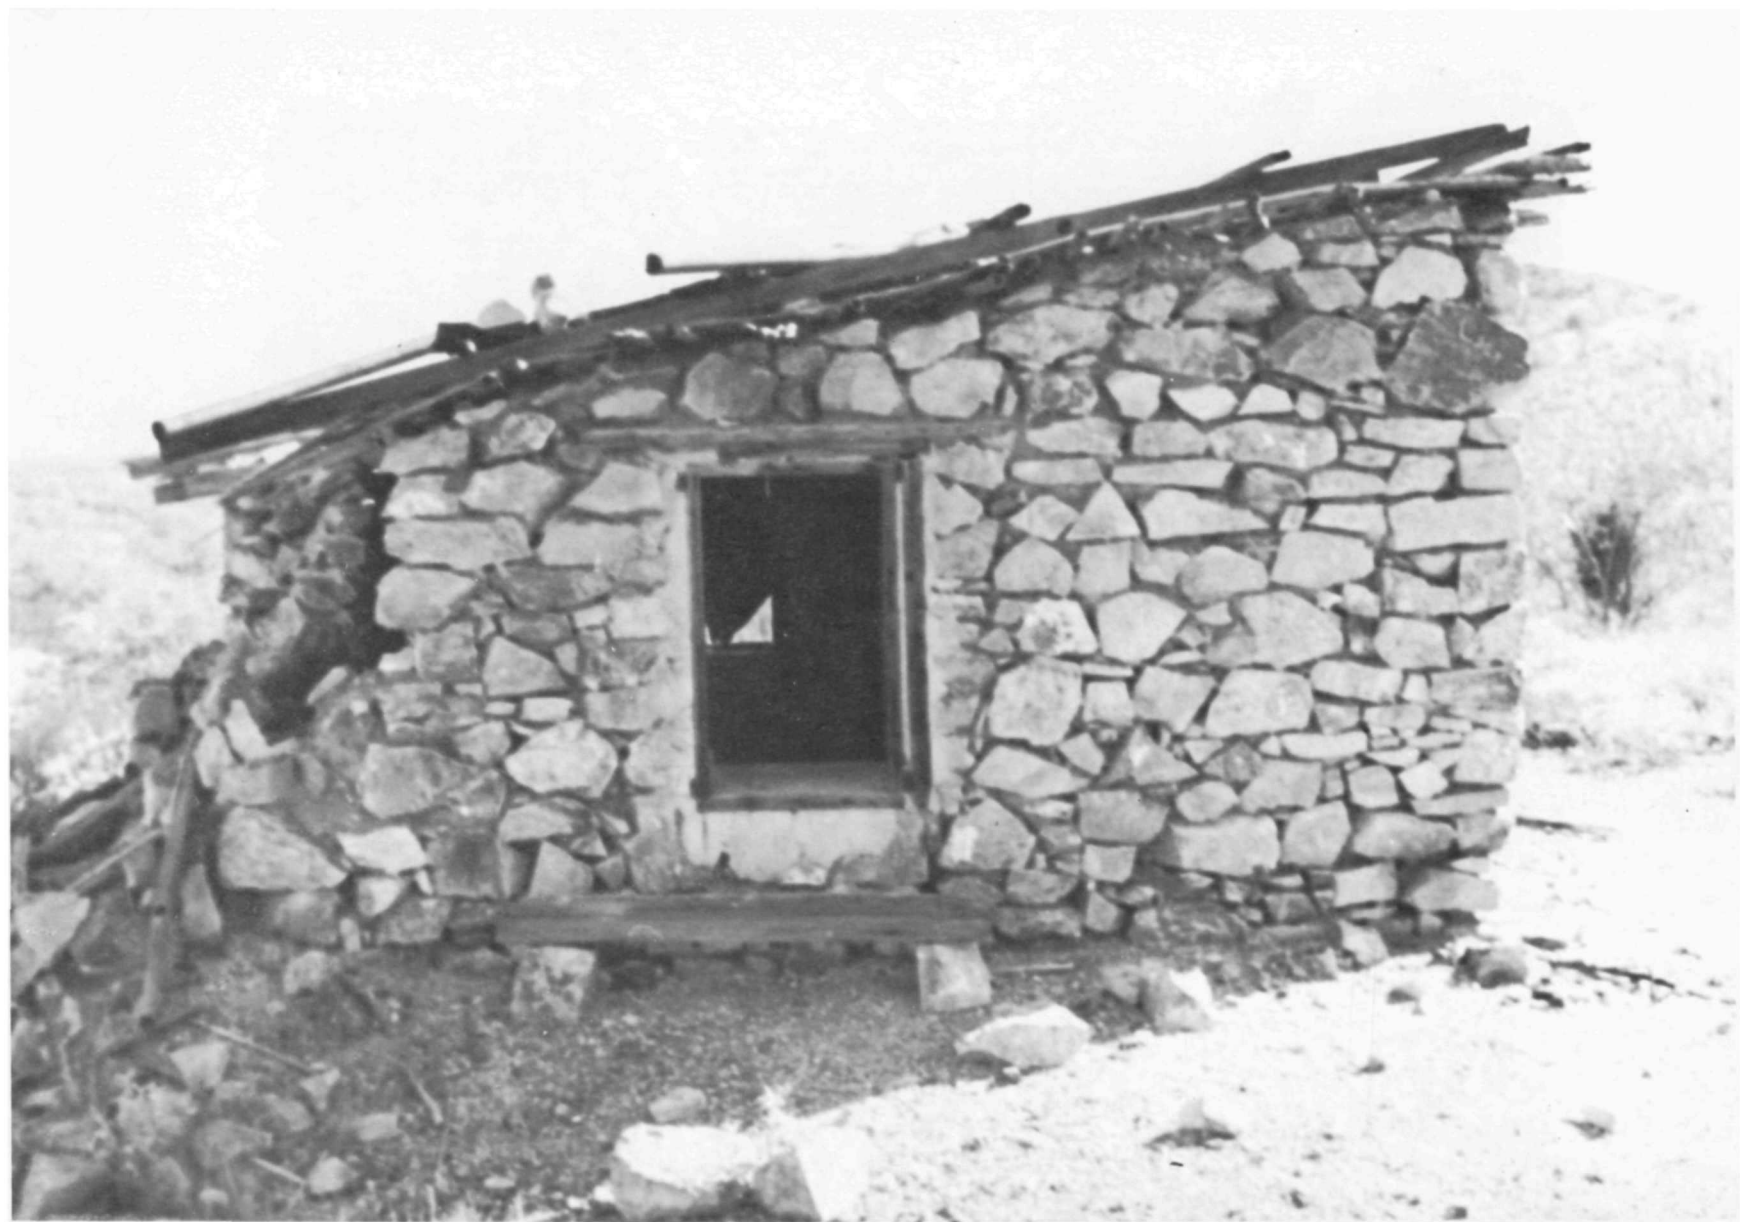
PLATE III

The over all measurements of the building are approximately 21 feet by 16 feet. The four exterior stone walls are laid with mud mortar and vary in thickness from 28-1/2 inches to 30 inches. There are no interior partitions. There is definite evidence that the building was originally flat roofed. To permit the installation of a shed roof the front wall was raised to its present height of 8 feet +, and the end walls sloped to the rear wall which remained at its original height. The southeast corner of the building has collapsed through neglect or accidently damaged. All mortar joints are badly eroded.

East Elevation, Note Collapsed Corner, October 1967.

1. There are no large cracks in the stone walls, therefore, no foundation work is recommended.
2. Remove adobe mortar and tuck point interior and exterior faces of all walls with lime-cement mortar, colored to match the existing mortar. Reset all loose stones and replace missing stones. Rebuild collapsed corner and adjacent walls. Realign top of front, rear and two end walls to receive new roof. Reinforce door and window lintels as necessary to support walls.
3. Replace deteriorated wood rafters as necessary, install additional rafters as may be required to support new roof. Rebuild roof in accordance with photographs from the monument files using Saguaro and Organ stems, brush and soil cement topping with an embedded waterproof membrane. Reuse existing material where practical and available.

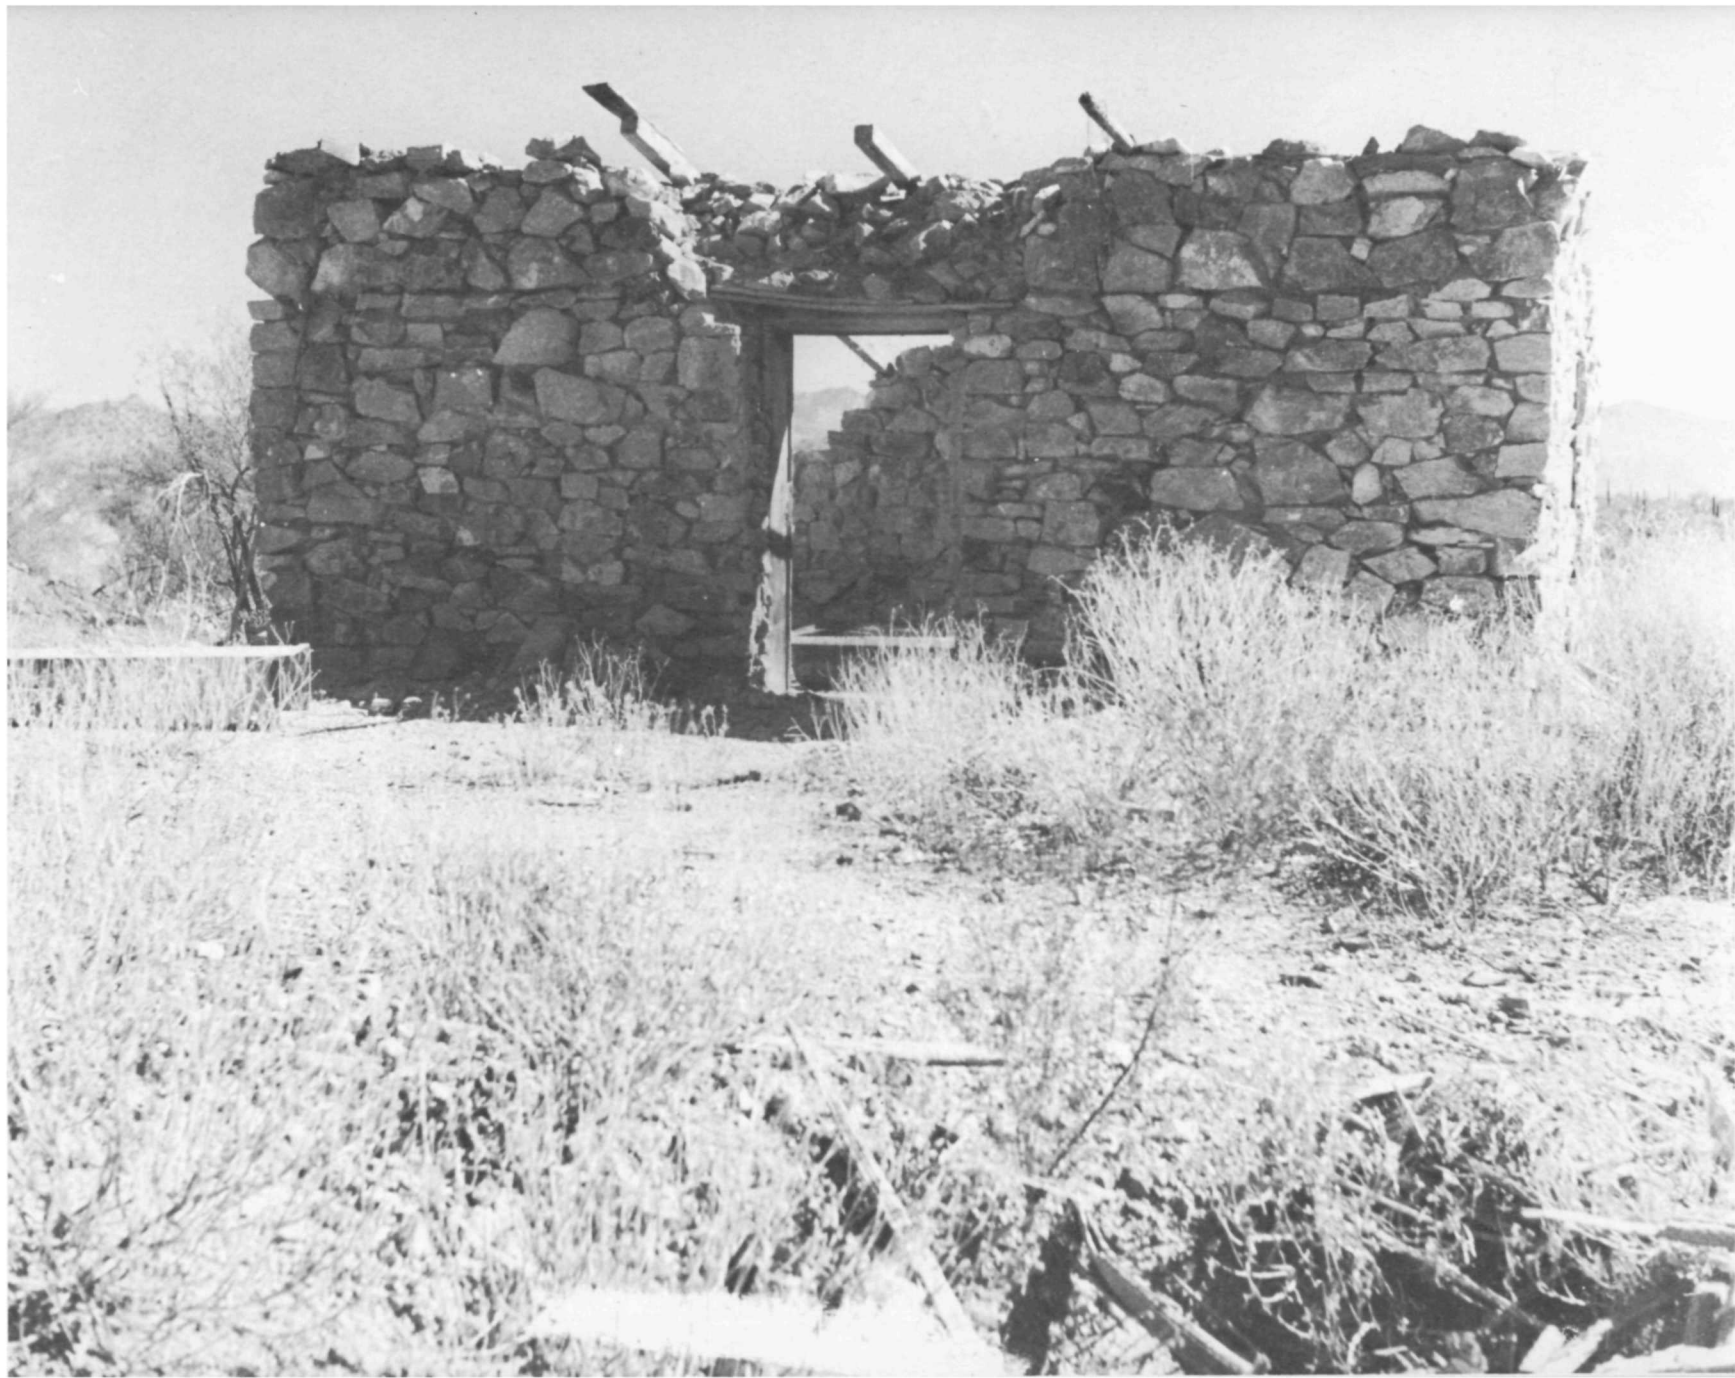
PLATE IV

Front View, October 1968

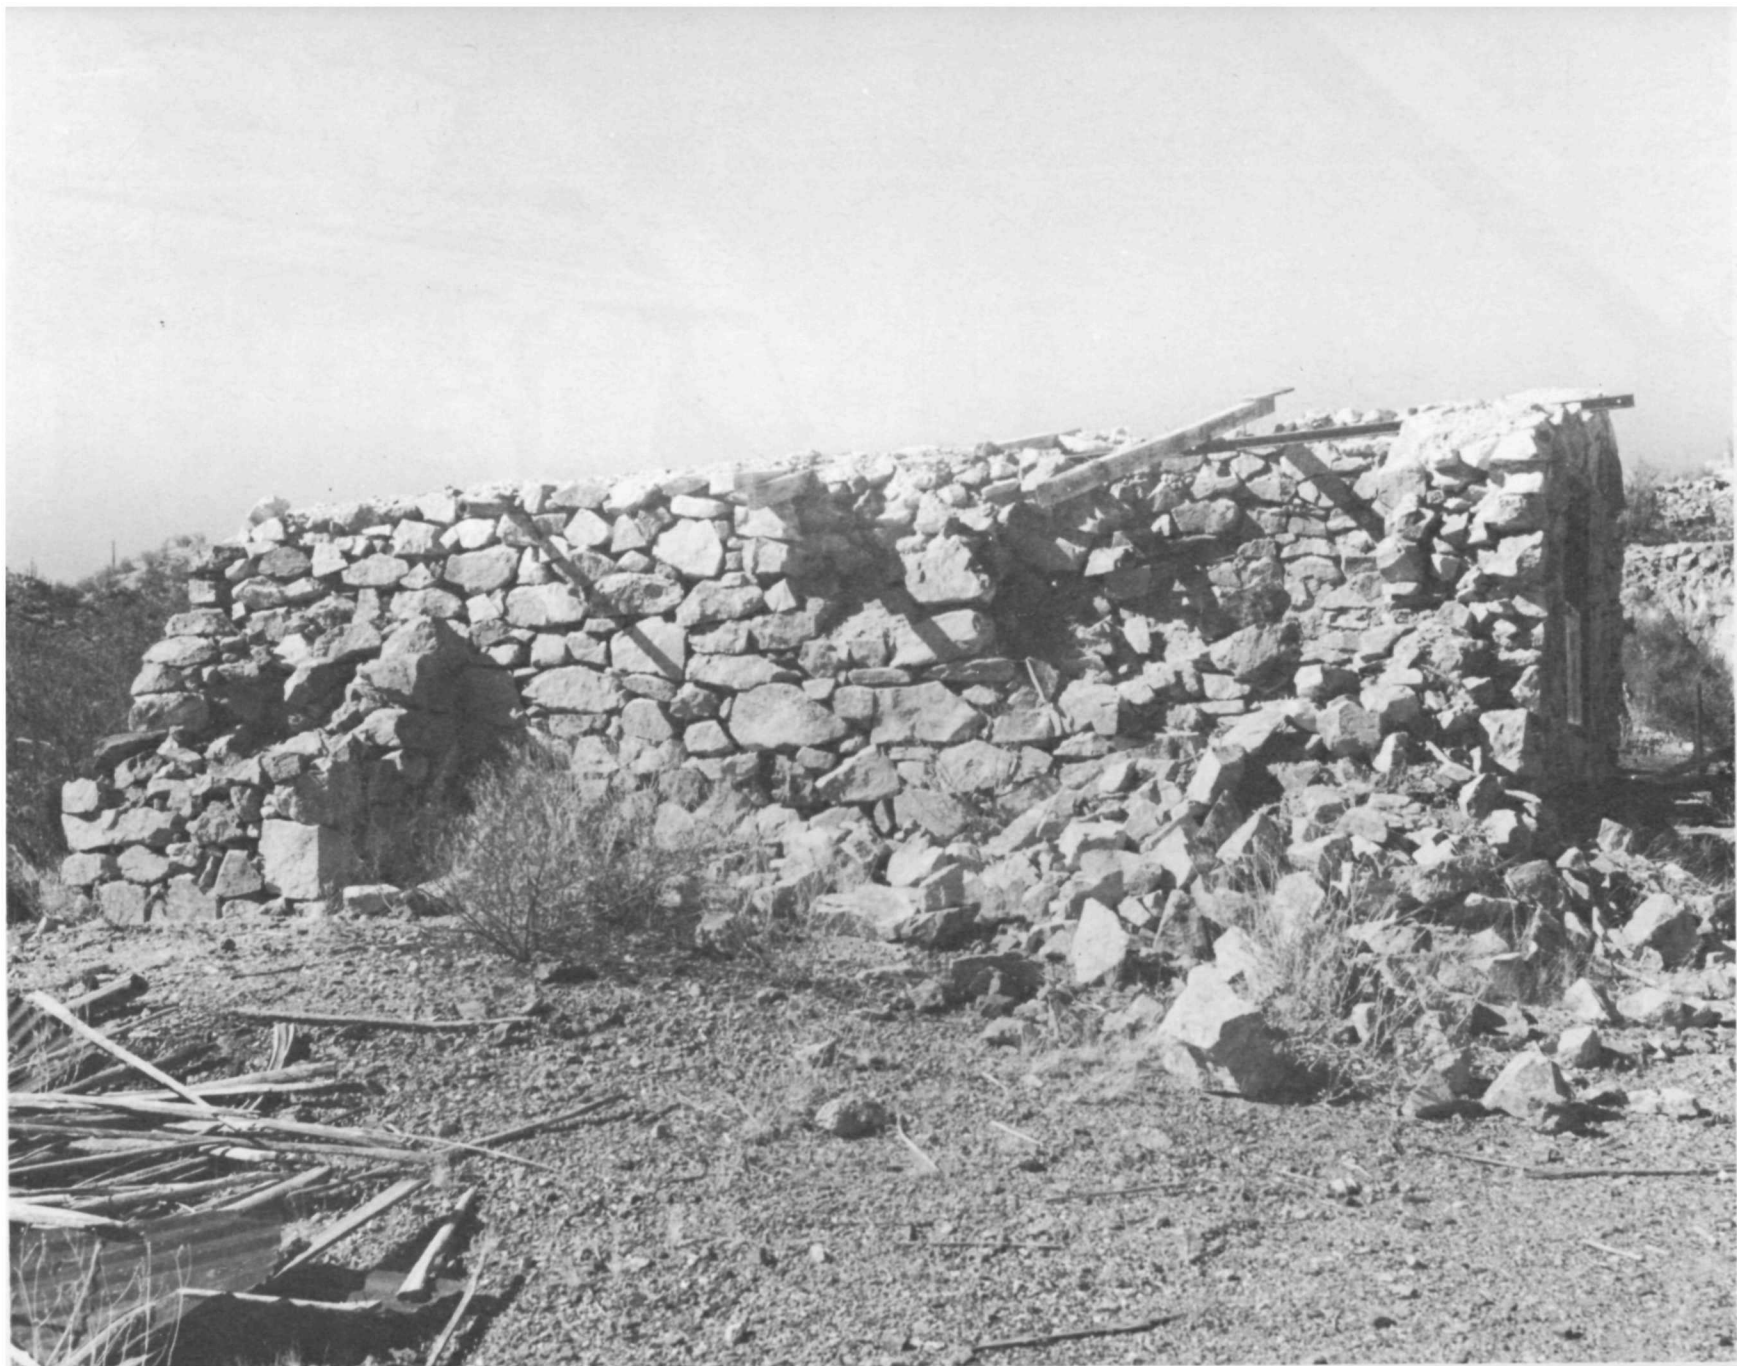
PLATE V

Rear View, October 1968, Showing Condition of Roof.

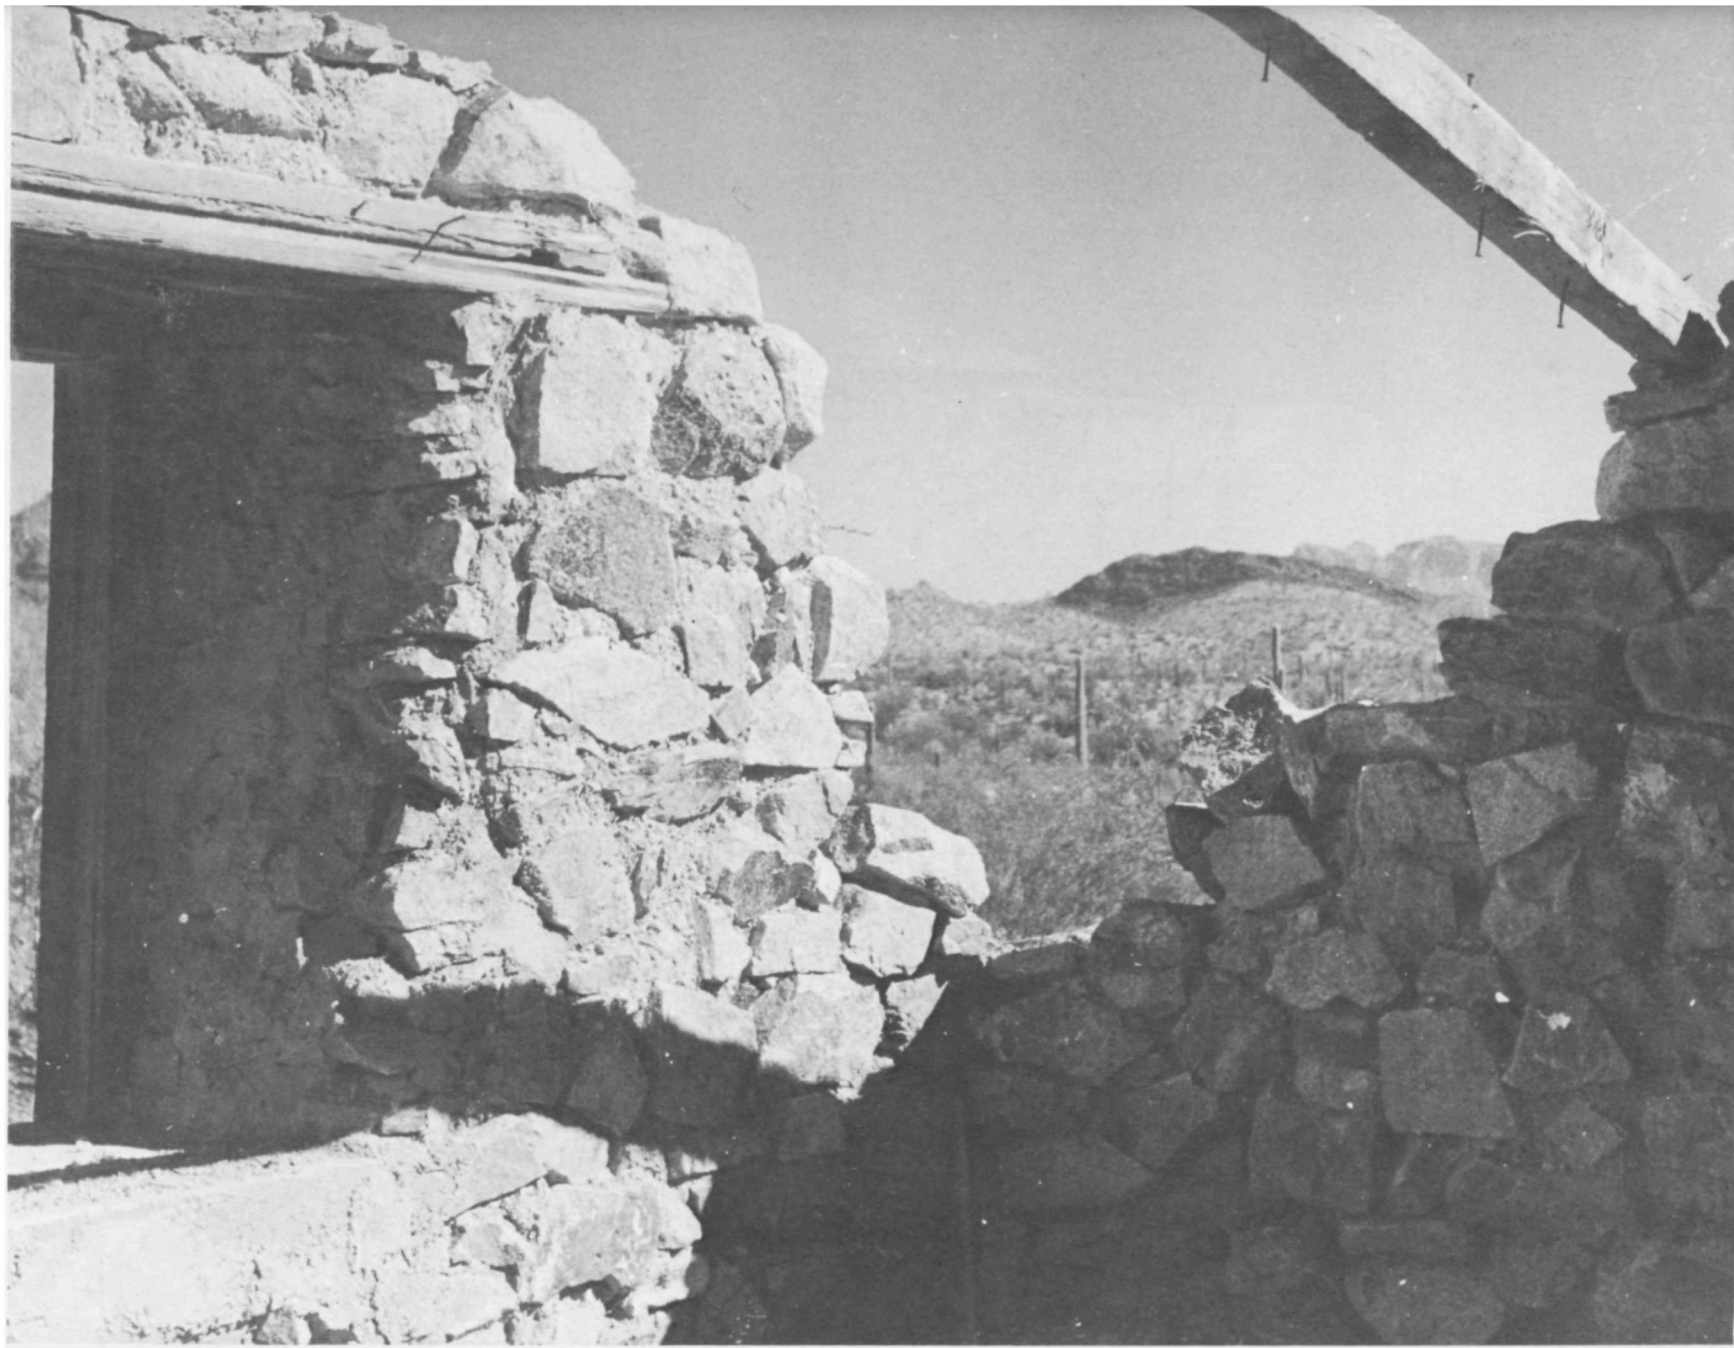
PLATE VI

Detail of Collapsed Southeast Corner from the Interior of the  
Building, October 1968.

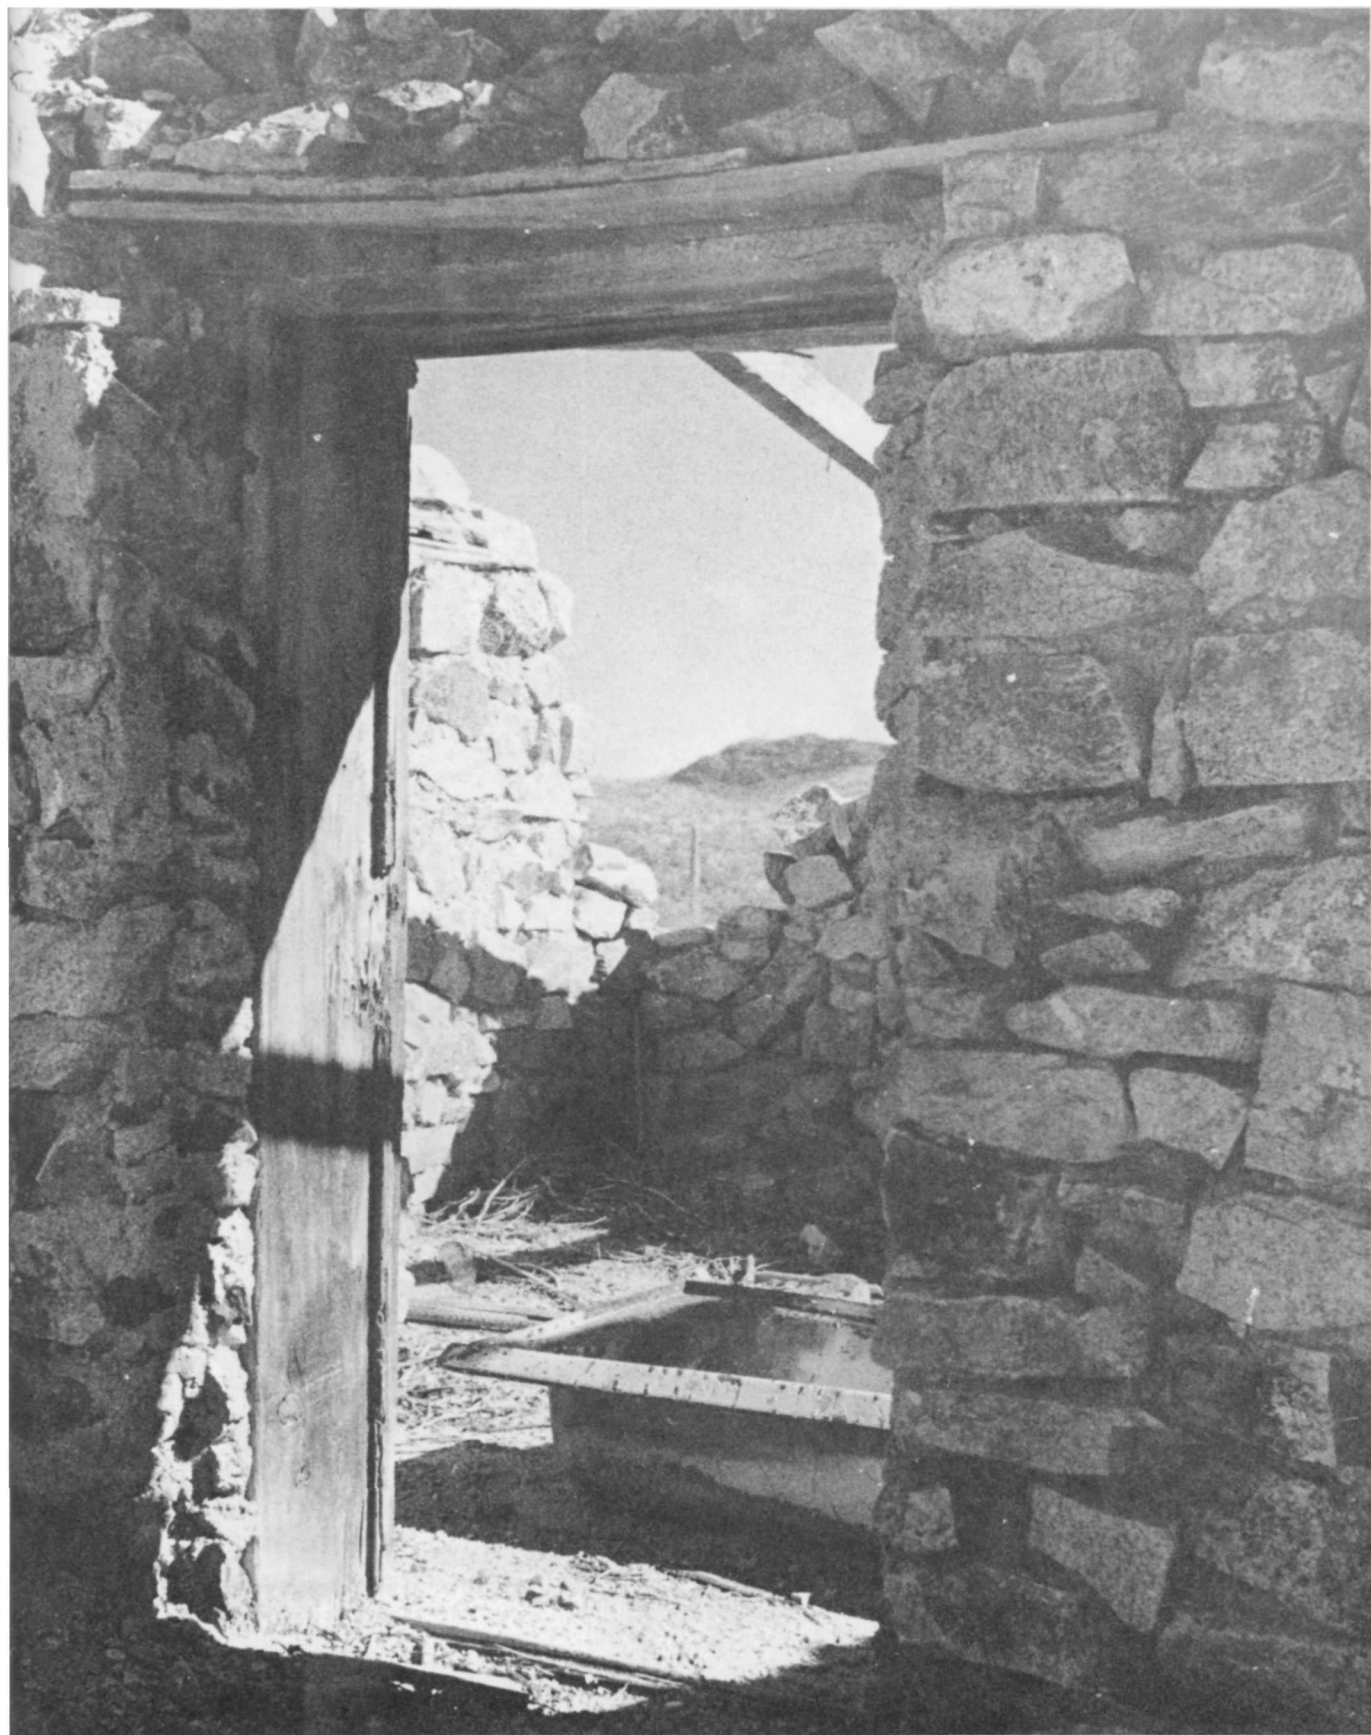
PLATE VII

The only door is located in the North (front) wall and is missing. The door frame is deeply weathered.

Detail, Doorway, October 1968
