# VICTORIA MINE

Historic Structures Report  
Organ Pipe Cactus National Monument  
ARIZONA

## Historic Structures Report, Parts I & II Organ Pipe Cactus National Monument ARIZONA

HISTORIC STRUCTURES REPORT  
PARTS I AND II  
ARCHITECTURAL DATA SECTION  
ON  
VICTORIA MINE  
Organ Pipe Cactus National Monument  
Arizona

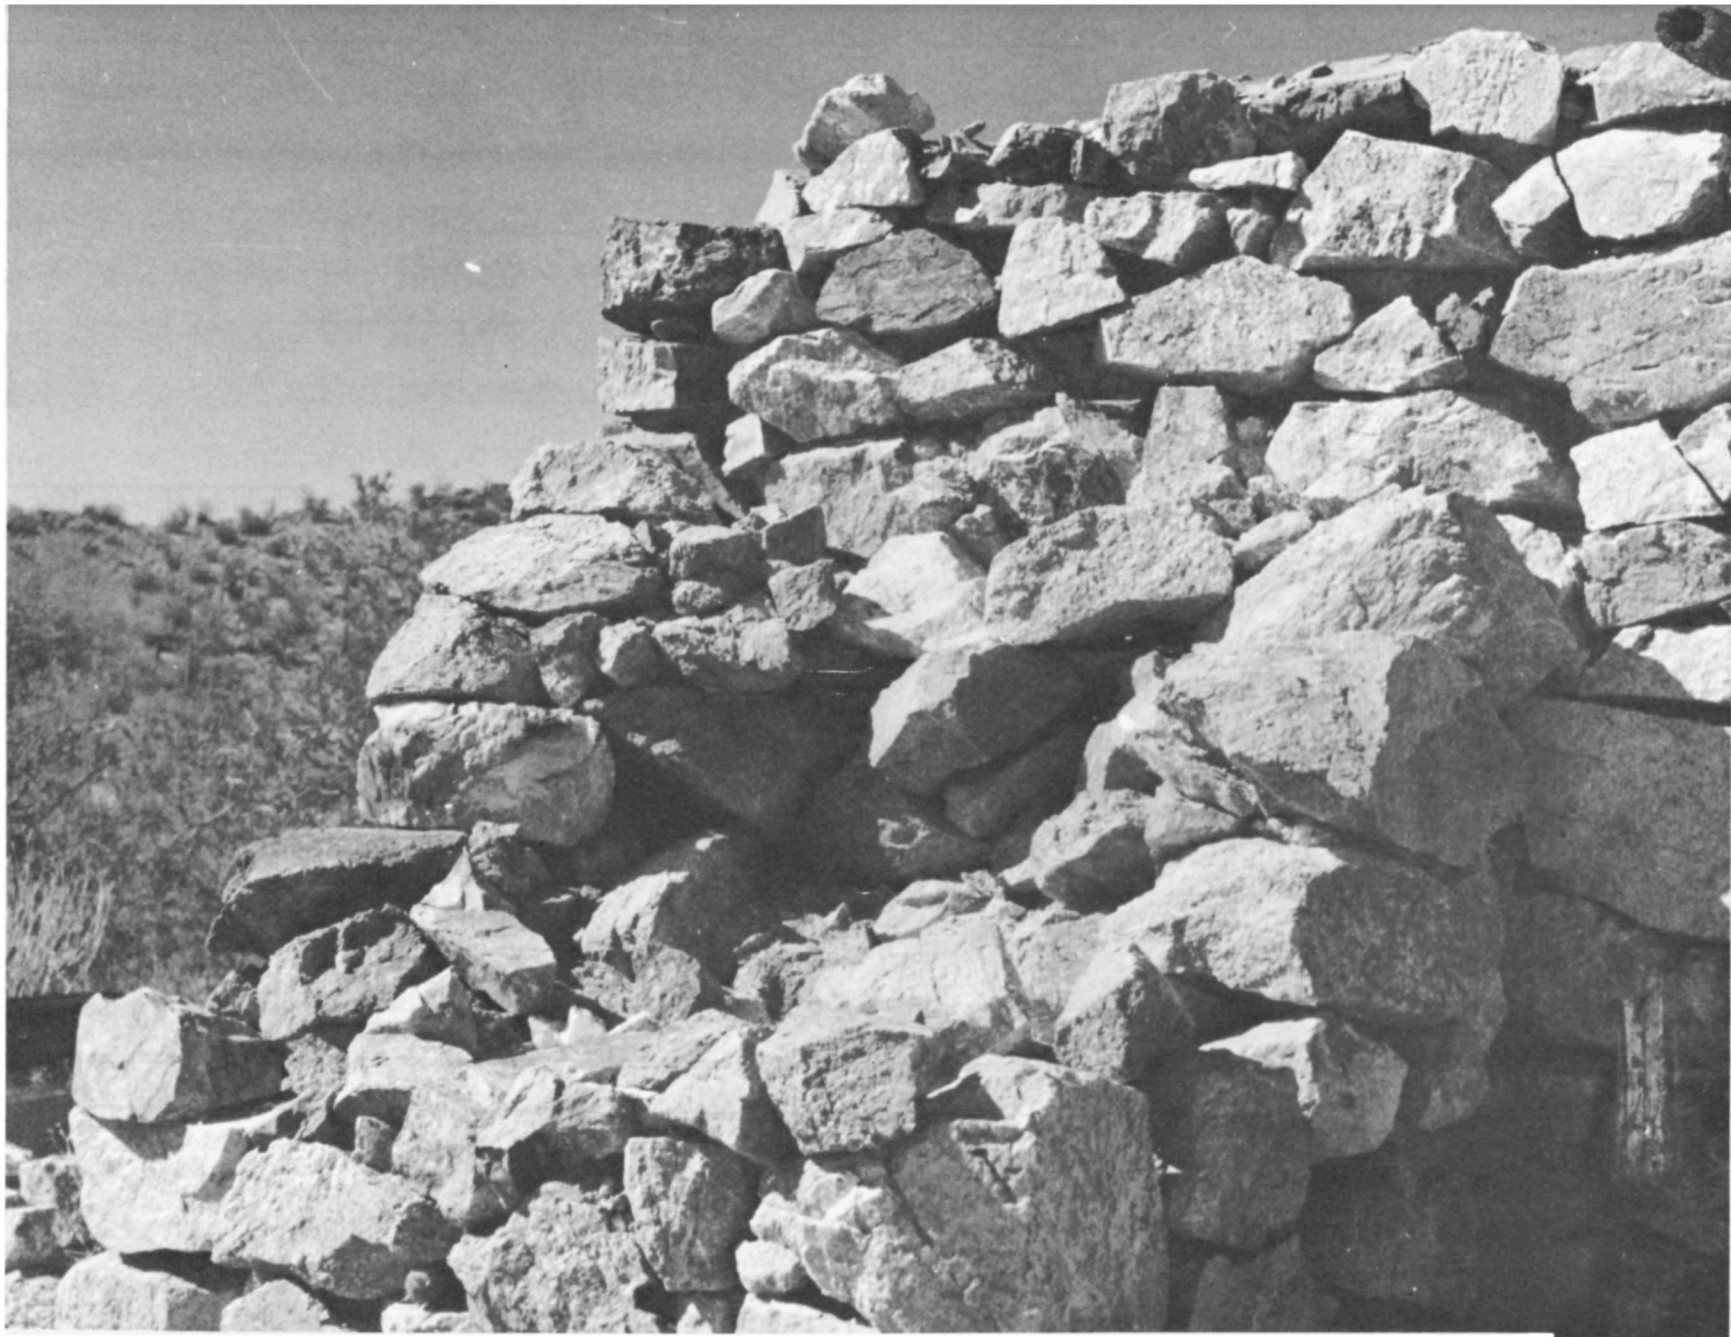
PLATE IX

Detail, Exterior Fireplace, October 1968.
