UNITED STATES DEPARTMENT OF THE INTERIOR  
NATIONAL PARK SERVICE**NATIONAL REGISTER OF HISTORIC PLACES  
INVENTORY -- NOMINATION FORM**

Chilton-Williams Farm Complex

Chilton Place

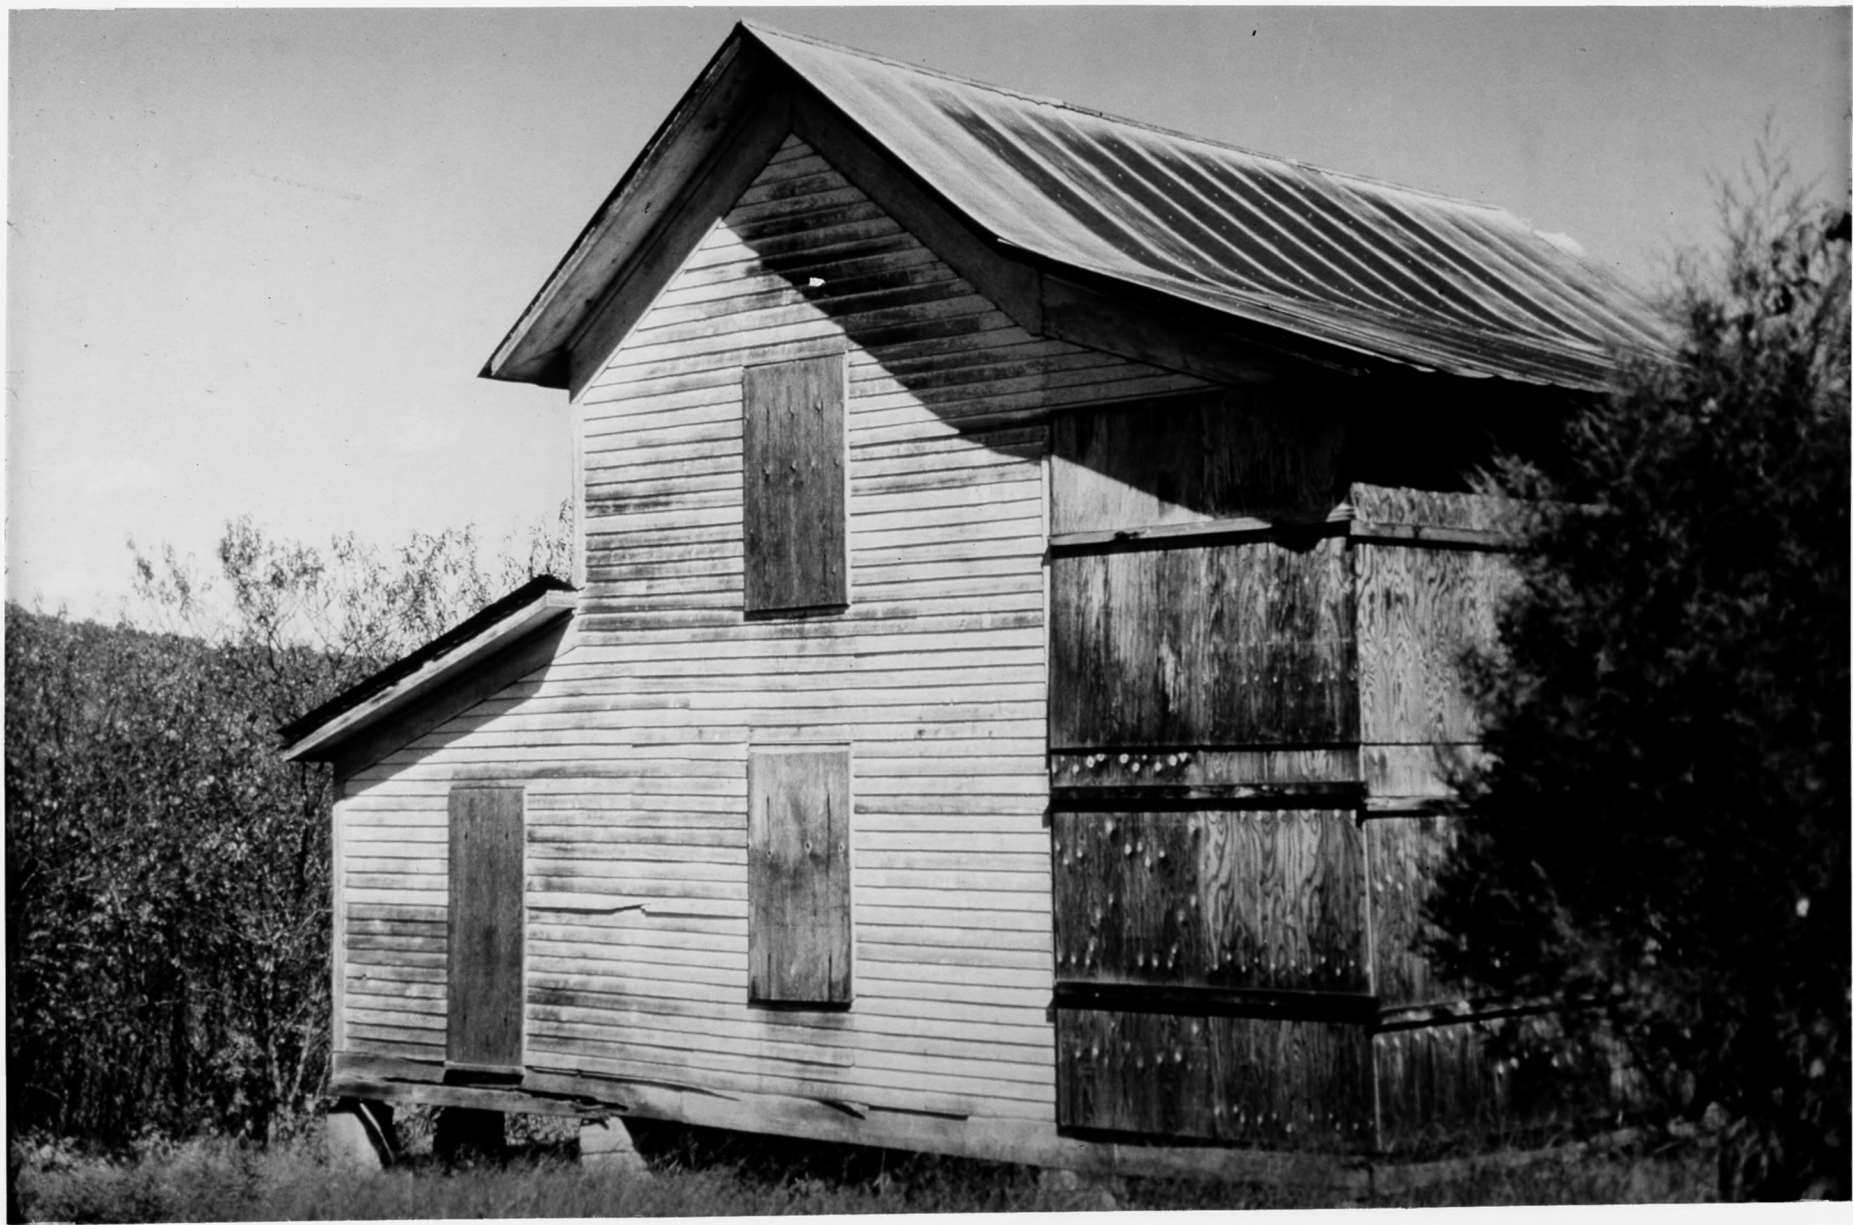
#1/6

CHILTON-WILLIAMS FARM COMPLEX  
CHILTON HOUSE

VIEW FROM NORTHWEST

Building #315 - Chilton House: A two-story frame 29' x 32' building facing the Old Powder Mill Road about 100 yards south of the Current River. It is oriented north-south. There are no outbuildings, though originally an outhouse, chicken house, smoke house and shed were immediately to the rear. Ruins of the first Owl's Bend Post Office (1923) and a blacksmith shop are immediately across the road and a storm cellar on the west side of the yard.

Exterior: Gable roof, covered with corrugated iron; front wall covered with 11 1/2" flush horizontal boards. The other three sides are sheathed with 4 1/2" clapboard, painted white. It has hand-hewn beams and sandstone piers. A two-story veranda extends across the front and an enclosed porch is in the northeast corner. An outside rough cut stone chimney is in the center of the east end.

Openings: There are five doors and twelve windows. The front has three bays, the center of which on both floors are doors. Both doors have false wooden transoms. An additional door at the west end of the first floor gives access to a stair to the second floor. There is a single window on each floor in the west wall and a kitchen door opened onto a roofless wood porch, now missing. In the east wall is a single window between the chimney and southwest corner, first floor. Two windows are in the rear wall of the second story. All windows are double sash with 6 x 6 lights.

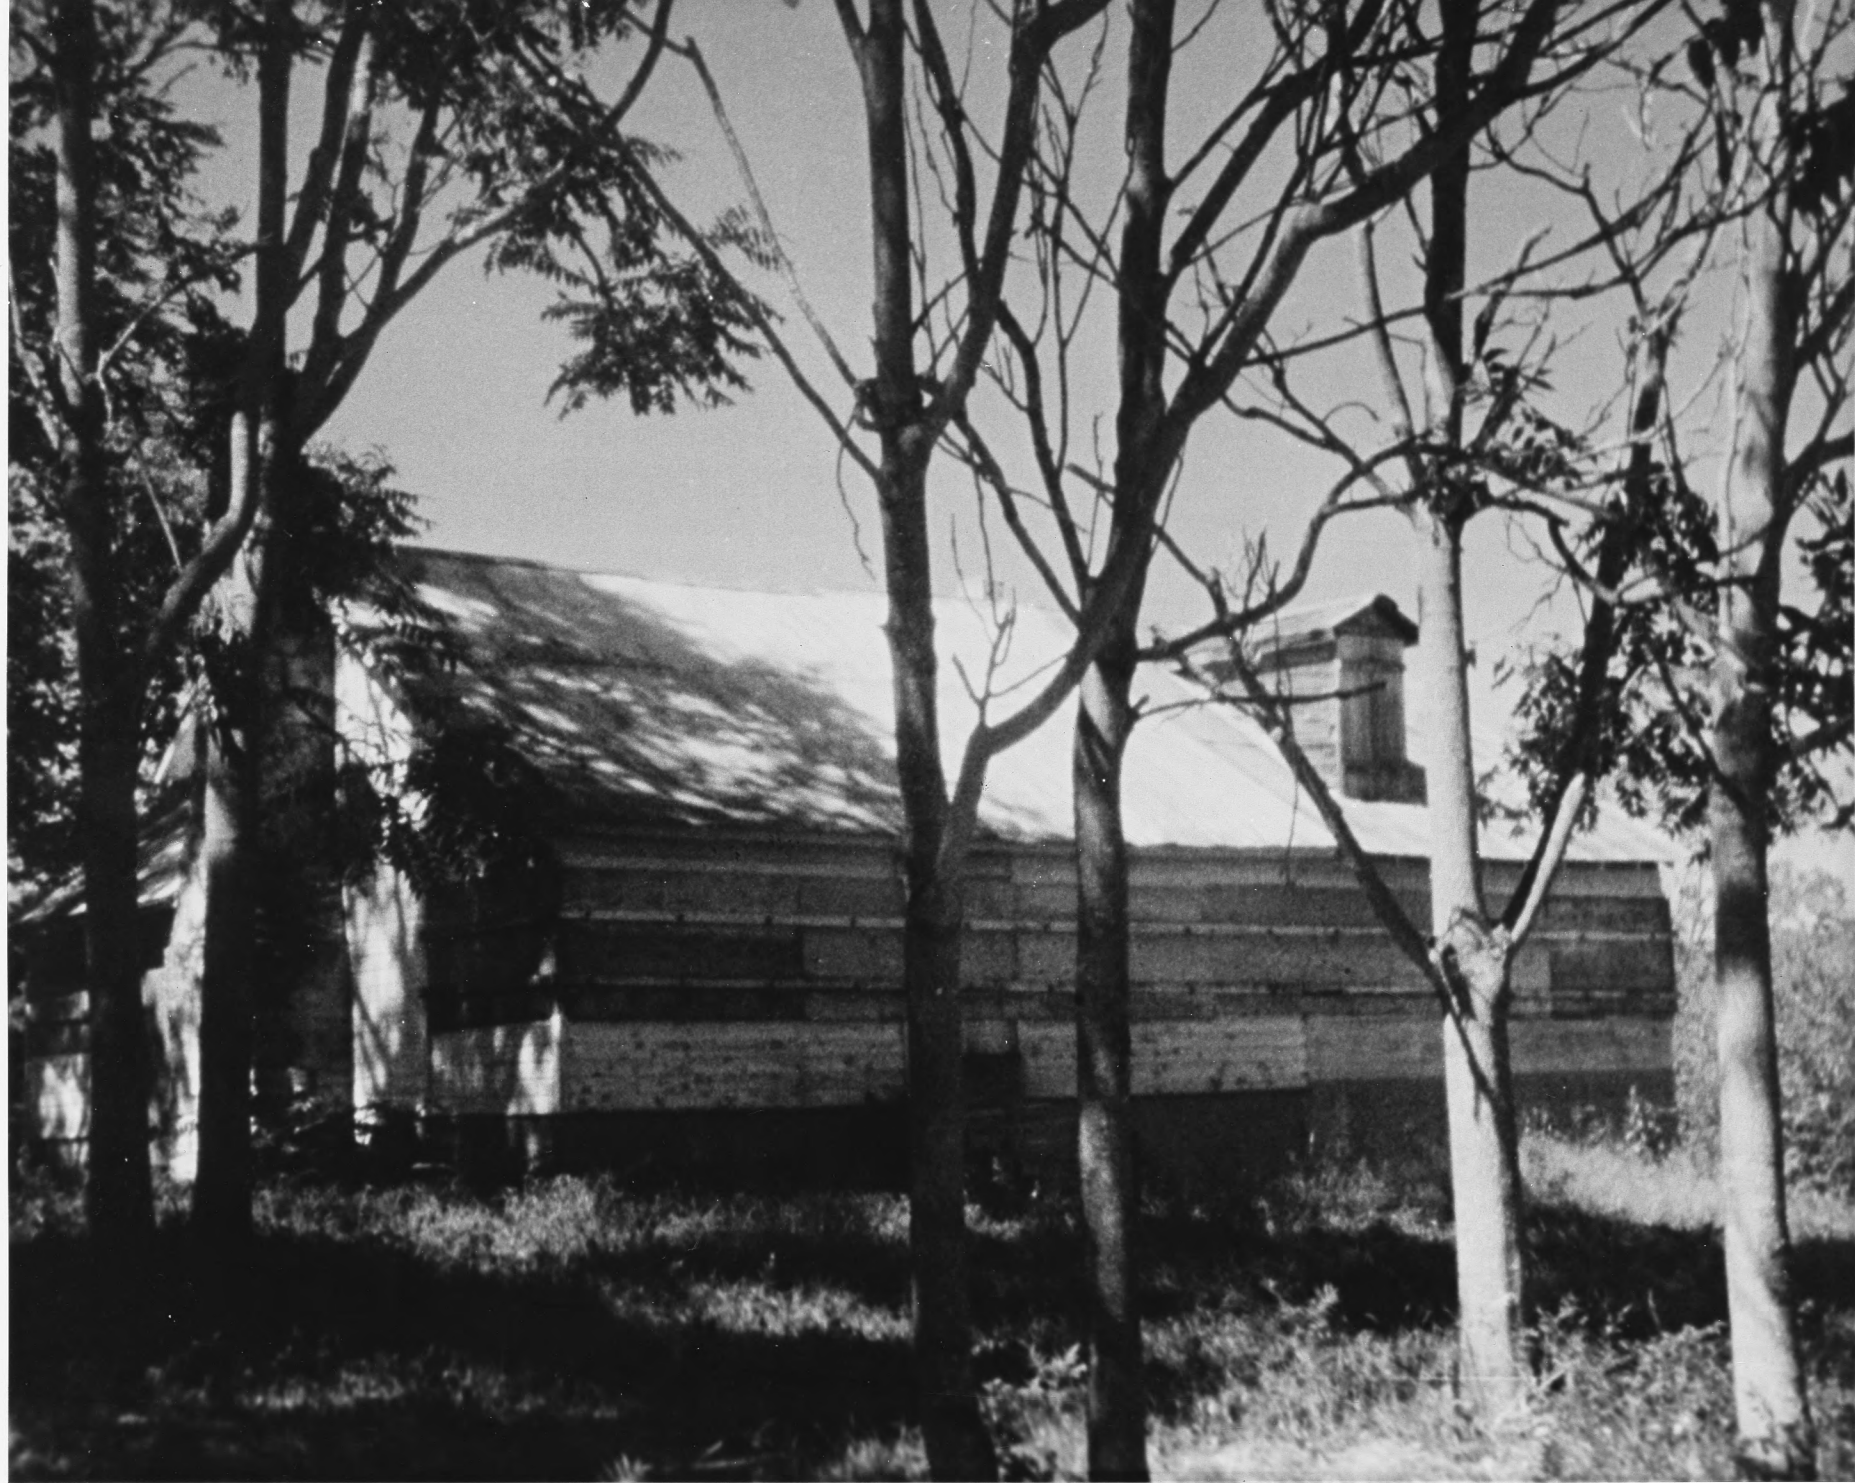
#2/6

VIEW FROM SOUTHWEST

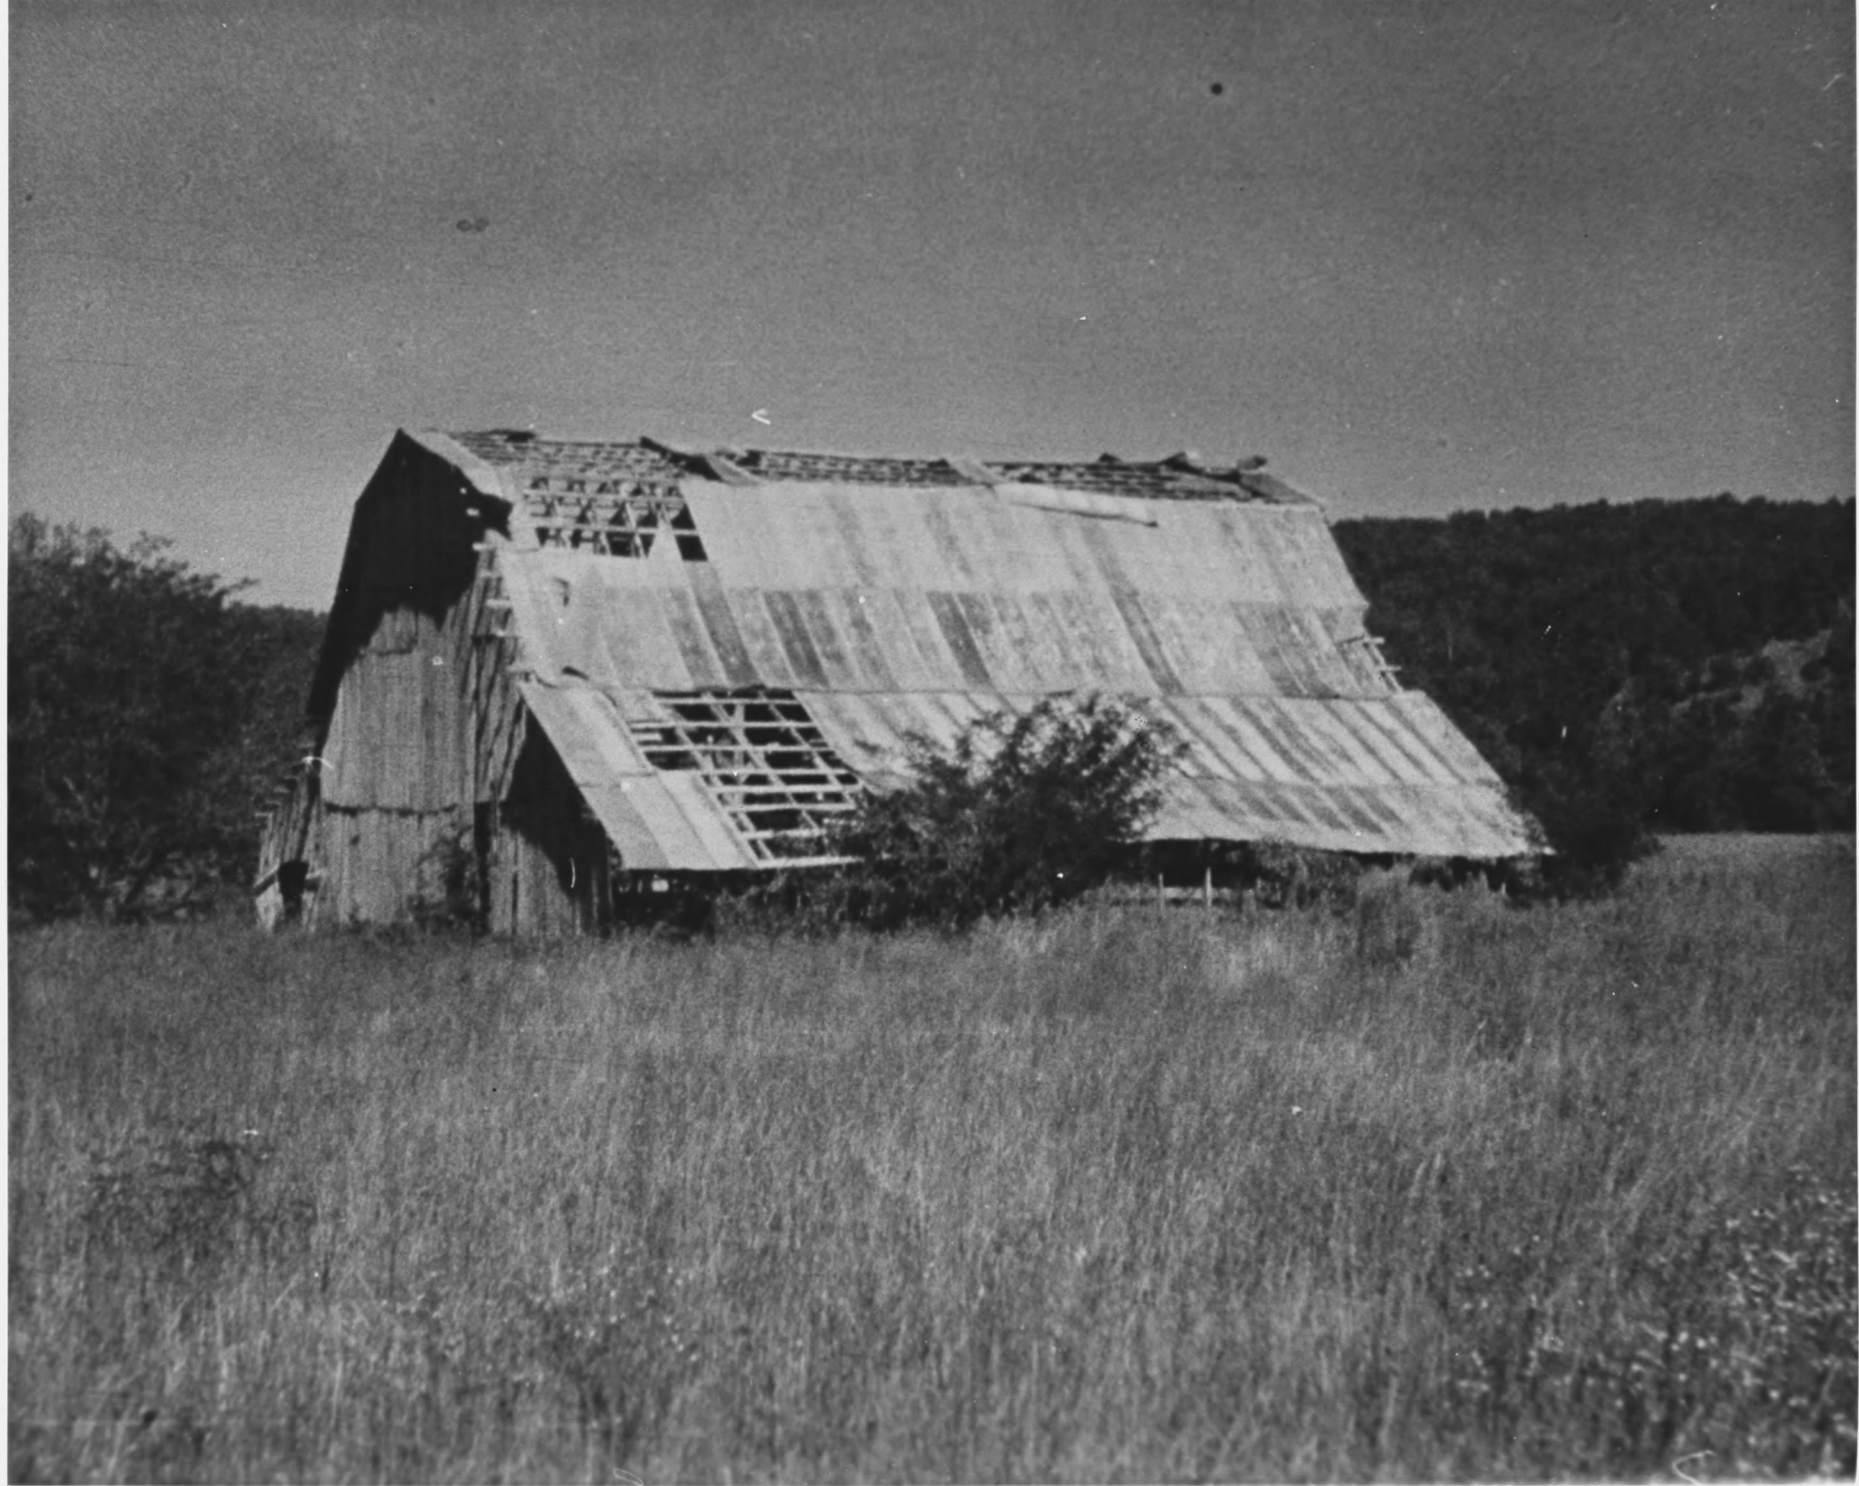
#3/6

VIEW FROM NORTHEAST

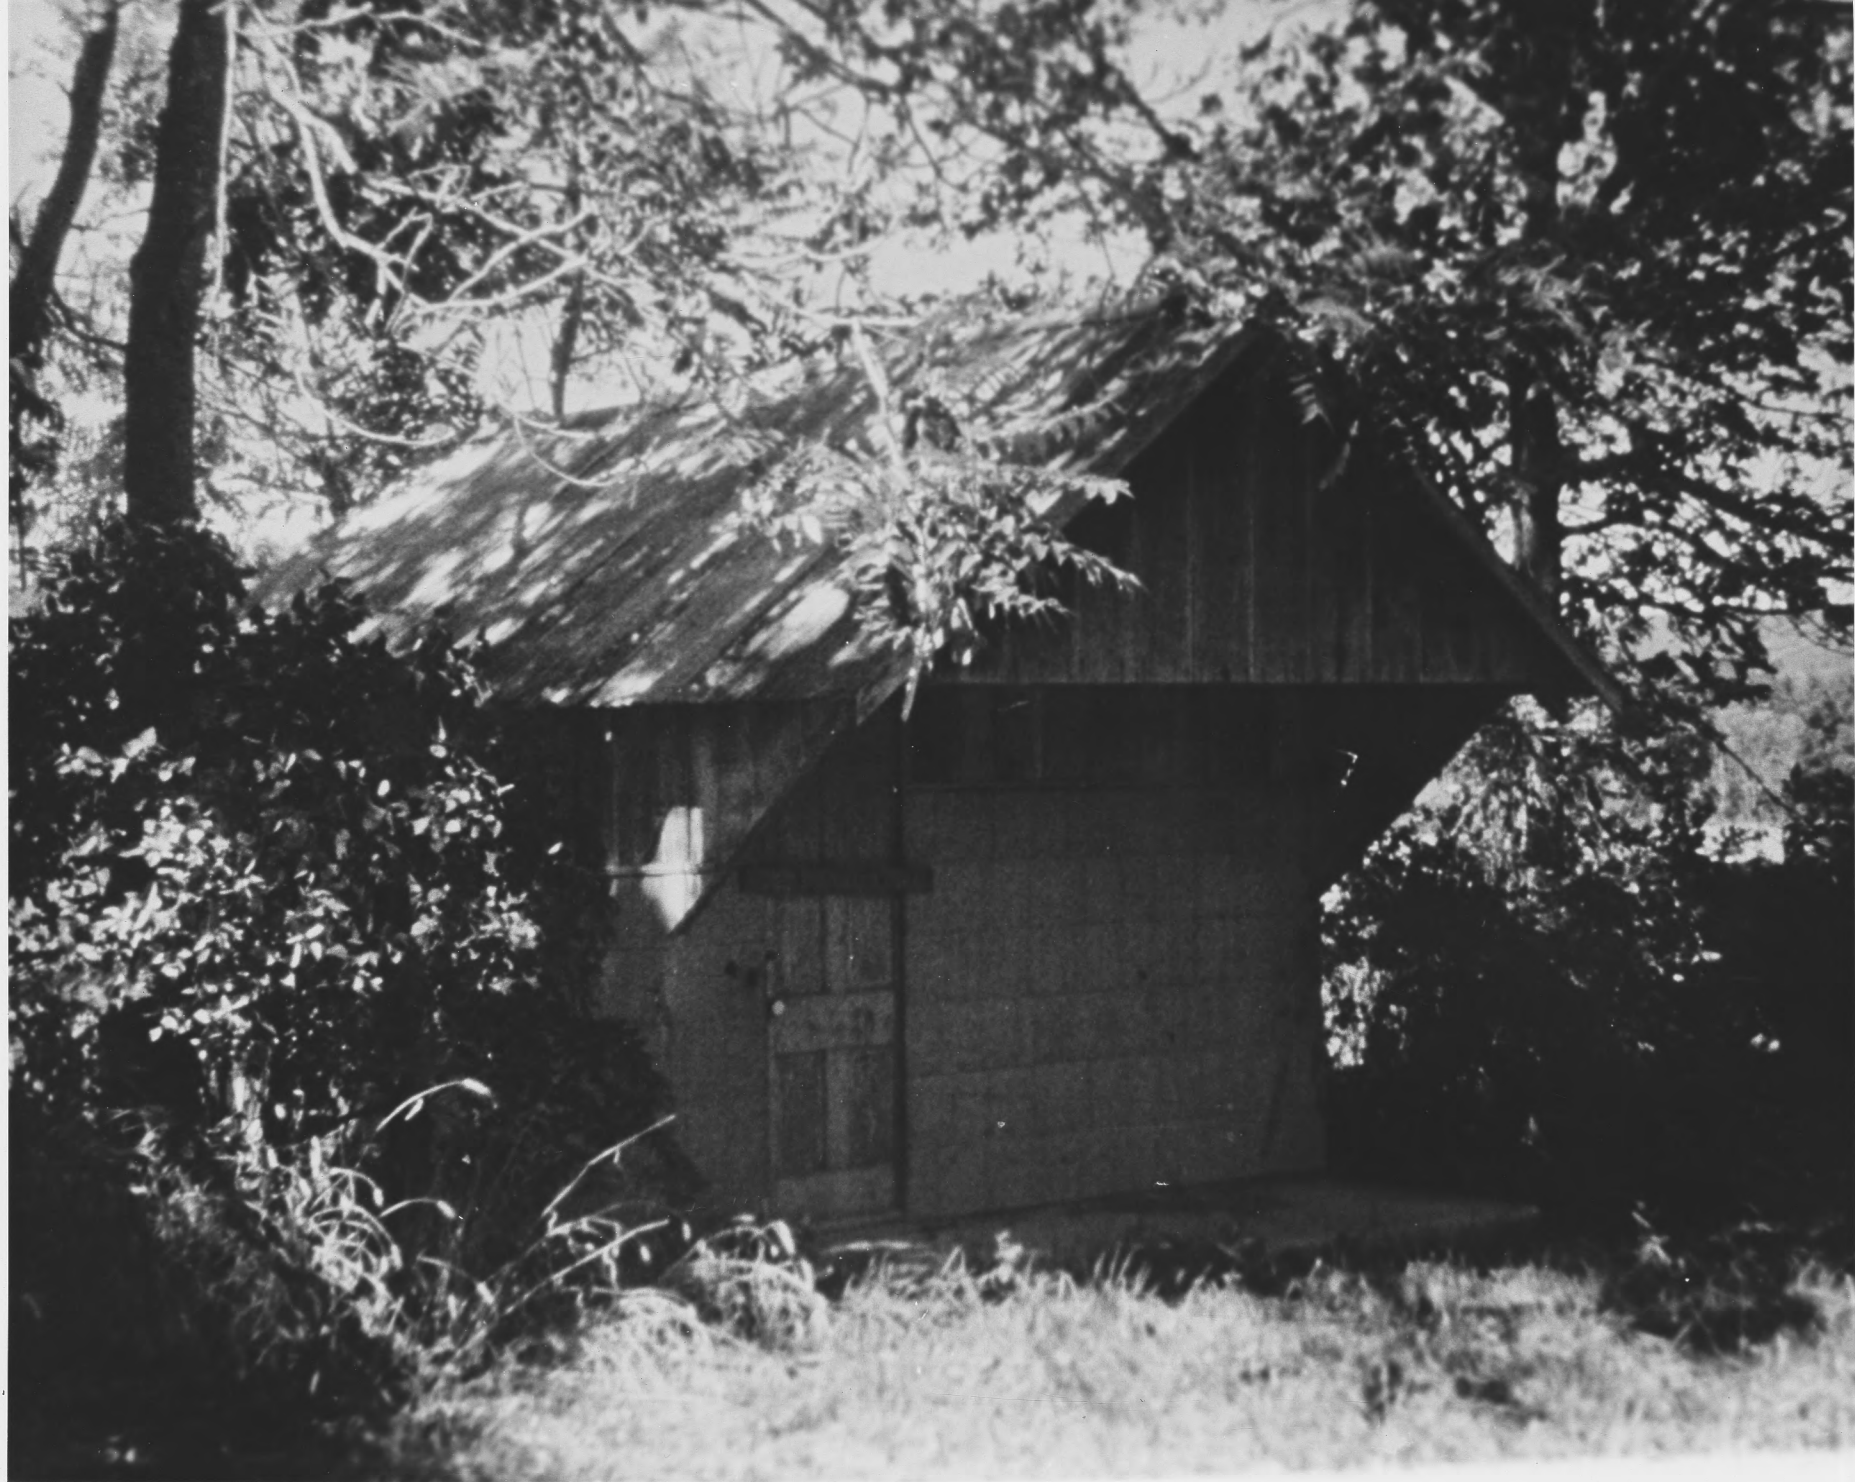
#4/6

CHILTON-WILLIAMS FARM COMPLEX  
SMOKEHOUSE

VIEW FROM WEST

Building #326 Smoke House: An 11'8" x 7'8" single-story building immediately to the rear of the house. The gable roof is covered with corrugated iron. A 3' x 11' concrete porch is on the east end. Its walls are rough sawn pine boards covered with green asphalt shingles. The interior floor is concrete.

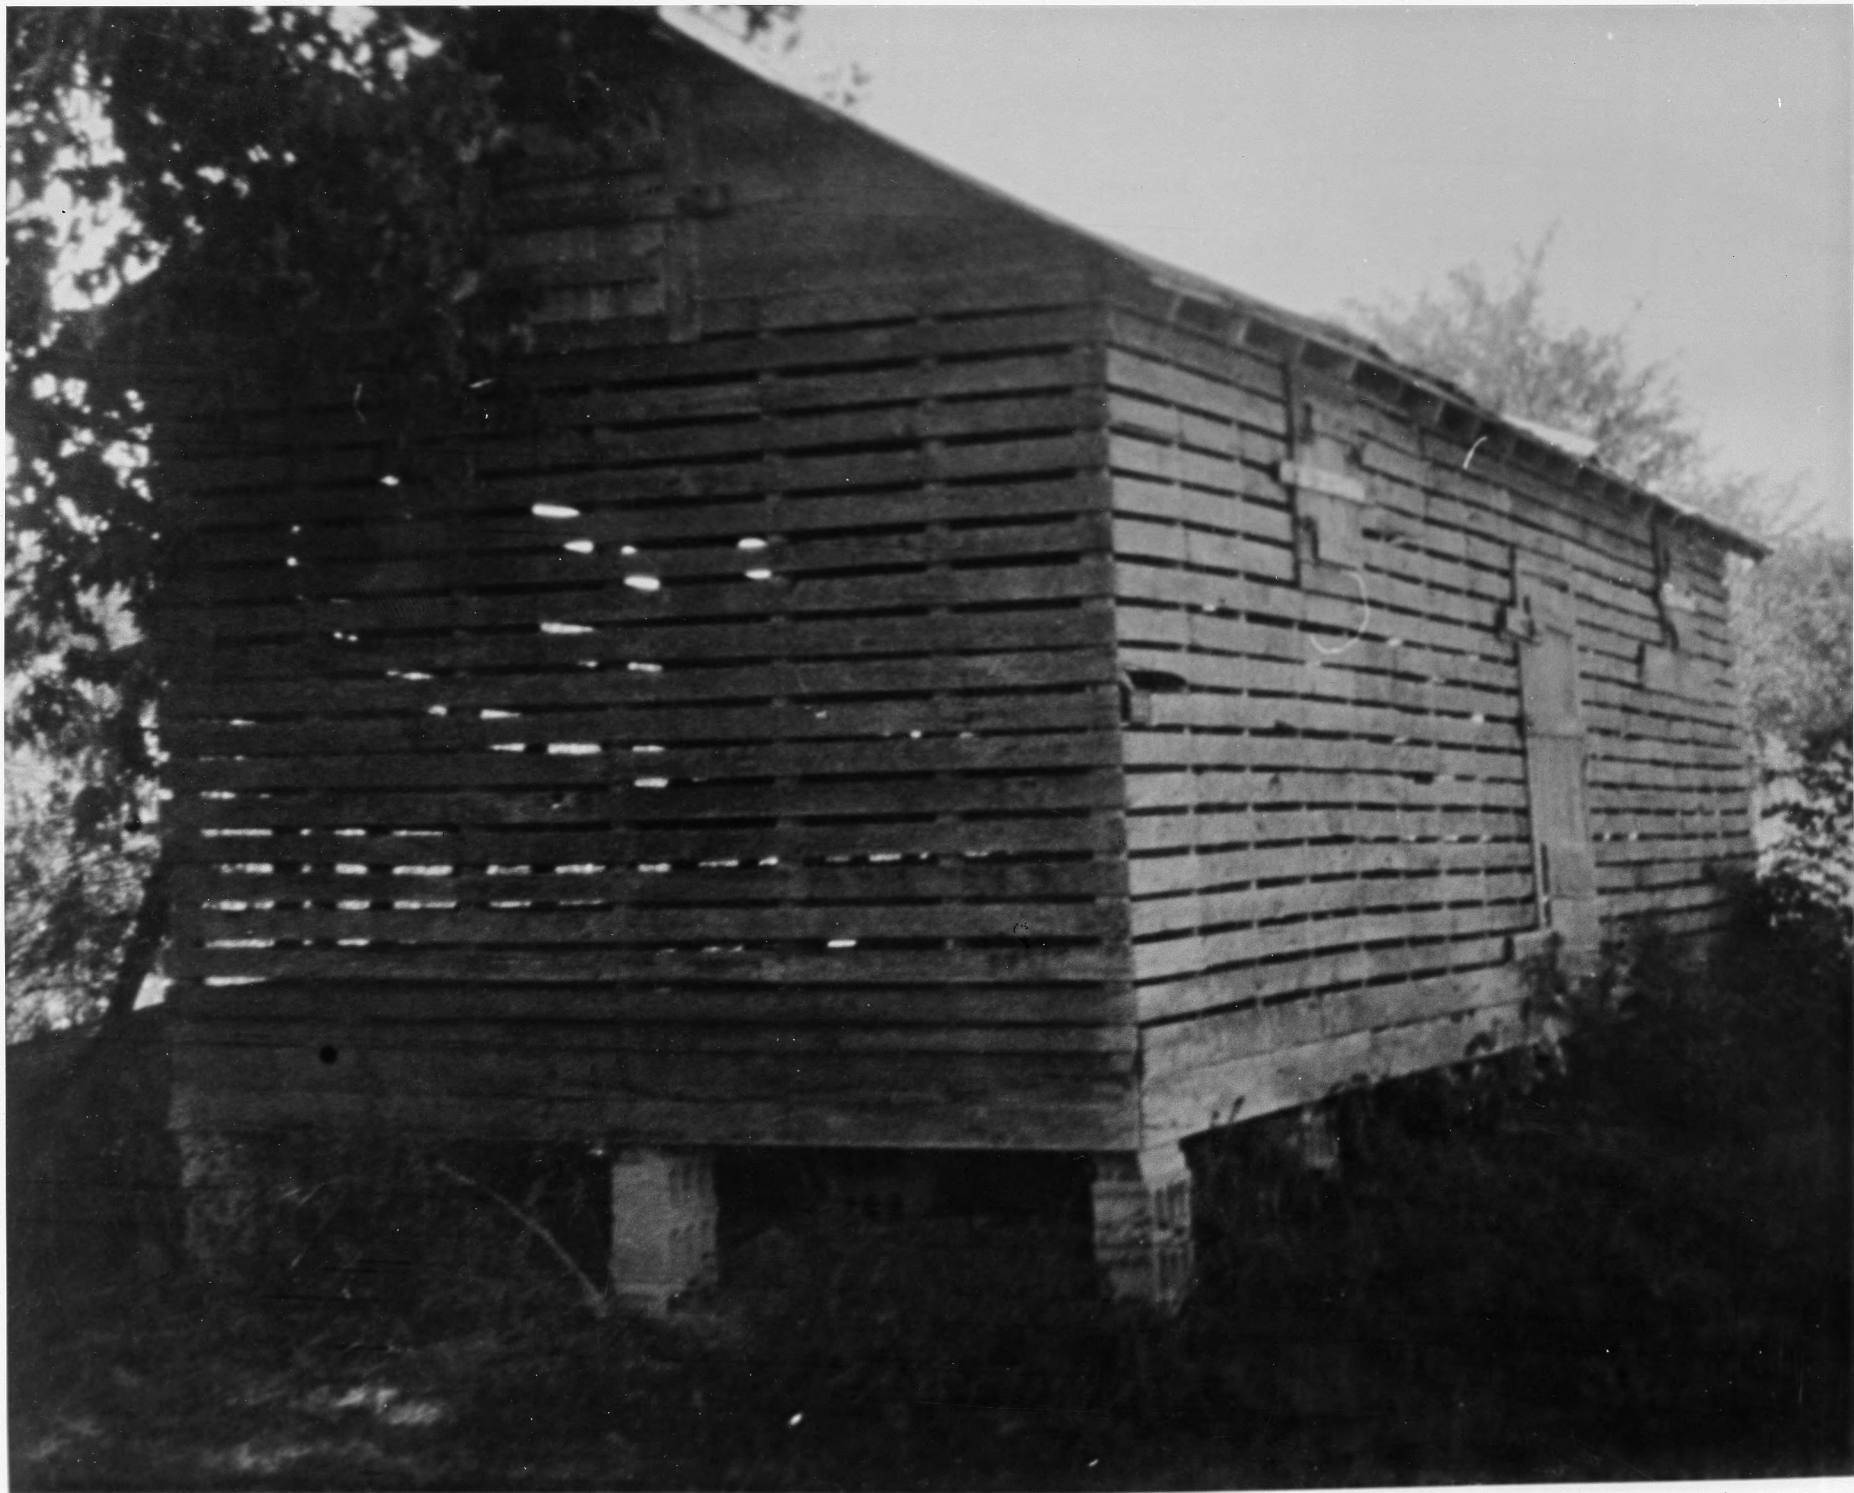
#5/6

VIEW FROM SOUTH
