National Register of Historic Places  
Registration Form

**1. Name of Property**historic name Klepzig, Walter, Mill and Farm  
other names/site number \_\_\_\_\_**2. Location**street & number Ozark National Scenic Riverways (OZAR) ☐ not for publication  
city, town Eminence ☒ vicinity  
state Missouri code MO county Shannon code 203 zip code 65466**3. Classification**

Klepzig, Walter, Mill and Farm

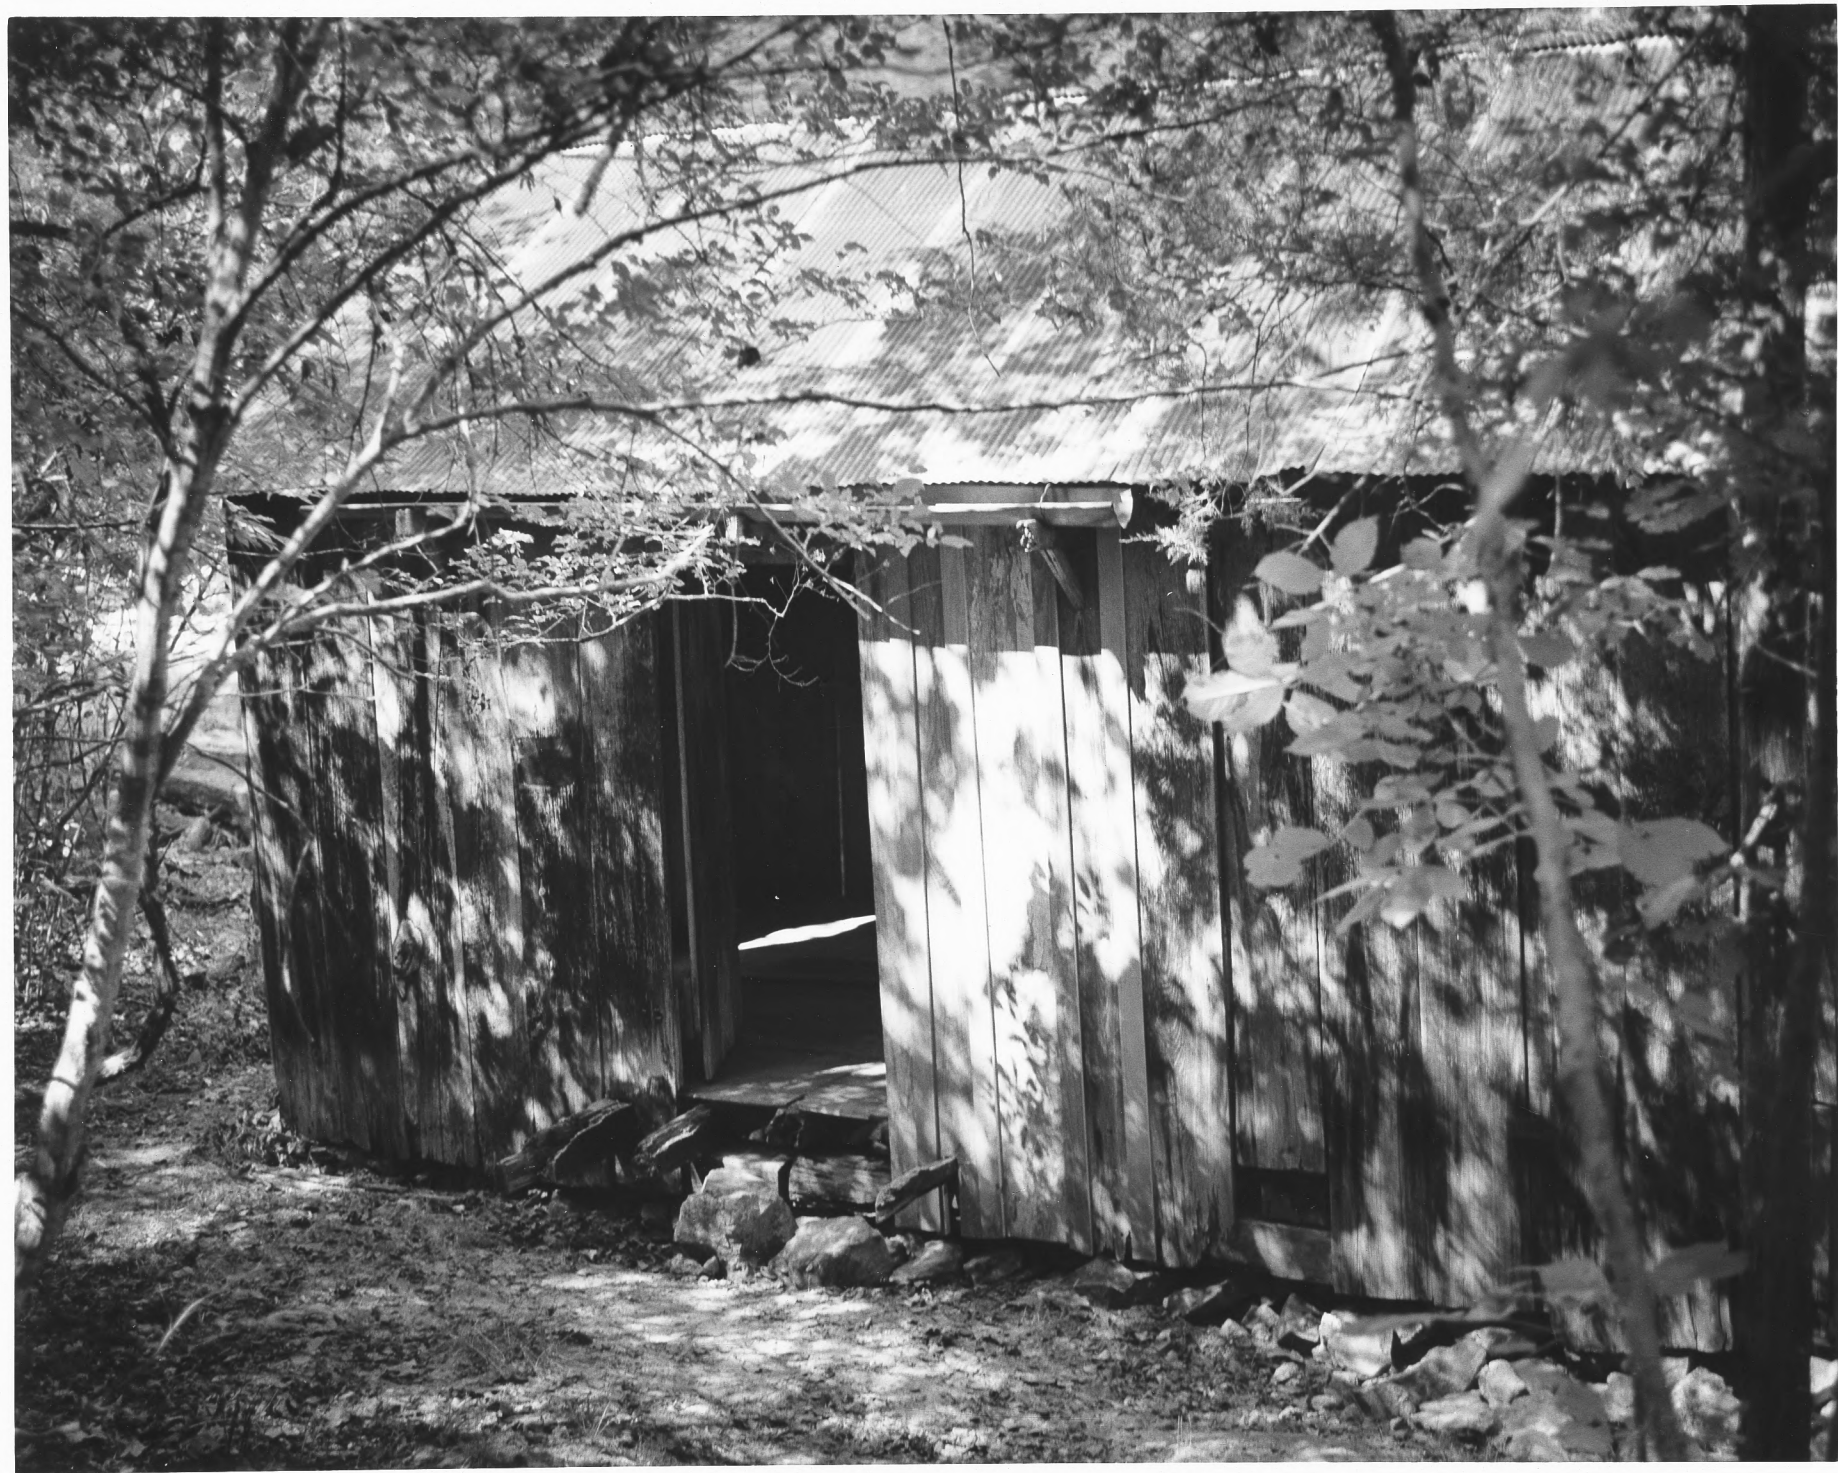
Photograph 1- 1. Klepzig Mill  
4. March 1988  
6. Mill exterior (sketch map feature 1) from south (from old road)

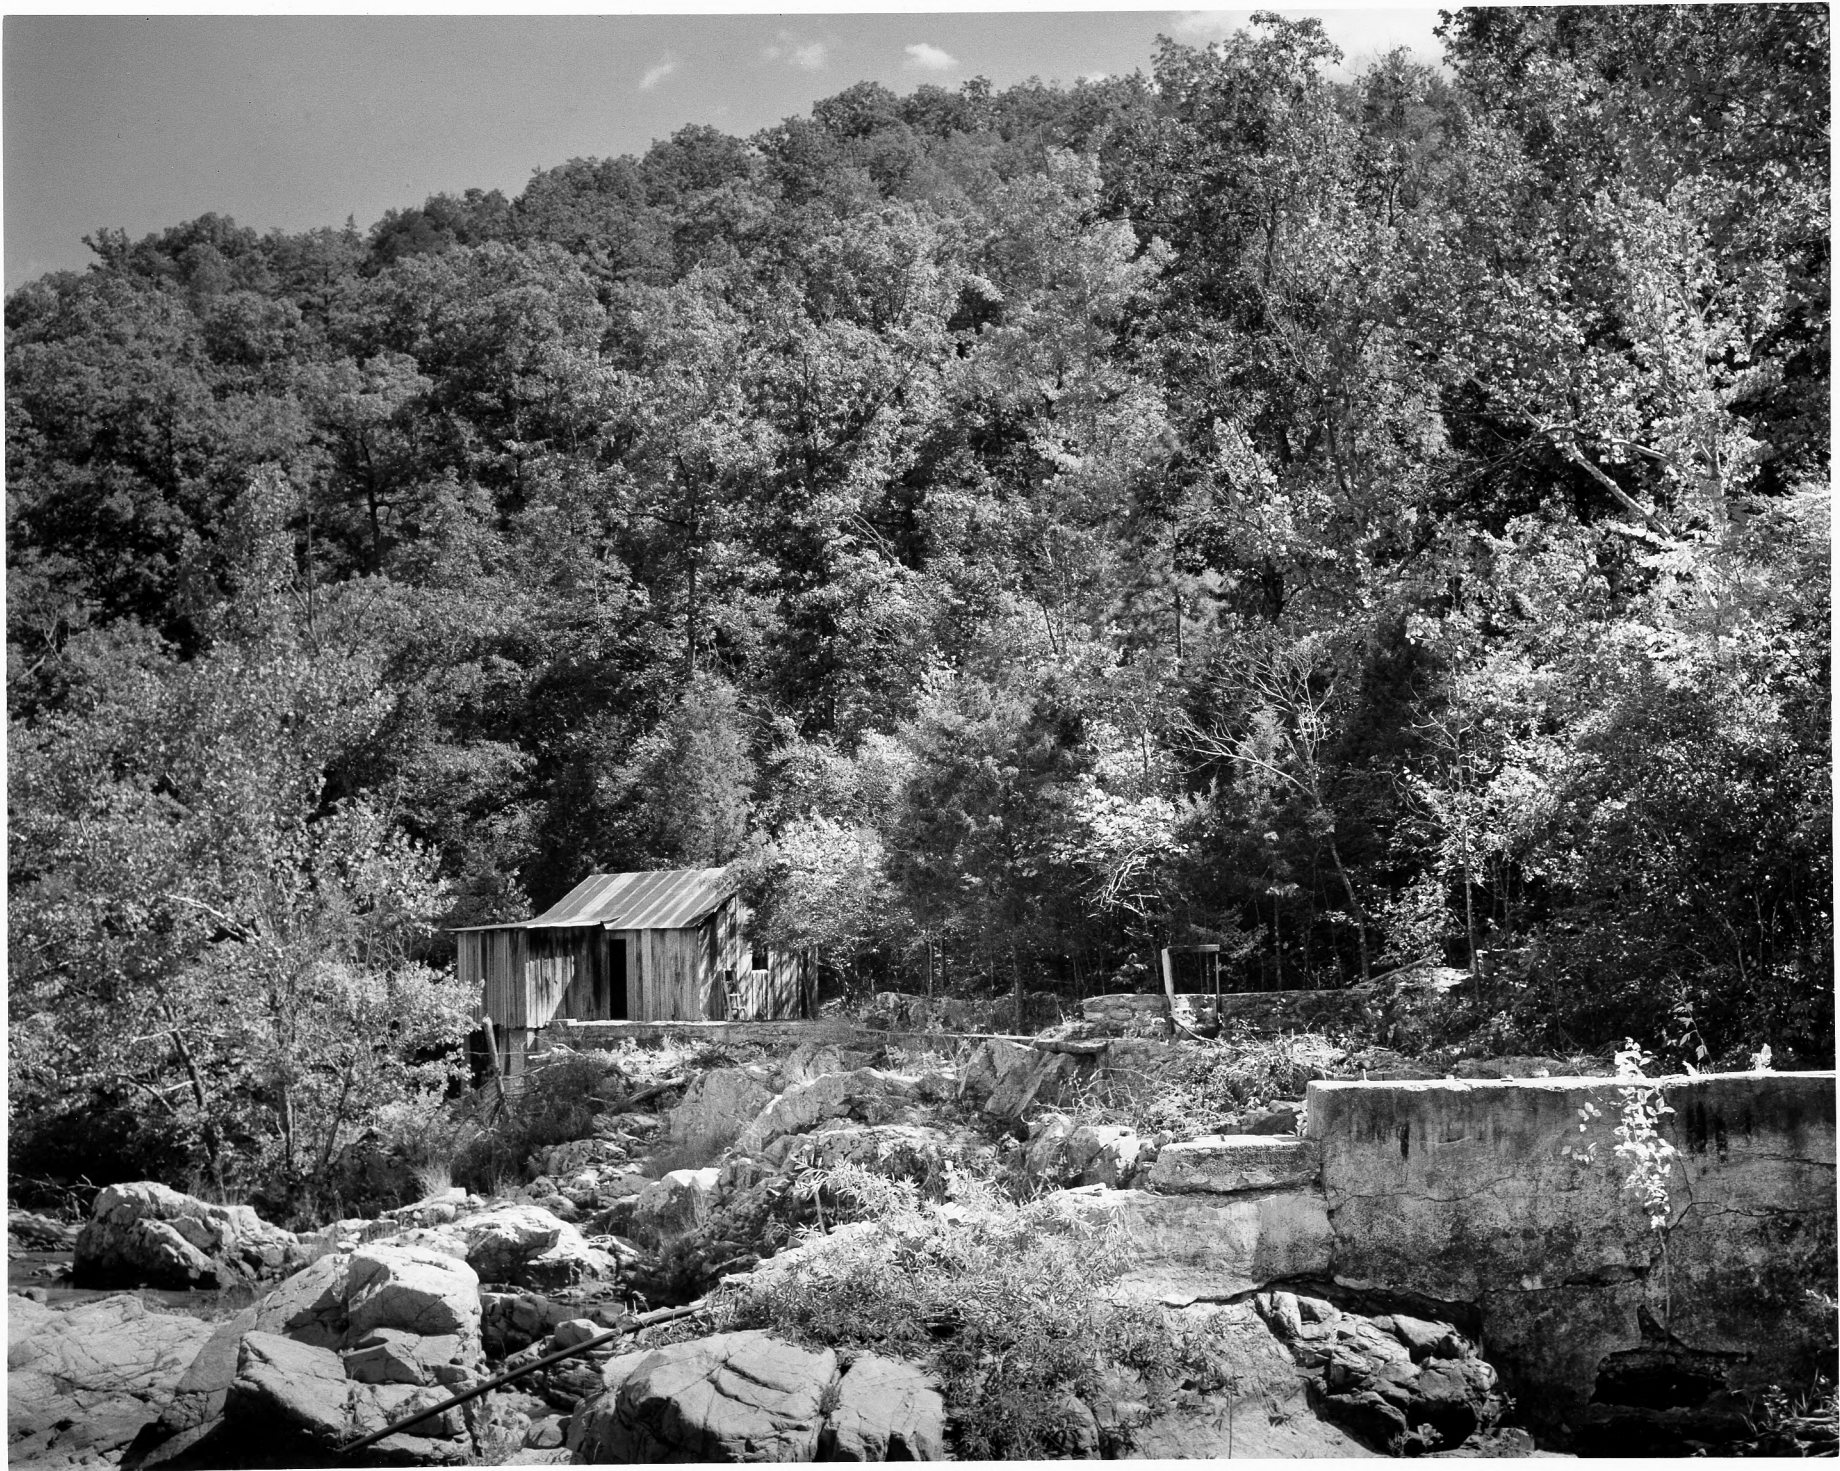
Photograph 2- 1. Klepzig Mill  
4. March 1988  
6. Mill (feature 1), dam and race (feature 15) in foreground, from northwest

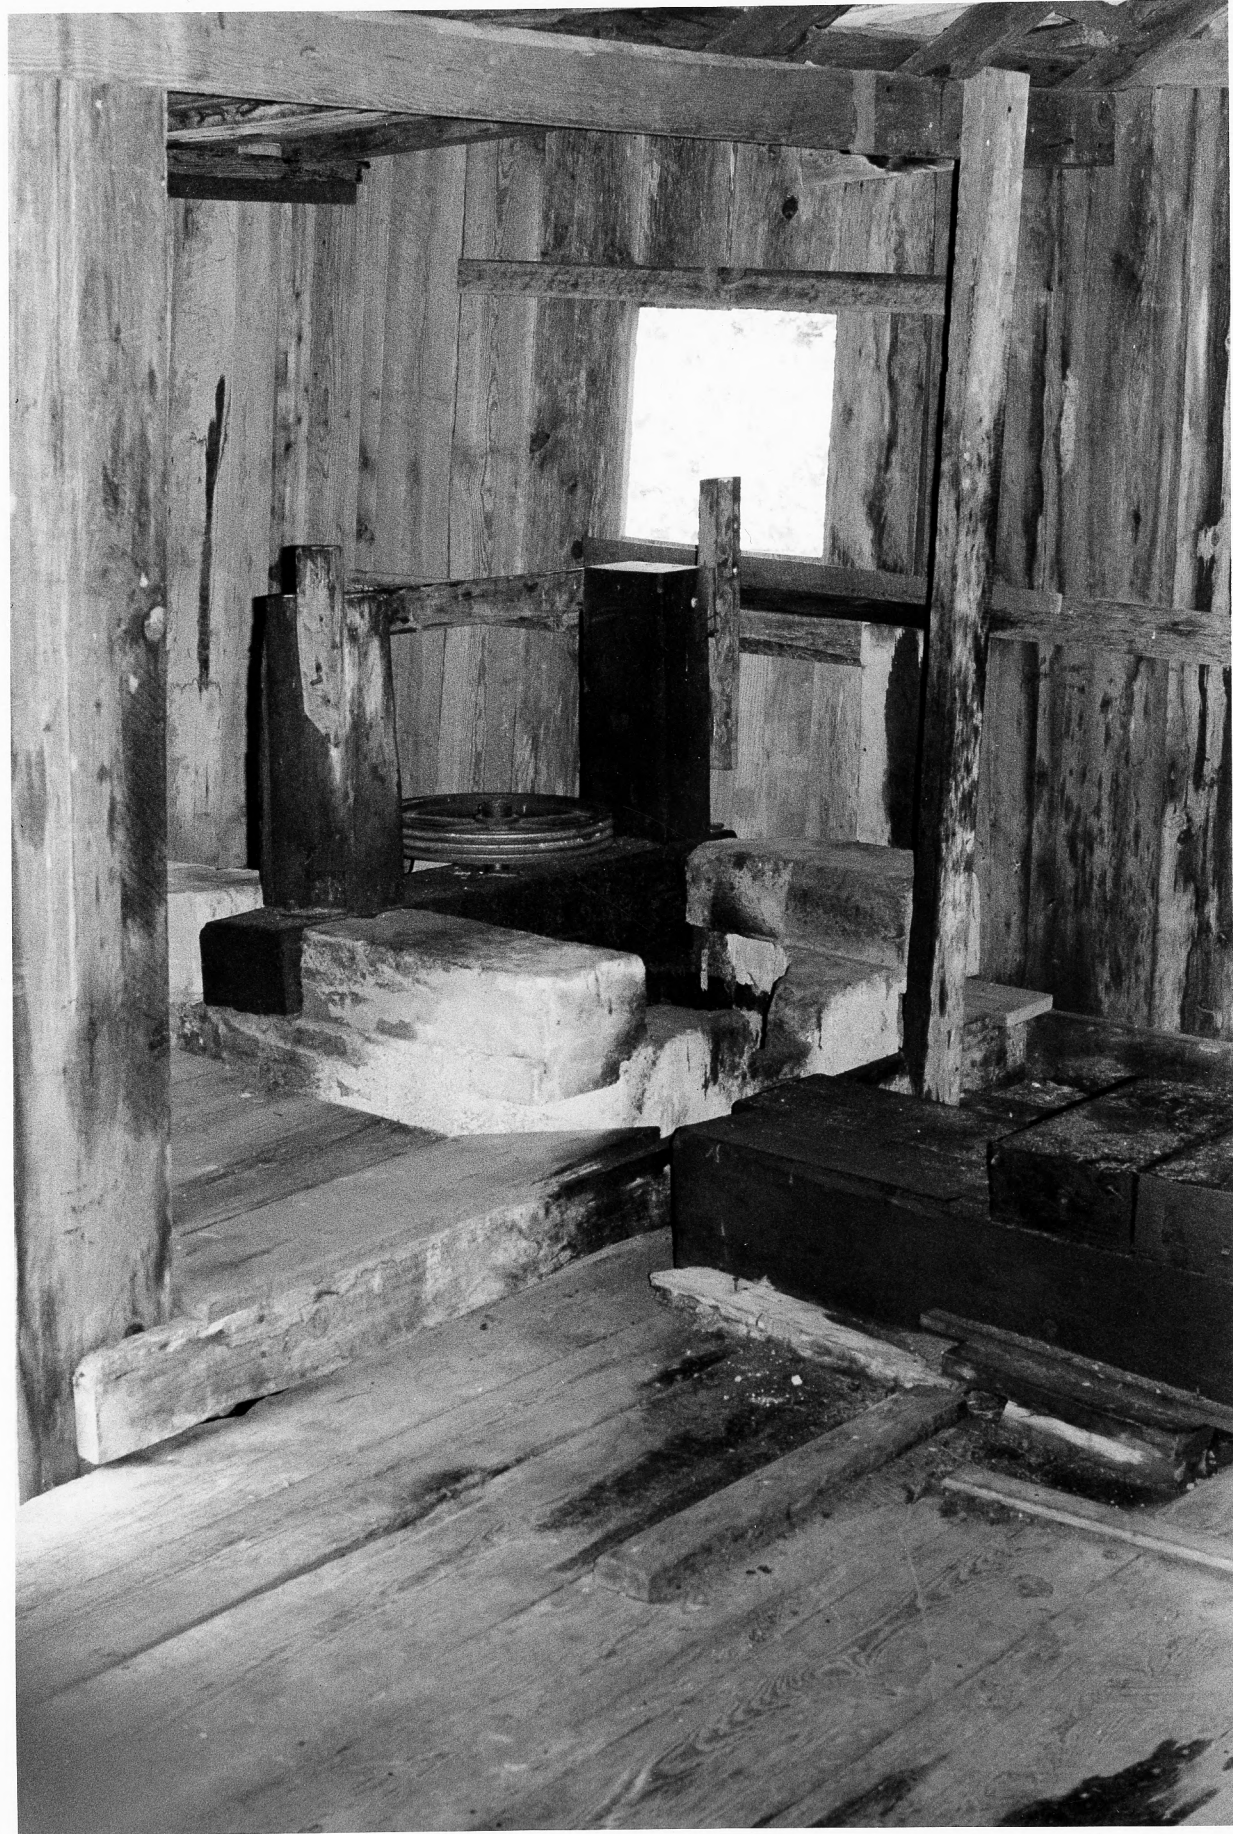
Photograph 3- 1. Klepzig Mill  
4. October 1988  
6. Mill (feature 1) interior, with view of upper turbine shaft in forebay, generator platform, and corner of meal box, from interior southeast corner

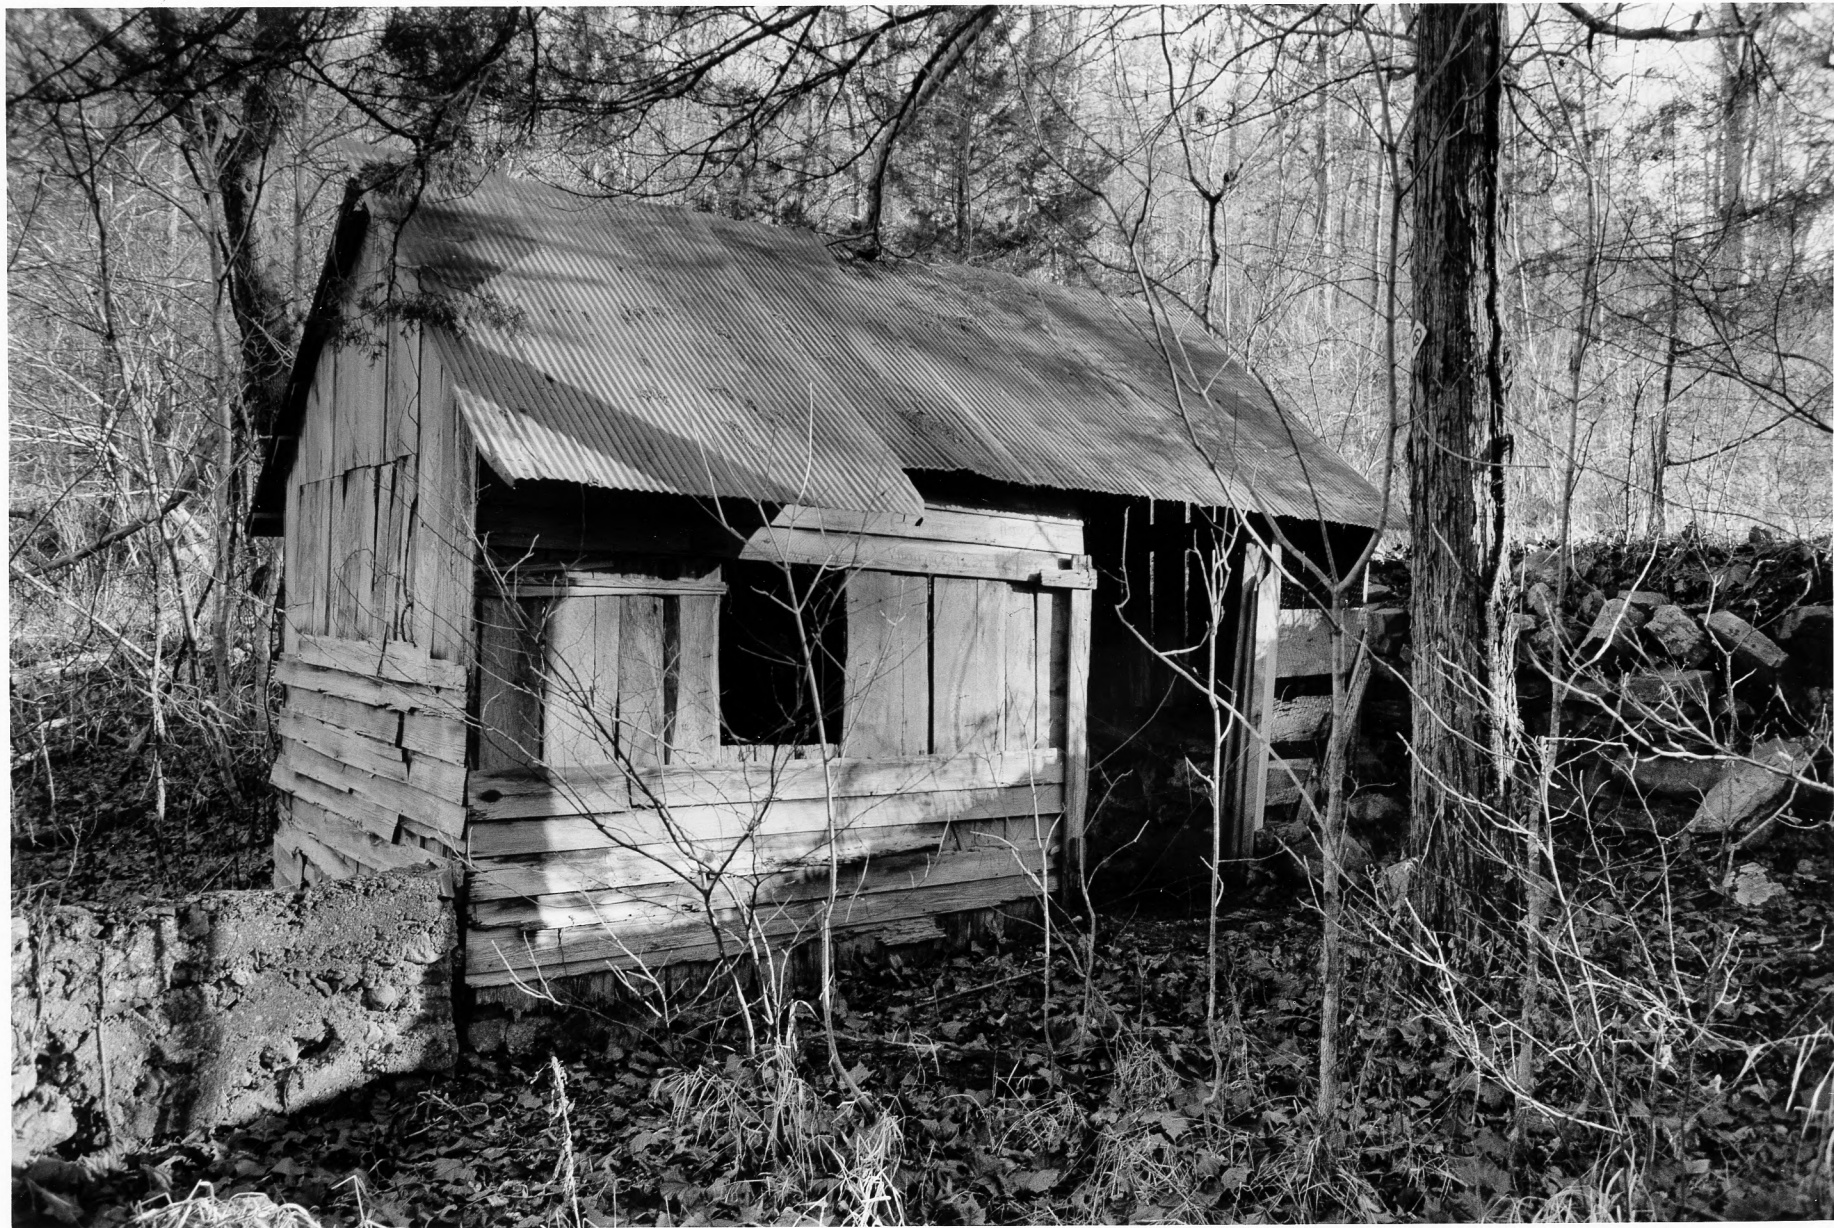
Photograph 4- 1. Springhouse  
4. December 1986  
6. Springhouse (feature 2) from west

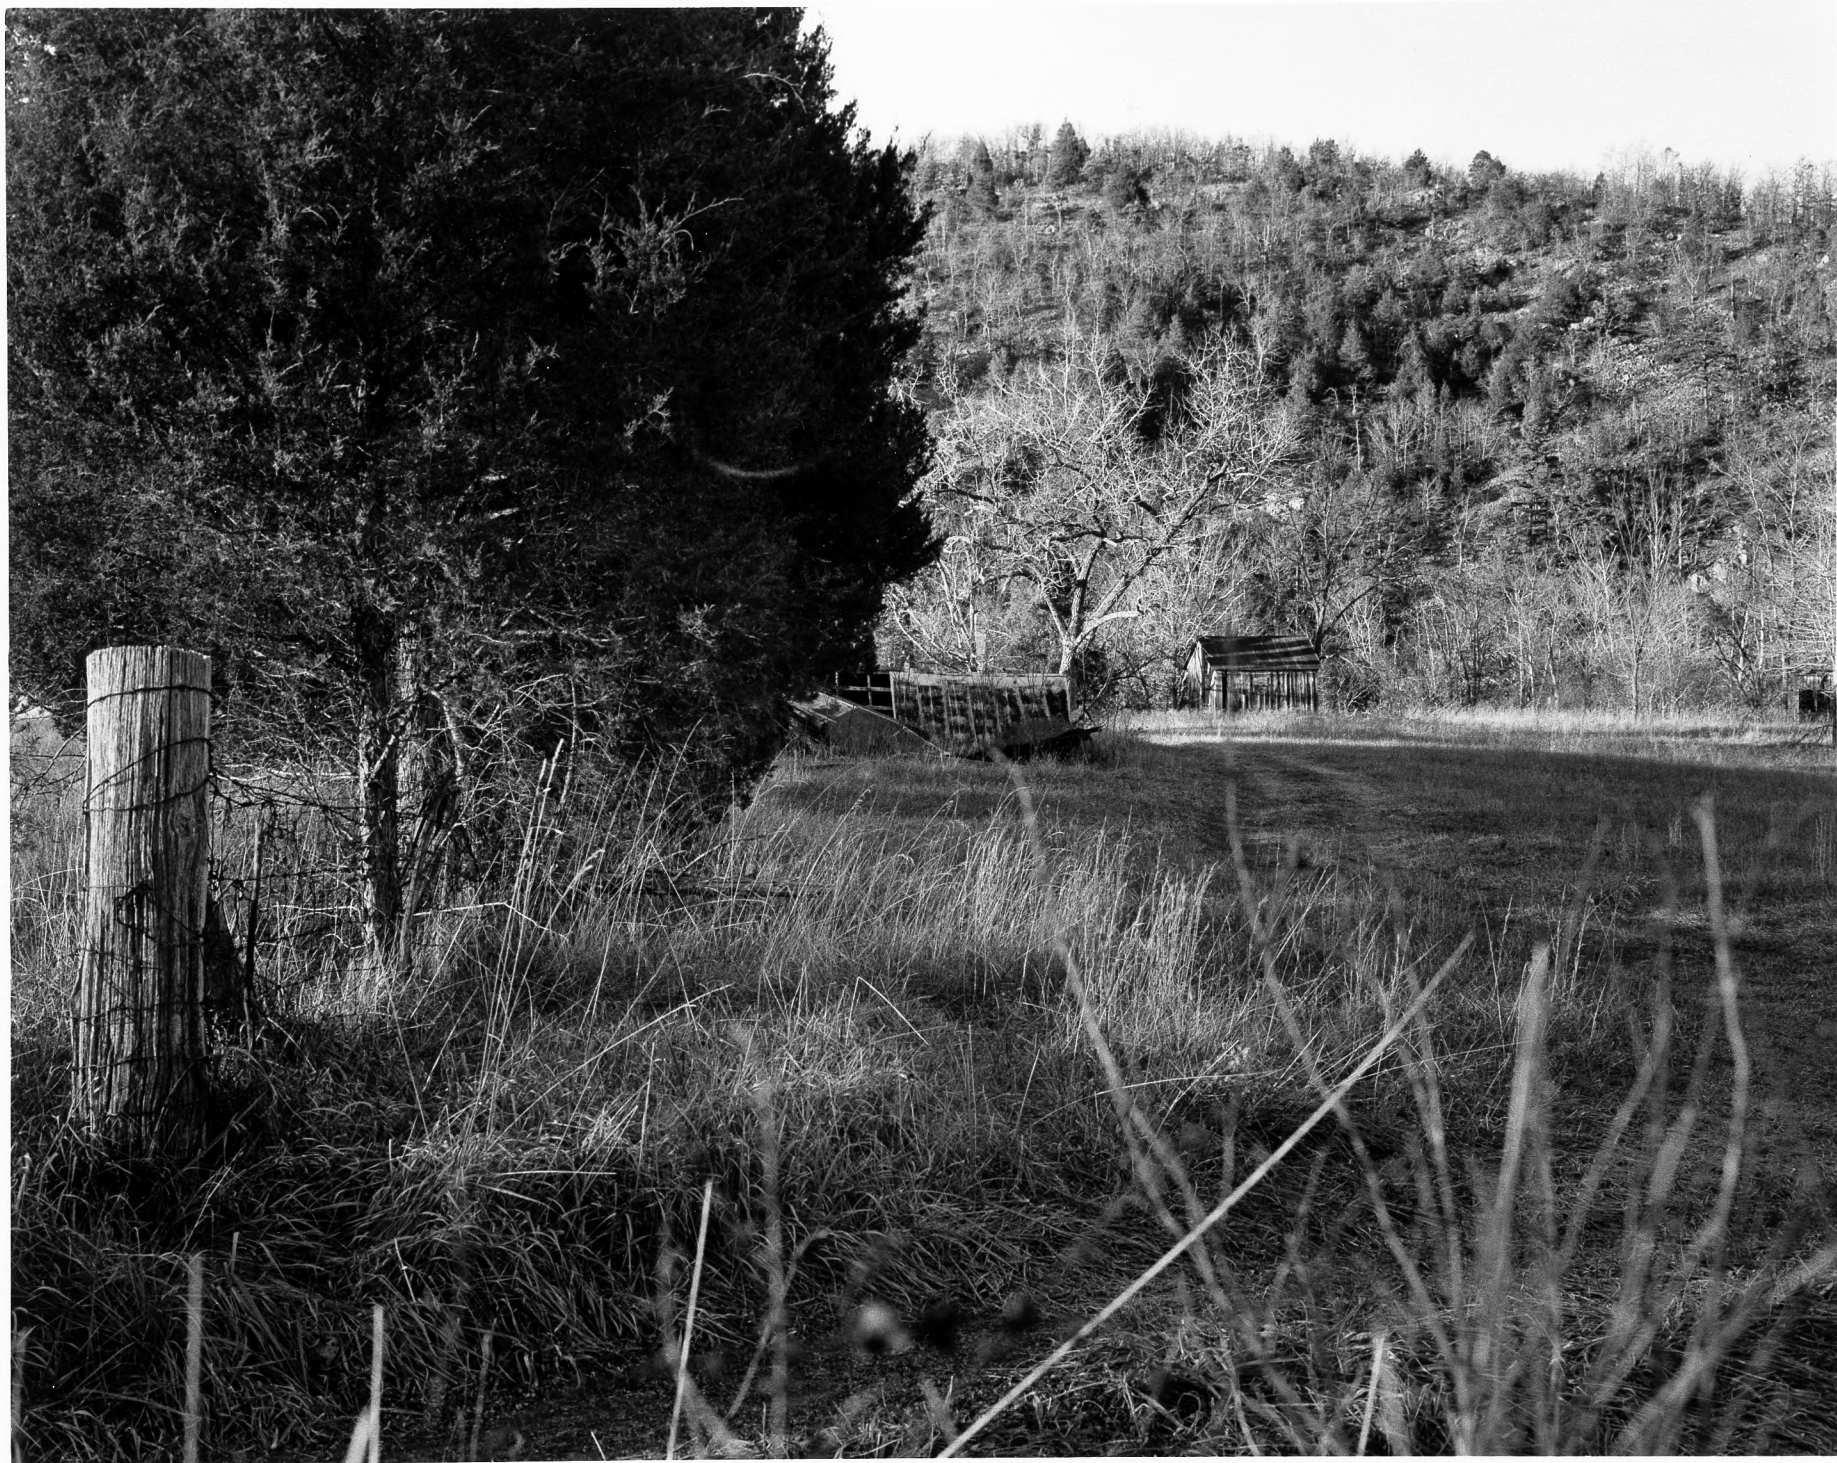
Photograph 5- 1. Farm equipment shed ruins, smokehouse, landscape elements  
4. December 1986  
6. Smokehouse (feature 6), farm equipment shed ruins (feature 13), tree and fence row, forested hillside on north side of Rocky Creek, from south

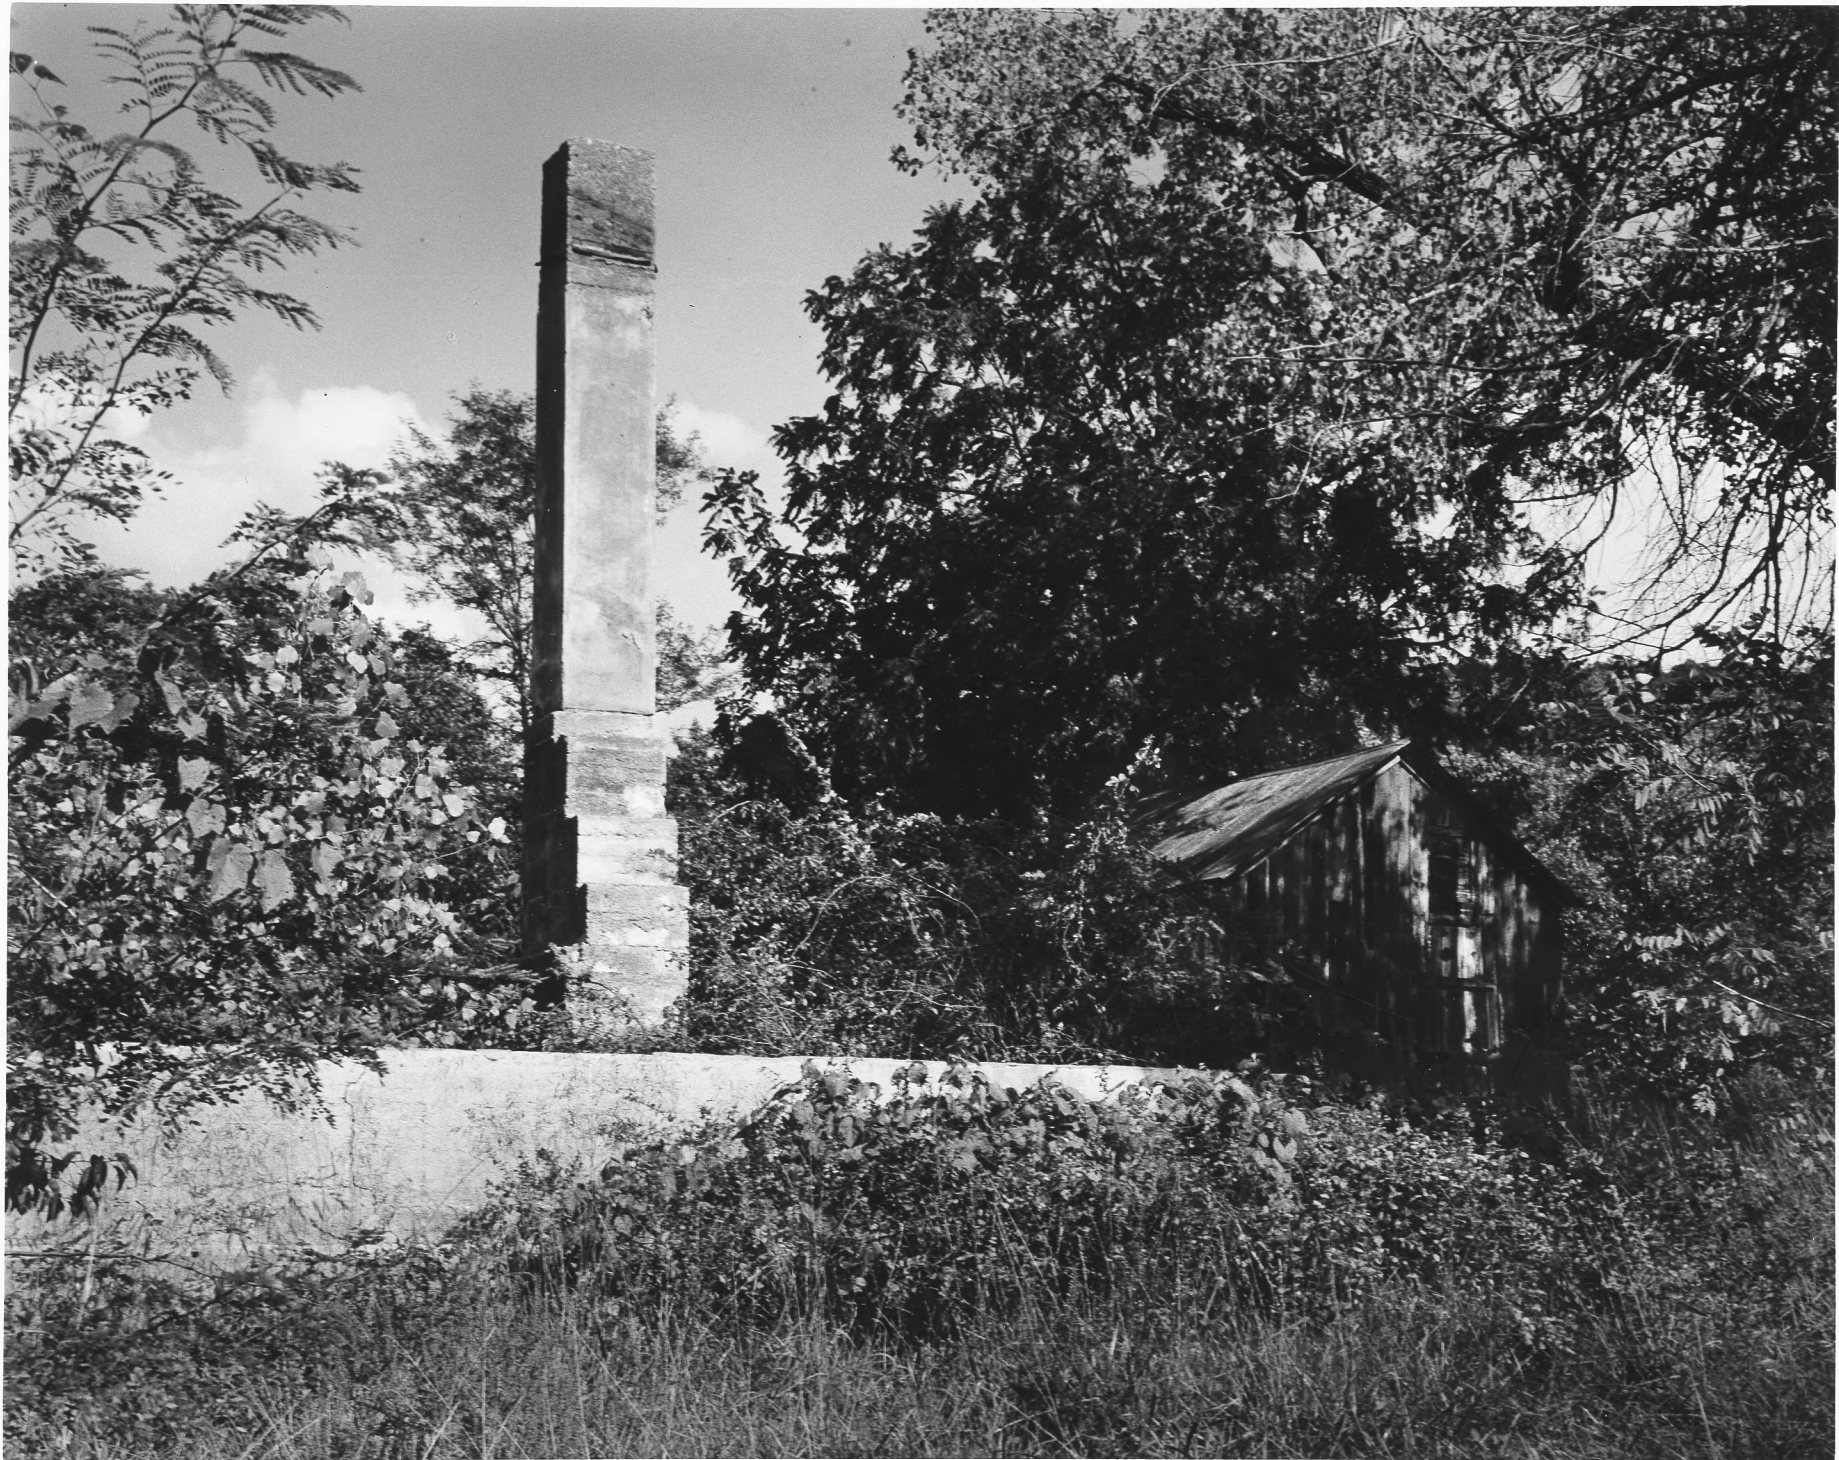
Photograph 6- 1. Smokehouse and Klepzig House foundation  
4. December 1986  
6. Smokehouse (feature 6) with Klepzig House foundation and chimney (feature 3), from northwest
