UNITED STATES DEPARTMENT OF THE INTERIOR  
NATIONAL PARK SERVICE**NATIONAL REGISTER OF HISTORIC PLACES  
INVENTORY -- NOMINATION FORM**

Painted Desert Inn

Petrified Forest National Park

## 7 DESCRIPTION

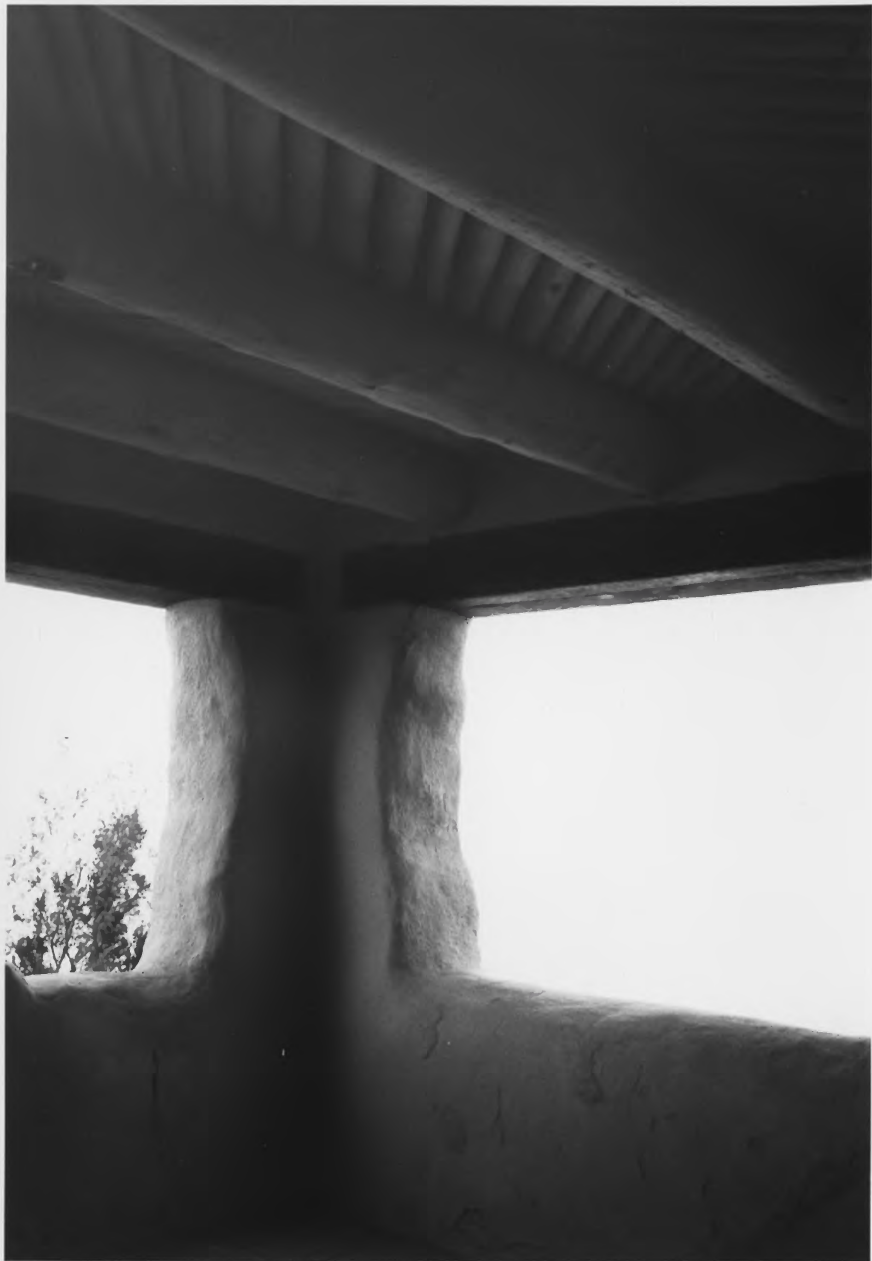
Wall and ceiling details, observation porch  
off Dining Room

The ceilings in the more architecturally significant portions of the building are structural peeled log vigas with half-round or split savinos above. The vigas are supported by posts with corbels carved in Spanish-Colonial designs. Vigas, posts, and corbels are ponderosa pine. Savinos are aspen. Most of the windows in the building are paired wood-frame casements and all retain their original hardware. The stock window frames and

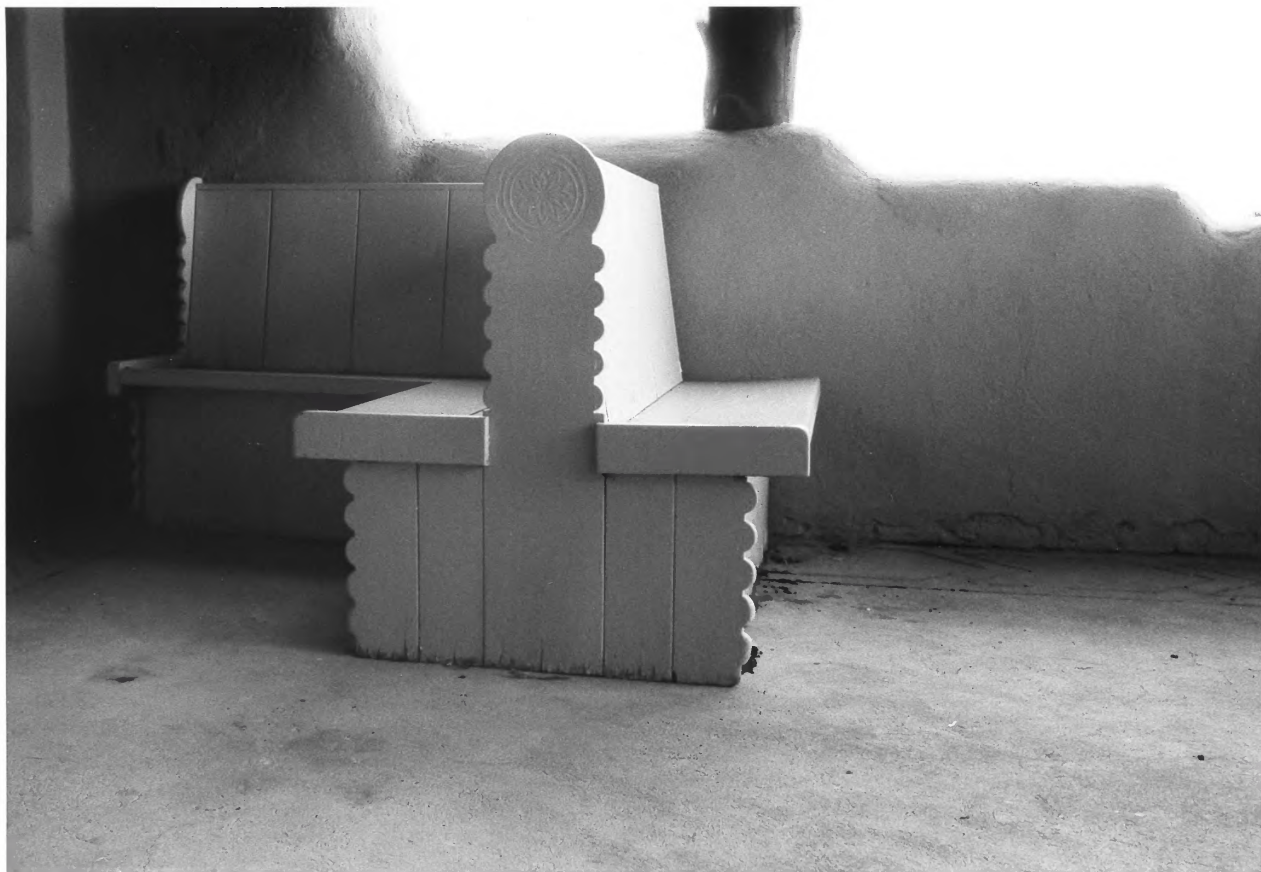
Benches on observation porch off Dining  
Room

The Kabotie room has Indian blanket designs scored into the concrete and painted in white, red oxide, and adobe colors. The room contains four murals by Hopi artist Fred Kabotie and one gouache painting that is framed and hangs in a wood built-in bookshelf. The light fixtures in this room are covered with deerskin. French doors lead out of this room to a recessed corner porch overlooking the Painted Desert. The porch has a scored concrete floor. Wooden benches with carved Spanish-Colonial designs provide seating on the porch.

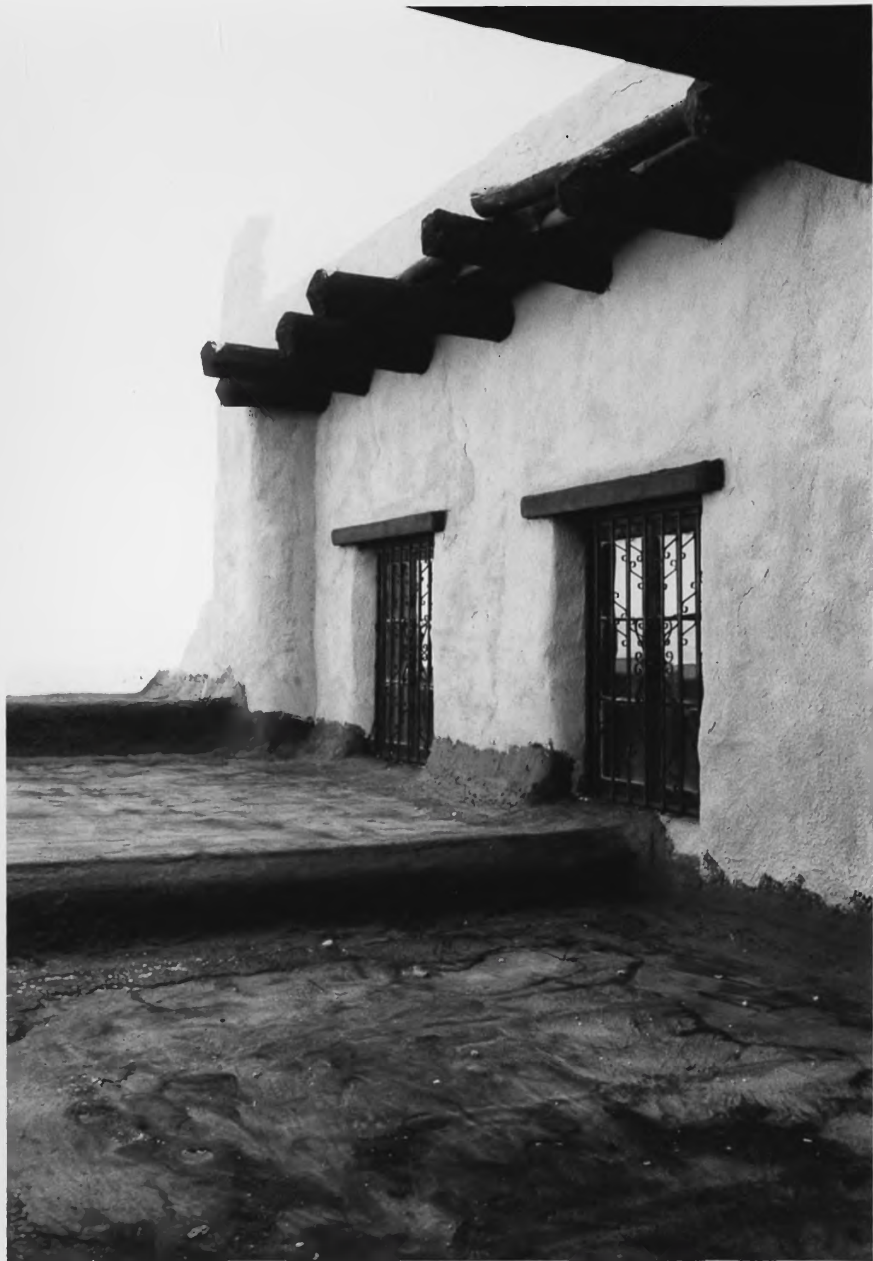
Exterior wall of Trading Post Room, and roof  
of guest rooms below

The stone walls of the building are more than two feet thick. On the exterior the walls are finished with a pink, earth-toned stucco. The multiple flat roofs are all surrounded by parapets and finished with built-up roofing. Exterior walls are pierced by canales that drain the roof and the structural viga ends, adding texture and a play between light and shadow to the walls.

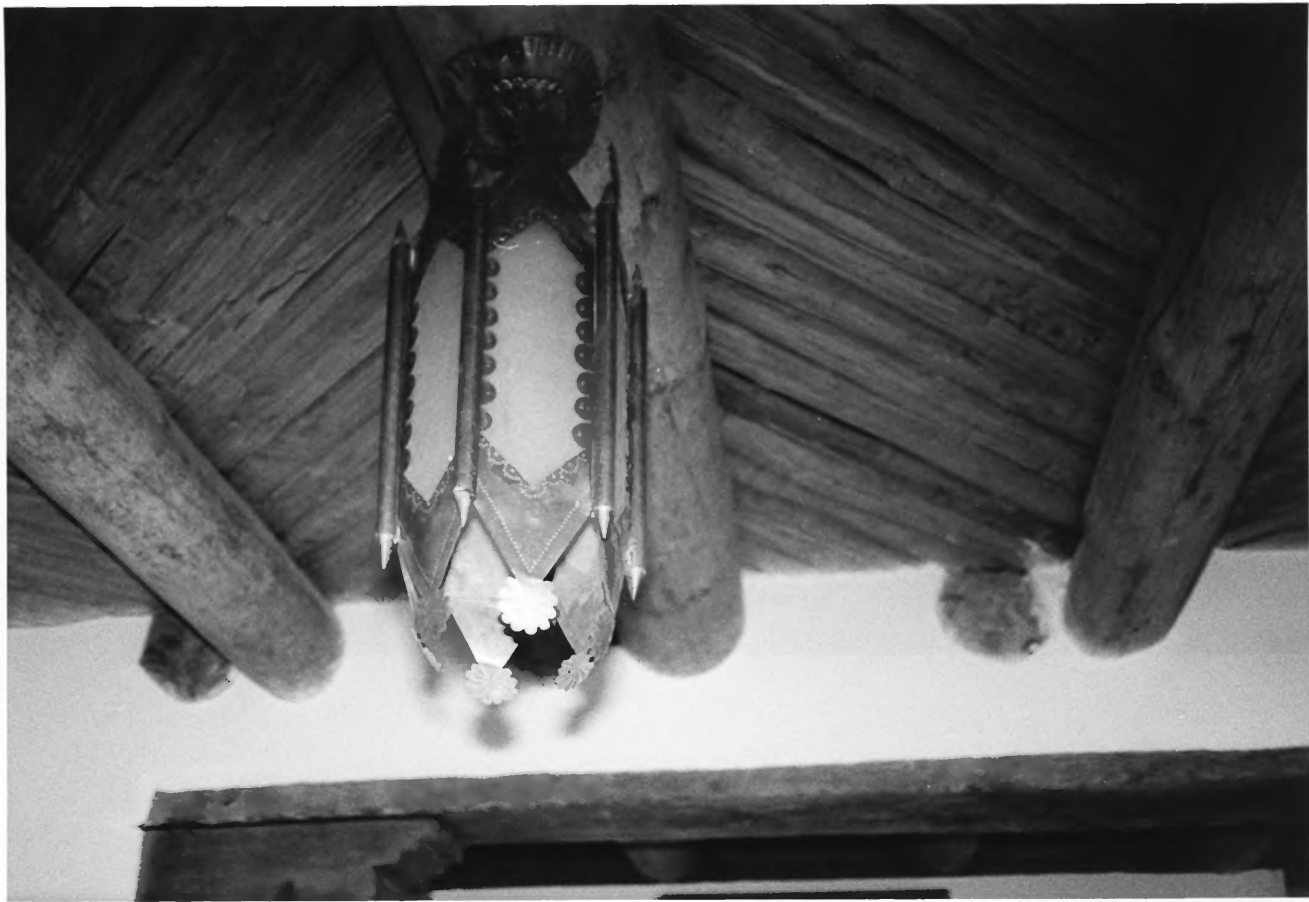
Tin light fixture, interior

The Trading Post room is a magnificent architectural space with six hammered-tin, Mexican-style chandeliers, an enormous skylight, and windows overlooking the desert for lighting. The skylight has multiple panes of translucent glass on which Indian pottery designs were painted in opaque paints. The posts supporting the corbels and vigas are painted in Spanish-Colonial designs in muted colors. Floors are random-width wood. The Ranger Room adjacent to this room contains an information desk and a small office space behind. The floor in this room is concrete scored in an Indian design.

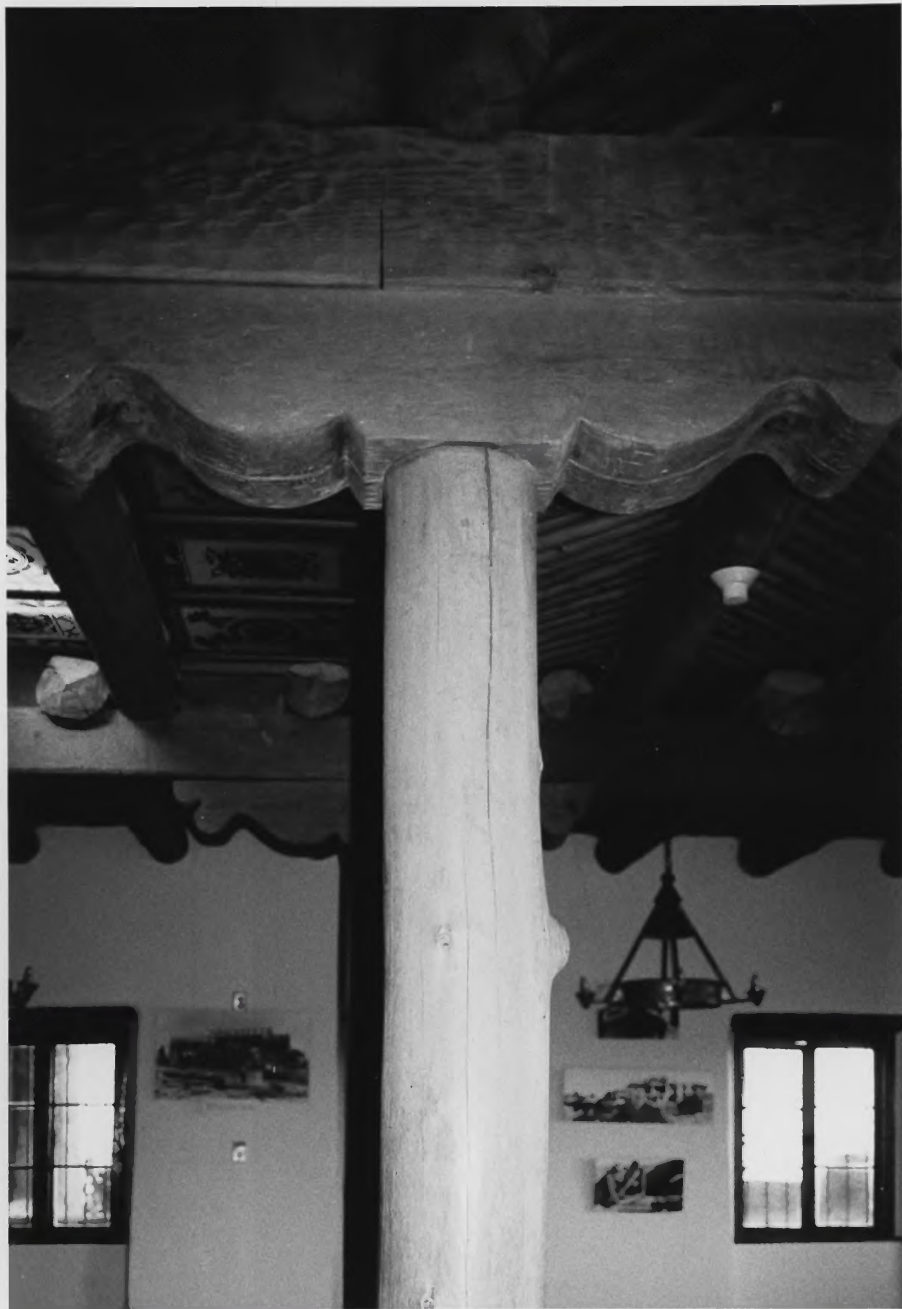
Corbel and ceiling details, Trading  
Post Room

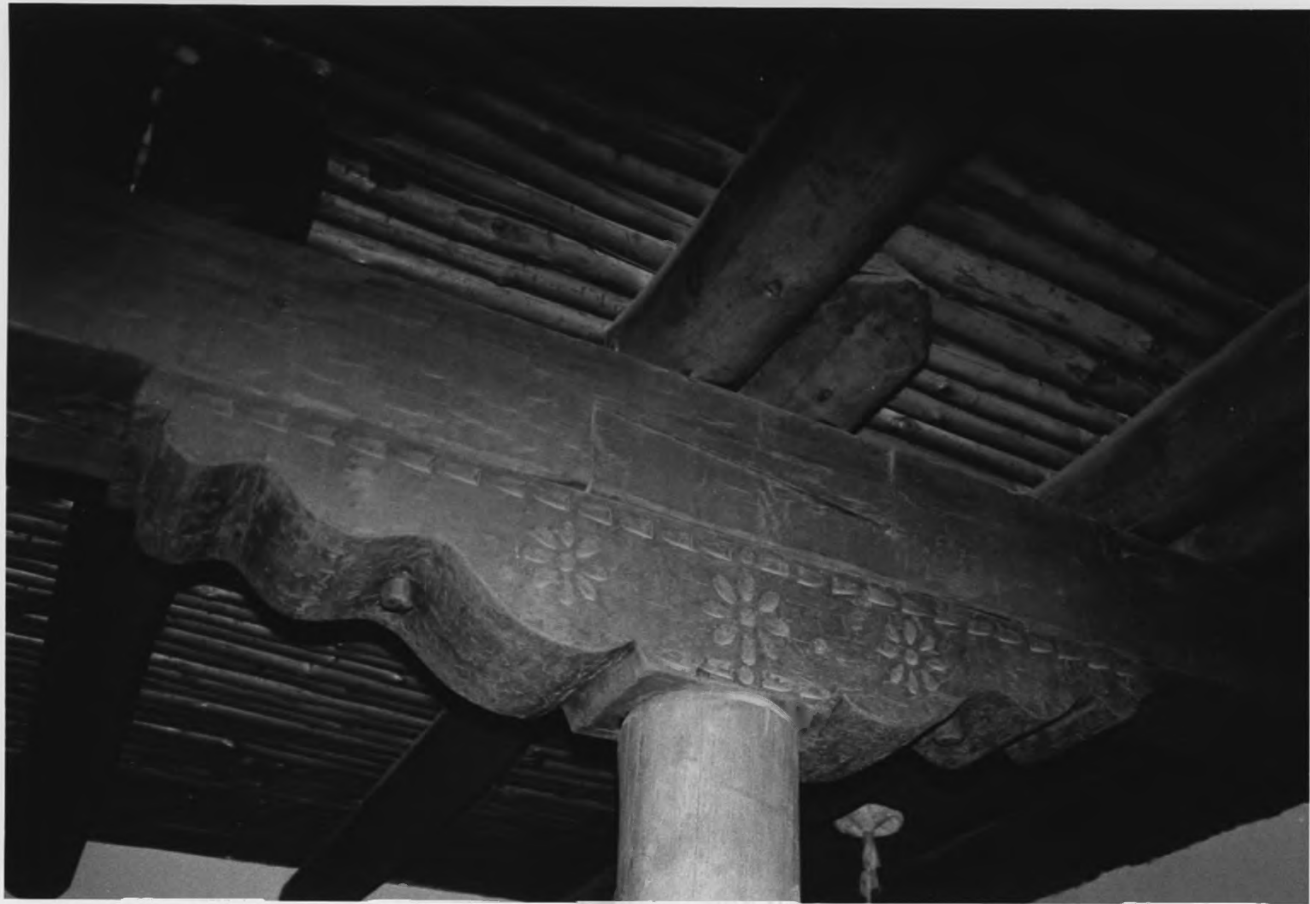
Hewn beams and corbels with vigas and  
savinas above. Trading Post Room

The park obtained ponderosa pine logs for vigas and structural timbers from Sitgreaves National Forest and aspen for the savinos from the White Mountain Apache Reservation. Both areas disguised the wood appropriation as "forest thinning" rather than timber harvesting for construction use which probably would not have

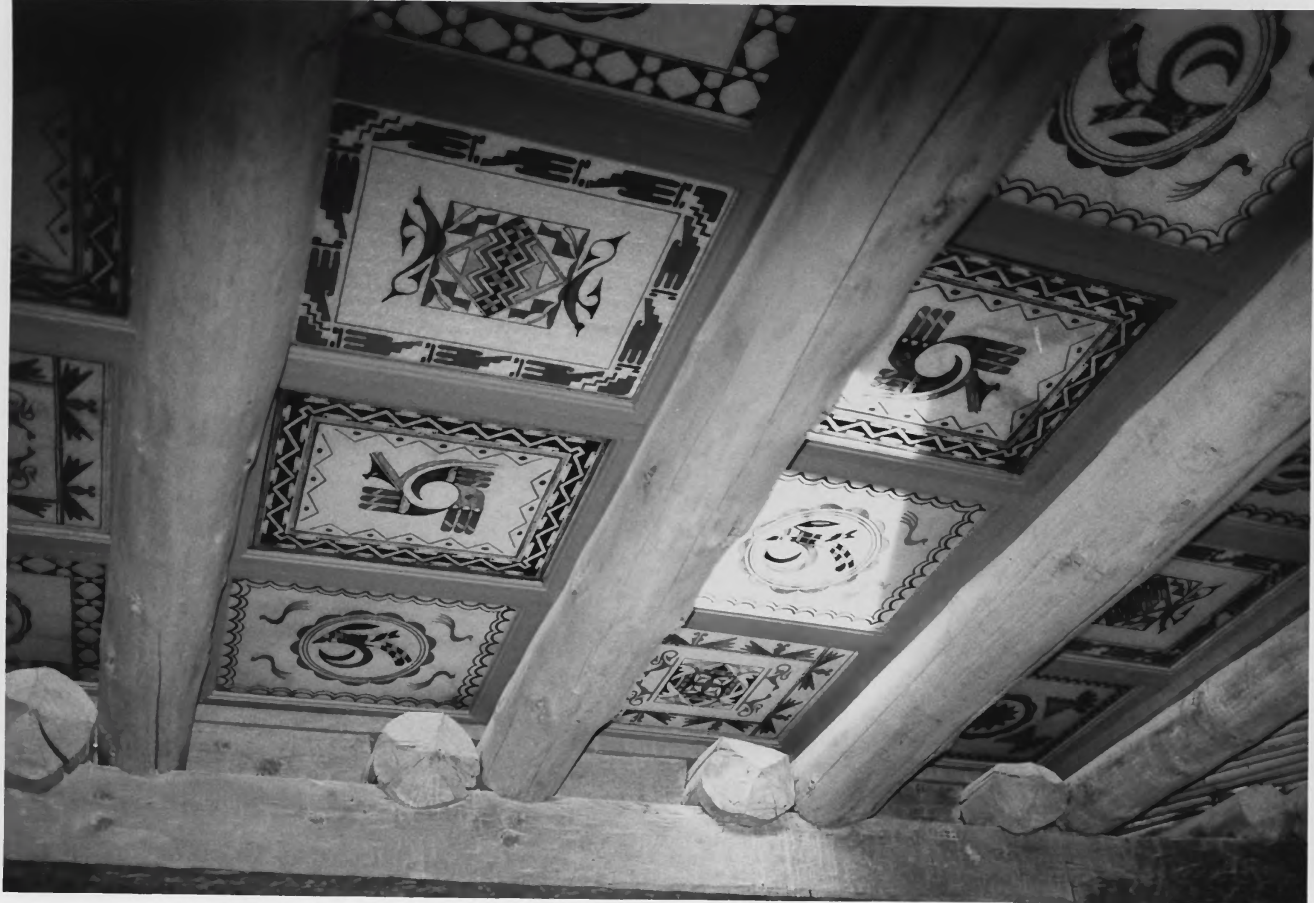
Skylight designed by Lyle E. Bennett,  
Trading Post Room

The concrete scored in Indian blanket designs, the Spanish Colonial furniture, the skylight with its prehistoric pottery designs and the subtle interior colors were all design contributions of Lyle Bennett. Bennett had received a degree in fine arts from the University of Missouri where his major field of study had been architecture. Bennett joined the park service as a ranger at Mesa Verde in 1927 where he worked in the museum and with park archeologists. He began doing architectural work for the park service in the early 1930s. He designed most of the CCC-built structures and furniture at Bandelier National Monument, a number of structures at Carlsbad Caverns, the 1930s buildings at White Sands National Monument, and additions to buildings at Mesa Verde. Although his admitted architectural preferences were along the modern lines of Frank Lloyd Wright he set those interests aside in the fine pueblo revival buildings he designed for the park service. His command of that southwestern idiom was masterful. His design for the skylight came from years of careful study of prehistoric pottery that he restored at Mesa Verde and that he read about in publications of the University of New Mexico.<sup>5</sup> He studied ceiling structure in pueblo-revival buildings in New Mexico. His sensitivity for colors came from his artistic training at the University of Missouri. His abilities to combine those finer elements of design with simple building materials to create impressive architectural spaces was a product of experience and talent.

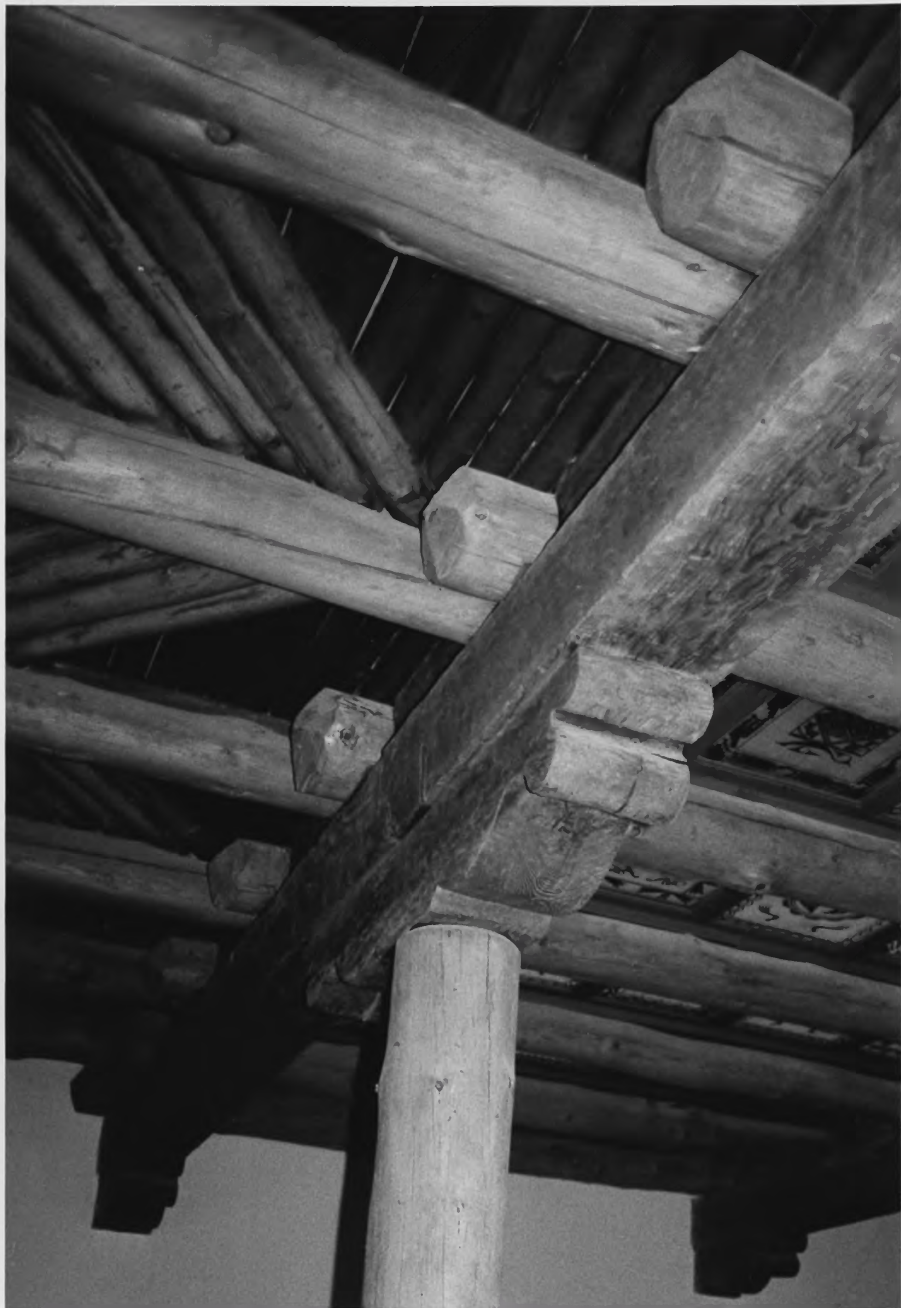
Detail of ceiling structure, Trading  
Post Room

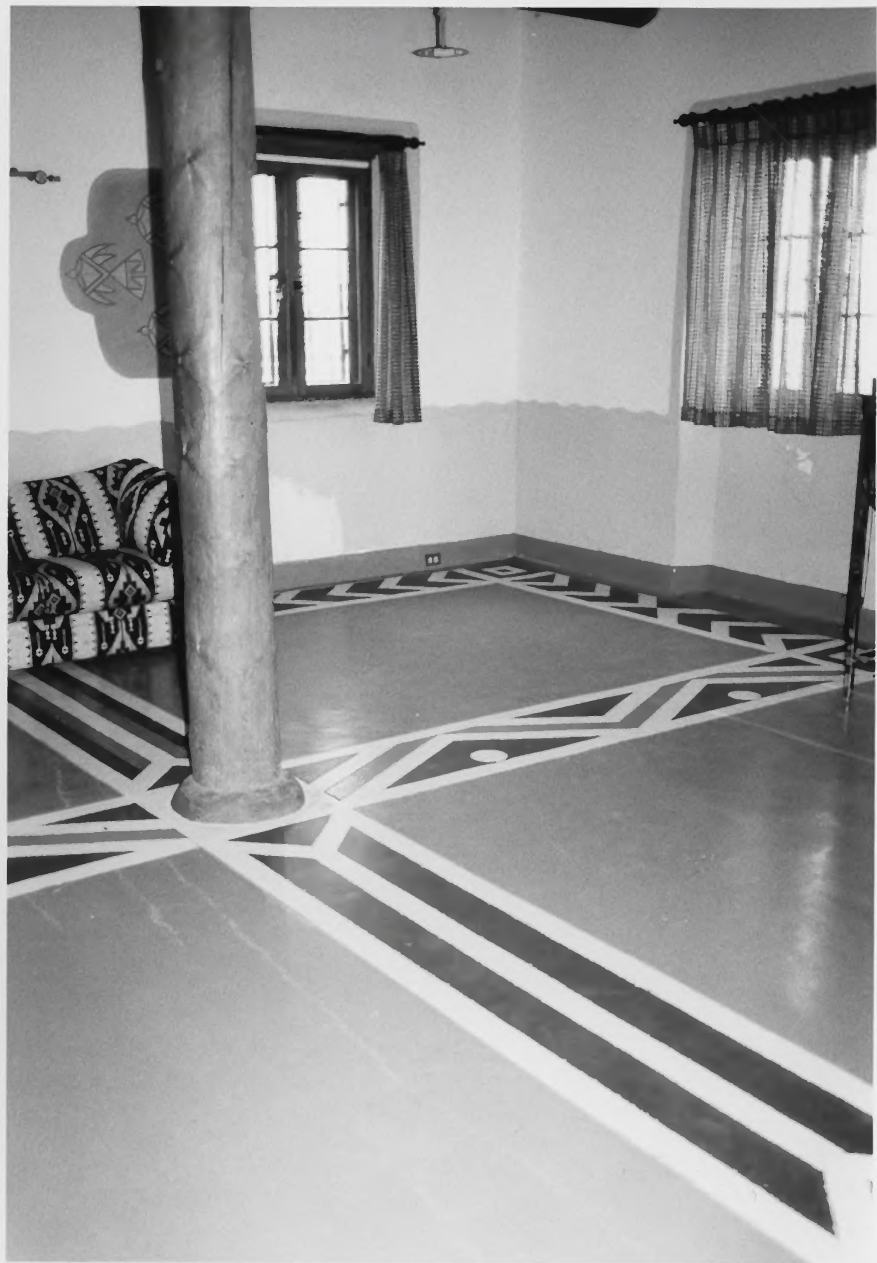
Indian Design scored into and painted on floor. Also note Kabotie bird mural on wall.

were able to proceed."<sup>3</sup> That same foreman recalled how the scoring marks in concrete resembled Indian blanket designs and were stained in soft tints and how the soft tints were repeated in the carved furniture colors and wall colors. In his words: "The whole interior seemed to glow with soft, blended coloring. The time I had personally spent with Mr. Bennett was a revelation to me on what can be accomplished with color combinations"<sup>4</sup>

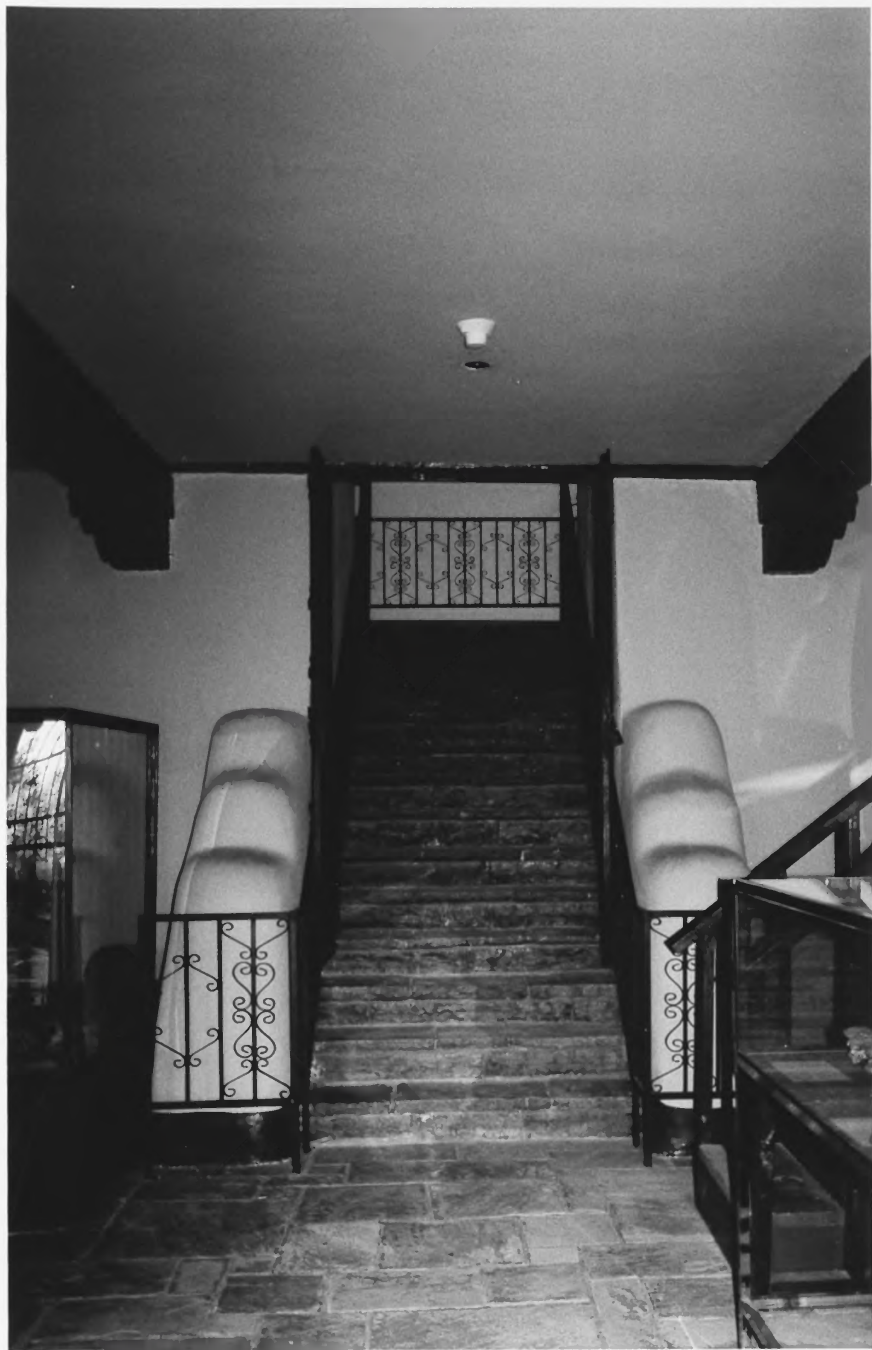
Staircase leading from bar to Trading  
Post Room

Flagstone steps lead down from the Trading Post room to the building's first floor which originally functioned as a bar. This room also has a flagstone floor laid in a pattern that repeats in 4x5-foot sections. The original bar is covered by a staging constructed to hold museum exhibits, although the bar remains intact underneath. The radiators to heat this rooms were incorporated into low walls and hidden by wooden grilles of Spanish-Colonial design.

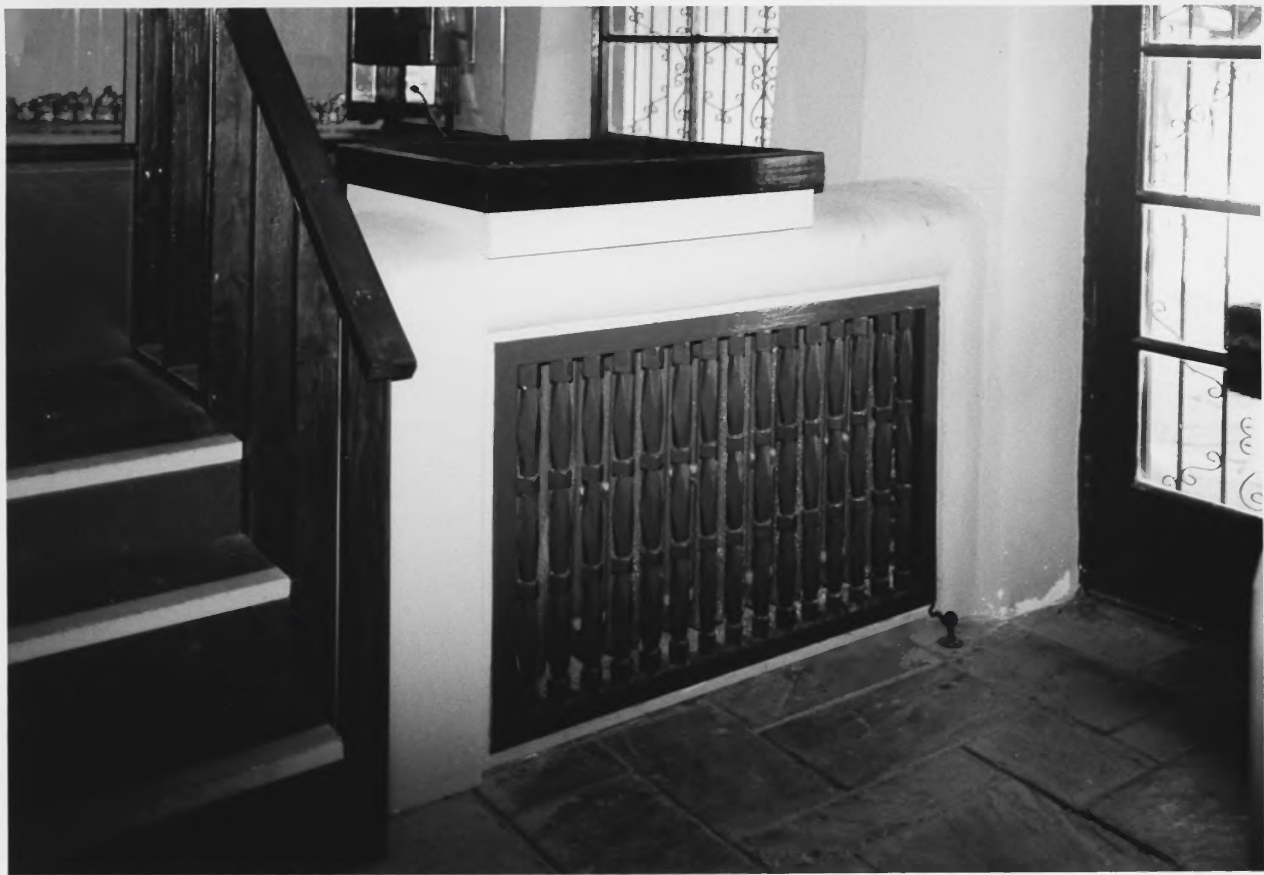
Spanish Colonial Style Radiator Covers  
in bar.
