Mission Nuestra Senora de la Purisima  
Concepcion de Acuna, Convent  
807 Mission Road  
San Antonio  
Bexar County  
Texas

HABS No. TX-319-B

HISTORIC AMERICAN BUILDINGS SURVEY

MISSION NUESTRA SENORA DE LA PURISIMA  
CONCEPCION DE ACUNA, CONVENT

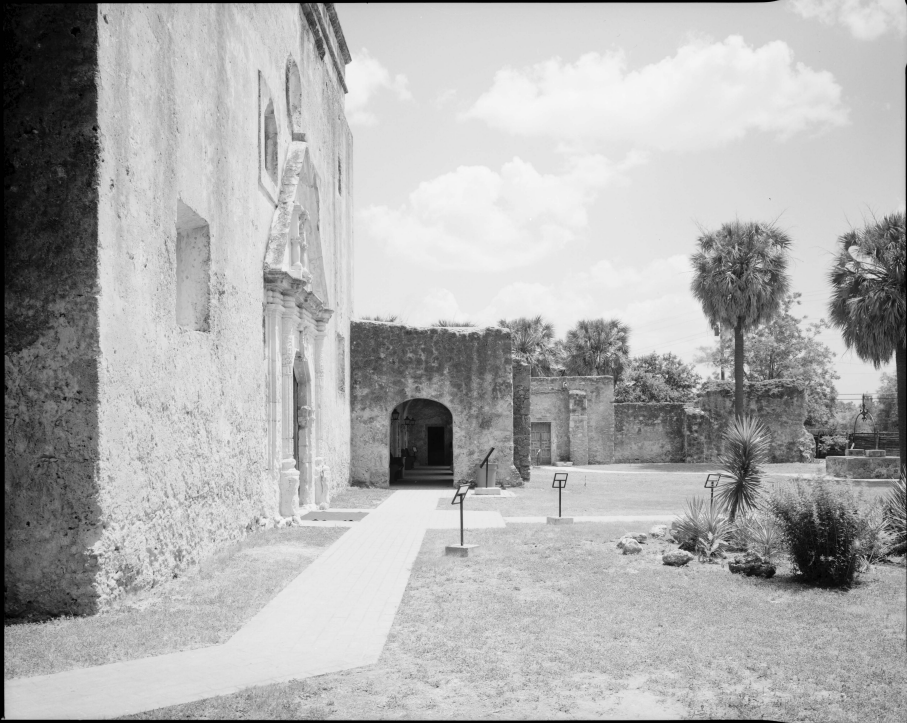
HABS No. TX-319 B-1

TX-319 B-1    GENERAL VIEW OF CONVENT, LOOKING SOUTH

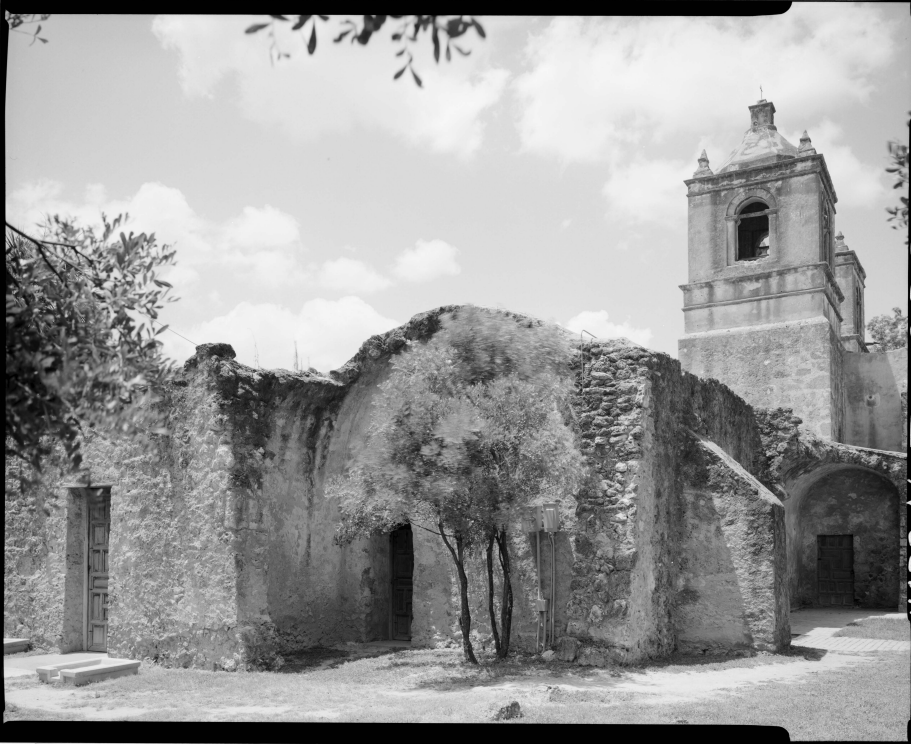
HABS No. TX-319 B-2

TX-319 B-2    REAR PORTION OF CONVENT, WITH VAULTED ROOF, LOOKING NORTHWEST

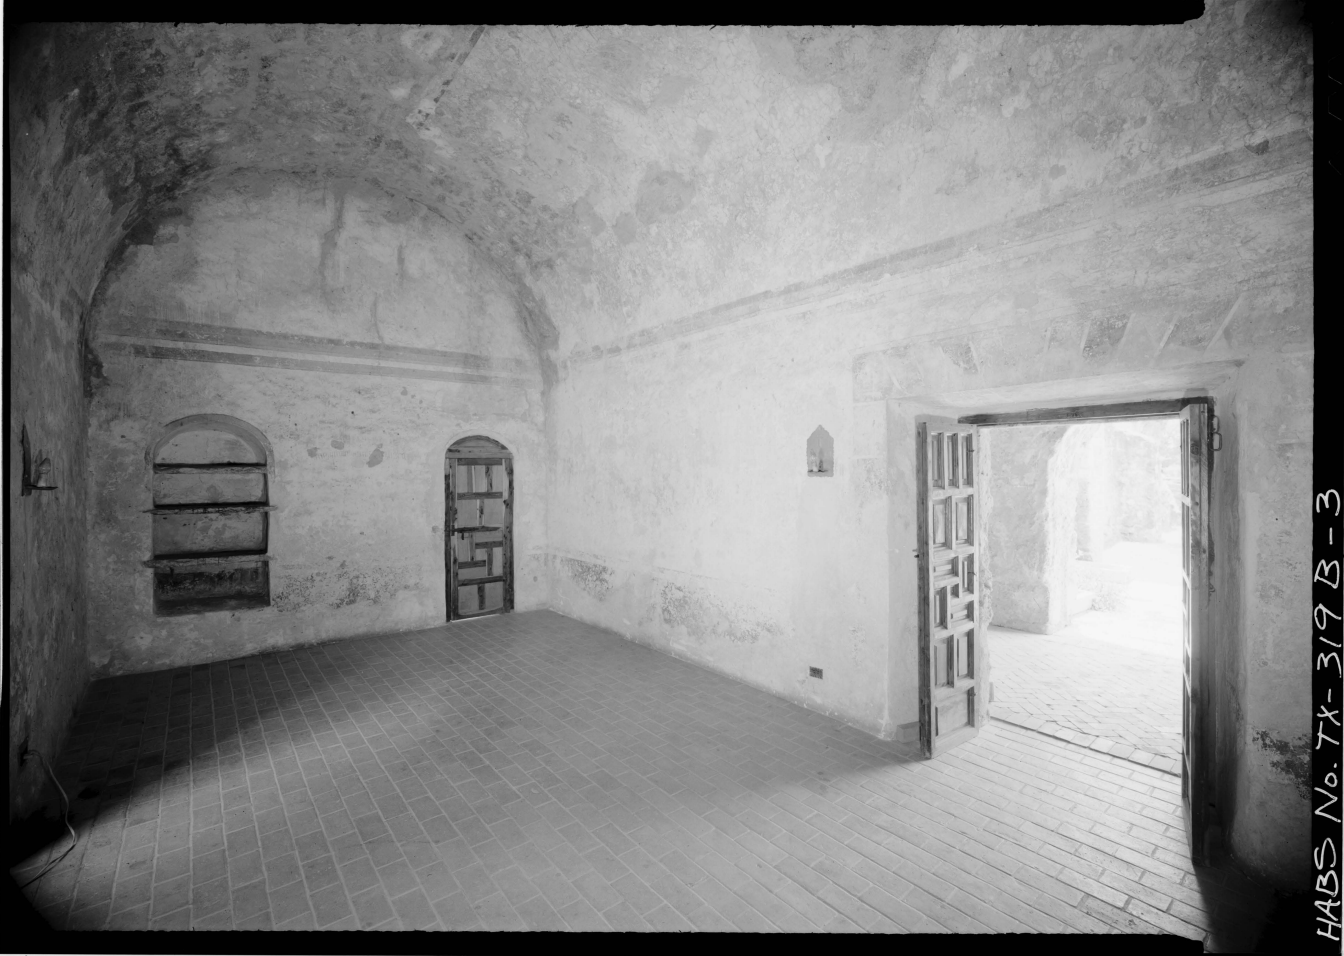
HABS No. TX-319 B-3

TX-319 B-3    INTERIOR OF CONVENT. NOTE VAULTED CEILING
