Mission San Jose Y San Miguel De Aguayo,  
The Ramparts  
6539 San Jose Road  
San Antonio  
Bexar County  
Texas

HABS No. TX-333 E

HISTORIC AMERICAN BUILDINGS SURVEY

MISSION SAN JOSE Y SAN MIGUEL  
DE AGUAYO, THE RAMPARTS

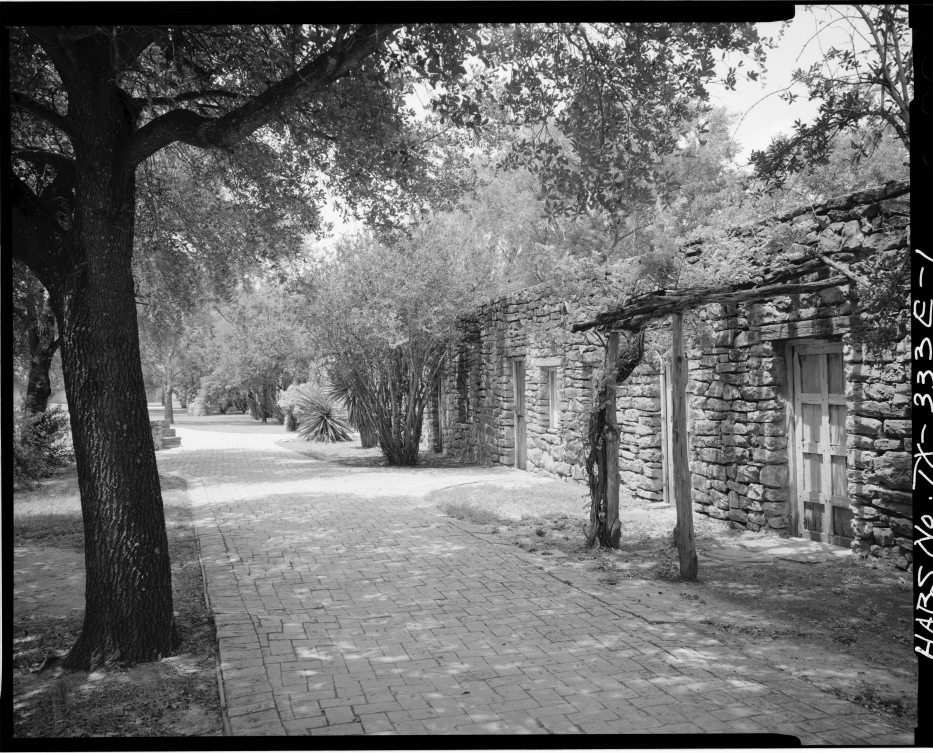
HABS No. 7X-333E-1

TX-333 E-1 INDIAN APARTMENTS\*

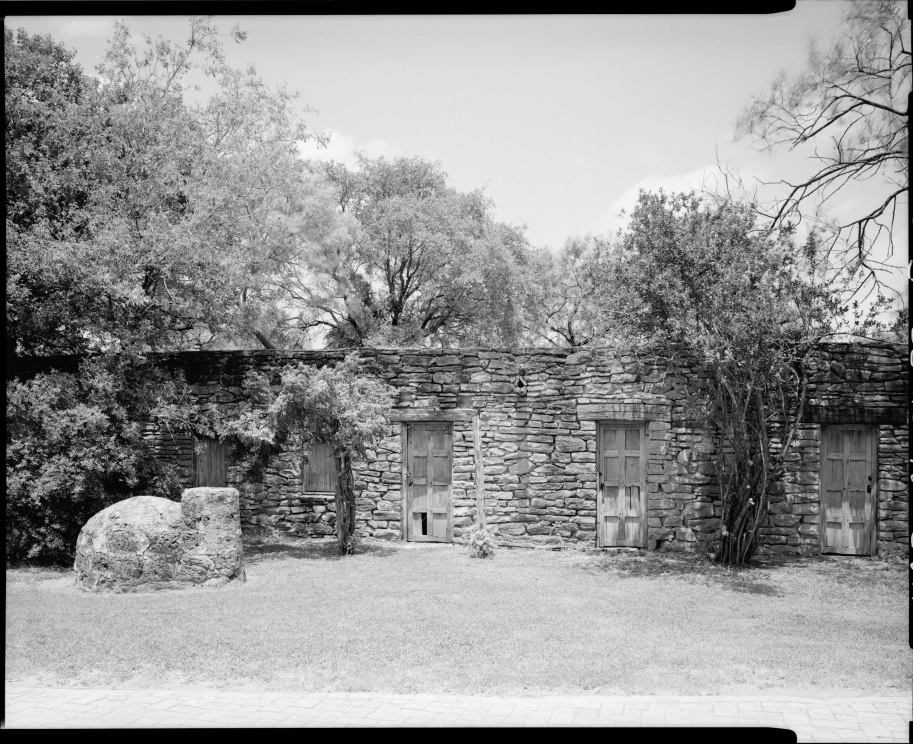
4ABS No. TX-3334-2

TX-333 E-2 INDIAN APARTMENTS

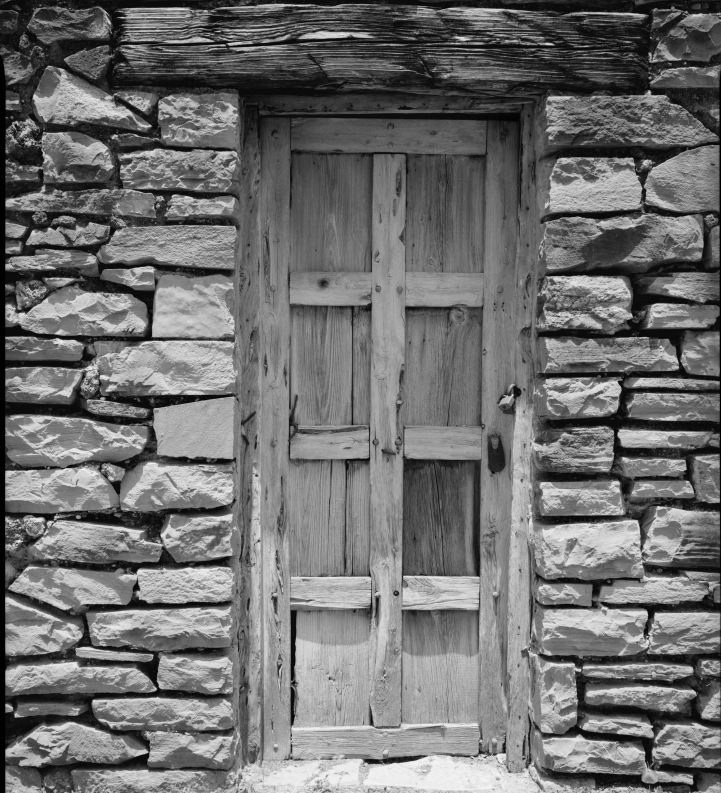
HABS No. TX-333 C-3

TX-333 E-3 DOORWAY AND LINTEL DETAIL

3. Walls: Rubble stone.
  4. Structural system, framing: Load bearing masonry walls; wood roof framing.
  5. Openings:
    - a. Doorways and doors: Openings spanned by wood lintels; wood doors.
    - b. Windows: Openings spanned by wood lintels; wood casement windows.
  6. Roof: Flat; covering not known.
- C. Description of Interior:
1. Floor plan: A series of adjacent rooms, all opening onto the Mission Plaza.
  2. Flooring: Originally packed earth.
- D. Site:
1. General setting and orientation: The buildings form the perimeter of the Mission Plaza, a large trapezoidal area oriented to the cardinal points of the compass.
