Form 10-300  
(July 1969)UNITED STATES DEPARTMENT OF THE INTERIOR  
NATIONAL PARK SERVICENATIONAL REGISTER OF HISTORIC PLACES  
INVENTORY - NOMINATION FORM

| COMMON:<br><b>Mission San Francisco de la Espada</b> | | | | |

## 7. DESCRIPTION

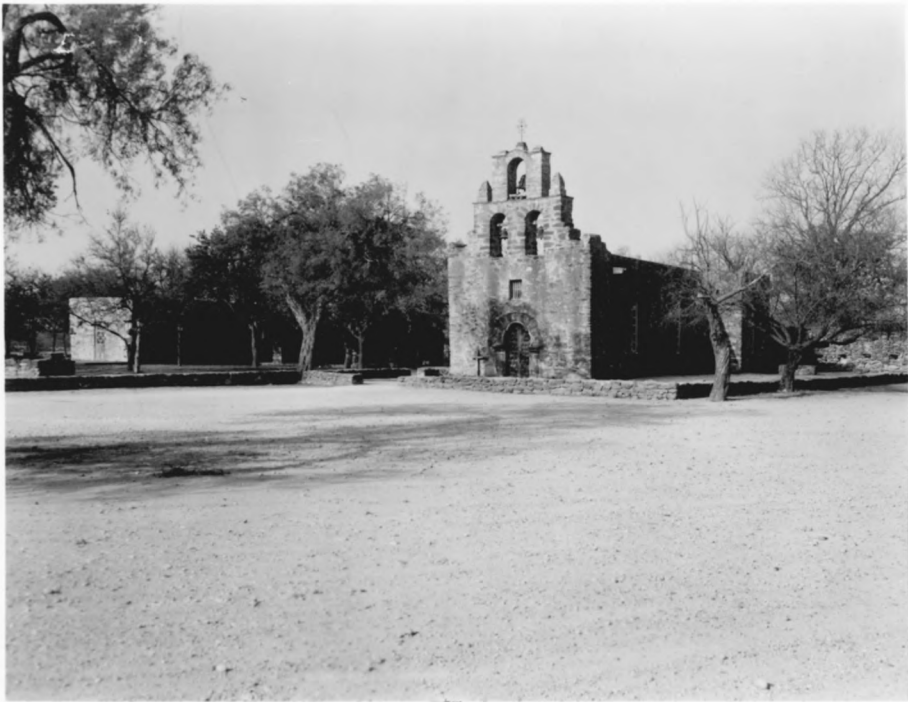
①

Loc. East facade of chapel.  
View southwest.

The Espada church is a small, rectangular building whose main facade faces east. Transepts on the south and north elevations give the building the traditional cross-shape. A two-tiered espadana the width of the east facade is pierced by two bells on the lower tier and a third at the top. Finials at either side of the tiers and a wrought iron cross at the top complete the decorations of the wall belfry. The arrangement of this espadana is virtually identical to that of San Juan.

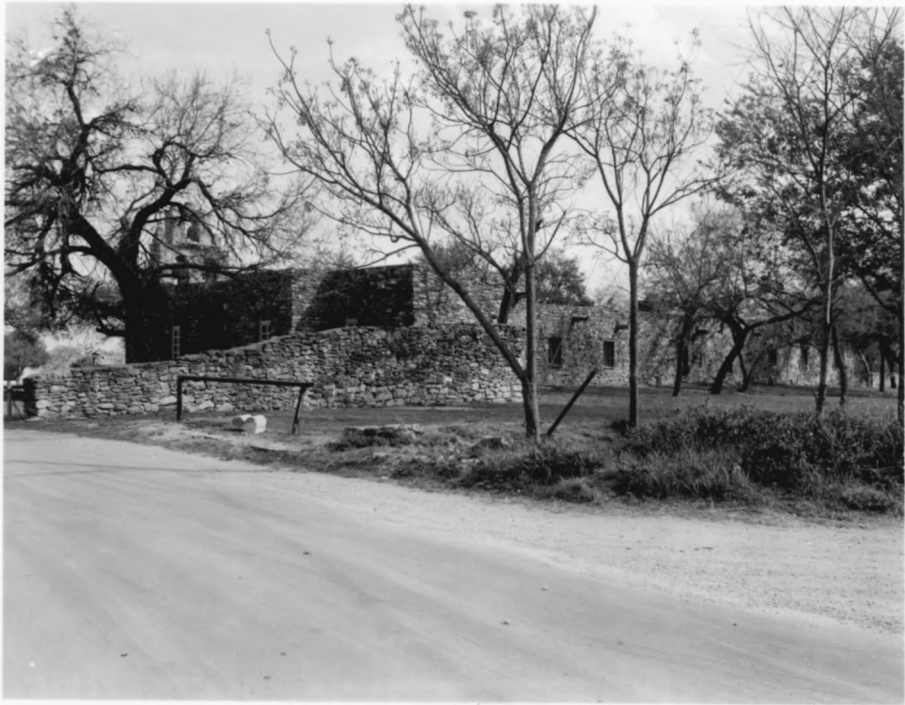
(2)

West face, Chapel & compound

wall. View from west entrance

off Espada Road. View east-southeast.

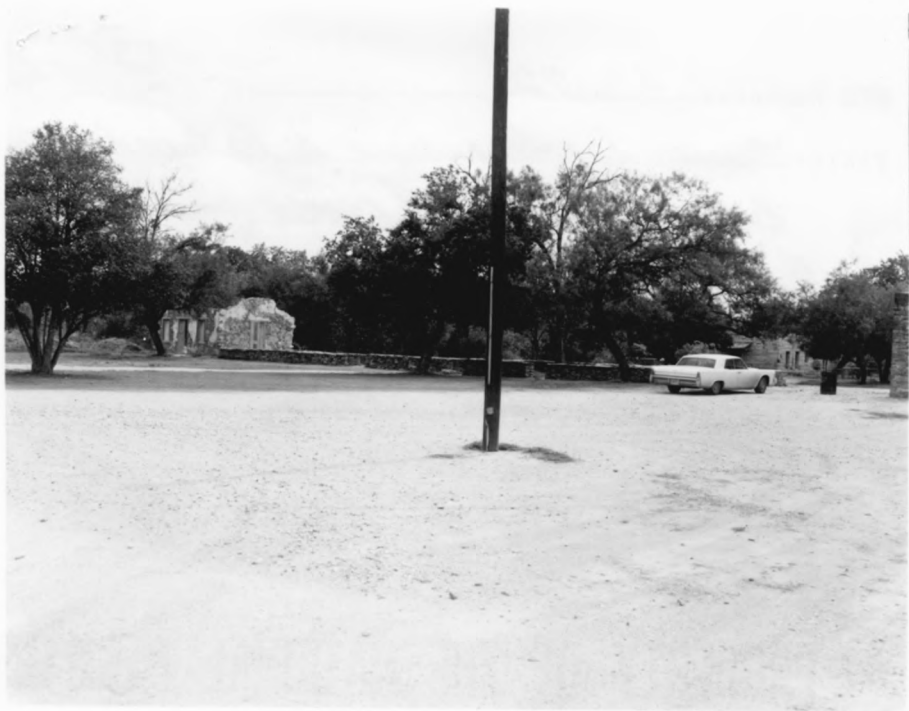
3

NPS Number 2.23.72

Title: Mission San Francisco de la Espada  
Bexar County, Texas

Loc. View across mission compound  
courtyard toward north wall.  
Note house. View north.

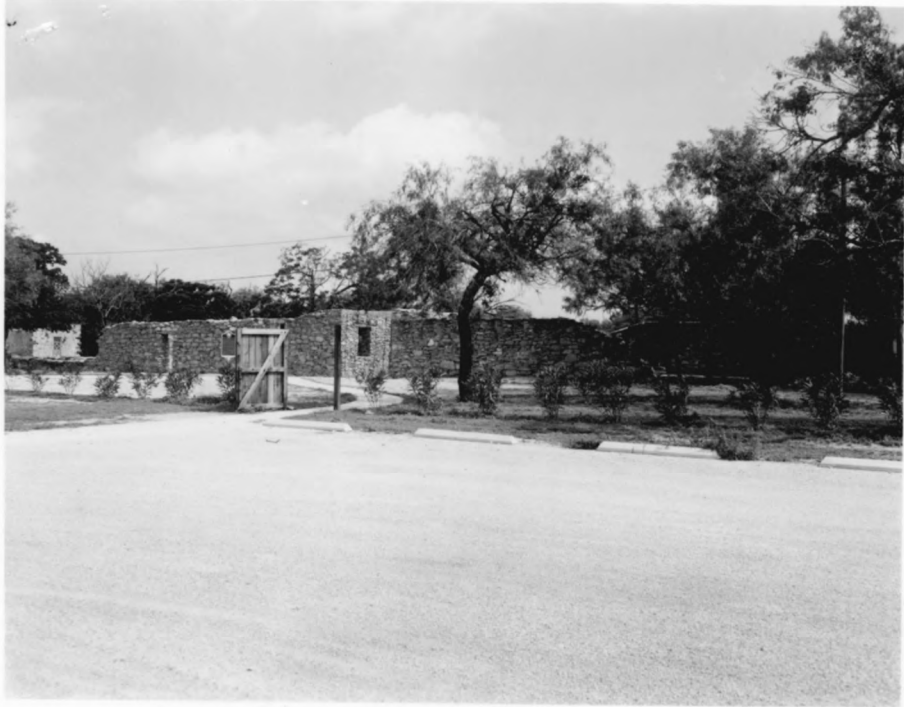
④

Loc. S. wall + original main  
entrance on south.

View northwest.

The mission complex follows a similar arrangement to that of other missions, particularly San Juan Capistrano. That is, rooms and buildings arranged in a rough quadrangle around a central courtyard. Entrances to the rooms are made through those walls facing the courtyard leaving the exterior protected. The main entrance to the mission compound was through a gate on the south.

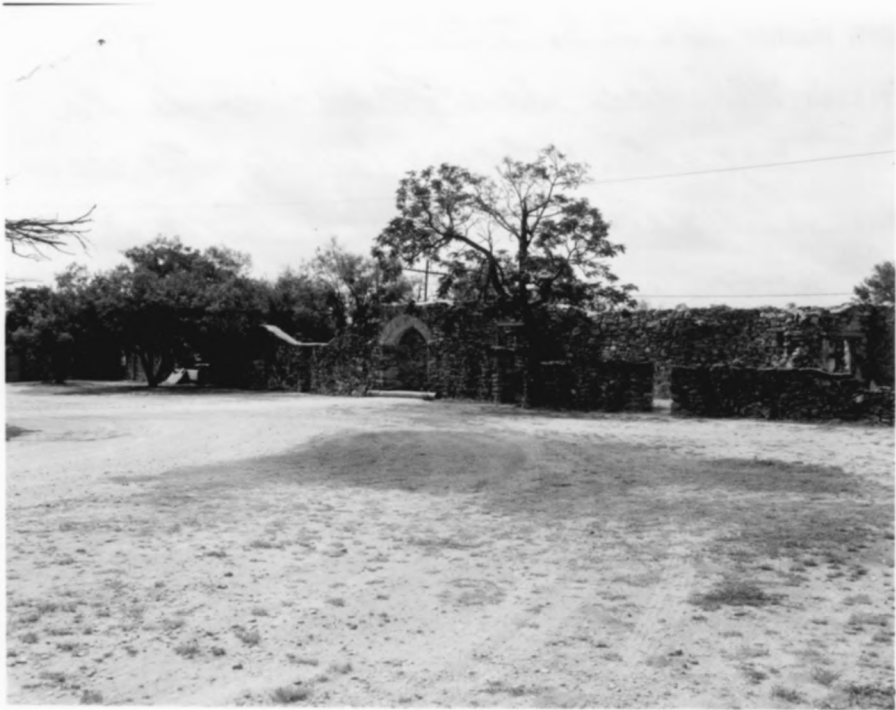
NPS Number 2.23.72

Title: Mission San Francisco de la  
Espada; Bexar County, Texas

Loc. S. wall. & entrance, interior  
view. View southeast.
