# **A Preliminary Assessment of Wetland, Riparian, Geomorphology, and Floodplain Conditions at Sand Creek Massacre National Historic Site, Colorado**

Technical Report NPS/NRWRD/NRTR-2005/335

June 2005

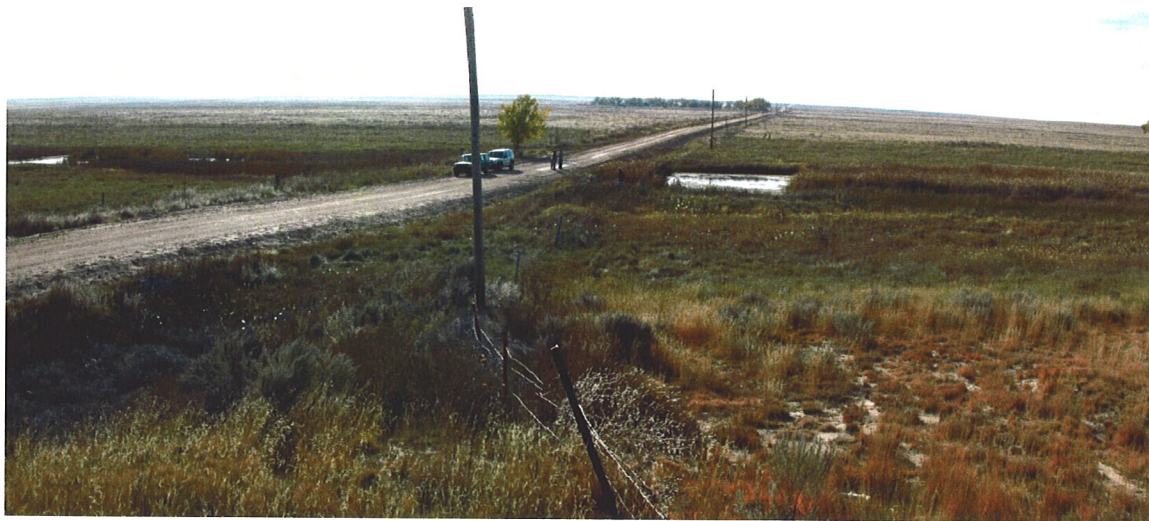
Figure 3: Big Sandy Creek at County Road W

Backwater may play a role in determining flood elevations especially in reaches just upstream from road crossings. Road crossings over broad floodplains usually represent an extreme reduction in flow width that greatly reduces flood conveyance. Just downstream of the Dawson Ranch Headquarters is a prime example - the county road W crossing (Figure 3).

We inspected this site (located on the boundary between Section 30 and 31, Township 17S, Range 45W) and estimated the unobstructed flow width of Big Sandy Creek to be about 90 feet wide. In contrast, the single culvert that allows water to pass under the road appeared to have a three-foot diameter. This represents a constriction ratio of about 30: 1. Not surprising, overtopping of the road and associated erosion is very common during flow events. Besides being a maintenance liability, road material is washed downstream into the riparian wetland system. We recommend improving flows under the road with a bridge, new box culverts, or numerous large culverts.

To alleviate or at least reduce the detrimental effects of the undersized passage of Big Sandy Creek under County Road W, we suggest replacing the steel culvert with a properly sized box culvert. If that approach is cost prohibitive, then at least several culverts could be installed to reduce the degree of constriction. Hydraulically, the most favorable crossing would be a bridge spanning a large portion of the floodplain, however, this option is likely cost restrictive.

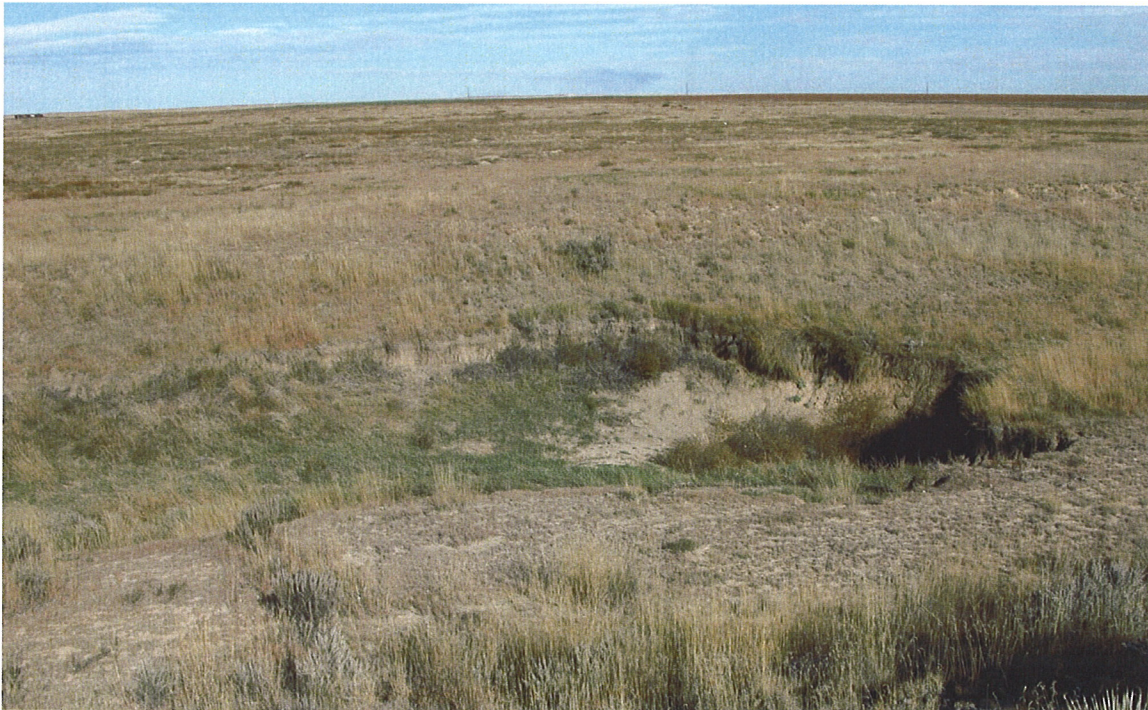
Figure 4: Head Cut Erosion within Canal Channel

After almost 100 years of neglect, the bottom of the canal has eroded down below its original design grade. As a result, there are numerous "head cuts" which are areas in the channel bottom that are eroding at significantly higher rates than what would erode from within a stable stream channel. Most of the head cuts north of the Kern spring stream crossing appear to be slowing down. There is, however, one head cut that should be stabilized to stop the erosion migration and to reduce sediment loading downstream. It is located just south of where the Kern spring stream crosses the levee. Please see Figure 4.

Stabilize the eroding head cut within the canal channel located just south of the spring stream crossing. This might be accomplished by excavating the wall of the head cut back and up the stream channel, creating a 3:1 or 4:1 slope along the centerline of the channel. The finished grade would have to be planted with appropriate grasses and temporarily protected with a stabilizing fabric.

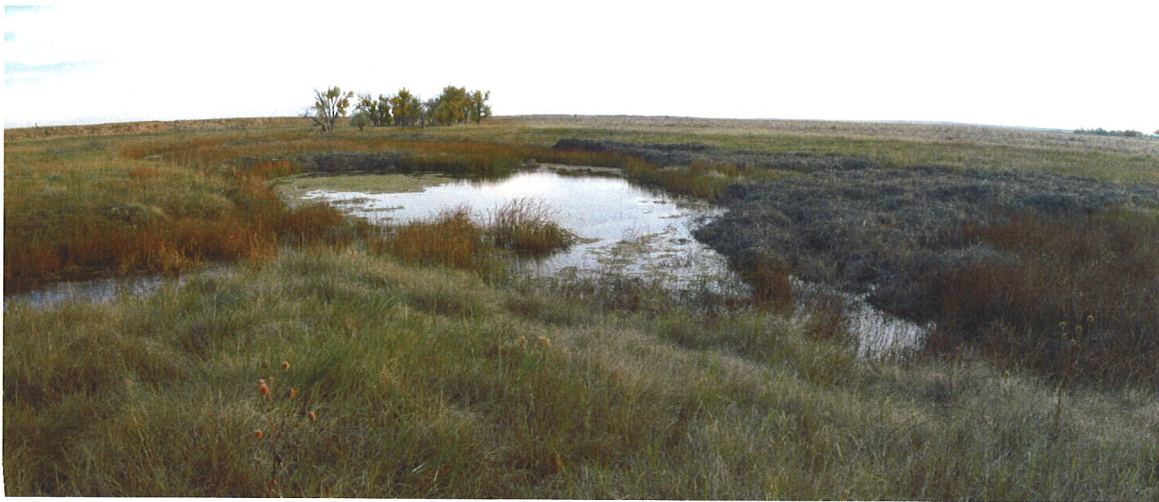
Figure 5: Confluence of Big Sandy Creek and Kern Spring Channels

The riverine and palustrine wetland areas increase in area along the Big Sandy Creek channel floodway for a distance of approximately 4,000 feet north from the county road W crossing, to where the Kern spring channel intersects with the Big Sandy Creek channel (please see Figures 5 and 6). The Kern spring is a perennial flow that supplies surface water to the creek floodplain. As a result, the wetlands are larger and more frequent along the 4,000-foot strip than in the channel floodway above the confluence.

The cottonwood groves, stream morphology, and wetland areas in the immediate floodplain and channel seem to be stable and properly functioning.

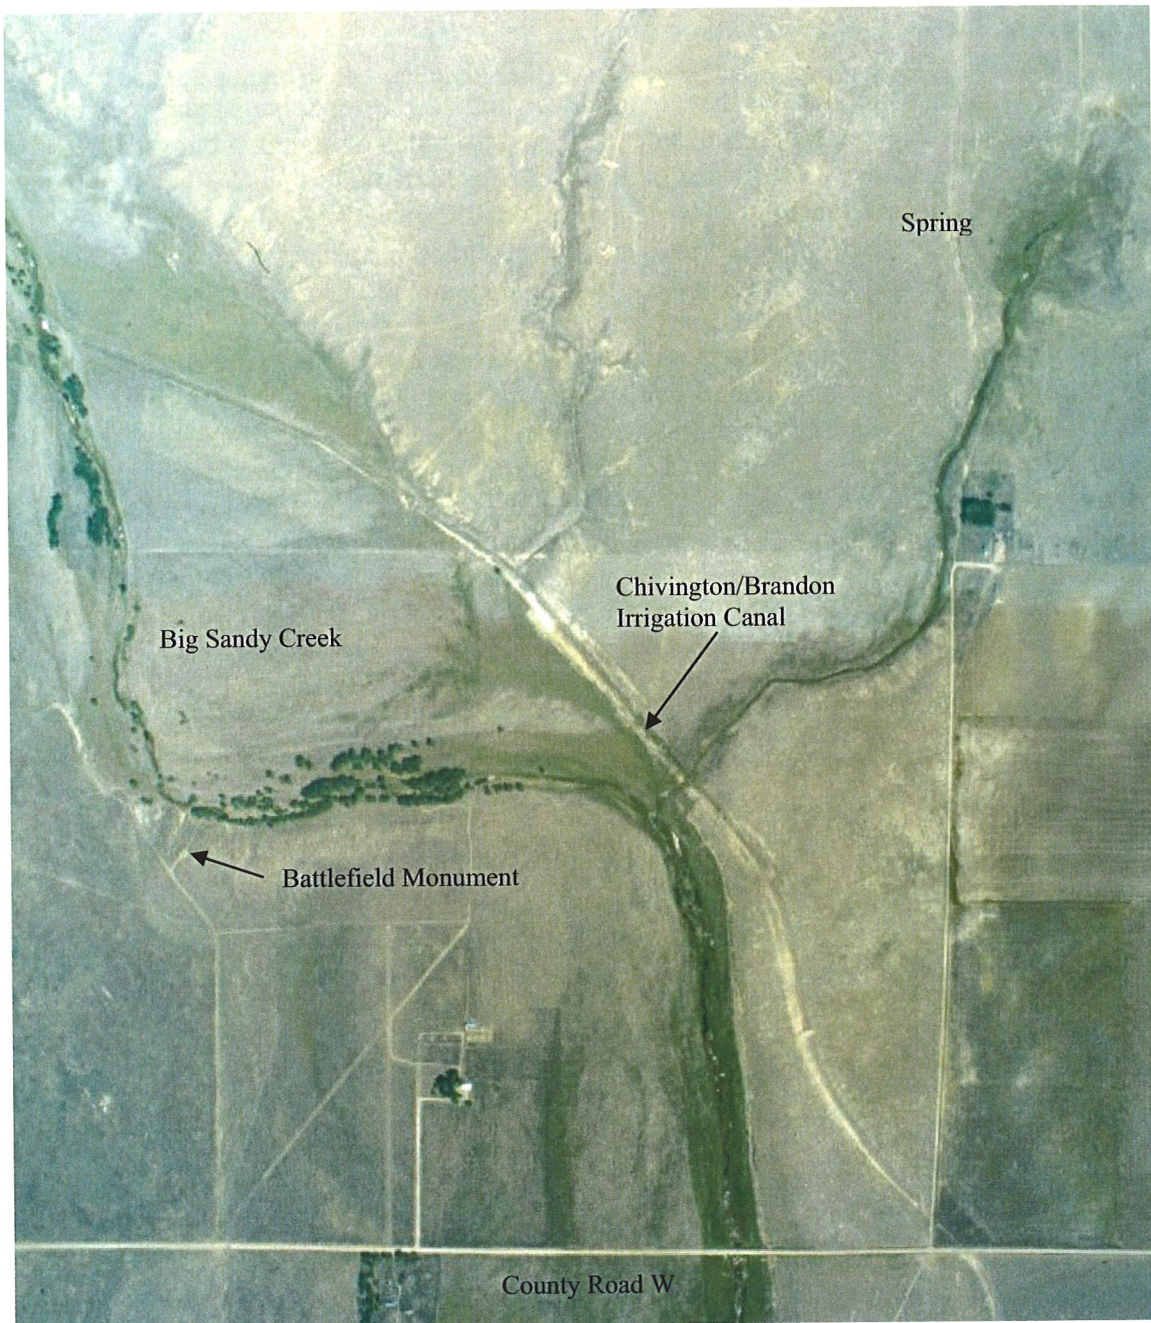
Figure 6: Southern Portion of the Current Park Area

We observed some individual, heavily browsed, willow saplings within the fluvaquent soils. Knowing that herbivores prefer willow as forage, we believe that stands of willow (and cottonwood) were typical in the historic scene at the time of the massacre and that livestock grazing has reduced the plant density and vigor significantly. We also feel that willow communities are an important component of the wildlife habitat along these riparian areas. Therefore, we recommend a willow establishment program be initiated.

Any proposed alterations such as trails, boardwalks, roads, or structures to the wetlands (including the stream channel of the Kern spring flow) in the fluvaquent soils will require a wetland delineation, analysis of impacts to wetland functions, and may require a Wetland Statement of Findings prepared according to NPS Procedural Manual 77-1: Wetland Protection.

Specifically, willow cuttings should be taken from appropriate donor sites in the watershed in early spring (prior to leaf out) and planted at suitable locations (with appropriate hydrologic conditions) along the Sandy Creek and Kern spring channels. These plantings would need to be protected from livestock grazing so that they can develop into mature thickets consistent with the historic landscape.
