John Neilson House(Saratoga National Historic Park)  
Bemis Heights  
Stillwater  
Saratoga County  
New York

HABS No. NY-3317

JOHN NEILSON HOUSE HABS No. NY-3317  
(SARATOGA NATIONAL HISTORIC PARK)

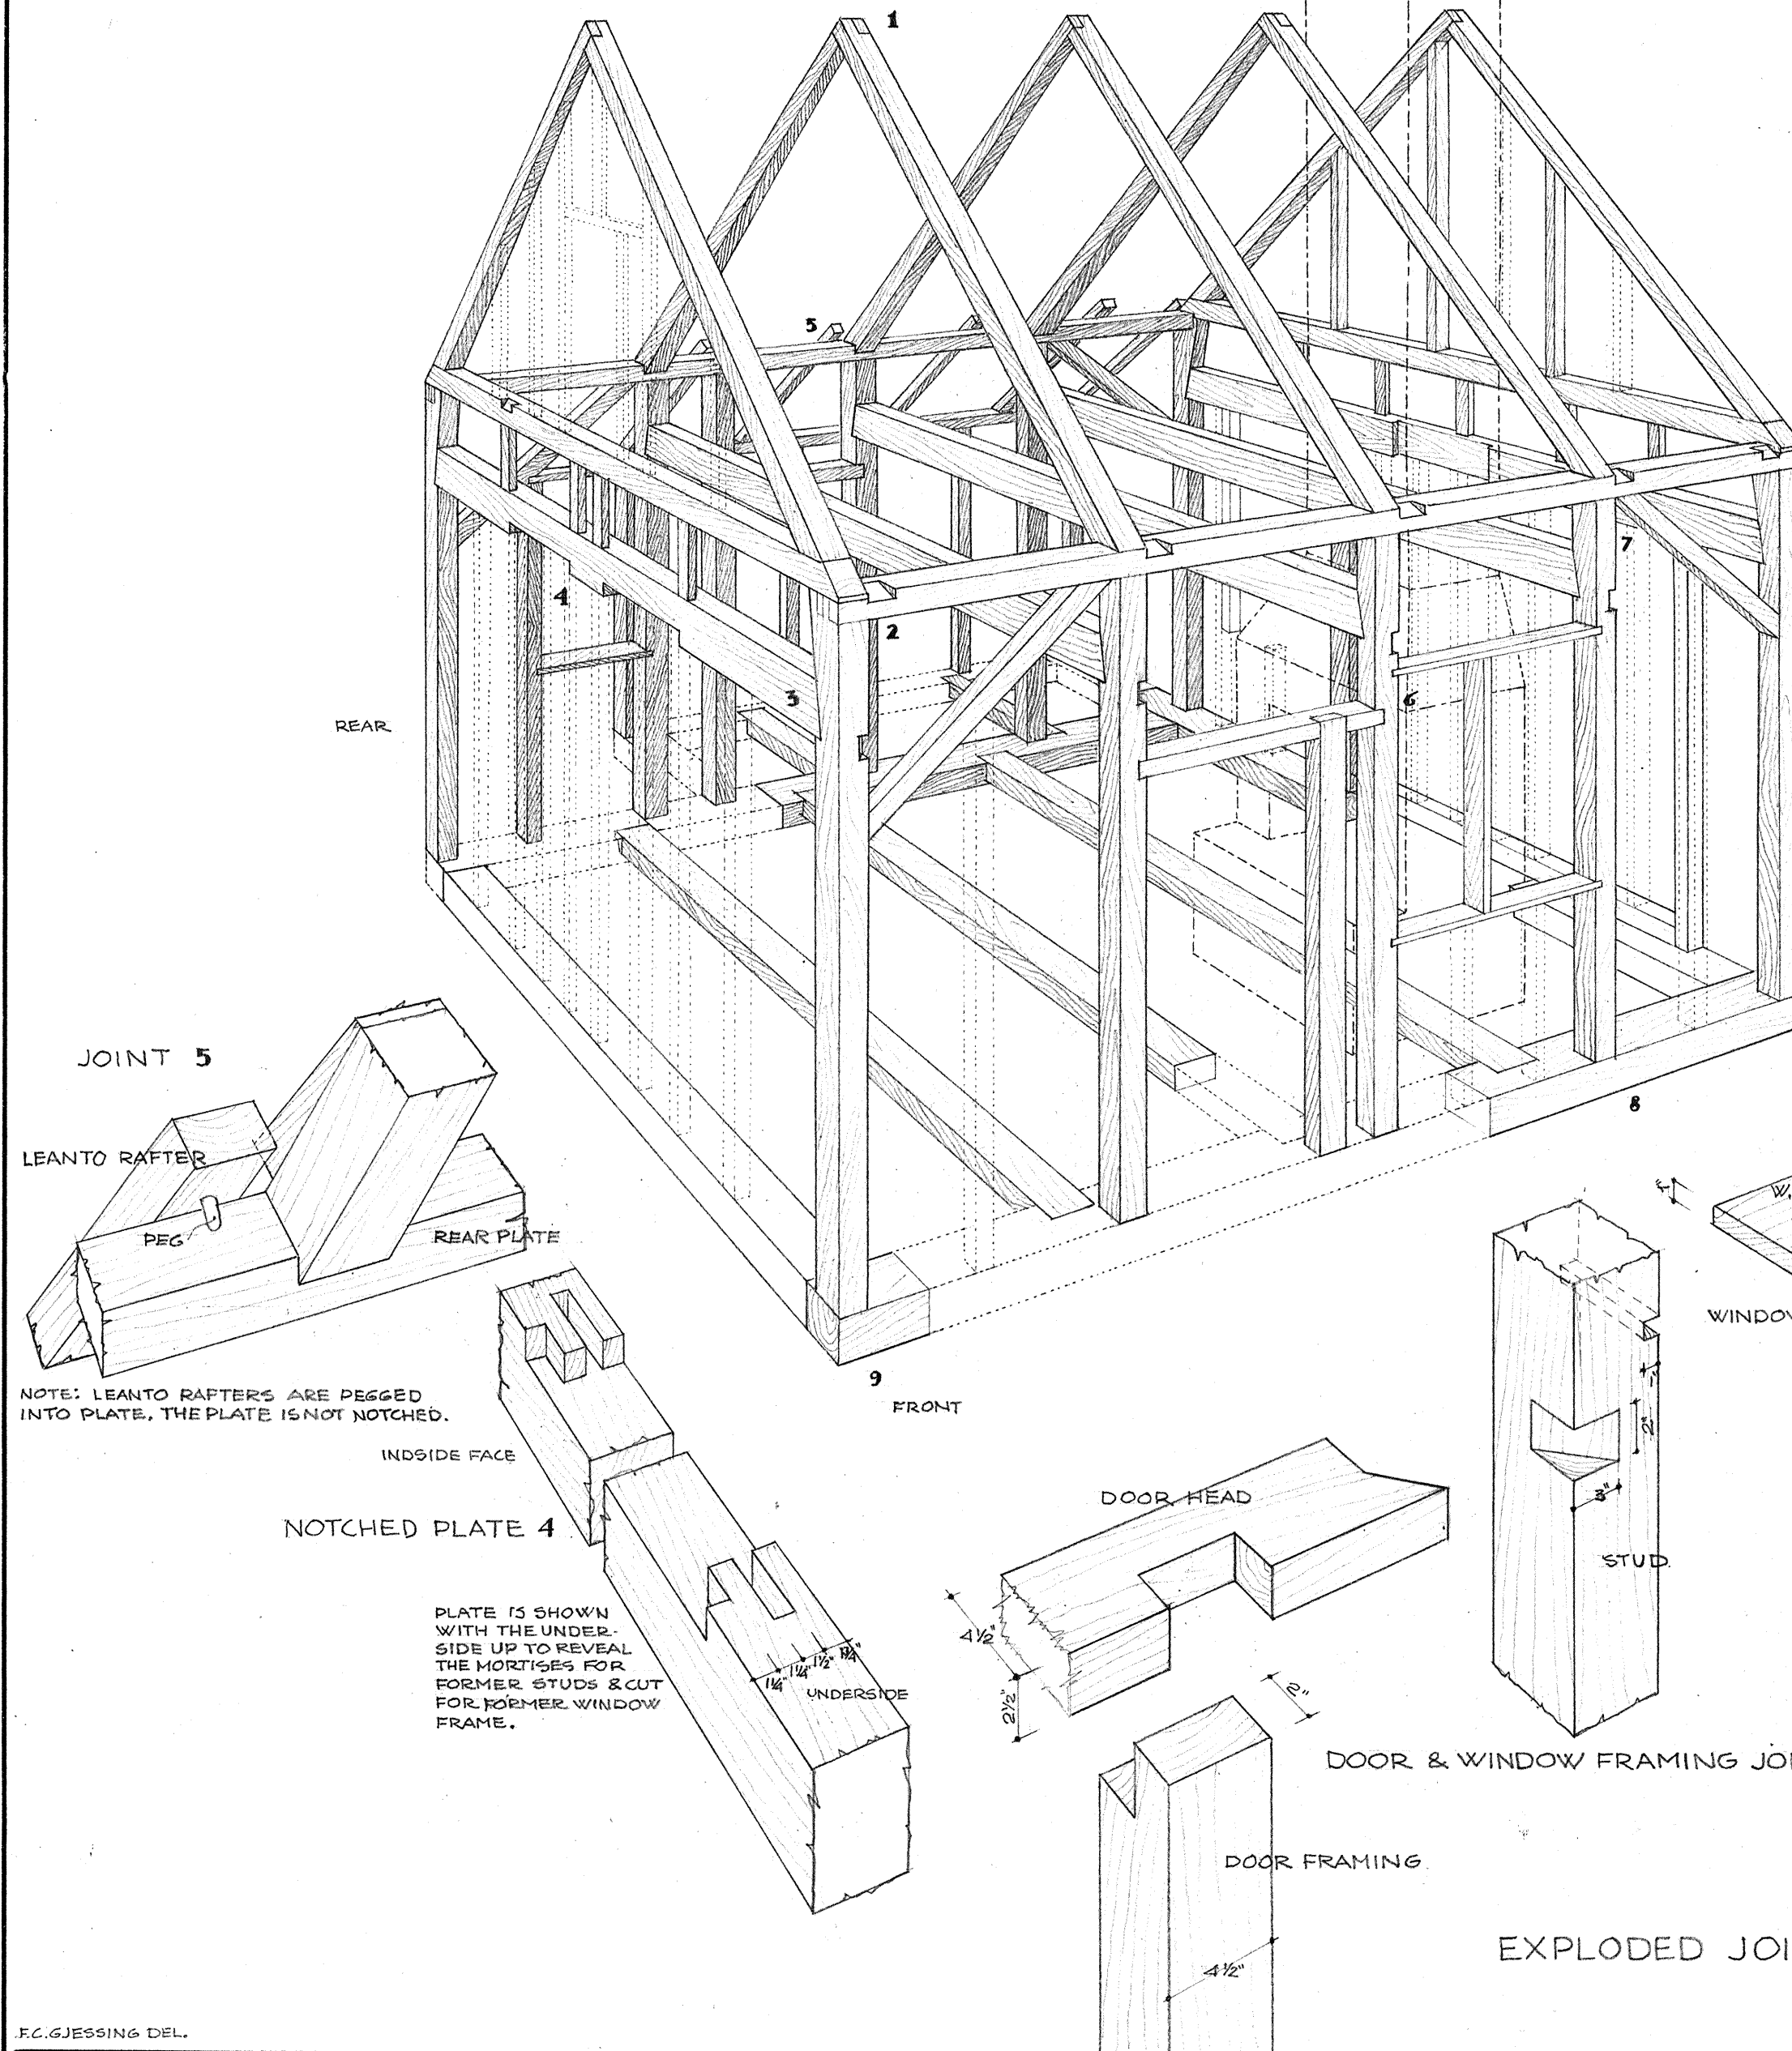
## PERSPECTIVE FRAMING DIAGRAM

ORIGINAL FRAMING SHOWN IN FULL LINE AND WITH WOOD INDICATION. FRAME PIECES OF OLD WOOD NOT PART OF THE ORIGINAL FRAME OR IN THEIR ORIGINAL POSITION ARE SHOWN IN FULL LINE ONLY. NEWER FRAMING IS INDICATED WITH A DOT LINE. CHIMNEY & FIREPLACE IN A DOT-DASH LINE.

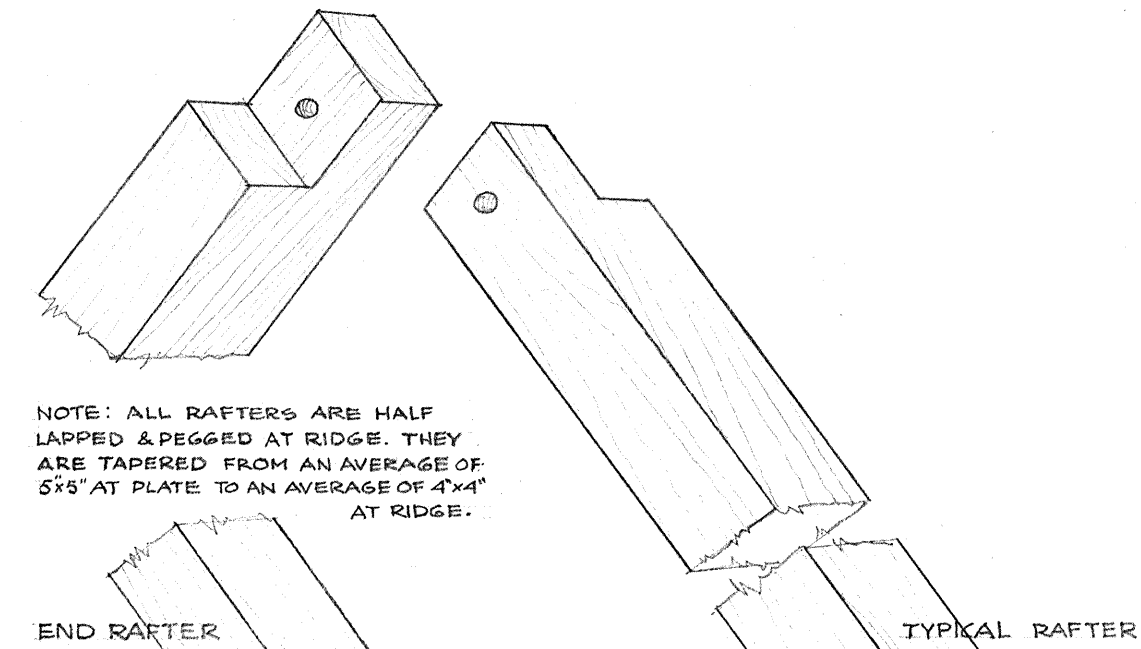
## RIDGE JOINT 1

NOTE: ALL RAFTERS ARE HALF LAPPED & PEGGED AT RIDGE. THEY ARE TAPERED FROM AN AVERAGE OF 5"x5" AT PLATE TO AN AVERAGE OF 4"x4" AT RIDGE.

- a. Shape, covering: Gable roof framed without ridgepole or ties. Sheathed with horizontal boards and shingled.
- b. Cornice, eaves: Box cornice across front and rear, added in 1927.
- c. Dormers, cupolas: None

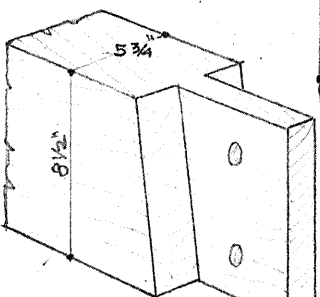
EXPLODED JOINTS

## CORNER JOINT 2

PLATE JOINT 3

DOOR &amp; WINDOW FRAMING JOINT 6

NOTCHED PLATE 4

JOINT 5

NOTE: JOINTS ARE DIAGRAMMATIC AND ARE NOT TO SCALE. ALL DIMENSIONS INDICATED ARE AVERAGE SIZES. ORIGINAL FRAME PIECES ARE OF CHESTNUT. OLD FRAMING NOT PART OF THE ORIGINAL FRAME ARE ALSO CHESTNUT. NEW FRAMING PIECES ARE GENERALLY PINE.

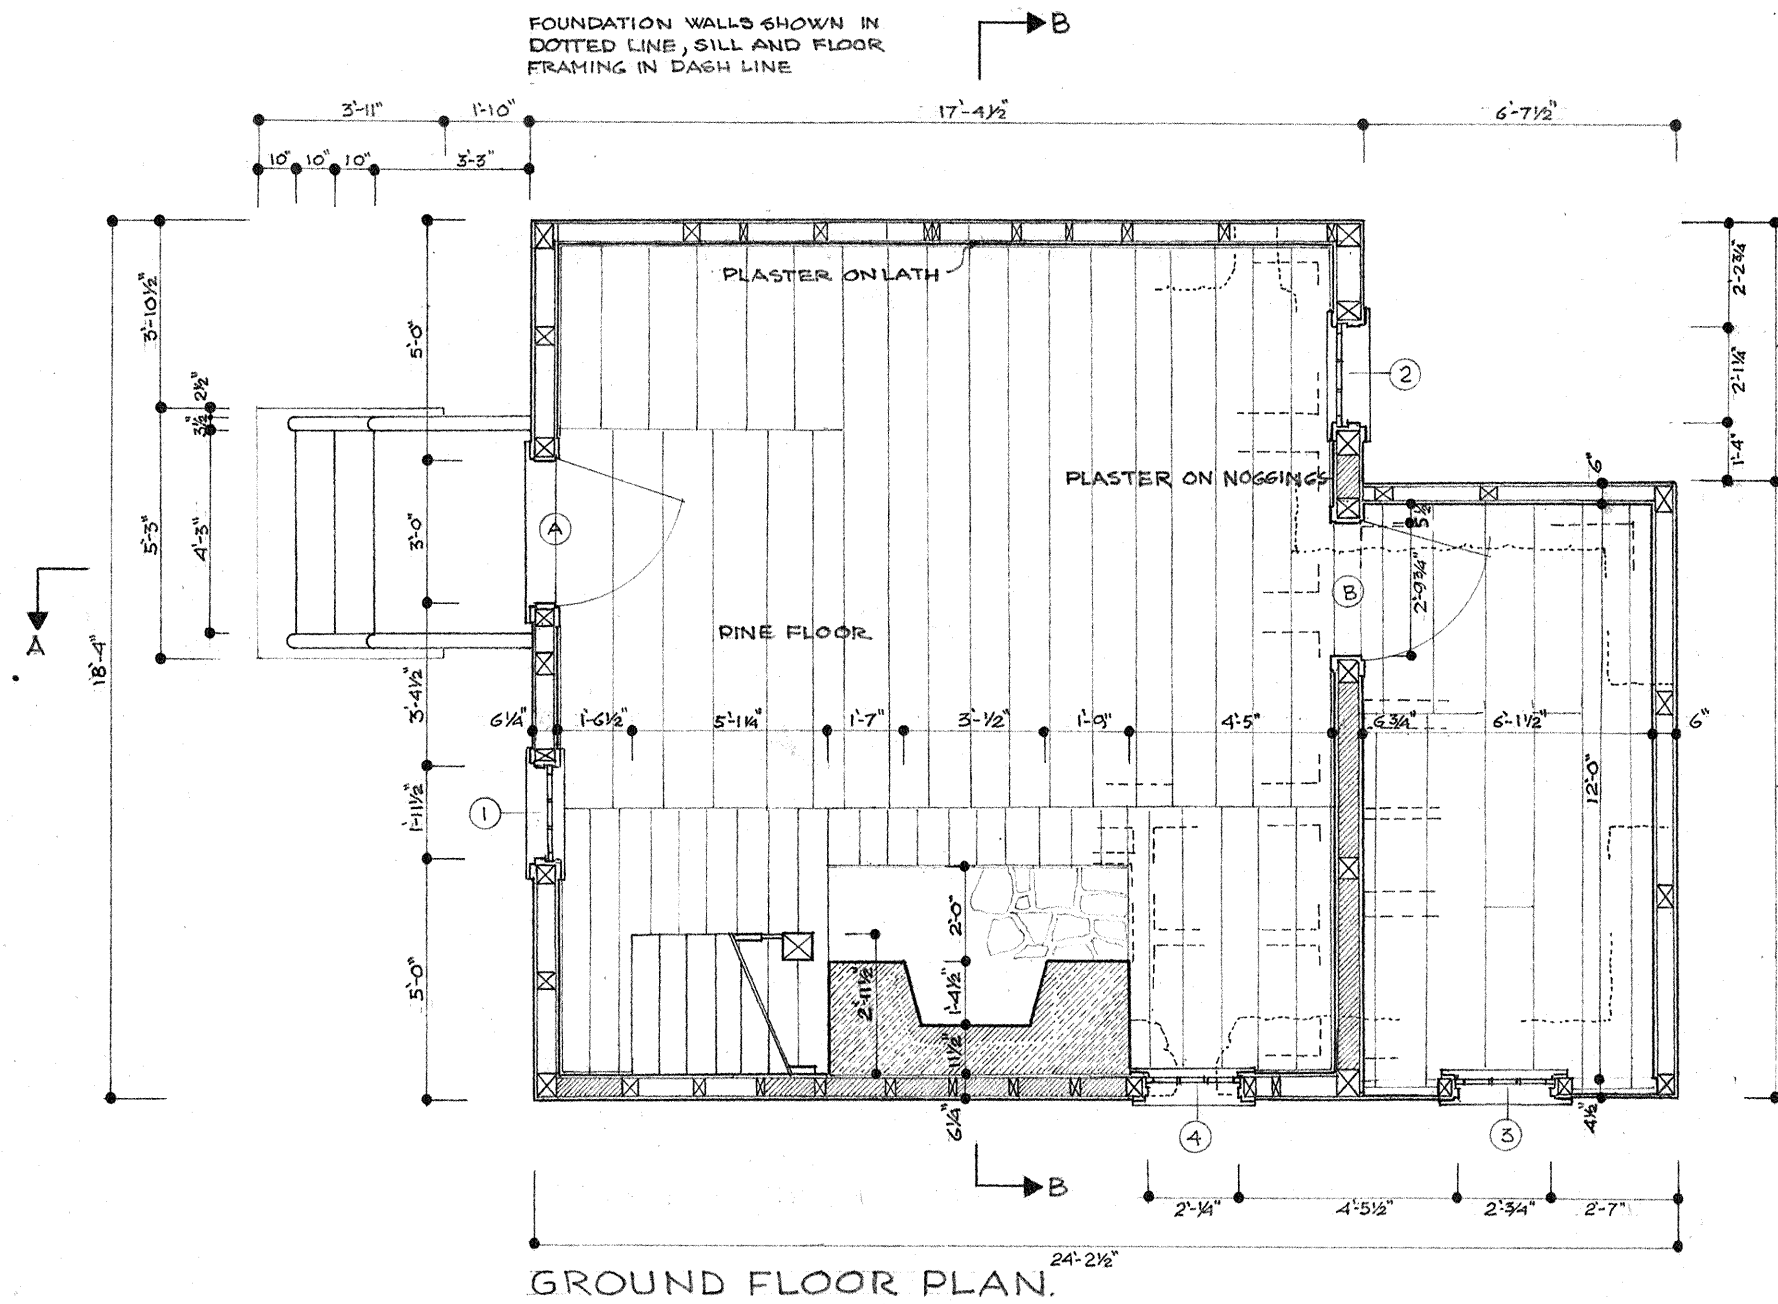
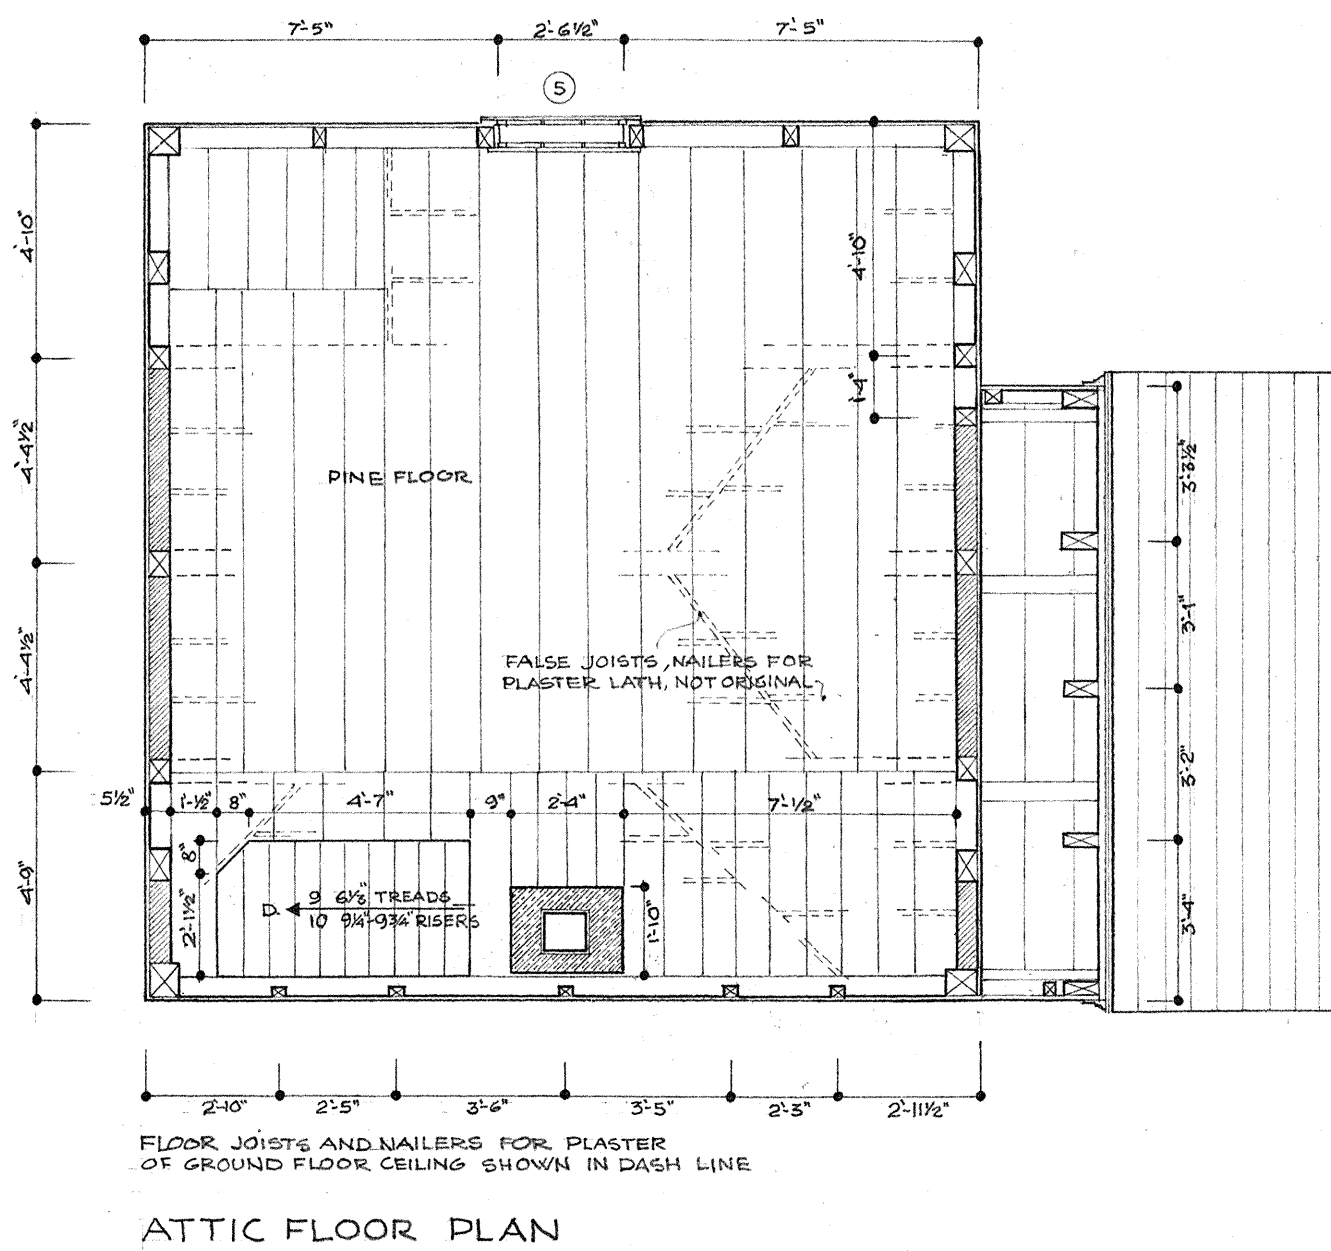
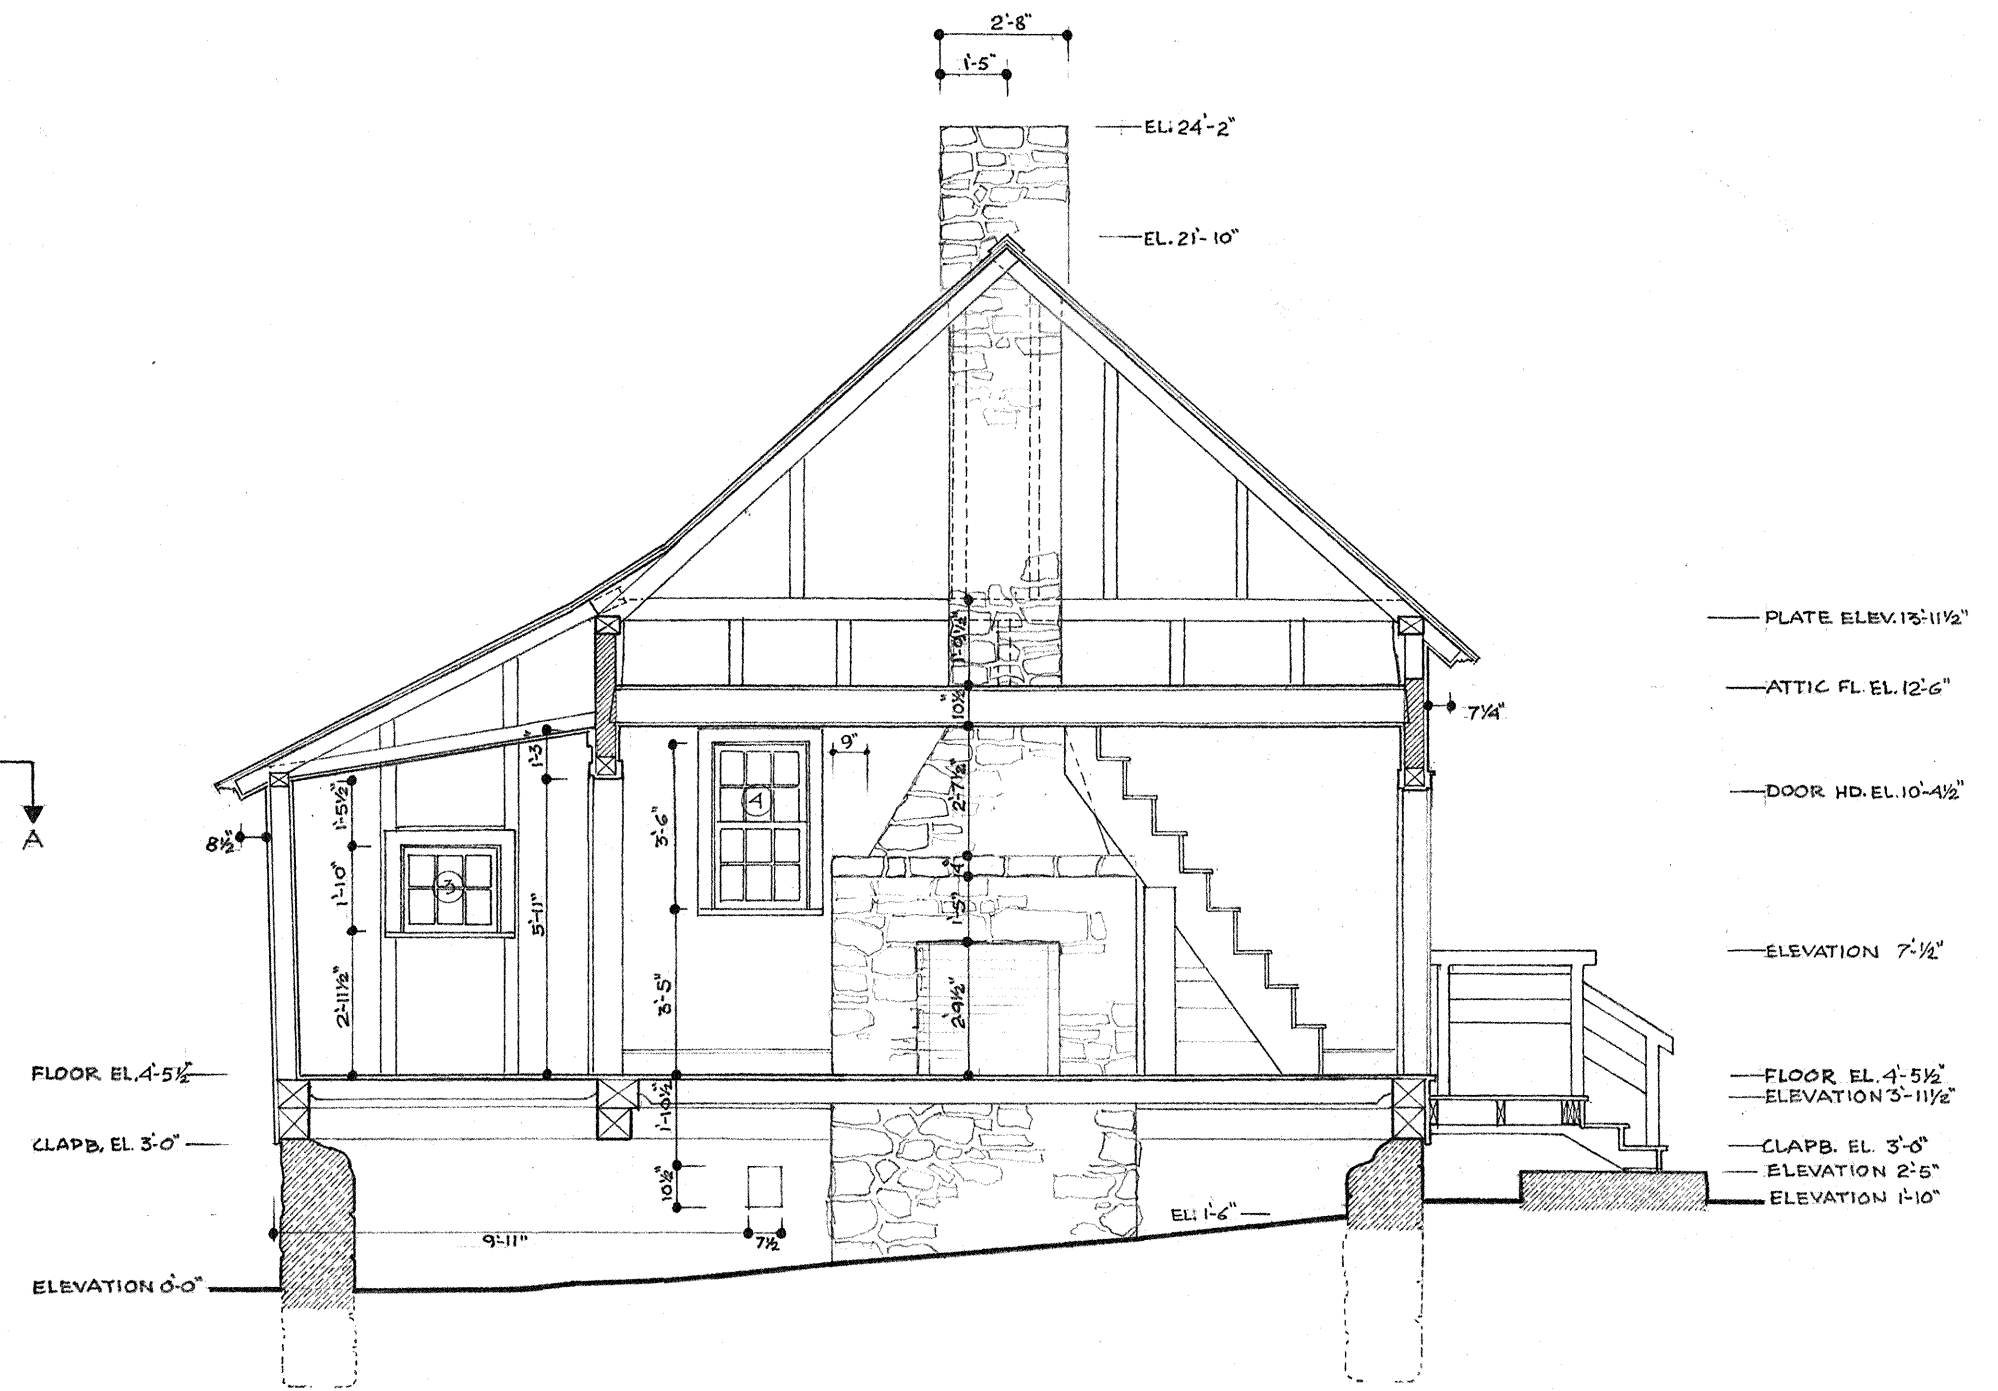
SECTIONAL ELEVATION A-A

NOTE: DATUM LINE SELECTED AS GROUND LEVEL OF SOUTHEAST CORNER

NOTE: EAST & WEST WALLS HAVE REMAINS OF ORIGINAL NOGGINGS SET IN CLAY MORTAR, NOGGINGS IN SOUTH WALL OF A LATER DATE. FIELD STONE CHIMNEY, HEARTH AND FIRE PLACE CONSTRUCTED 1927, BRICK LINING ADDED 1951

ROOF SHEATHING IN RANDOM WIDTHS SPACED FROM 0" TO 5" APART

3. Wall construction: Frame nogged with baked and sundried brick in a clay mortar.

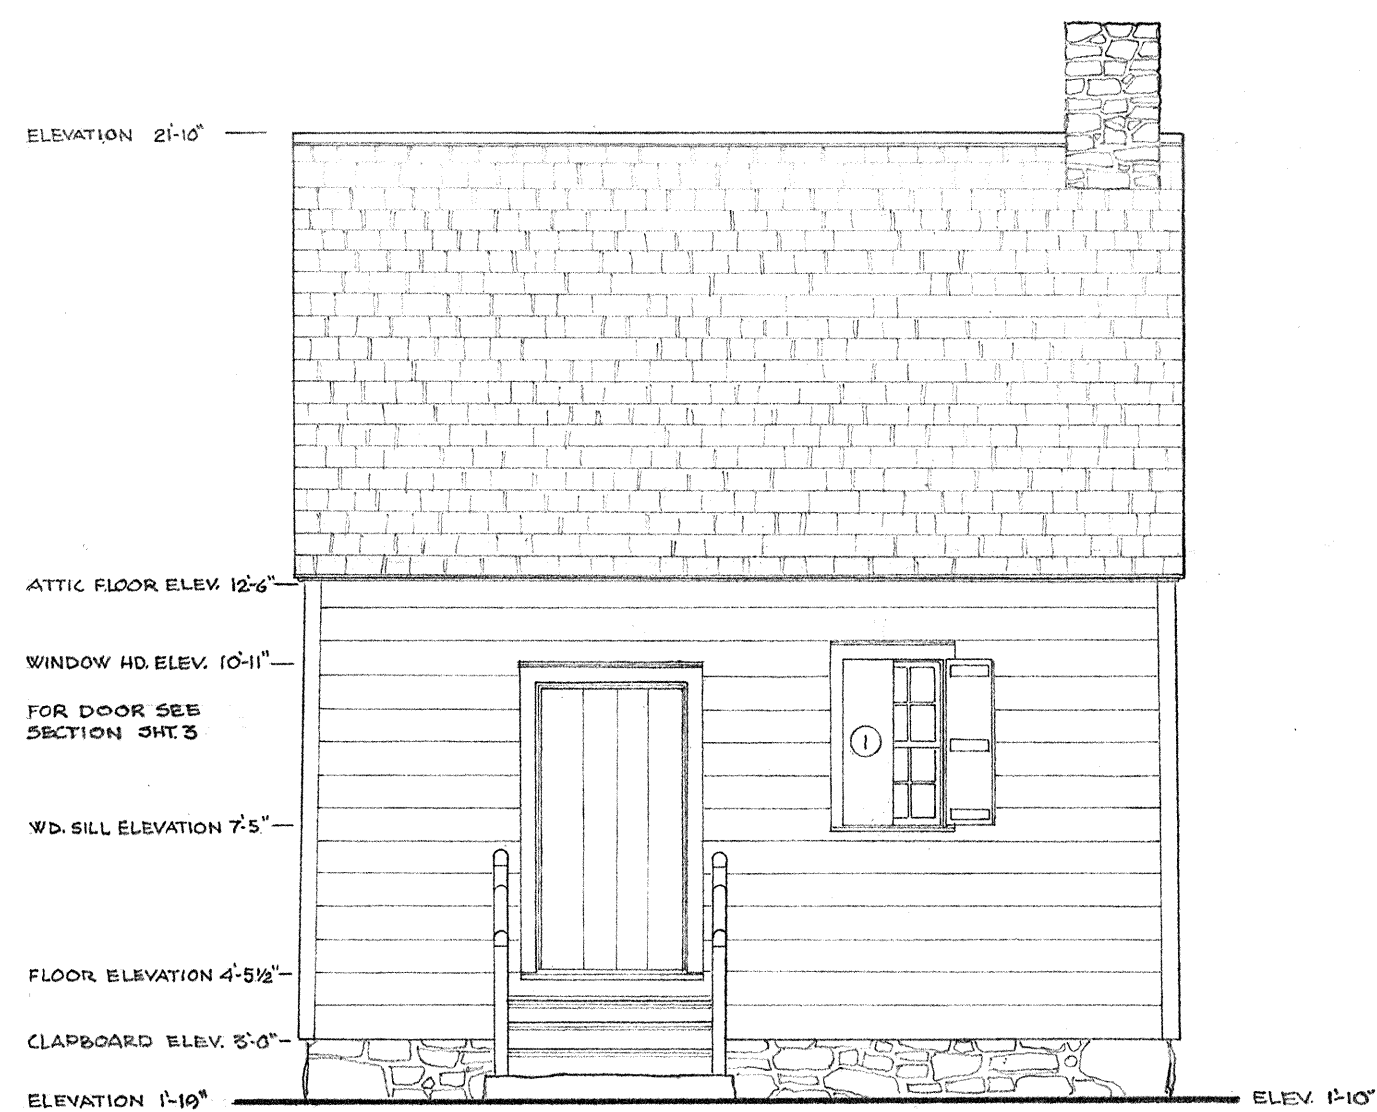
WEST ELEVATION

NOTE: DATUM LINE SELECTED AT GROUND LEVEL OF SOUTHEAST CORNER.

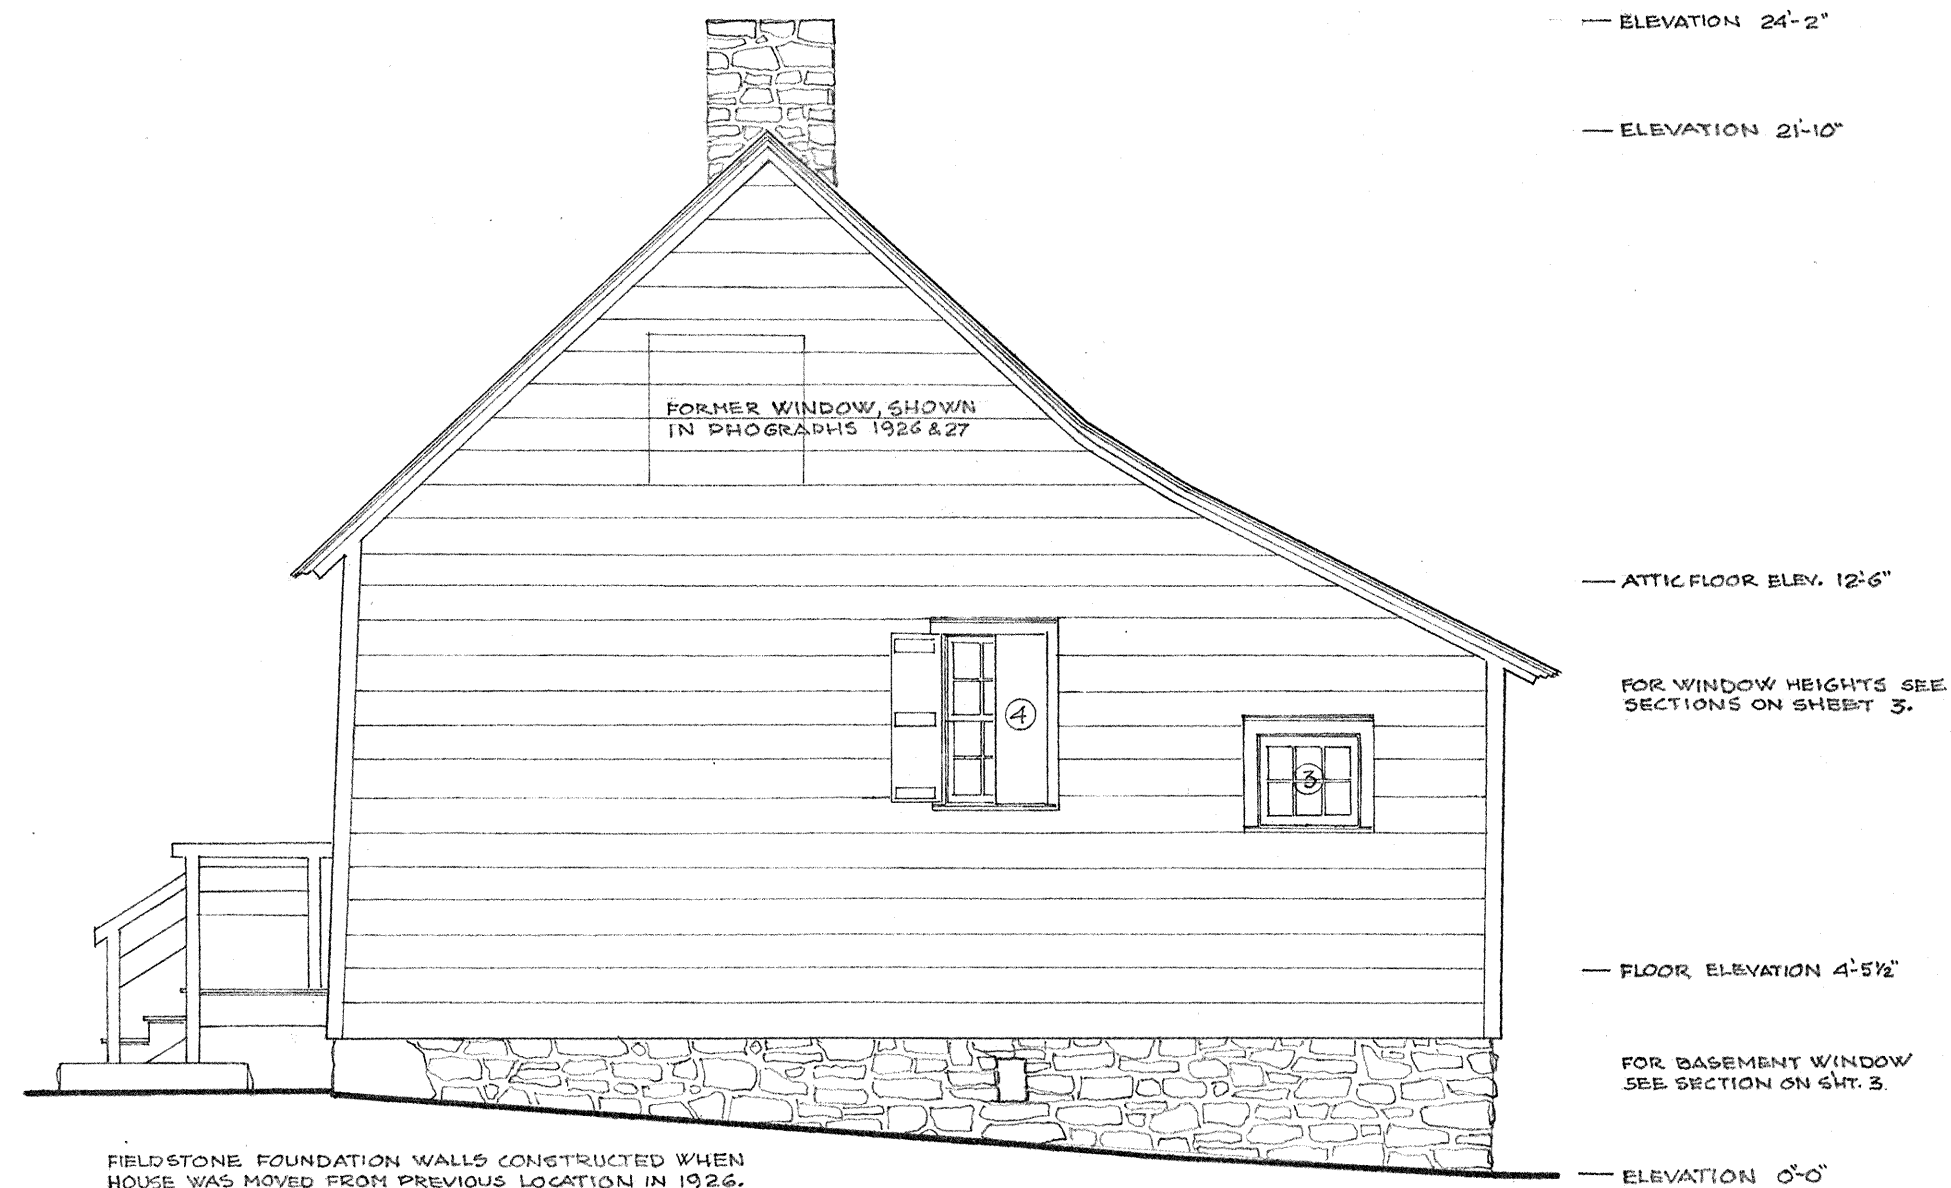
SOUTH ELEVATION

FIELDSTONE FOUNDATION WALLS CONSTRUCTED WHEN HOUSE WAS MOVED FROM PREVIOUS LOCATION IN 1926.

2. Foundations: Fieldstone, dating from 1926 and higher than original foundation.

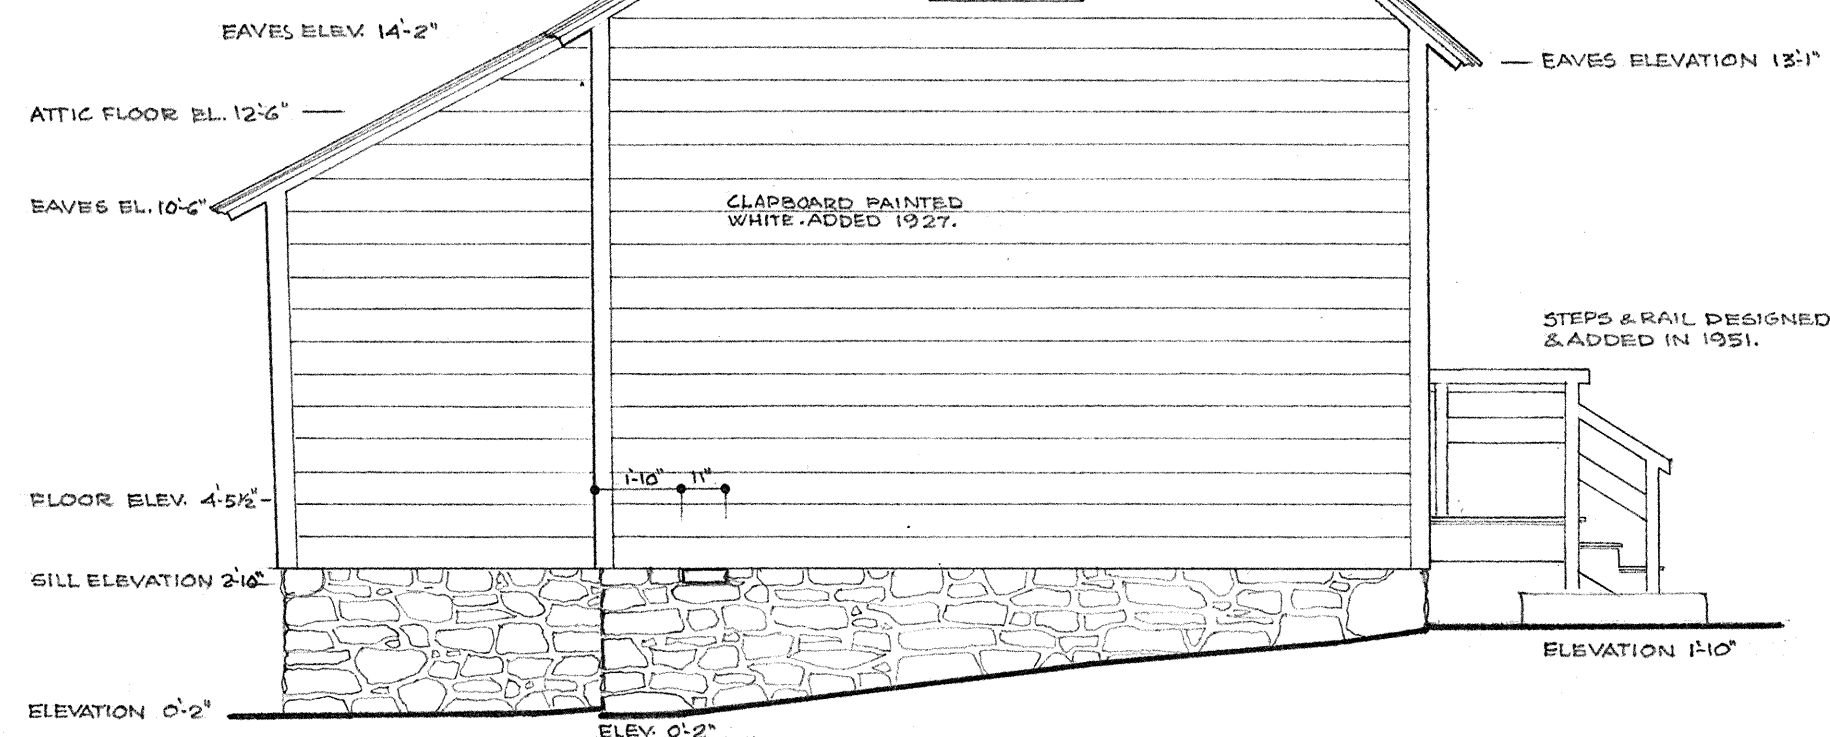
NORTH ELEVATION

NOTE: CORNICE MOULDING & TRIM AND 4" CORNER BOARDS ADDED IN 1927 IN RESTORATION BY NEW YORK STATE. ALL EXTERIOR WOODWORK, EXCEPT FOR SHINGLES & STEPS, IS PAINTED WHITE. ALL EXISTING WINDOW SASH ARE REPLACEMENT. WINDOWS 1 & 2 HAVE THEIR ORIGINAL FRAMING. WINDOW 3 IS PRESUMEDLY ORIG. WINDOW 4 ADDED BEFORE 1848. WINDOW 5 ADDED AFTER 1926. FOR WINDOW ELEV. SEE SECTION SH. 3

- a. Doorways and doors: Doors and door trim are original. They have no ornamentation.
- b. Windows and shutters: Small pane, double-hung, old style sash, probably replacements. Two windows out of five have original frame and trim. Simple board shutters with exposed cleats.

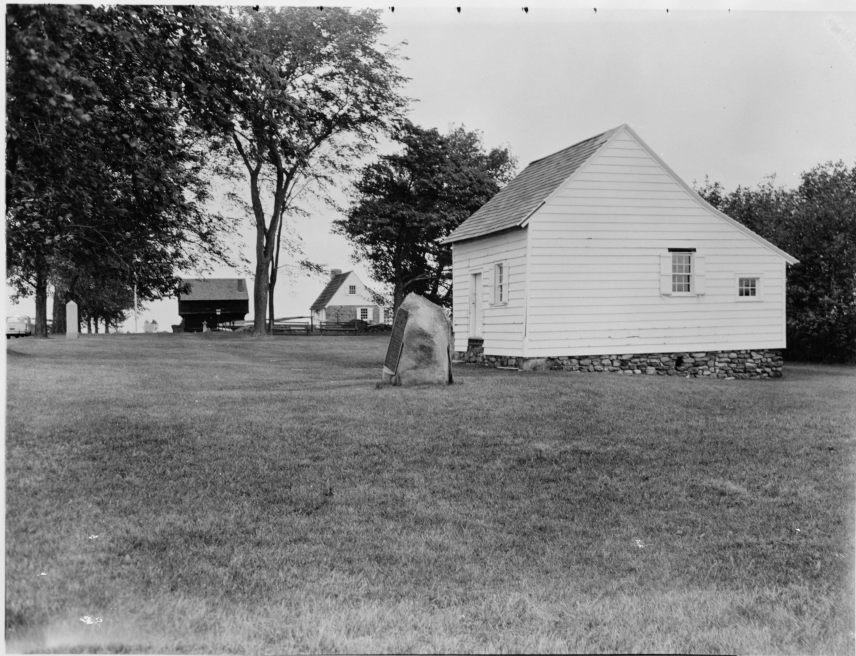
HAAS NO. 10 19-337-1

NY-3317-1 GENERAL VIEW FROM SOUTHWEST

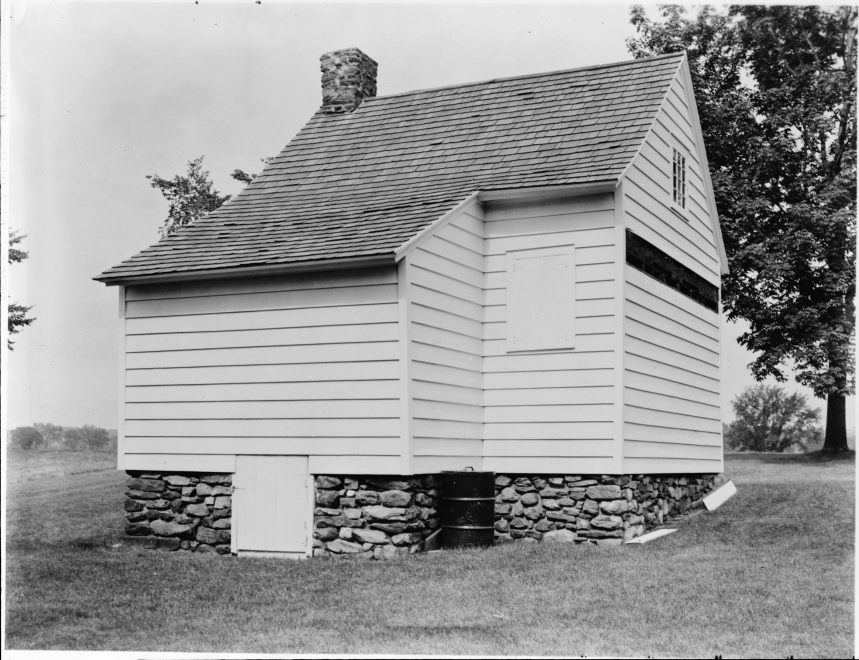
14985 No. 19-33/7-2

NY-3317-2 VIEW FROM NORTHEAST

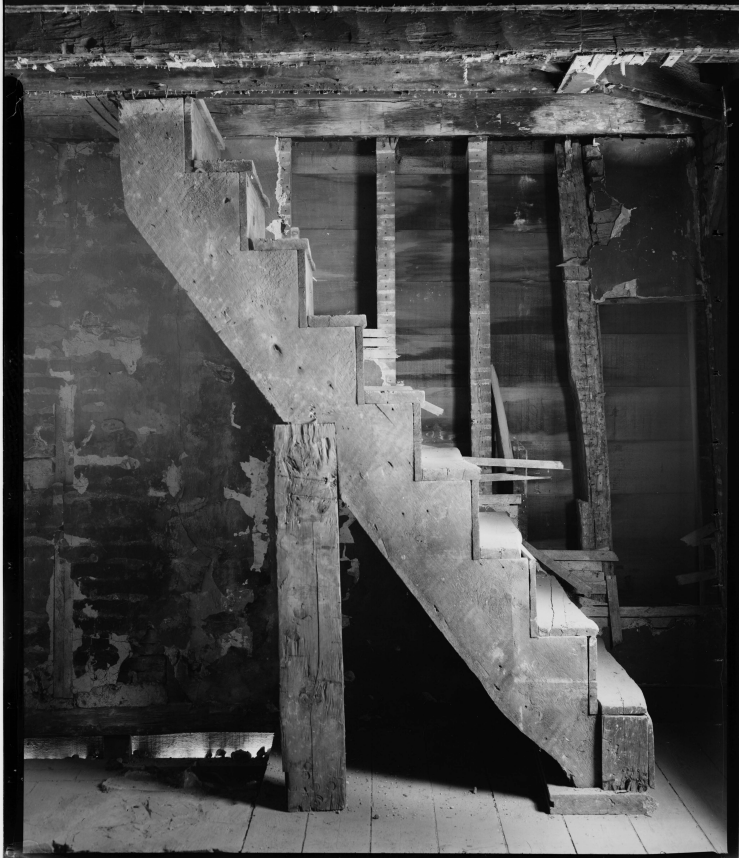
NY 100-111111 HABS NY-3317-10

NY-3317-10        STAIR ELEVATION ON SOUTH WALL WEST OF FIREPLACE

2. Stairways: Stair to attic in southwest corner, not original.
