National Park Service  
Cultural Landscapes Inventory

Revised: 1/2026

Appalachian Trail - North District  
Shenandoah National Park

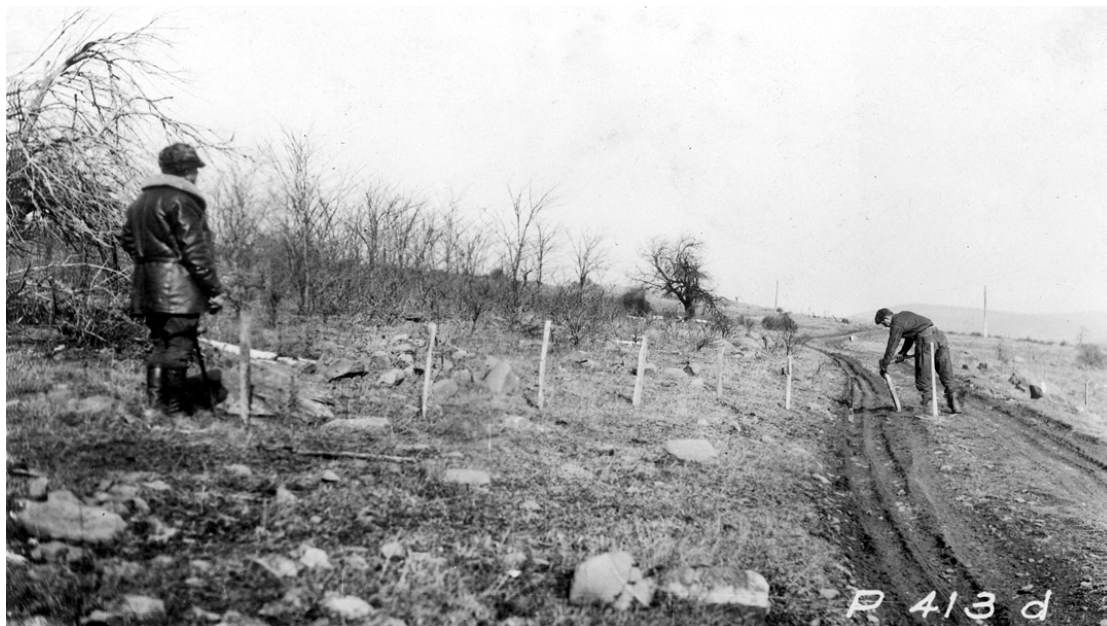
Figure 4: Civilian Conservation Corps (CCC) photo showing two men staking the alignment of the AT near Range View Cabin, circa 1935. (Shenandoah NP Archives)

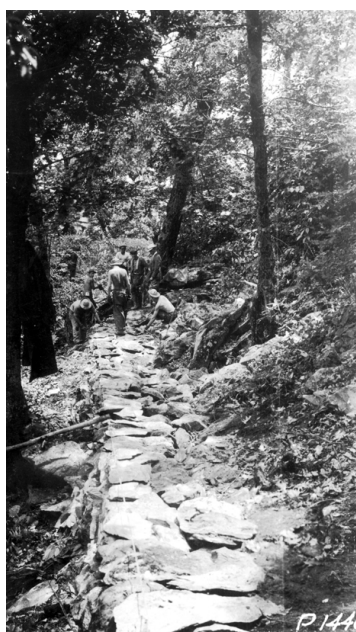
Figure 5: A CCC crew constructing a retaining wall for the AT, which will be surfaced with a gravel walking tread, circa 1935. A string line is used to guide stone placement (location of photo unknown). (Shenandoah NP Archives)

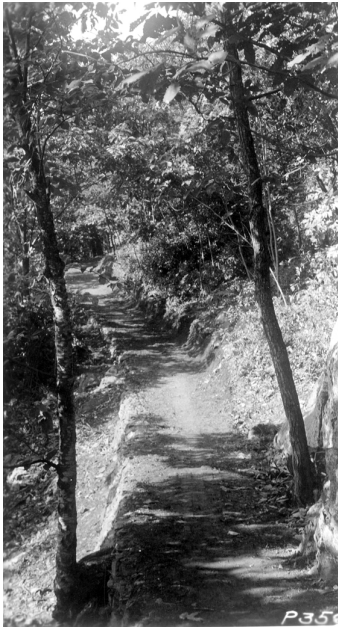
Figure 6: CCC photo showing a completed section of the AT with a bench cut into the natural slope, a lower retaining wall, and graded gravel tread at an even grade and width, circa 1935 (location unknown). (Shenandoah NP Archives)

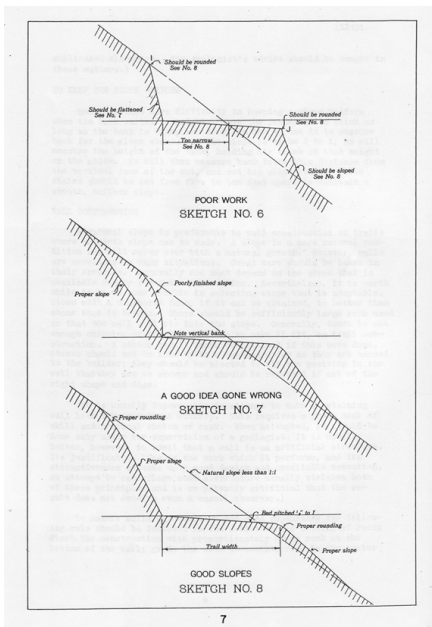
Figure 7: U.S. Department of the Interior 1937 manual, *Construction of Trails*, used by the CCC. Diagram illustrates proper construction of bench cuts for side-hill trails, such as the trail section in Figure 6. (Shenandoah NP Archives)

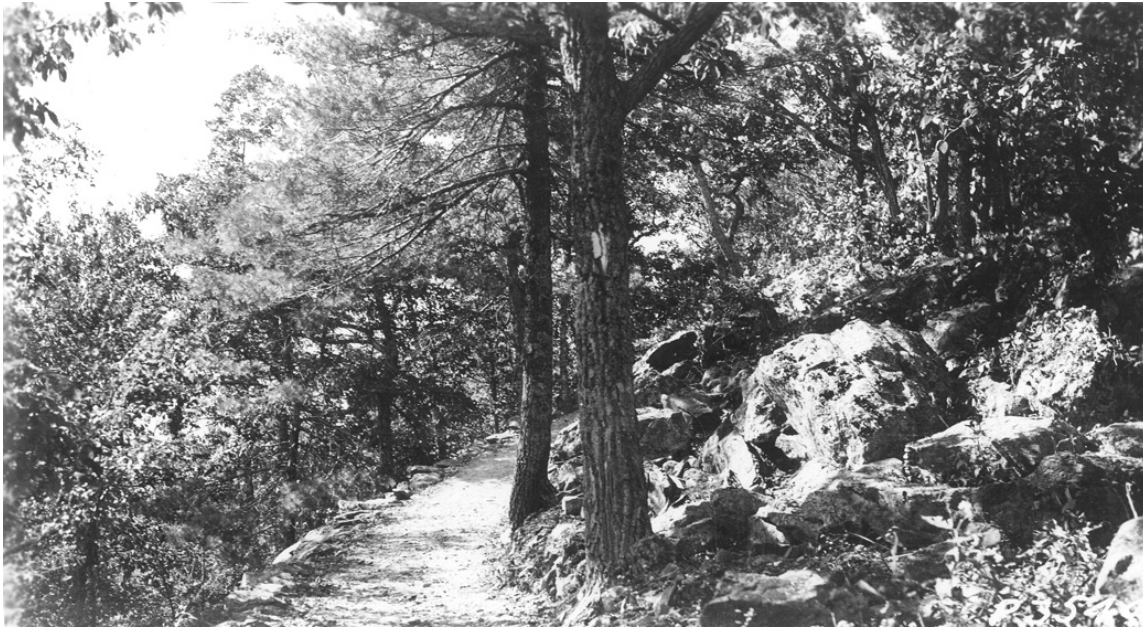
Figure 8: CCC photo showing completed Neighbor Mountain side trail, circa 1935. The trail has a width of 42-48 inches, is edged with stones, and is surfaced with gravel. (Shenandoah NP Archives)

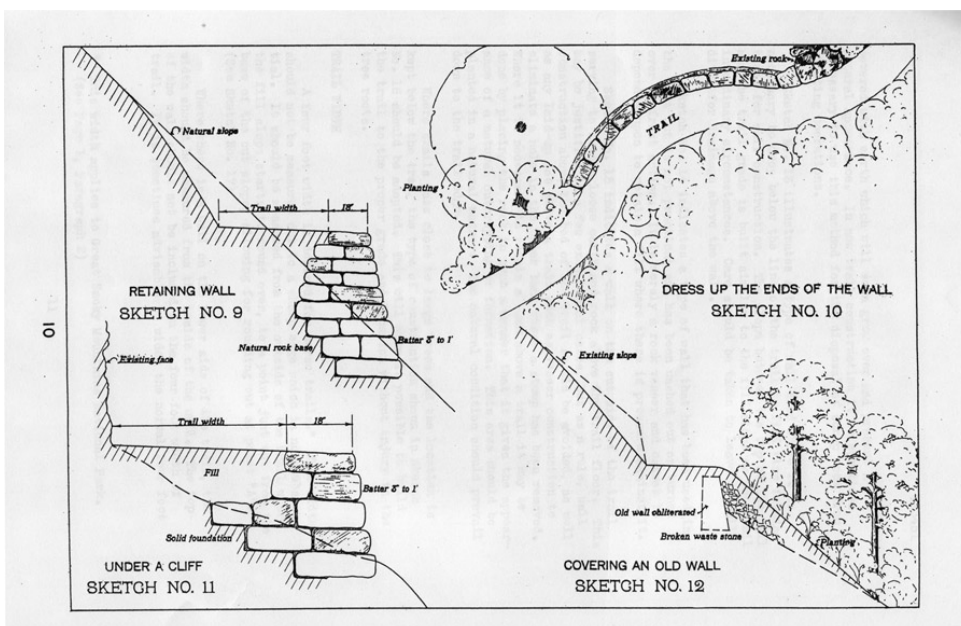
Figure 9: U.S. Department of the Interior 1937 manual, *Construction of Trails*, illustrates proper construction of retaining walls. The structure widens under the tread for durability and drainage. (Shenandoah NP Archives)

"Some planting may be done by the foreman (during his construction) with the material he takes out of the right-of-way when he is clearing. Good plants should be carefully taken up when clearing and planted naturally in places that are bare or they may be used to conceal construction. In all the planting policy should be to create a condition that is as natural as possible" (Fig. 9) (USDI, Construction of Trails, 1937:25).

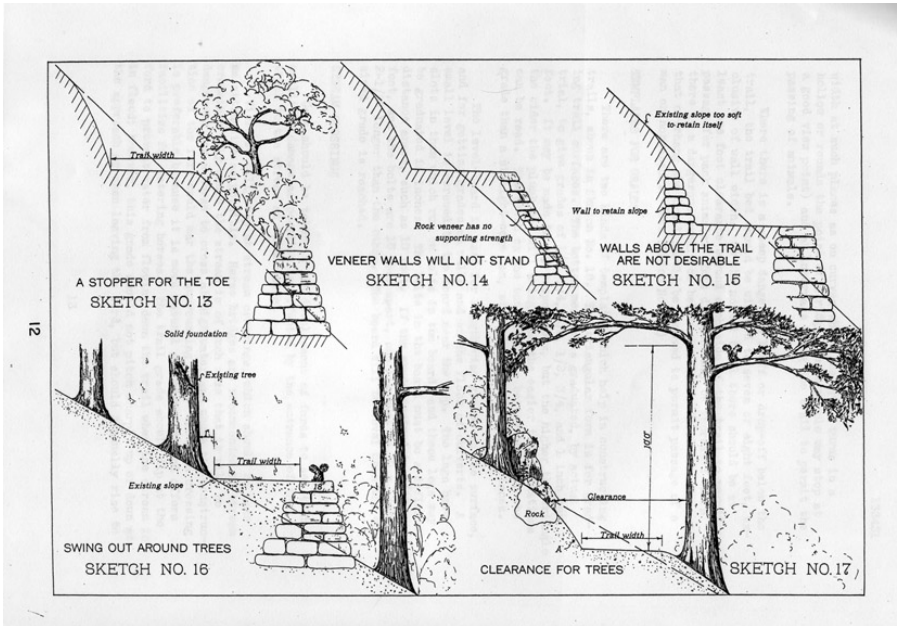
Figure 10: The 1937 manual, *Construction of Trails*, shows proper construction of retaining walls around trees, dissuades use of walls above the trail, and suggests a 10-foot clearance for horses. (Shenandoah NP Archives)

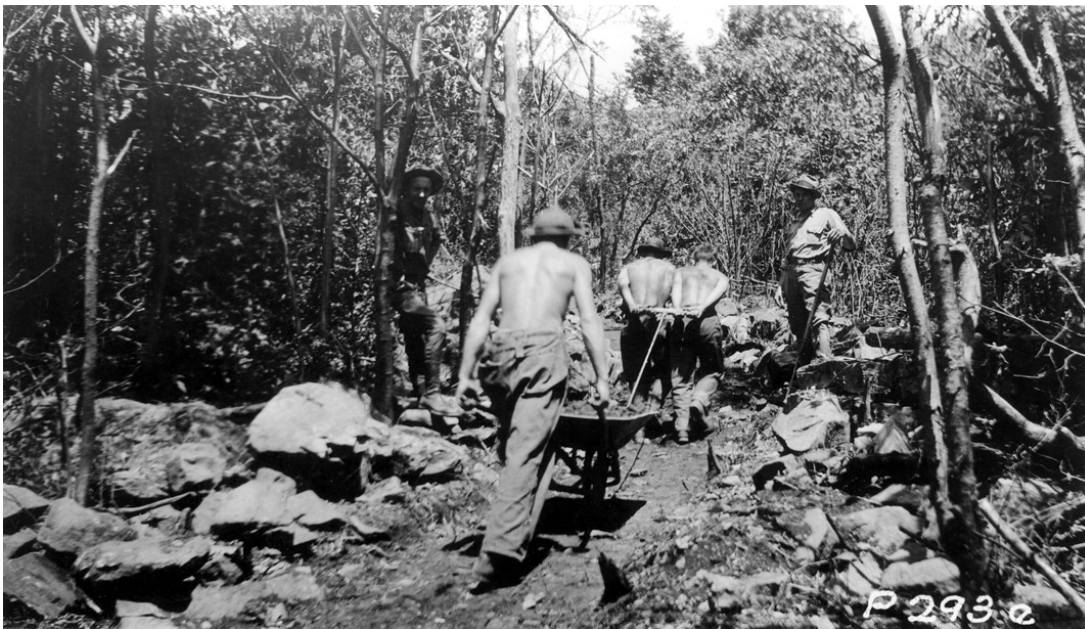
Figure 11: CCC photo showing heavy hauling during the construction of the AT south of Mt. Marshall Trail, circa 1935. The CCC used wheelbarrows to bring in material from borrow pits for surfacing the trail tread. (Shenandoah NP Archives)

"Rubble masonry may be laid coursed or uncoursed....Most of the low retaining walls, slope walls, and miscellaneous structures in park projects are laid up in rubble masonry. It fits into the surroundings better than more formal kinds of masonry, and is usually built of stones found nearby. For these projects, it is the most attractive masonry when well built, and satisfies all of the requirements of such field structures. More than that, rubble masonry is a thing of beauty when well done, and its composition and pattern call for good judgment and imagination...Rubble masonry is one of the best things that an enrollee (CCC) can learn to handle, for experts in this trade are in demand, and architects and landscape architects always have need of men who can lay up this type of masonry in an artistic manner. The thing we find most beautiful is that which satisfies our sense of proportion and of suitability of materials, and our feeling of good taste in design. It will be simple and appropriate, in a pattern pleasing in its variety and balance, and having unity with its surroundings" (USDI, Brick and Stone Work ,1937:9,11) (Figs. 11-12).

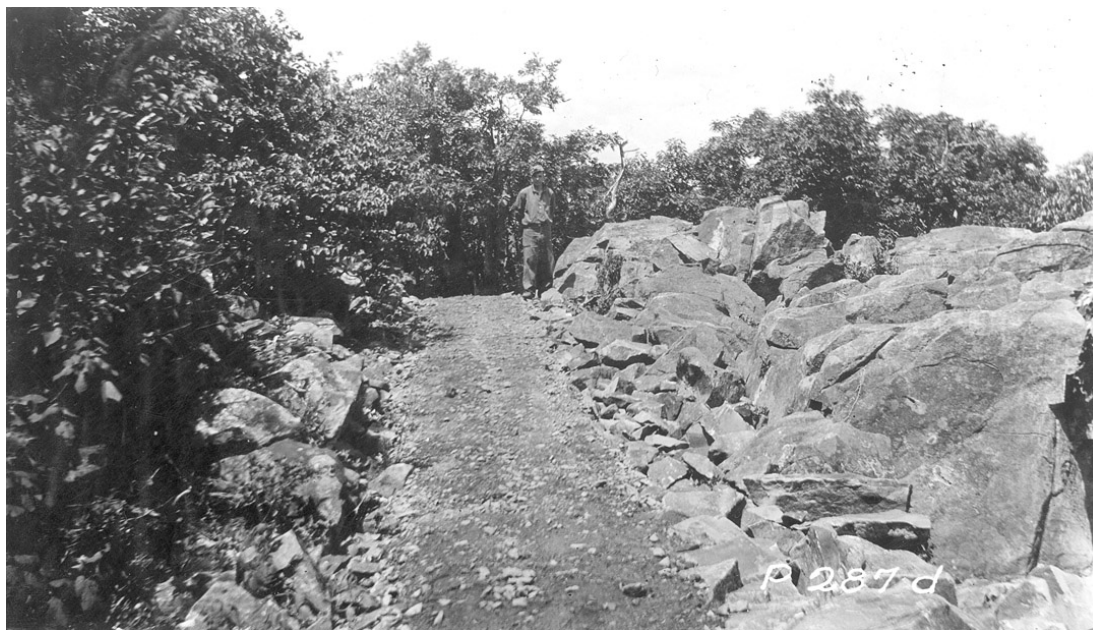
*Figure 12: CCC photo showing rubble walls along AT near Mt. Marshall, circa 1935. The trail ascends at an even grade and width, with a substantial amount of gravel added for a durable tread. (Shenandoah NP Archives)*

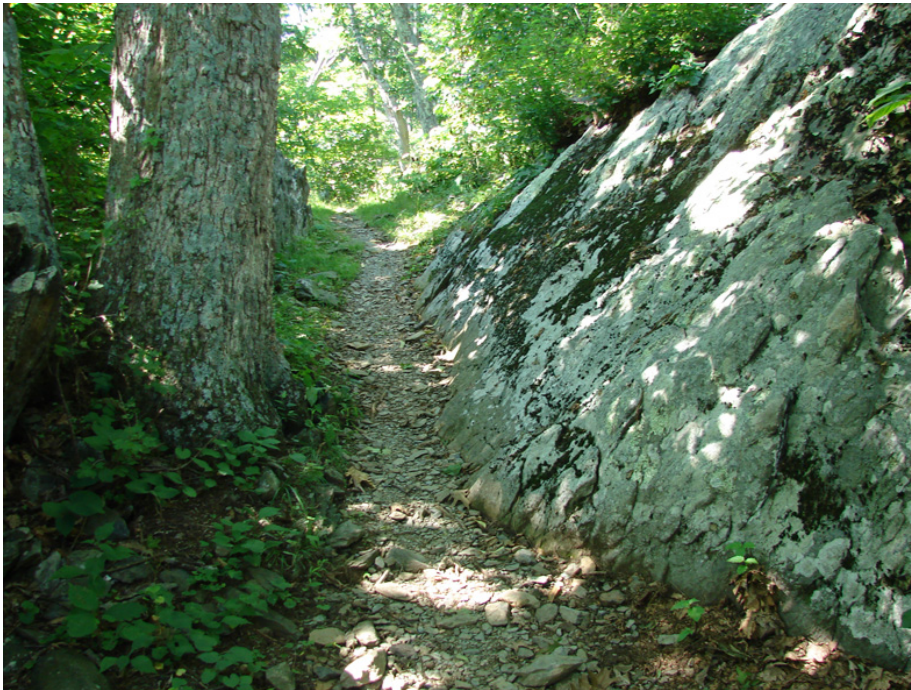
*Figure 14: The AT passes an old tree and rock outcrop near Neighbor Mountain Trail. The 1937 manual, Construction of Trails recommended that trails pass rock outcrops to display local geological history. (SUNY, 2006)*

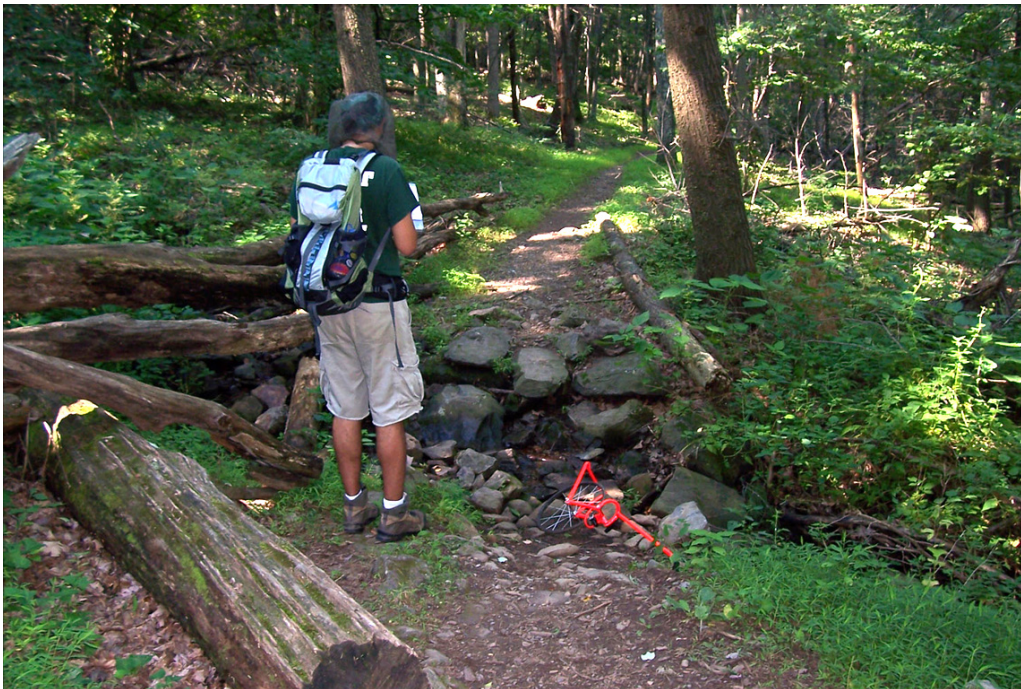
*Figure 15: The AT crosses a stream near Elkwallow Gap. A collapsed abutment suggests the CCC may have constructed a small bridge over the stream to provide an even walking tread.(SUNY, 2006)*

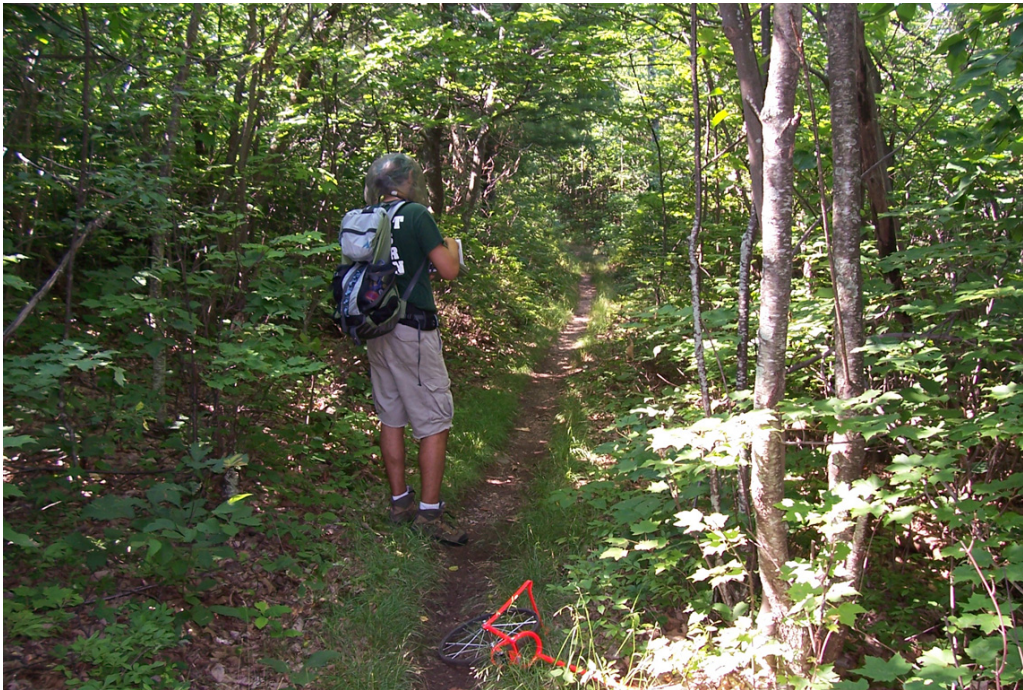
*Figure 16: The typical “green tunnel” enclosed character of the AT in the North District as seen in this photo near Jeremy’s Run Overlook. (SUNY, 2006)*

Since 1942, woods have enclosed the majority of the trail corridor. Many of the once open fields are now filled with successional growth. The variety and rhythm of the open and enclosed areas has diminished and the AT is now often described as a “green tunnel.” It appears, however, that this change in the spatial character was at least in part intentional, as many old fields were not maintained during the historic period, and so subsequently grew into woods. Secondary growth of trees and shrubs have obscured many broad and long views. In places, the “green tunnel” opens up where views remain because of rock outcrops or intentional clearing by park management. The AT still crosses Skyline Drive in eleven places, which act as open areas between the wooded parts of the trail. However, these crossings are inventoried as circulation features (Fig. 16).

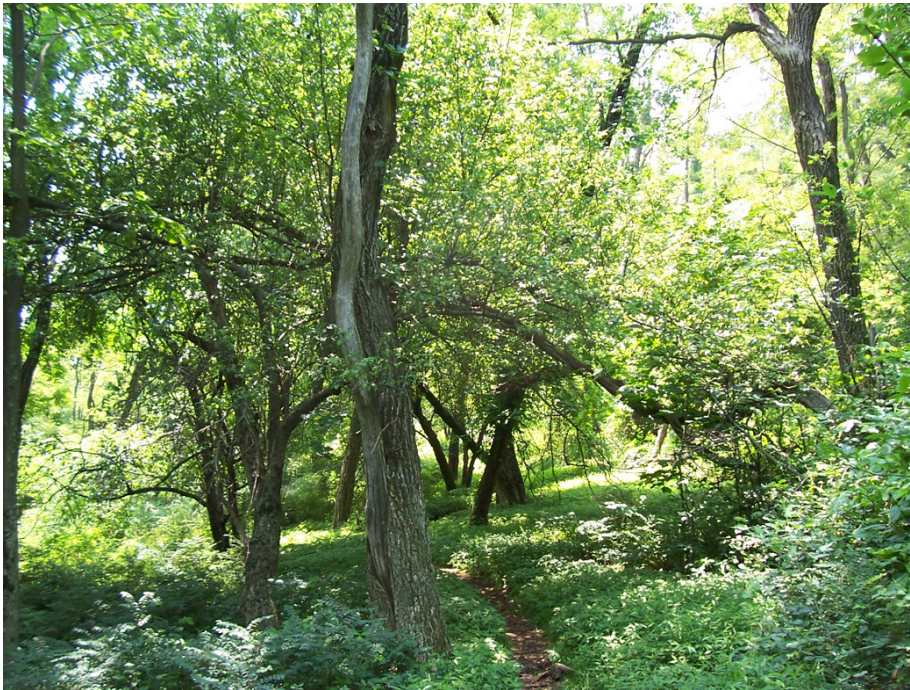
*Figure 17: The AT travels through a remnant orchard near Hogwallow Gap. (SUNY, 2006)*

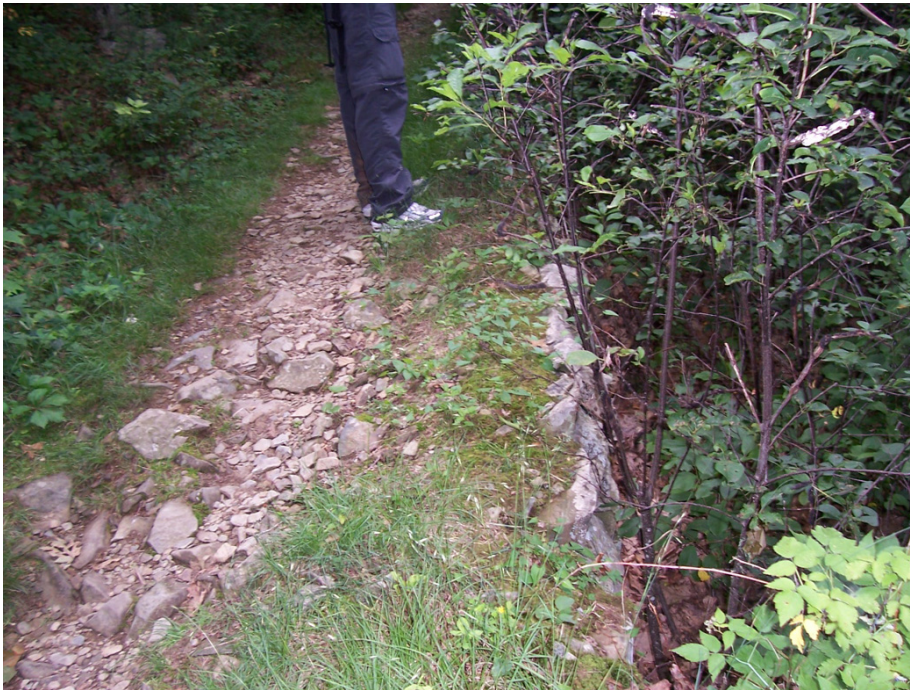
*Figure 18: A CCC-built stone retaining wall supports the AT treadway near Compton Peak. (SUNY, 2006)*

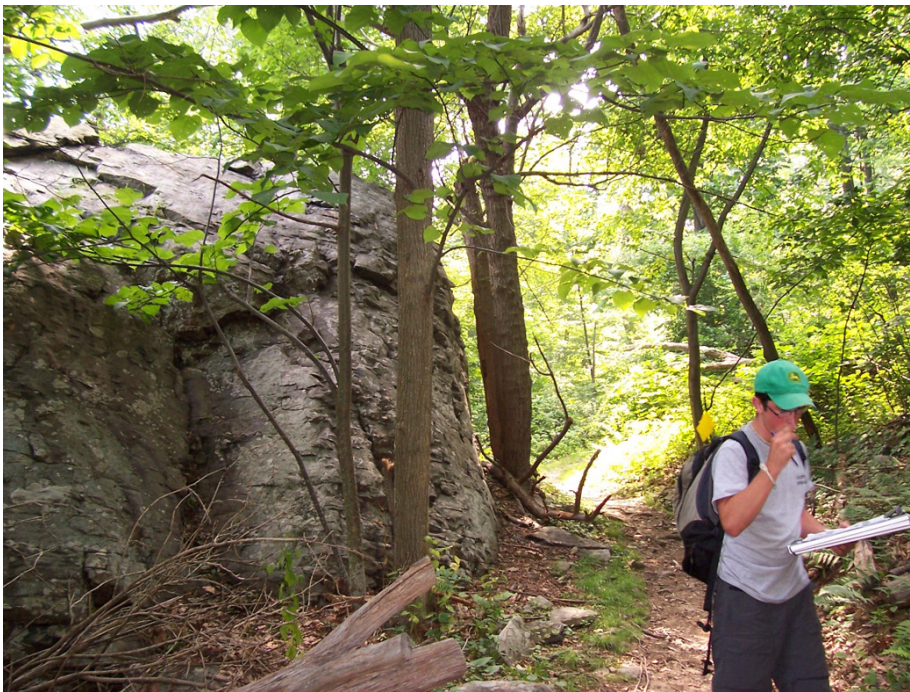
*Figure 19: In accordance with the 1937 manual, Construction of Trails, this section of the AT passes an exposed rock outcrop of geological interest near Compton Peak. The tread is evenly graded along the ridgeline. (SUNY, 2006)*

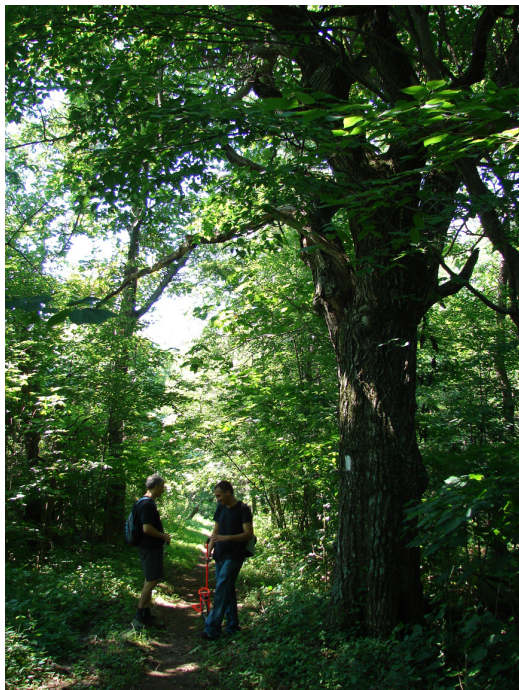
*Figure 20: A red oak wolf tree along the AT indicates an old field near the junction with Pass Mountain Hut Trail. (SUNY, 2006)*

Wolf trees, which are field trees with low branches around which younger woods have grown up, are numerous and recall the farm fields that once existed. They're usually large in diameter and height and contrast with the younger woods that surround them (Fig. 20). These ancient trees stand out along the trail corridor and recall the rich history of the park and the trail.

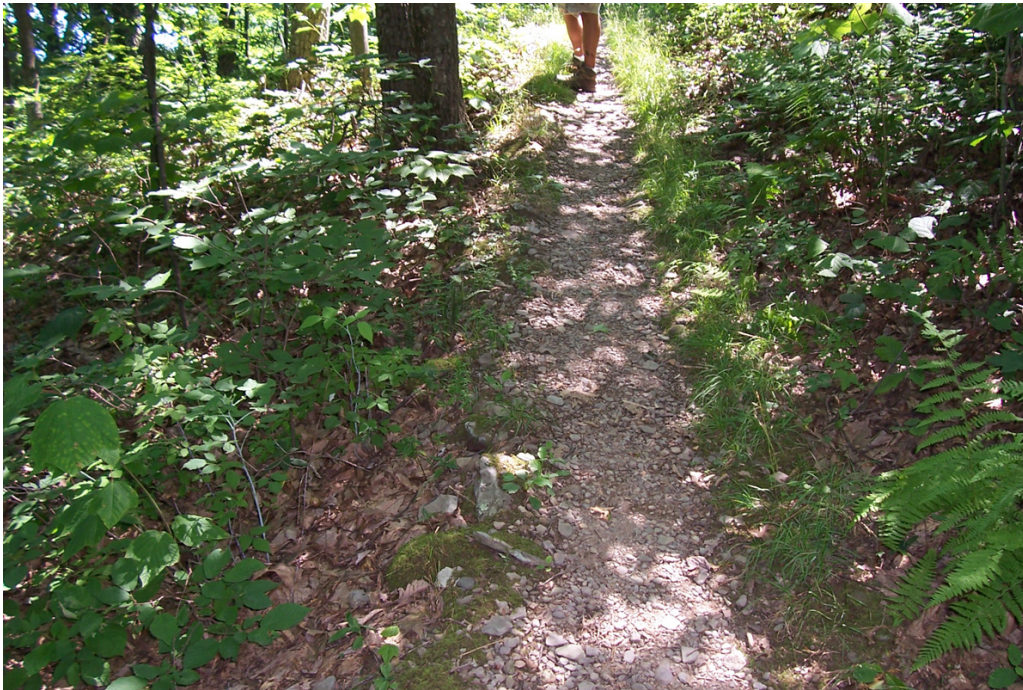
*Figure 21: Some sections of stone edging placed along the AT by the CCC to define the trail is disappearing because of erosion and heavy use near Neighbor Mountain Trail. (SUNY, 2006)*

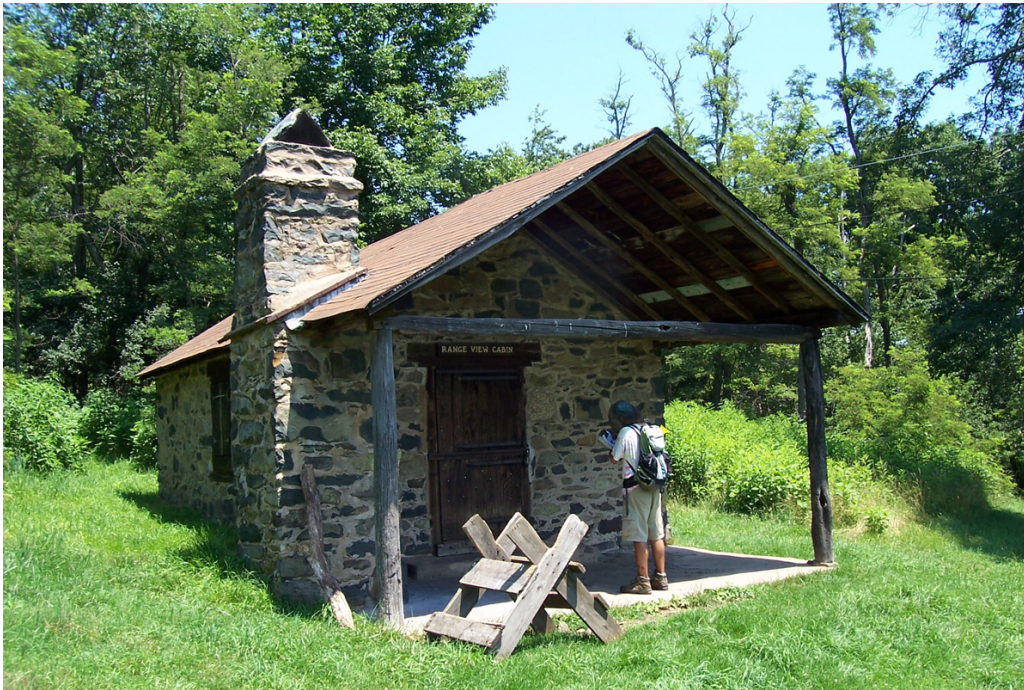
*Figure 22: The historic Range View Cabin built in 1933 by the PATC on the east side of the AT in the Piney Branch area. (SUNY, 2006)*

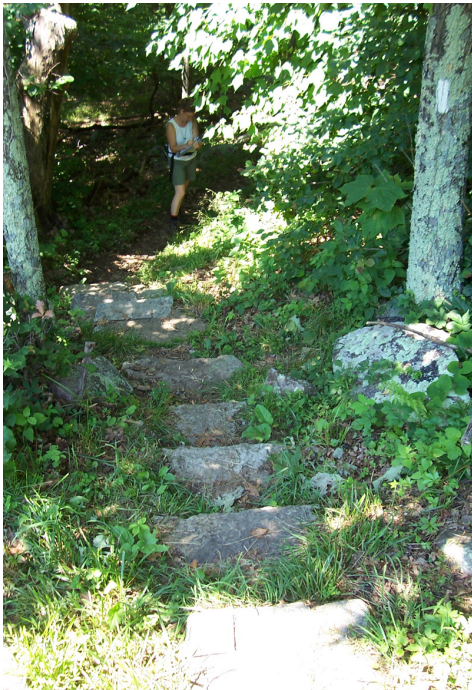
*Figure 23: Slab-laid stone steps, built by the CCC in the 1930s near the north end of Hogback Overlook. The CCC stonework was often built in association with overlooks to accommodate a wider range of hiking abilities. (SUNY, 2006)*

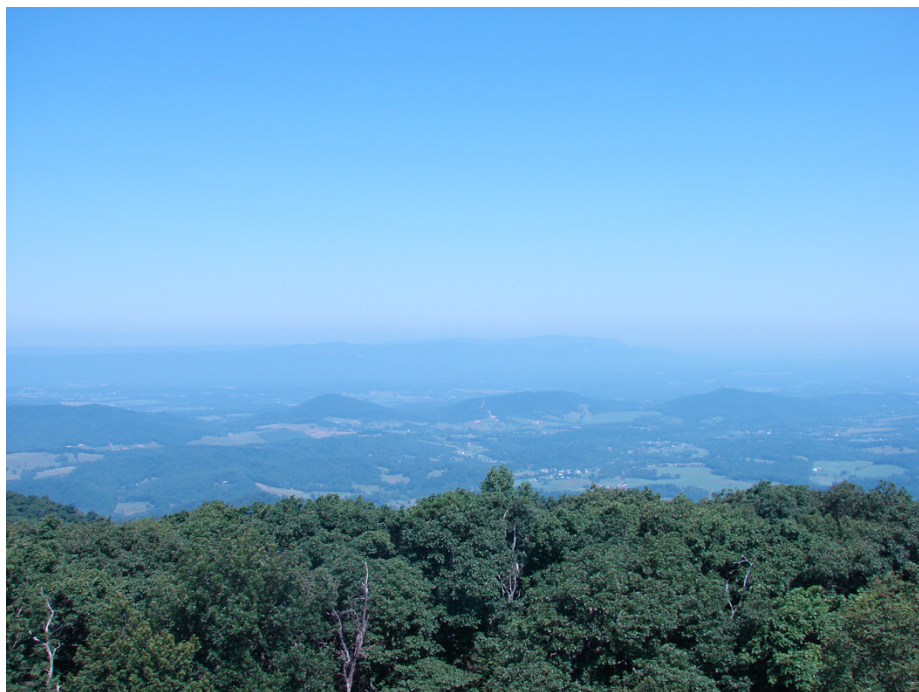
*Figure 24: A 44-foot long unobstructed view to the west along the AT near Mt. Marshall, between Hogwallow Gap and Gravel Springs Gap, offers a view to the farmland that lies at the foot of the mountain range. (SUNY, 2006)*

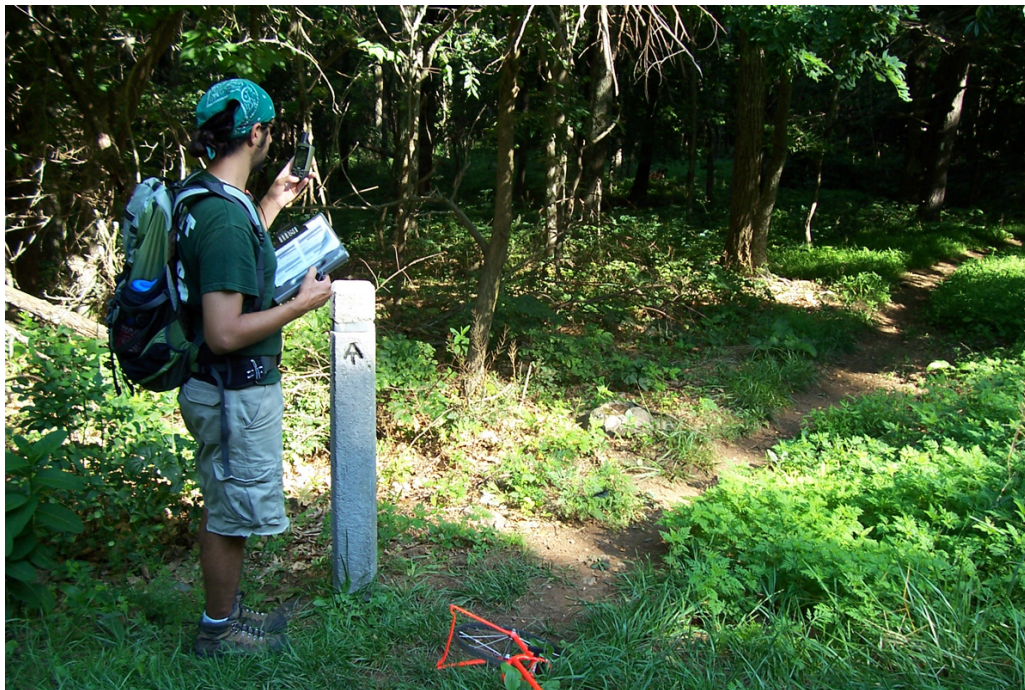
*Figure 25: A historic concrete and zinc AT marker circa 1935 near Elkwallow Gap. (SUNY, 2006)*

In somewhat of a departure from the NPS Rustic style, stylized concrete-post trail markers, reminiscent of hitching posts, with stamped zinc bands were installed as a standardized identification system throughout the trail within Shenandoah NP. The different design (many parks at the time were using rustic logs for signs) was most likely intended to enhance visibility and increase durability. Since the end of the historic period in 1942, the trail has been managed to maintain its historic rustic design, and the concrete trail marker posts continue to be maintained as the standard trail marker. While some aspects of the trail's historic design have changed, such as the introduction of metal culverts or the addition of asphalt in limited high-use areas, the AT–North District overall continues to exhibit integrity of design.
