UNITED STATES DEPARTMENT OF THE INTERIOR  
NATIONAL PARK SERVICE  
**NATIONAL REGISTER OF HISTORIC PLACES  
INVENTORY -- NOMINATION FORM**  
FOR FEDERAL PROPERTIES

SOUTH MANITOU ISLAND LIGHTHOUSE COMPLEX AND LIFE-SAVING STATION HISTORICAL DISTRICT  
AND/OR COMMON

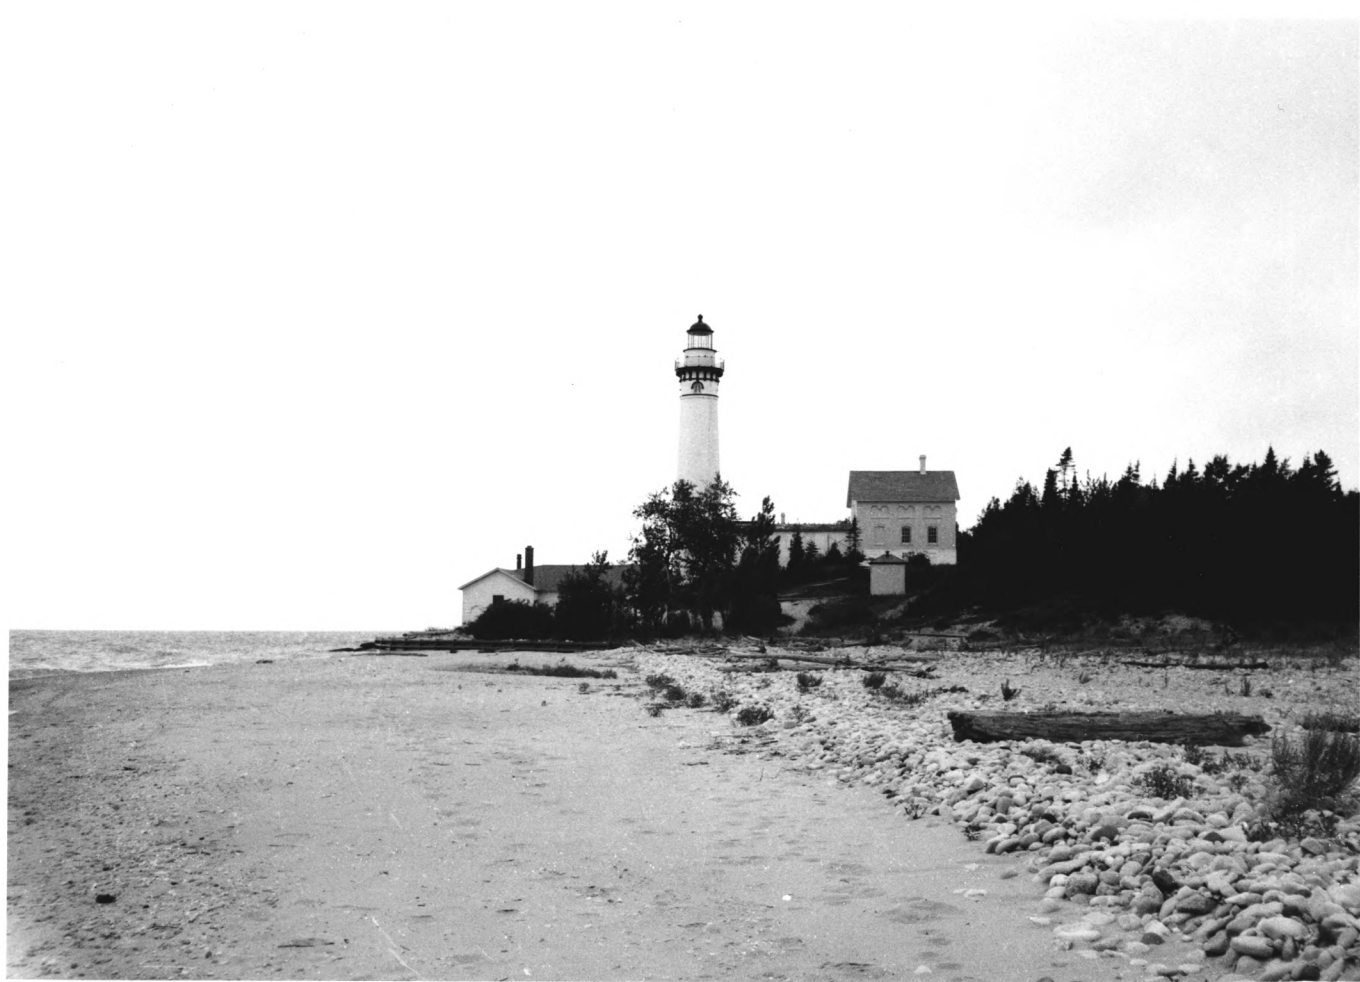
1. SOUTH MANITOU ISLAND  
Lighthouse Complex  
southern end of bay  
facing southwest

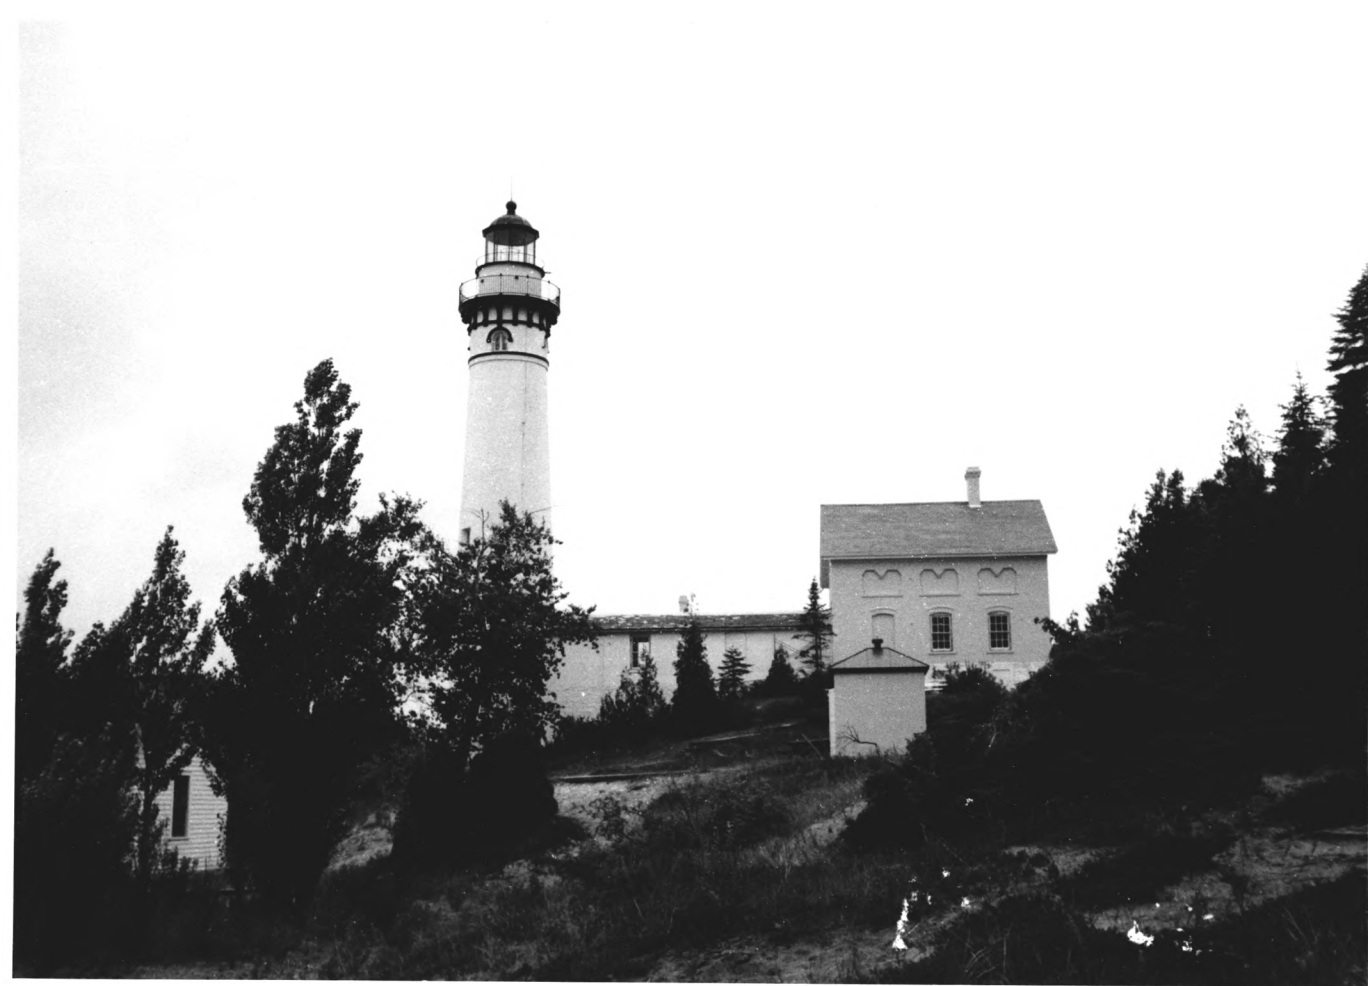
2. SOUTH MANITOU ISLAND

The Lighthouse Keeper's Residence is a 2½-story, 30- by 32-foot rectangular building with full basement. The residence has stone masonry foundations and yellow brick masonry walls. The simple gable roof has gray slate shingles. The floors, partitions, and roof are of simple wood construction. The house, constructed in 1858, originally had a wooden light tower attached to the roof. This tower was removed in 1872, when the separate brick light tower was completed. At this time, a brick walkway was constructed, connecting the residence and the tower. Other features of the residence include 3 wooden exterior doors; double-hung windows in segmentally-arched brick masonry openings with a single corbel-coursed eyebrow topping the arch ring; a brick chimney with 2 flues that spirals through the roof rafters; 3 interior wooden staircases; and wood flooring. The condition of the exterior of the residence is good; the interior is in poor condition.

The 40- by 8-foot brick walkway connects the keeper's residence with the light tower. It has a stone foundation and gabled roof with slate shingles. The walkway has four windows, two on each side. The walkway's exterior condition is fair; the interior is poor. The walkway was built in 1871-72.

HS-51120A Keeper's Residence (right)

HS-51120B South Manitou Lighthouse Walkway (center)

HS-51120C South Manitou Lighthouse (left)

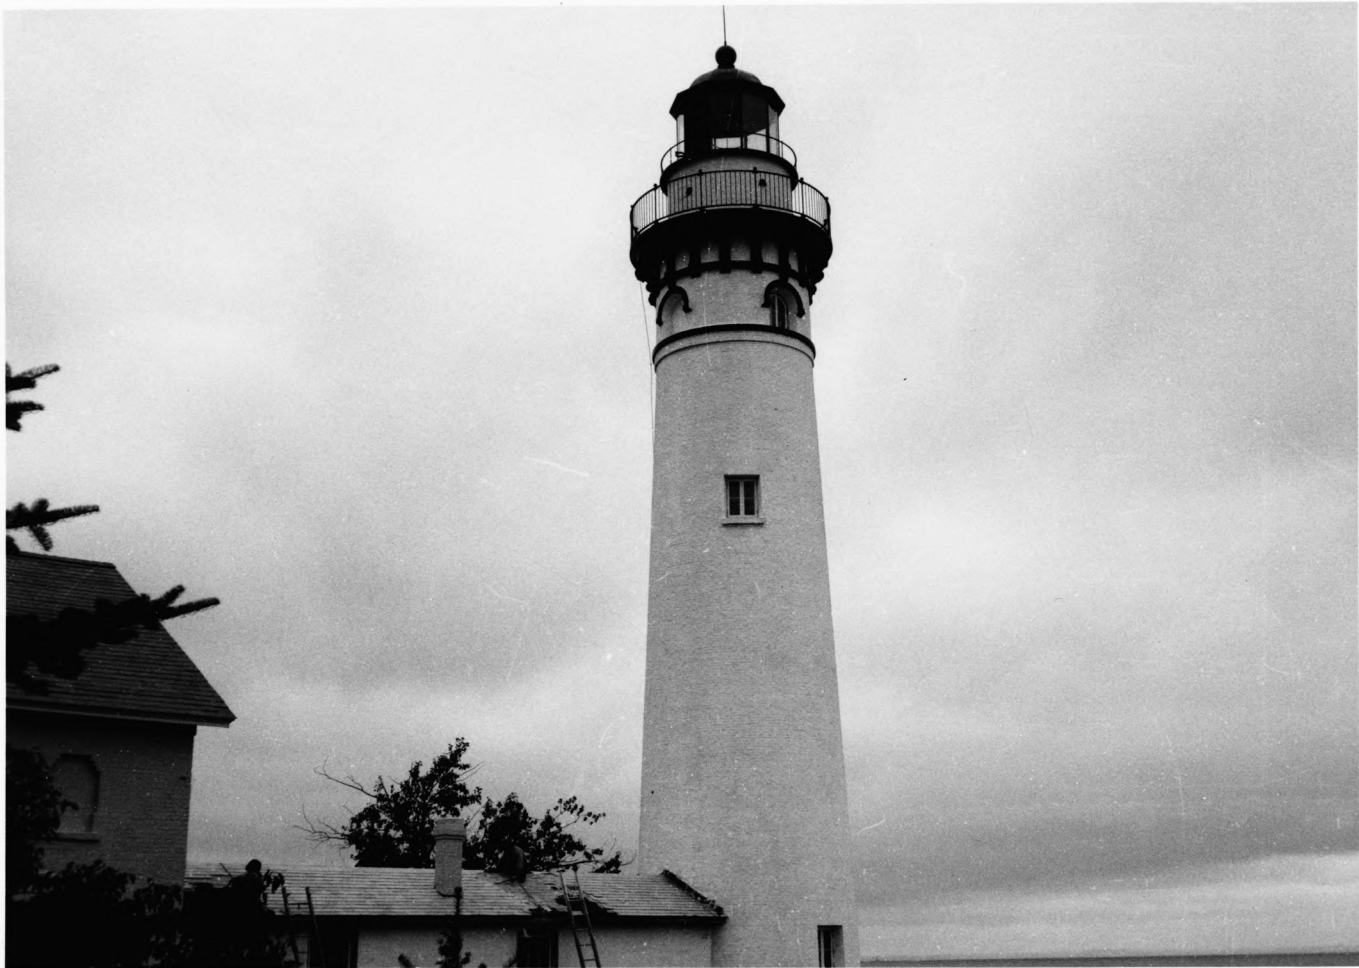
The brick light tower built in 1871-72 is 104 feet tall. Conical in shape, the exterior diameter measures 18 feet at the base and 12 feet at the parapet. There are four two-light, round-headed casement windows at quarter points below the brackets supporting the balcony, and three rectangular casement windows located randomly along the tower shaft. The projecting wrought iron balcony, which encircles the tower, is supported by cast iron brackets. The brick tower housed a third order Fresnel lens, which projected light a distance of 17-¾ miles. The light, built by Henri Lepaute of Paris, contained a plunger-type lamp that required 3 wicks. The lens appa-

tus contained 5 panels: 4 panels of 72 degrees and 1 small prismatic panel which formed a reflector of 72 degrees. The central drum of the lens had 13 elements in each panel. Each panel above the central drum had 11 prisms. Those below the drum had 4 prisms each. The lens has been removed, and the tower is now empty. The tower's exterior is in good condition; the interior is in fair condition.

3. SOUTH MANITOU ISLAND  
Lighthouse Complex  
southern end of bay  
HS-51120C South Manitou Lighthouse  
facing southeast

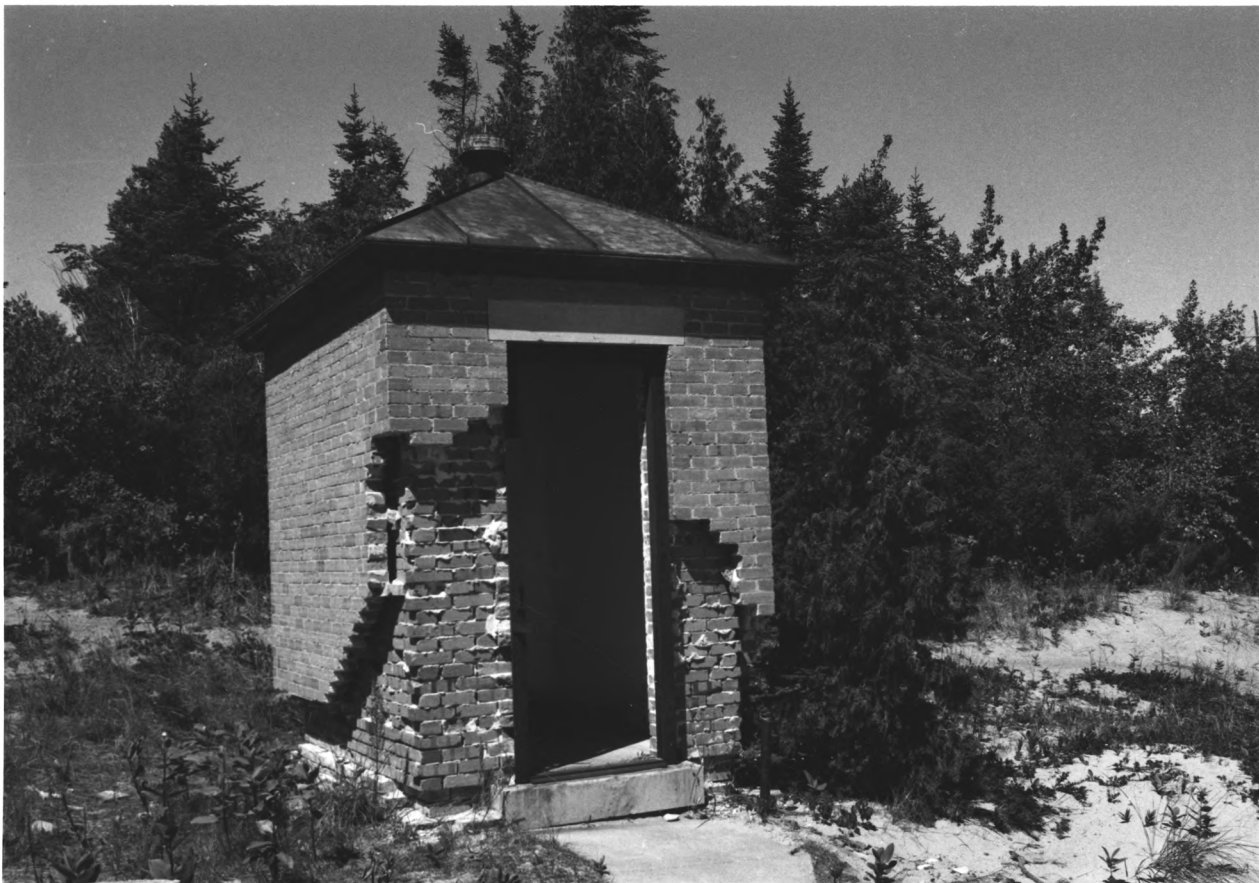
This 8½- by 7-foot building was once used for storage. The brick masonry structure has a standing seam metal hip roof with a metal vent and top. The magazine rests on a concrete slab. Its exterior is unfinished. The interior is painted white. The structure has a single door on the south side. The magazine is in fair condition. The magazine was probably built ca. 1875.

4. SOUTH MANITOU ISLAND  
Lighthouse Complex  
southern end of bay  
HS-51120D Magazine  
facing north/northeast

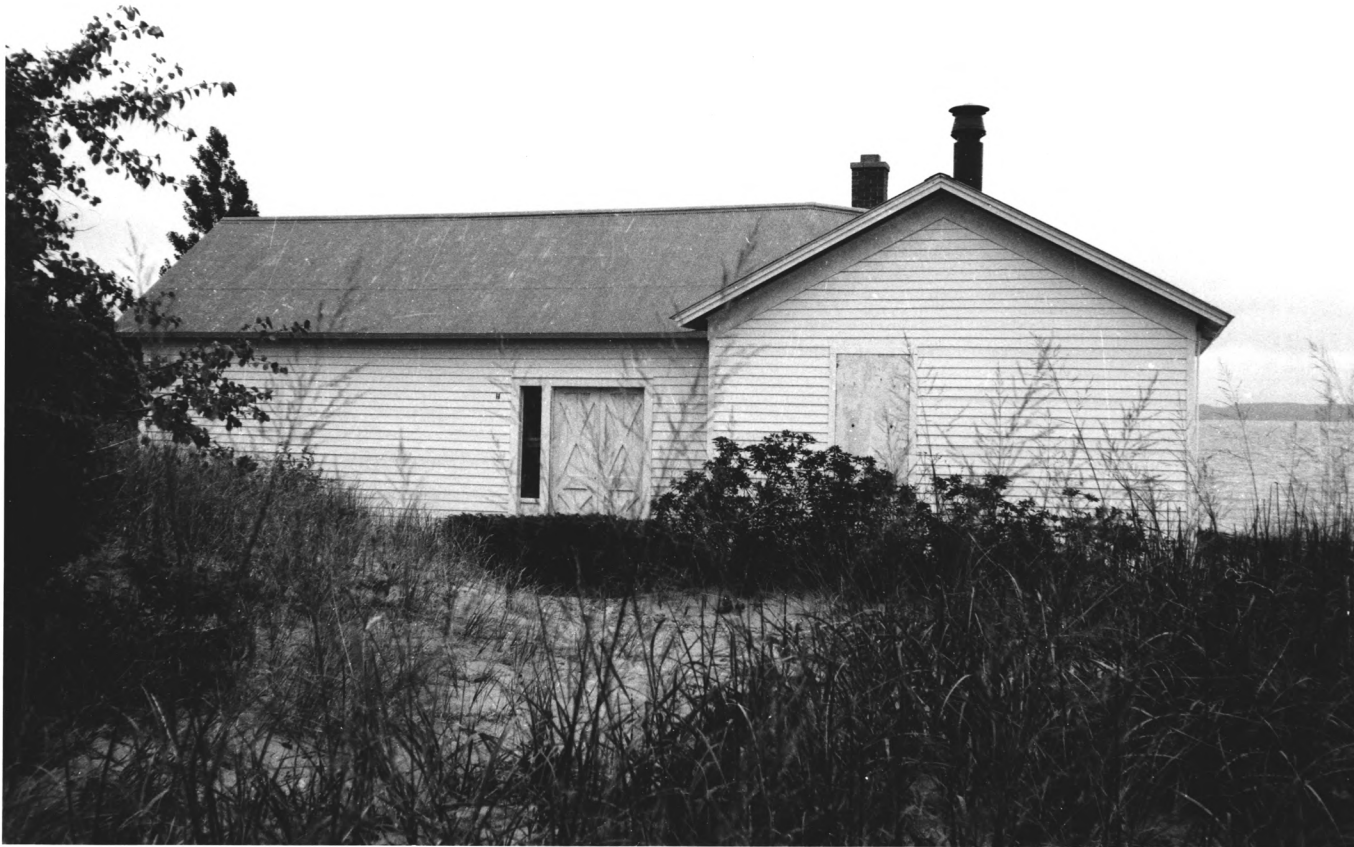
The whistle shed is located 70 feet north of the tower. The original structure, built in 1875, was replaced by the existing whistle shed in 1896. The frame building has horizontal wood siding. The machinery and air compressor that operated the bad weather warning whistle were removed when the station closed in 1958. The exterior of the whistle shed is in fair condition; the interior is poor.

5. SOUTH MANITOU ISLAND  
Lighthouse Complex  
southern end of bay  
HS-51120 Whistle Shed  
facing east

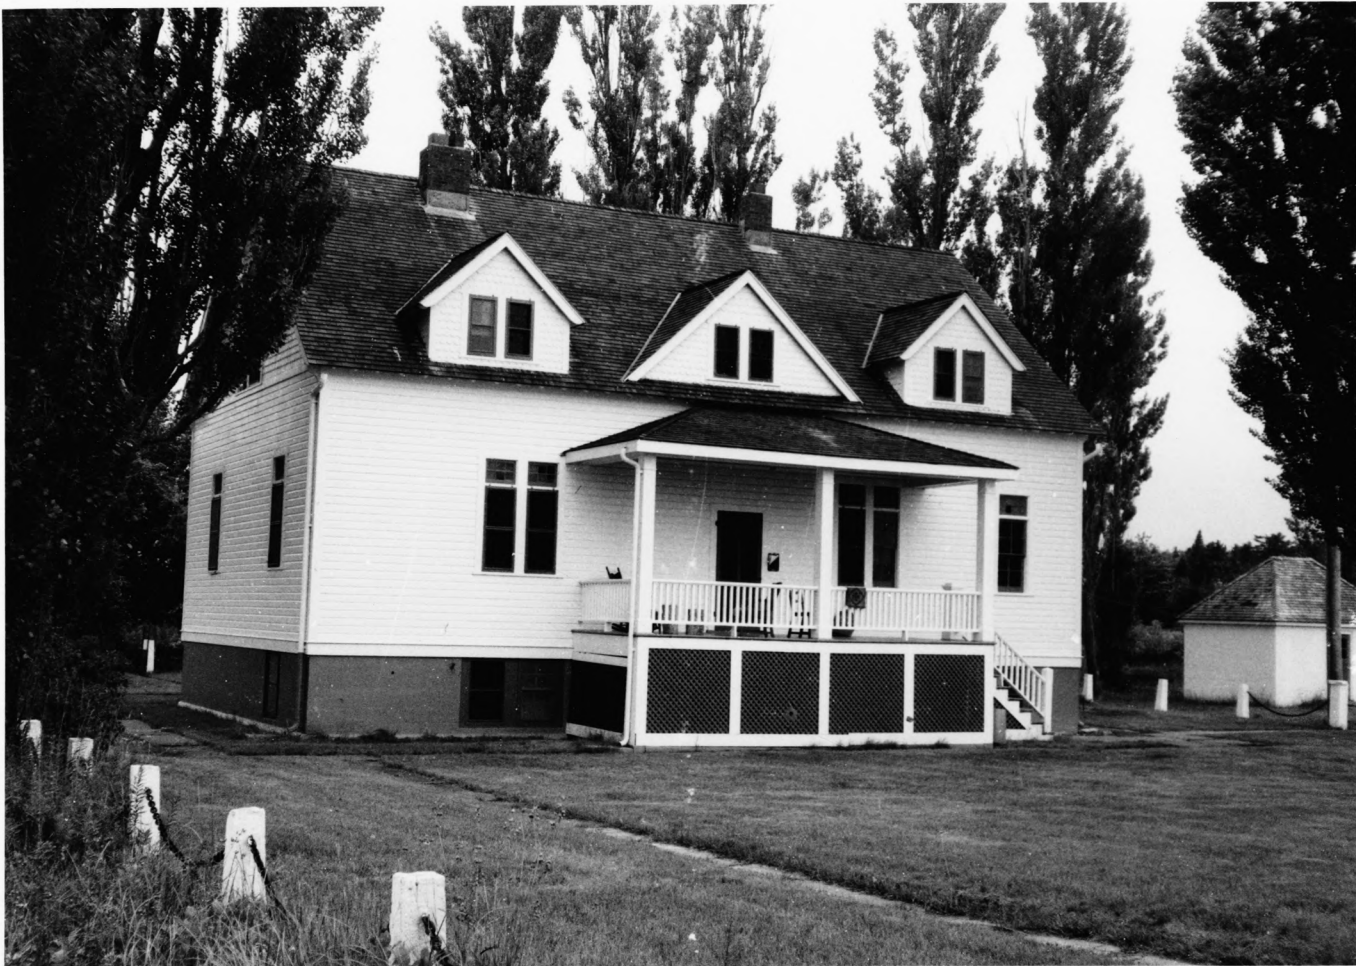
The Main House is a 30- by 50-foot rectangular structure, 1½ stories tall, with a full basement. It has a 22- by 8-foot porch on the north side and a 24- by 5-foot stairwell on the east side. The frame structure is set on a 4-foot poured concrete foundation. Originally the building was on grade, but it was later raised to create the full basement. The structure has shiplap siding, painted white with green trim. The gabled roof has sawn

wood shingles. The porch of the house has three columns which support the roof overhead, and stairs opening to the west. Other features of the structure are three exterior doors and 28 window openings. The house is in good condition.

The posts and chain fence surrounds the main house yard. The posts are concrete pyramidal sections painted white. The chains are iron and painted black. The fence and posts are deteriorated.

6. SOUTH MANITOU ISLAND  
Life-Saving Station  
southern end of bay  
HS-51123A Main House  
(foreground includes HS-51123G, Fence and Posts)  
facing southwest

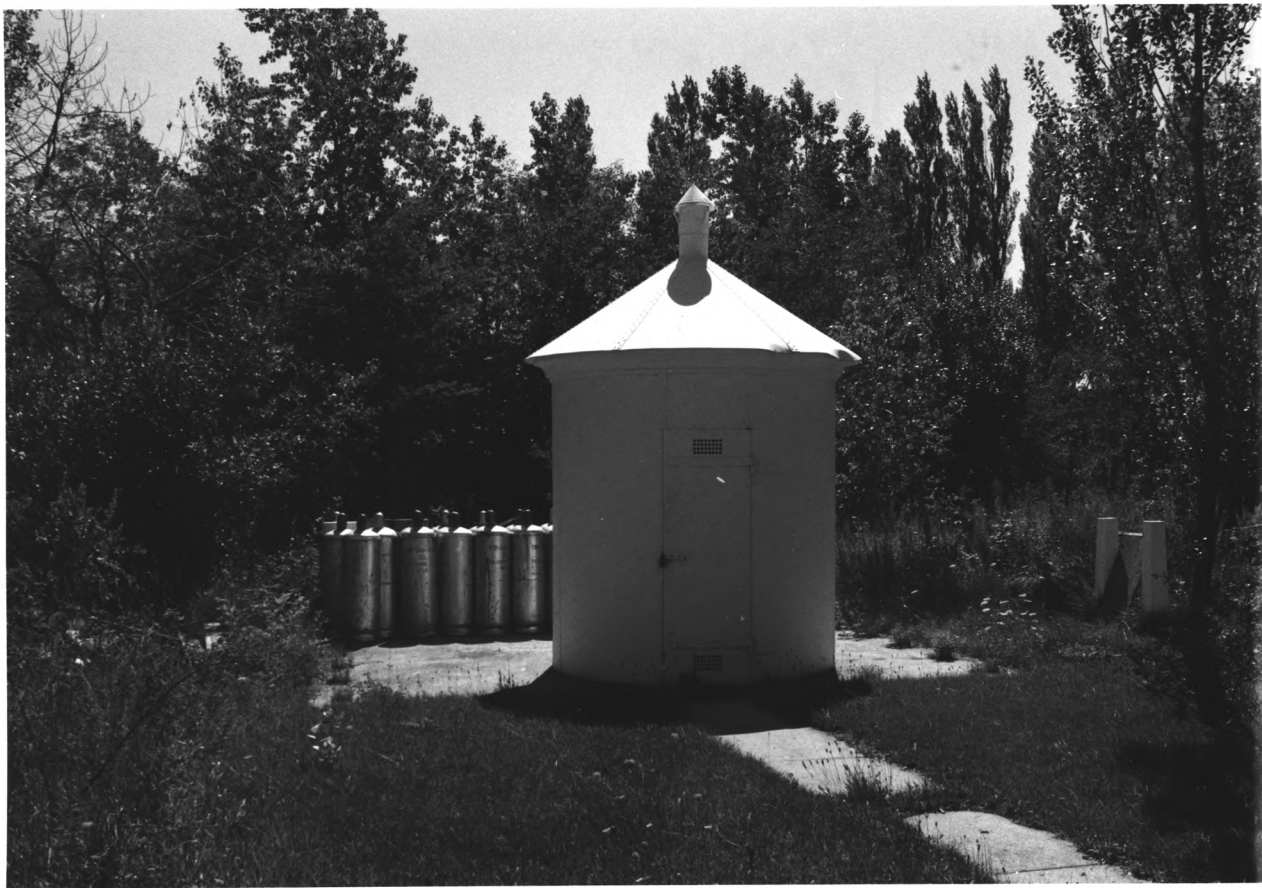
The oil shed is a cylindrical structure with a conic roof made out of metal. It sits on a concrete slab foundation. The exterior is painted white, and the interior is painted in a bright orange. The roof has a short venting stack in the center. The floor is wooden. The door is metal with vent holes. The oil shed measures 8 feet in diameter. It is in excellent condition.

7. SOUTH MANITOU ISLAND  
Life-Saving Station  
southern end of bay  
HS-51123B Oil Shed  
facing west

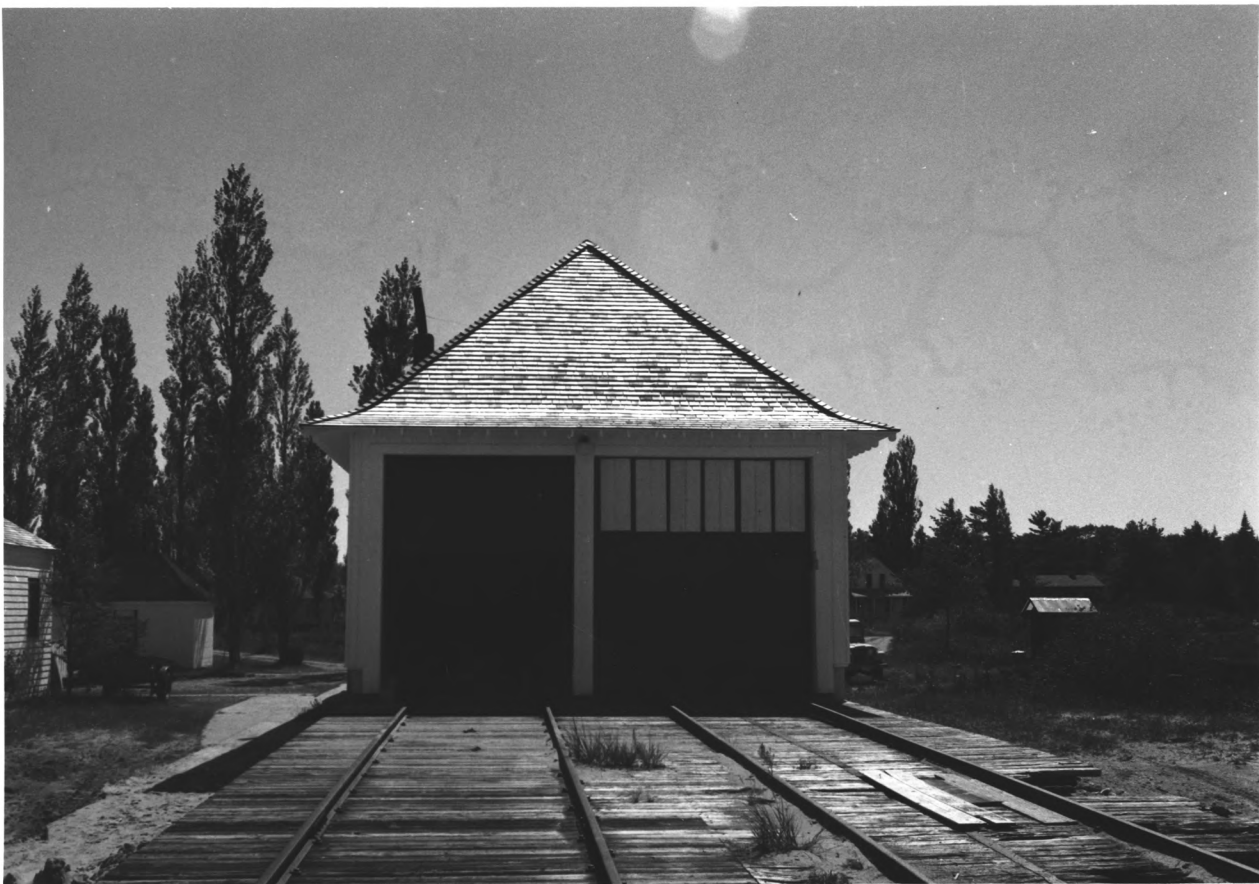
The boathouse, built in 1901, is a rectangular wood frame building measuring approximately 50 by 24 feet. It has a hip roof with flaired eaves and red stained cedar shingles. The board and batten siding is painted white with green painted sashes and trim. The interior has one wooden floor with attic. There are 4 doors; 2 overhead, 1 two-door swinging, and 1 plank door. The structure has 4 windows, double hung, 4 over 4 by 4 over 4. There is one chimney, brick with metal piping. Other features of the boathouse include two ramps, one concrete ramp facing landward and one wooden ramp with metal rails facing toward the lake and extending to a slip at the water's edge. The boathouse is in good condition.

8. SOUTH MANITOU ISLAND  
Life-Saving Station  
southern end of bay  
HS-51123C Boathouse  
facing west

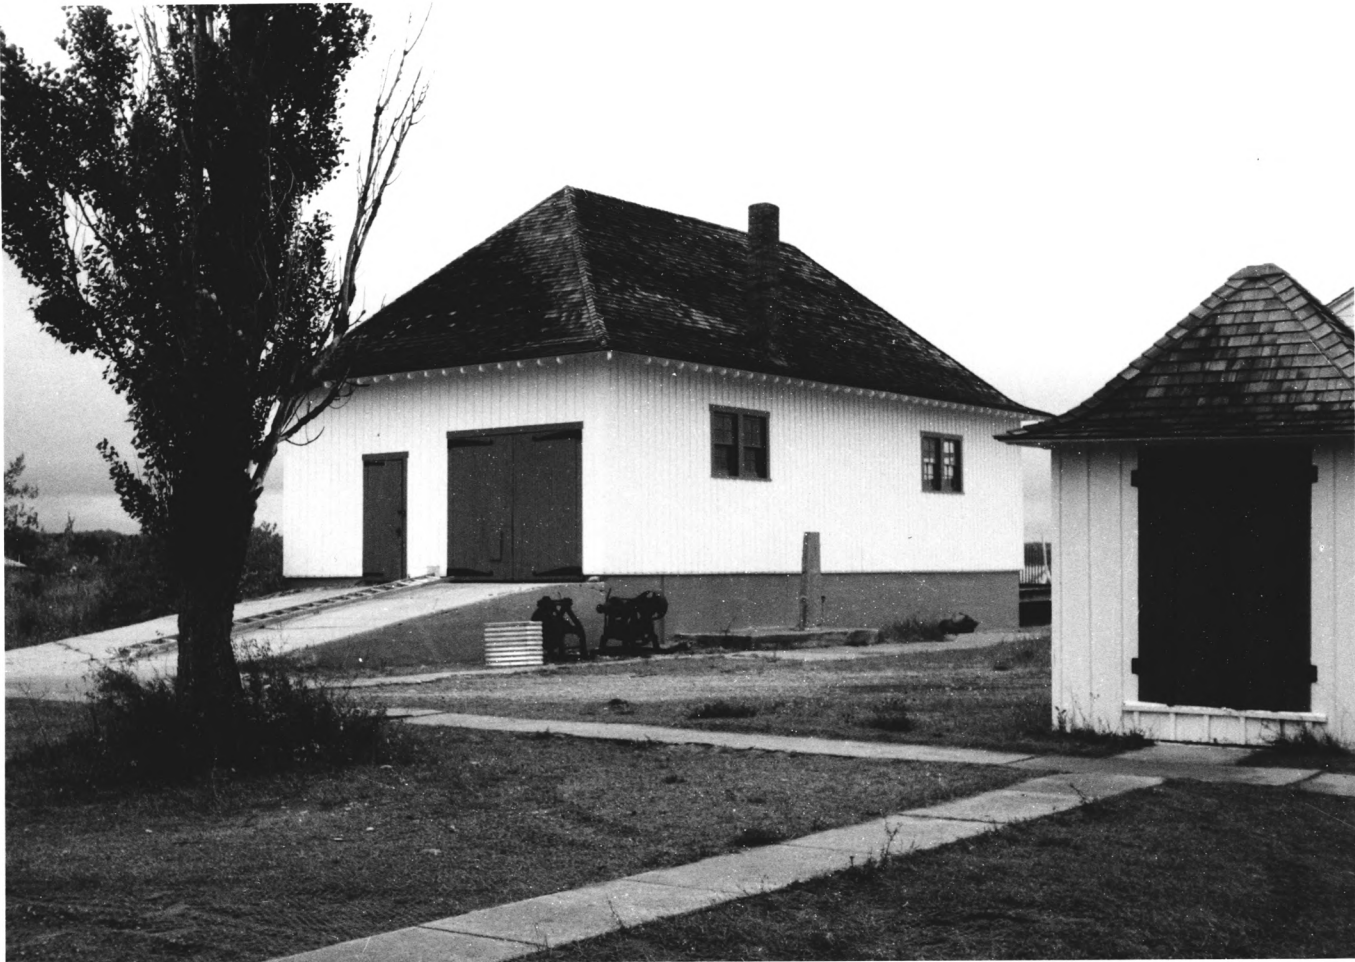
9. SOUTH MANITOU ISLAND  
Life-Saving Station  
southern end of bay  
HS-51123C Boathouse  
(foreground includes HS-51123D, Frame Shed)  
facing north/northeast

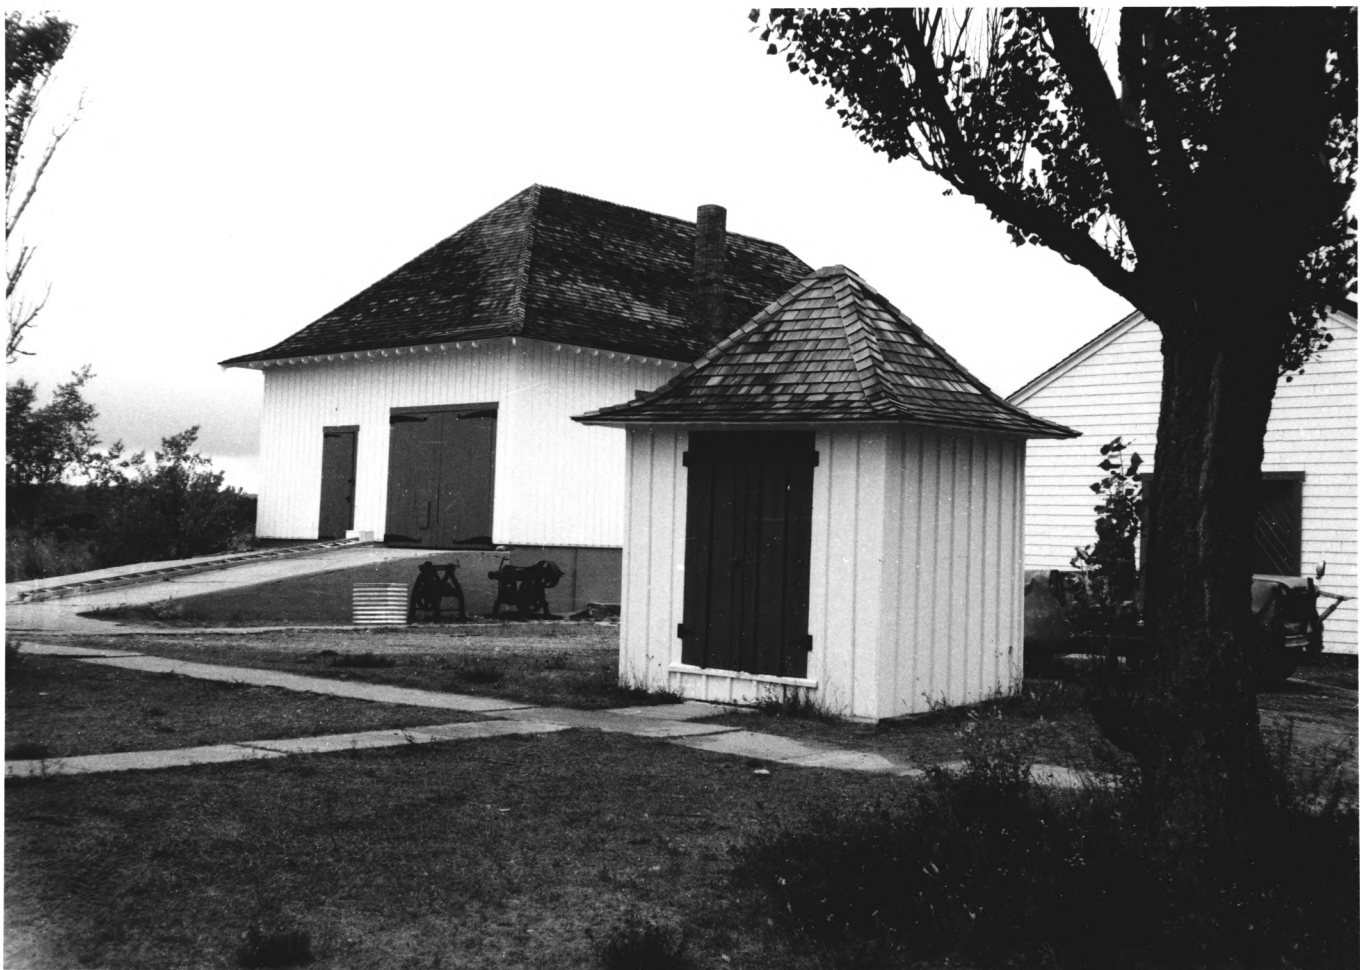
This shed, measuring 8'5" by 7'4", has one floor. The wooden board and batten siding is painted white on the exterior with green doors. The interior is open frame. The shed sits on a poured concrete slab foundation. The shed has a hip roof with flaired eaves. It has red asphalt shingling. Other features include 2 doors, board and batten with wooden latches and knobs, and a concrete ramp. Its condition is good.

10. SOUTH MANITOU ISLAND  
Life-Saving Station  
southern end of bay  
HS-51123D Frame Shed  
facing north/northeast

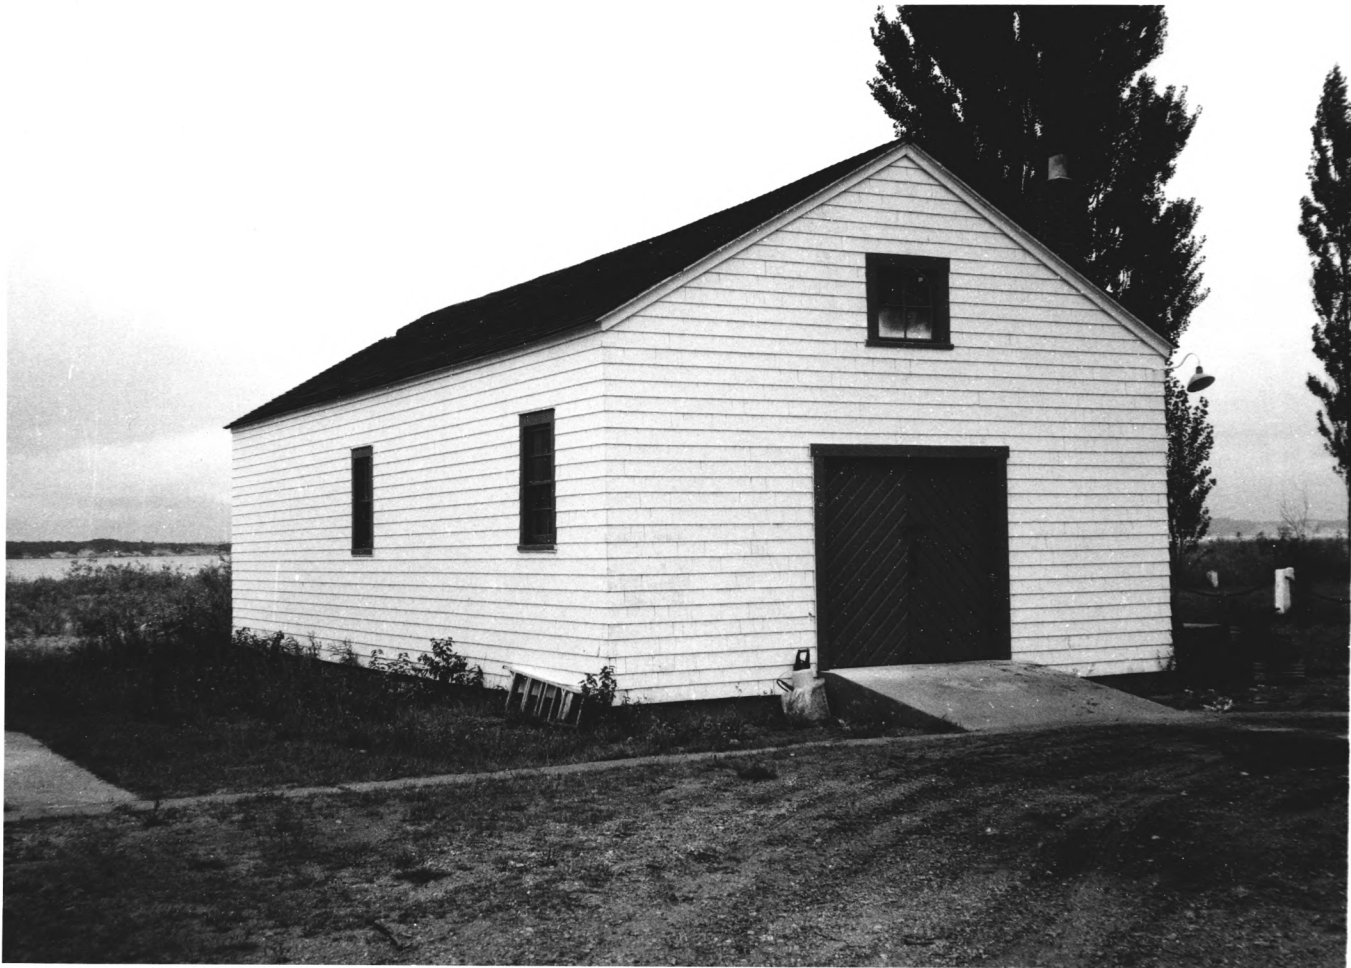
This frame work shed measures 42 by 21 feet. It is a wood frame structure with diagonal wood plank siding. The exterior is covered with cedar shingles painted white with green

doors and trim. The open frame interior has no finish. The shed sits on a structure of concrete and timber piles and sills construction. The work shed has 1½ floors, one plank floor on the main level and a half floor loft which is located above the main floor. An L-shaped staircase connects the two. There are 2 doors, 8 windows, 1 chimney, and 1 fireplace used for heat. The building is divided into three rooms with two 2-inch tongue-in-groove partitions. The shed is in good condition.

11. SOUTH MANITOU ISLAND  
Life-Saving Station  
southern end of bay  
HS-51123E Work Shed  
facing east/southeast

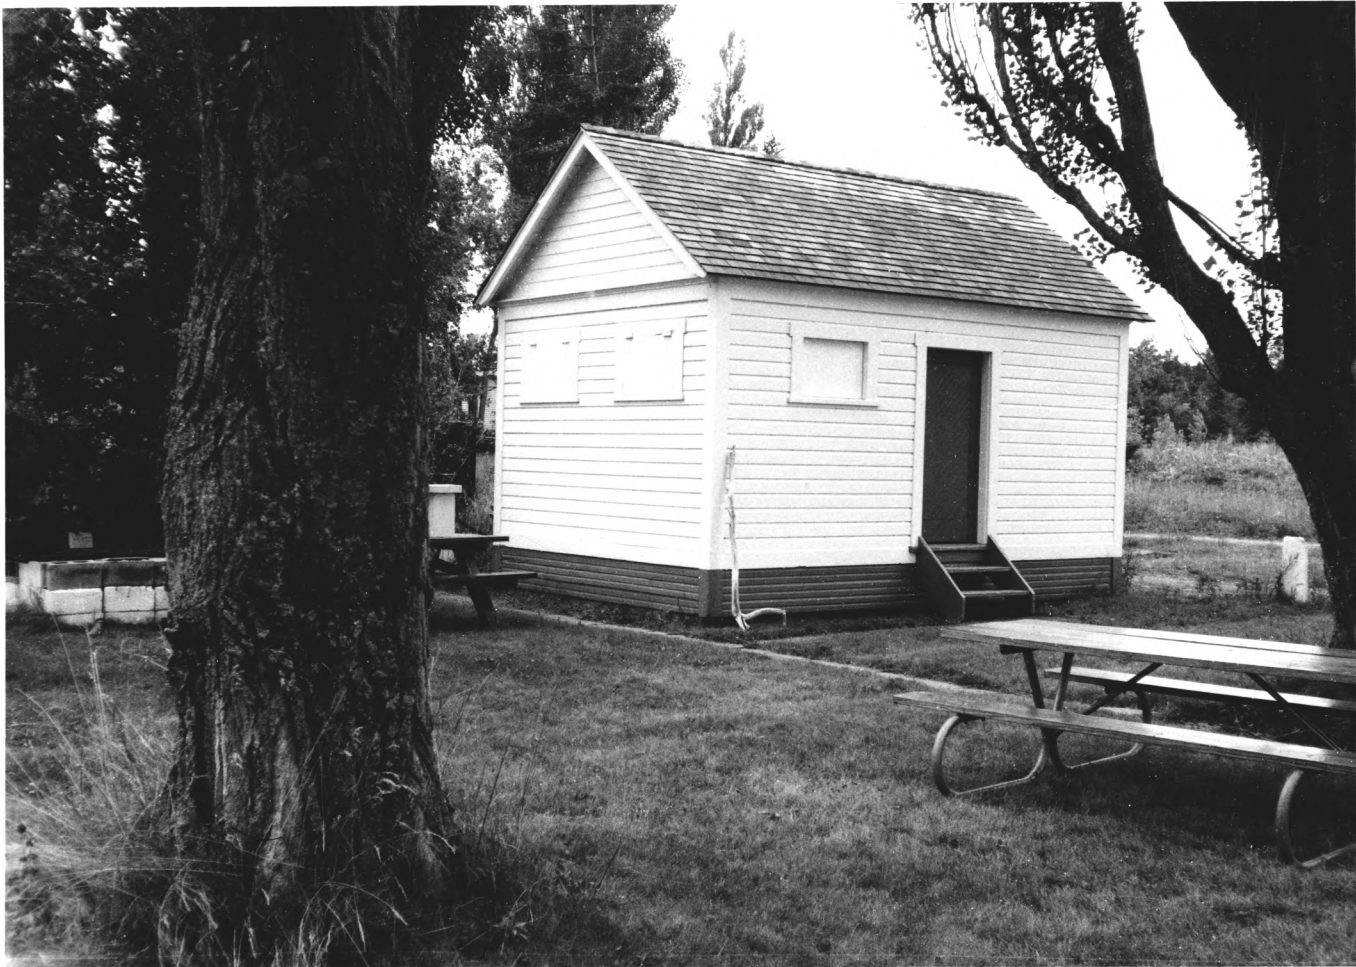
This storage shed measures 18 by 12 feet. The walls consist of wood shiplap siding with corner boards and shingle gabled ends. The exterior siding is painted white with green trim. The concrete foundation is painted gray. The roof is a simple gable with asphalt shingles. The foundation of the shed consists of concrete blocks with narrow shiplap siding. Other features of the shed are one floor plus loft storage, a single door with diagonal boards, 6 windows, 1 brick chimney, and 1 interior partition which makes two rooms. The shed, built in approximately 1901, is in good condition.

12. SOUTH MANITOU ISLAND  
Life-Saving Station  
southern end of bay  
HS-51123F Wood Shed  
facing northwest

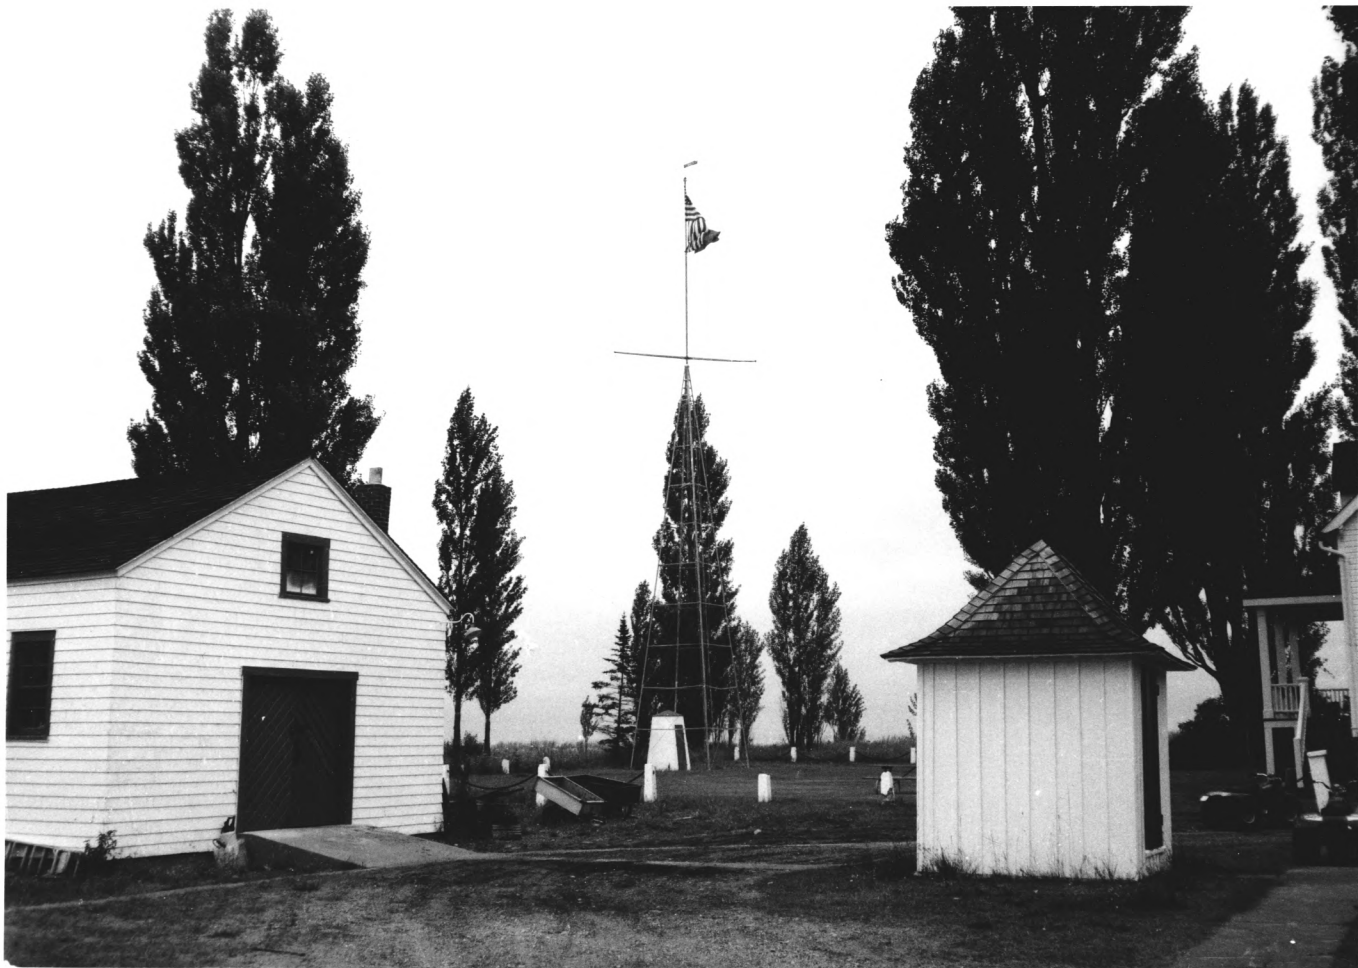
The 8- by 8-foot open metal frame tower tapers off to hold the flagpole. There is a ladder on the frame. The frame is diagonally braced. The tower/flagpole is in good condition.

13. SOUTH MANITOU ISLAND  
Life-Saving Station  
southern end of bay  
HS-51123H Coast Guard Station Tower and Flagpole  
facing south/southeast

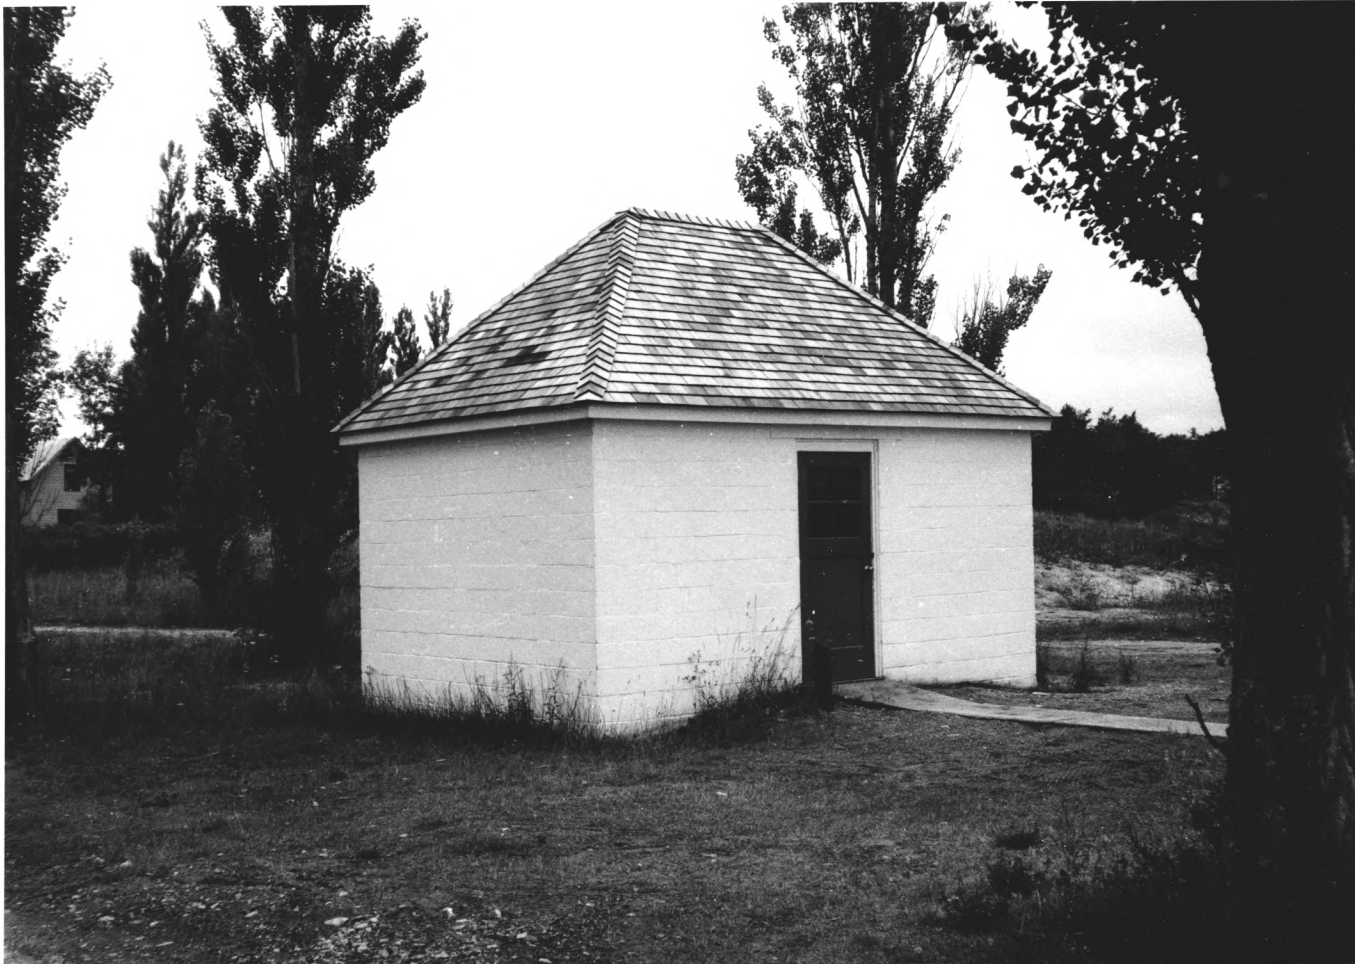
This shed has concrete block walls. The exterior is painted white. It has a simple gabled roof with red asphalt shingles. It is in good condition.

14. SOUTH MANITOU ISLAND  
Life-Saving Station  
southern end of bay  
HS-51123I Flammable Storage Shed  
facing northwest

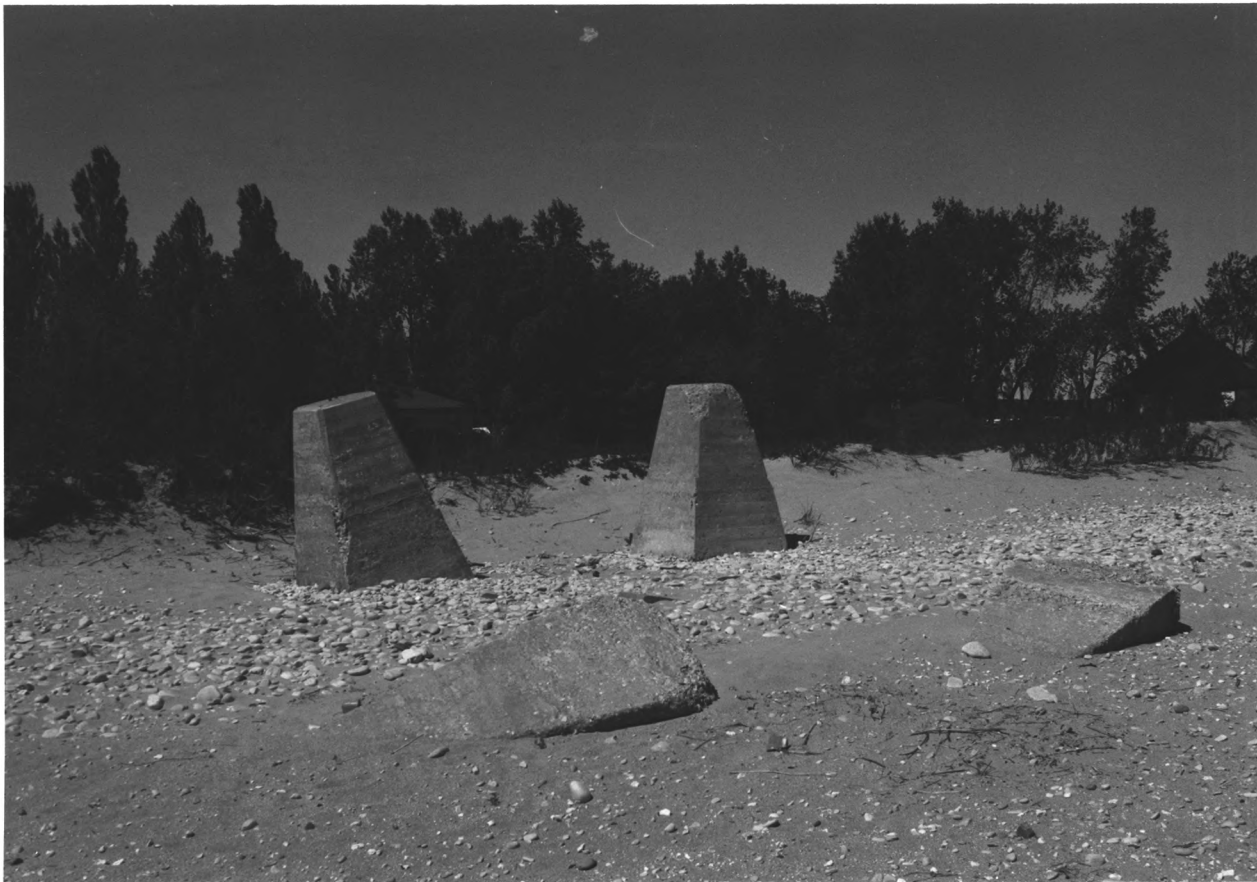
Coast Guard personnel used the lookout station, which resembled the fire tower, to watch for distressed vessels. Currently, only the foundations of the station remain. The 4 concrete pillars are 6 feet tall, 4 feet square at the base, and 2 feet square at the top. Two of the pillars are upright; the other 2 are fallen. The lookout station foundation is located immediately southeast of the light tower (UTM Reference 16 571550 4984200).

15. SOUTH MANITOU ISLAND  
Life-Saving Station  
southern end of bay  
HS-51122 Lookout Station Foundation  
facing northeast

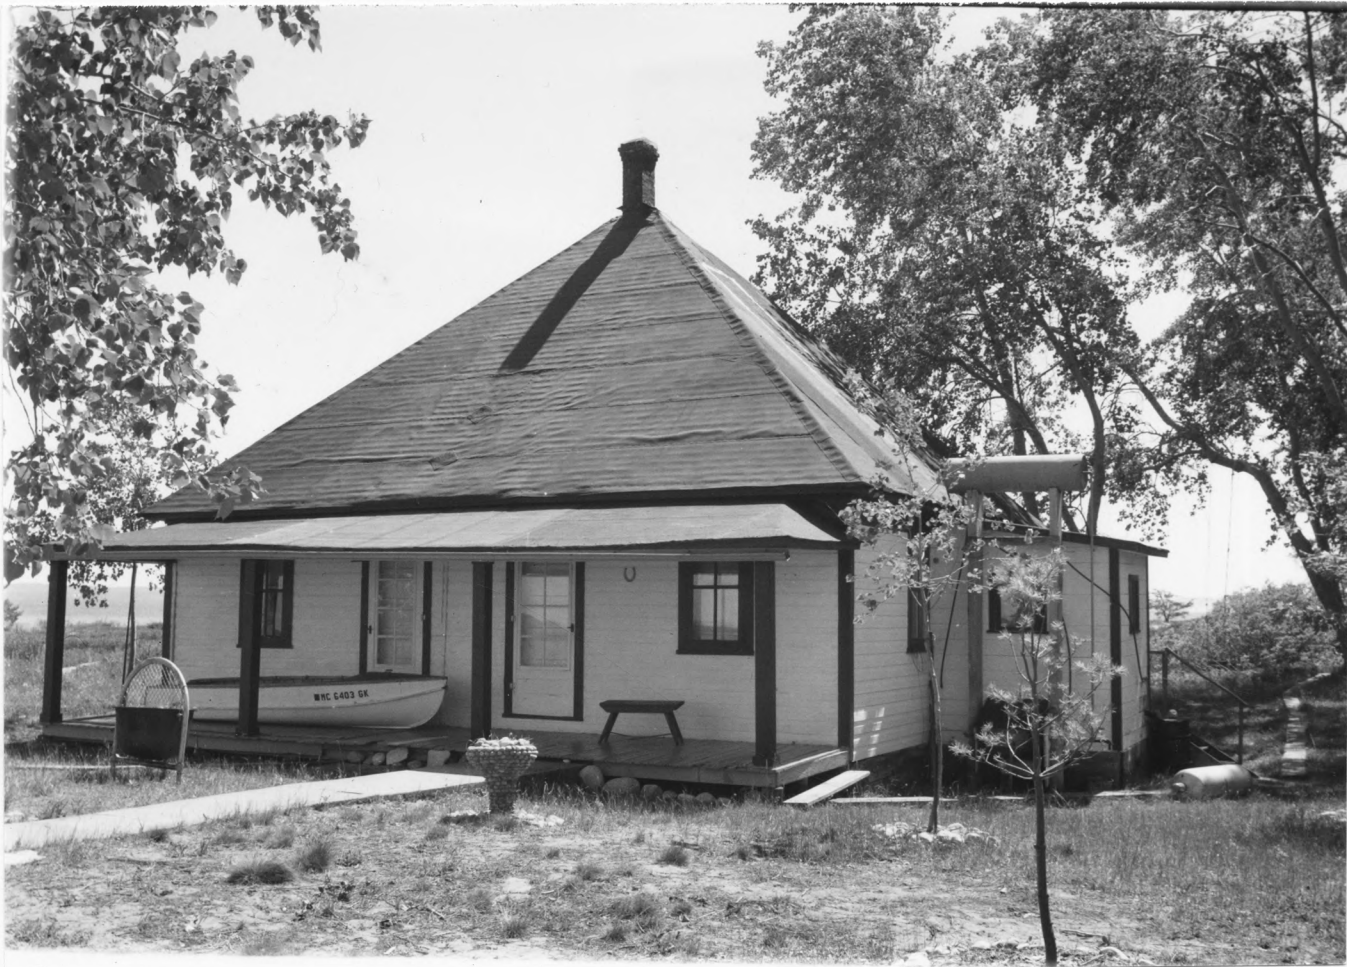
The 24- by 24-foot structure has a tall pyramidal hipped roof. A chimney is situated at the peak of the roof. There is a full porch at the entrance. The roof covering is asphalt roll. The house is sided with shiplapped horizontal boards. The Johnston House, in good condition, is located on a one-quarter acre plot. (See enclosed map for location.)

16. SOUTH MANITOU ISLAND  
HS-51142A Johnston House  
southern end of bay  
facing southeast
