UNITED STATES DEPARTMENT OF THE INTERIOR  
NATIONAL PARK SERVICE  
**NATIONAL REGISTER OF HISTORIC PLACES  
INVENTORY -- NOMINATION FORM**  
FOR FEDERAL PROPERTIES

SOUTH MANITOU ISLAND LIGHTHOUSE COMPLEX AND LIFE-SAVING STATION HISTORICAL DISTRICT  
AND/OR COMMON

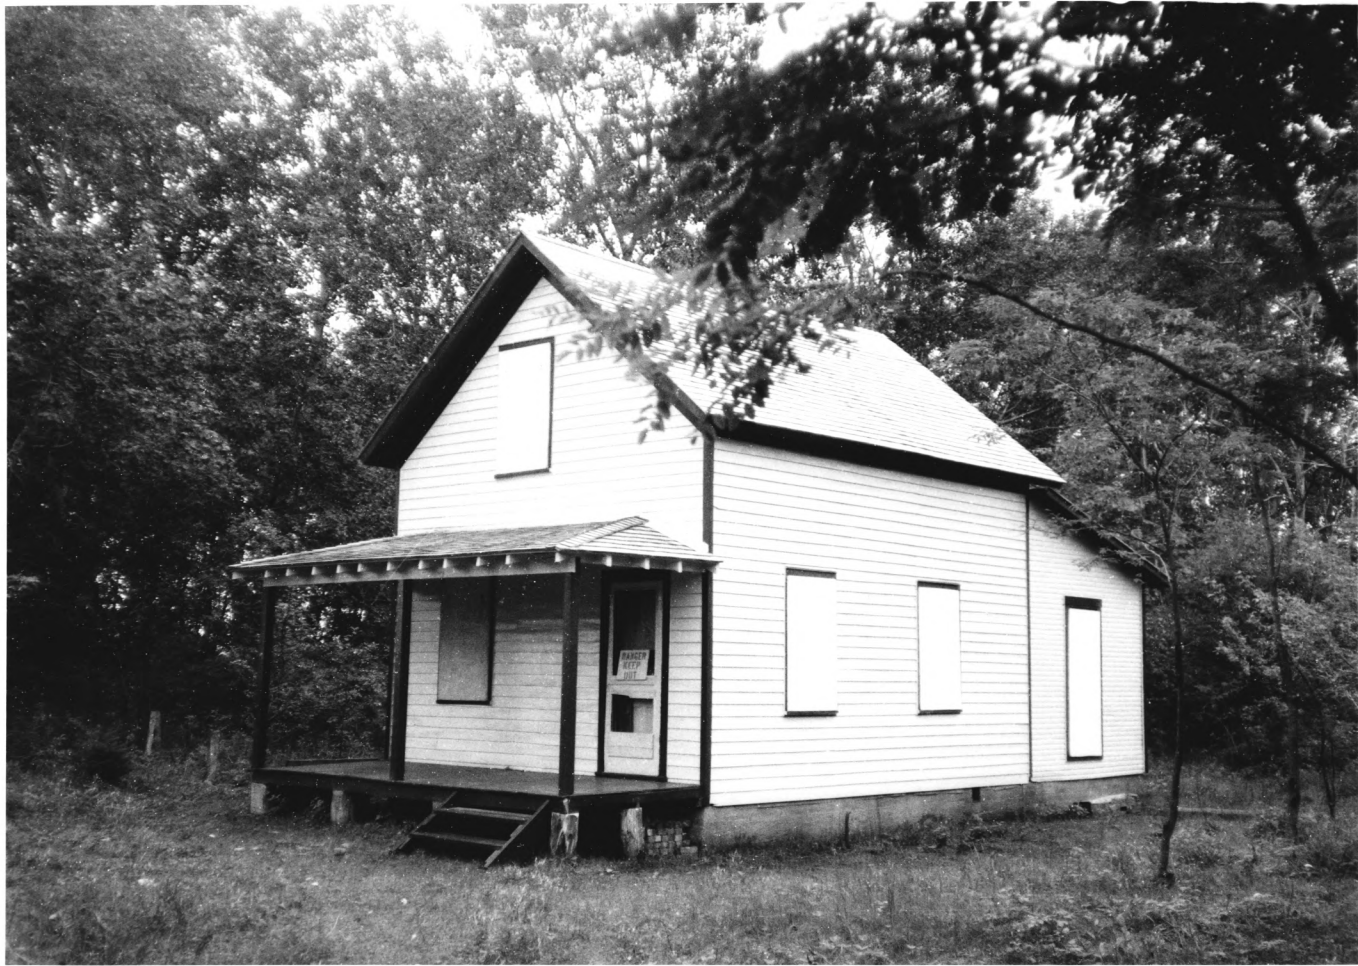
The 15- by 20-foot, 1½-story house has a porch on the front and a one-story addition to the rear. The main section has a gable roof, and the rear addition has a shed roof. Asphalt roll covers wood shingles on the roof. The house has wood clapboard siding. The residence rests on a one-half acre plot. The exterior is in good condition; the interior is poor. The date of construction is not known, although the structure is believed to have been built circa 1930.

17. SOUTH MANITOU ISLAND  
HS-51141 Leinbach House  
village  
facing southwest
