National Park Service  
Cultural Landscapes Inventory  
2016

Theodore Roosevelt Island  
Theodore Roosevelt Island

## Inventory Unit Summary & Site Plan

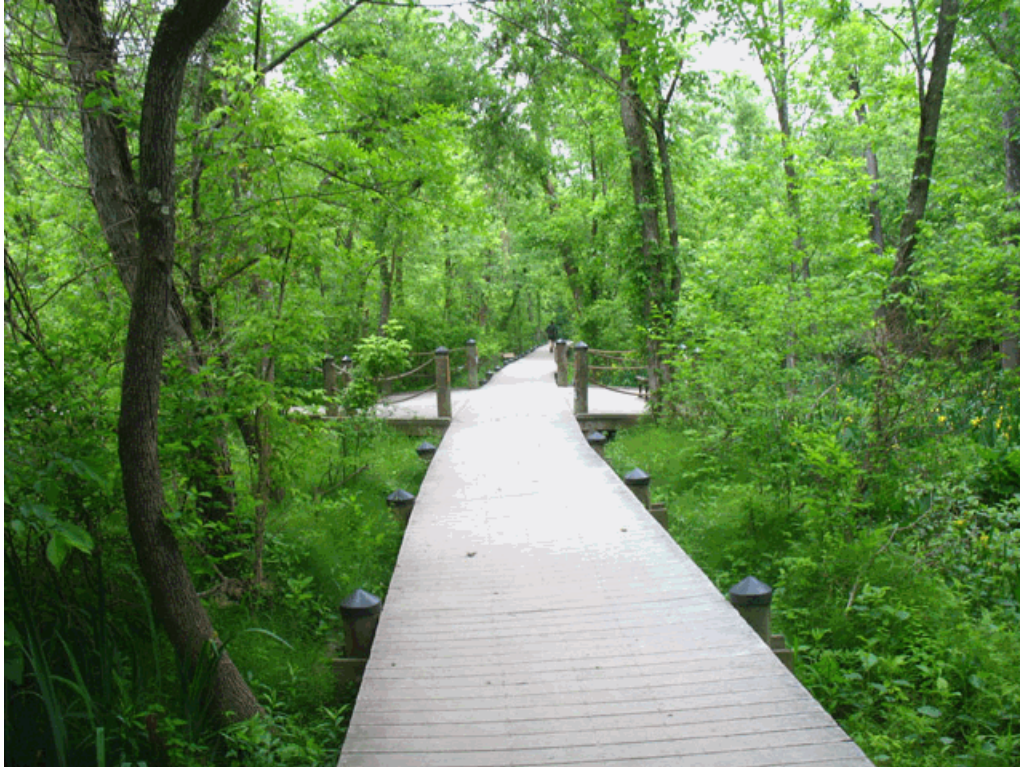
*In the late 1990s a boardwalk of recycled materials was built along the same path as the historic Swamp Trail, a contributing feature on the island (NCR CLP 2010).*

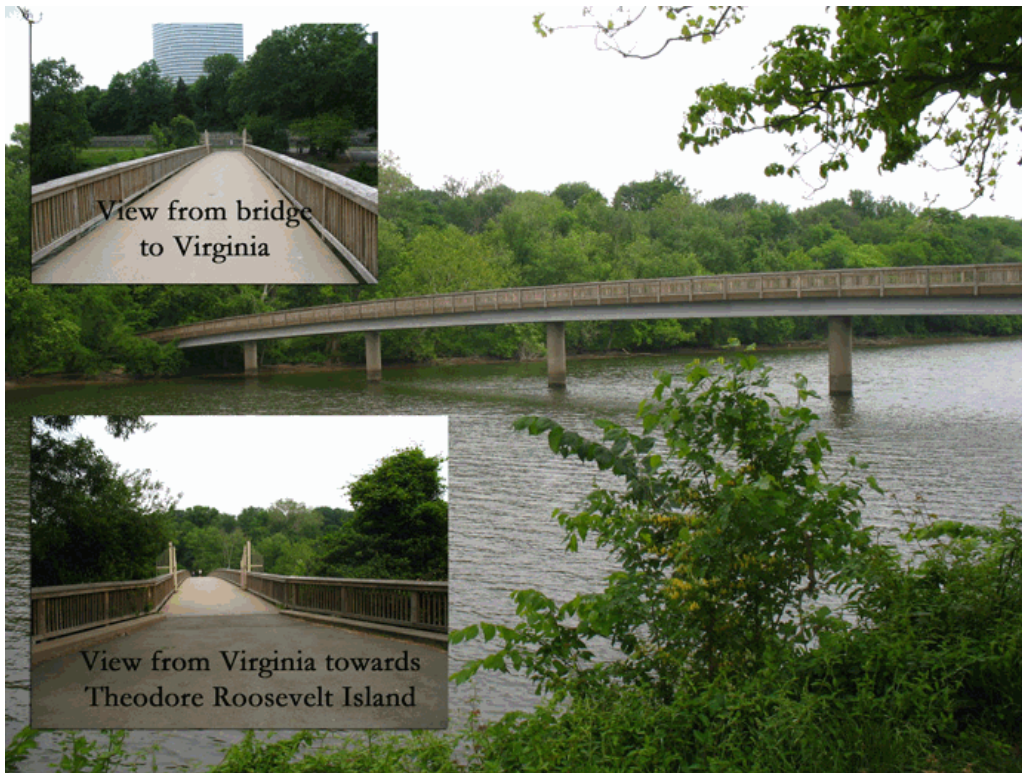
*The pedestrian bridge, built in 1979, provides access to the island from the Virginia shore. Since it was built outside of the period of significance, it is considered a non-contributing resource (NCR CLP 2010).*

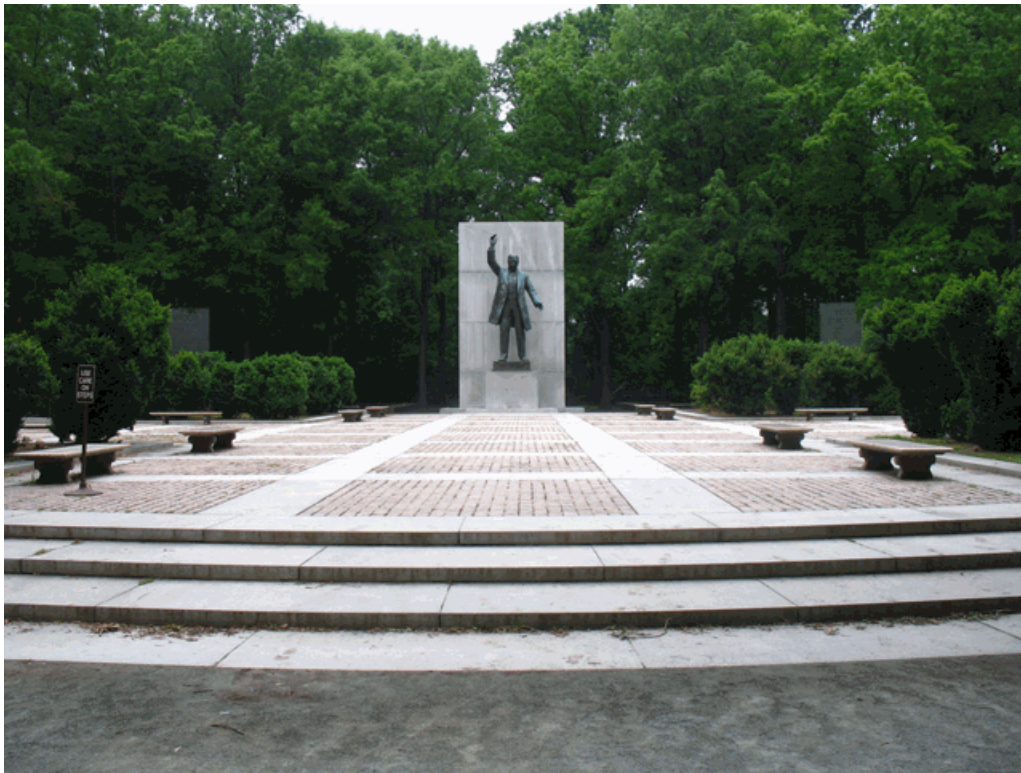
*The 19'-10" tall Theodore Roosevelt by Paul Manship is the focal point of the memorial plaza designed by New York architect Eric Gugler and dedicated by President Lyndon B. Johnson on October 27, 1967 (NCR CLP 2010).*

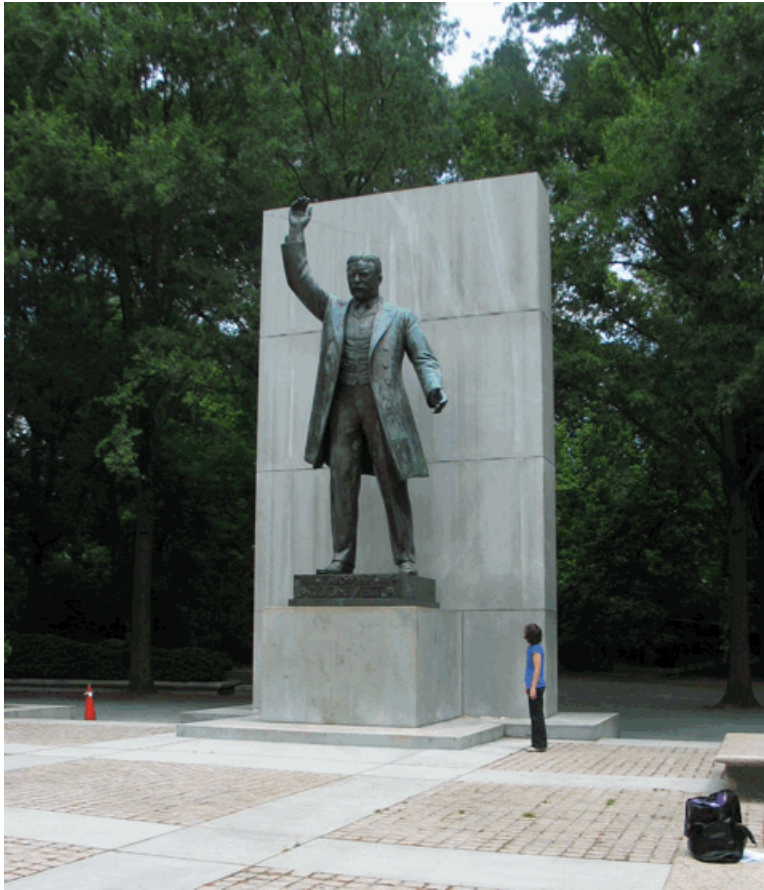
*Including the bronze base, the tip of Paul Manship's Roosevelt statue is 21' 6" off of the ground. (NCR CLP 2010).*

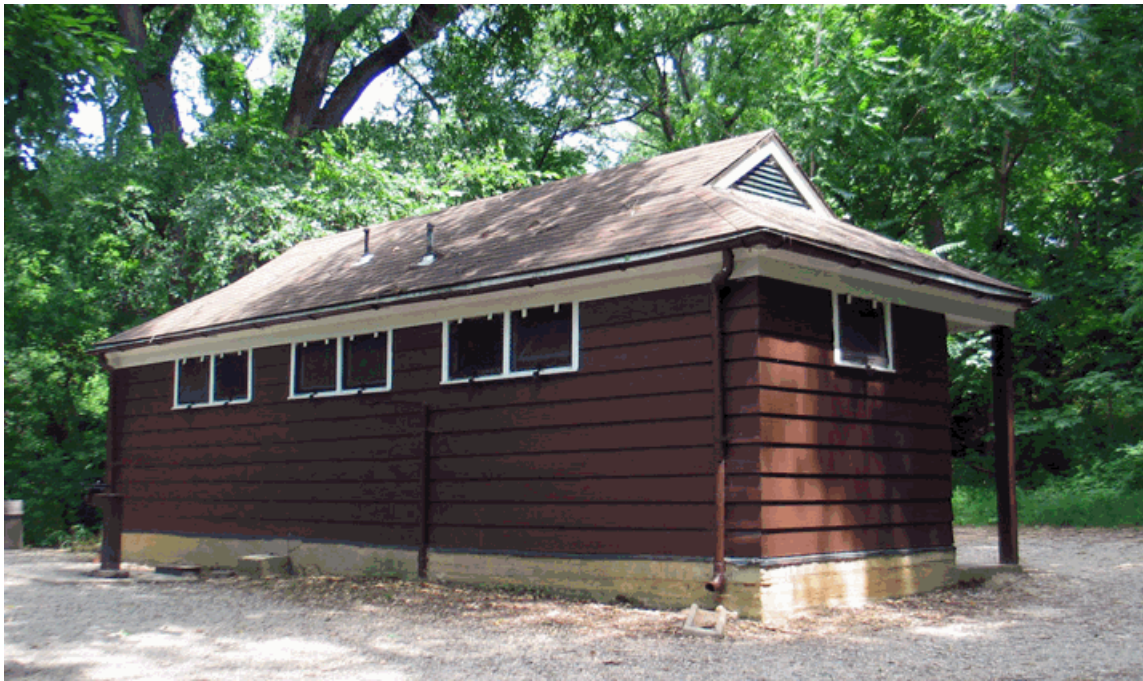
*The comfort station was built in 1955. It contributes to the integrity of buildings and structures on the site (NCR CLP 2010).*

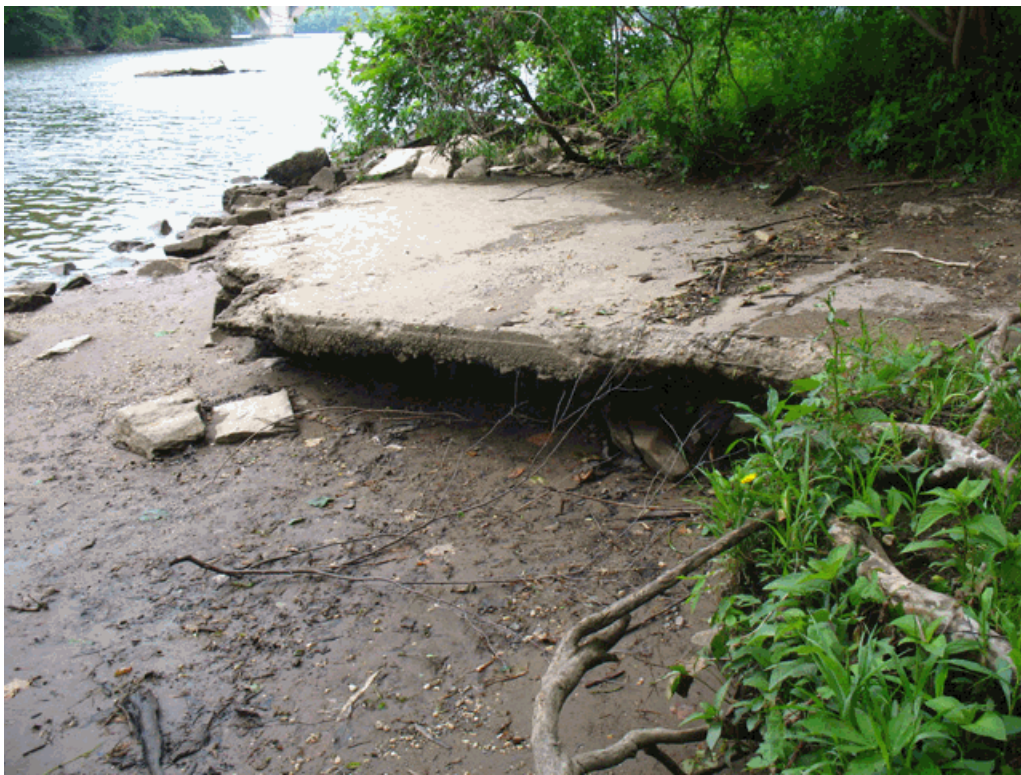
*The concrete seen here was once part of a causeway that led from the Virginia shore to the island. The materials seen here do not derive from the Mason era causeway. At least three causeways were built here over time (NCR CLP).*

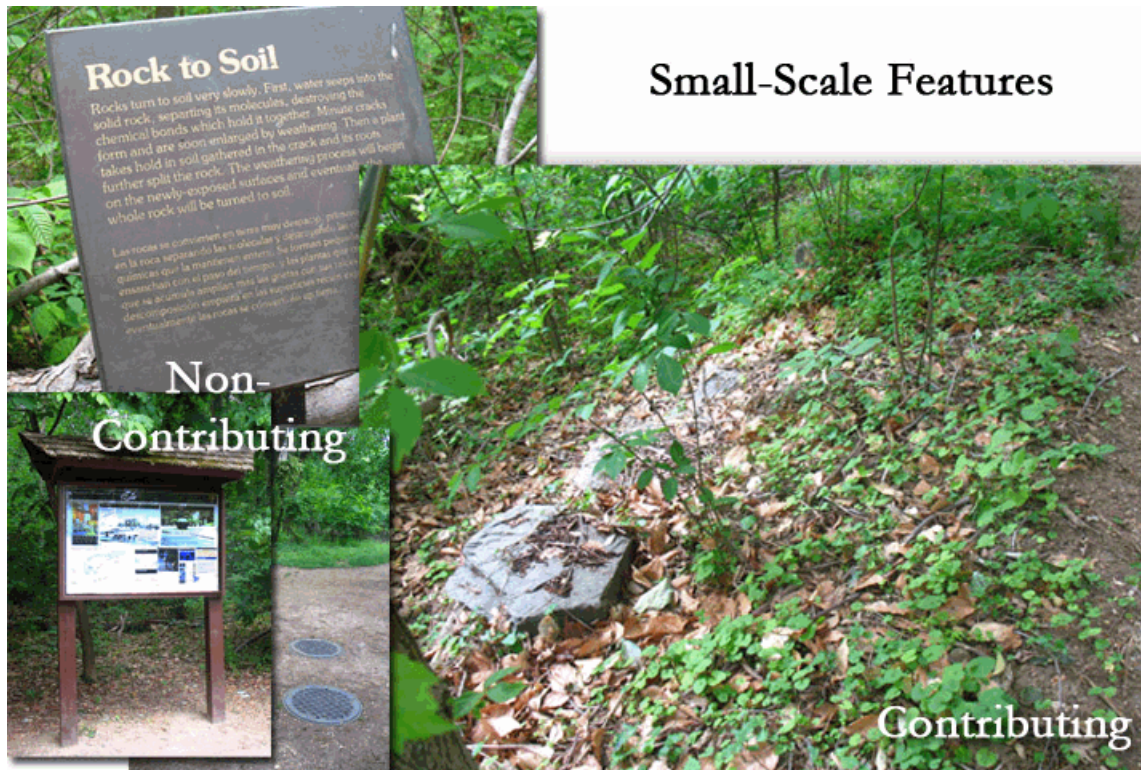
*With the exception of the sections of low rough-faced stone retaining walls, all small-scale features on site are considered non-contributing (NCR CLP 2010).*

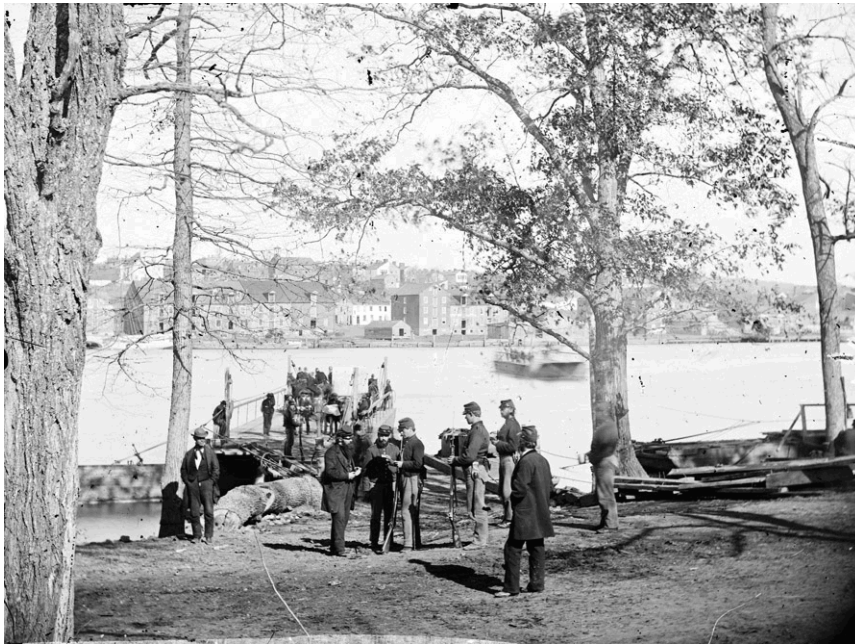
*Transportation was once a primary land use on site. This photograph is titled "Washington, D.C. Guards at Ferry Landing on Mason's Island Examining a Pass." 1862-1865 photograph by George N. Barnard (Library of Congress, Prints & Photographs Division).*

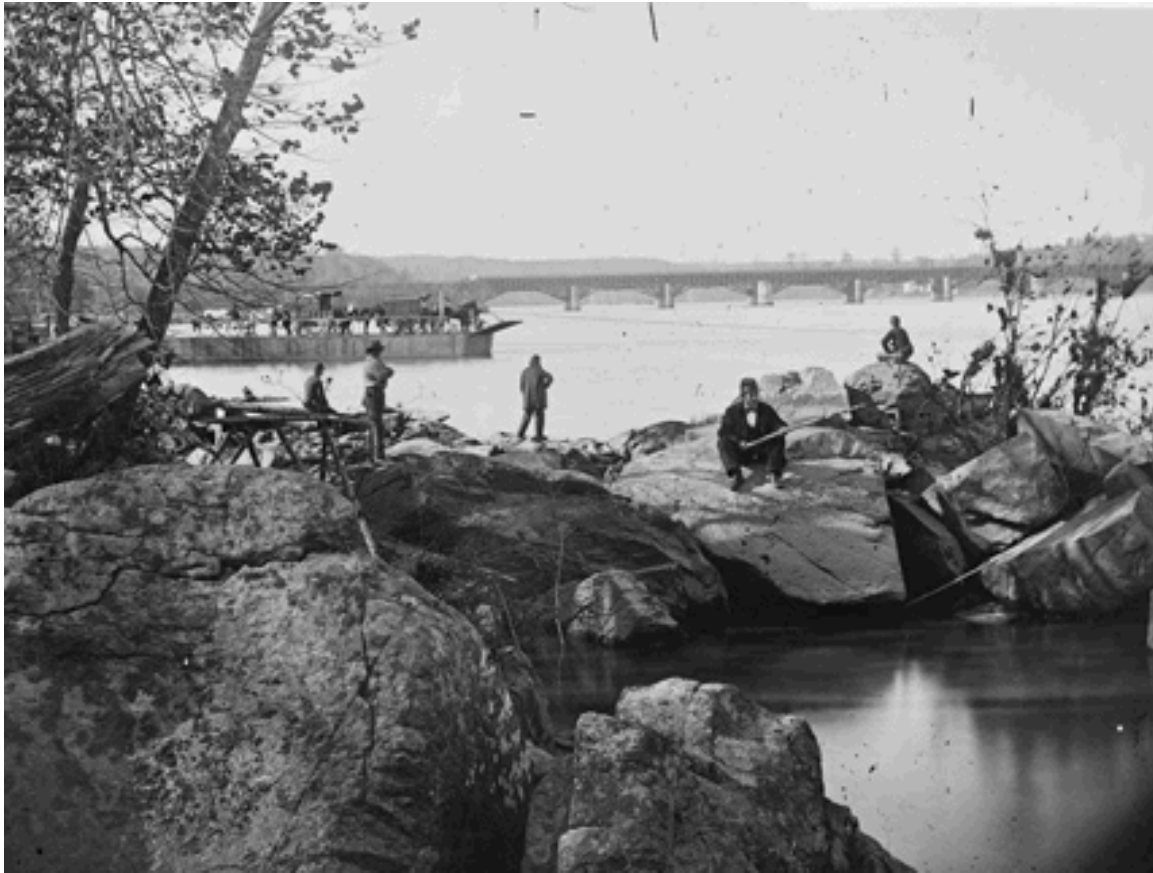
*"Washington, D.C. Georgetown Ferry-boat Carrying Wagons, and Aqueduct Bridge Beyond, from Rocks on Mason's Island," photograph c. 1862-1865 by George N. Barnard (Library of Congress, Prints & Photographs Division).*

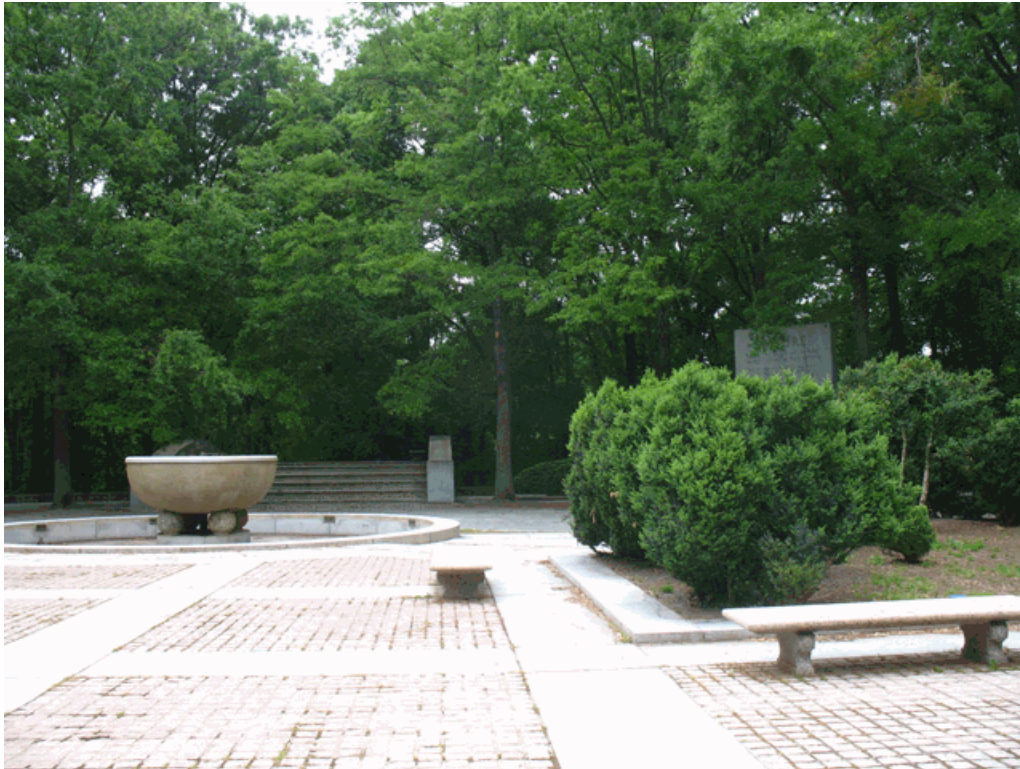
*The boxwood in the plaza is overgrown and impedes views across the plaza (NCR CLP 2010).*

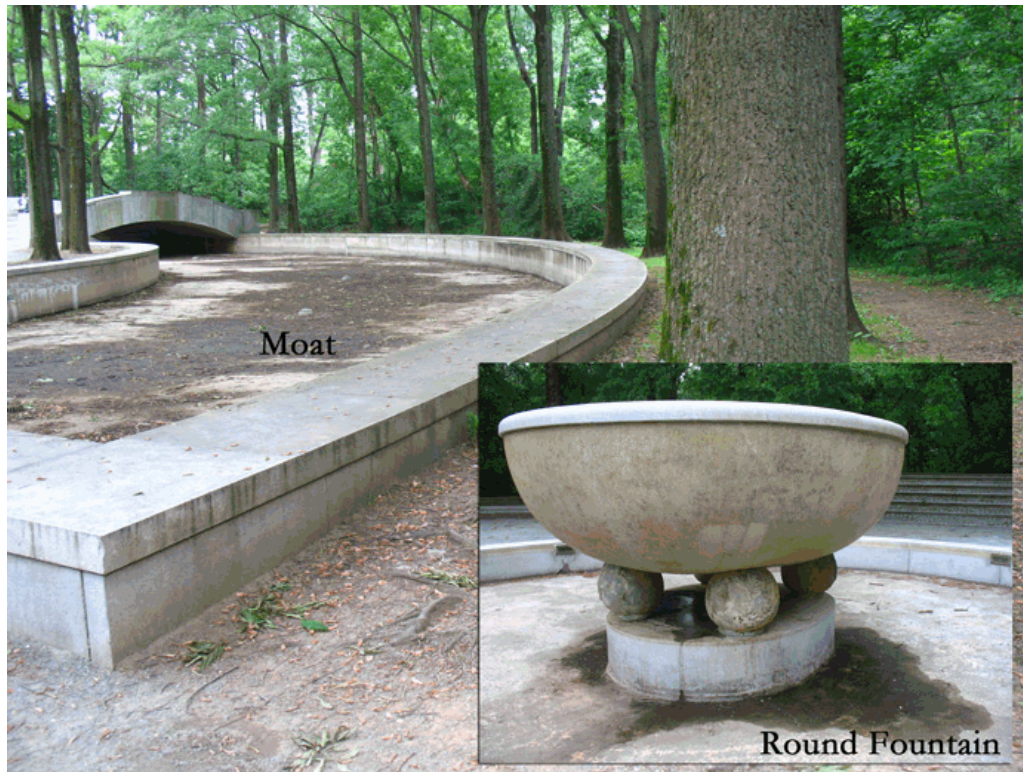
*The two contributing constructed water features on the site are the large moats and the shallow round fountains(NCR CLP 2010).*

A 2010 American Recovery and Reinvestment Act (ARRA) is planned for the site. The project focuses on repair and rebuilding of the infrastructure, bottom and sides of the moat, piping, motor and water level sensors in the fountains and some stonework repair and repointing around the memorial plaza. The result will be part of the process in upgrading the site condition from fair to good.
